Phase 2B

Stairway & Marble Panels Installation

February 25, 2013

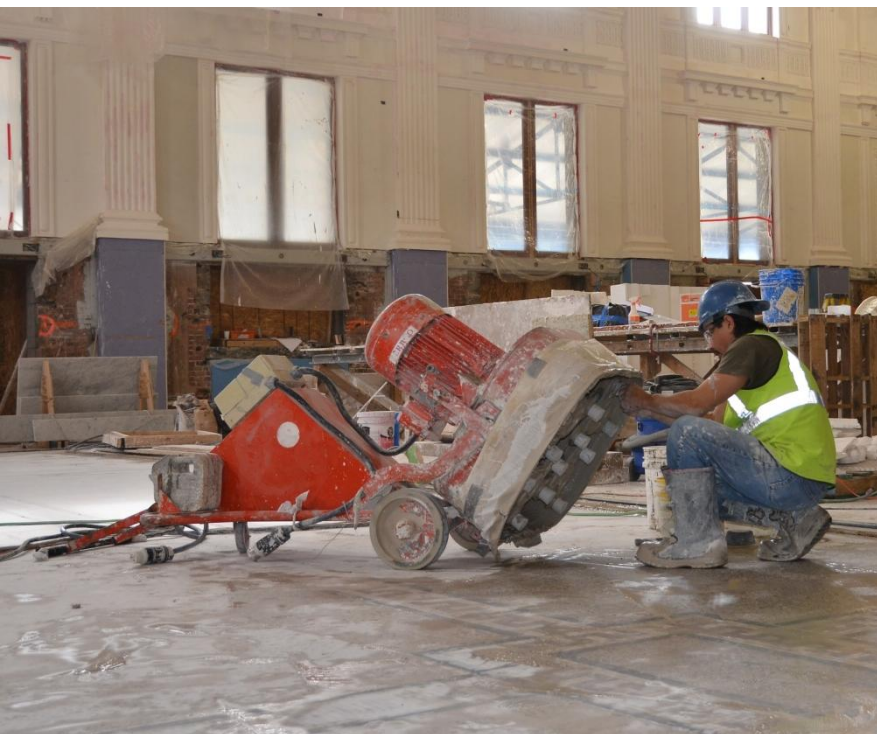
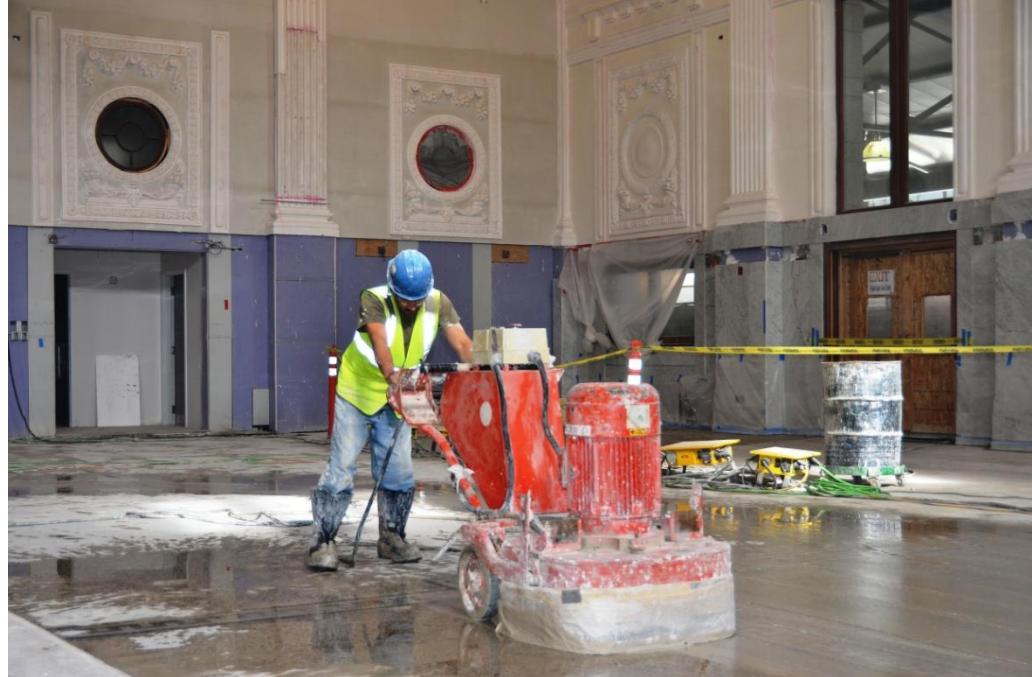
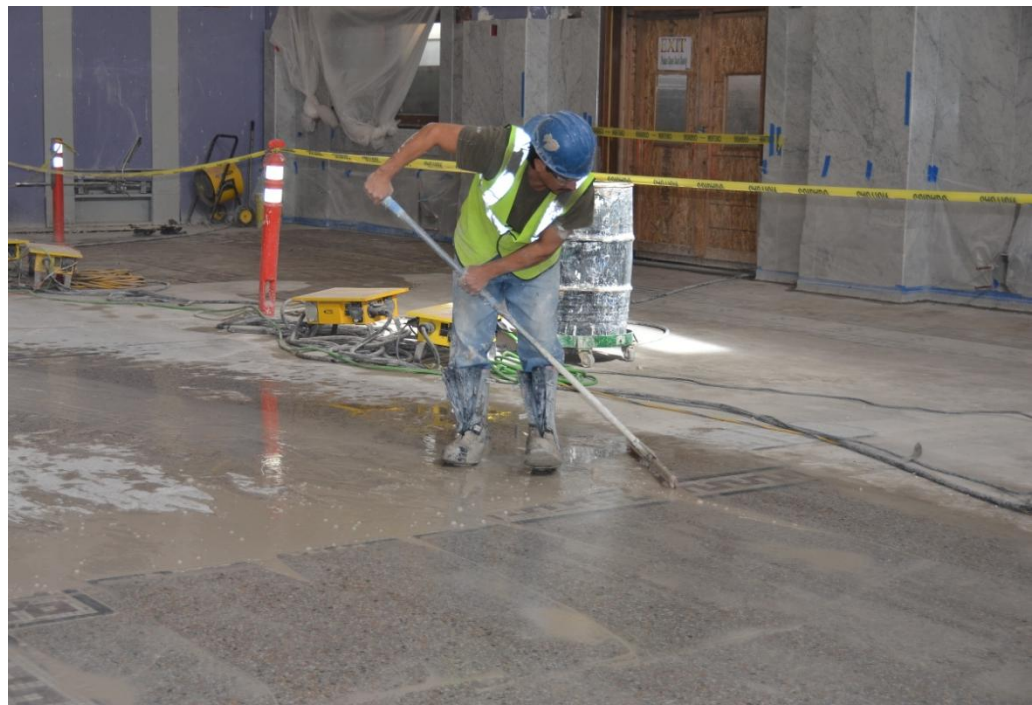
The waiting room terrazzo floor cracks and trip hazards in front of doorways will be repaired, leveled and refinished.

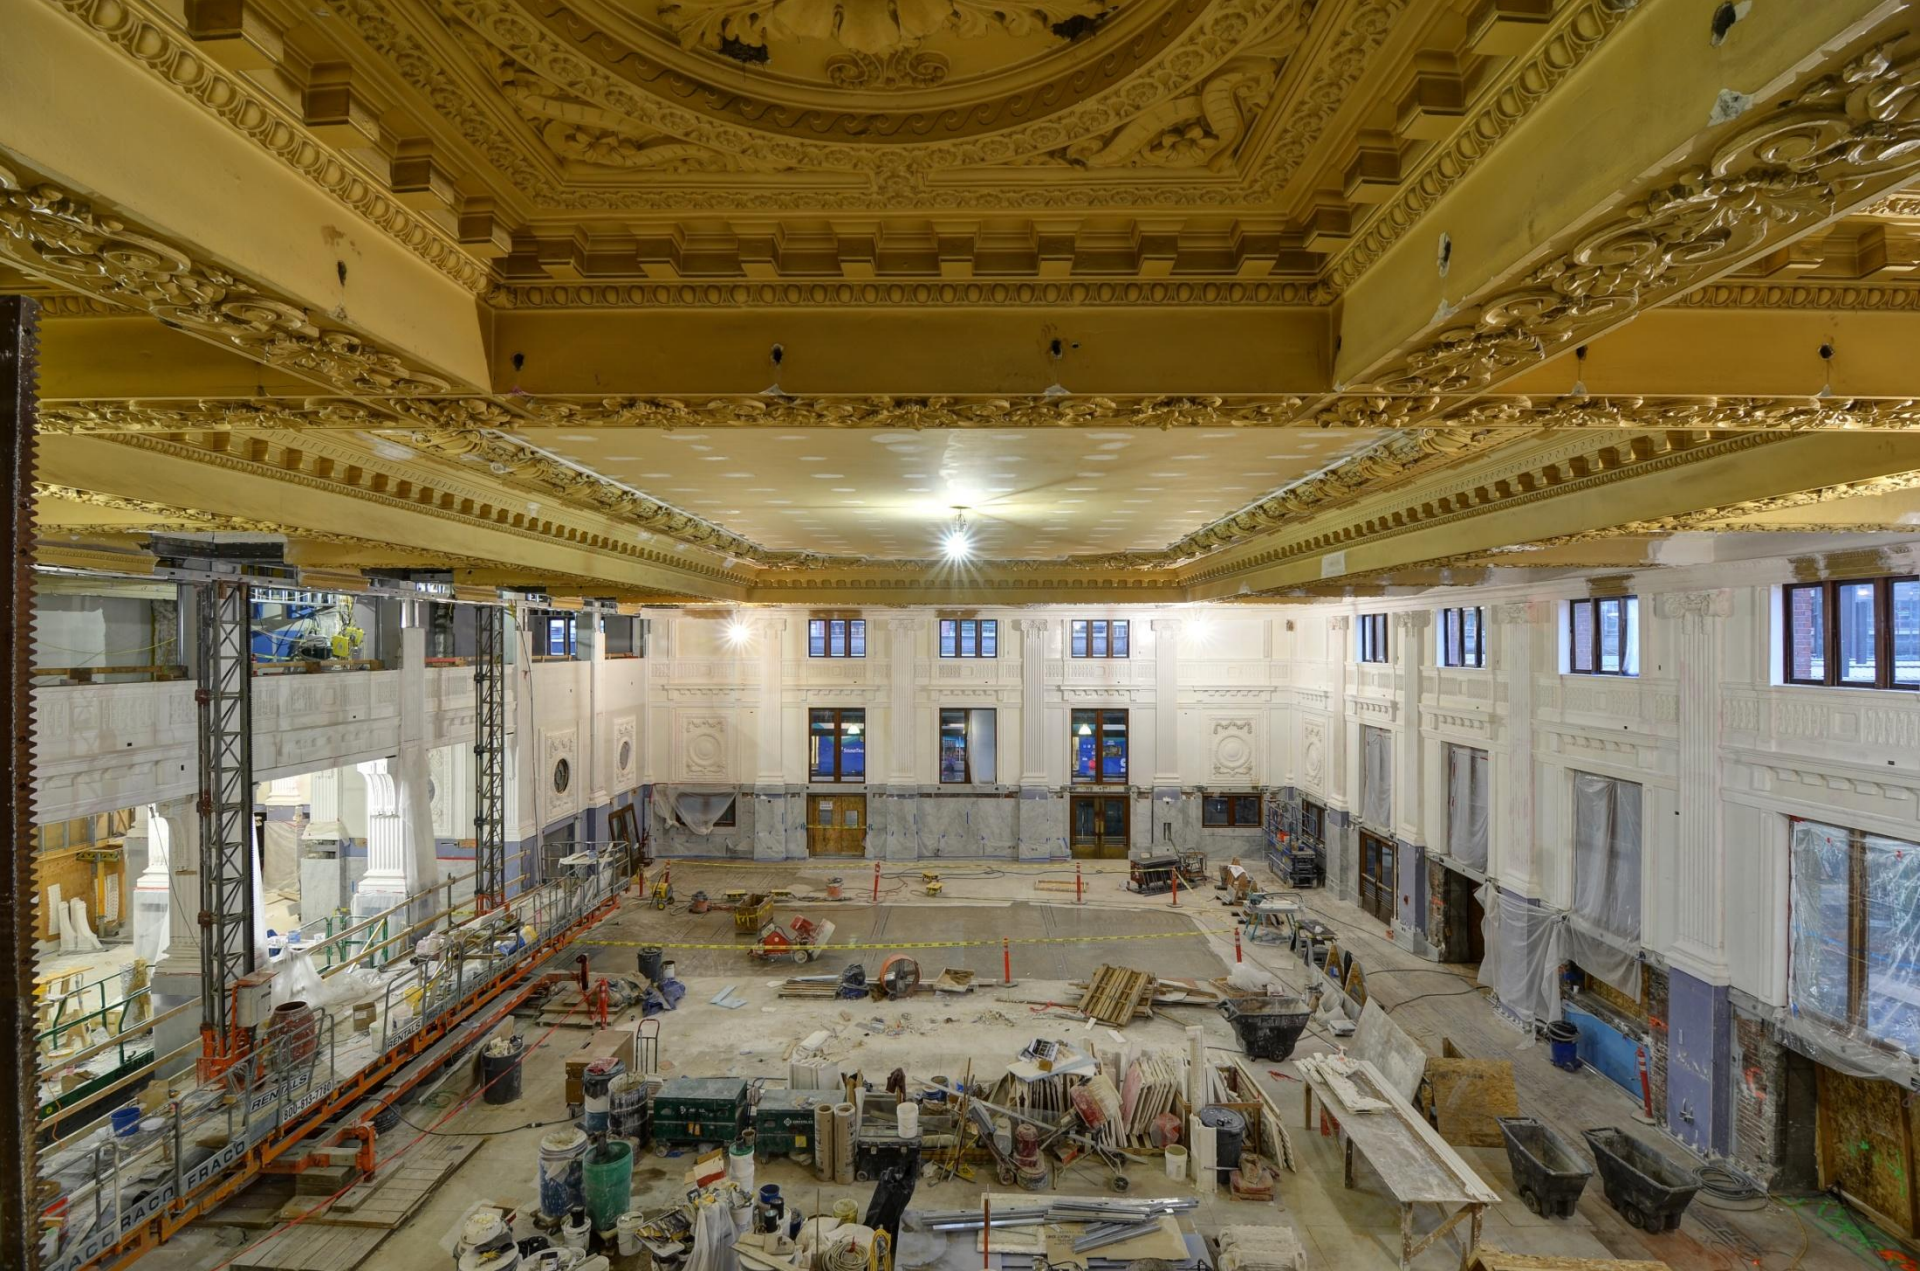
Some holes and damaged areas in the ceiling still need to be repaired. A night crew shift was added to increase productivity.

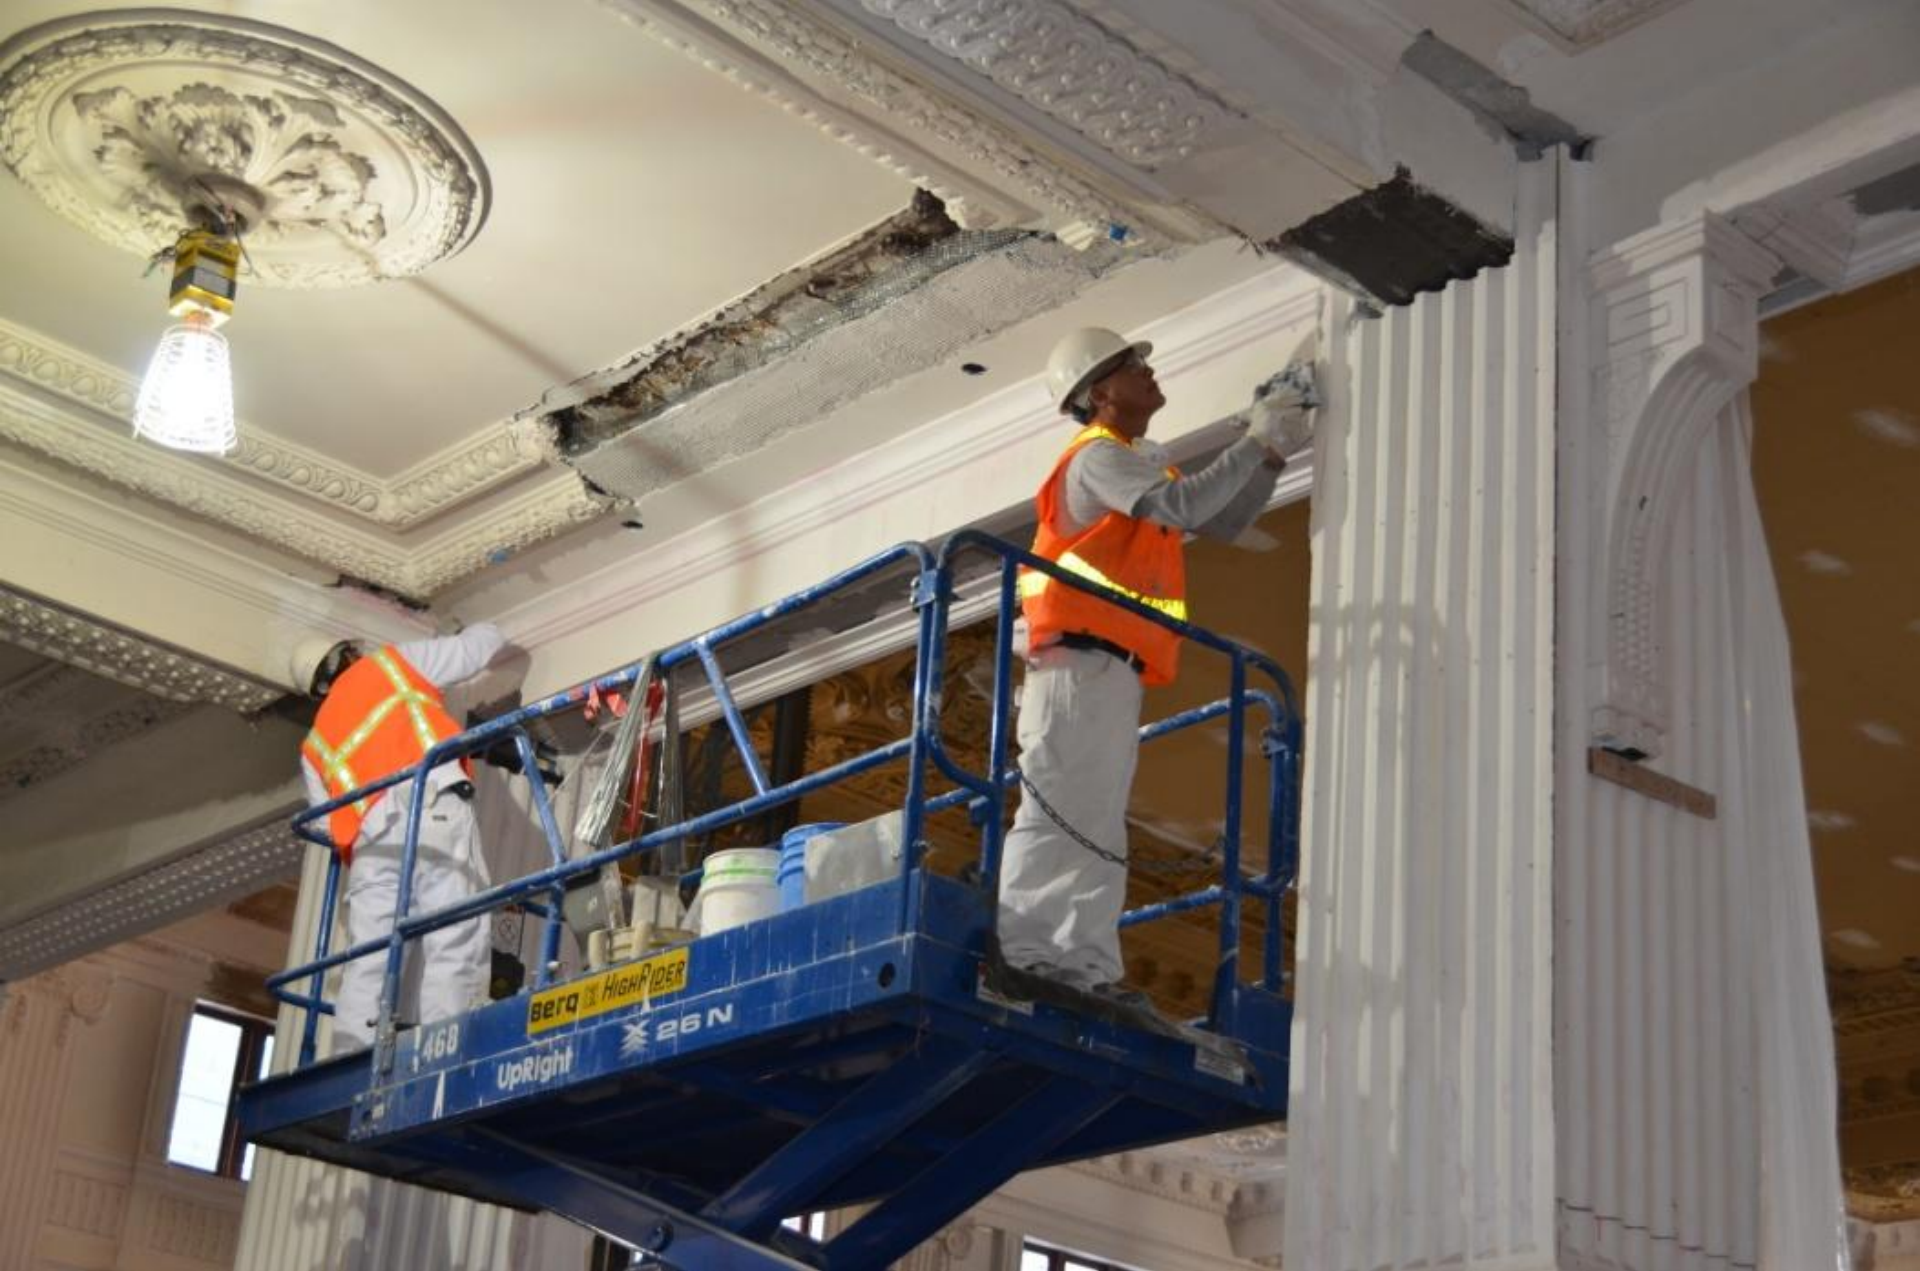
Two Evergreene craftsman repairing plaster damages on a couple columns in the pre-ticketing area.

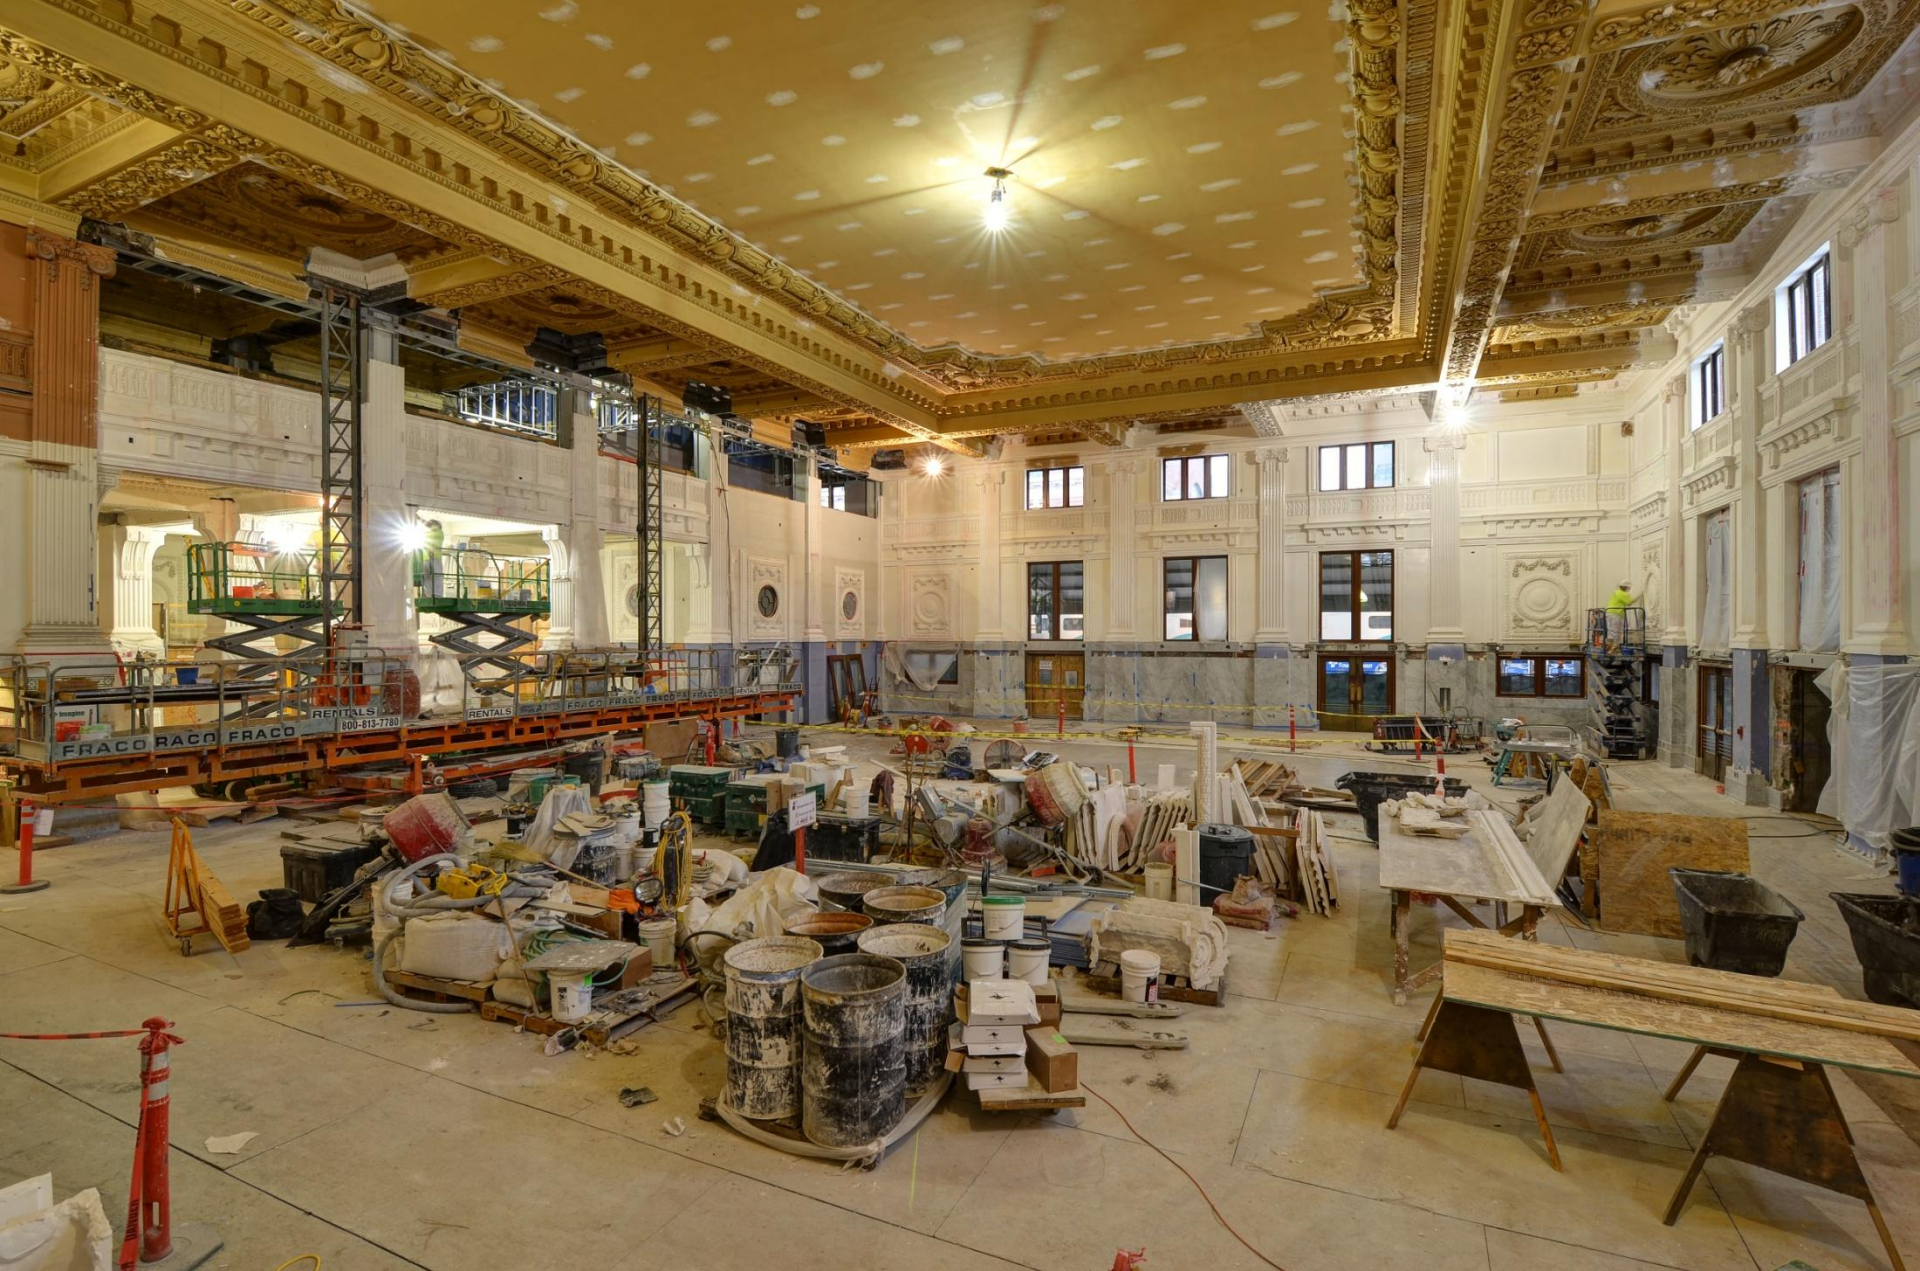
Most new ornamental plaster pieces are in place and damaged sections repaired.

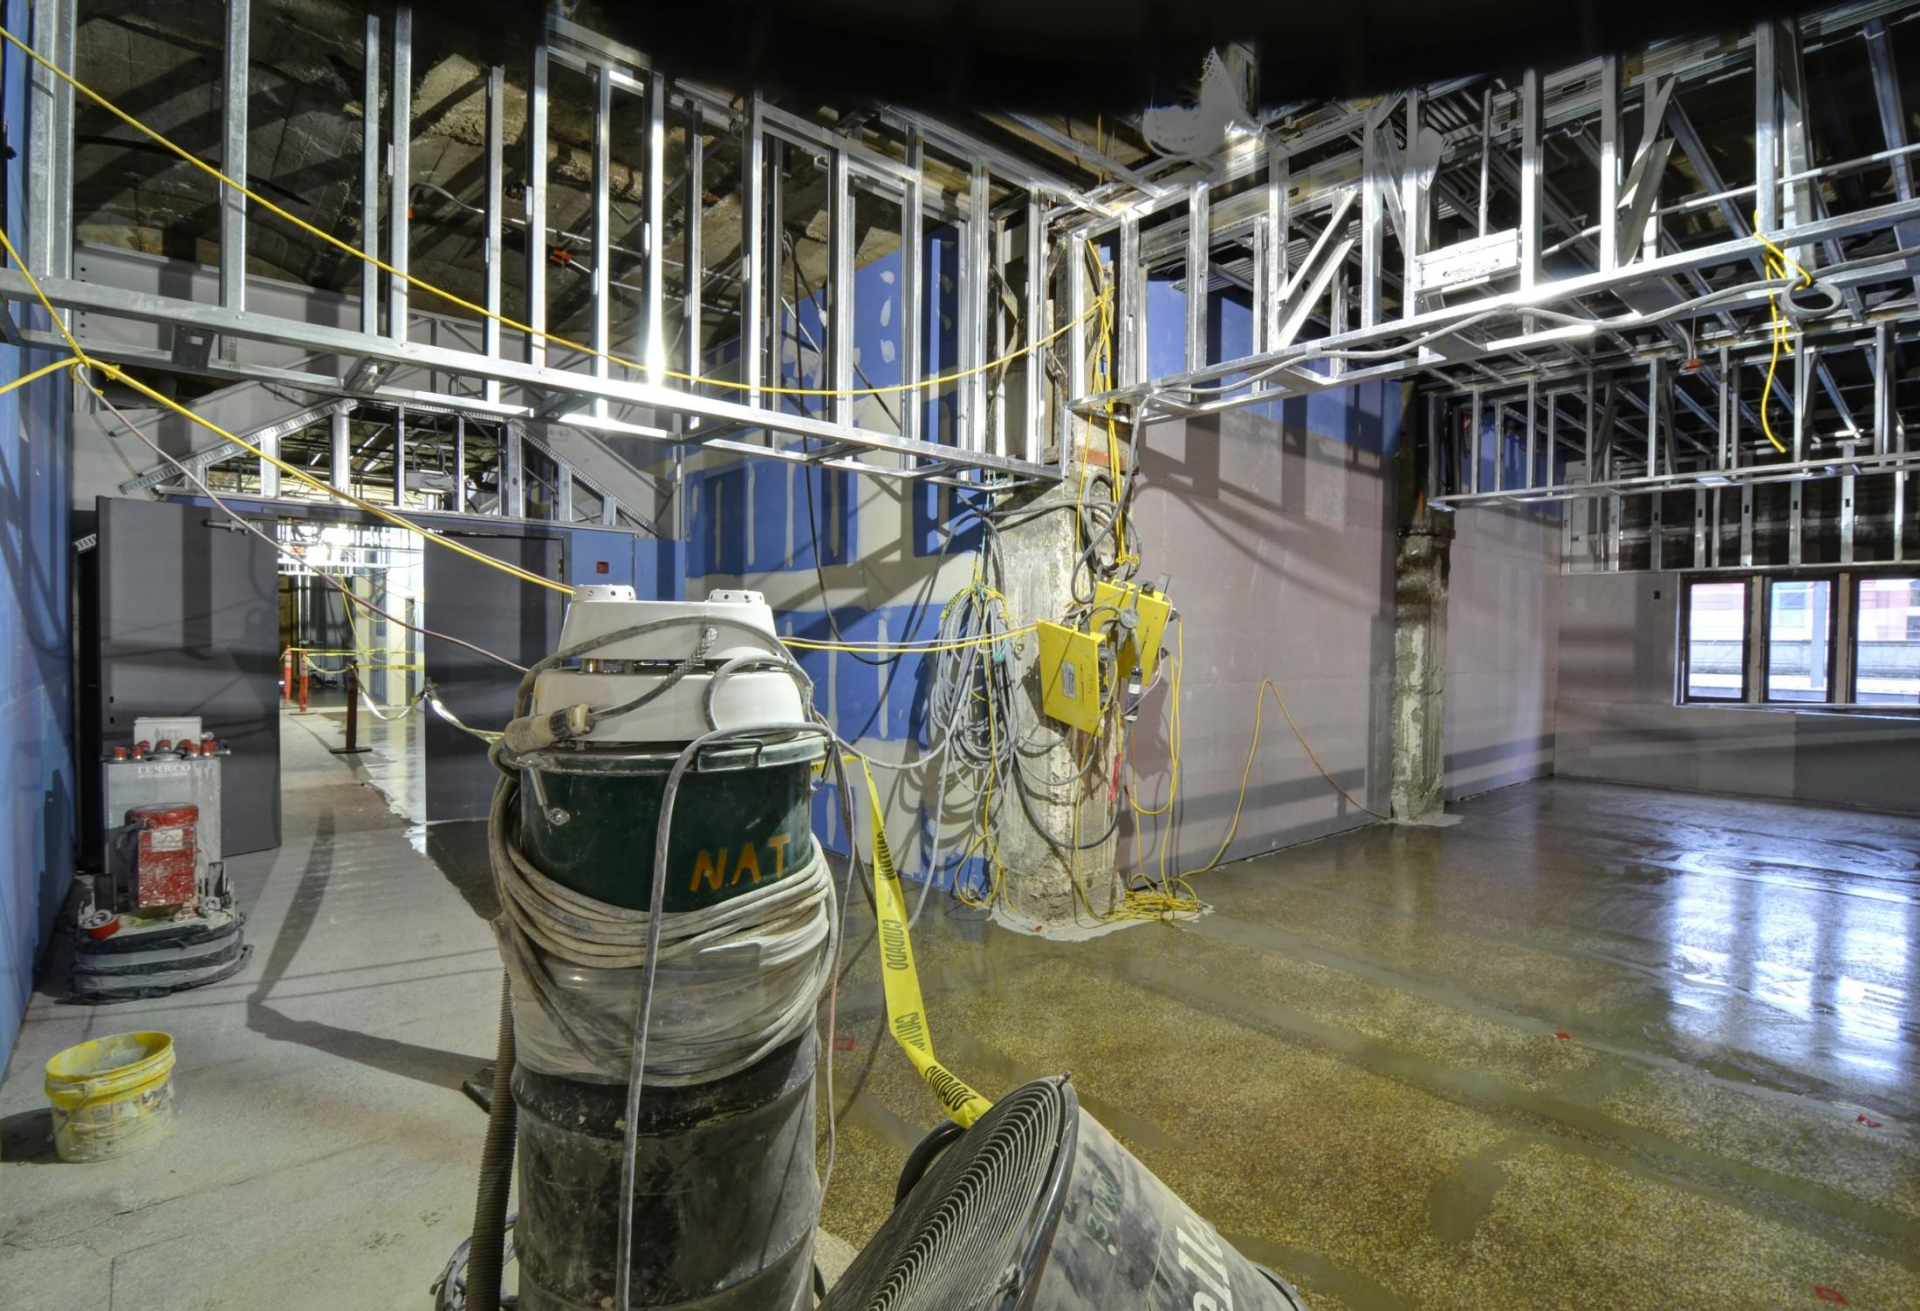
The second floor balcony terrazzo floor is being refinished to restore its original look.

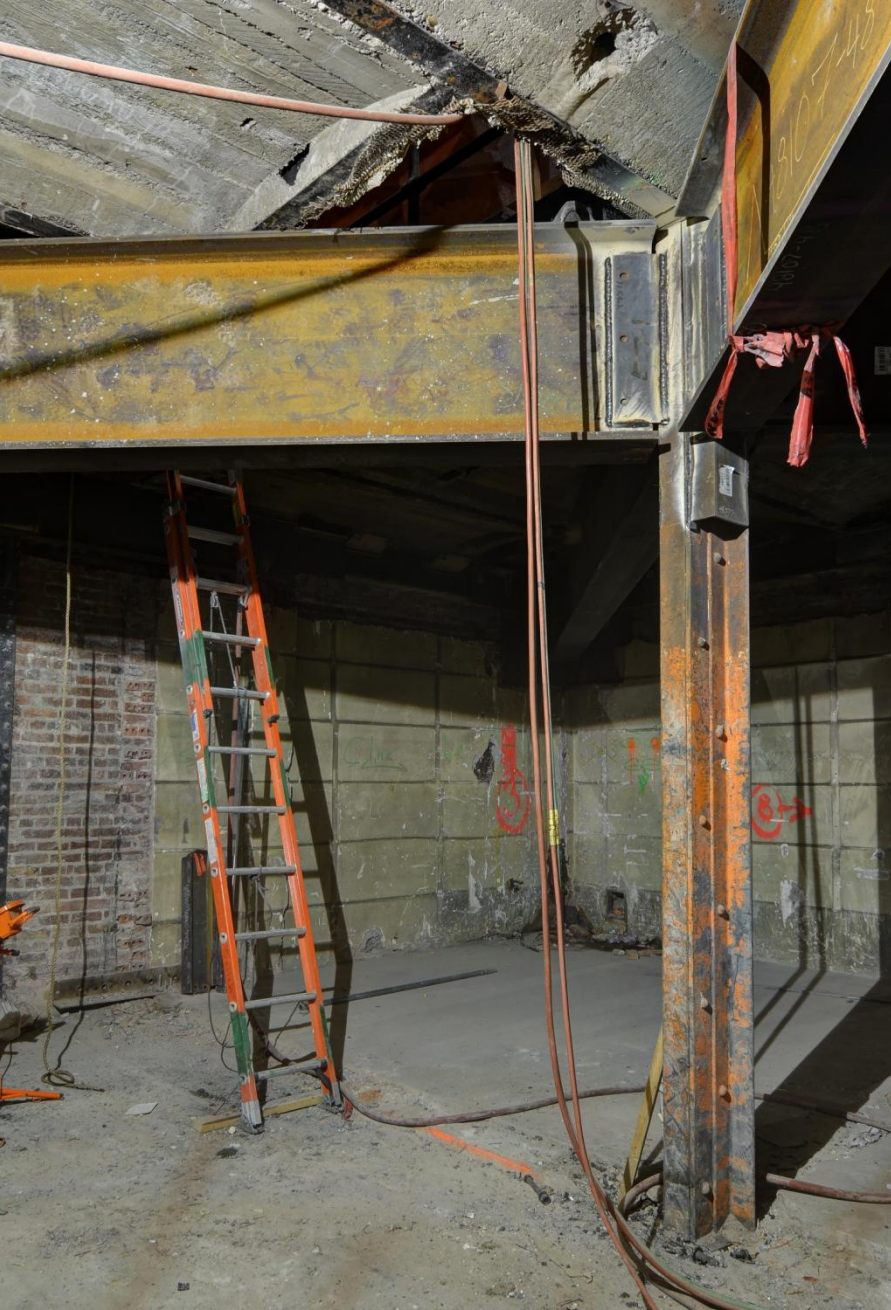
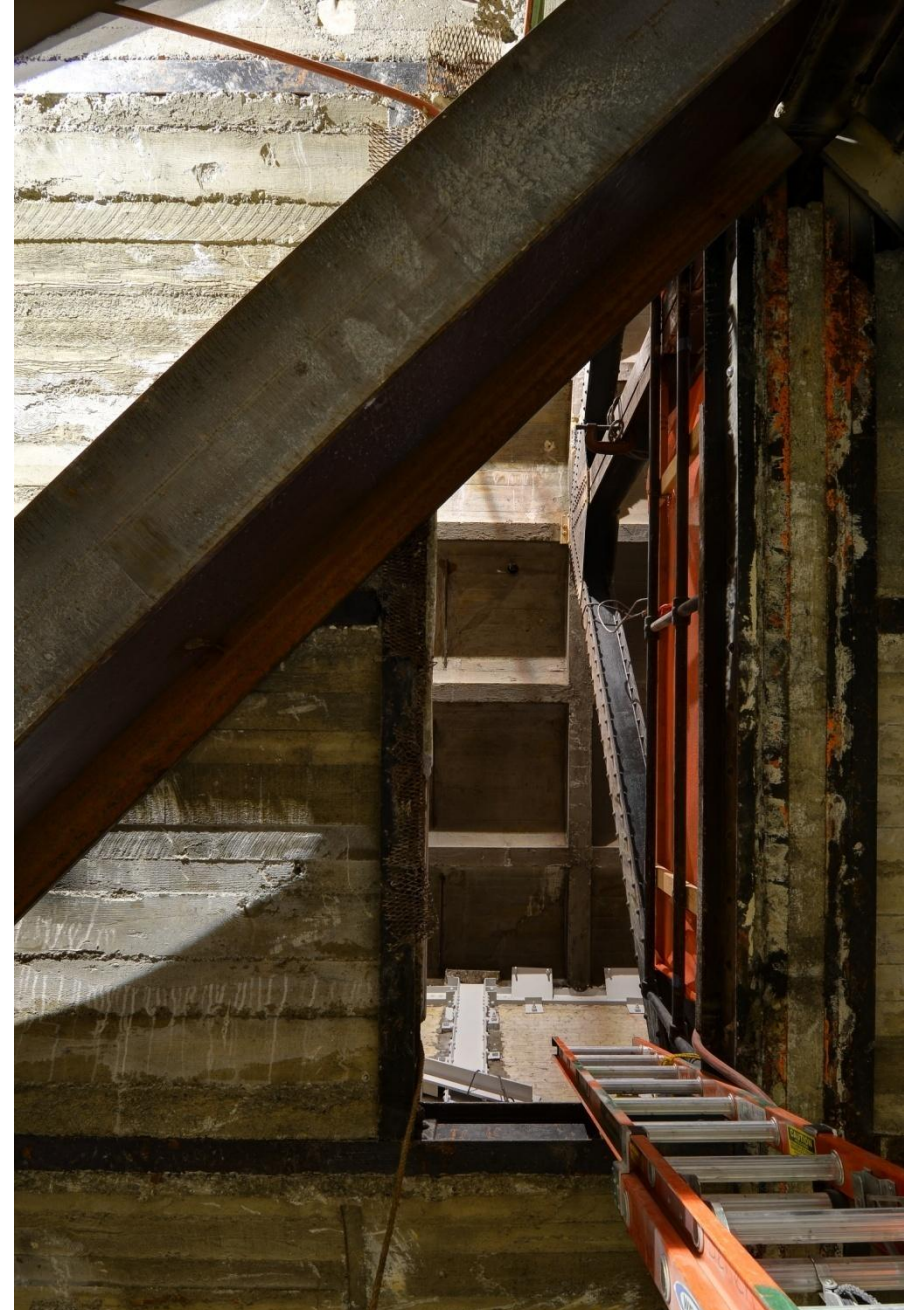
Due to conflict with the new seismic steel, the 3rd floor stairs to the clock tower was removed. A new one will be installed with a different orientation for safe access.
