Hazardous Materials Survey Report

**SDOT Mercer Expansion
Parcel 30
1000 Mercer Street
Seattle, Washington**

**Seattle Department of
Transportation
700 Fifth Avenue, Suite 3900
P.O. Box 34996
Seattle, Washington**

June 30, 2009

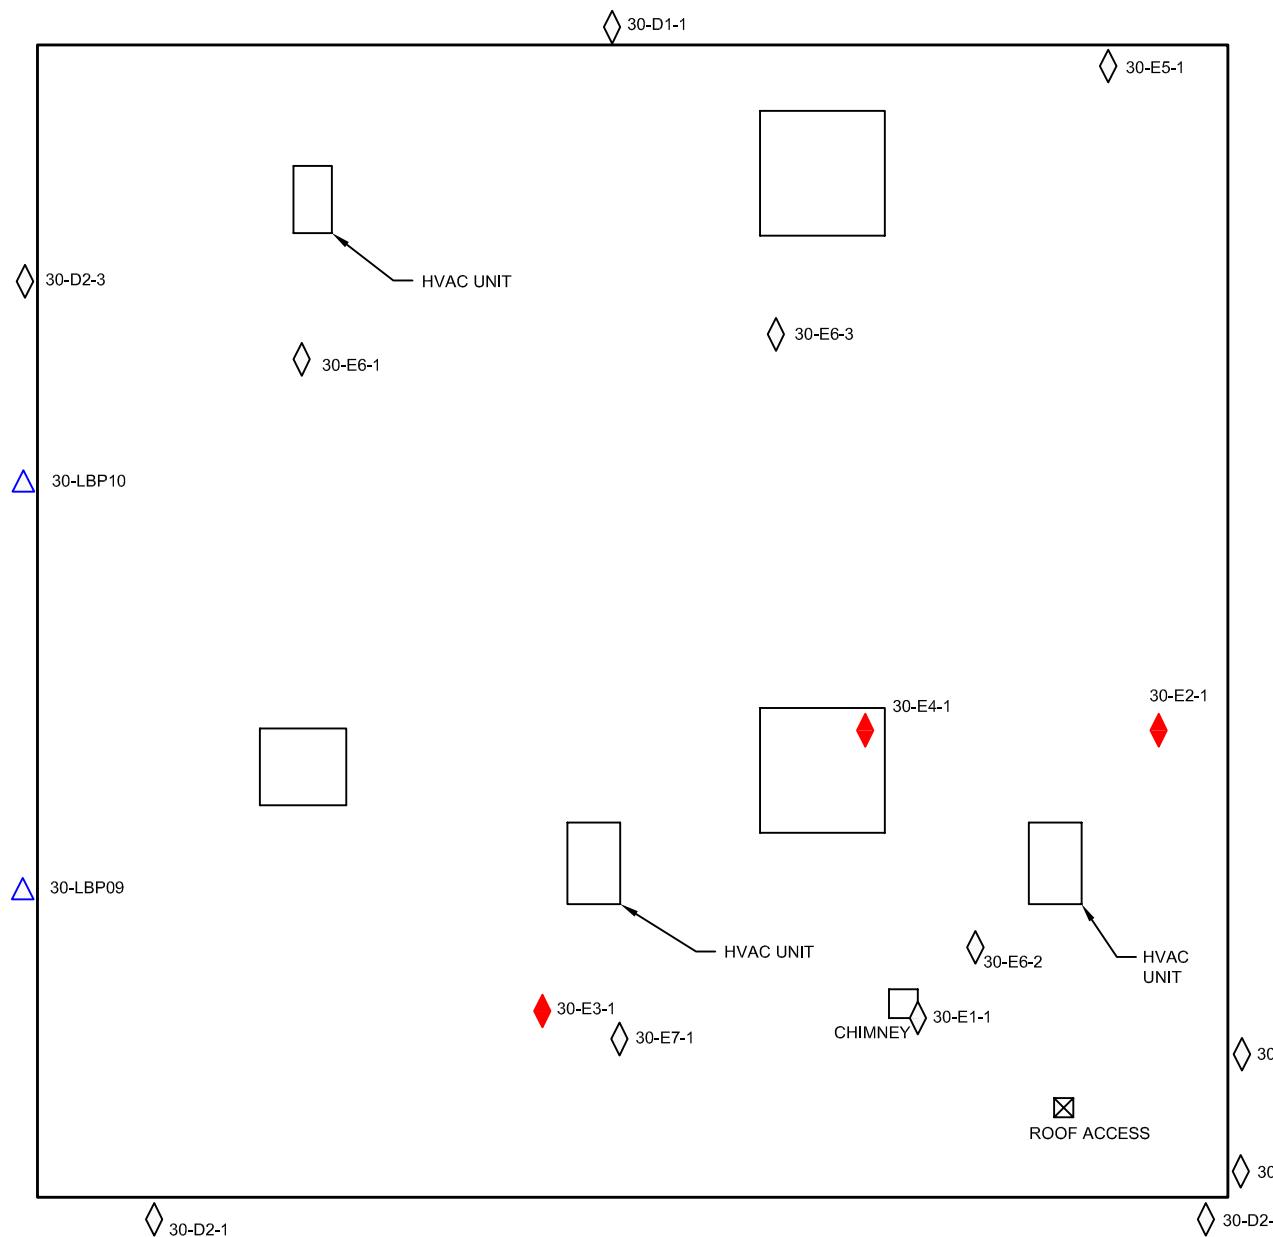
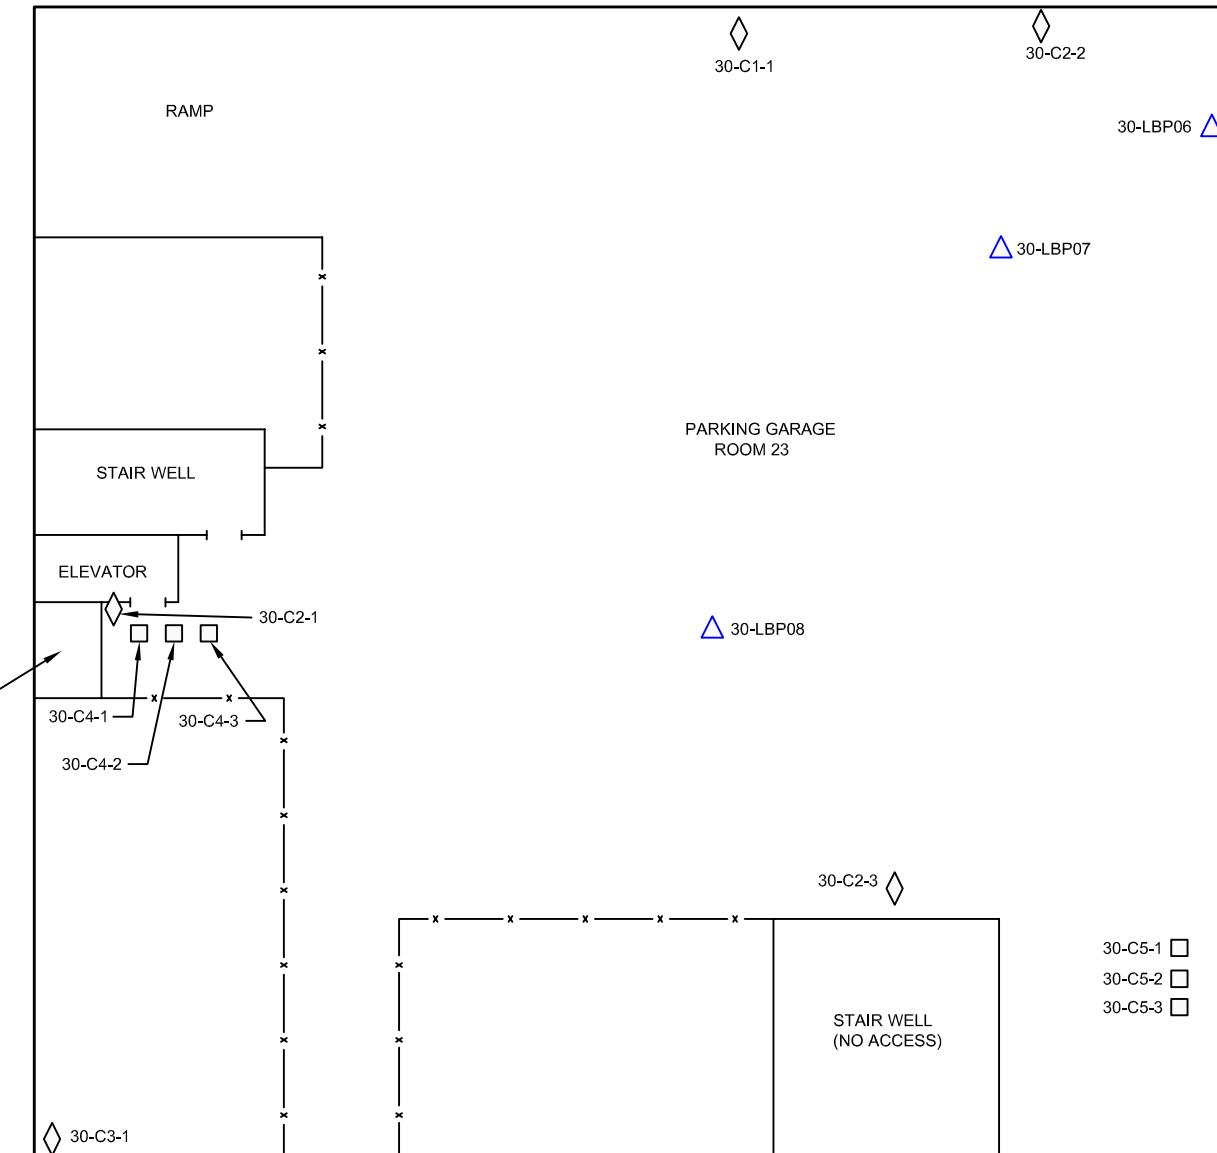
FIGURE 3
ROOF, EXTERIOR AND BASEMENT ASBESTOS
AND LEAD SAMPLE LOCATIONS

Roof

Black roofing felt associated with lead vent tubes, vent systems, and risers. Located on the roof (approximately 600 square feet).

Planning and coordination of ACM removal should begin prior to demolition or renovation activities. The ACM in areas identified in this report should be removed by properly certified, trained, and protected personnel using appropriate work practices and engineering controls prior to disturbance by renovation or demolition, as outlined in Washington Administrative Code (WAC) 296-2, I-1. Asbestos-containing material with less than 1 percent asbestos should be handled according to WAC 296-2, which outlines general work practices and air monitoring requirements when building materials containing less than 1 percent asbestos are impacted by renovation or demolition.
