**NELSON GEOTECHNICAL
ASSOCIATES, INC.**
GEOTECHNICAL ENGINEERS & GEOLOGISTS

Geotechnical Engineering Evaluation
Harbor Avenue SW Site
27XX Harbor Avenue SW
Seattle, Washington
NGA File No. 986517

This report presents the results of our geotechnical engineering evaluation of the Harbor Avenue SW Site project located at 27XX Harbor Avenue SW in Seattle, Washington, as shown on the Vicinity Map in Figure 1. The current parcel number on file for the property is 6911200225. The purpose of this study is to explore and characterize the surface and subsurface conditions within the site and to provide general opinions and recommendations for potential future site development.

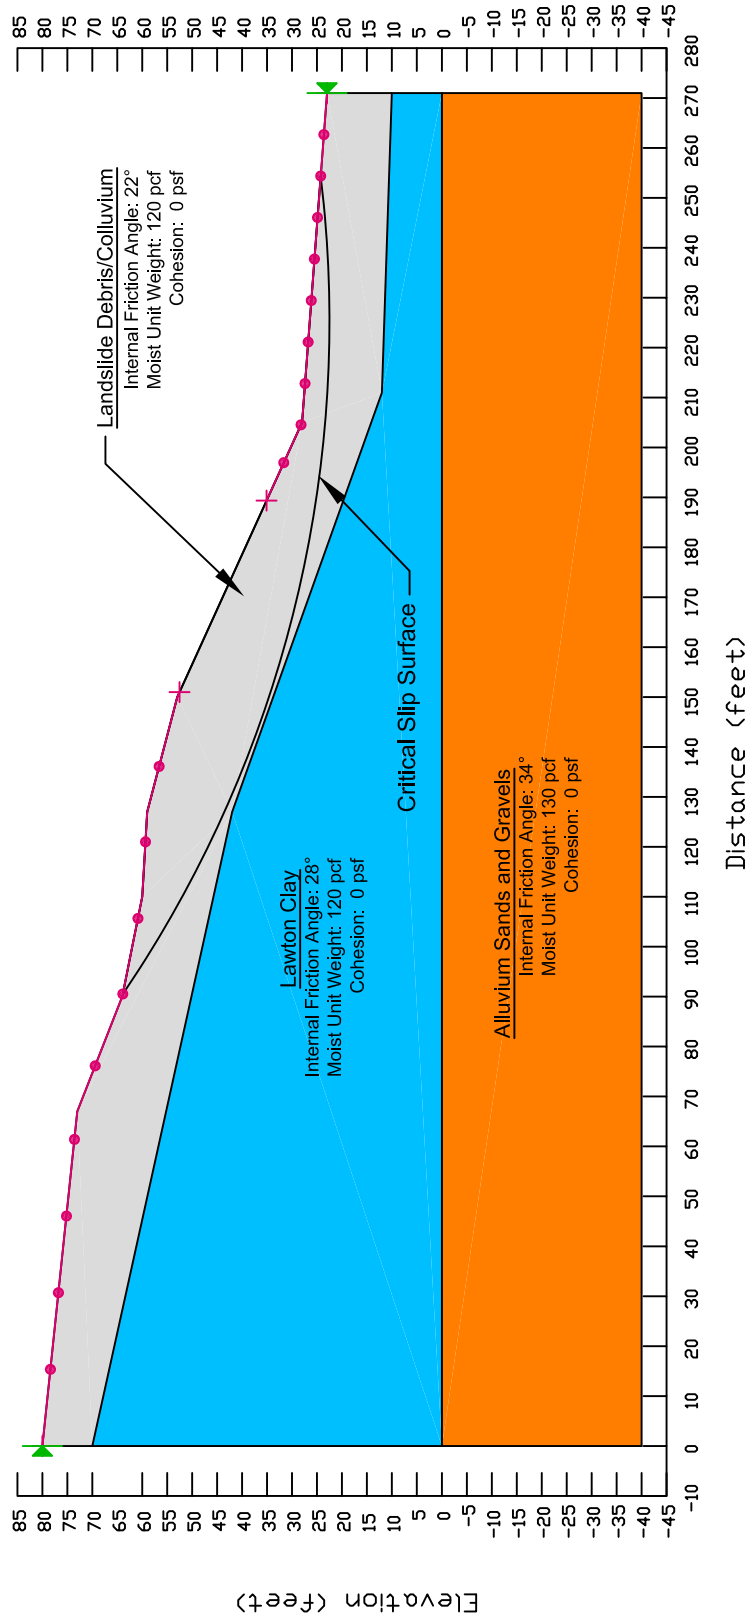
Our slope stability analyses indicated the site is moderately stable with regards to shallow to intermediate landsliding events originating within the upper moderate to steep slope and extending down to the proposed development area under static conditions with a critical slip surface resulting in a factor of safety of 1.4. However, the critical slip surface for the anticipated seismic condition results in a factor of safety of 0.8 indicating a slope failure extending from the upper moderate to steep slope through the lower bench area. We also modeled the placement of an approximately 15-foot tall soldier pile shoring wall resisting approximate uniform surcharge loads of 1,600 PSF to protect the lower development area from such shallow to intermediate landslide events and support the lower portion of the steep slope area. The critical slip surfaces for this case achieved factors of safety greater than or equal to 1.5 and 1.2 for the static and seismic cases, respectively indicating relatively stable conditions.

Morgenstern-Price most critical surface with minimum FOS = 1.4

1.4

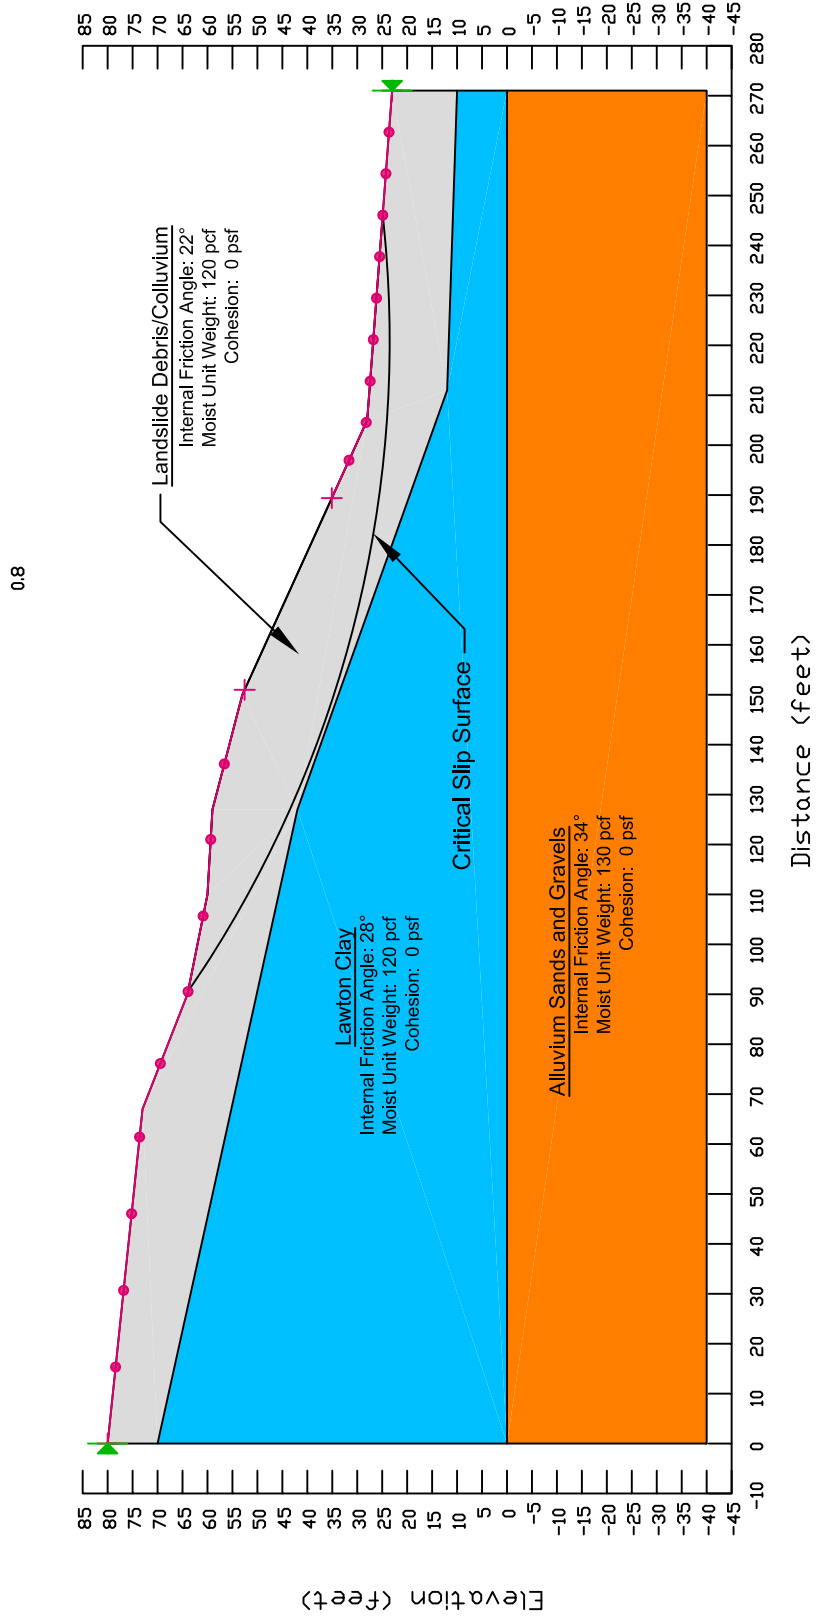
Slope Stability Analysis- Cross Section A-A' Existing Seismic Conditions

Morgenstern-Price most critical surface with minimum FOS = 0.8
with a seismic coefficient of ground acceleration = 0.20g

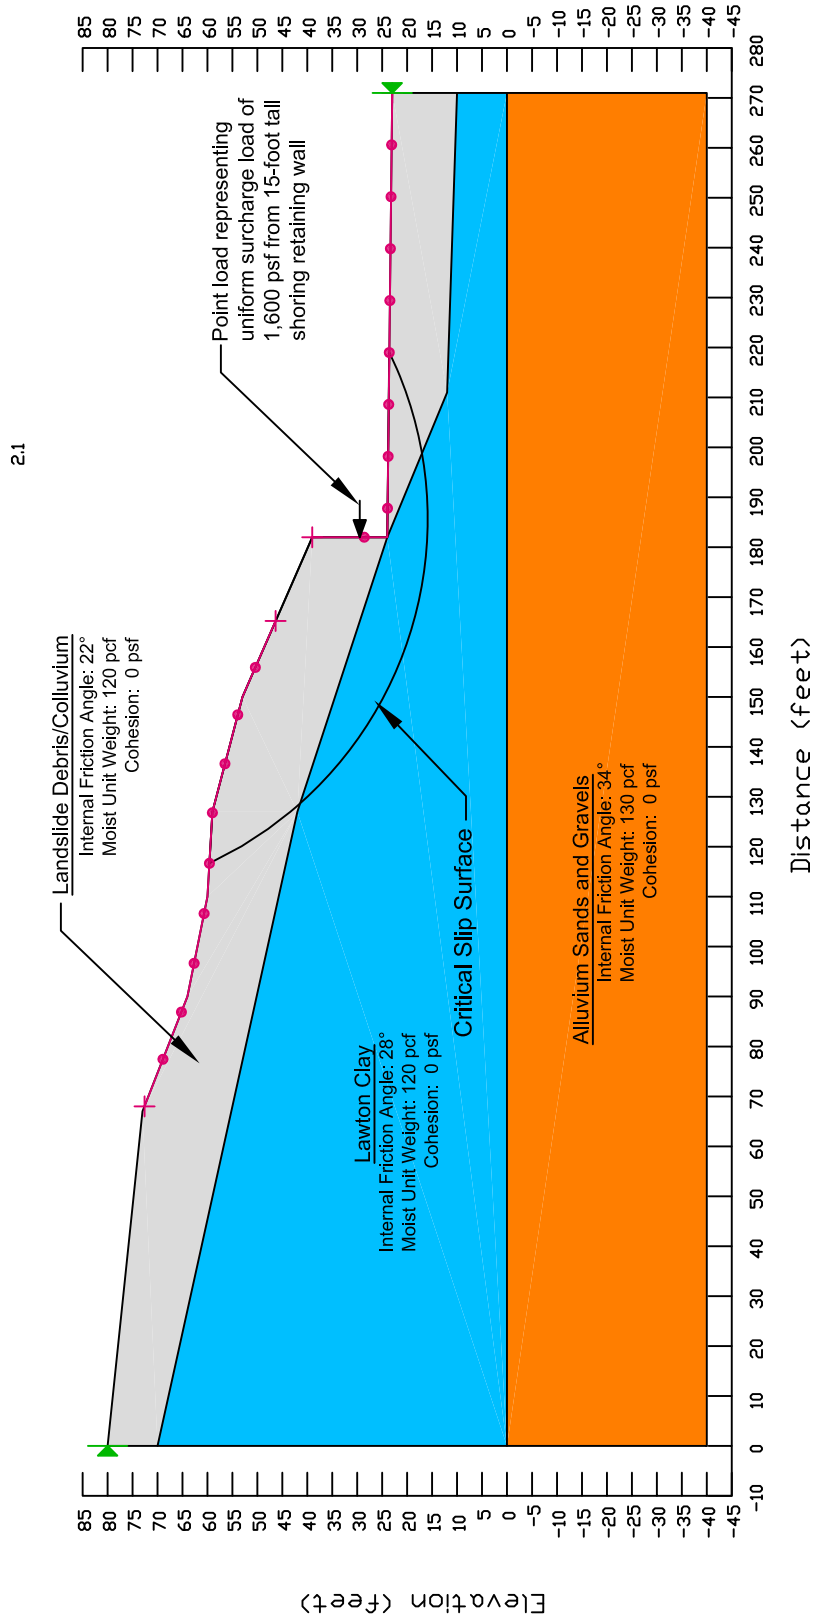
Slope Stability Analysis- Cross Section A-A' Proposed Static Conditions

Morgenstern-Price most critical surface with minimum FOS =2.1

We recommend that the shoring wall be designed using a uniform earth pressure of 1,600 psf for the exposed height of the retaining wall to support the toe of the steep slope against shallow to intermediate landsliding above the wall.

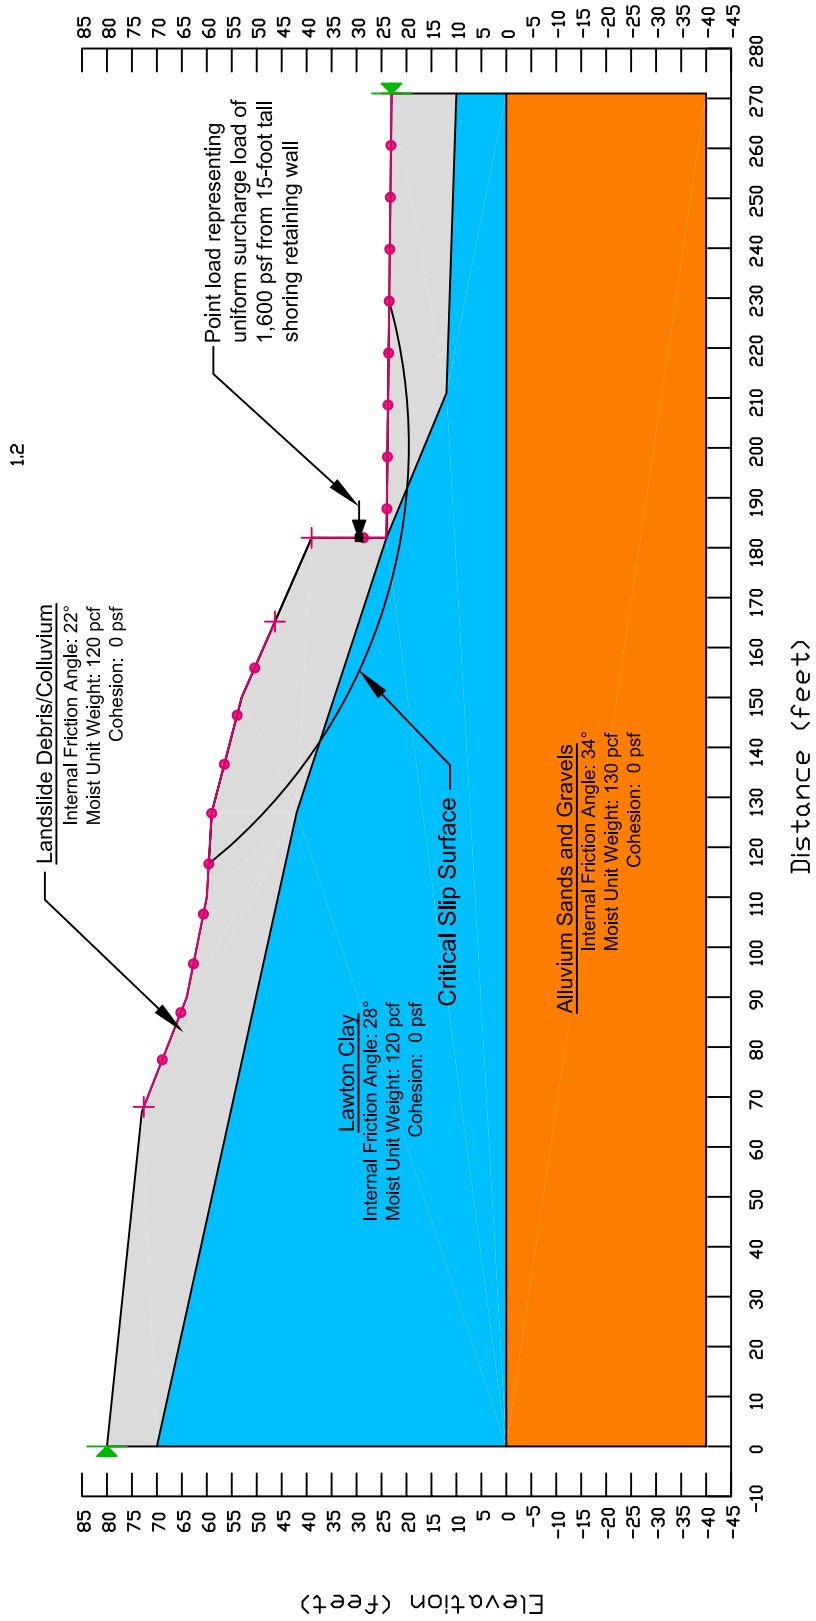
Slope Stability Analysis- Cross Section A-A' Proposed Seismic Conditions

Morgenstern-Price most critical surface with minimum FOS = 1.2
with a seismic coefficient of ground acceleration = 0.20g
