HAZARDOUS MATERIALS SURVEY REPORT

Interim Fire Station 9 Property
3500 Interlake Avenue North
Seattle, Washington

October 7, 2013

Project No.: 0987-005

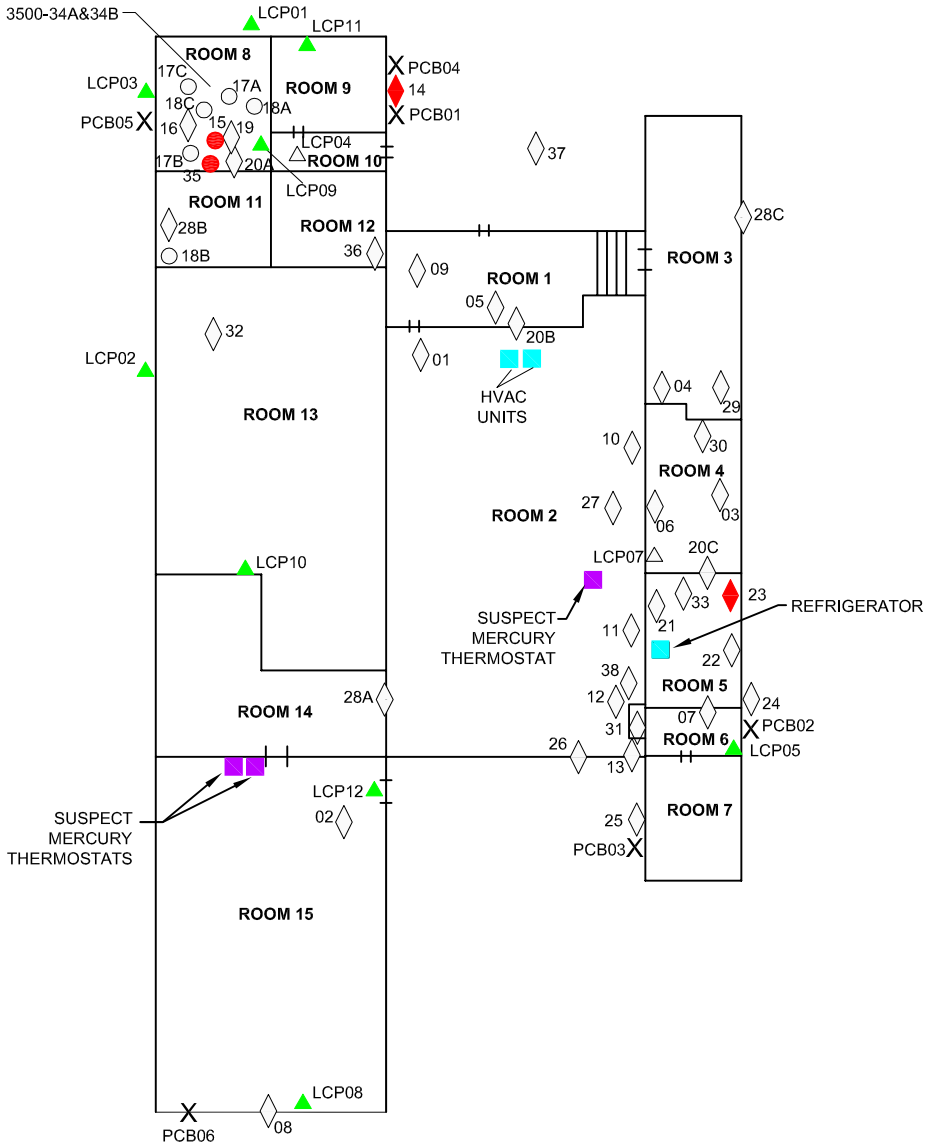
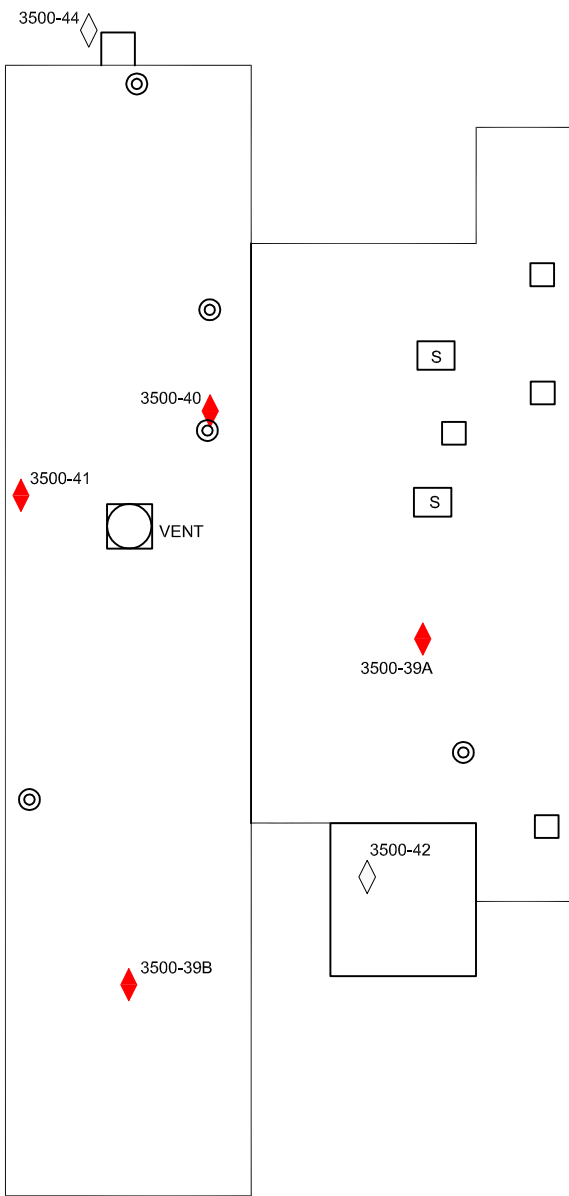
FIGURE 2
ASBESTOS, LEAD, AND PCB
SAMPLE LOCATIONS

SoundEarth collected a total of 54 samples of suspect ACM from the interior and exterior of the Property. Sample locations are presented on Figure 2, and an inventory of the samples is provided in Table 1. Laboratory analytical reports are provided in Appendix B. Building materials identified as asbestos-containing include the following:

- Approximately 250 linear feet of white window putty (sample 3500_14) located in Rooms 9, 13, 14, and 15.
- Approximately 36 square feet of white fibrous insulation (sample 3500_15) located on the lower portion of the furnace in Room 8.
- Approximately 5 square feet of sink undercoating (sample 3500_23) underneath the sink on the northeastern corner of Room 5.
- Approximately 10 linear feet of boiler rope gasket (sample 3500_35) on the southern portion of Room 8.

- Approximately 3,000 square feet of built-up roofing material with silver paint (samples 3500_39B and 41) on the western portion of the roof of Building 1.
- Approximately five square feet of penetration mastic with silver paint (sample 3500_40) at five leaded vent tubes on the roof of Building 1.
- Approximately 2,250 square feet of silver paint (sample 3500_39A) on the eastern portion of the roof of Building 1.

Twelve paint chip samples were collected from representative interior and exterior painted surfaces on Building 1. An inventory of the samples is provided in Table 2; sample locations are presented on Figure 2. Laboratory analytical reports are provided in Appendix B. The following samples were identified as lead-containing: LCP01, LCP02, LCP03, LCP05, and LCP08 through LCP12.

SoundEarth identified one lead door on the Property during the survey. The door measured approximately 21 square feet and was located at the entrance to Room 8. Five leaded vent tubes were identified on the roof of Building 1. The vent tubes and door were not sampled, and the presence of lead is assumed based on the inspector's observations.

SoundEarth collected six samples of suspect PCB putty and paint. Sample locations are presented on Figure 2, and an inventory of the samples is provided in Table 3. The laboratory analytical report is provided in Appendix B.

Two HVAC units located on the floor of Room 2 (Figure 2) were observed during the hazardous material survey. Refrigerant labeling was not observed on the HVAC units. A refrigerator was observed in Room 5.

Planning and coordination of ACM removal should begin prior to demolition activities. The ACM identified in this report should be removed by certified, trained, and protected personnel using appropriate work practices and engineering controls prior to disturbance by renovation or demolition, as outlined in WAC 296-2, I-1.

A representative sample of the demolition waste associated with samples LCP01, LCP02, LCP03, LCP05, and LCP08 through LCP12, each of which contained elevated concentrations of lead, should be collected and analyzed using a toxicity characteristic leaching procedure (TCLP) to characterize the waste for disposal. Demolition waste streams with leachable lead concentrations exceeding 5.0 milligrams per liter when analyzed for lead by the TCLP test are considered hazardous and require special handling according to federal and state regulations, including 40 CFR 247.

Any identified lead-painted surfaces or leaded material (e.g., lead vent pipes/exhaust stacks on the roof) slated for impact by future demolition activities should be removed, handled, and disposed of or recycled in accordance with WAC 296-155, which applies to construction work with materials containing lead.
