**1005 SOUTH KING STREET,
SEATTLE NAILS SUPPLY**

Historic Property Report
1001-1005 South King Street
Seattle, WA 98104

October 2018

Prepared by
d/Arch LLC.
2412 Westlake Avenue North
Seattle, WA 98109
206.547.1761, Matt Driscoll, AIA
mattd@darchllc.com

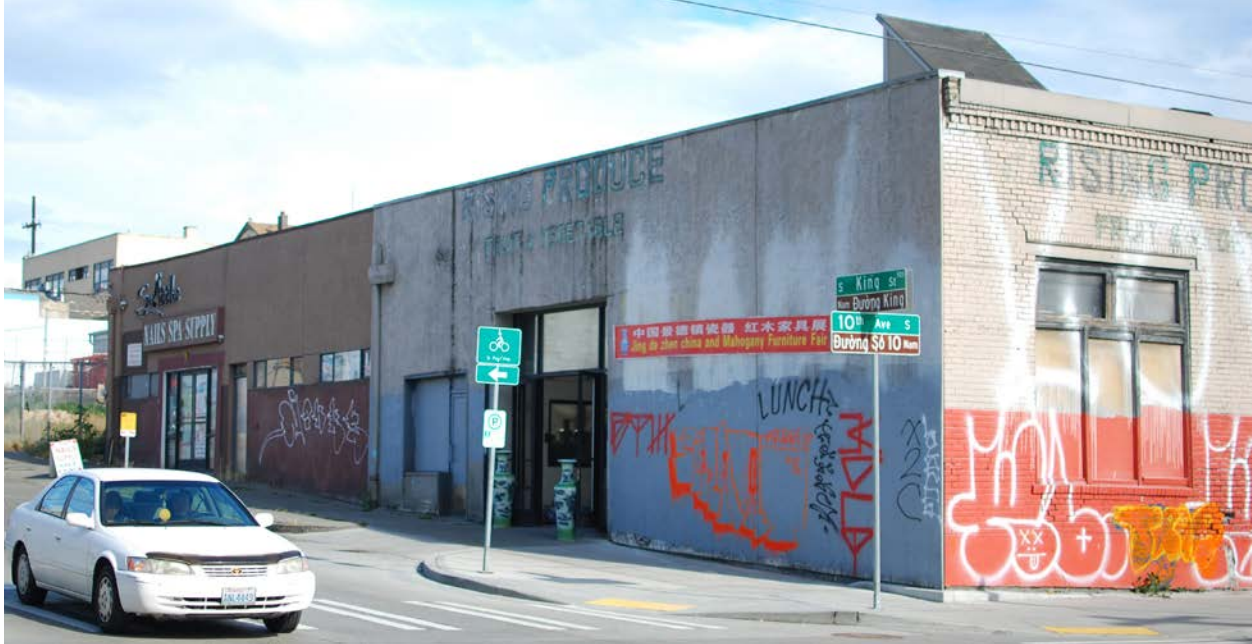
The front facade is in poor condition and is in need of maintenance. The facade has been painted over several times with colors that do not match the colors of the plastered finish and is unevenly painted across the base of the building and around seven feet up the wall. The unused smaller storefront has been painted over and does not appear to have been maintained. The lettering from the signage of the previous owners is still visible and the material has been damaged by water. The facade has also been vandalized by graffiti that has not been painted over as of writing this report. The glass on the main front entry storefront has been broken out in multiple places and has, as of the writing of this report,

FIGURE 3.3b: 1001 S. King Street (Oct. 2018)

The masonry that finishes the wall has fallen into disrepair due to lack of maintenance and vandalism. There is multiple large cracks in the wall as missing bricks and broken bricks in many places in the wall. The wall has been painted gray but the paint has been work off in several places. The lower half of the facade has been painted a bright orange that does not continue to any of the other facades or the building and is not painted to a consistent level on the facade. The facade has also been covered with various graffiti that has not been covered as well as the old lettering from the previous owners near the corner of the building. The wood that is present on the facade as part of the assembly on the service entrance is also in very bad condition. See *Appendix A.1 for exterior condition photos.*

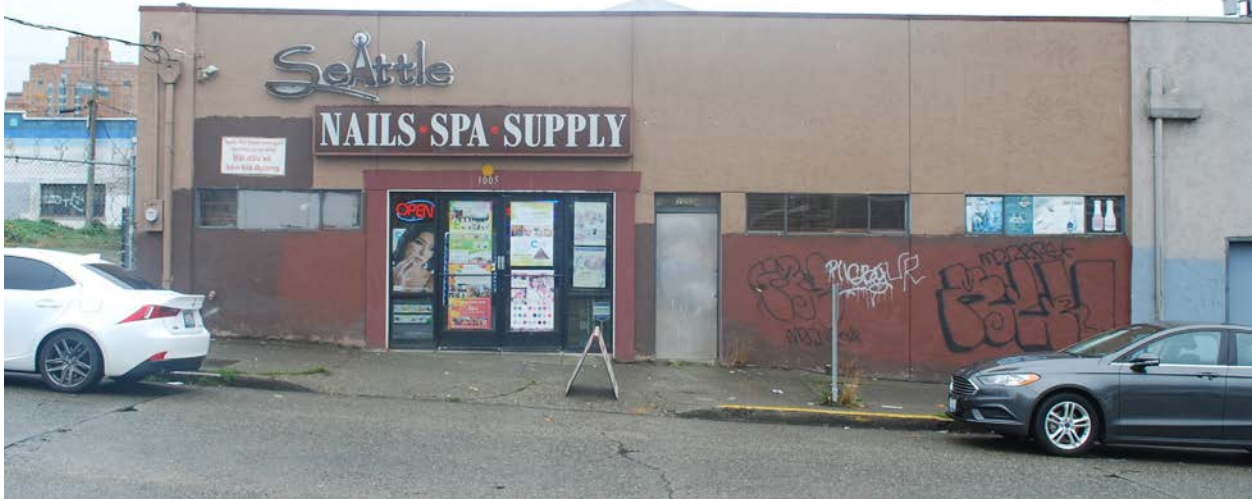
FIGURE 3.3b: 1007 S. King Street (Oct. 2018)

condition than the adjoining building. The painting is uneven and patches of paint are placed in odd parts of the facade facade has been the victim of vandalism. The section of the ribbon window east of the storefront has been painted over for years and recently the west ribbon section has been postered over and is no longer usable as a window.

front of them. The brick wall itself is in relatively poor condition with broken and cracked bricks all over the wall. The grouting is now multiple colors ranging from light gray to black. The wall has also been painted over multiple times with at least four different paint colors (light red, dark red, light gray, and dark gray) on top of the exposed original brickwork color. The wall has been relatively unvandalized. *See Appendix A.1 for exterior condition photos.*

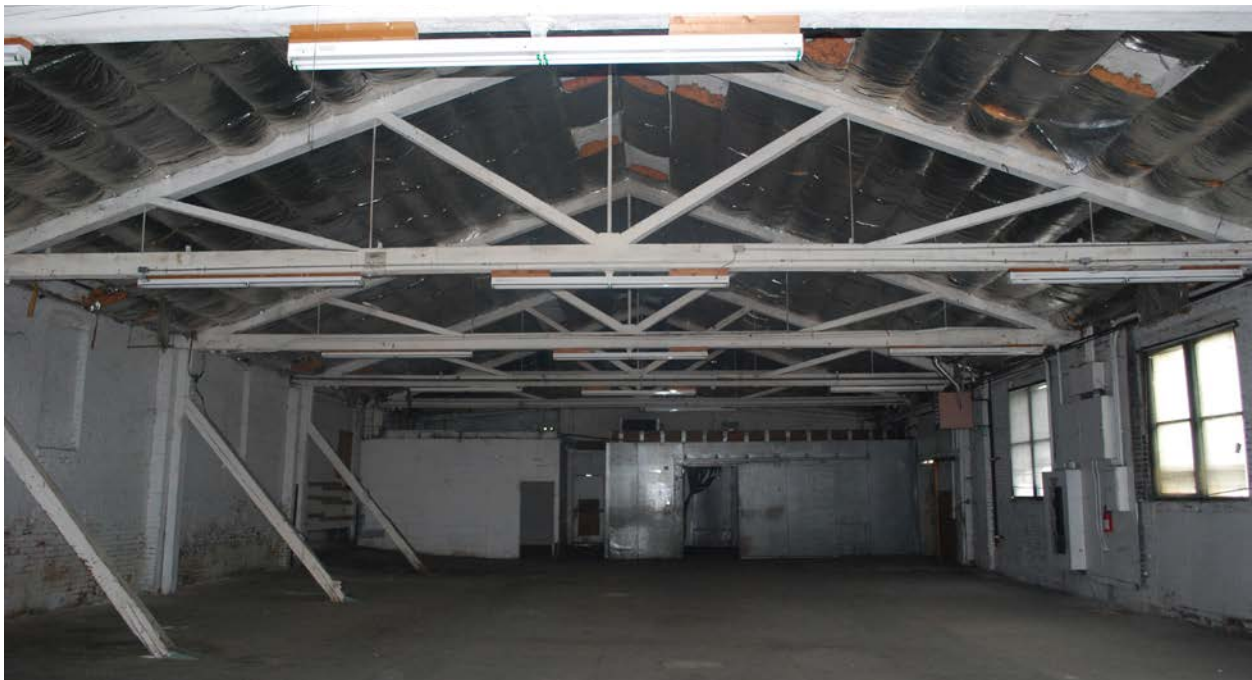
FIGURE 3.4a: 1001 S. King Street Interior Photo (Oct. 2018)

The poor condition of the exterior of the project are reflected and evident on the interior. The main floor space is unfinished as well as the two rear spaces. The former rear delivery door, that had been boarded up on the west facade, is not sealed completely and is full of holes to the exterior of the building some caused by damage and others through poor construction. The brickwork, which continues from the exterior to the interior, is cracked and broken in many spaces. The white paint that covers the interior brickwork is flaking off or

discolored in many places. Many places on the walls are sealed using large metal plates that are bolted to the walls to patch them where damage has occurred. See *Appendix A.2 for interior condition photos.*

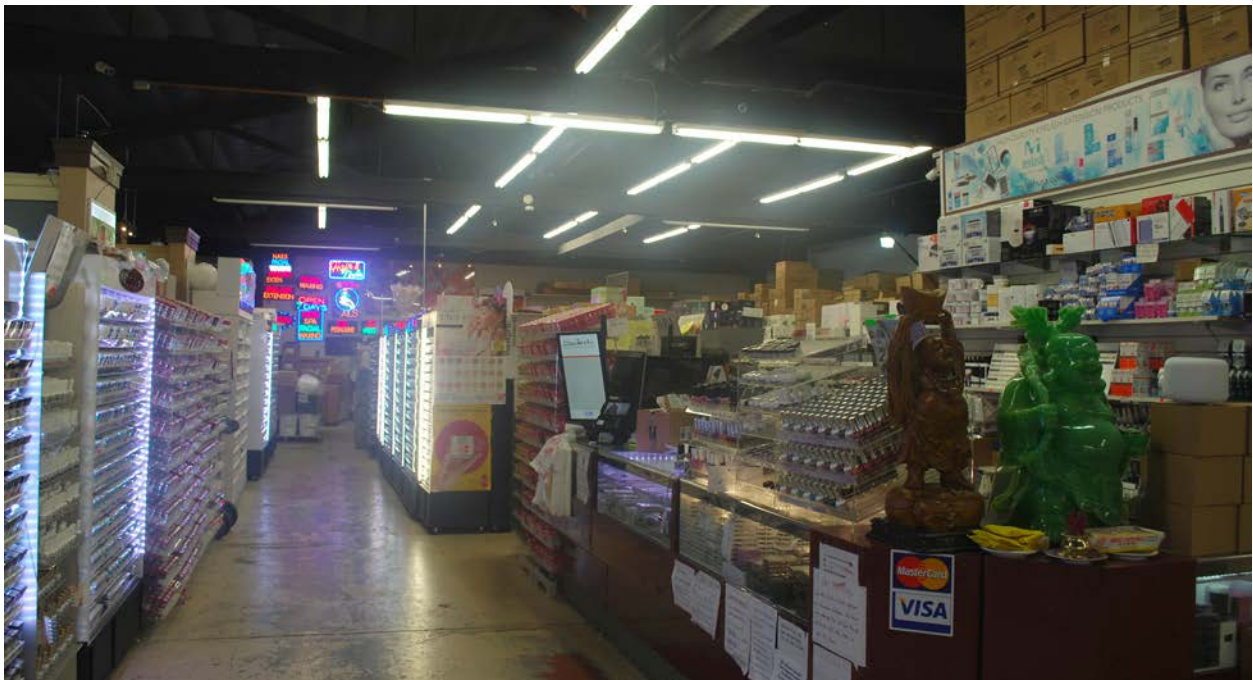
FIGURE 3.4b: 1007 S. King Street Interior Photo “Seattle Nails Supply” (Oct. 2018)

Seeing as this is a currently operating business the interior has been well maintained and most of the damages that are visible on the exterior of the property are not visible or covered in the interior of the space. See *Appendix A.2 for interior condition photos.*
