Arborist Report

To: Mill Creek Residential Trust LLC. c/o Matt Quigley
Site: 1032 S Jackson St., Seattle, WA 98104; Parcel# 8591900145
Re: Tree Inventory and Assessment
Date: April 27, 2022
Project Arborist: Sean Dugan, Registered Consulting Arborist # 457
ISA Board Certified Master Arborist #PN- 5459B
ISA Qualified Tree Risk Assessor
Referenced Documents: Site Plan A100 (Tiscareno Associates; plotted January 31, 2022)
Attached: Tree Inventory - Table of Trees
Aerial Photograph with Tree Locations

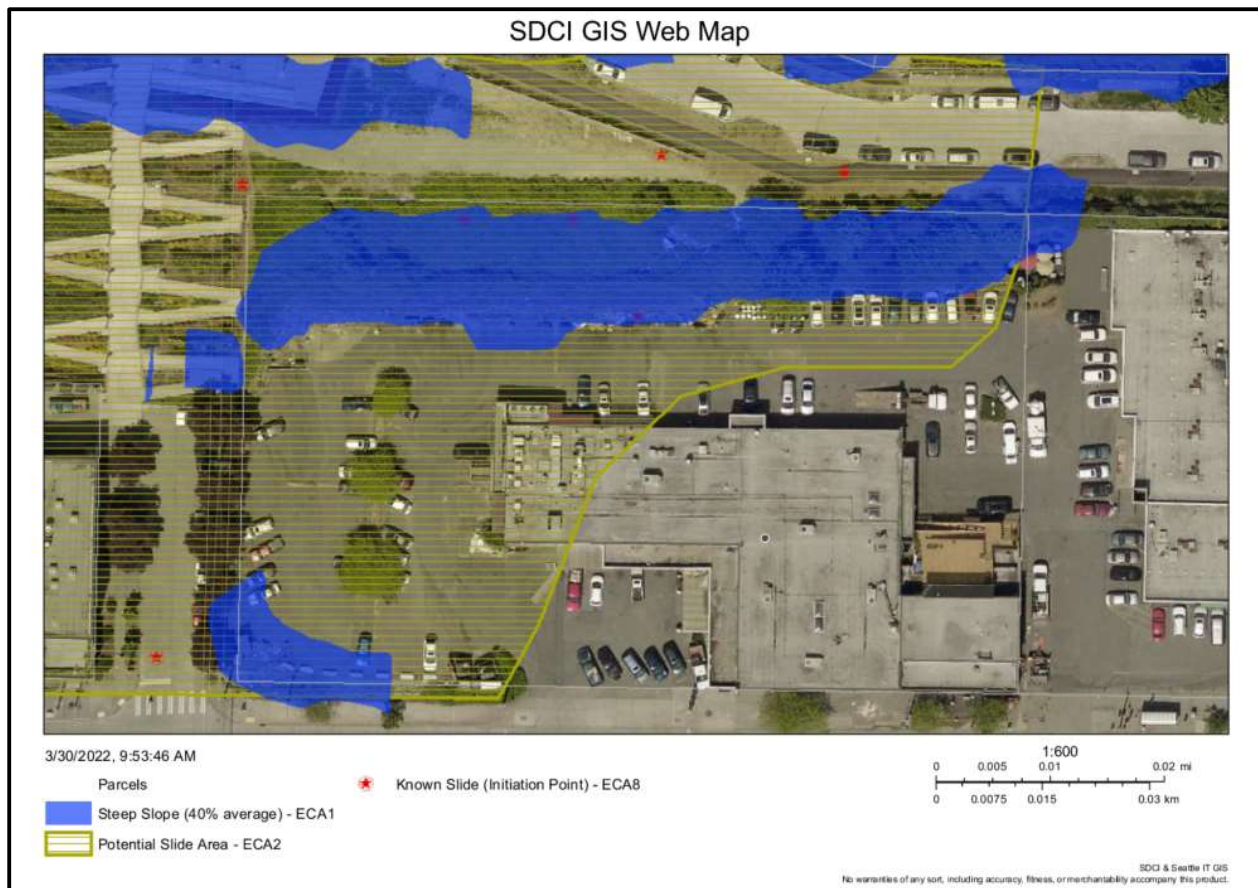
A steep slope and potential slide environmental critical area (ECA) are located on the site (see Figure 2). An unmaintained landscape swath is located along the north portion of the property above a rockery retaining wall. Several trees on the slope show symptoms consistent with slope creep (soil movement down slope). Several trees have failed at the roots in the shallow soils in this area.

Figure 2. Aerial photograph with environmental critical areas. (Source: Seattle GIS Web Map accessed March 30, 2022)

- Unless removal is approved by the Director, site planning around exceptional trees must follow the requirements outlined in SMC 25.11.050.²
- Site planning around trees in critical areas must follow the requirements outlined in SMC 25.09.070.³

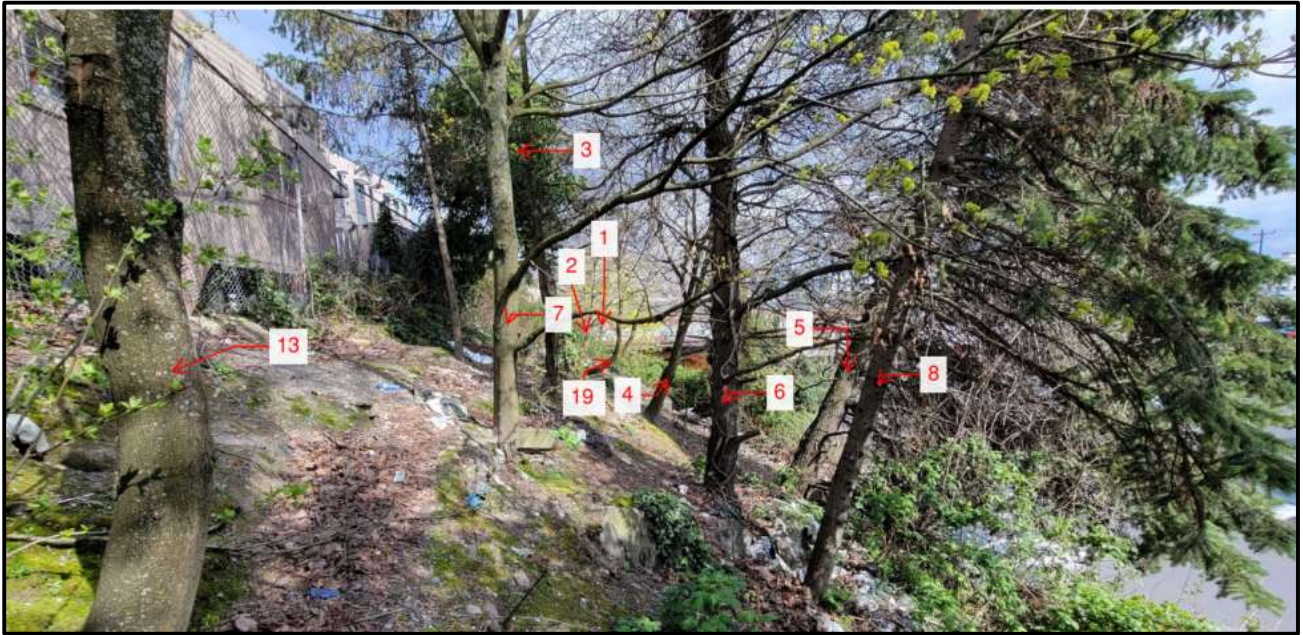
Tree 5 is an exceptional Shore pine (*Pinus contorta*) tree that has a lean to the south (Photos 1, 2 and 5). The majority of the canopy is located over the parking lot. There is a slight correction at the top of the tree to vertical, indicating the tree is currently stable.

Photograph 1. View looking east on the north slope.

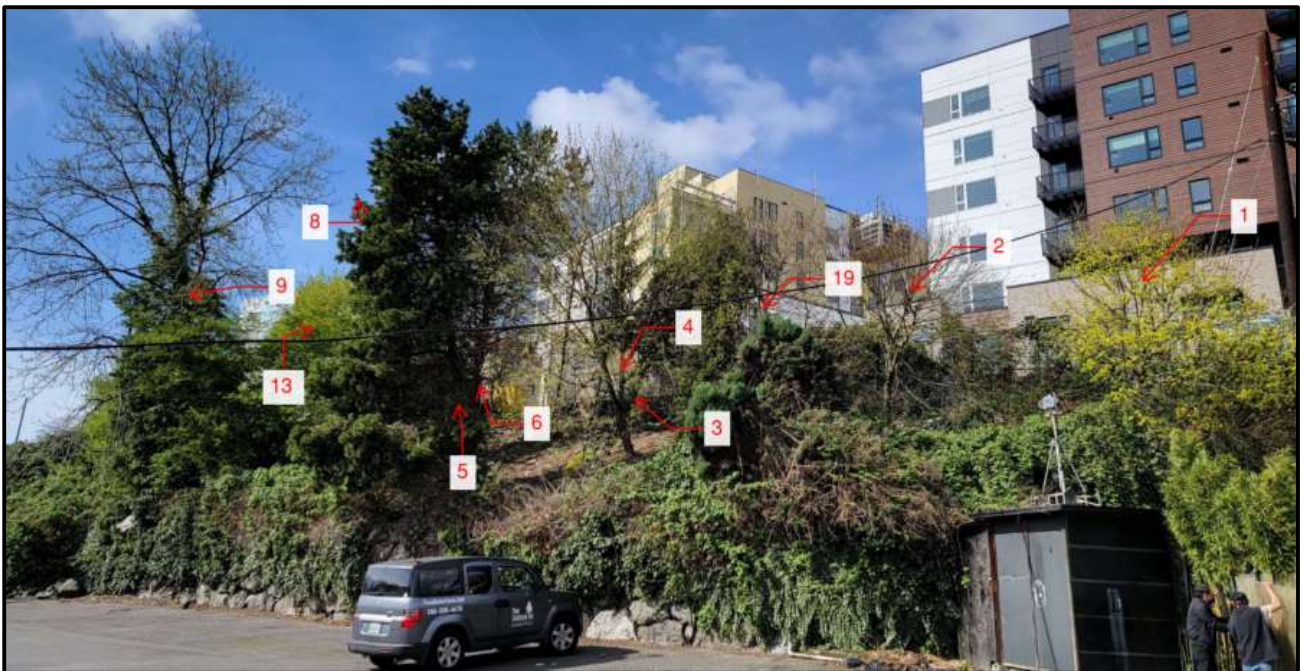
The largest tree in the stand is a 23-inch diameter Black cottonwood (*Populus trichocarpa*) tree at the top of the rockery (Photos 2 and 6). This tree is not to be considered exceptional unless part of a grove, which does not exist.

Photograph 2. View looking northwest from the parking lot.

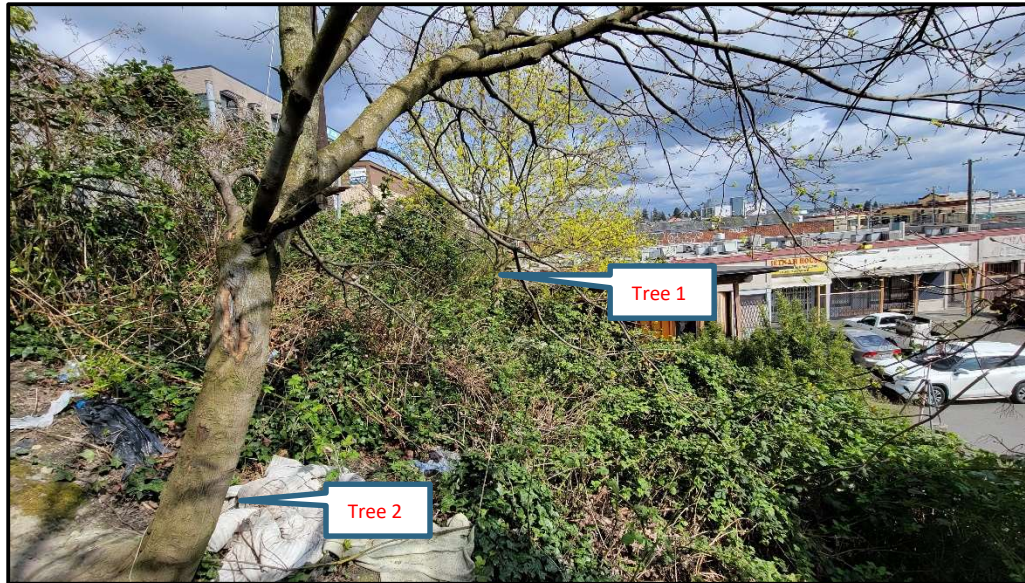
Trees 1 and 2 are small diameter maple (*Acer spp*) trees (Photos 3 and 4). Tree 2 has a swept or "J-hook" base that indicates possible slope creep. The same structure can be seen in Tree 19 in Photo 5. Tree 3 is a Douglas-fir (*Pseudotsuga menziesii*) tree that has failed at the base in the shallow soils (Photo 5). The tree's structure is considered to be poor.

Photograph 3. View looking east at Trees 1 and 2.

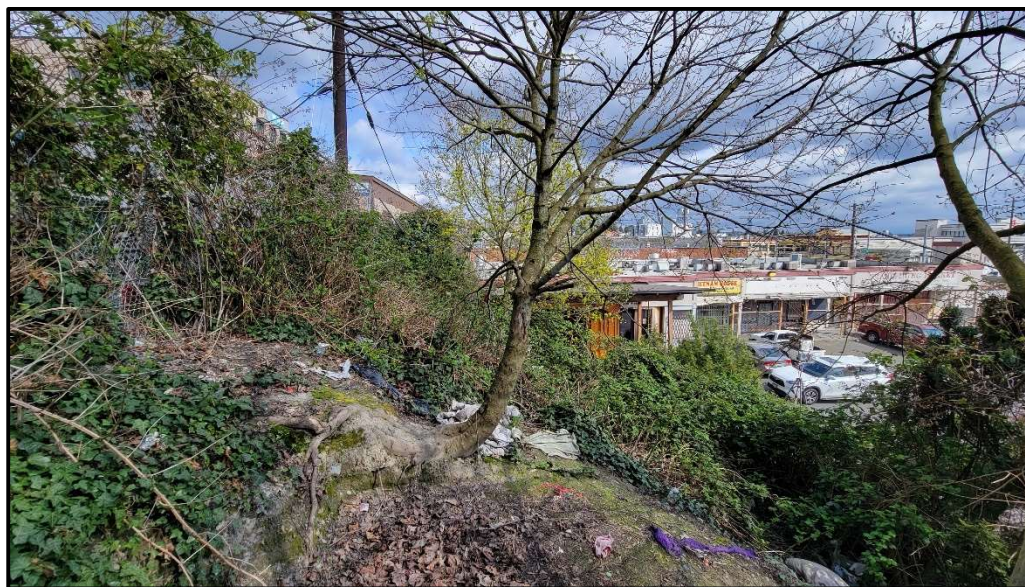
Photograph 4. View looking east at Tree 2. Tree 2 has a swept base, an indicator of slope creep.

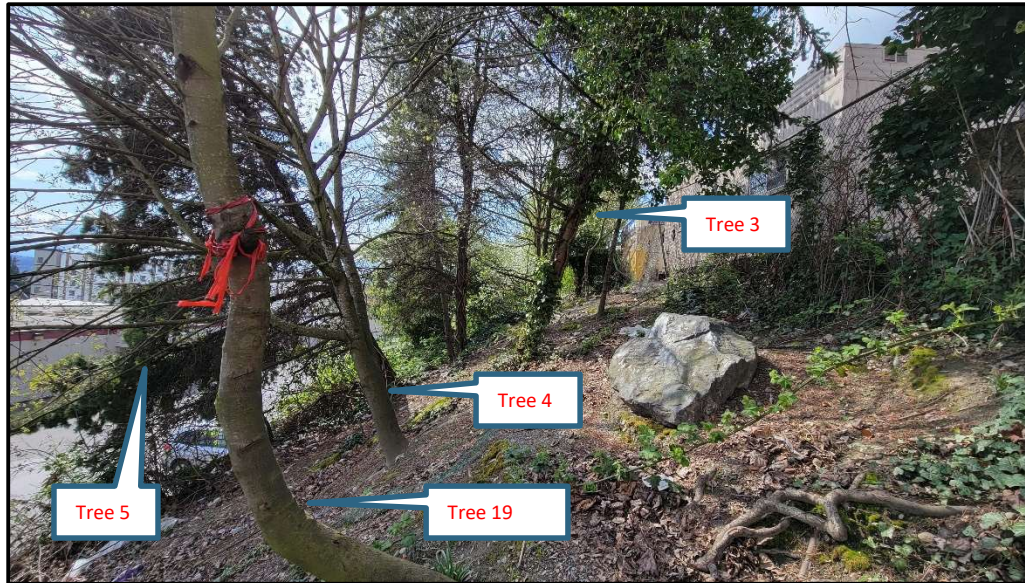
Photograph 5. View looking to the west from Tree 2.

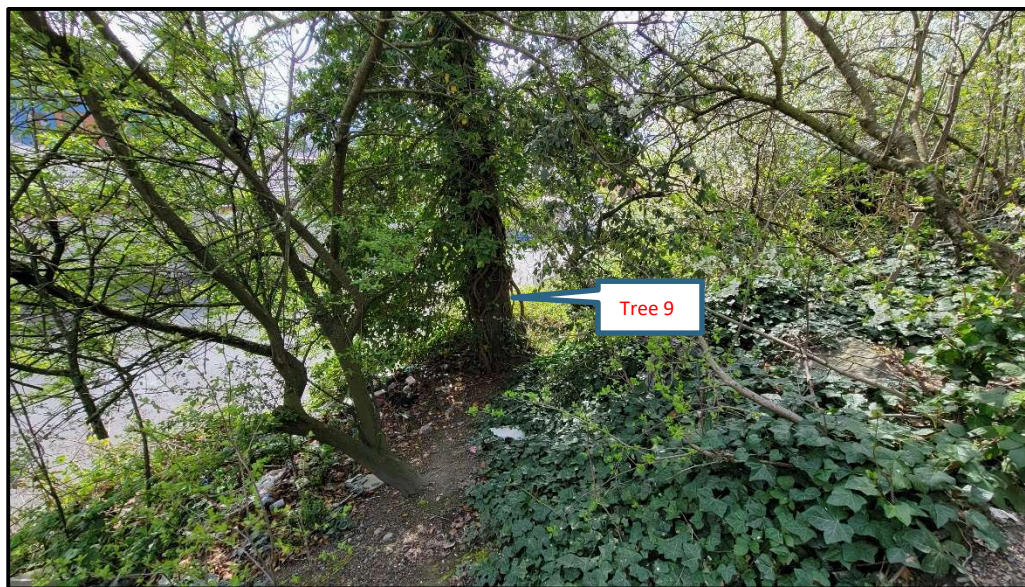
Photograph 6. View looking west at the base of Tree 9.

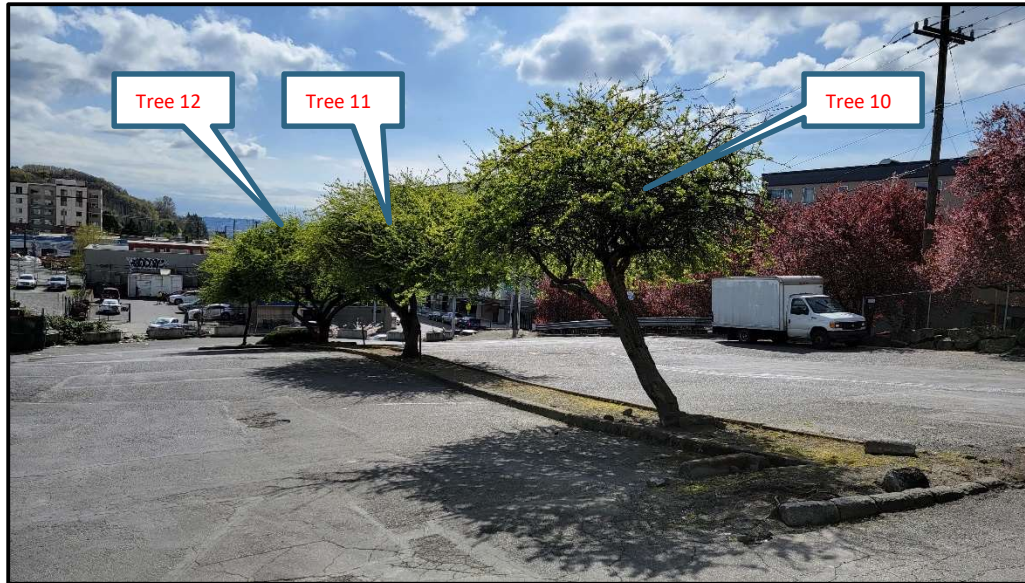
There are three Pear (*Pyrus communis*) trees located in the parking lot west of the existing structure (Photo 7). These trees are in good condition but are damaging the surrounding infrastructure. Trees 14, 15 and 16 are pear trees located along the north property line (Photos 7 and 8).

Photograph 7. View looking south at the parking lot Trees 10, 11, and 12.

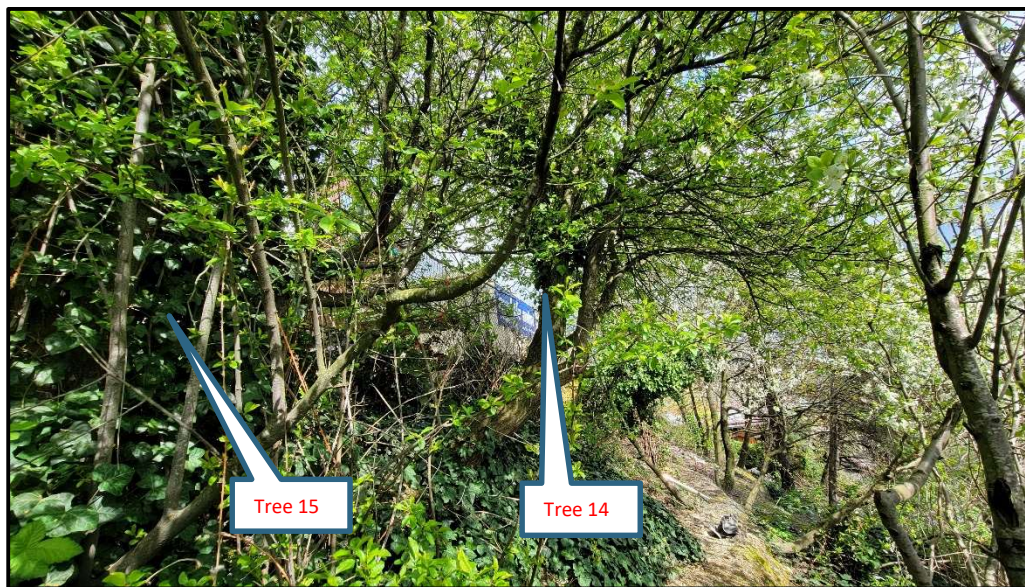
Photograph 8. View looking east at Trees 14 and 15.

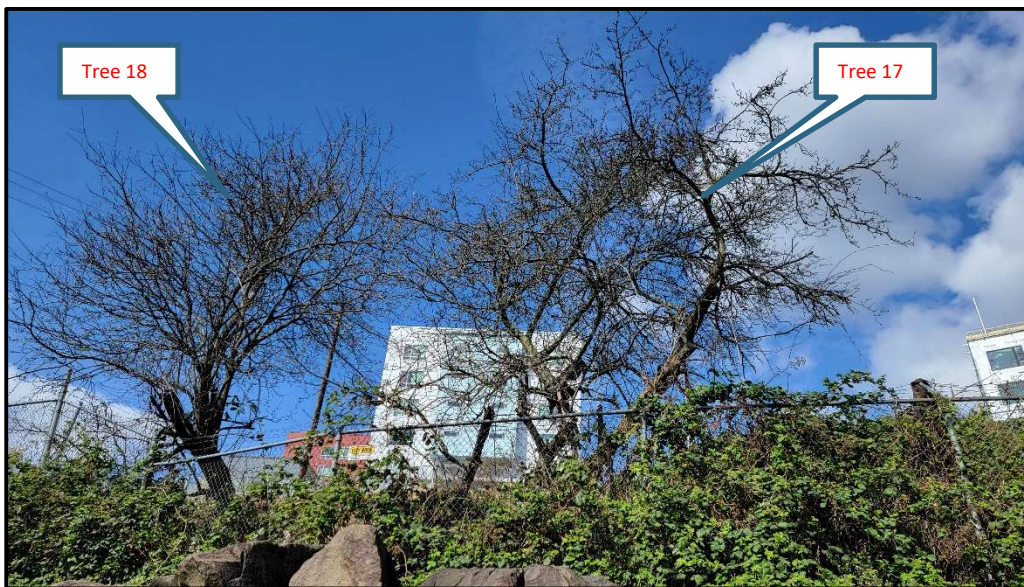
Tree 17 is an exceptional willow (*Salix spp*) tree located on the west portion of the site (Photos 10, 11, 12). The tree is in poor structural condition, having previously failed at the roots. A saprophytic fungus is growing along the trunk. It is unclear if the chain-link fence is acting as a support to keep the tree upright. The tree is a poor candidate for retention and is proposed for removal.

Photograph 10. View looking north at Trees 17 and 18. Tree 17 meets the exceptional species/size threshold.

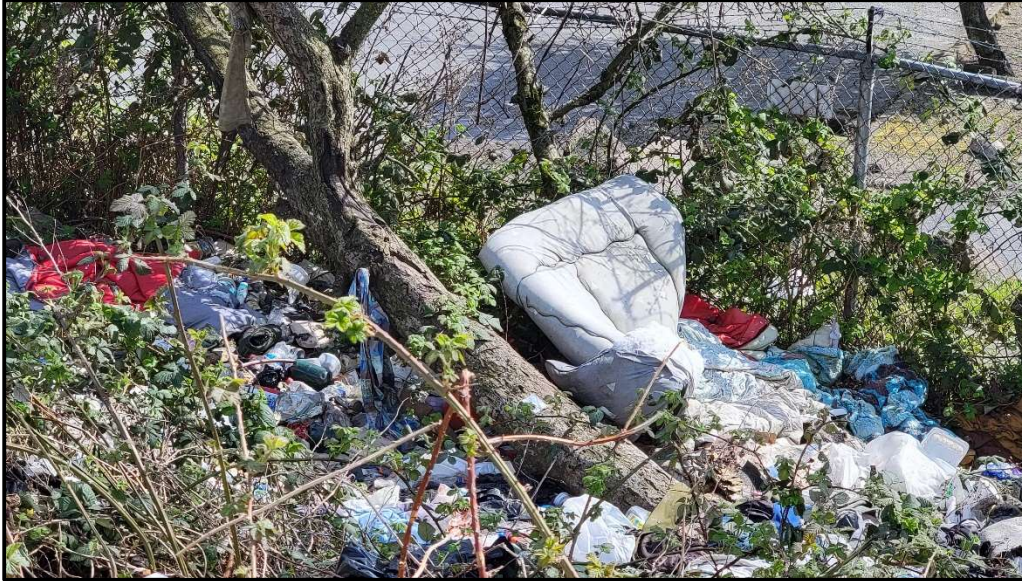
Photograph 11. Base of Tree 17.

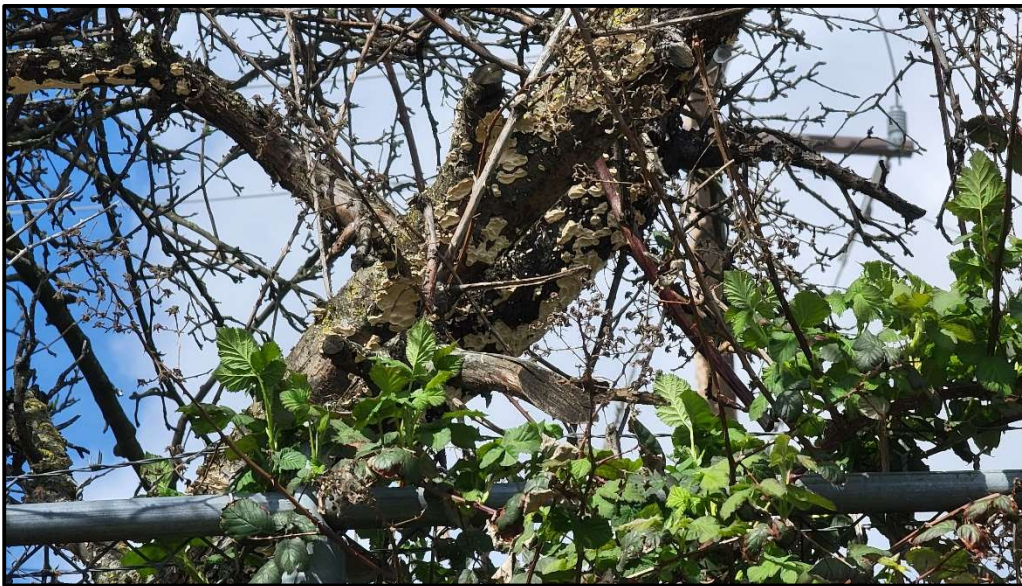
Photograph 12. Fruiting bodies on the trunk of Tree 17.
