ABC Herron Tree LLC  
P.O. Box 64  
Gold Bar, WA 98251  
425-293-2443  
mountainredd@comcast.net

RE: Property Name: D.A.R. Rainier Chapter House  
Taxpayer Name: Rainier Chapter Regent  
Site Address: 800 E Roy St, Seattle, WA 98102  
Parcel#: 9831200275  
Lot Size: 6,800 sq ft

ABC Herron Tree LLC is pleased to submit this report compiling the visual Tree Risk and Evaluation Assessments performed on a tree located on or near the above-reference parcel as shown on the site map in my report.

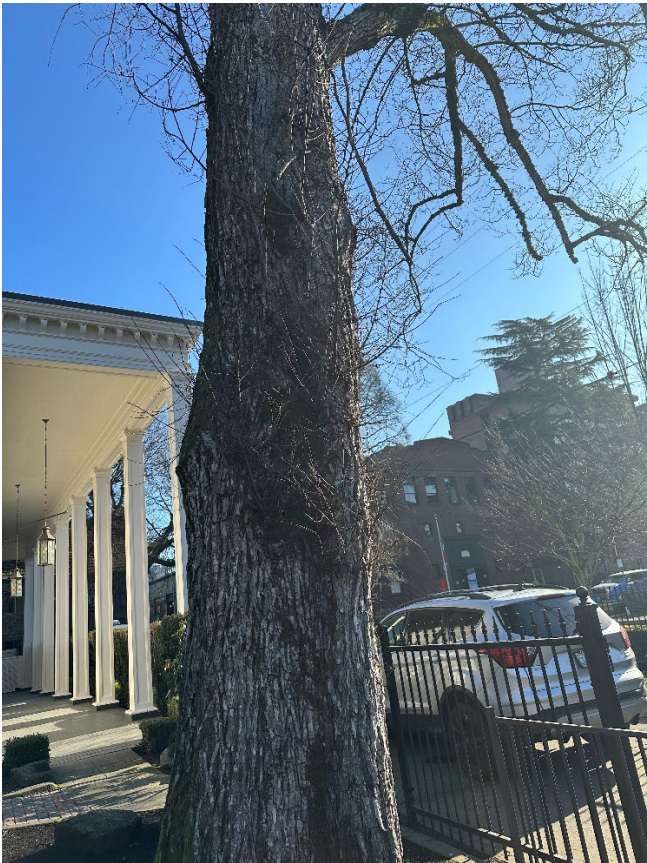
Tree to be removed

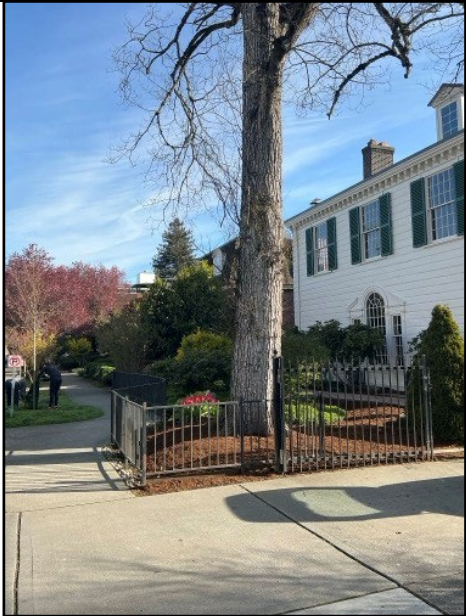
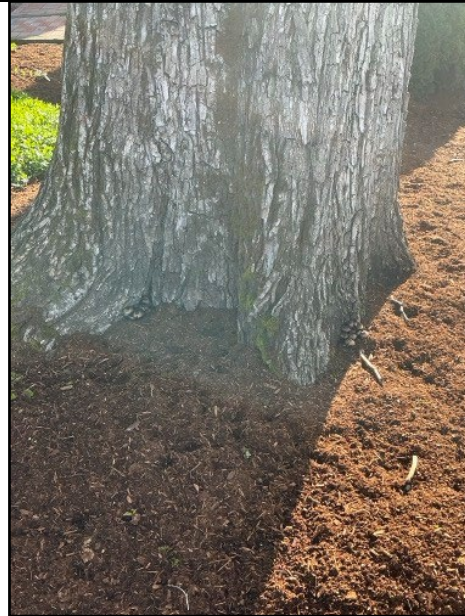
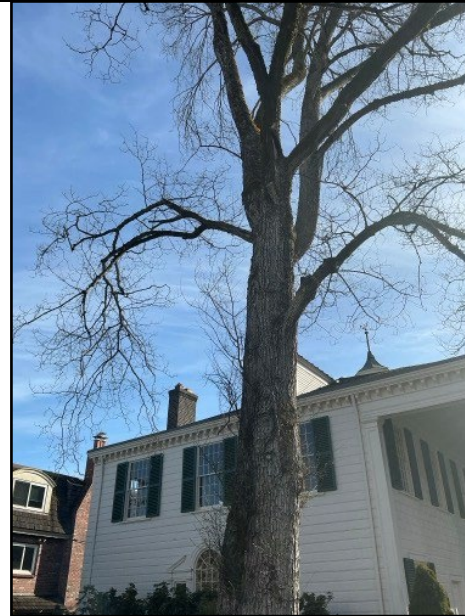
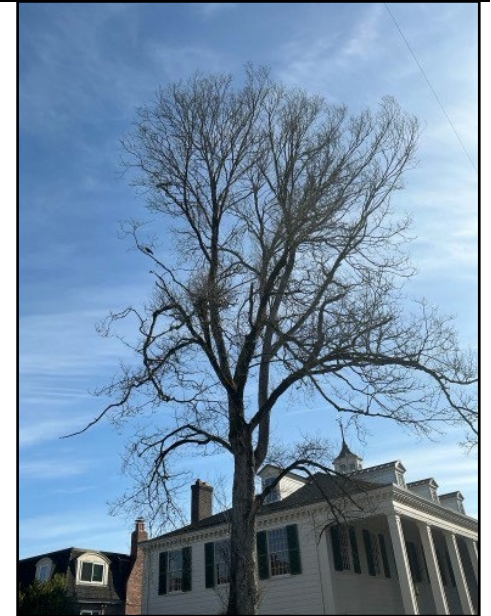
Tree	Species	DBH (in)	Drip (ft)	CRZ (ft)	Condition	Structure	Risk	Pres. Value	Recommendations
1	American elm <i>Ulmus americana</i>	34.0	25.0	34.0	1 Dead	1 Dying/Dead	High	N/A	Tree Removal
Notes/ Defects	<p>This tree's upper canopy is dead with limbs constantly shedding onto the property, causing damage. There are mushrooms at the base of the tree, indicating root rot. This tree is infected with Dutch elm disease. A neighboring tree was removed some time ago and was also infected with the same disease. Removal of this tree is recommended. Mica cap mushrooms were identified at the base of the tree. This is a non-parasitic mushroom that breaks down rotten wood. This tree is Seattle Street tree TRE-43508.</p>

I arrived on site at about 9:00 am on April 4, 2025, to examine one tree. The subject tree is high risk, and I recommend its removal as soon as possible. I have attached a BTRAF with additional details. The removal of this tree will require setting up in the parking area of this street.

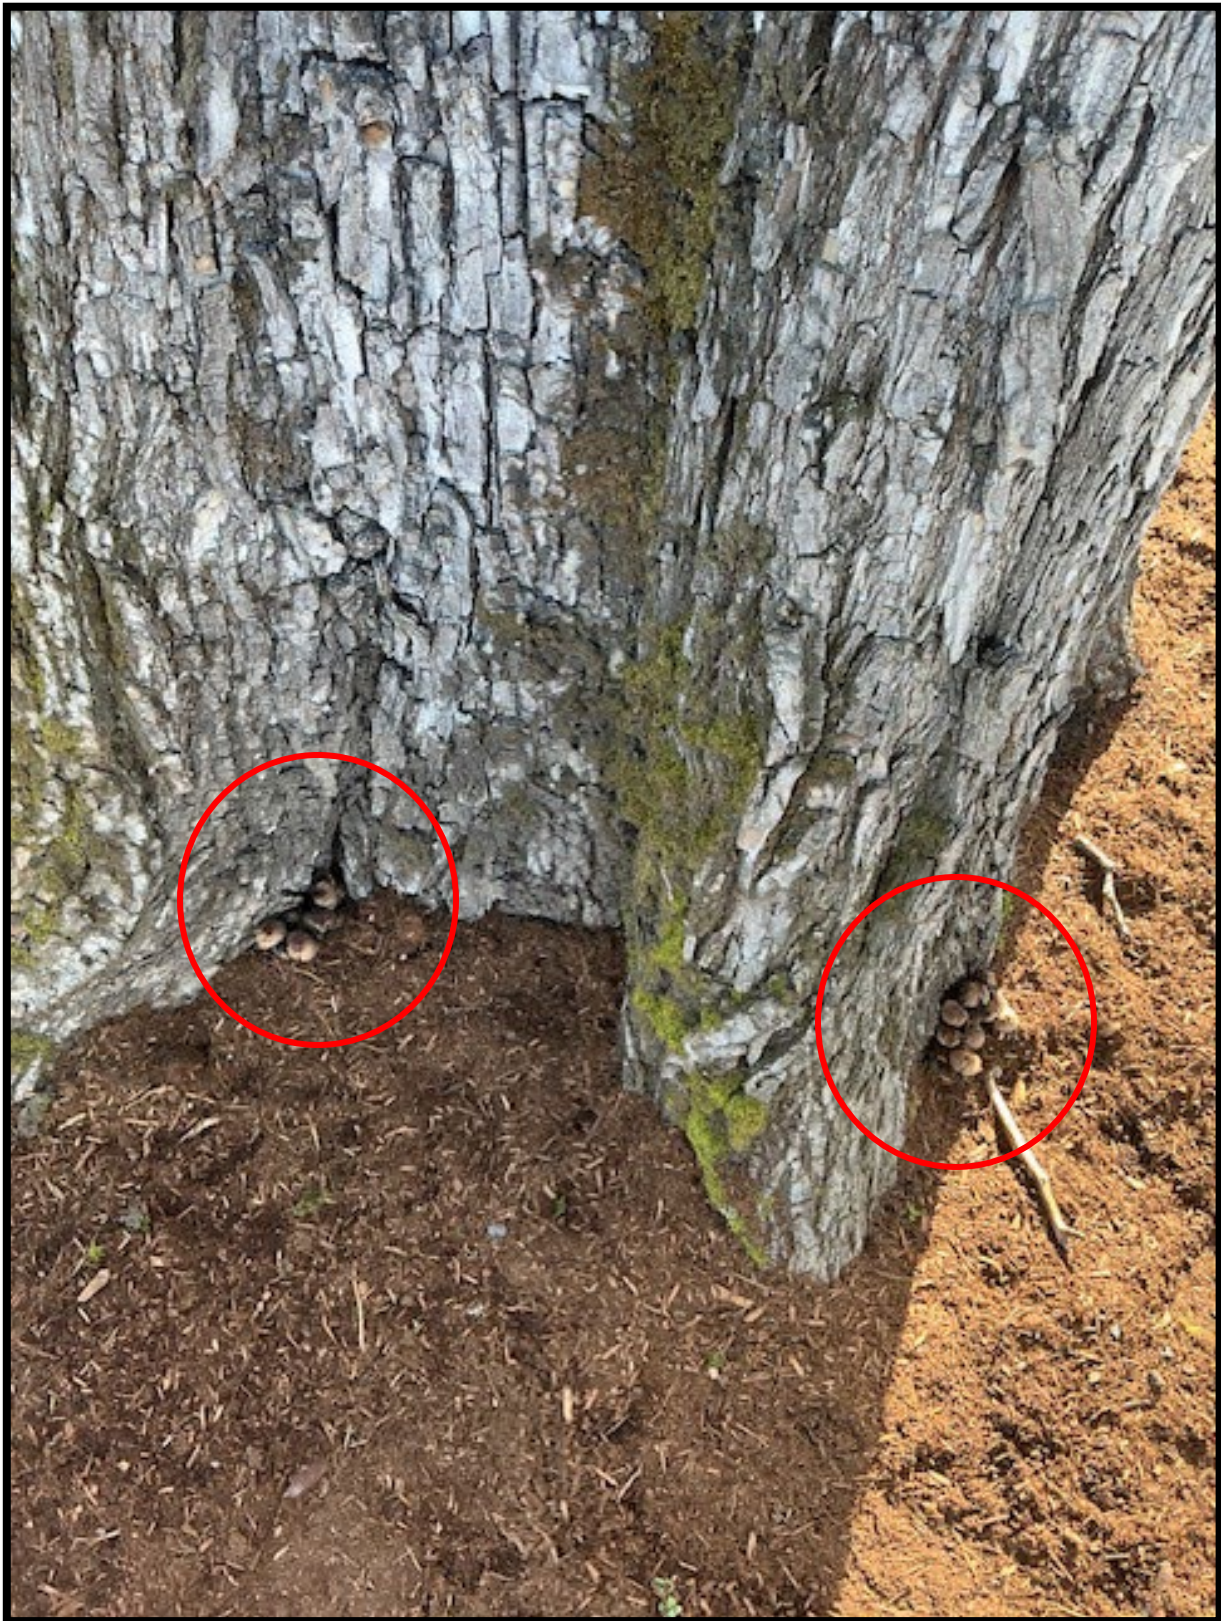
**Photo 1** Figure 6 Mica cap mushrooms at the base of the tree growing from decayed wood.

**Notes, explanations, descriptions** Tree is dying and has indicators of advanced decay. Tree is infected with Dutch elm disease that killed another elm in the immediate area. This failure resulted in significant damages to the neighborhood. Removal of tree is highly recommended.

**Mitigation options** Remove tree and replant to city code and specifications.

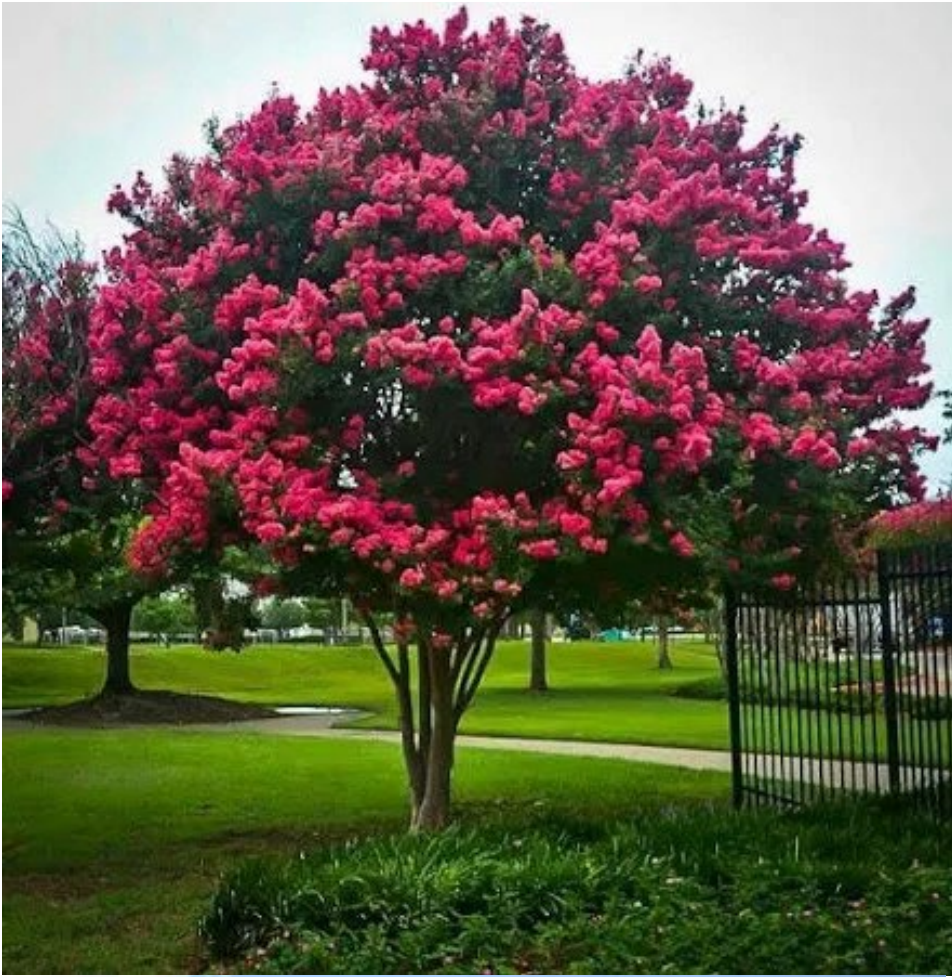
Proposed new tree -  
Crape Myrtle

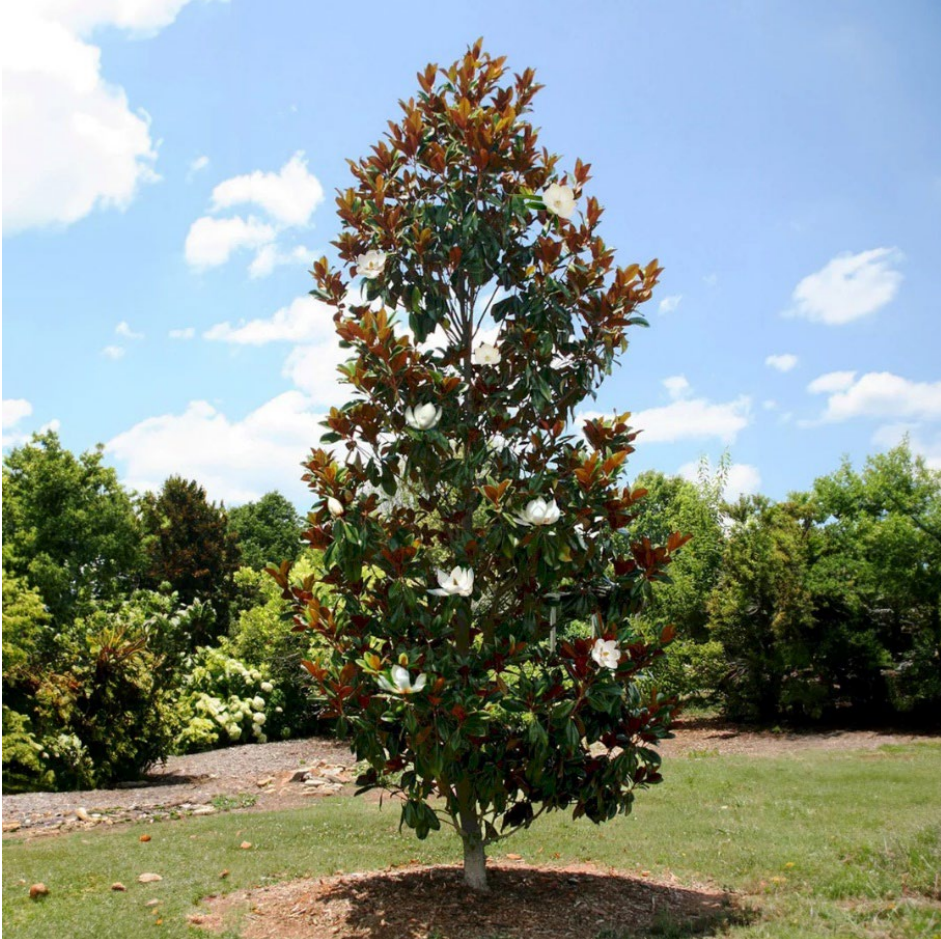
Proposed tree -  
Little Gem Magnolia
