Ballard/Howe Mansion, 22 W Highland Drive – viewed from the south

Arborist Report

To: City of Seattle, SDCI
Site: 22 W Highland Dr, Seattle, WA 98119
Re: Exceptional Tree Removal Permit Application
Date: October 6, 2021
Project Arborists: Haley Galbraith,
ISA Board Certified Master Arborist PN-7512BM
ISA Qualified Tree Risk Assessor
Connor McDermott,
ISA Certified Arborist PN-8704A
ISA Qualified Tree Risk Assessor
Attached: ISA Basic Tree Risk Assessment Forms
Statement of Financial Responsibility

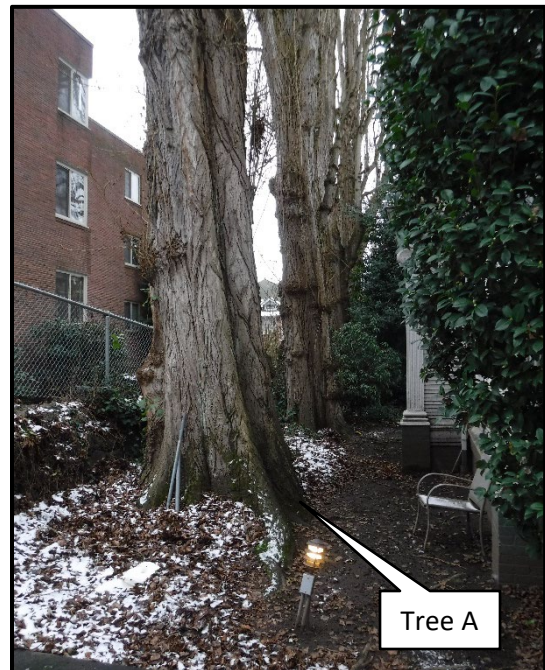
Tree A is the northernmost tree of the four subject trees. The base of tree A has significant fluting, but no visible areas of decay. One micro-resistance drill test at the base showed sound wood (see Figure 3).

Wildlife cavities visible from ground level exist in large canopy parts due to decay from past topping cuts, which is why failure rated probable over a three-year timeframe. The large north-central topping cut is of most concern.

Photo 1. Base of tree A viewed from parking area to north. This photo was taken in January 2020, during the first visit we performed to evaluate the trees for risk.

Based on the current condition of the tree, and with consideration for species characteristics, we recommend tree A be removed. In order to retain the tree and reduce risk presented to surrounding targets, extensive and ongoing crown reduction pruning maintenance would be required, and further pruning injury would lead to increased decay over time, ultimately exacerbating the existing structural issues.

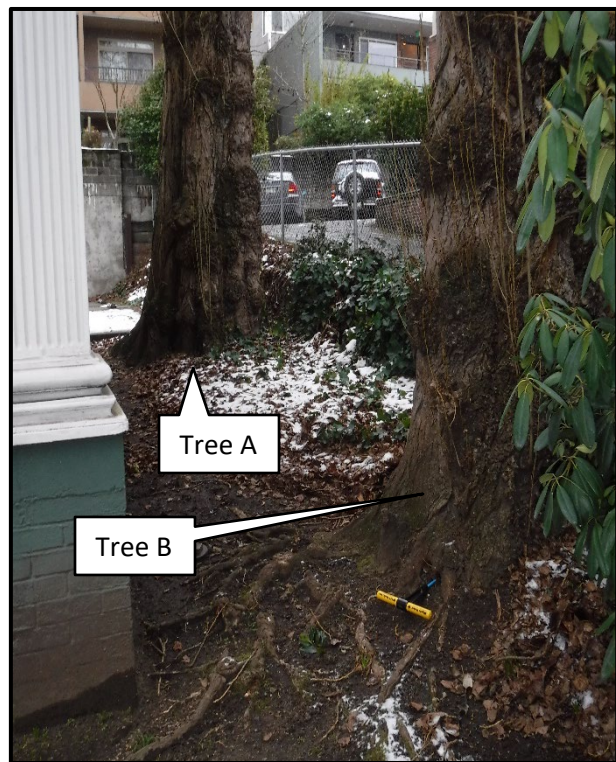
Tree B also has a fluted base, and vigorous basal sprouting. Two micro-resistance drill tests at the base confirmed significant decay in both locations tested (see Figures 4 and 5).

The attachment points throughout the canopy of tree B appear more stable than those of the other three trees, but past topping cuts have still resulted in areas of visible decay and a probable likelihood of failure.

Photo 2. Base of tree B with 40-inch steel probe fully inserted into cavity at base. This photo was taken in January 2020, during the first visit we performed to evaluate the trees for risk.

Based on the current condition of the tree, and with consideration for species characteristics, we recommend tree B be removed. In order to retain the tree and reduce risk presented to surrounding targets, extensive and ongoing crown reduction pruning maintenance would be required, and further pruning injury would lead to increased decay over time, ultimately exacerbating the existing structural issues.

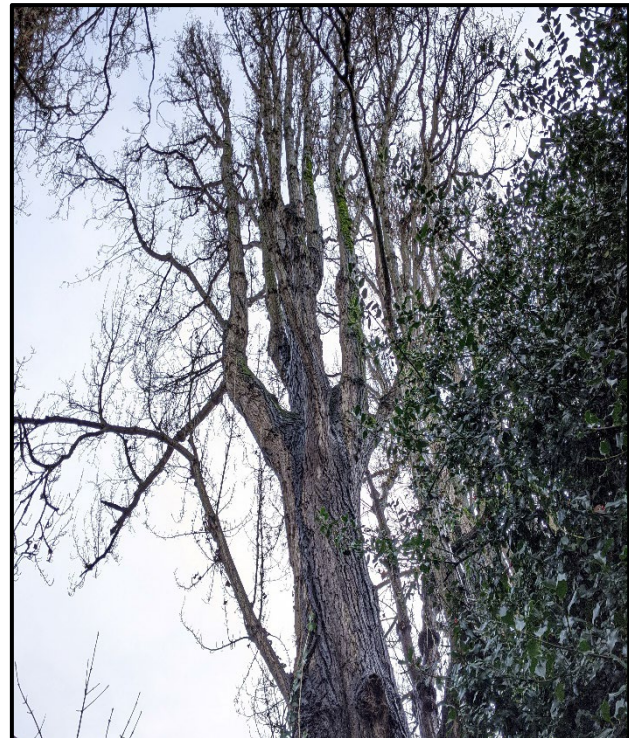
Tree C has the most candelabra-shaped crown structure of the four trees. The central leads do not appear well-attached and several large wildlife cavities are visible from ground level. Decay was confirmed in the basal trunk and aerially, using the micro-resistance drill (see Figures 6 through 10).

Photo 3. Past topping of tree C resulted in the growth of multiple reiterative leads that are now weakly attached to decaying past topping locations. This photo was taken in January 2020, during the first visit we performed to evaluate the trees for risk.

Based on the current condition of the tree, and with consideration for species characteristics, we recommend tree C be removed. In order to retain the tree and reduce risk presented to surrounding targets, extensive and ongoing crown reduction pruning maintenance would be required, and further pruning injury would lead to increased decay over time, ultimately exacerbating the existing structural issues.

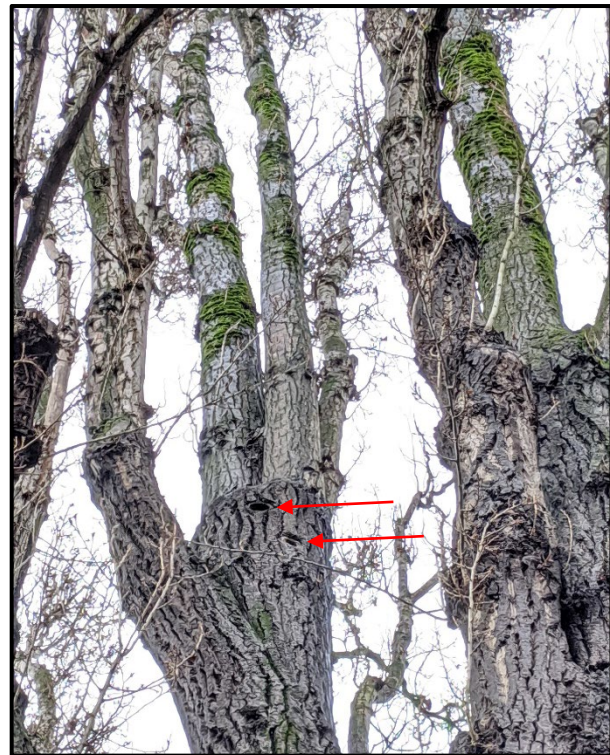
Tree D has a large basal trunk cavity on the north side and several wildlife cavities visible in large parts throughout the canopy, particularly along the east side of the central leader. A significant amount of decay was confirmed in the basal trunk and aerially, using the micro-resistance drill (see Figures 11 through 16).

Photo 4. Past topping of tree D resulted in the growth of multiple reiterative leads that are now weakly attached to decaying past topping locations. This photo showing wildlife cavities (indicated by red arrows) was taken in January 2020, during the first visit we performed to evaluate the trees for risk.

Based on the current condition of the tree, and with consideration for species characteristics, we recommend tree D be removed. In order to retain the tree and reduce risk presented to surrounding targets, extensive and ongoing crown reduction pruning maintenance would be required, and further pruning injury would lead to increased decay over time, ultimately exacerbating the existing structural issues.

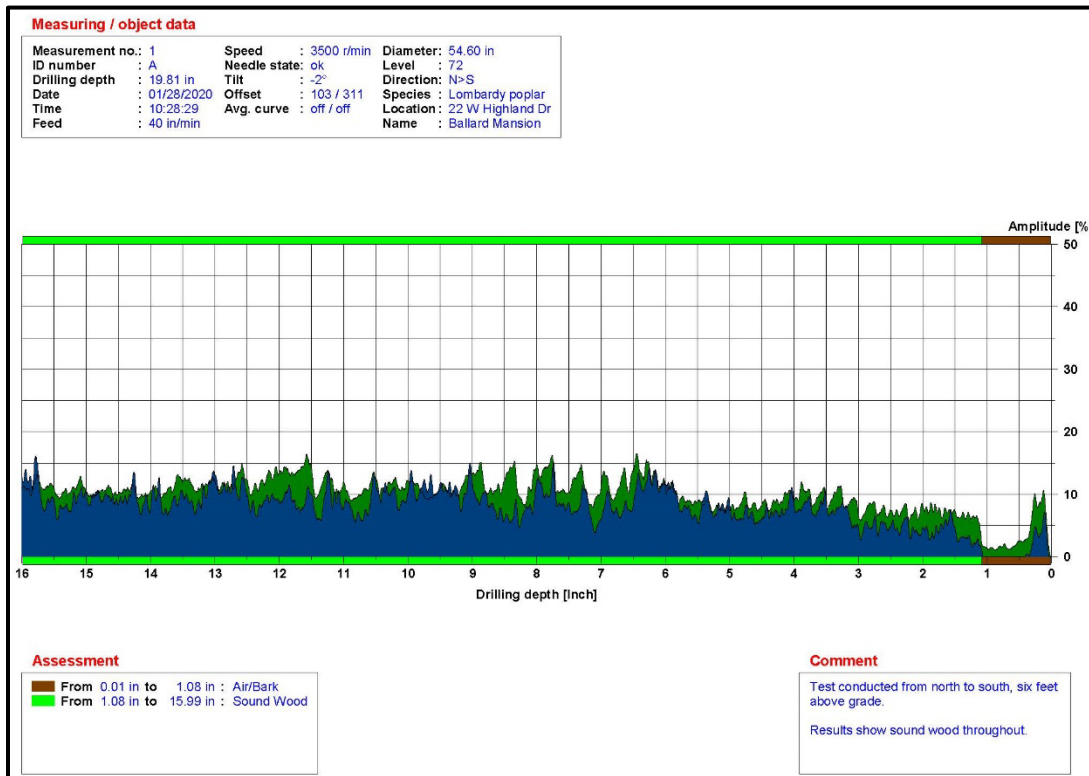
Figure 3. Results of test 1 on tree A, conducted at the base of the tree from north to south.

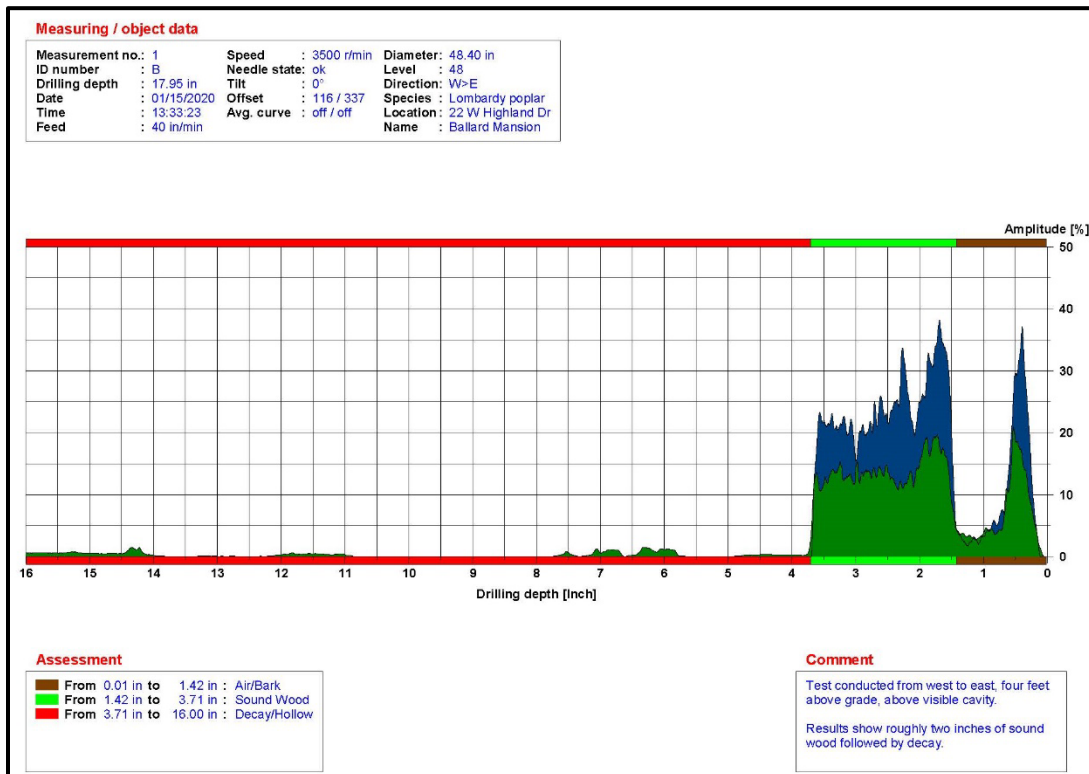
Figure 4. Results of test 1 on tree B, conducted at the base of the tree from west to east.

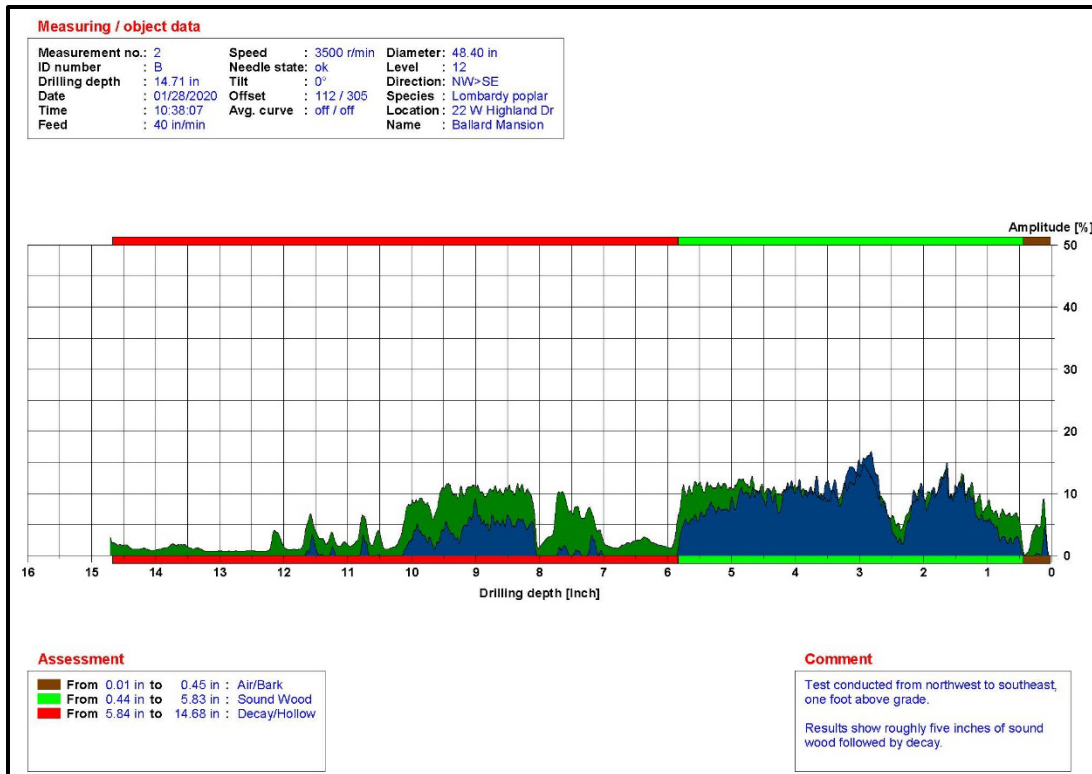
Figure 5. Results of test 2 on tree B, conducted at the base of the tree from northwest to southeast.

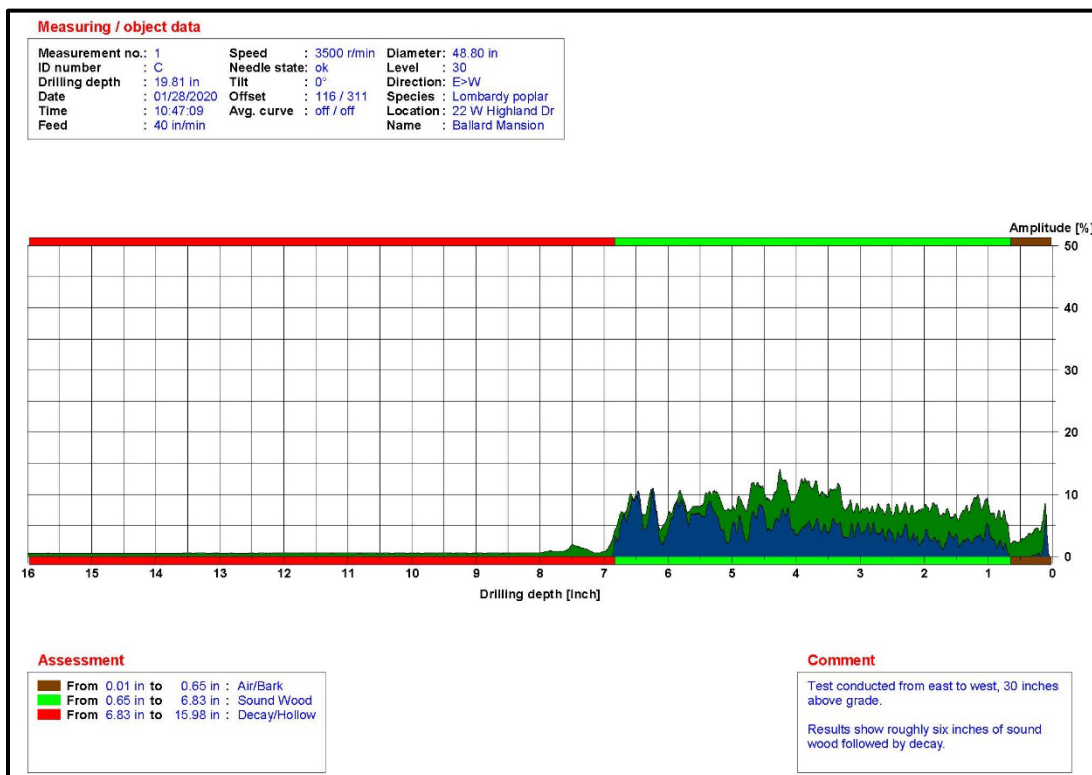
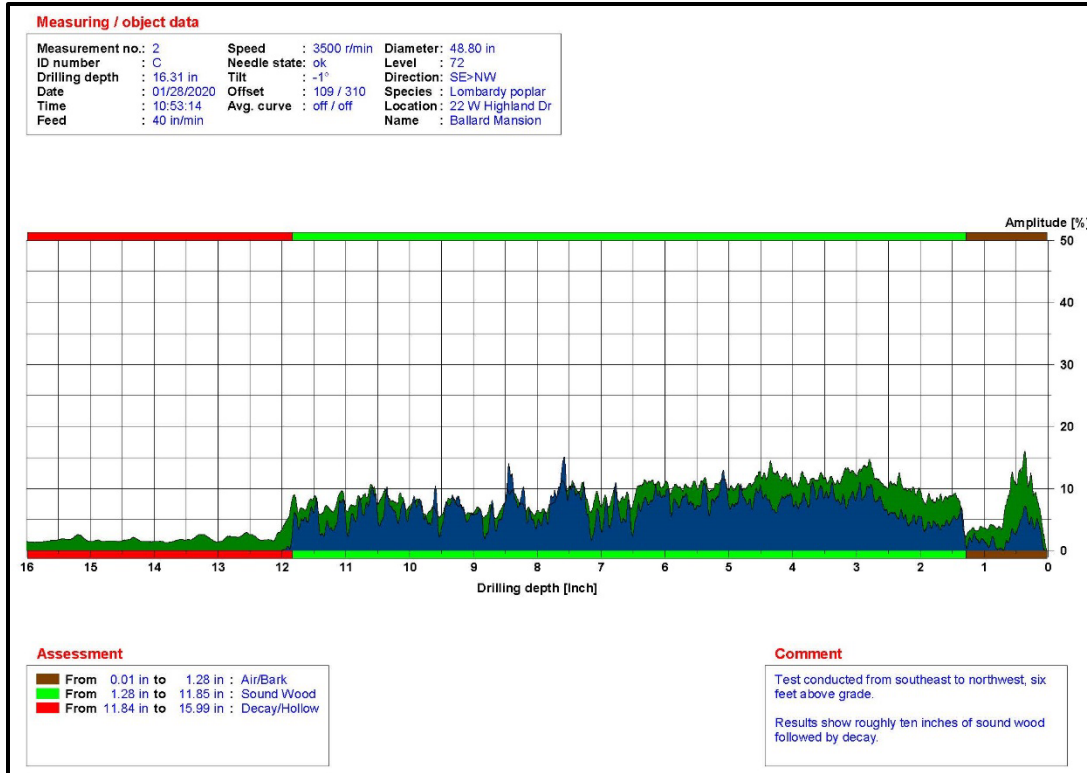
Figure 6. Results of test 1 on tree C, conducted at the base of the tree from east to west.

Figure 7. Results of test 2 on tree C, conducted at the base of the tree from southeast to northwest.

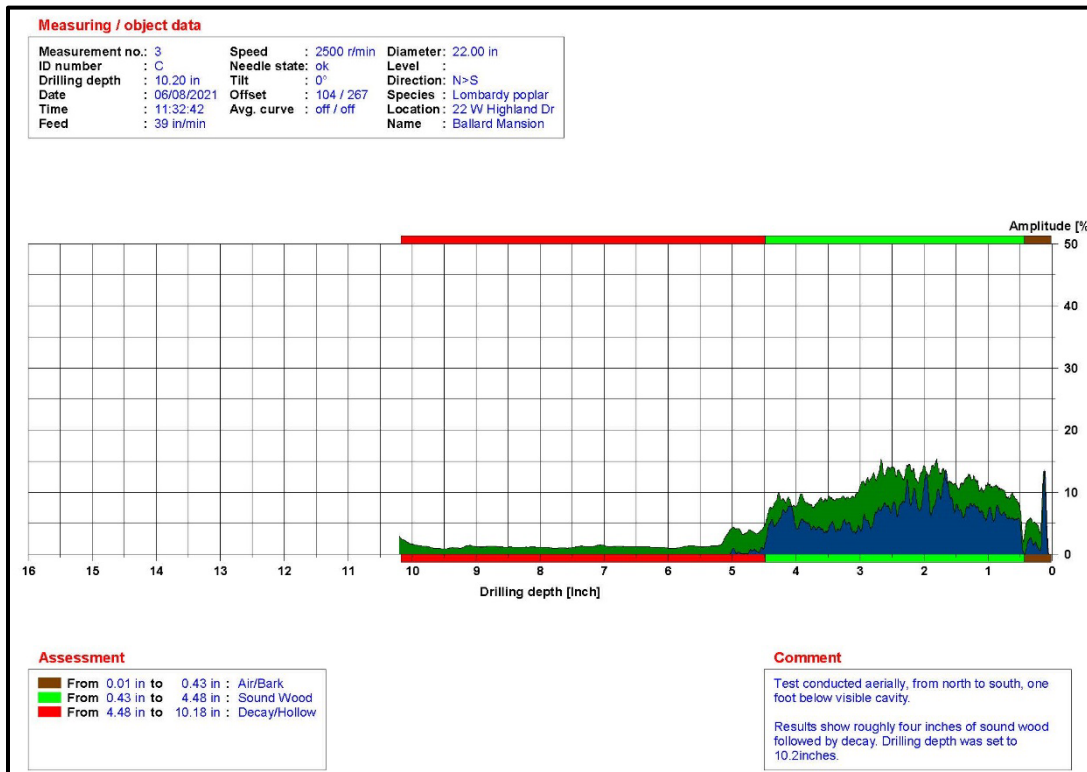
Figure 8. Results of test 3 on tree C, conducted aerially, from north to south one foot below visible cavity.

Photo 6. Close-up of Connor performing aerial inspection; red arrows point to wildlife cavity and approximate location of test 3 on tree C (see Figure 8) which showed only four inches of sound wood.

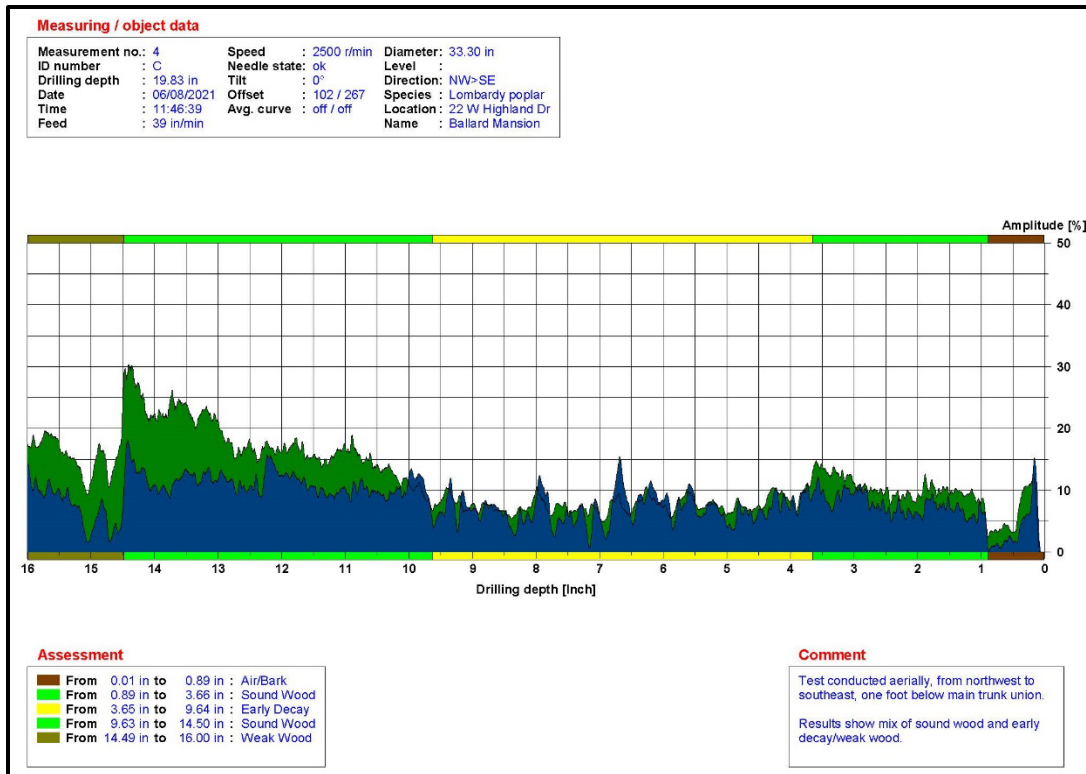
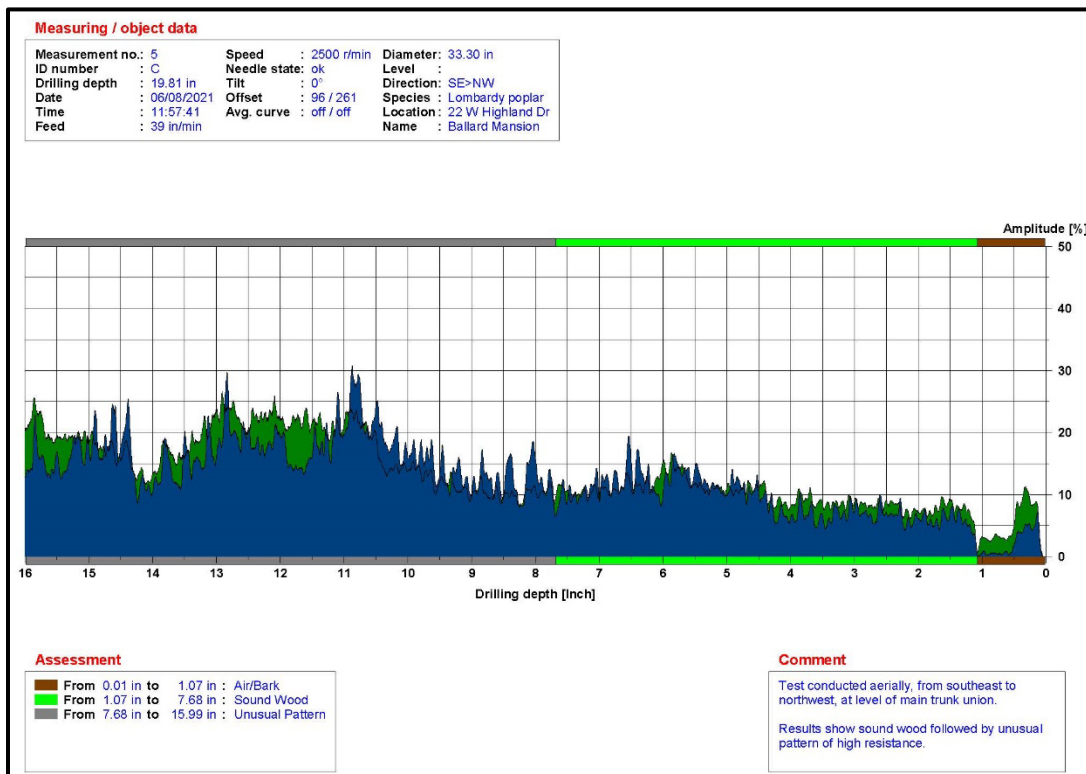
Figure 9. Results of test 4 on tree C, conducted aerially, from northwest to southeast one foot below main trunk union.

Figure 10. Results of test 5 on tree C, conducted aerially, from southeast to northwest at level of main trunk union.

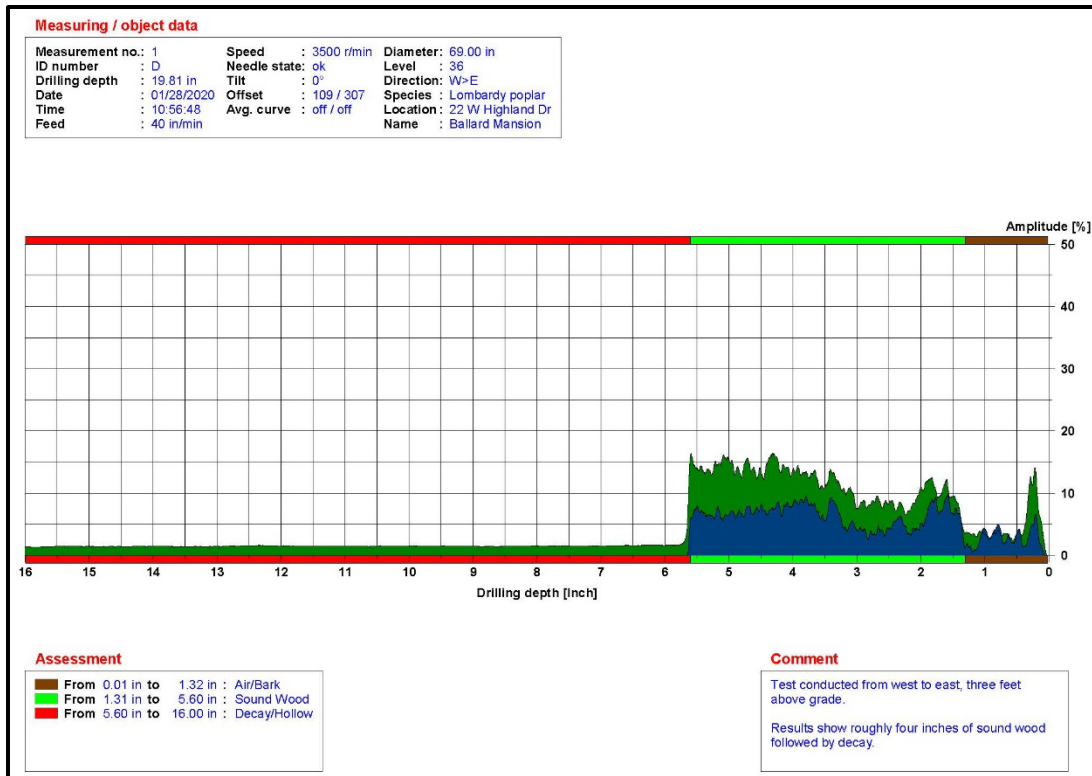
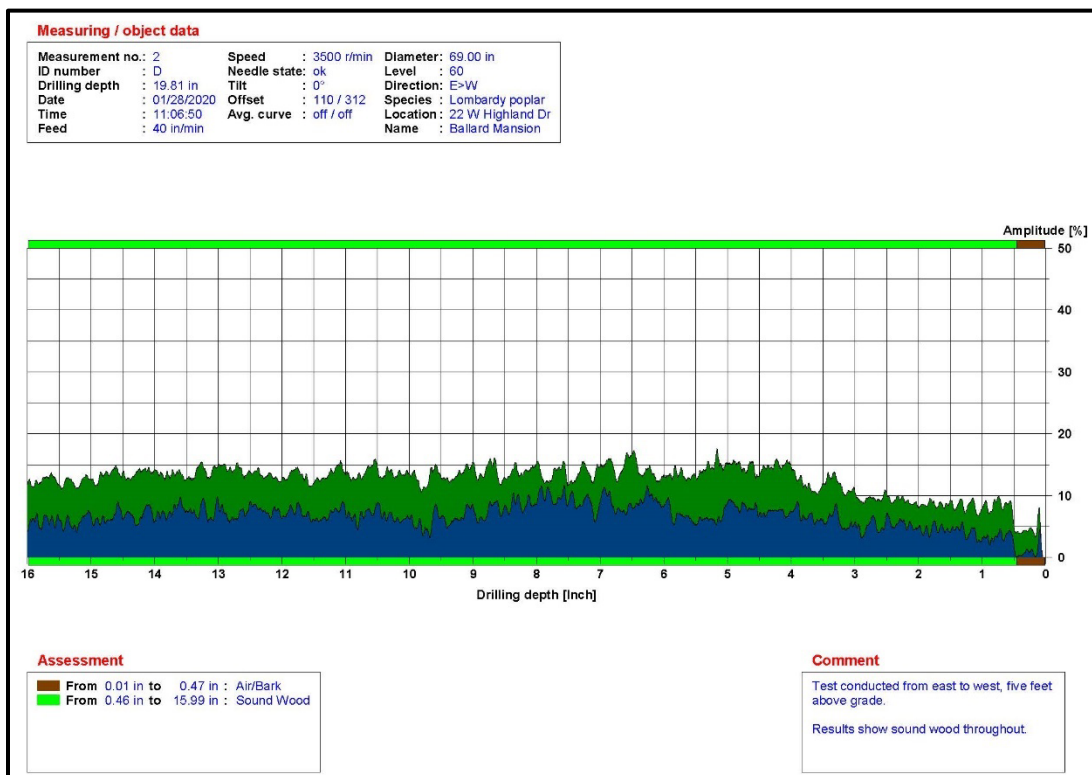
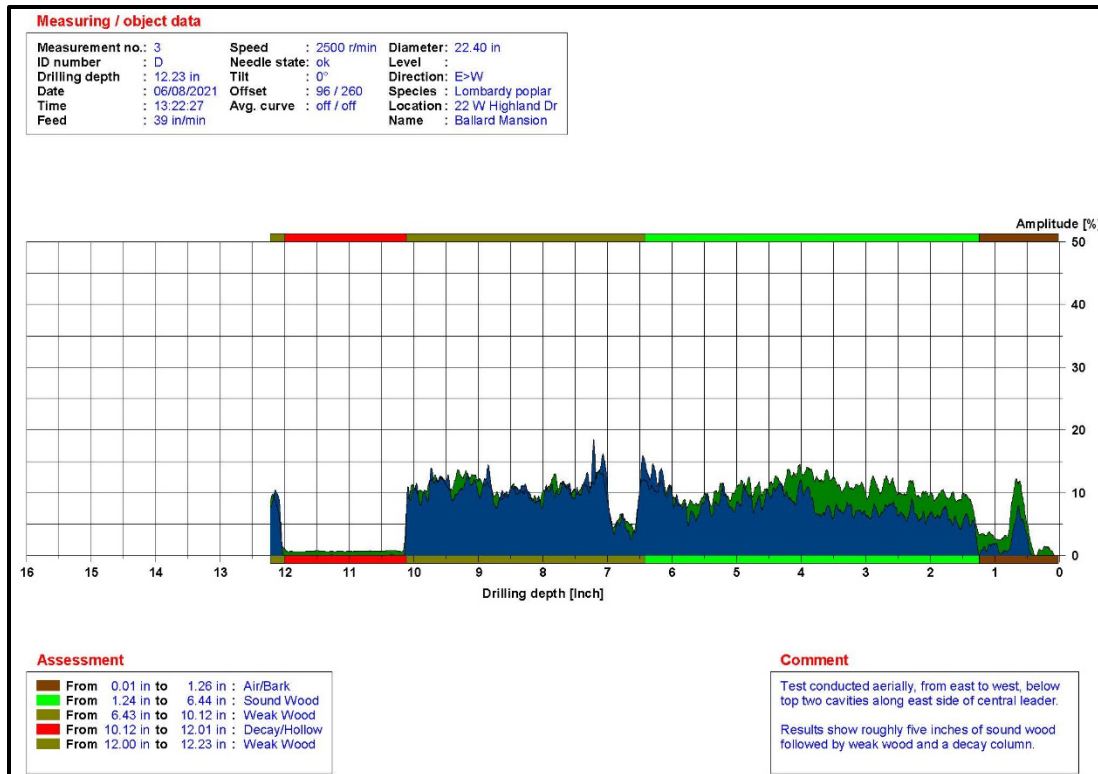
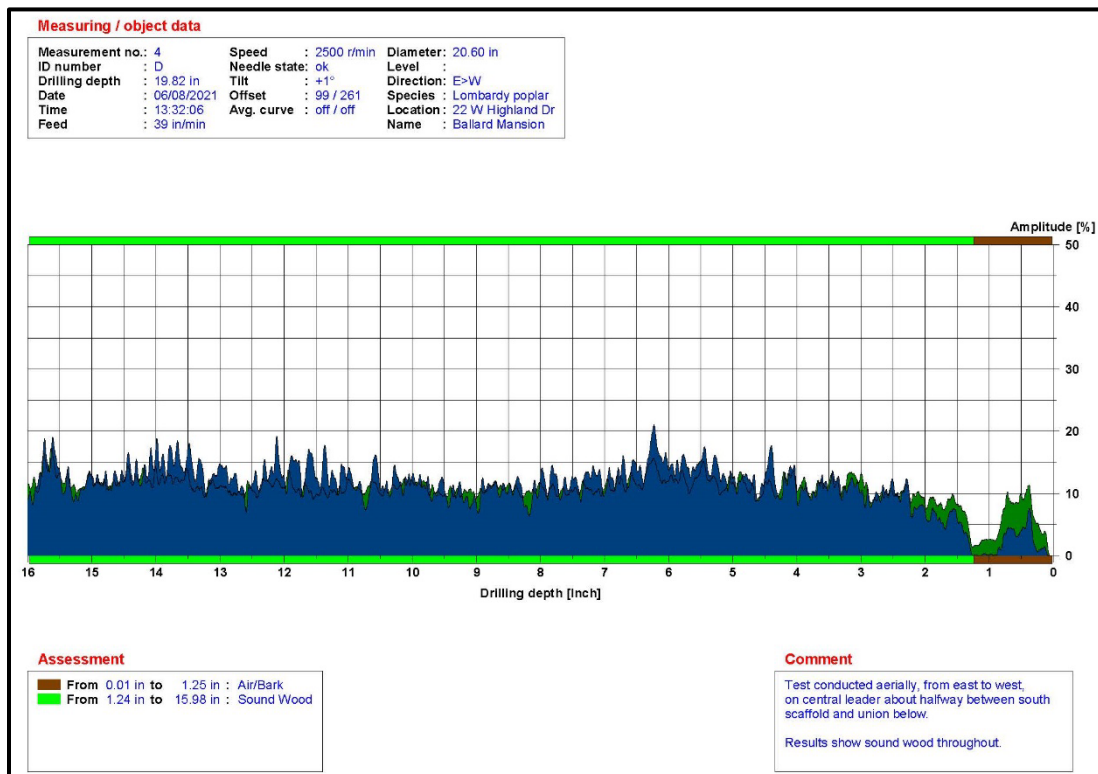
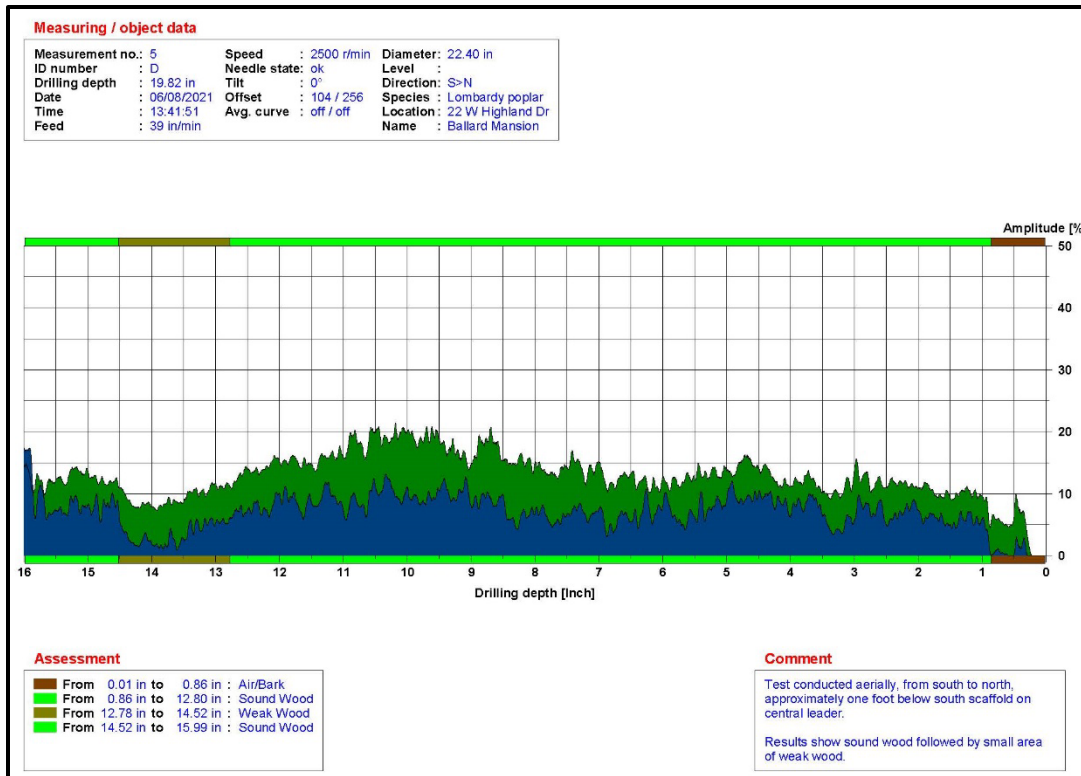
Figure 11. Results of test 1 on tree D, conducted at the base of the tree from west to east.

Figure 12. Results of test 2 on tree D, conducted at the base of the tree from east to west.

Figure 13. Results of test 3 on tree D, conducted aerially from east to west, below top two cavities along east side of central leader.

Figure 14. Results of test 4 on tree D, conducted aerially from east to west, on central leader about halfway between south scaffold and union below.

Figure 15. Results of test 5 on tree D, conducted aerially from south to north, approximately one foot below south scaffold on central leader.

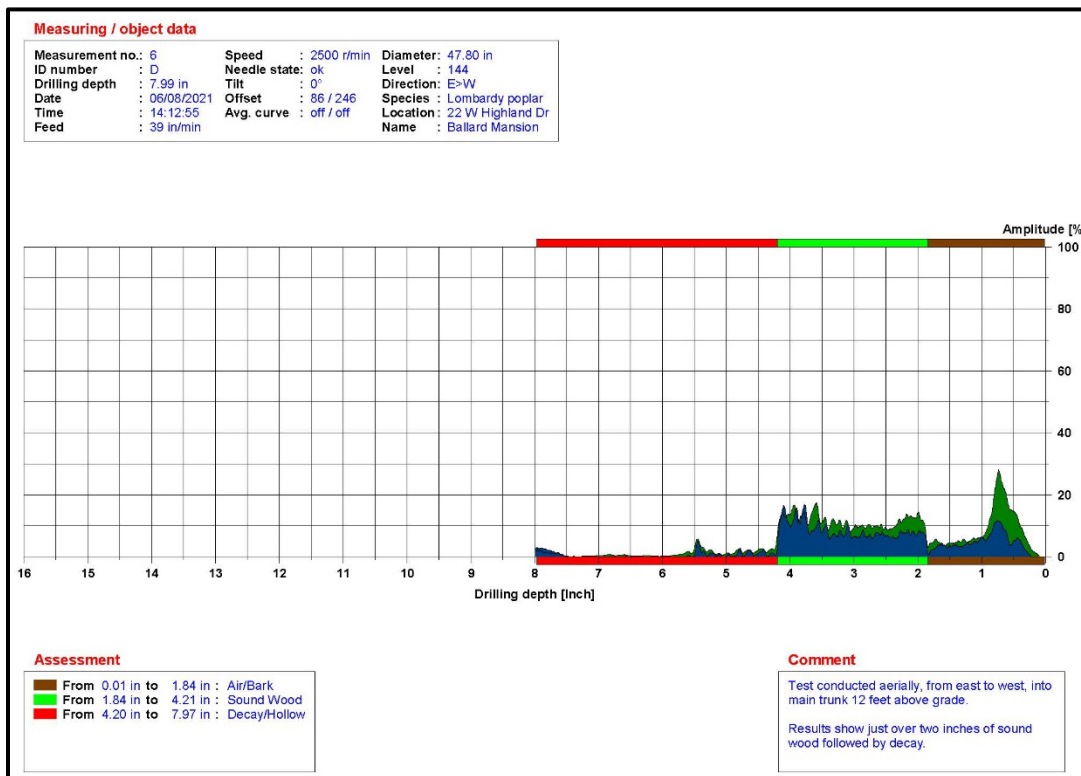
Figure 16. Results of test 6 on tree D, conducted aerially from east to west, into main trunk 12 feet above grade.

Photo 7. Tape around trunk of tree D indicates level at which test 6 was conducted (see Figure 16). The results of this test showed just over two inches of sound wood; this test result was the most concerning of all in our opinion because of how much tree material is supported by the weakened trunk of this tree.

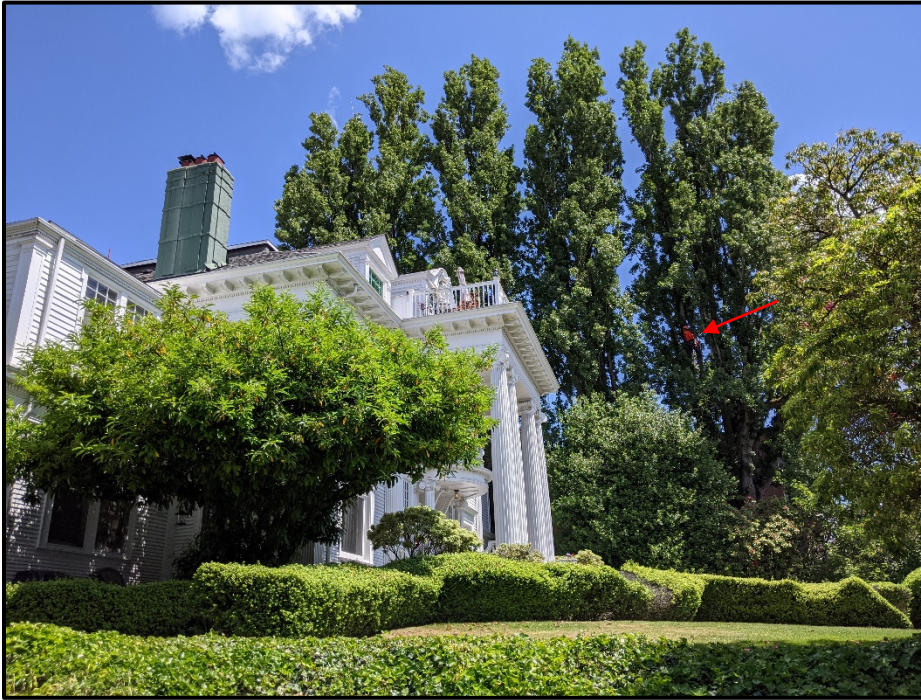
Photo 5. Looking east at row of subject trees with red arrow pointing to Connor in tree D. This provides size reference for amount of tree above average level of defects where Connor is located in tree.
