Villa Costella Condominium
Historic Preservation Certificate of Approval to Remove Tree
August 25, 2022
Prepared by: Elizabeth Friesen, President of Homeowner's Association Board of Directors

Request for Certificate of Approval to remove Palm Tree at NW corner of building

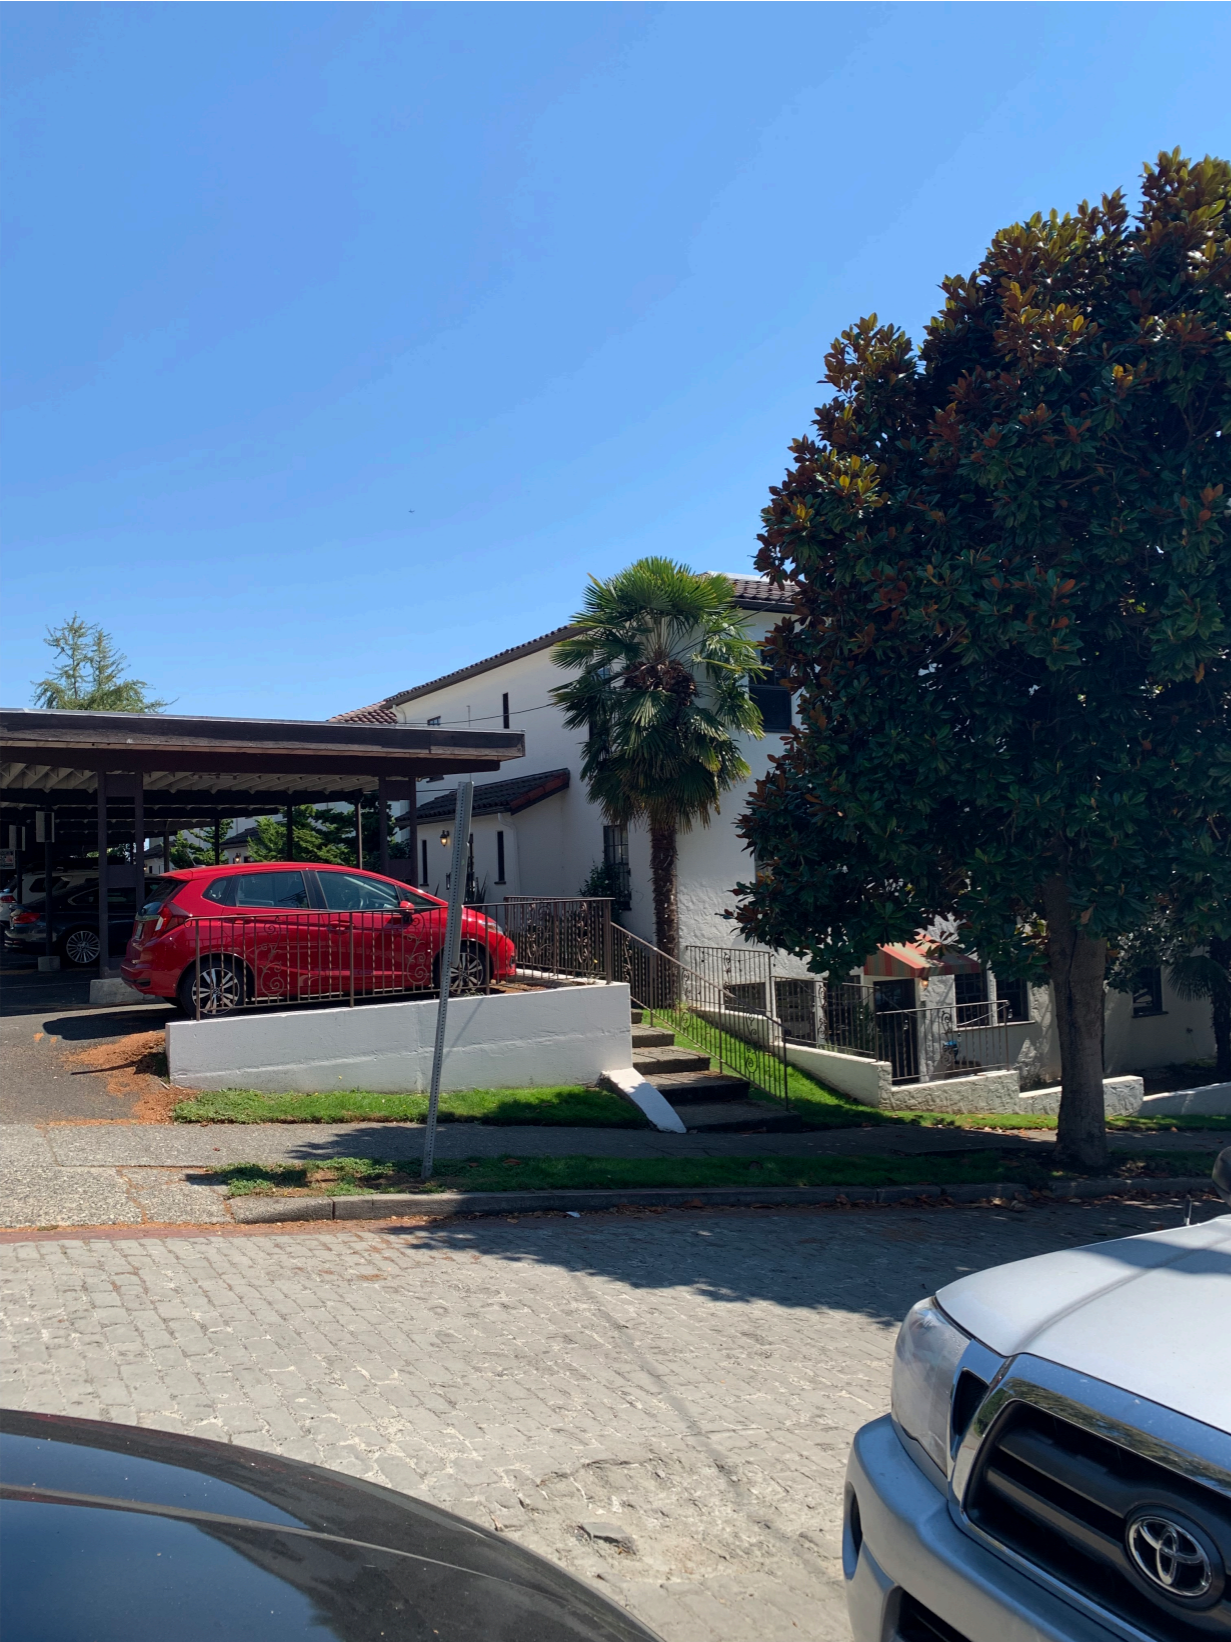
View from 5th Ave W

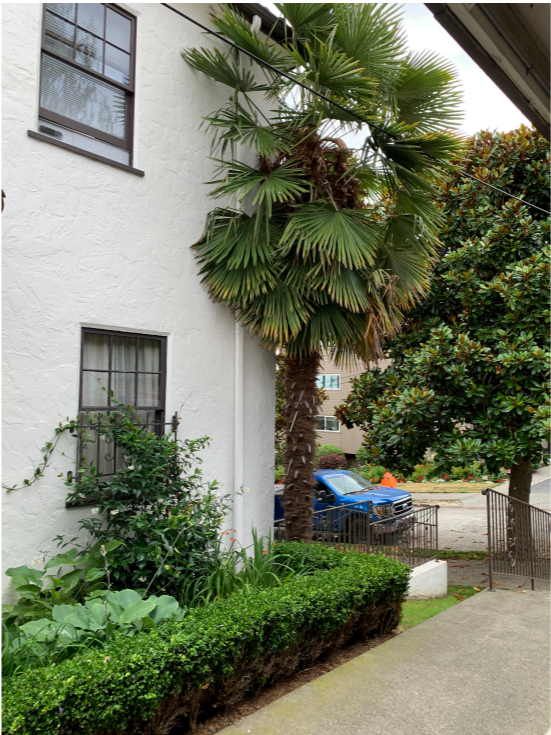
View from carport

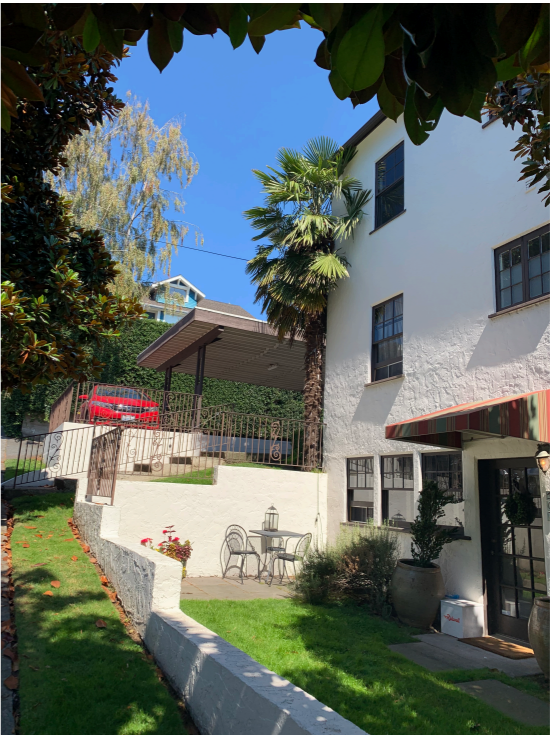
View looking North from 5th Ave W

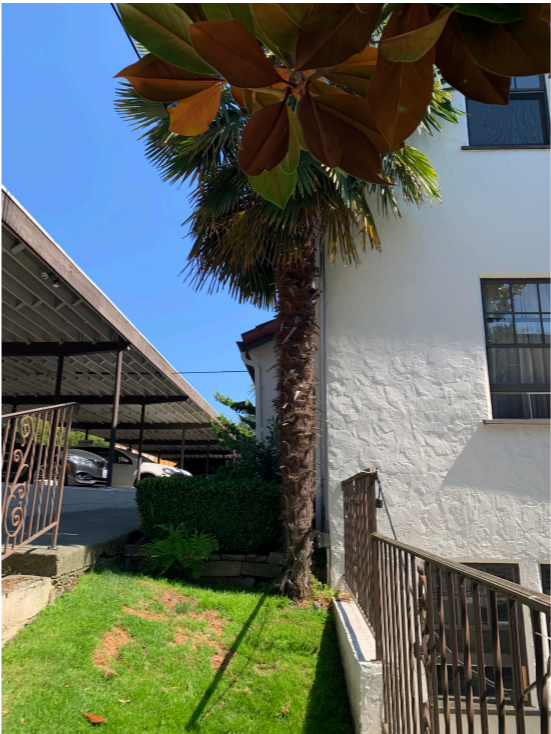
True North conducted an investigation of the cause of mold on February 17, 2022. The Leak Investigation Report concluded that the north foundation contain insufficient waterproofing and drainage. Further, it indicates that the vapor barrier may have been compromised by tree roots from a mature palm tree. The tree is located too close to the building, and its trunk at the base stands at eight (8) inches from the building. Recommendations in the report require excavation of dirt and plantings at the full height of the foundation where the tree is located, in order to remove intruding roots, and apply a vapor barrier to the foundation. The tree needs to be removed before work begins as at least 50% of the roots will be damaged by the excavation, making the tree unstable.

Base of tree 8" from building

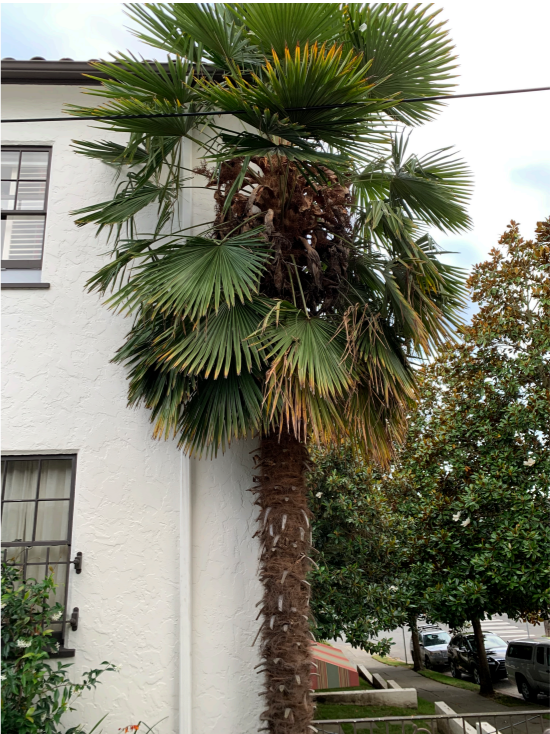
We're advised the palm is native to Peru, and a species that survives well in our Northwest climate. It is approximately twenty feet (20') tall, eleven inches (11") in diameter at four and half feet (4.5') from the ground. The trunk is 8" from the building and the fronds are against the walls and roof. A power line runs through the fronds.

Top of tree against building and through power line

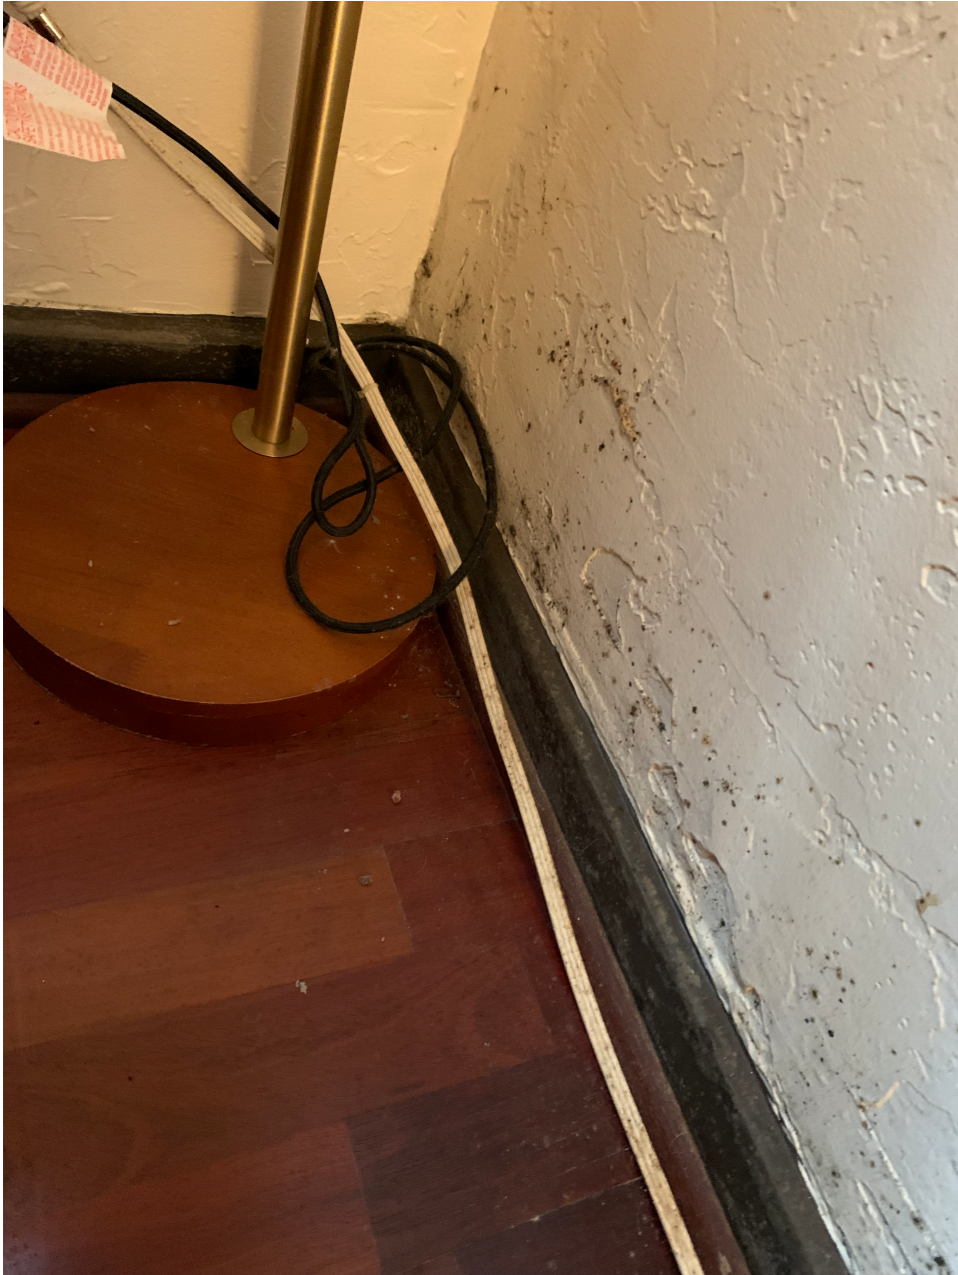
Mold growth at Northwest corner of Unit 107

Our construction consultant, True North, investigated the source of the leaks into the unit and determined that the foundation has been compromised, recommending repairs to the vapor barrier and ensuring tree roots are not able to continue intruding on the foundation.

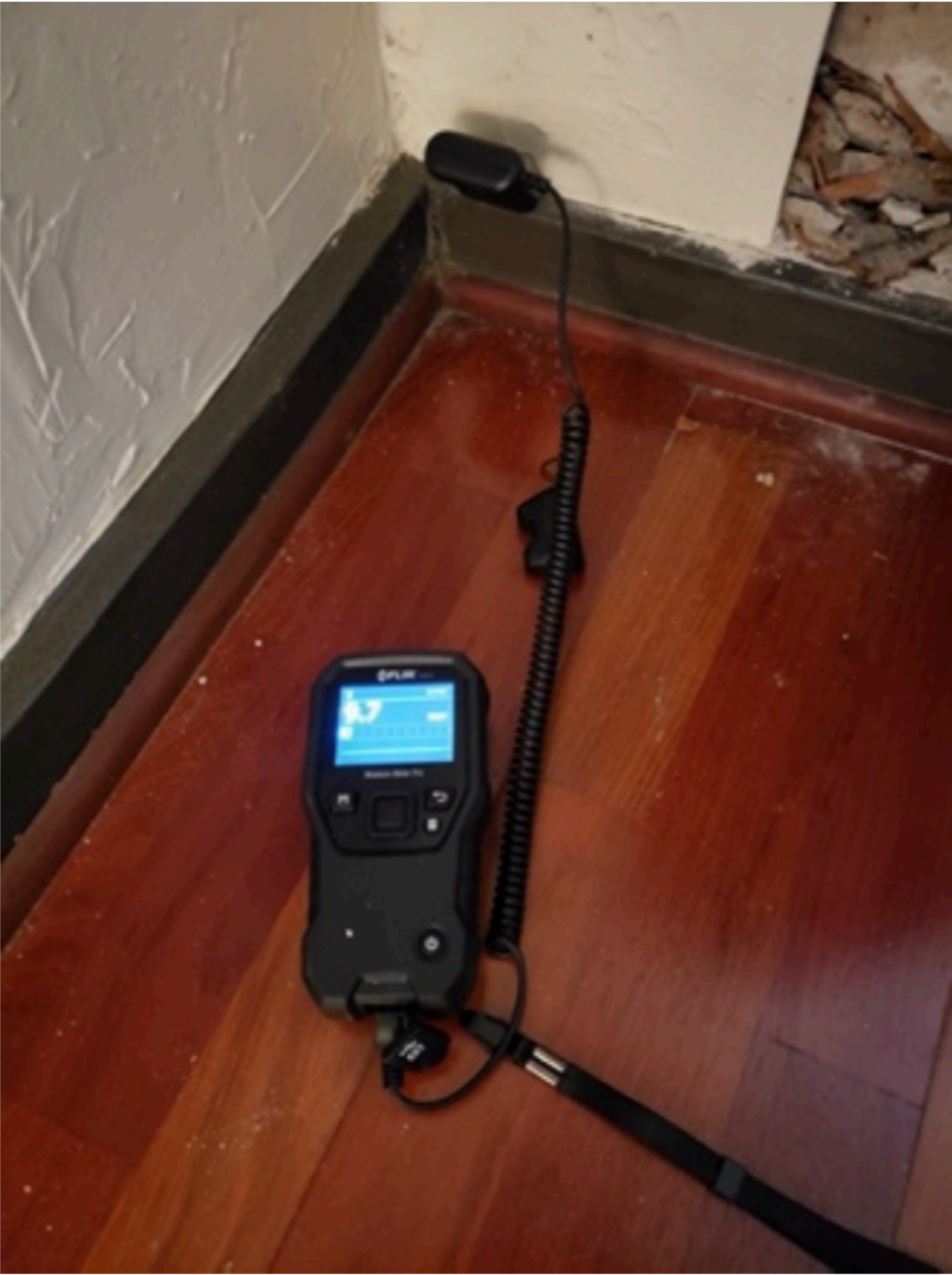
Elevated moisture readings at test location

True North Leak Investigation Report dated March 4, 2022 revealed high moisture readings at the base of the foundation where the tree is located. The report concludes that the moisture barrier and drainage system are compromised. The recommendation is that the dirt and plantings be excavated to full height of the foundation.
