DATE: October 6th 2022
BY: Marc Tegen

PART 1 – PROJECT NARRATIVE

1.1. Nathan Eckstein Middle School description

1.2. Brief Scope of work description

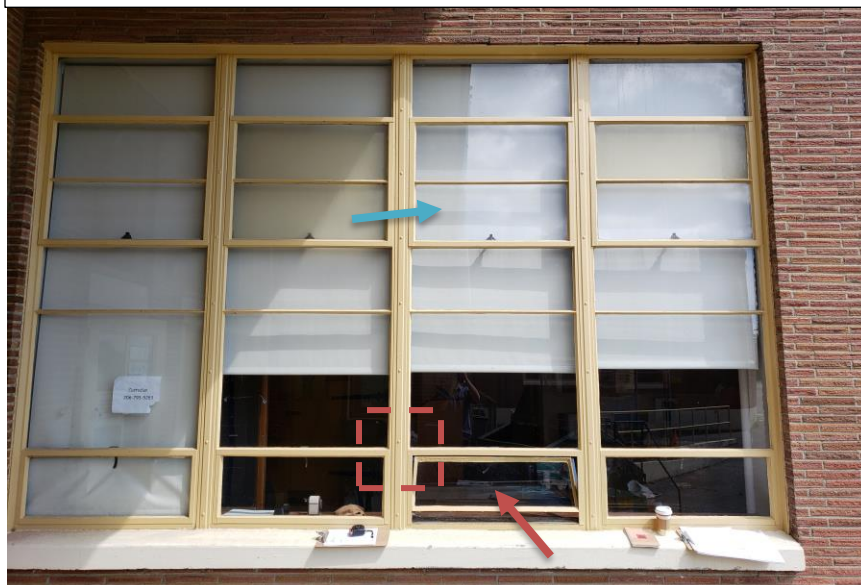
Photo-1 below depicts a series of original windows consisting of fixed, operable hoppers (red arrow), and awnings (blue arrow). Red dashed area below depicts the location of photo-4

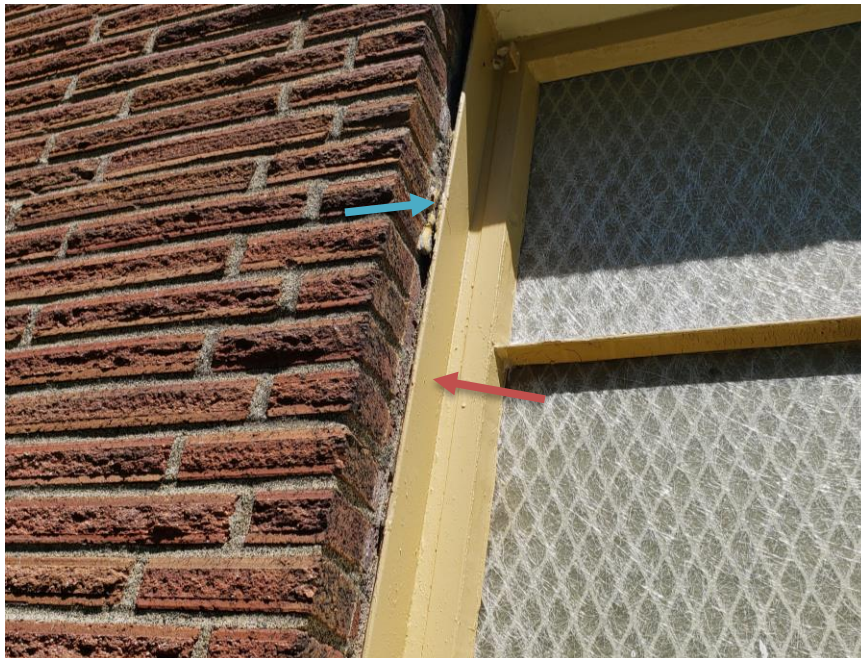
Photo-4, Red arrow above points to a painted steel plate used to secure the flange at the jamb of an original window. Blue arrow points to asbestos containing sealant. This photo also shows an example of how the original glazing has been replaced in many locations with reinforced fiberglass panels

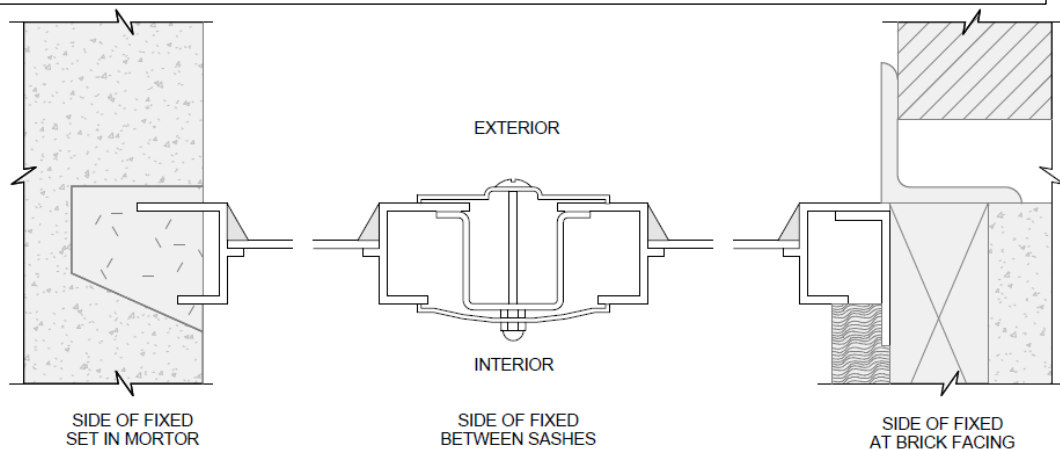
Sketch-1 below depicts the historic fixed window profiles at the two most common rough opening conditions at the window jambs.

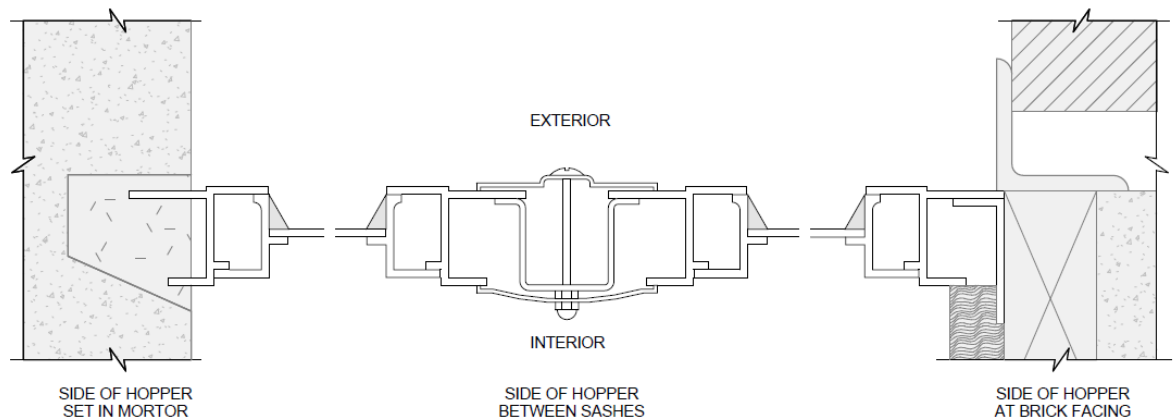
Sketch-2 below depicts the most common type of operable historic window profiles (in-swing hopper) at the two most common rough opening conditions at the window jambs.

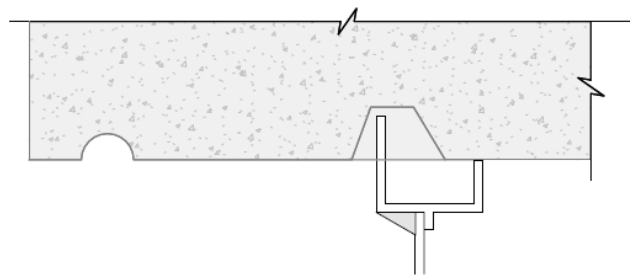
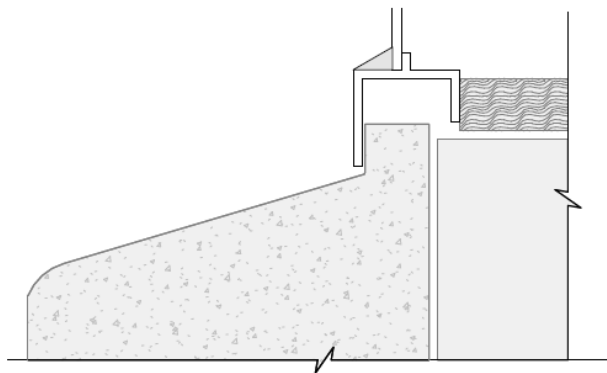
CONCRETE HEAD AT FIXED

Sketch-7 below depicts the historic fixed window profiles at the two most common head/sill rough opening conditions.

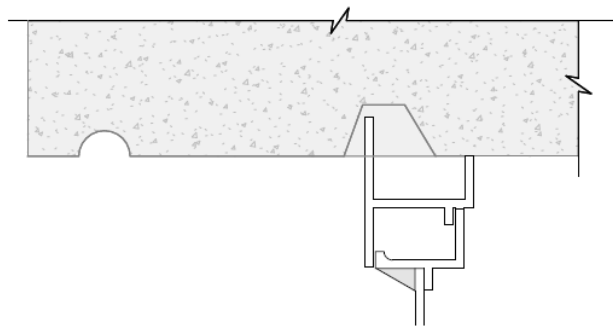
CONCRETE HEAD AT HOPPER

Sketch-8 below depicts the historic operable window profiles at the two most common head/sill rough opening conditions.

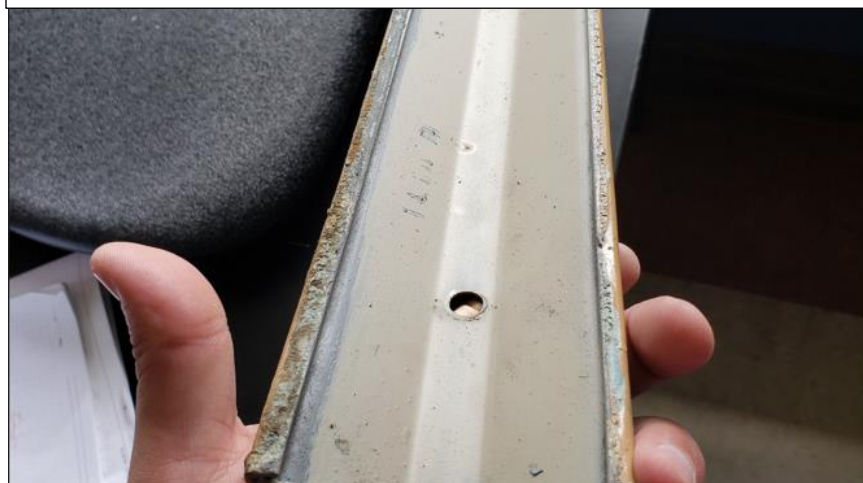
Photo-5 above was taken within the sill of an operable window sash where the current top paint coating (non-historic, see red arrow), can be seen dripping over an underlying tan colored coating (presumed historic top coat, see blue arrow) that is currently peeling off an underlying green colored coating (presumed primer, see green arrow).

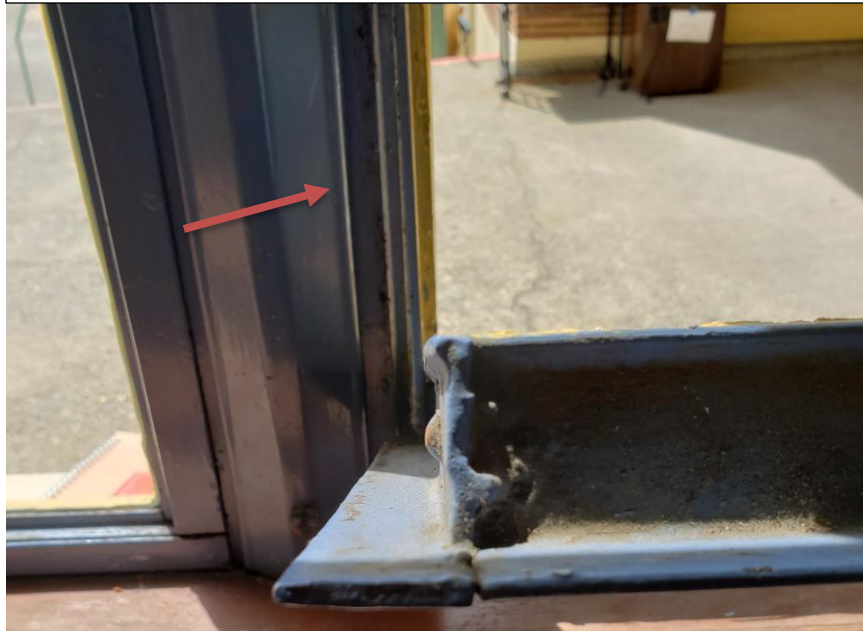
Photo-7 below depicts the typical “blue” color found on the interior portions of the original steel framed windows/operable sashes. Red arrow points to the 1/16-inch thick formed steel plates that are also used to secure the window jambs on the interior side of the windows.

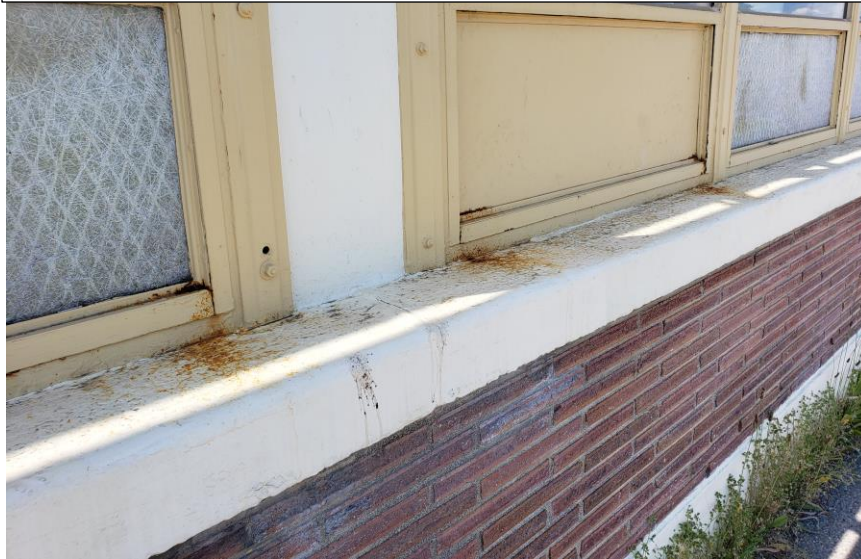
Photo-8 below depicts the common form of corrosion found at the lower corners of in-swing hopper windows.

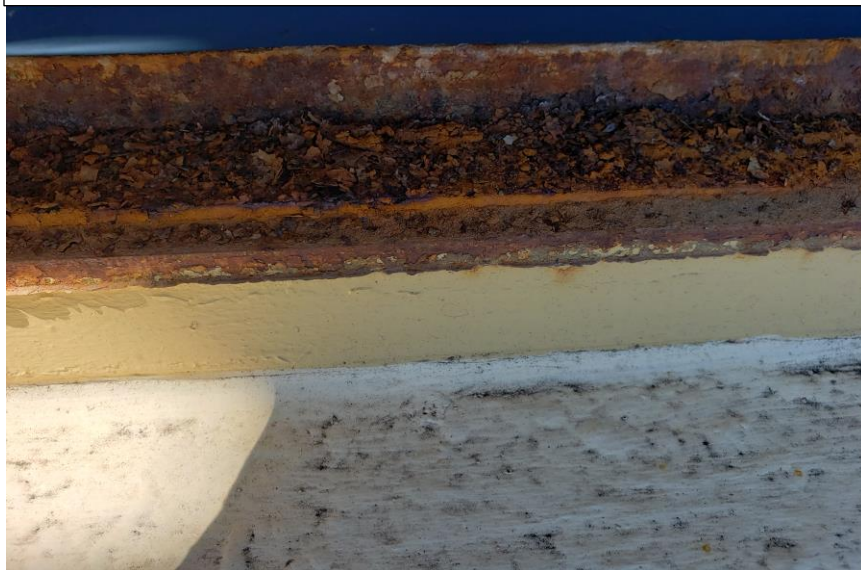
Photo-9 below depicts the sill of a window frame that is corroding due to moisture leaks at the lower corner of an in-swing hopper window.

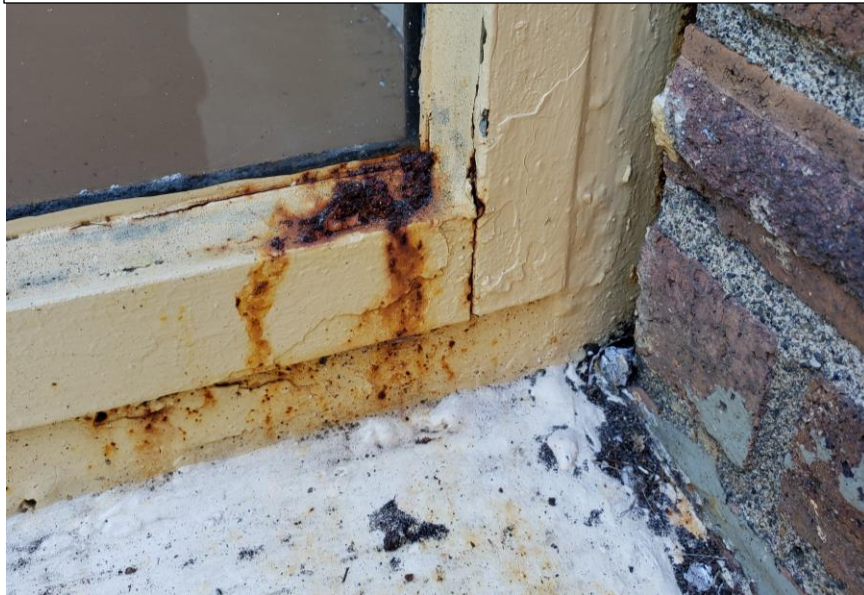
Photo-11 below depicts a close up view of the corrosion found at the lower corners of in-swing hopper windows.

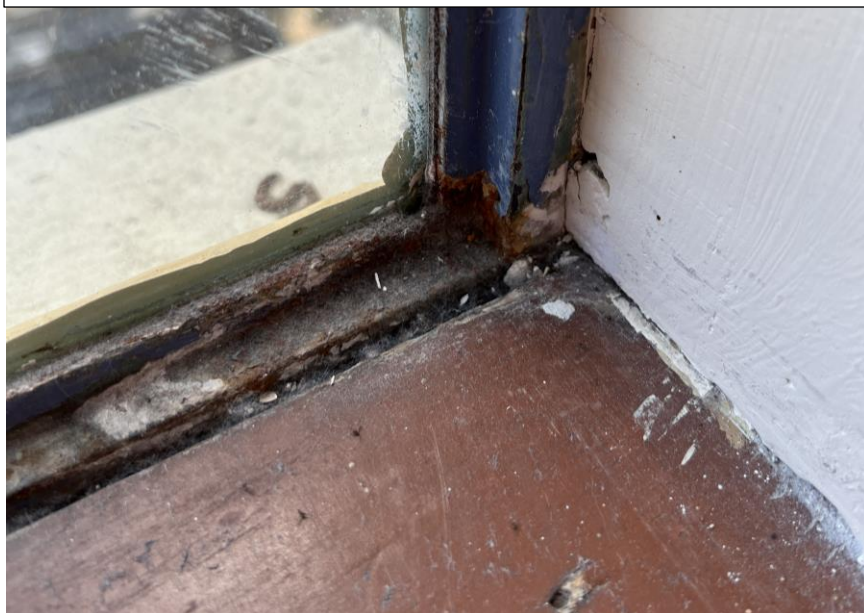
Photo-12 below depicts corrosion on the interior side of a fixed window.

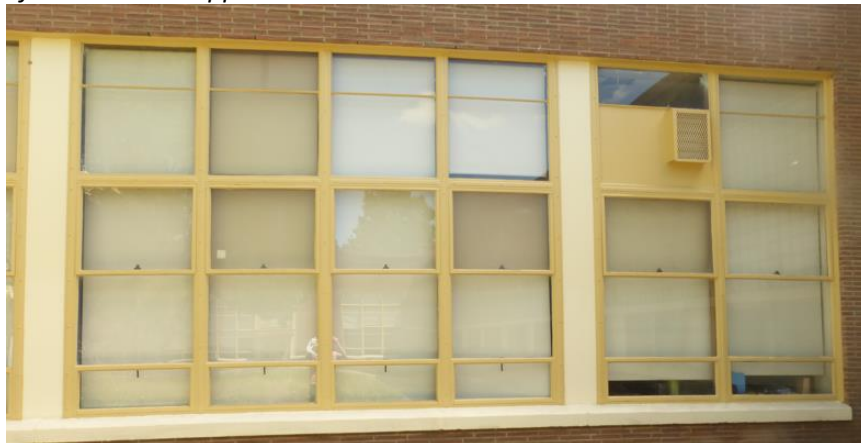
Photo-13 above depicts three distinct glazing colors over a series of adjacent windows as well as an example of a glazing panel that was infilled for an exhaust vent.

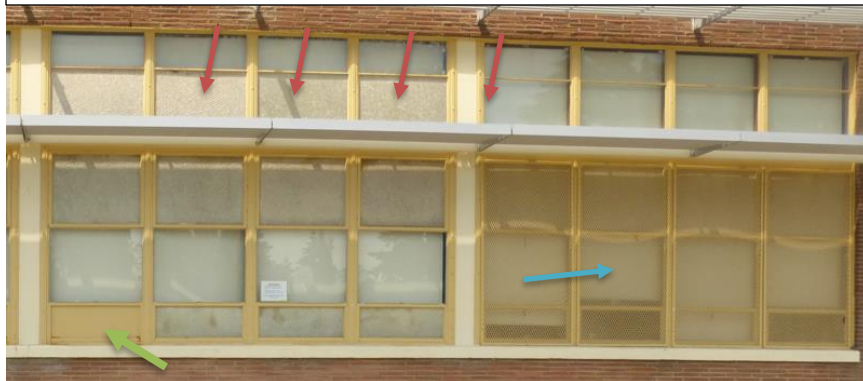
Photo-15 above depicts window glazing that has been replaced with fiberglass/expanded steel mesh panels (red arrow), where the glazing of a lower in-swing hopper has been replaced with a painted sheet metal panel (green arrow), and where a painted steel screen is installed over a section of windows (blue arrow).
