Arborist Report

To: Seattle Public Schools, c/o Ethan Bernau
Site: 7201 Beacon Ave S., Seattle WA 98108
Re: Preliminary Tree Inventory
Date: August 17, 2021
Project Arborist: Josh Petter
ISA Board Certified Master Arborist #PN-8406B
ISA Qualified Tree Risk Assessor
Reviewed By: Katie Hogan
ISA Certified Arborist #PN- 8078A
ISA Qualified Tree Risk Assessor
Attached: Table of Trees
Tree Site Map

Summary

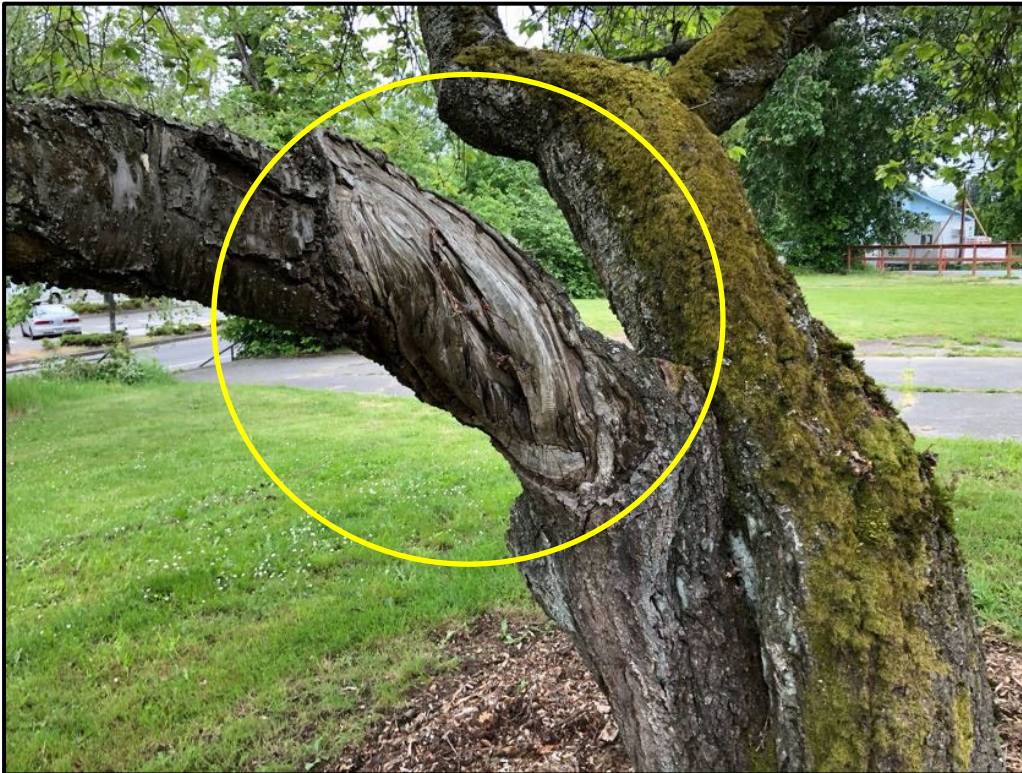
Tree 123 is a flowering cherry (*Prunus serrulata*) in fair health and structural condition. This tree has codominant trunks at the base, with decay visible between the union. There are also a number of large old pruning wounds.

Photo 1. Exceptional tree 123, the yellow circle shows an old branch tear out.

Tree ID	Scientific Name	Common Name	DSH (inches)	DSH Multistem	Health Condition	Structural Condition	N	E	S	W	Exceptional Threshold	Exceptional by Size	Proposed Action	Notes
123	<i>Prunus serrulata</i>	Flowering cherry	23.3	19,13.5	fair	fair	19.0	17.5	16.0	13.0	23.0	Exceptional	Retain	Codominant trunks at base; decay between union; 10 inch pruning wound with decay column on east side of trunk; old branch tear out on west side
124	<i>Betula pendula</i>	European white birch	21.0		fair	poor	21.9	19.9	19.4	20.4	24.0	-	Retain	Measured at narrowest point below union; lots of low scaffold branches; unusual form for this tree; pruning wounds and decay present
125	<i>Cornus kousa</i>	Kousa dogwood	22.2		good	fair	20.9	18.9	15.9	16.9	12.0	Exceptional	Retain	Check on species; ivy climbing the trunk; blackberry at base; close to existing trunk; some minor dieback; cherry laurel near base; old dead leader, approximately 3 in diameter should be removed; wound at base

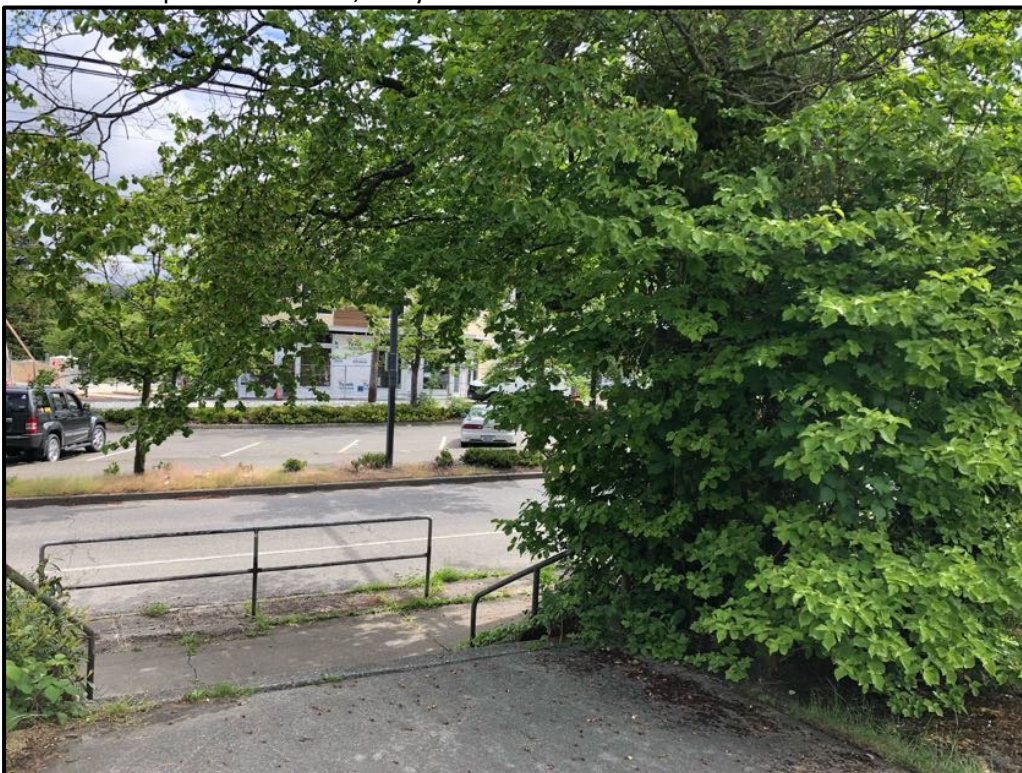
Tree 125 is a Kousa dogwood (*Cornus kousa*) in good health and fair structural condition. This tree has a large amount of invasive blackberry (*Rubus bifrons*) and ivy (*Hedera* sp.) at the base; the invasive plants should be carefully removed by hand.

Photo 2. Exceptional tree 125 is in close proximity to an existing staircase and has a large amount on ivy on the trunk

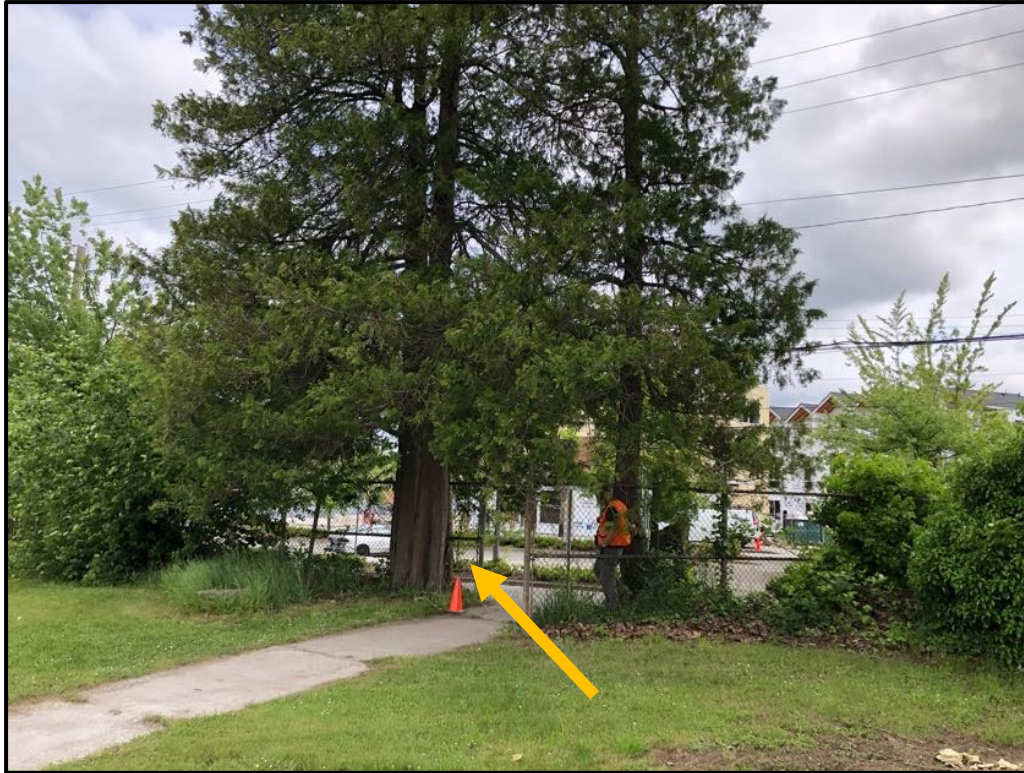
Tree 126 is a Lawson cypress (*Chamaecyparis lawsonia*) in good health and fair structural condition. It is growing next to an existing staircase and pushing against a chain-link fence.

Photo 3. Exceptional tree 126, is in close proximity to an existing staircase and abutting the fence.

126	<i>Chamaecyparis lawsoniana</i>	Lawson cypress	30.3	23,19.8	good	fair	14.3	11.8	14.3	14.3	30.0	Exceptional	Retain	Some decay between union; wound on inside of north trunk
127	<i>Chamaecyparis lawsoniana</i>	Lawson cypress	16.7		good	fair	9.7	8.7	12.7	15.7	30.0	-	Retain	Ivy on trunk; dead trunk on east at base
128	<i>Populus trichocarpa</i>	Black cottonwood	54.0		good	good	33.8	33.8	46.8	33.8	Not Exceptional except in grove	-	Retain	Populus deltoides; large amount of ivy in trunk which limited assessment; some deadwood under 2 inches; while it looks good this species is known for dropping branches; i would not build too closely to this tree; we were only able to measure half diameter and double it due to access, fence against the trunk of tree; must remove ivy climbing into canopy
129	<i>Quercus macrocarpa</i>	Burr oak	36.8		good	good	20.5	28.5	39.5	21.0	30.0	Exceptional	Retain	Ivy climbing trunk

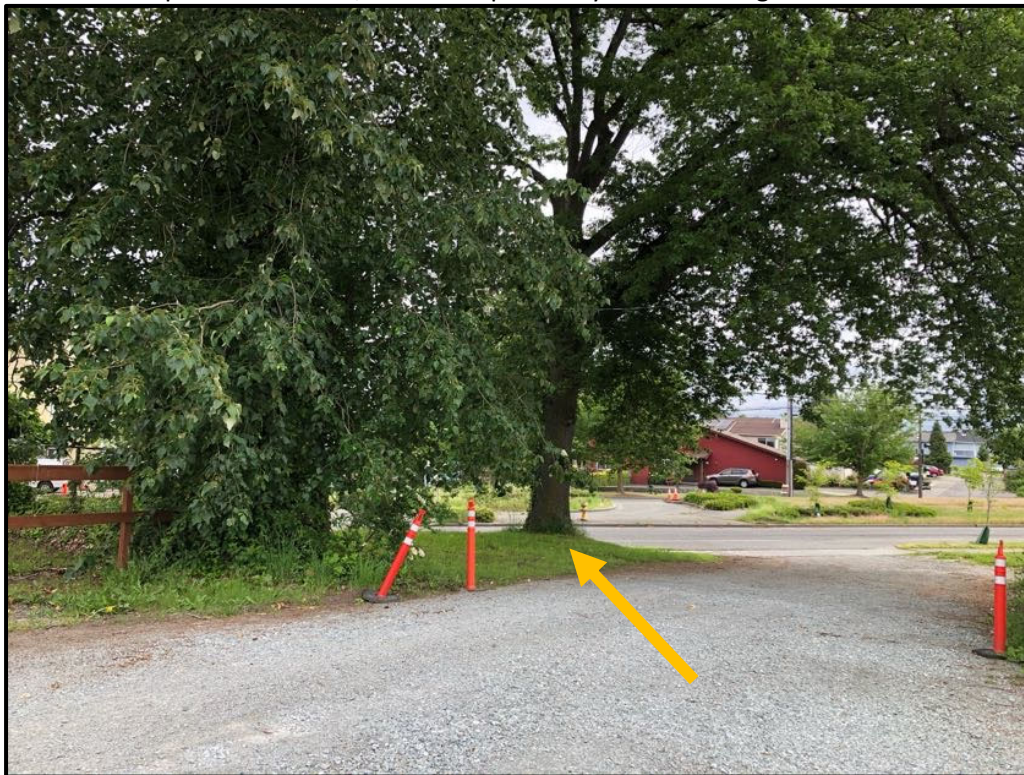
Tree 129 is a burr oak (*Quercus macrocarpa*) in good health and structural condition. This tree is in close proximity to an existing gravel driveway.

Photo 4. Arrow pointing to exceptional tree 129 is in close proximity to an existing gravel driveway.

In order to accommodate the roundabout tree 128, a black cottonwood, will have to be removed. This tree is growing adjacent to tree 129 and have shared canopies. This tree must be directionally felled away from the oak to prevent damage to the trunk of the tree. Additionally, the stump must be ground out to prevent disturbance to the root system of the retained tree.
