PHOTOGRAPHS
BEFORE REHABILITATION

RAINIER BREWERY
BOTTLING PLANT
(SEATTLE BREWING & MALTING CO)

5710 Airport Way S, Seattle, WA 98108

PHOTOGRAPHS
AFTER REHABILITATION

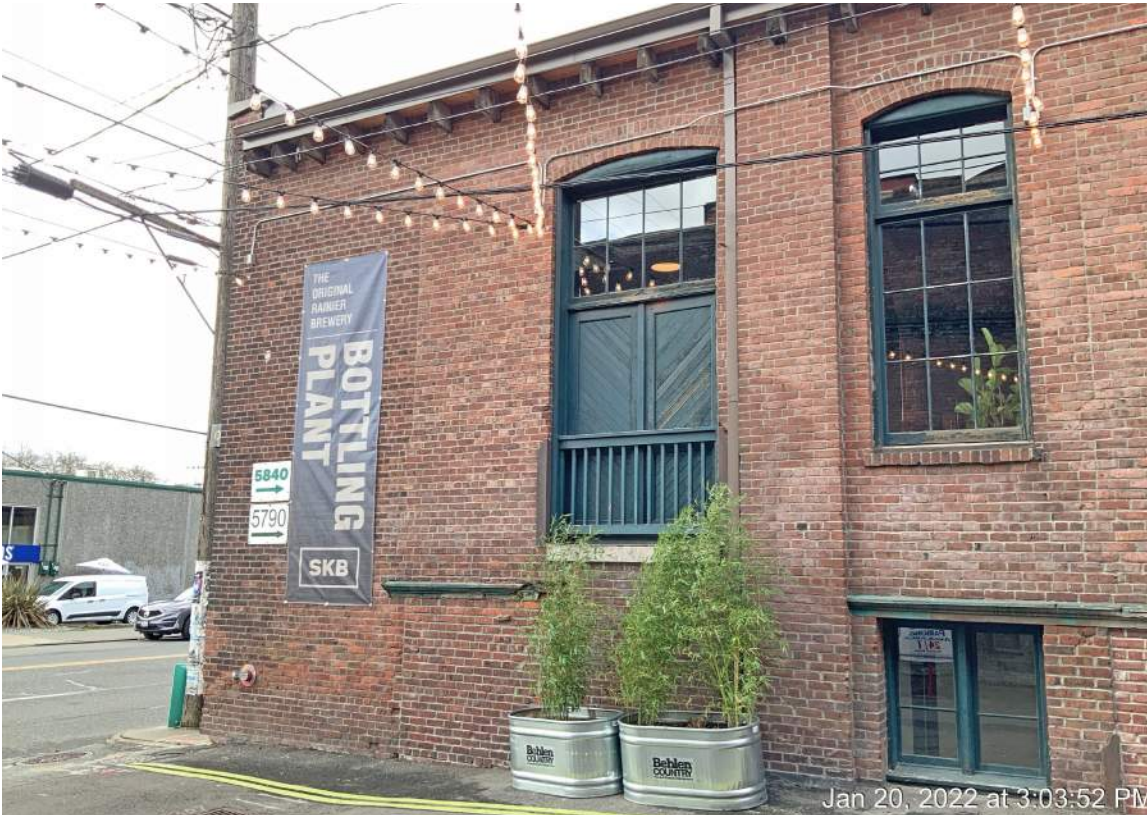
01

Brick wall; wood windows; repointed brick; new roof trim and gutter; new conduit and string lighting.

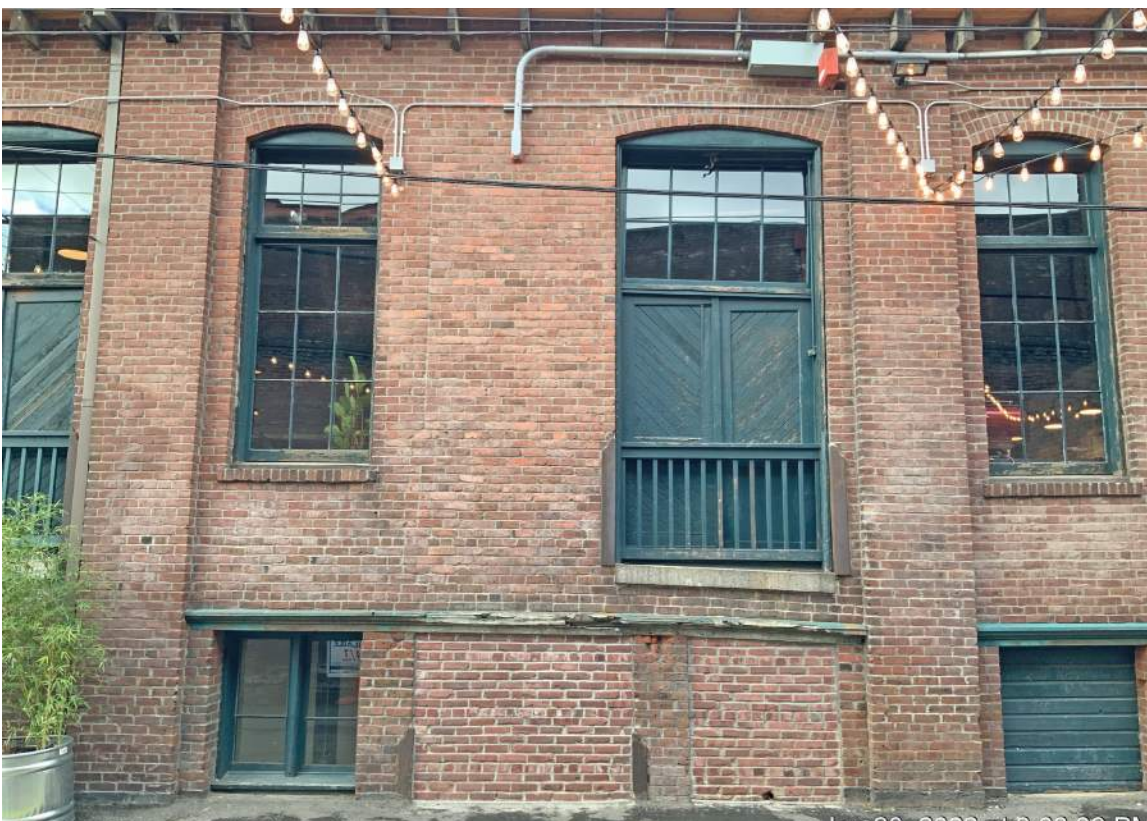
02

Brick wall; wood windows; new brick infill at existing openings; new light fixture and conduit; new downspouts; new conduit and string lighting.

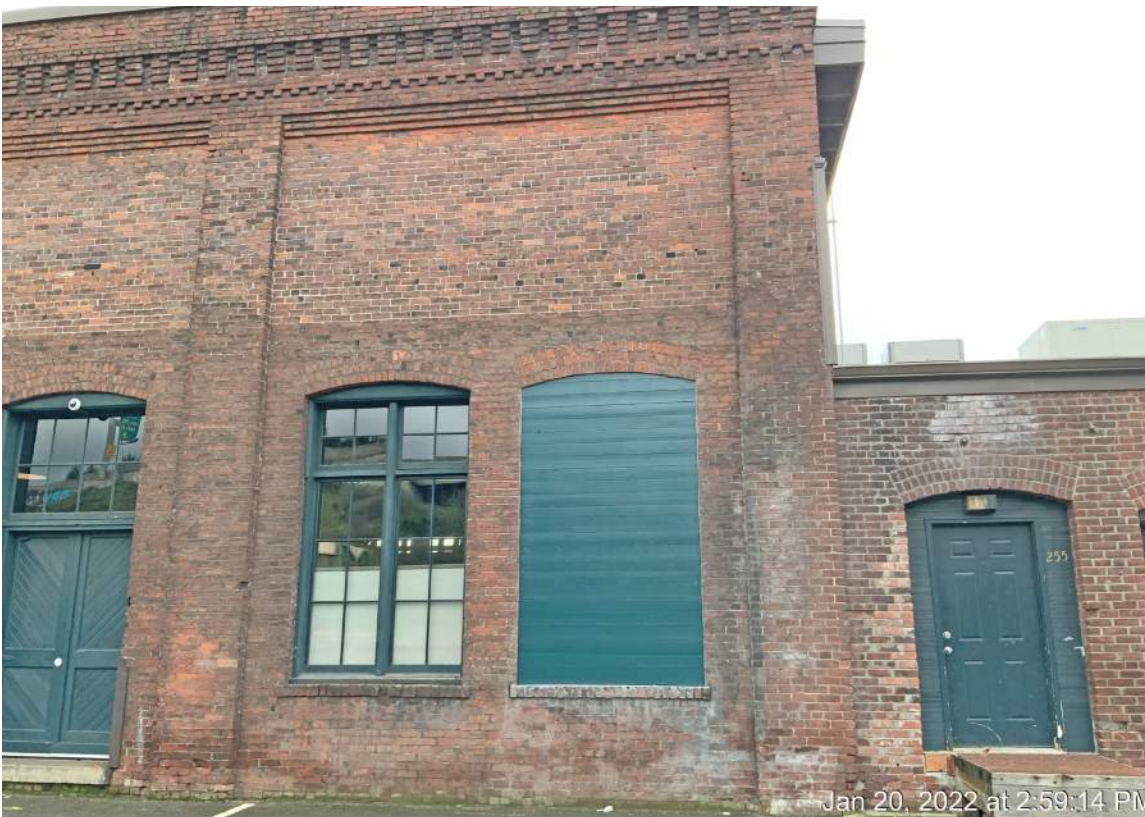
08

Brick wall; wood windows;
previous new wood infill
at existing opening; new
roof trim, parapet cap,
and gutter; new rooftop
mechanical.

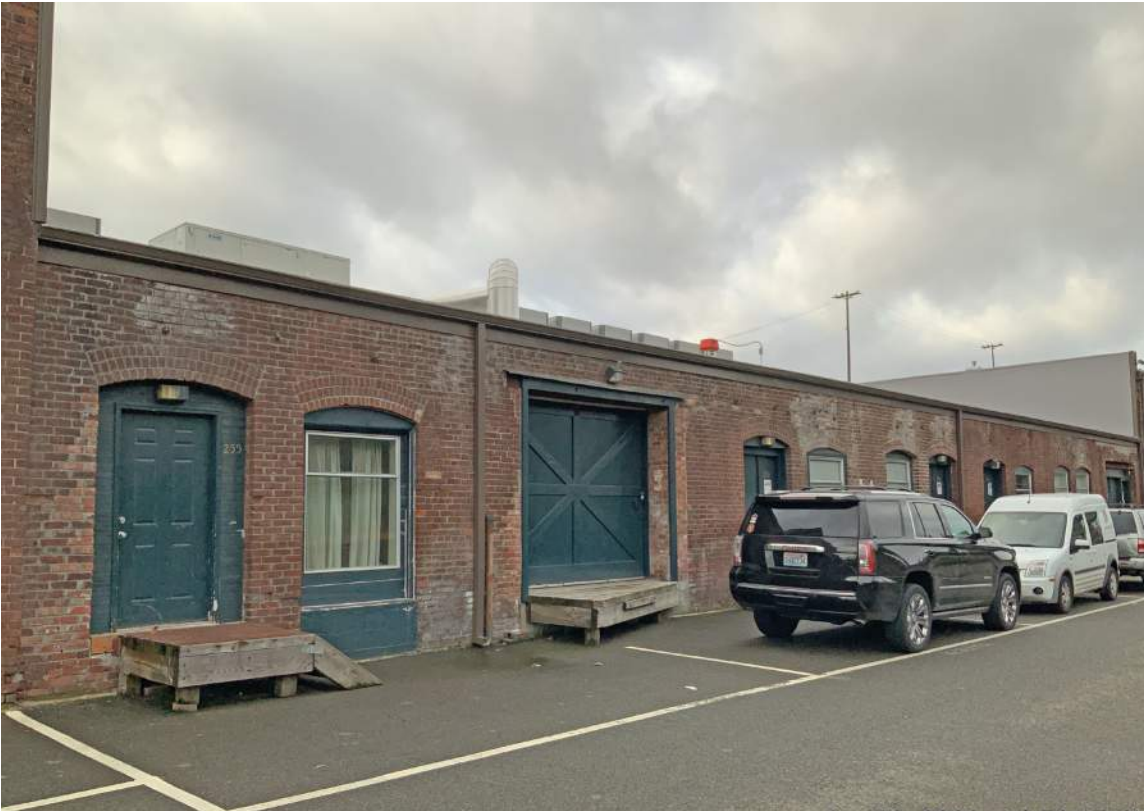
09

Brick wall; previous replacement windows; previous infill openings; new wood infill at existing opening; new light fixtures; new roofing; new roof trim, parapet cap, and gutter; new downspouts; new rooftop mechanical.

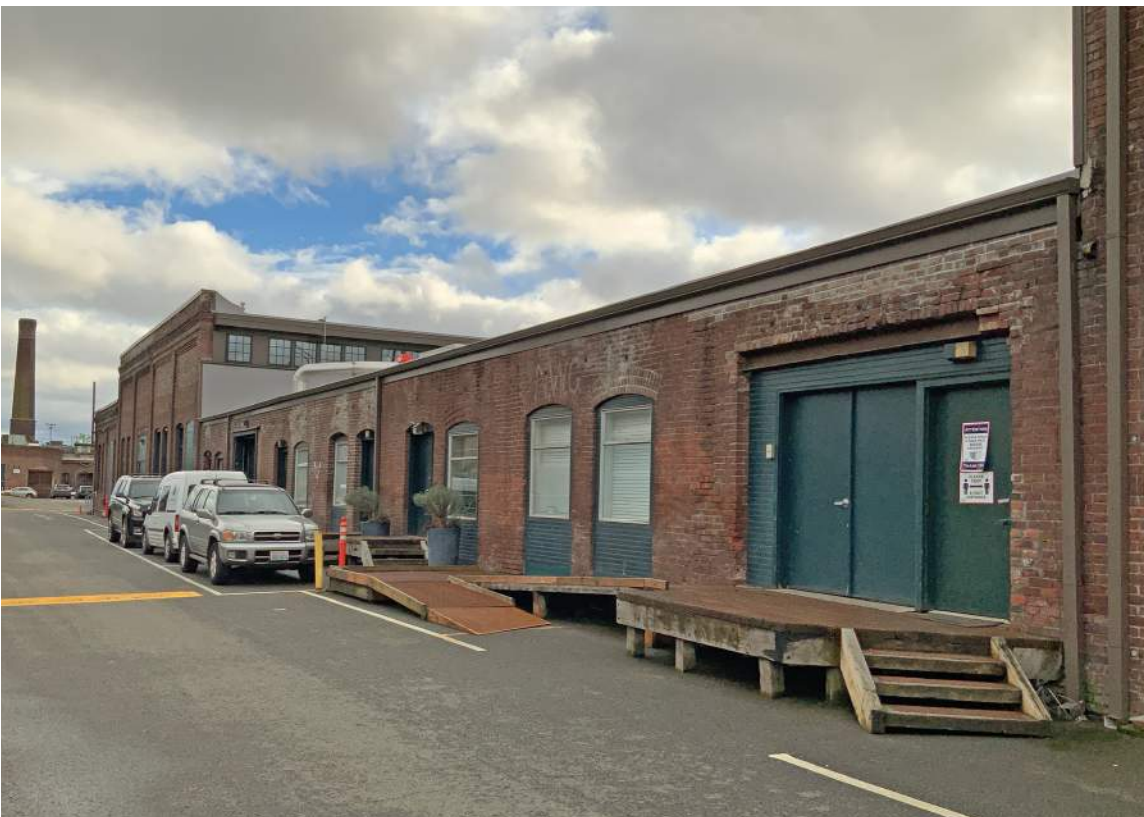
10

Brick wall; previous replacement windows; previous infill openings; new wood infill at existing opening; new light fixtures; new roofing; new roof trim, parapet cap, and gutter; new downspouts; new rooftop mechanical.

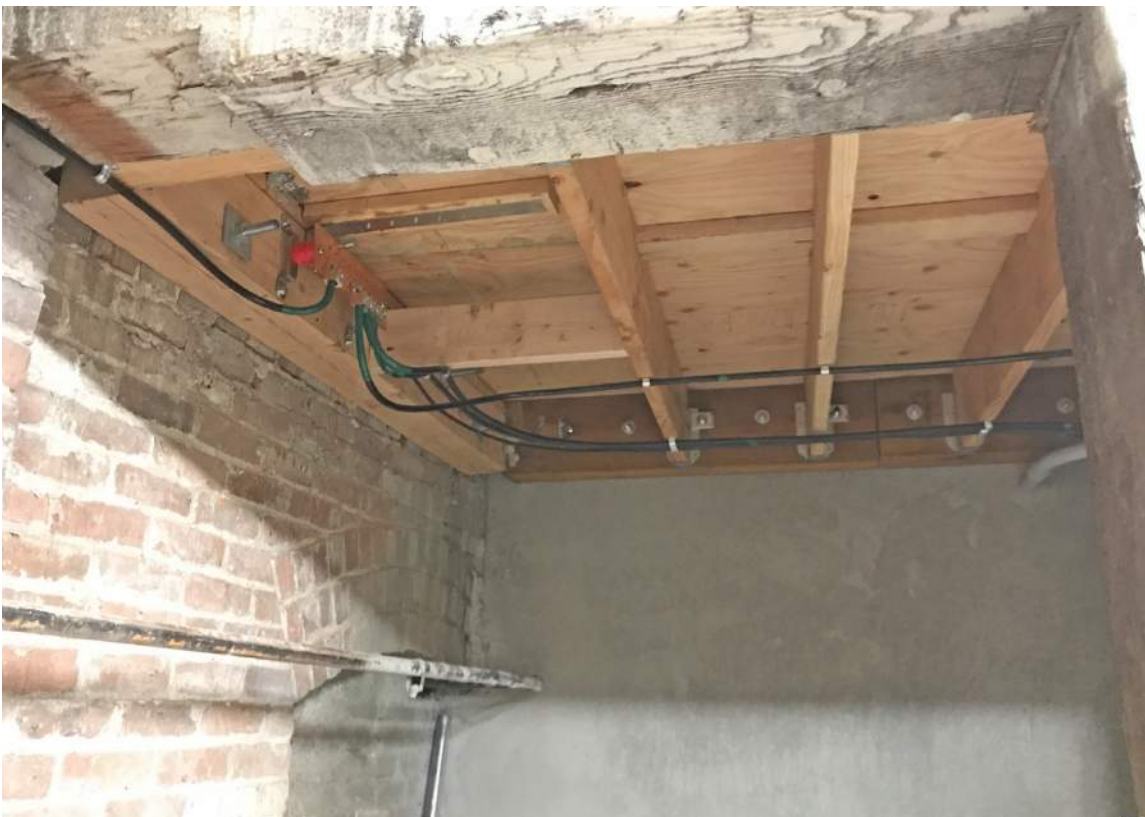
Painted wood beam &
column; brick walls; new
concrete shear wall; new
wood floor framing; new
electrical conduit.

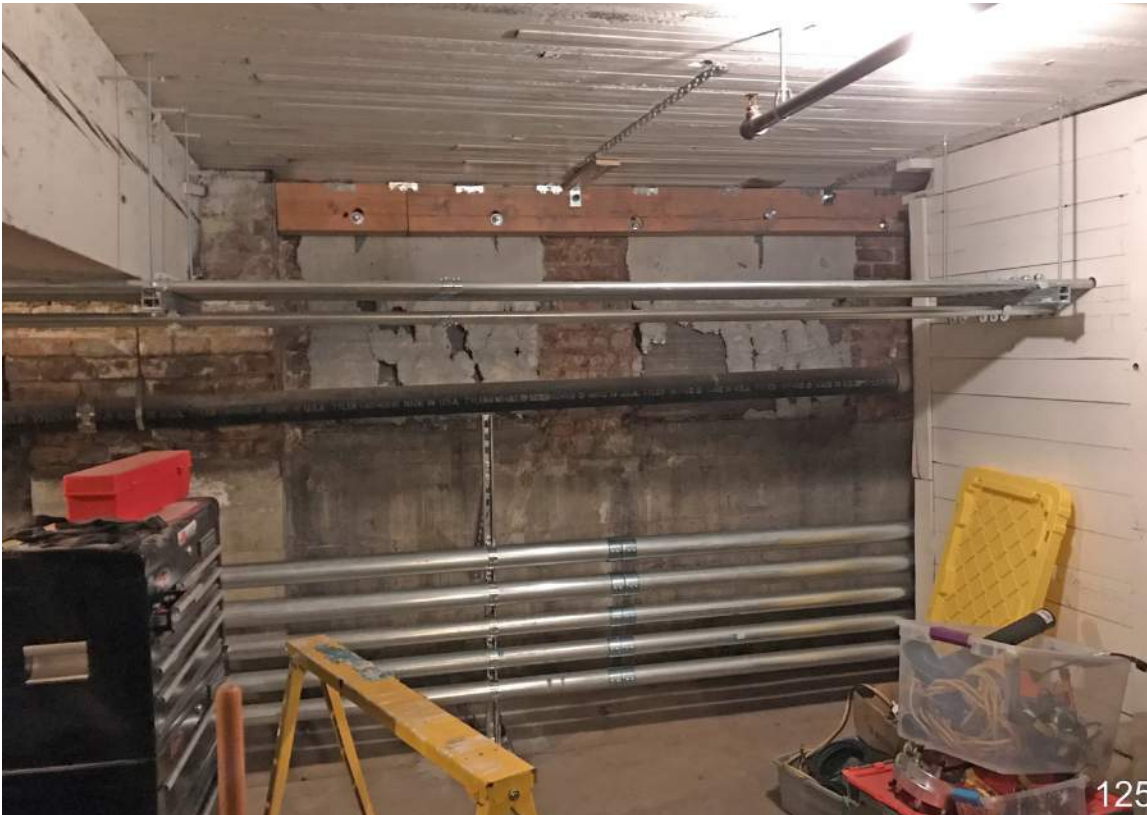
Painted wood ceiling;
brick walls; painted wood
wall; concrete pony
walls; wood beam; new
anchor bolts, strapping,
and wood blocking; new
concrete infill at existing
opening; new electrical
conduit.

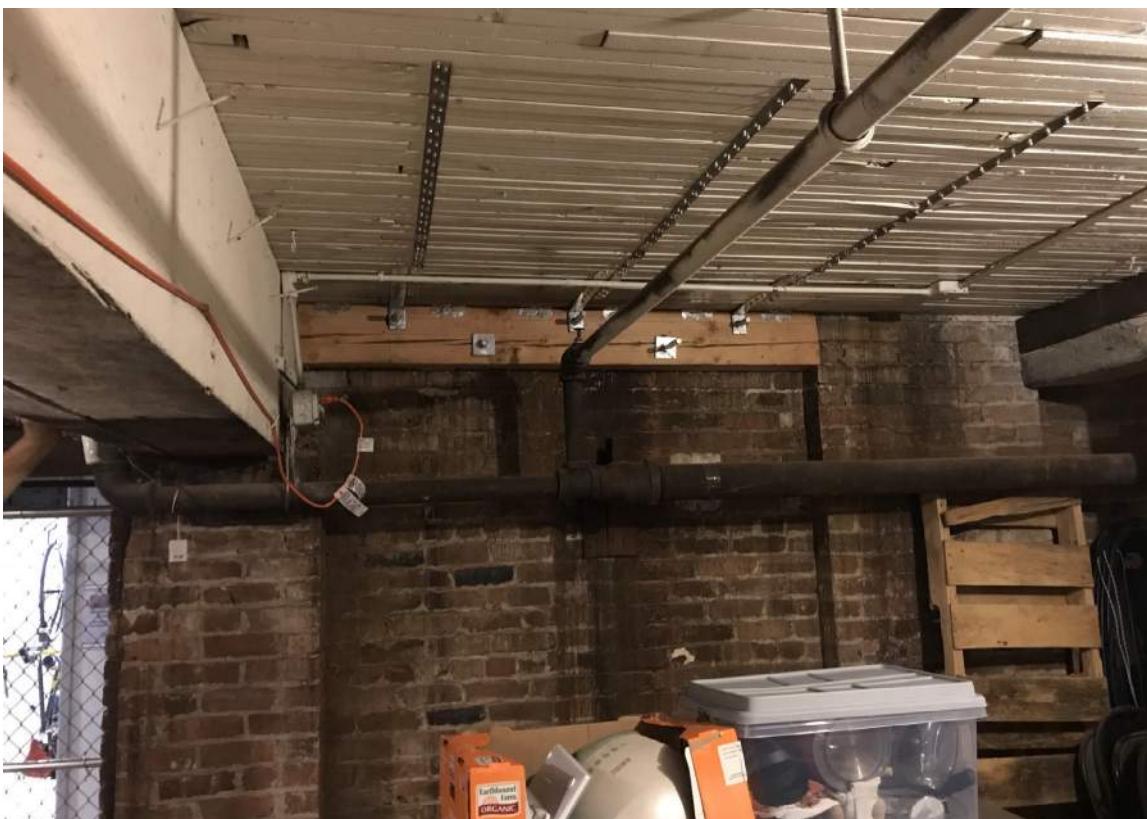
24

Painted wood ceiling; brick
walls; wood beams; new
anchor bolts, strapping,
and wood blocking.

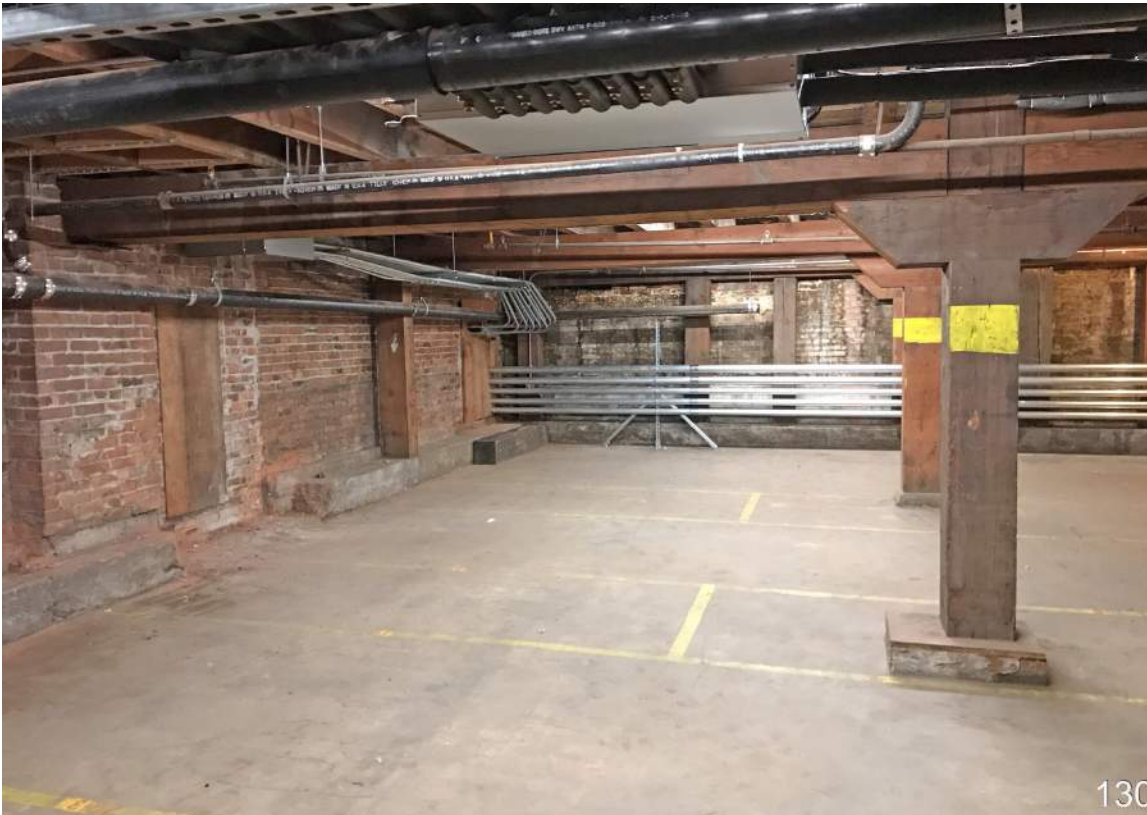
Wood ceiling; brick walls; concrete floor; wood beams, joists, and columns; concrete pony walls; new anchor bolts, strapping, and wood blocking; new electrical conduit and equipment.

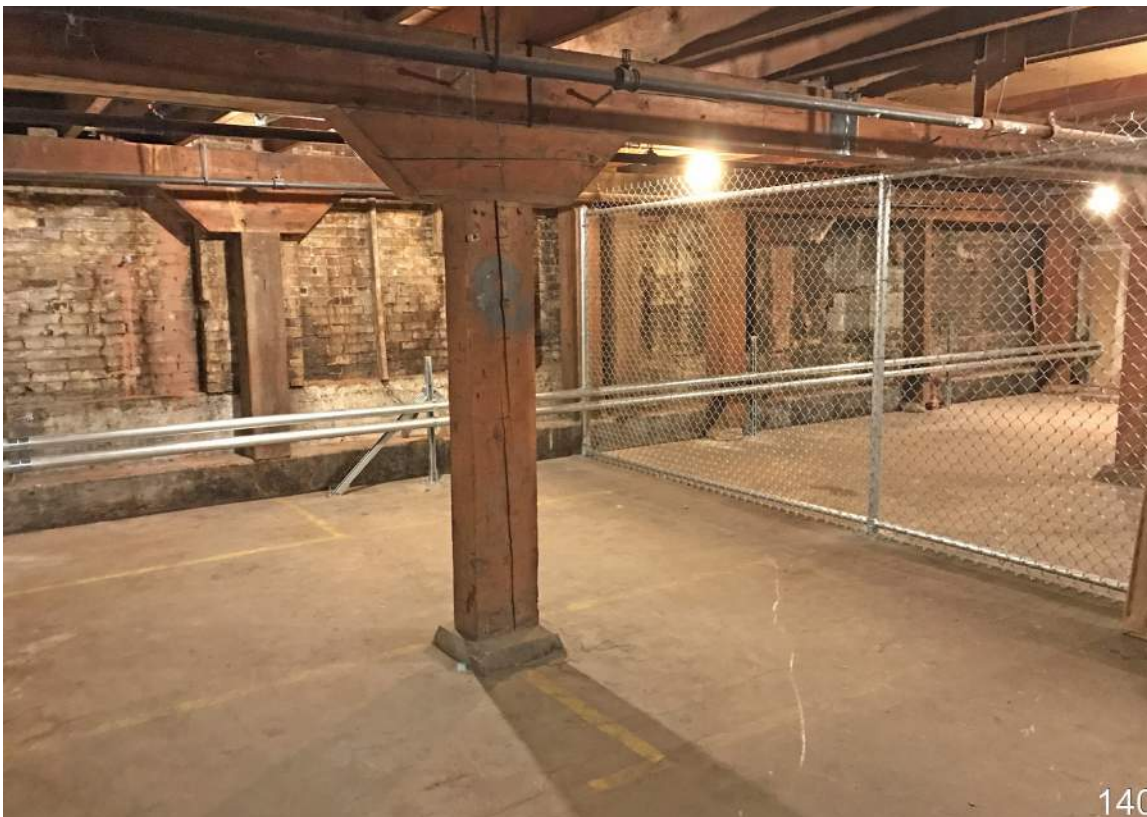
27

Wood ceiling; brick walls; concrete floor; wood beams, joists, and columns; concrete pony walls; previous concrete block infill; new anchor bolts, strapping, and wood blocking; new electrical conduit.

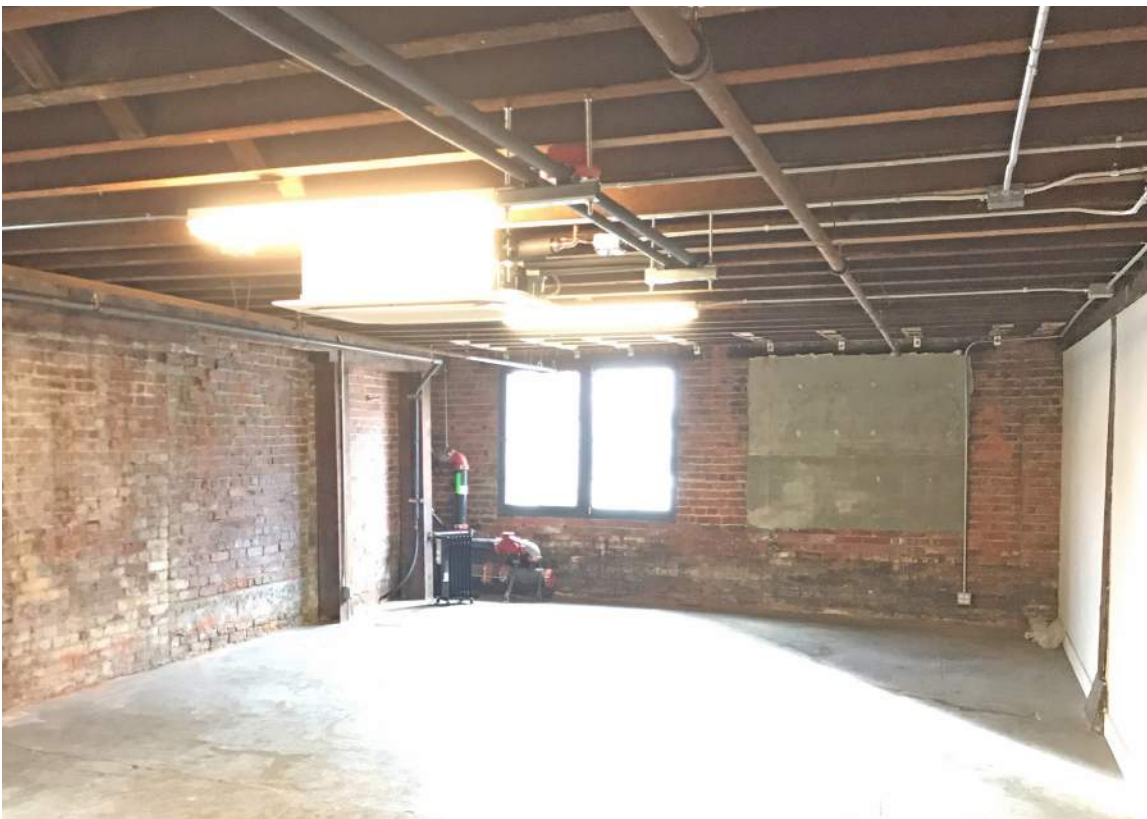
Wood ceiling; brick and gypsum board walls; concrete floor; wood beams, joists, and columns; new anchor bolts, strapping, and wood blocking; new concrete infill at existing opening; new conduit; new mechanical equipment.

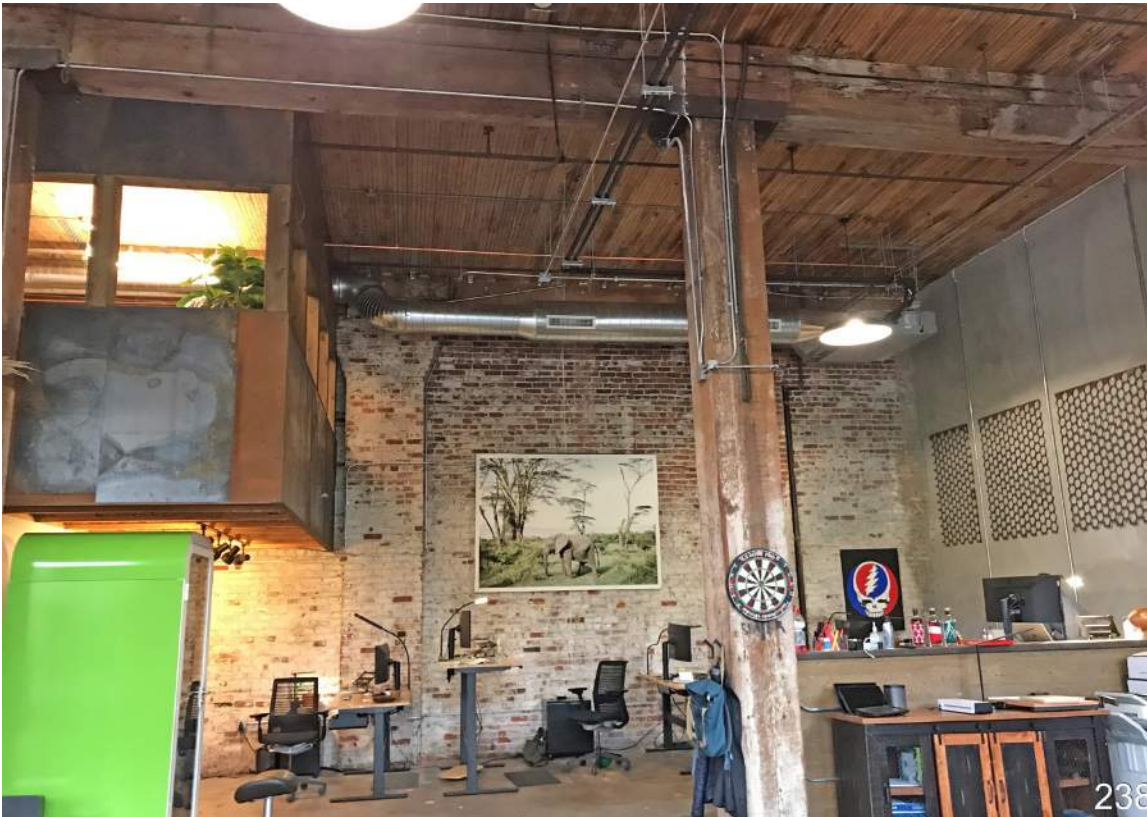
Wood ceiling; brick walls; concrete floor; wood beams and columns; new concrete shear wall; new metal strut; new anchor bolts, strapping, and wood blocking; new conduit; new mechanical equipment and ductwork.

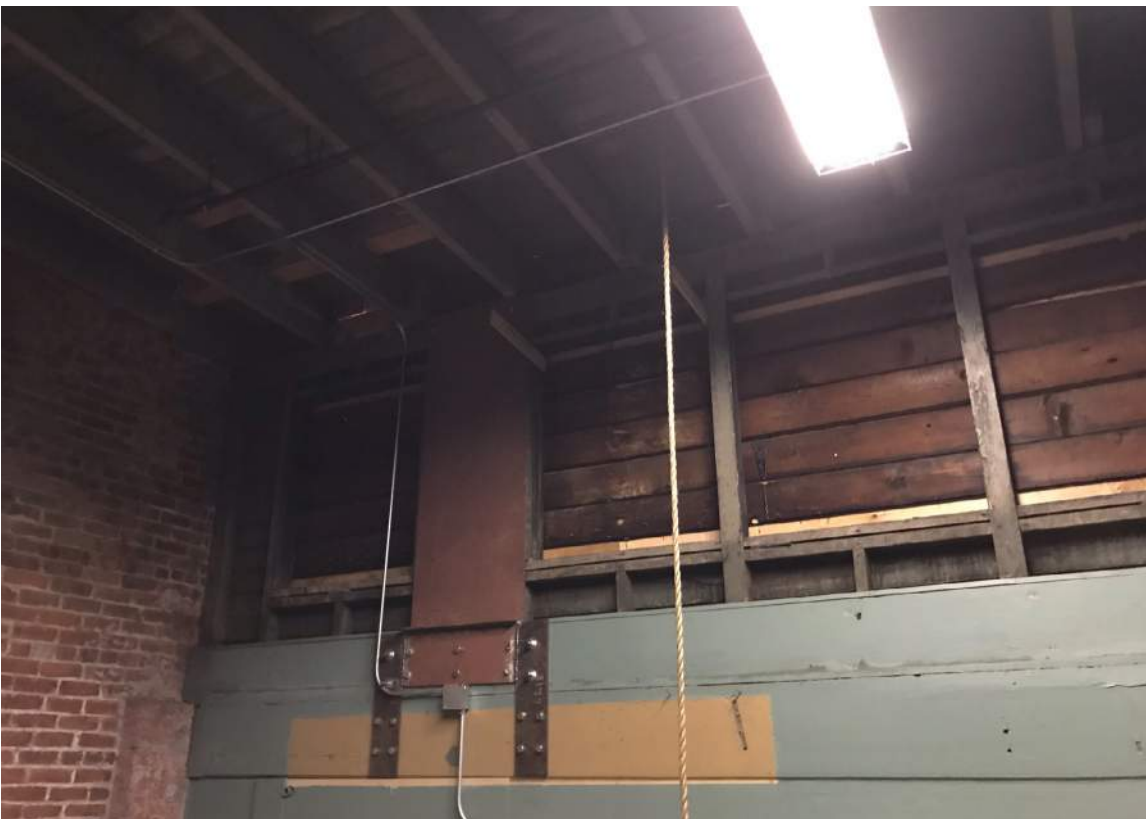
Wood ceiling; painted
wood wall; brick walls;
wood joists; new steel
plates between previously
infilled clerestory
windows.

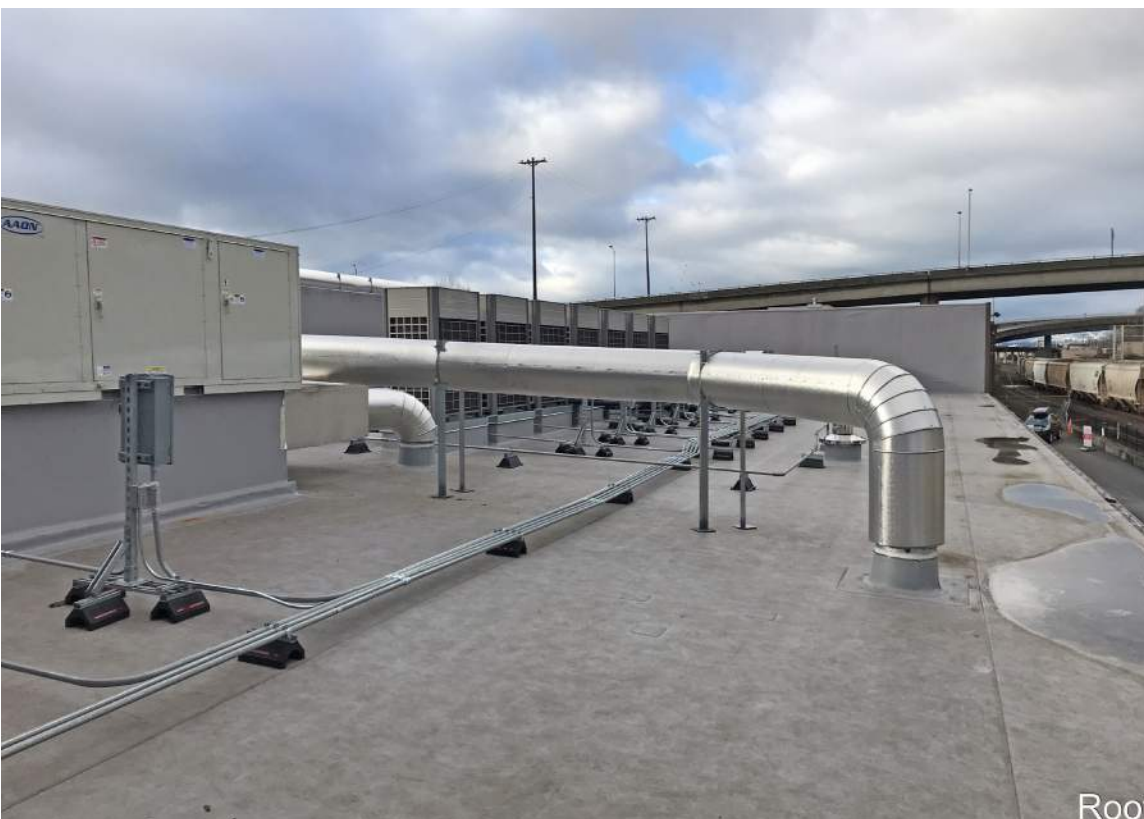
Mechanical equipment; new TPO roof over insulation and extended up back side of parapet walls; new roof access hatch; new roof trim and parapet cap; new conduit; new mechanical equipment and ductwork.

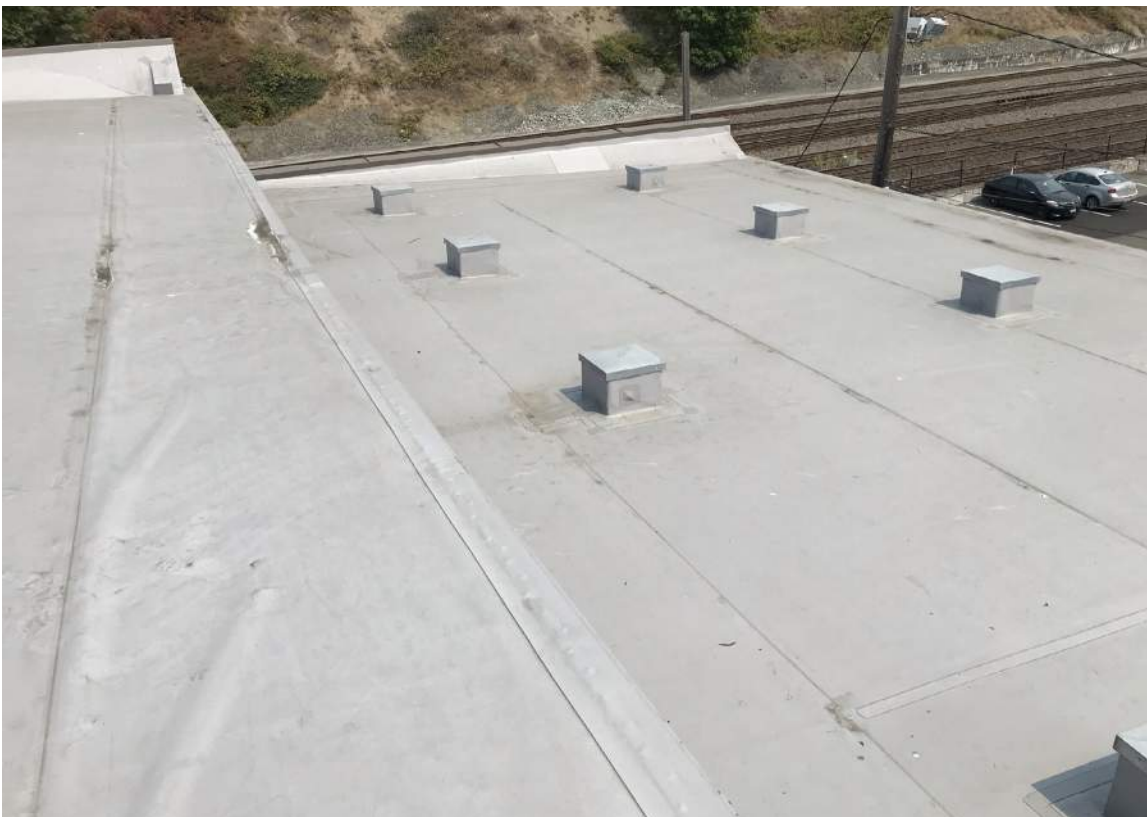
New parapet bracing; new TPO roof over insulation and extended up back side of parapet walls; new roof trim and parapet cap.
