OVERVIEW

The stone paving in the Plaza in front of SAAM has deteriorated significantly within the primary vehicle drive areas. Seattle Department of Parks and Recreation investigated repair alternatives and conducted an initial briefing with the Architectural Review Committee on August 13, 2021 to solicit ARC guidance on repair alternatives. This submittal presents the proposed repairs incorporating the ARC recommendations for final review and approval by the ARC and full Landmarks Preservation Board.

VOLUNTEER PARK DRIVE PLAZA PAVING

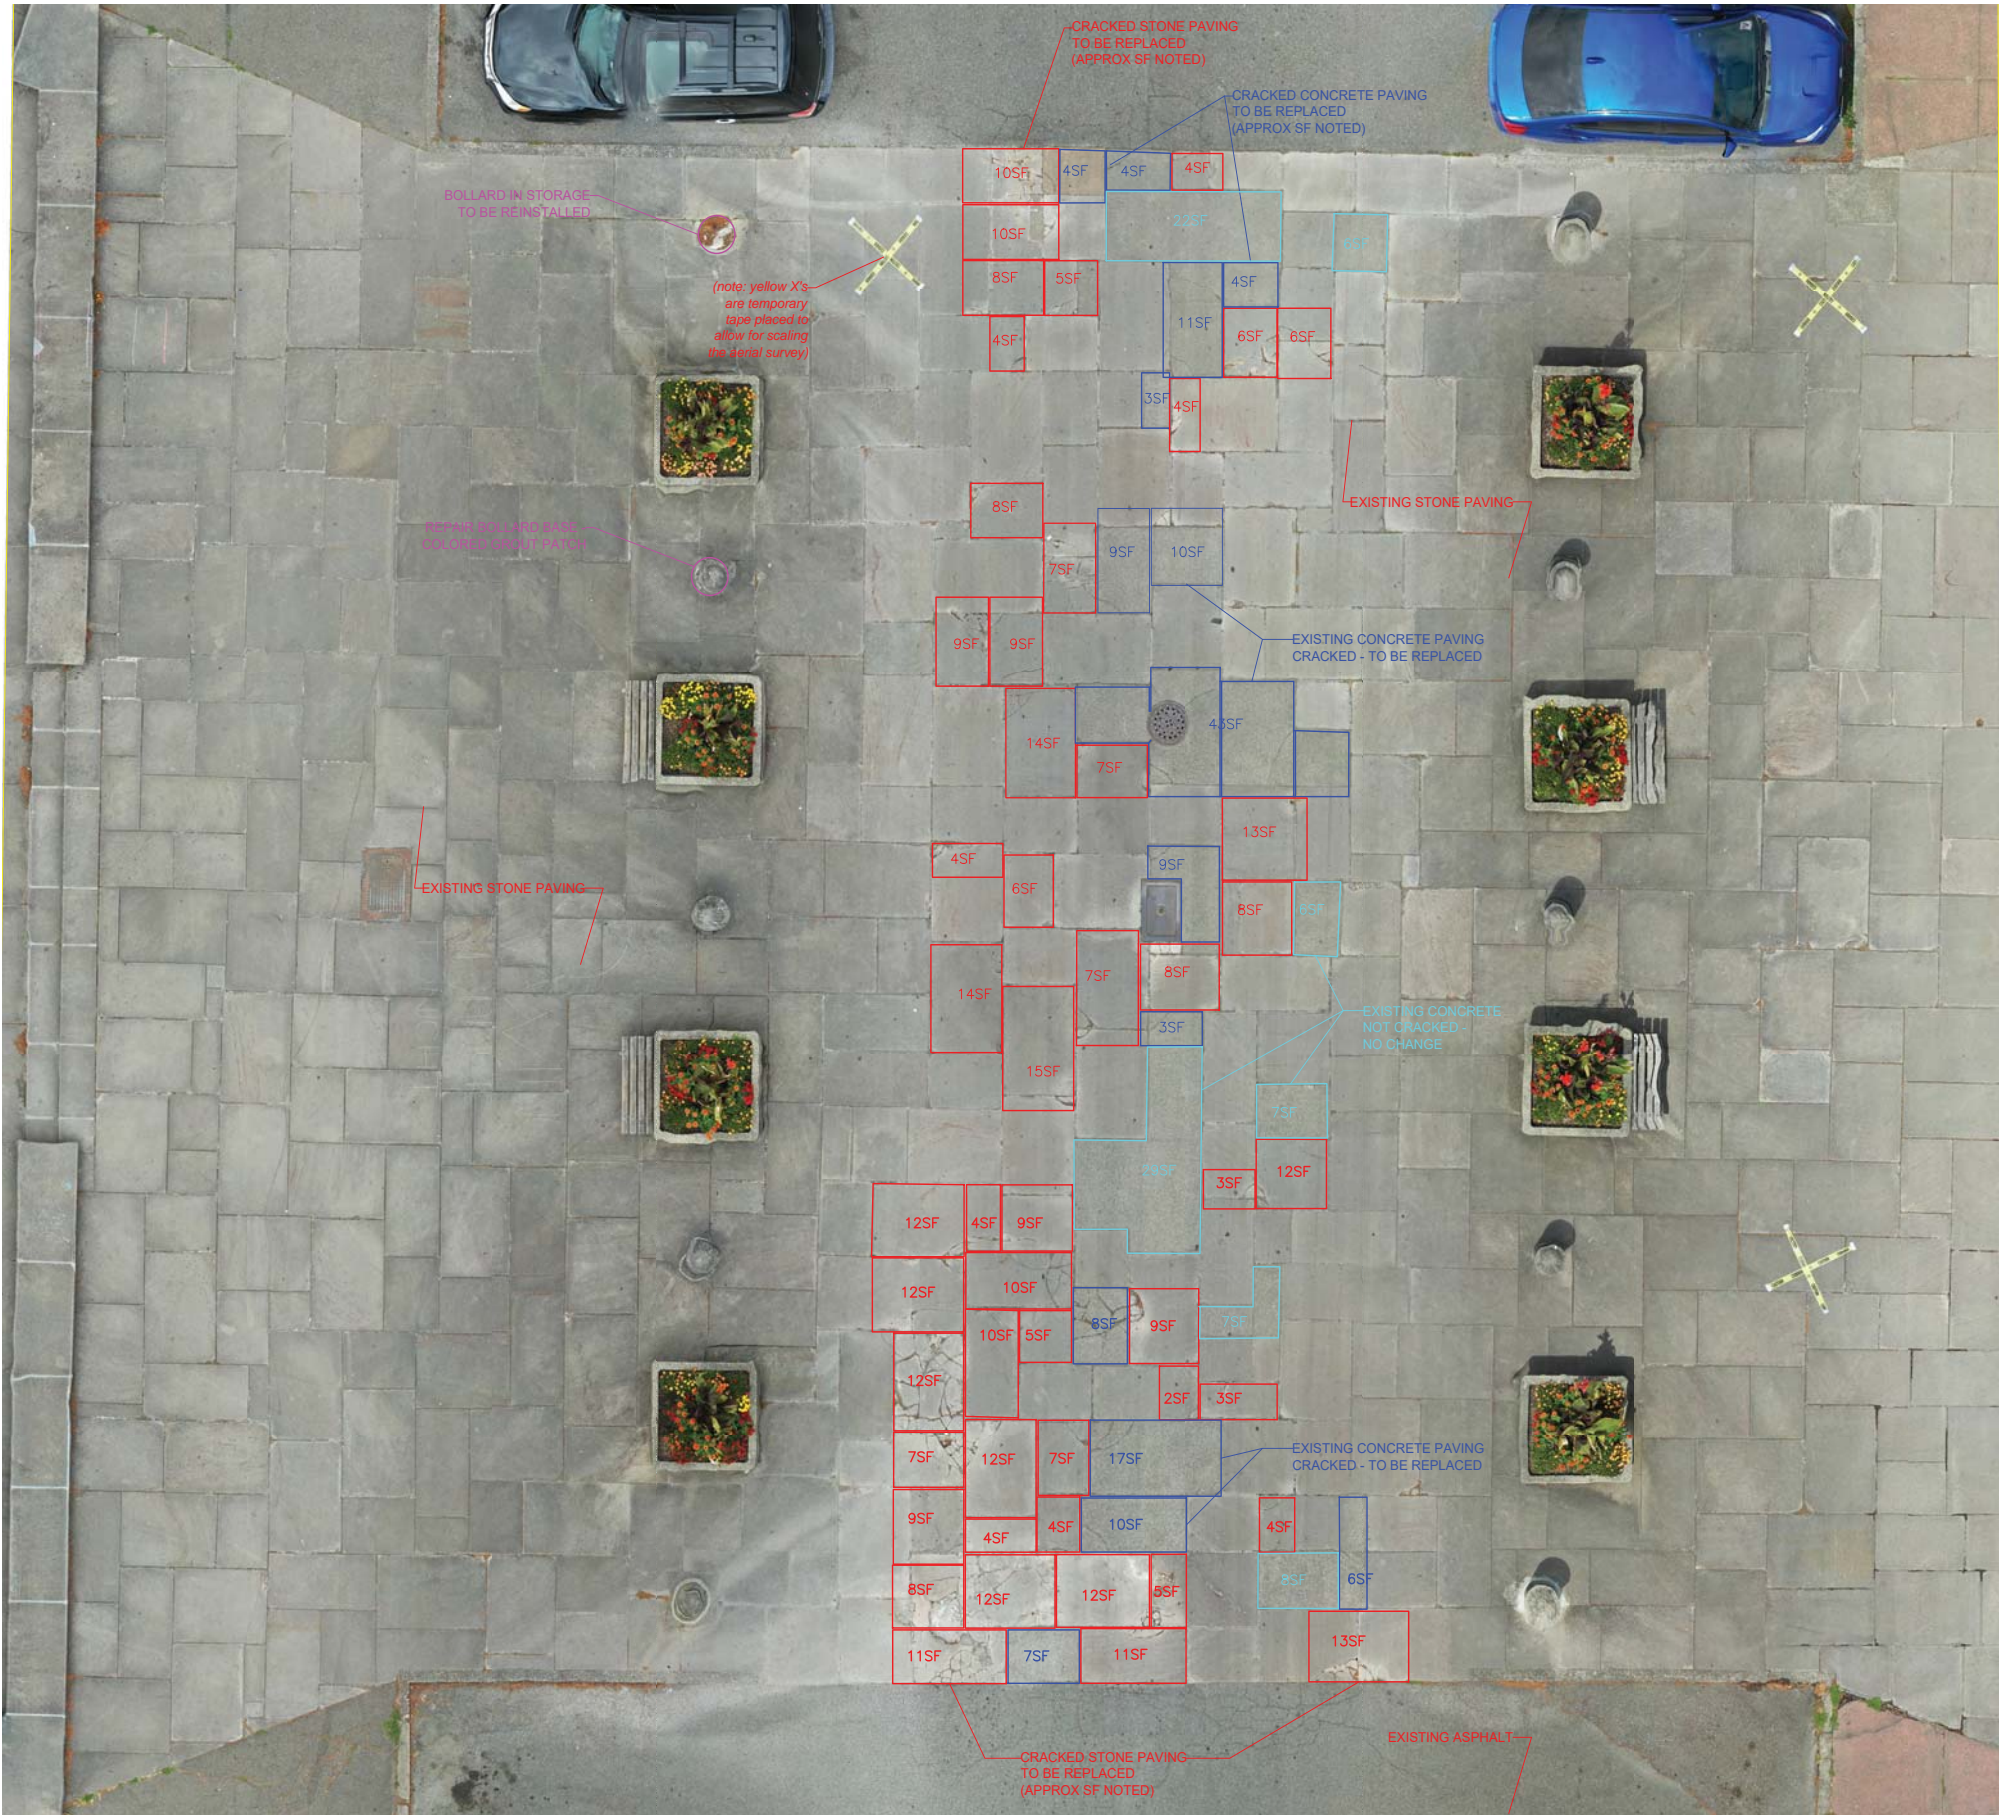
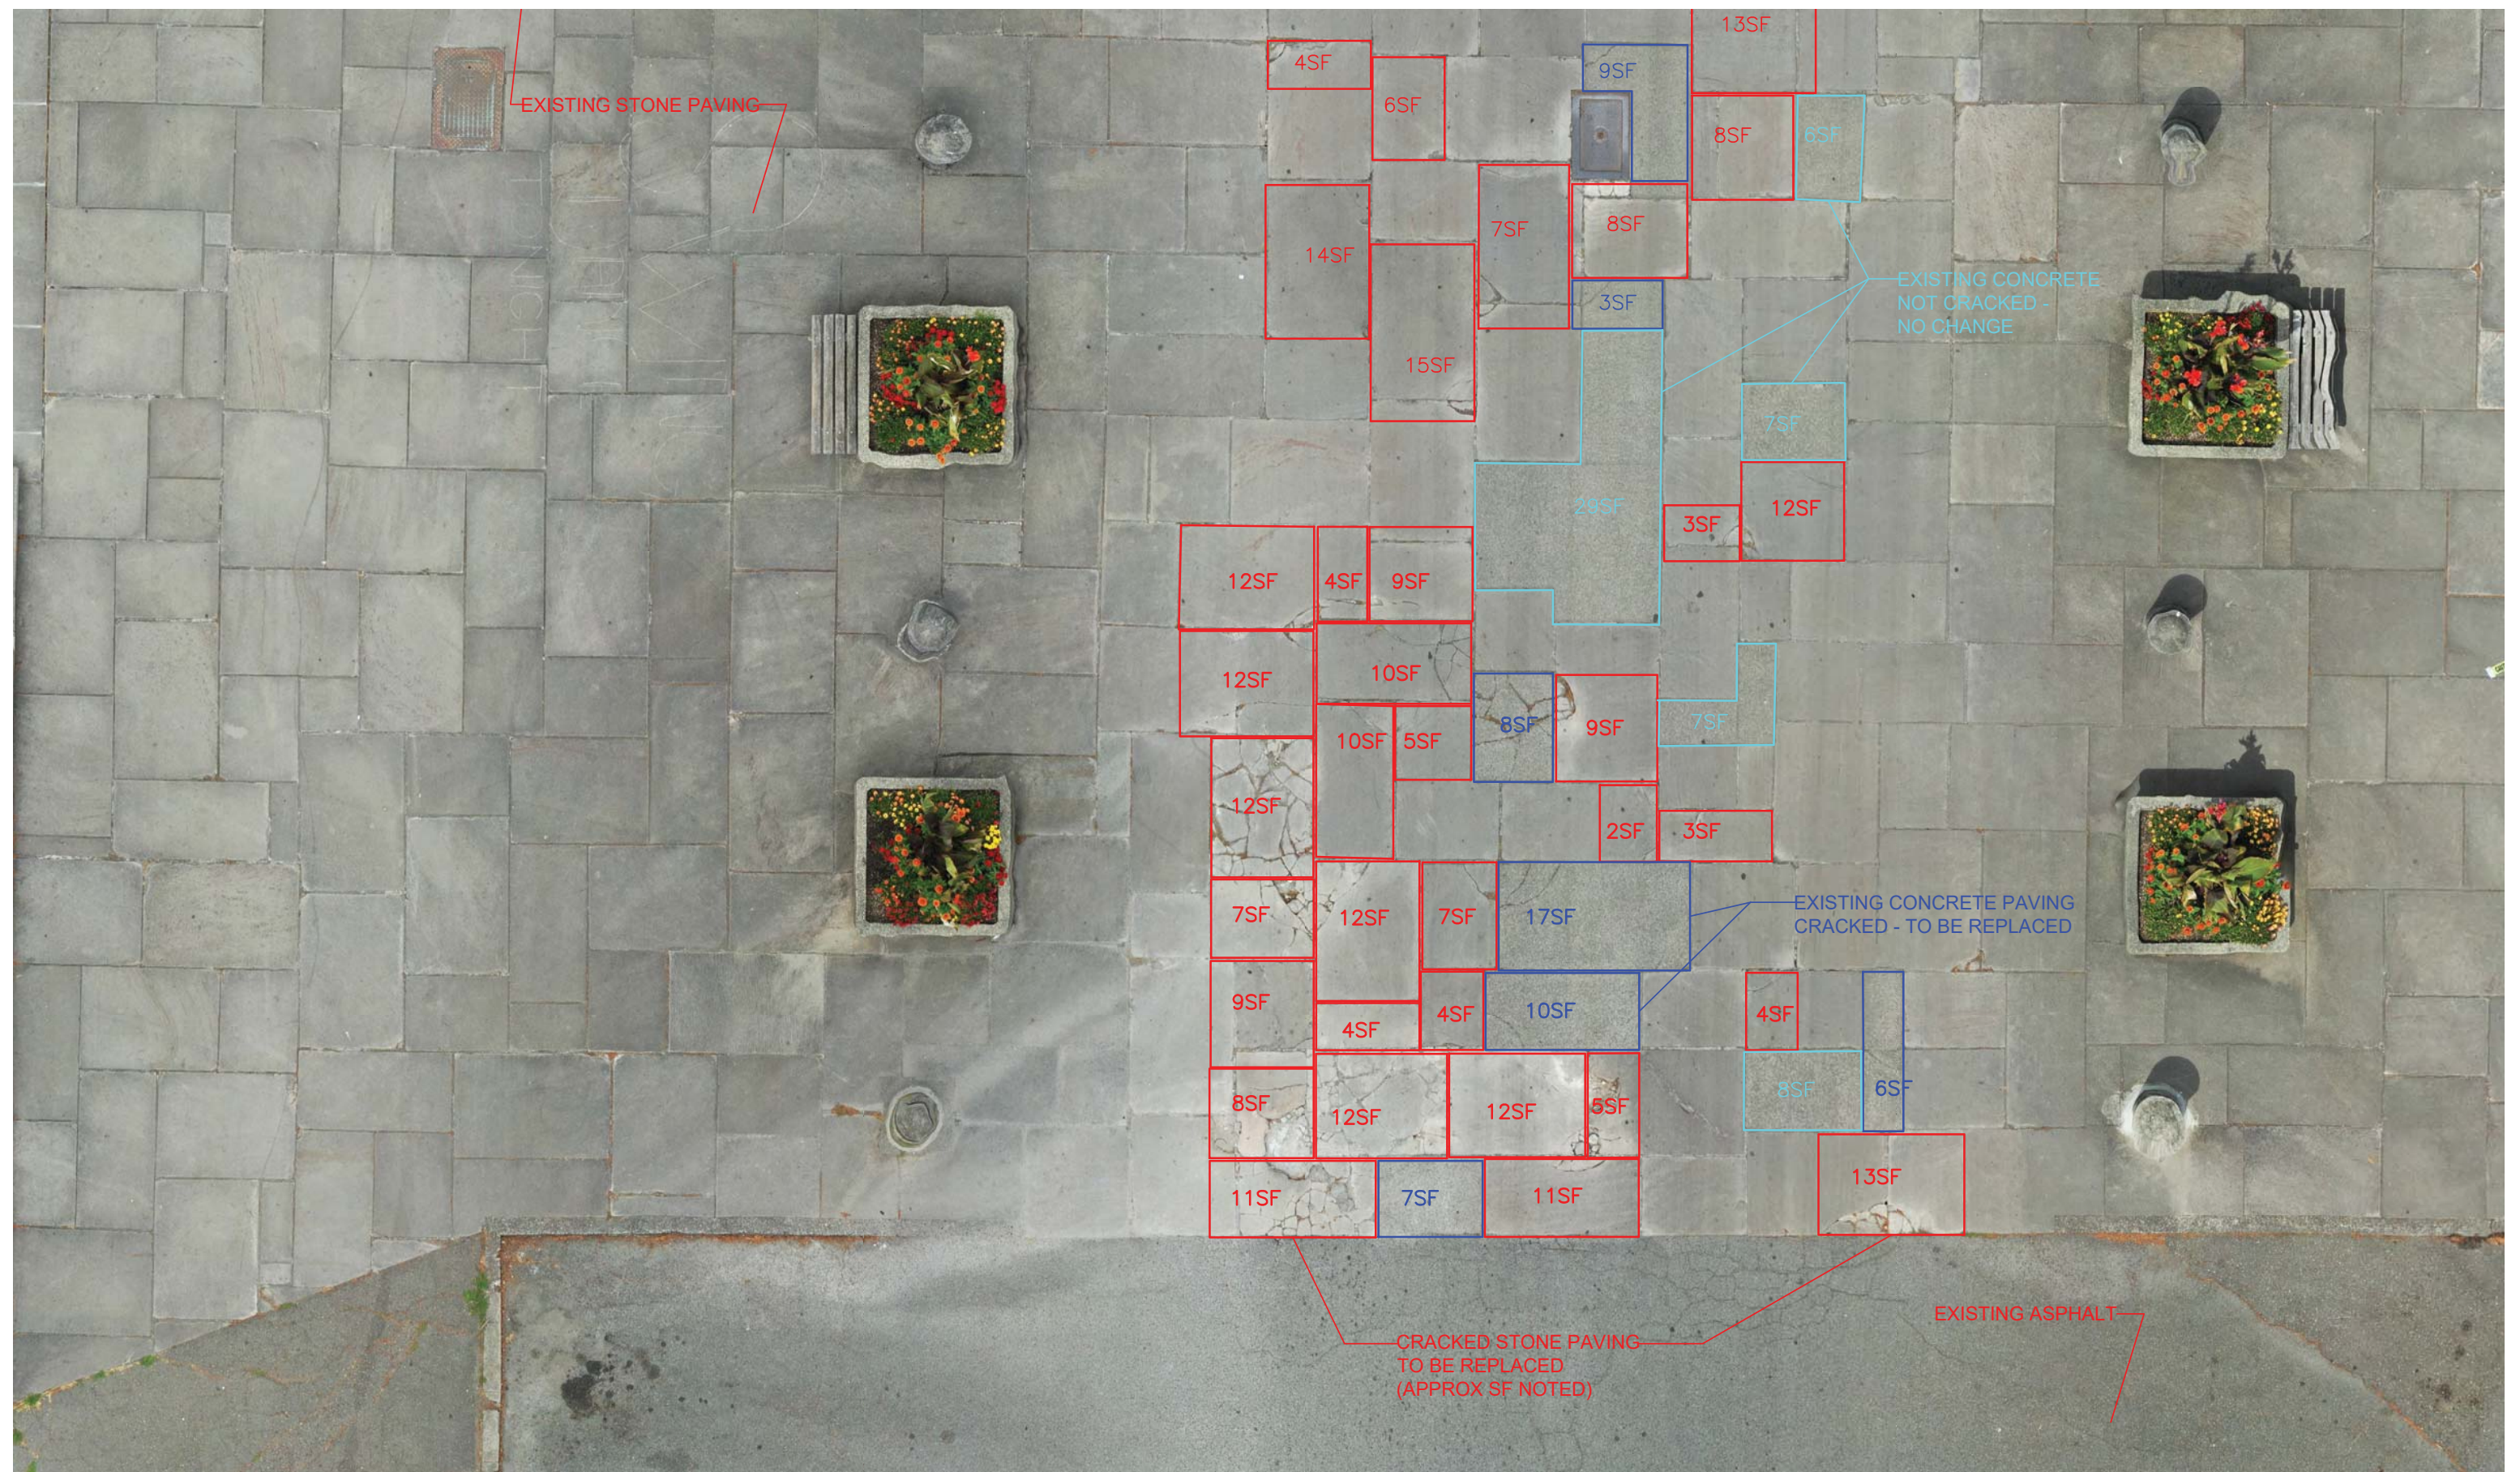
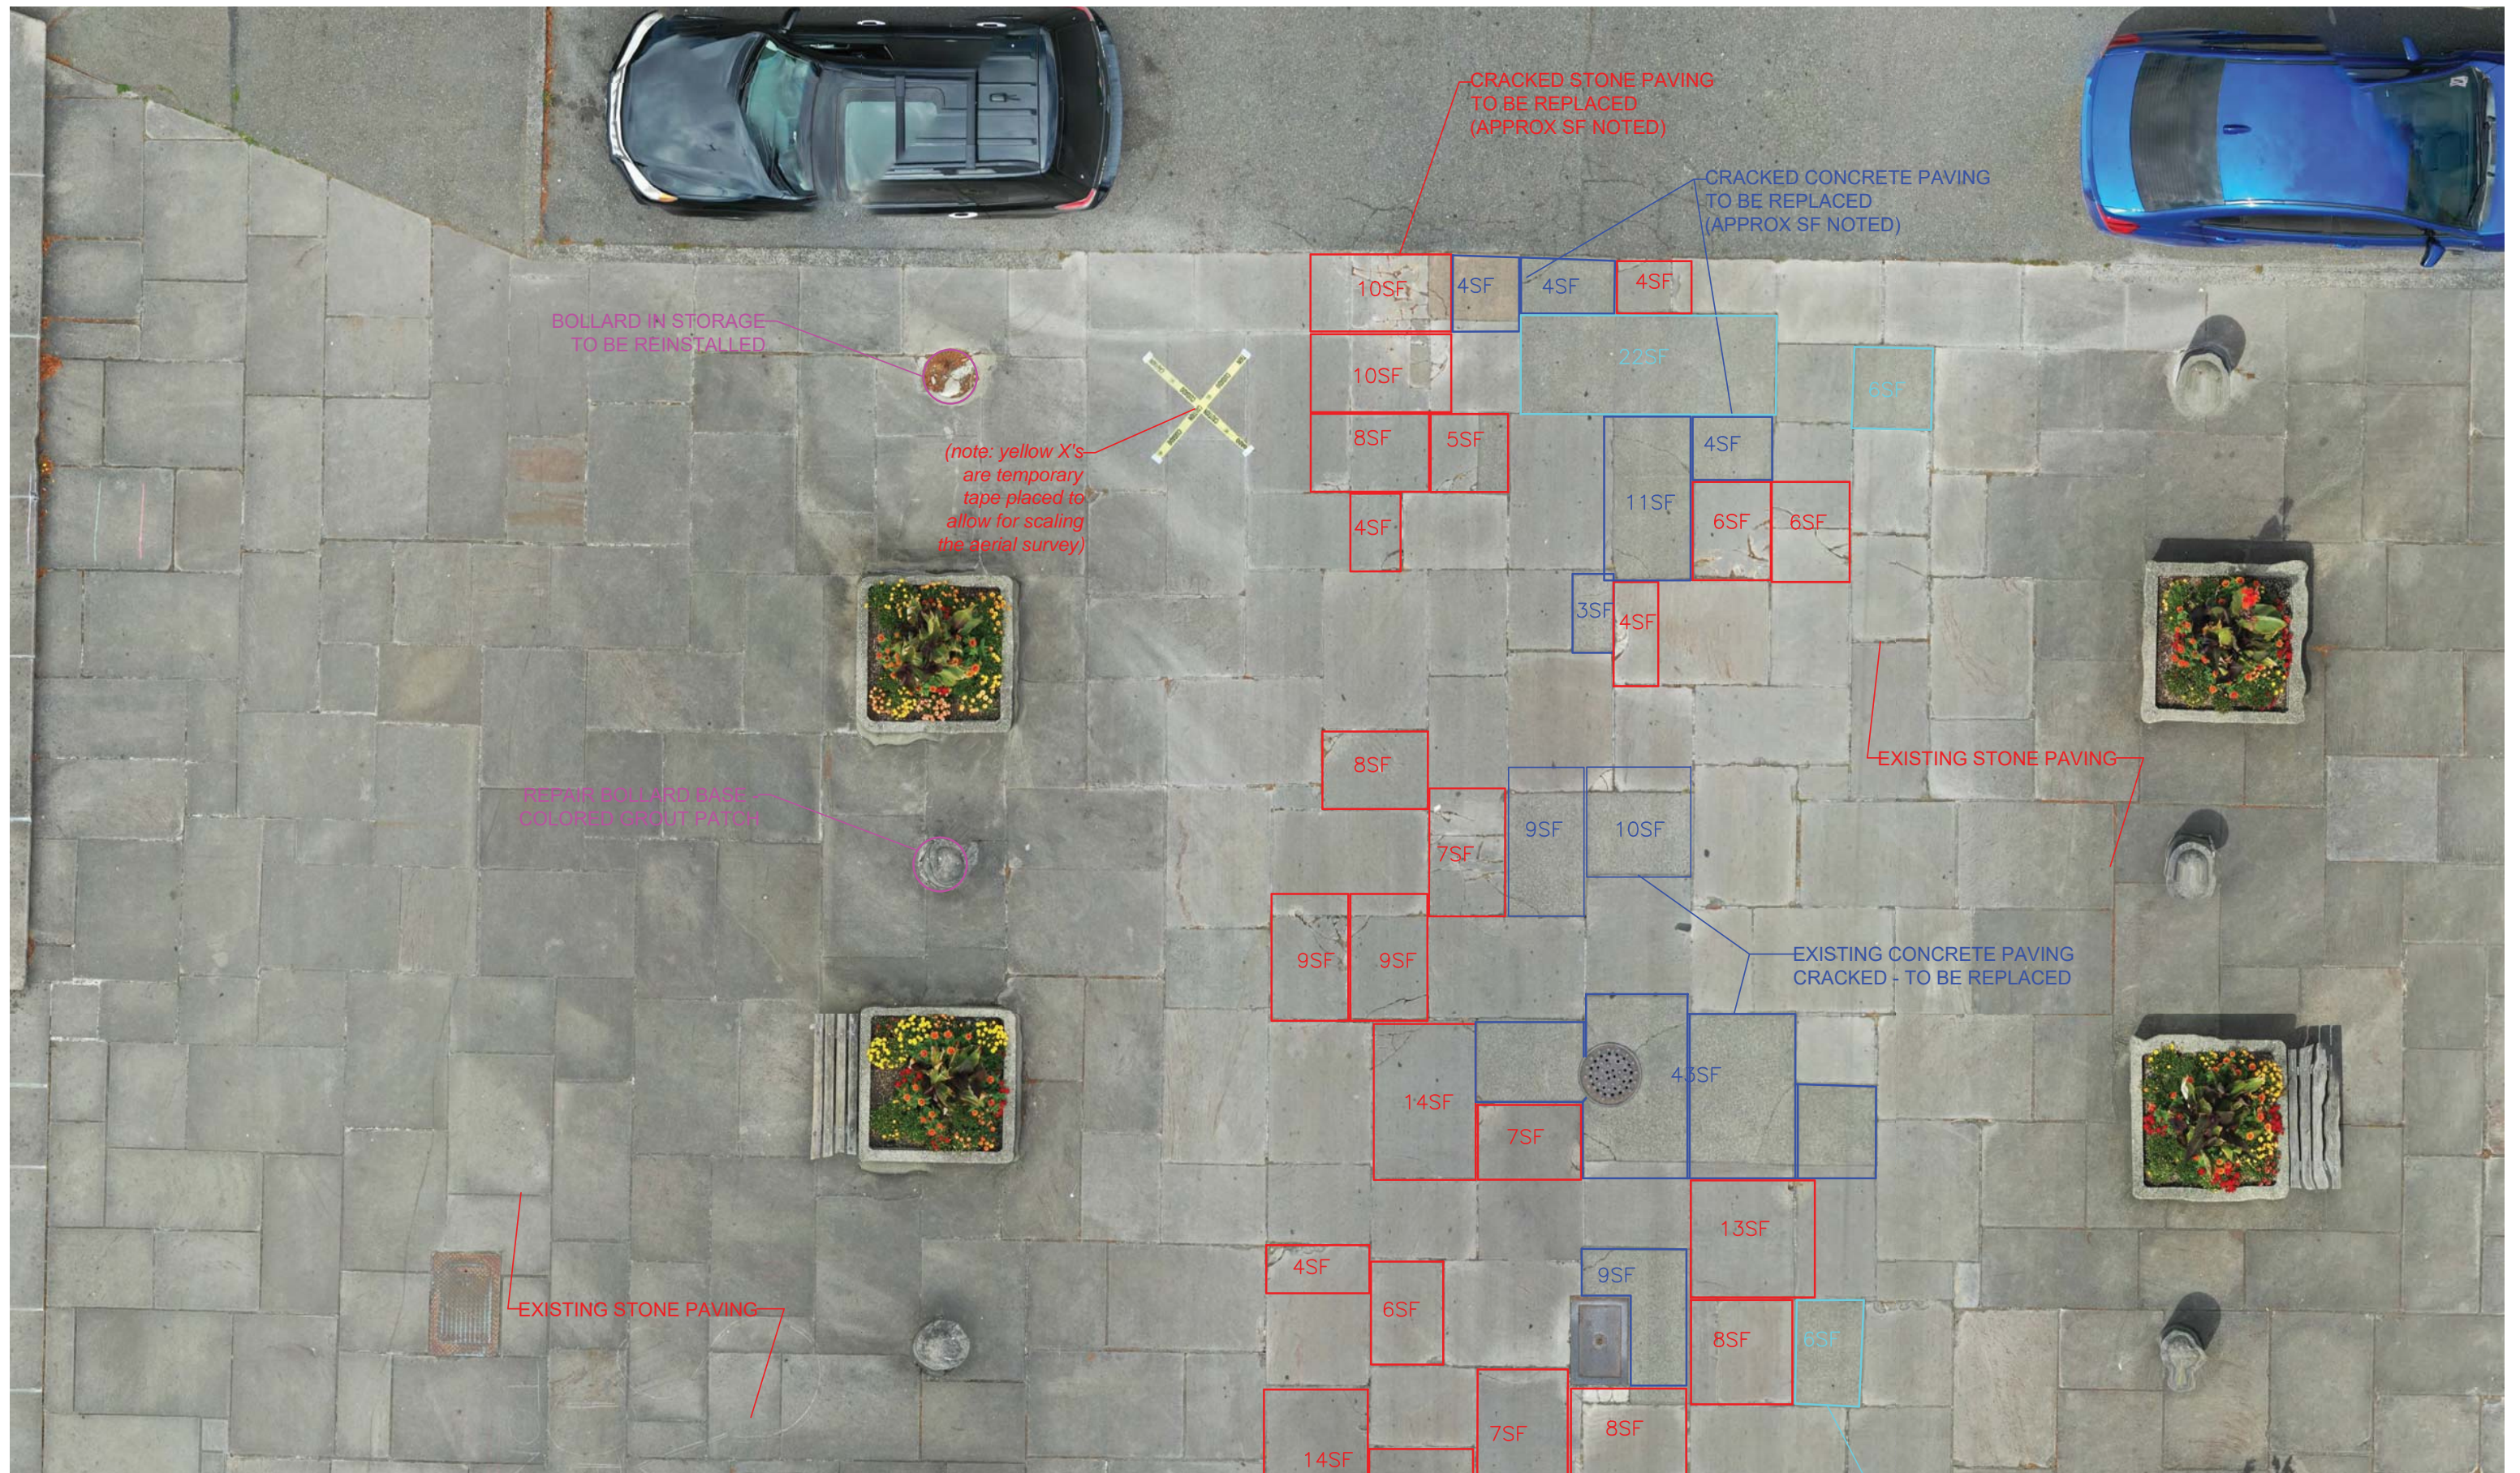
AERIAL SURVEY: PLAZA PLAN - NORTH

The aerial survey plan was compiled from 70 stitched drone photographs to provide a high resolution plan, facilitating documentation of the extent of existing issues and necessary repairs. (The yellow X's visible in the survey are tape placed 40' apart by the survey company to facilitate scaling of the aerial photograph to a CAD drawing.)

Based on detailed site reviews, the plan highlights three areas as follows:

Red: stone pavers with significant deterioration and recommended to be replaced: (410 sf)

Blue: concrete paving with some cracking which is not as problematic as the disintegrating stones, but would ideally be replaced if feasible within the budget: (150 sf)

Light blue: other existing conc. paving infills without any cracking: (80 sf)

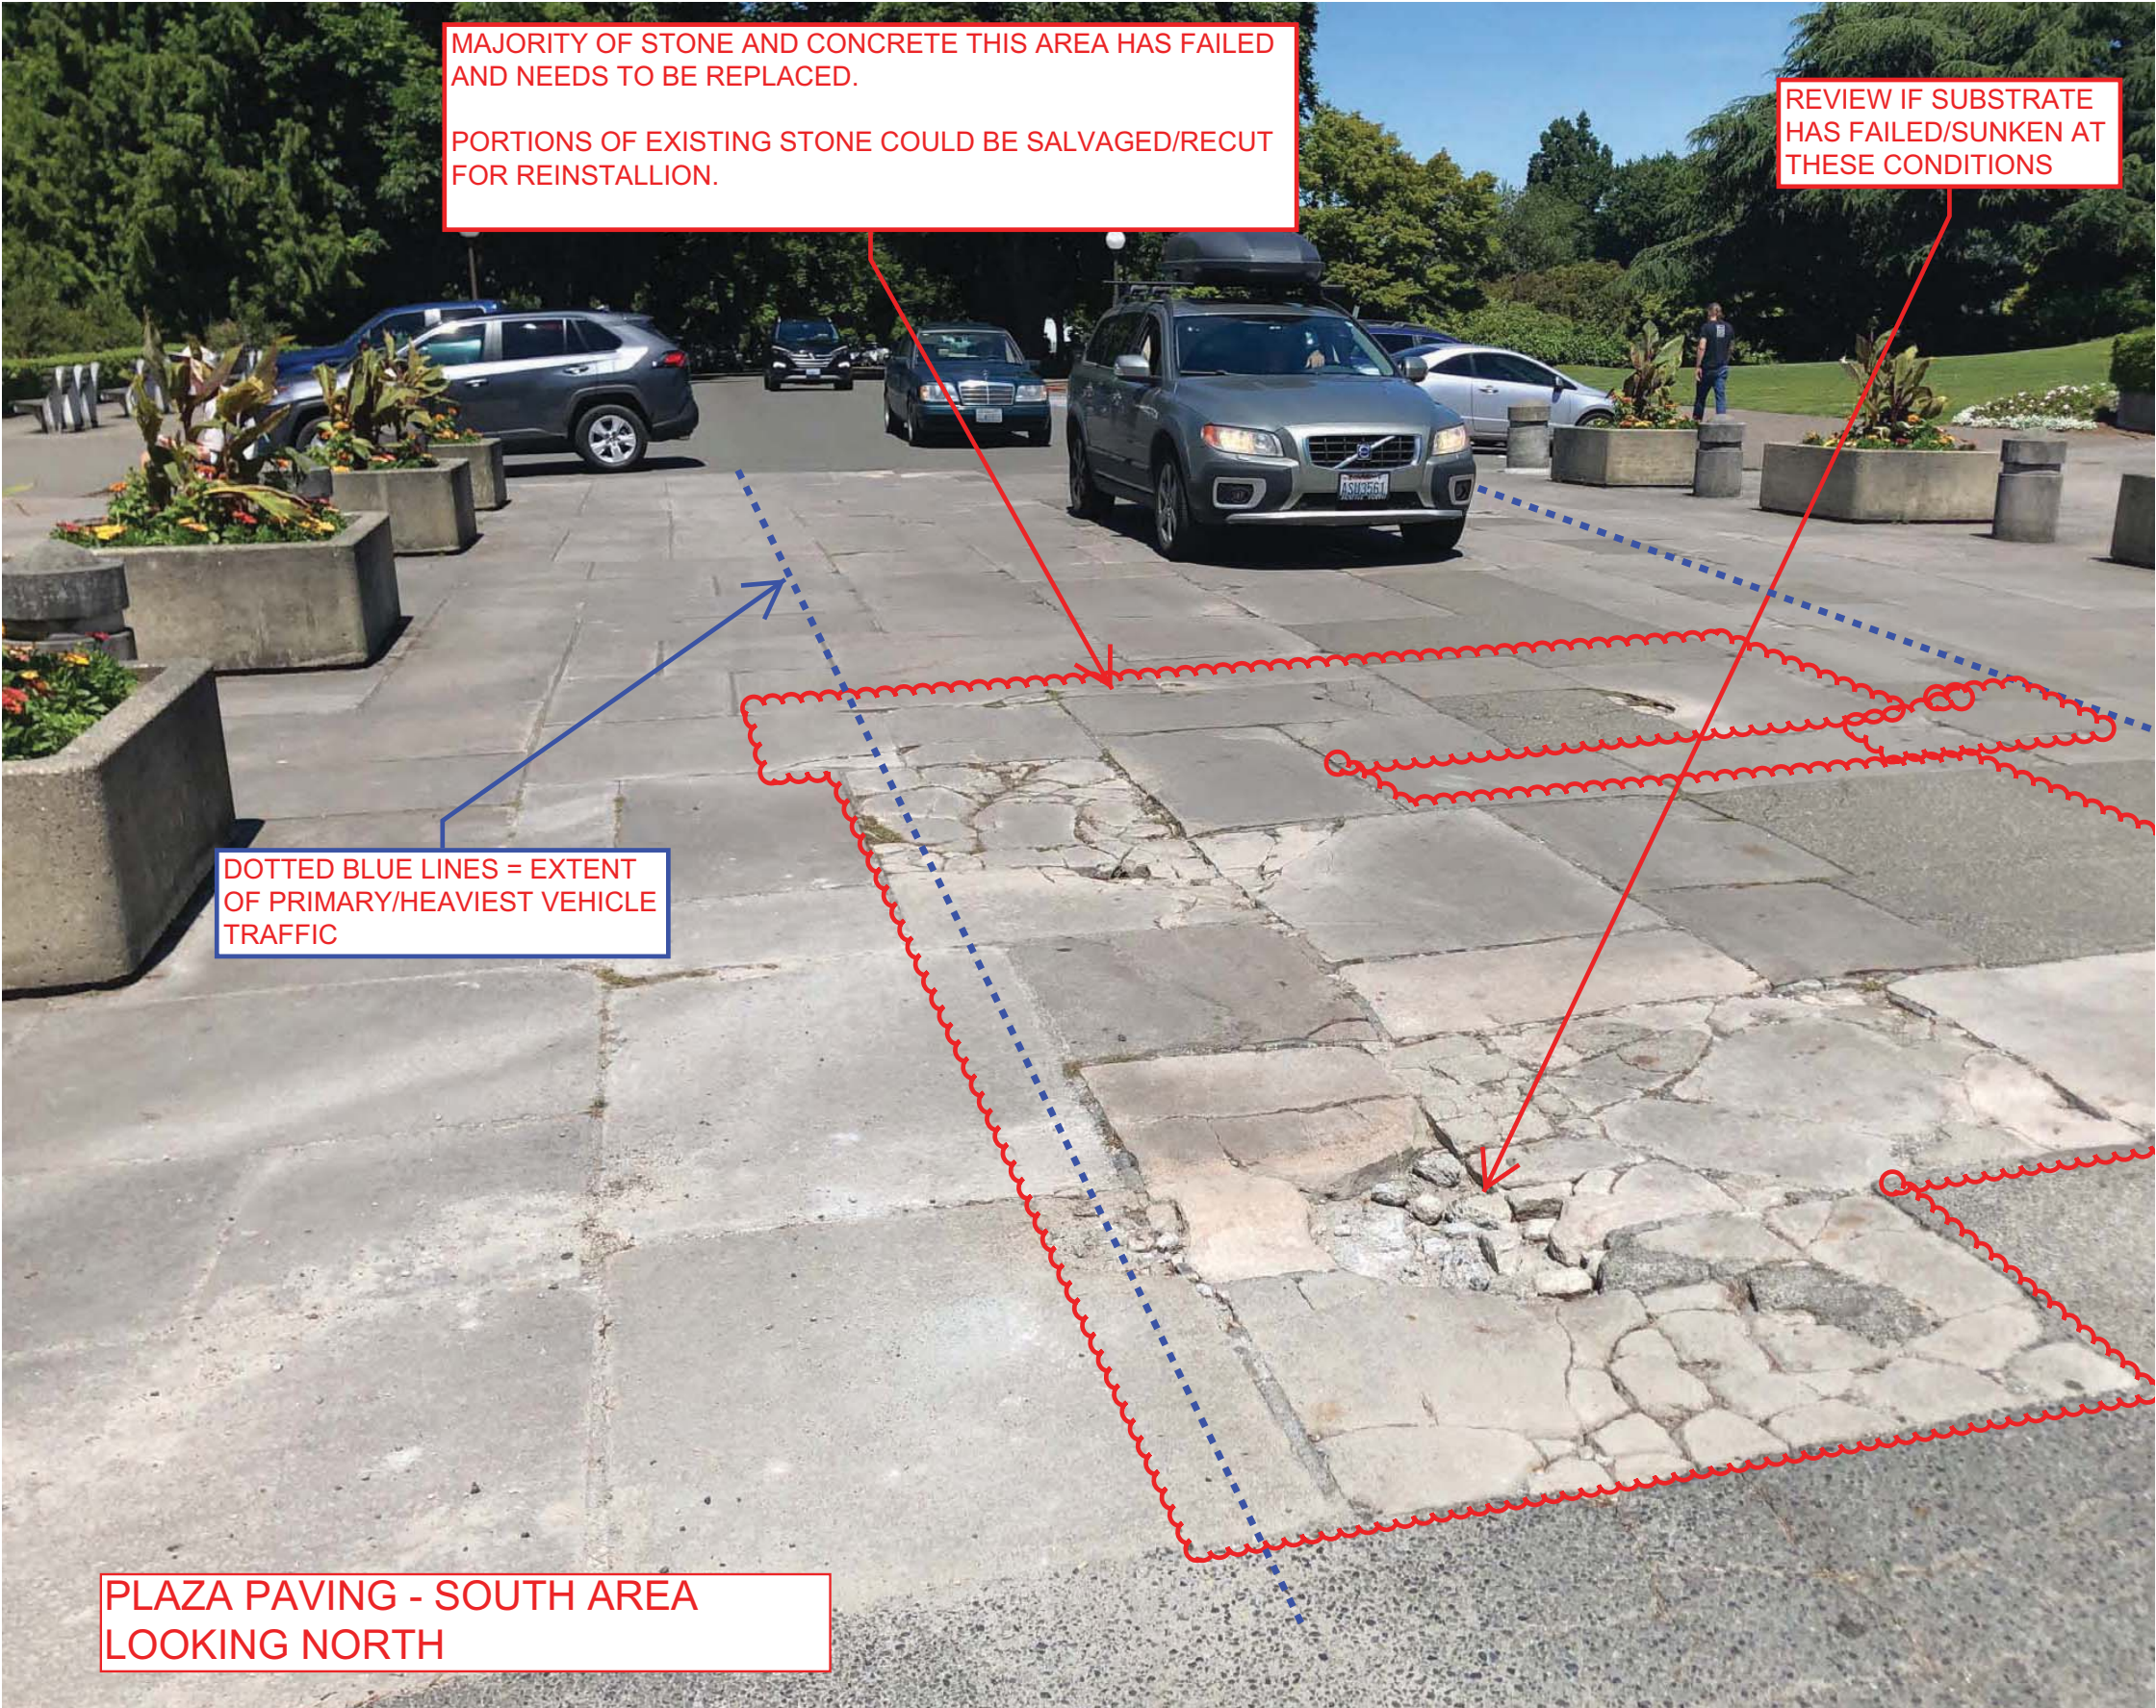
The Southwest portion of the plaza represents the most extreme area of deterioration, with numerous stones completely disintegrated.

The blue dotted lines show the primary vehicle pathway which is where nearly all deterioration has occurred.

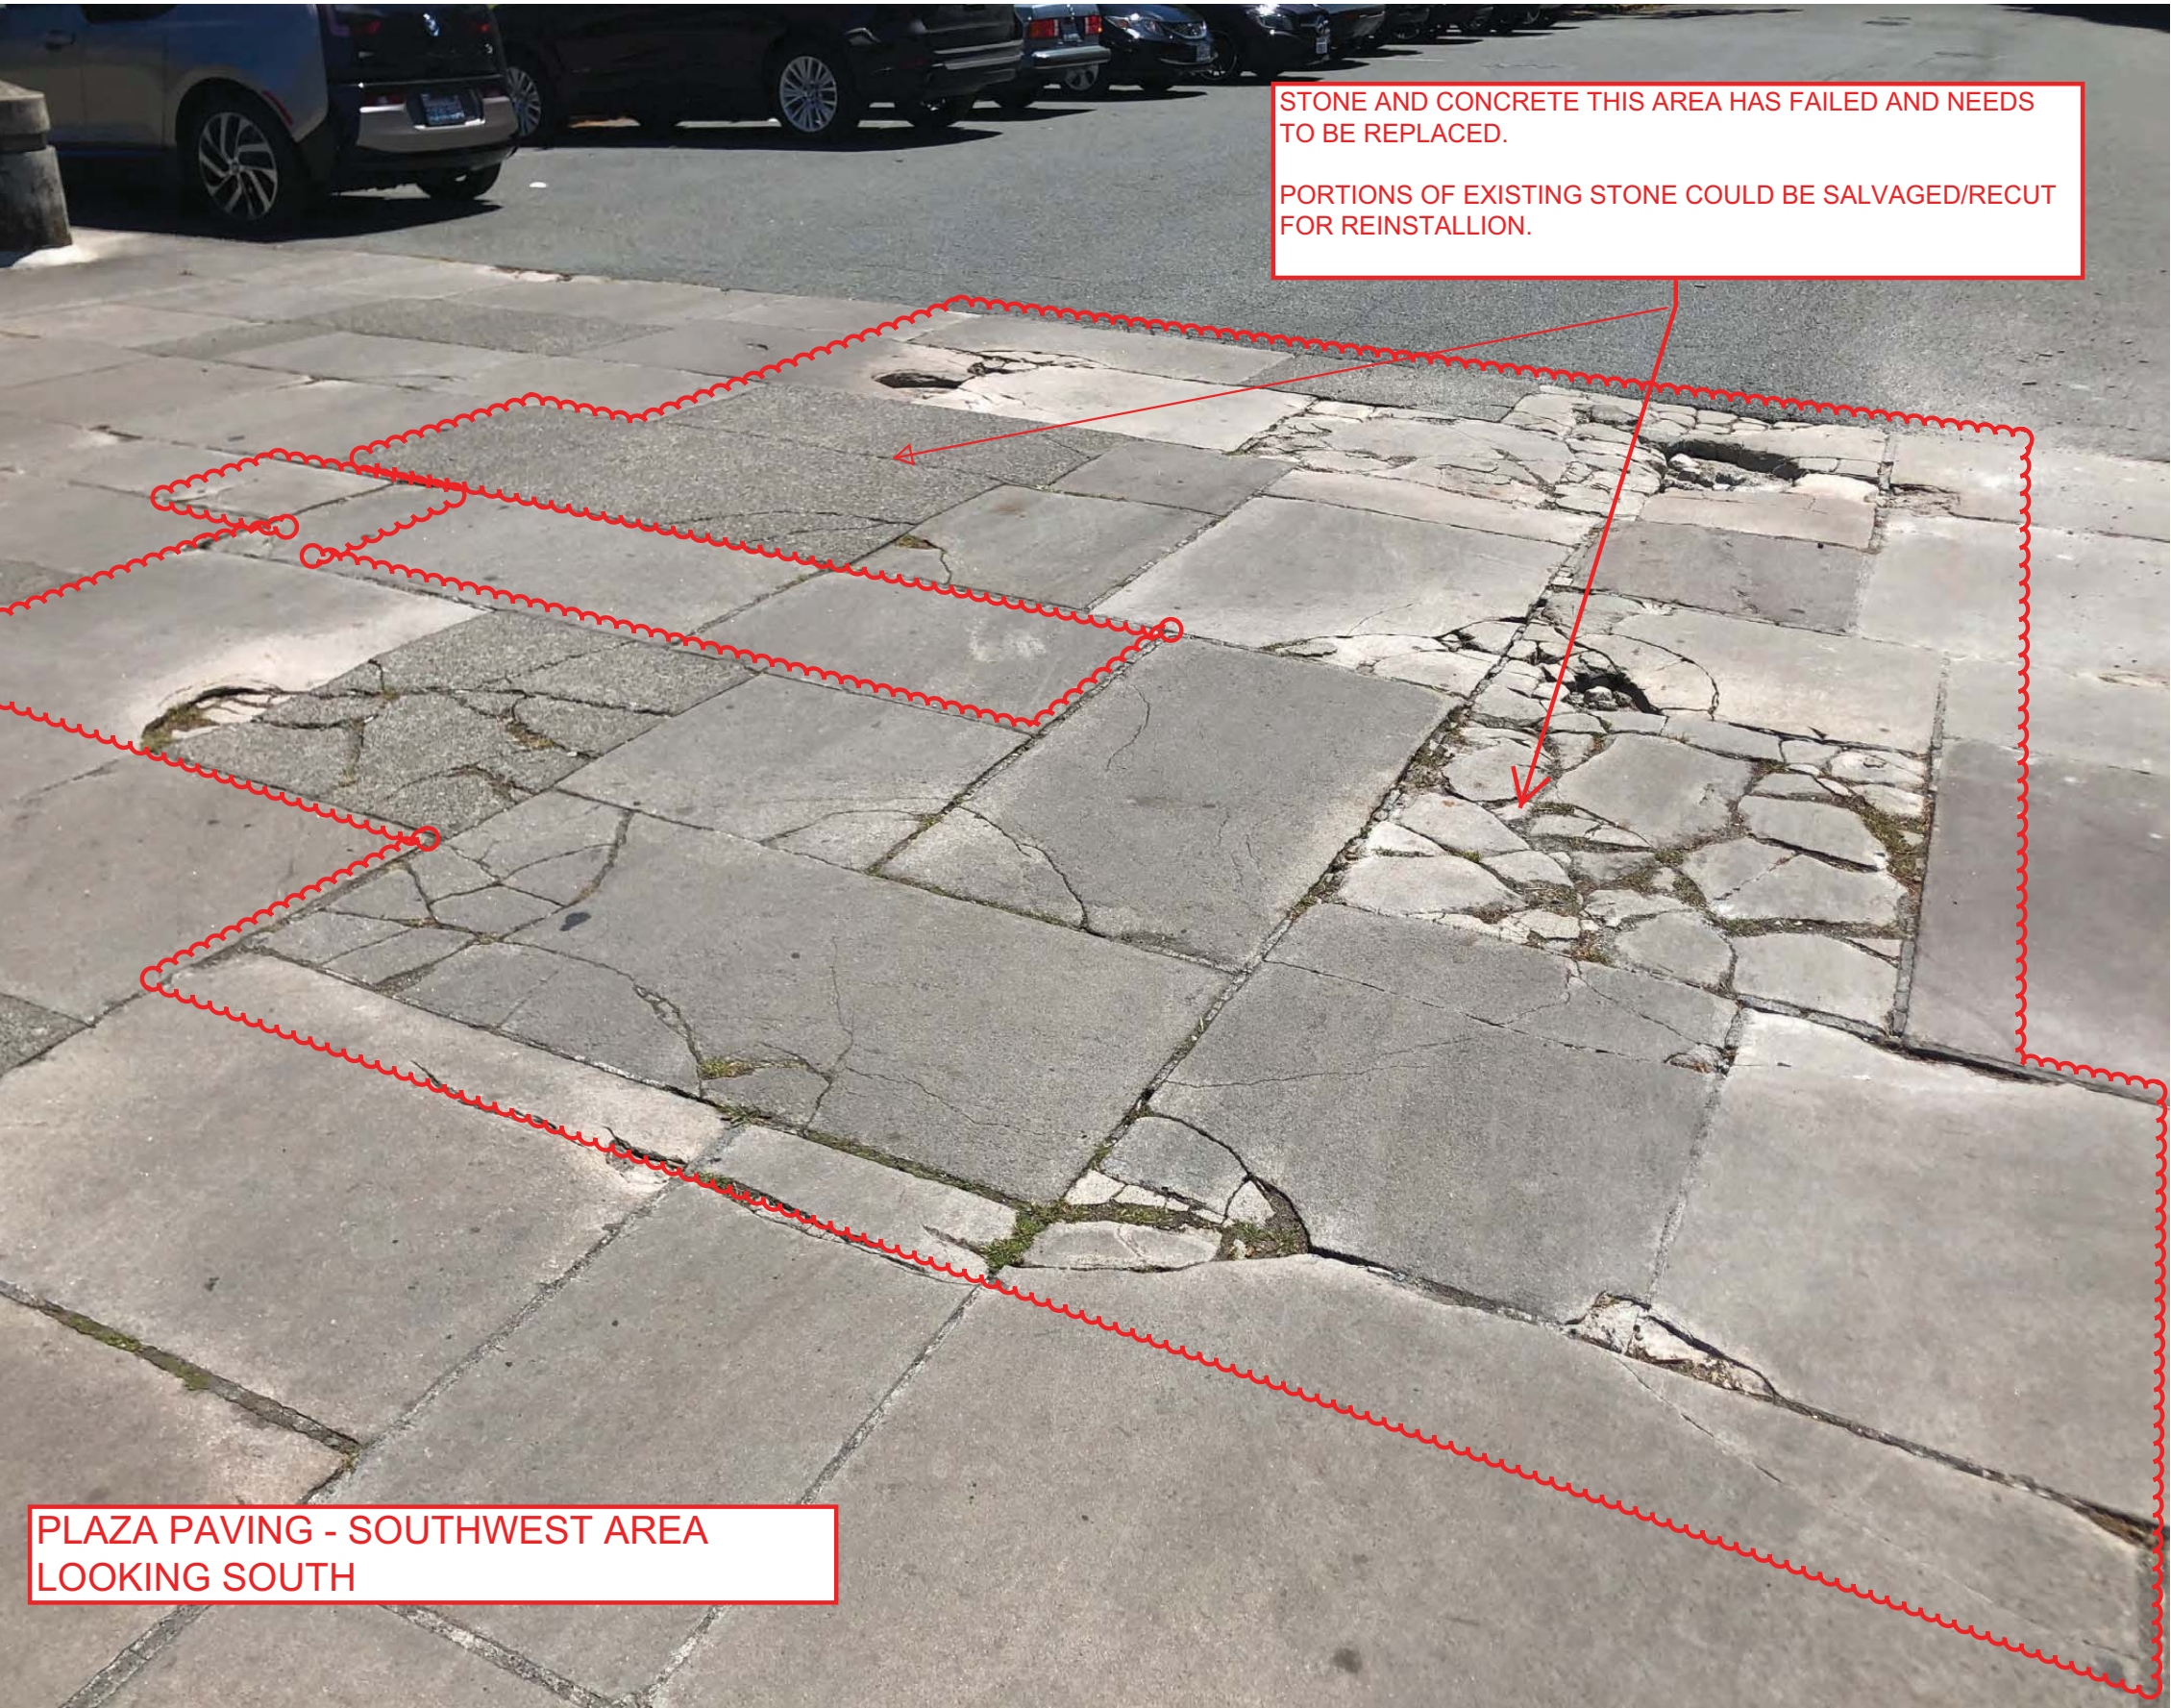
The Southwest portion of the plaza represents the most extreme are of deterioration, with numerous stones completely disintegrated.

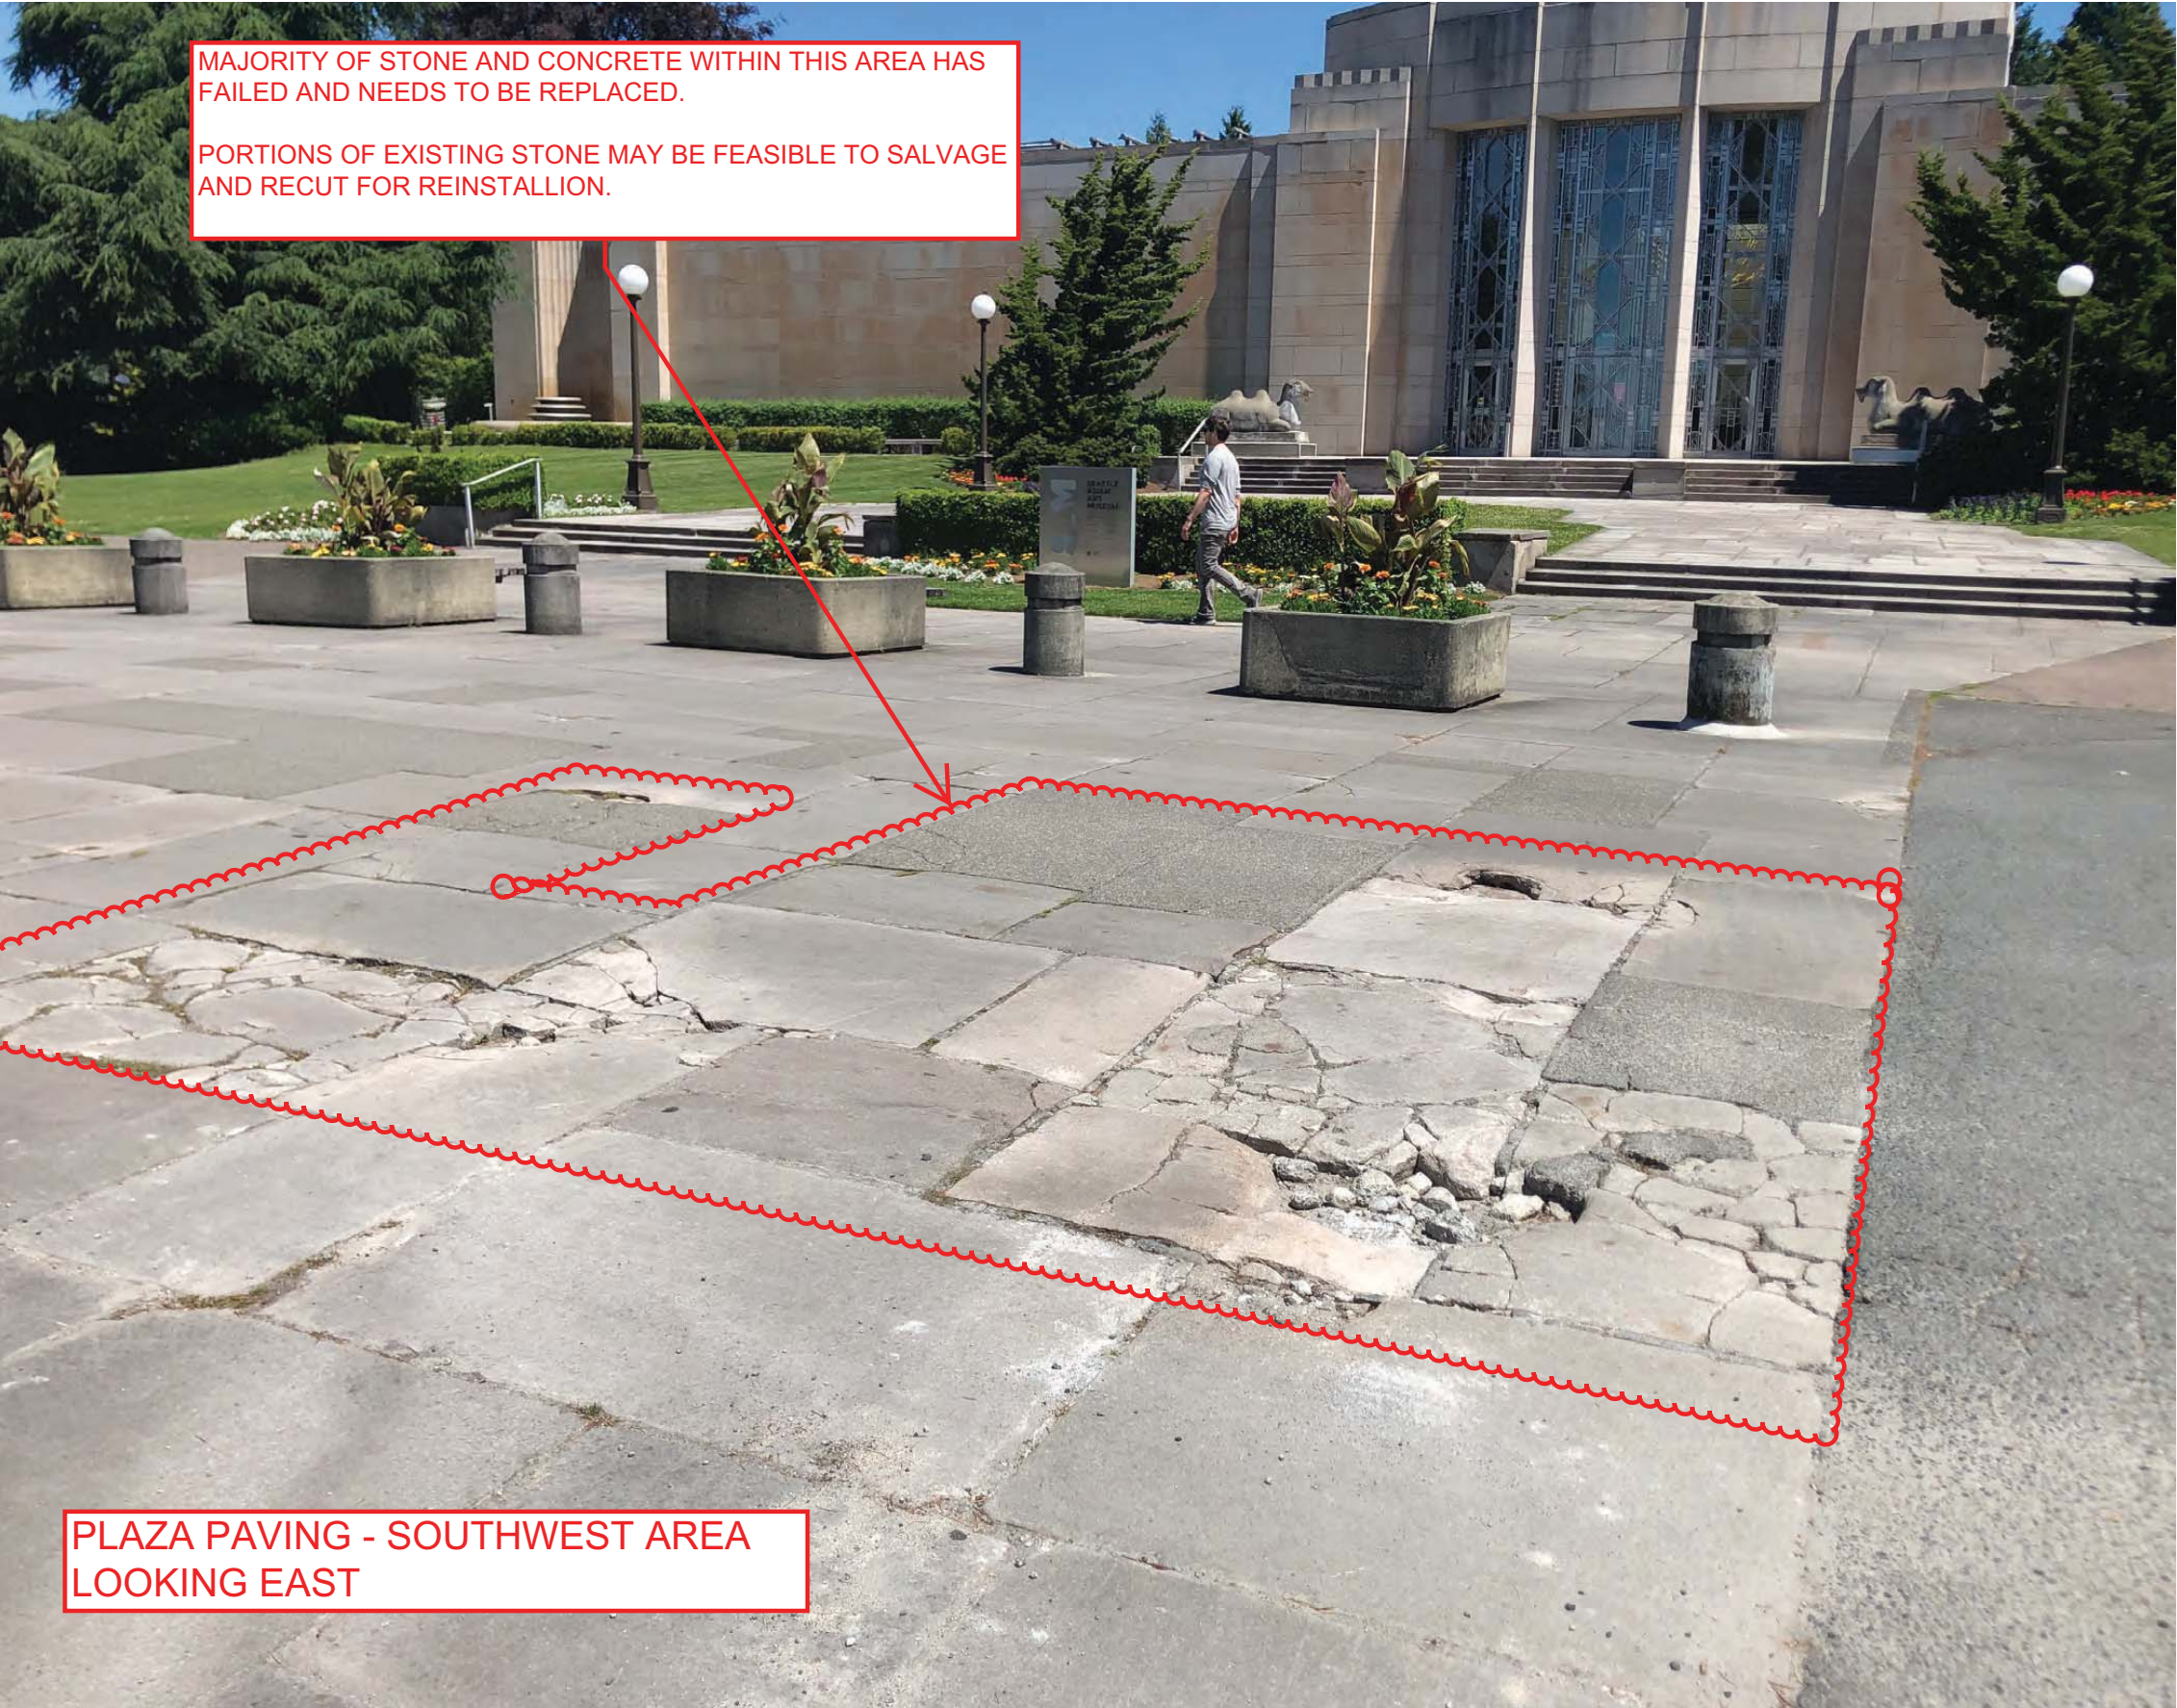
The Southwest portion of the plaza represents the most extreme are of deterioration, with numerous stones completely disintegrated.
