OVERVIEW

The stone paving in the Plaza in front of SAAM has deteriorated significantly within the primary vehicle drive areas. Seattle Department of Parks and Recreation investigated repair alternatives and conducted an initial briefing with the Architectural Review Committee on August 13, 2021 to solicit ARC guidance on repair alternatives. This submittal presents the proposed repairs incorporating the ARC recommendations for final review and approval by the ARC and full Landmarks Preservation Board.

VOLUNTEER PARK DRIVE PLAZA PAVING

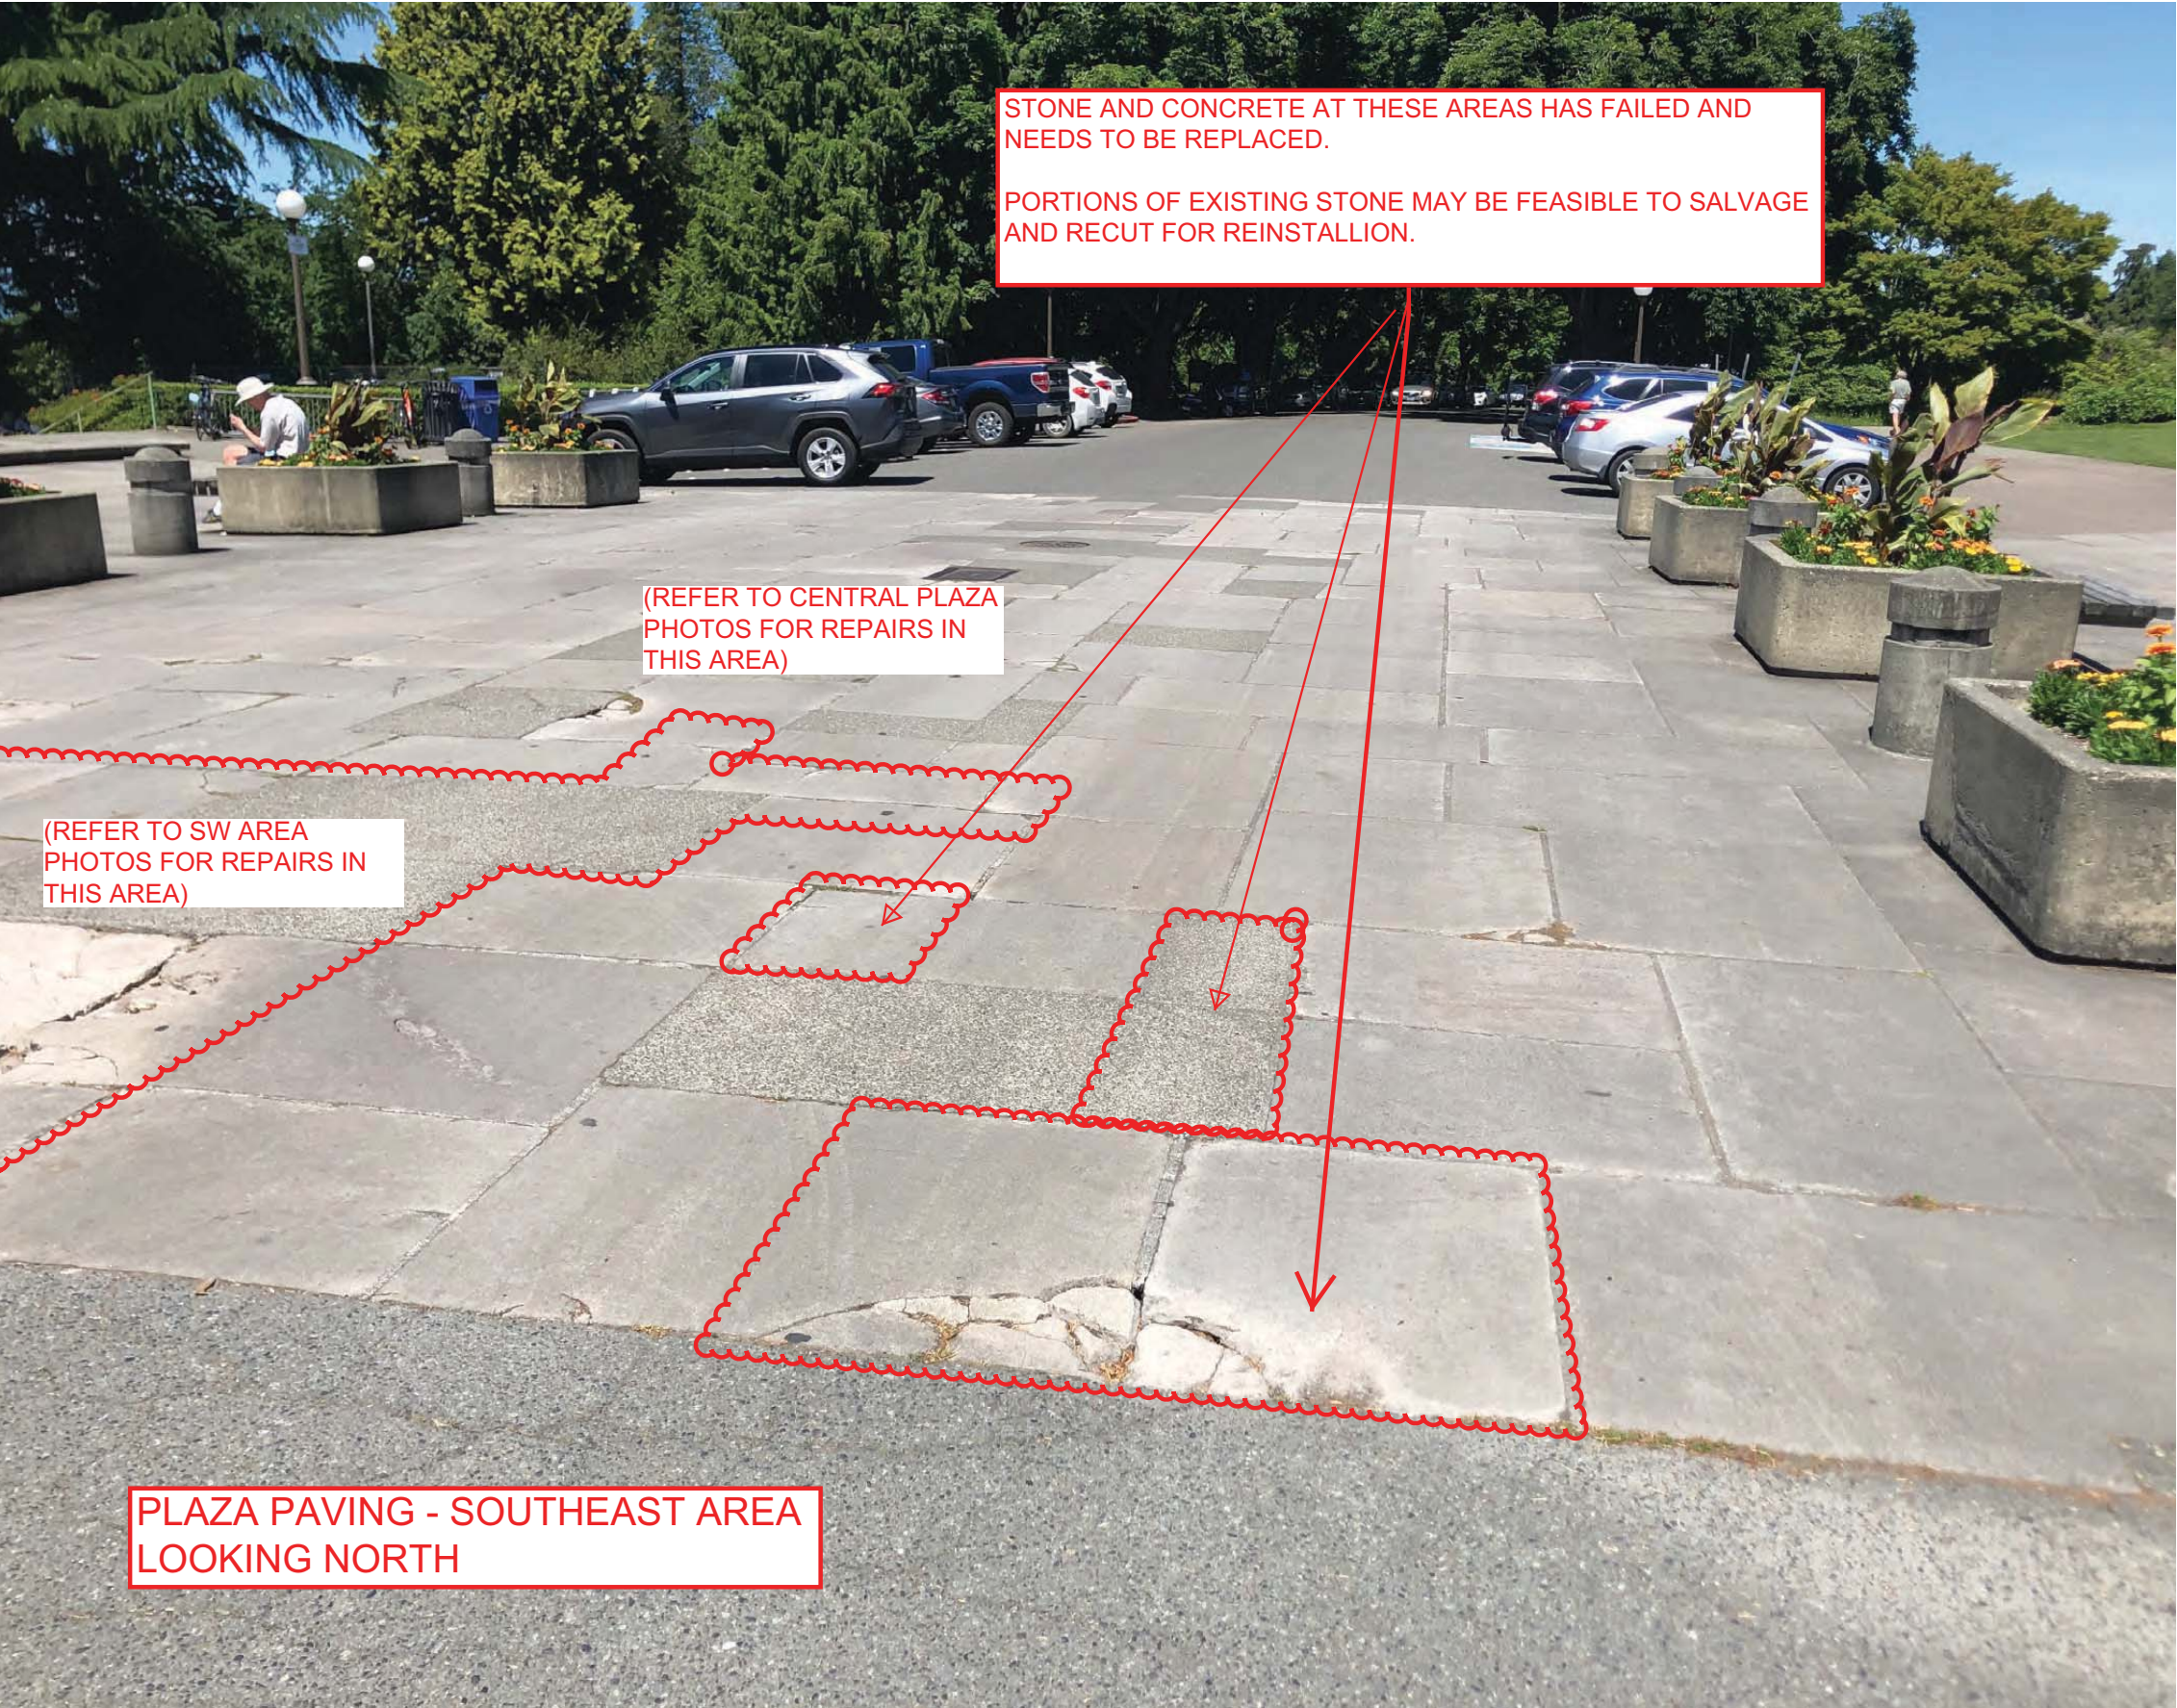
The Southeast portion of the plaza has less extensive deterioration than at Southwest, but the stones closest to asphalt have failed, notably along the edge of asphalt paving. An adjoining concrete infill has minor cracks so is noted to ideally be replaced if feasible within the budget.

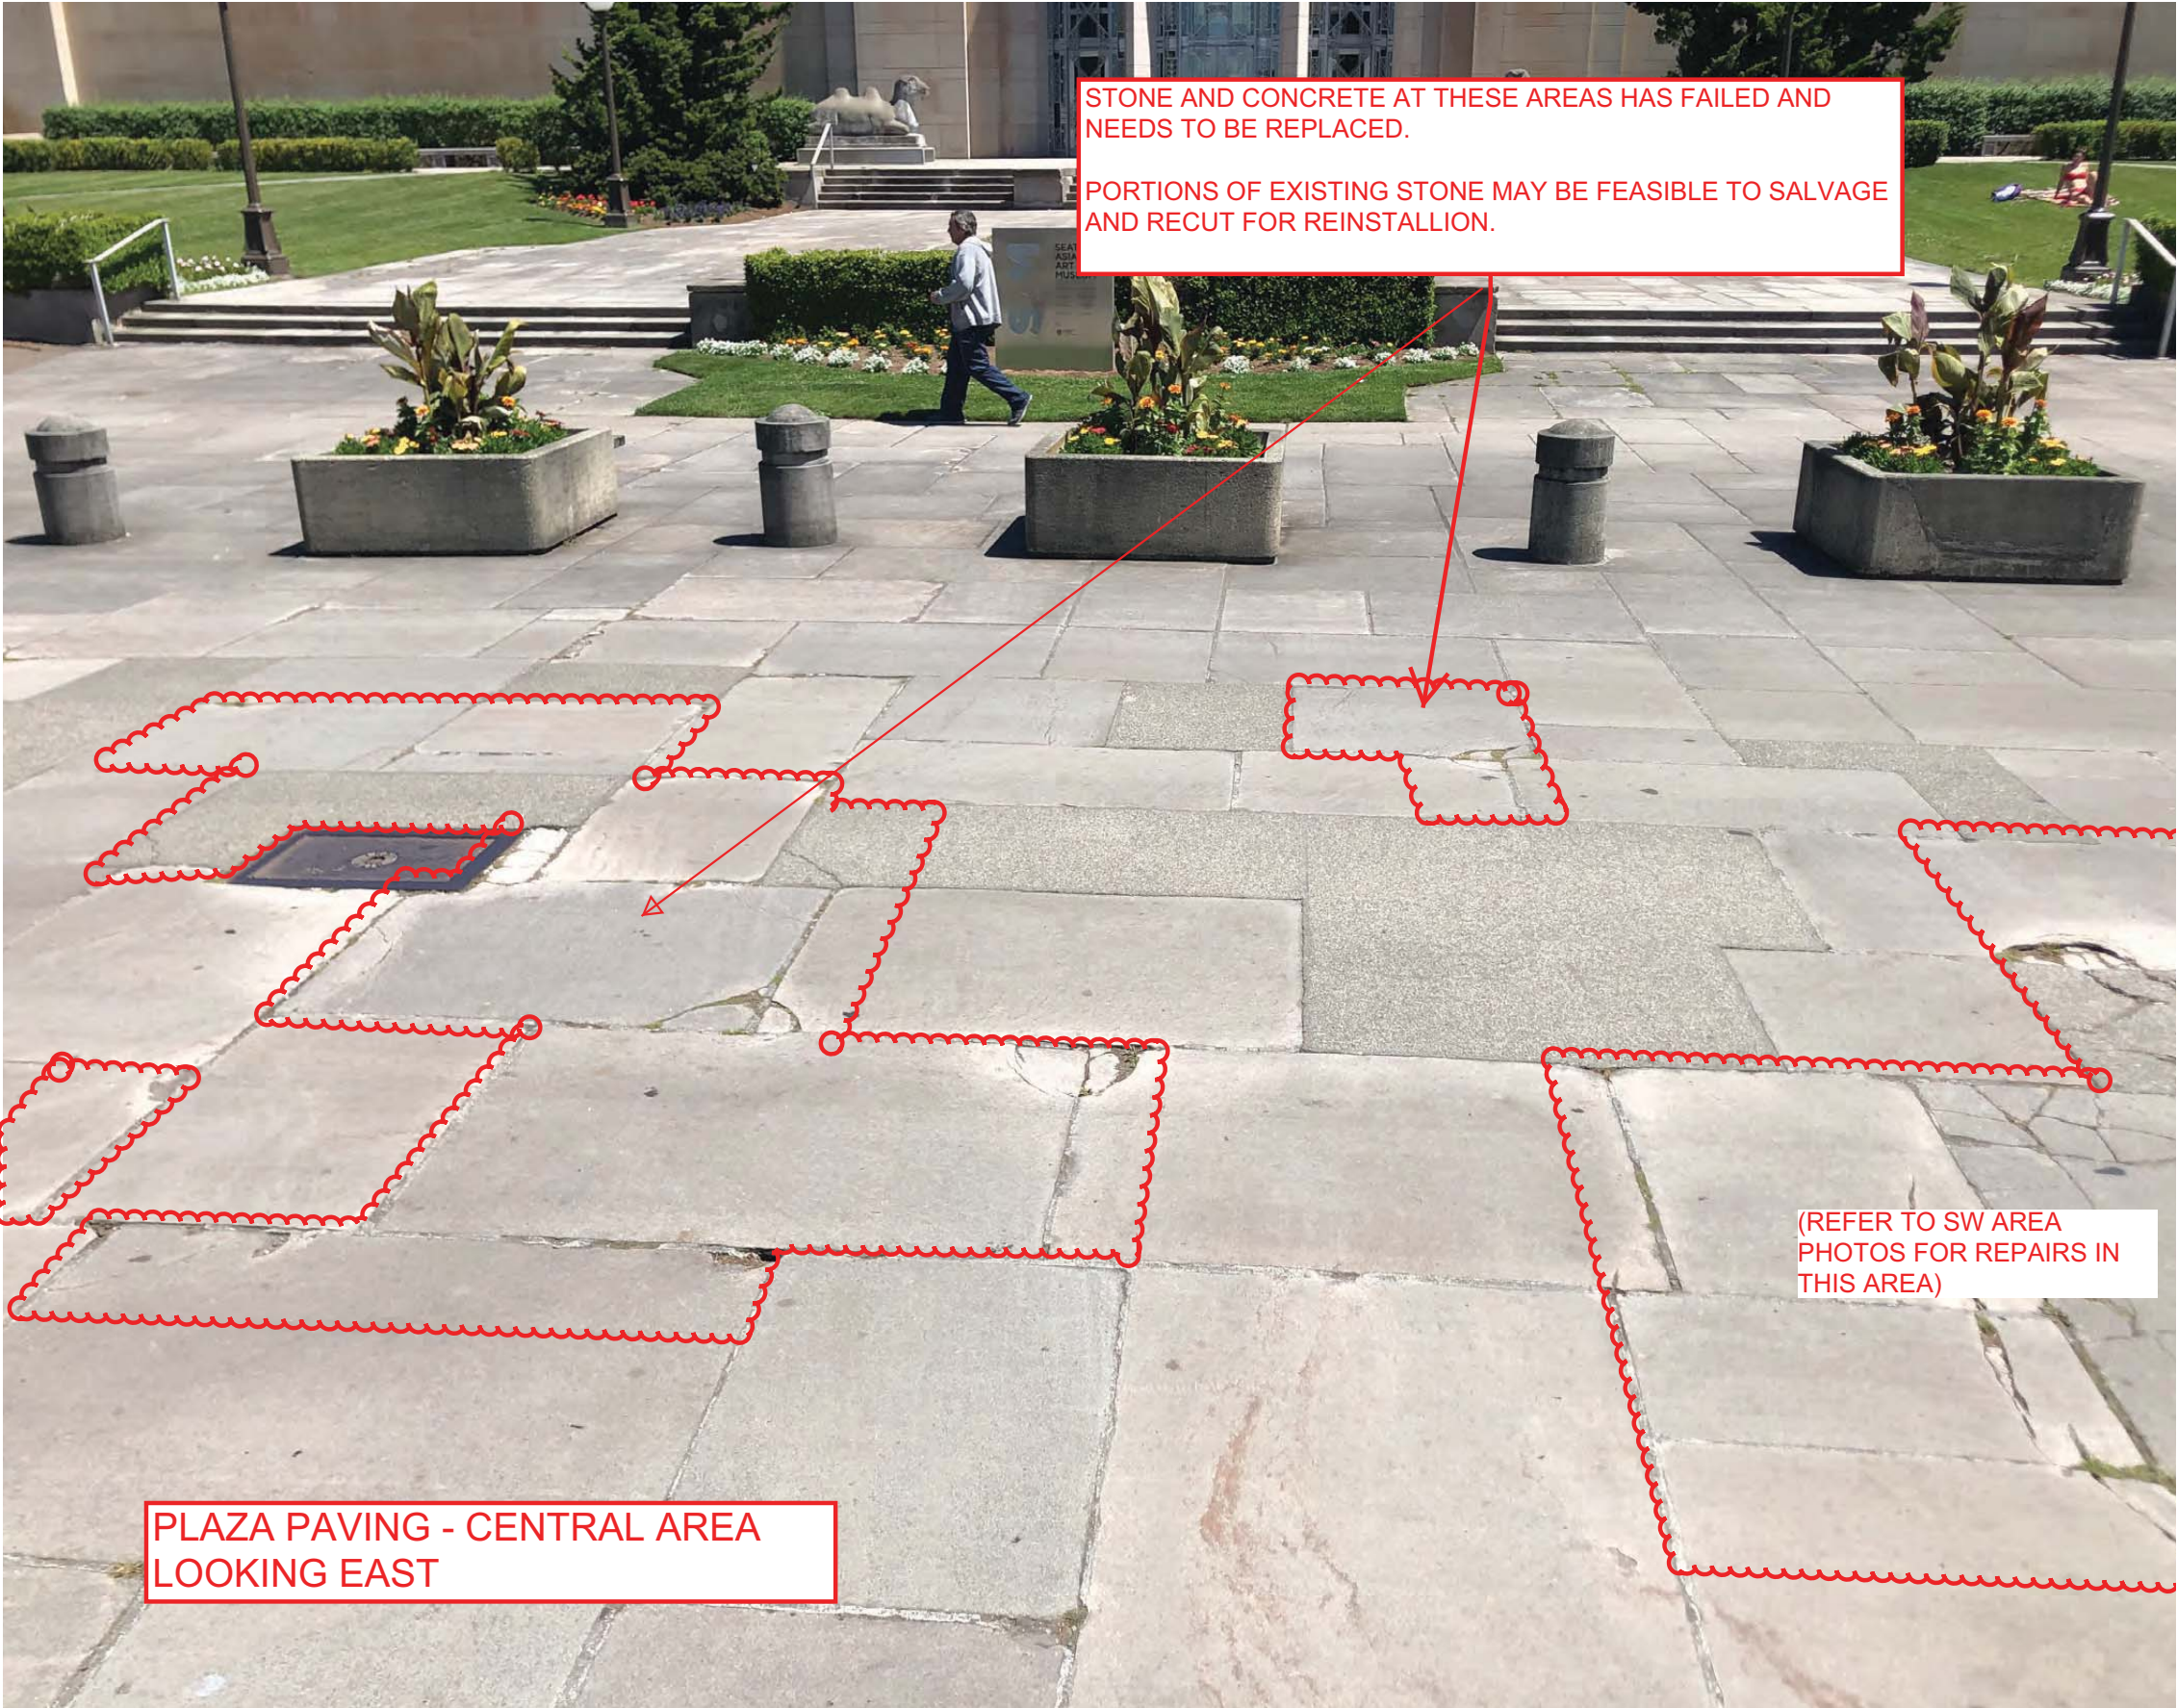
The central plaza area has numerous stones with edges and corners that have eroded or cracked to the extent that water accumulates in the pockets, resulting in further erosion and water infiltration below the stones, contributing to accelerated deterioration. The deterioration is exacerbated in winter by freeze thaw of ice and when snow removal has resulted in further damage to irregular stone edges.

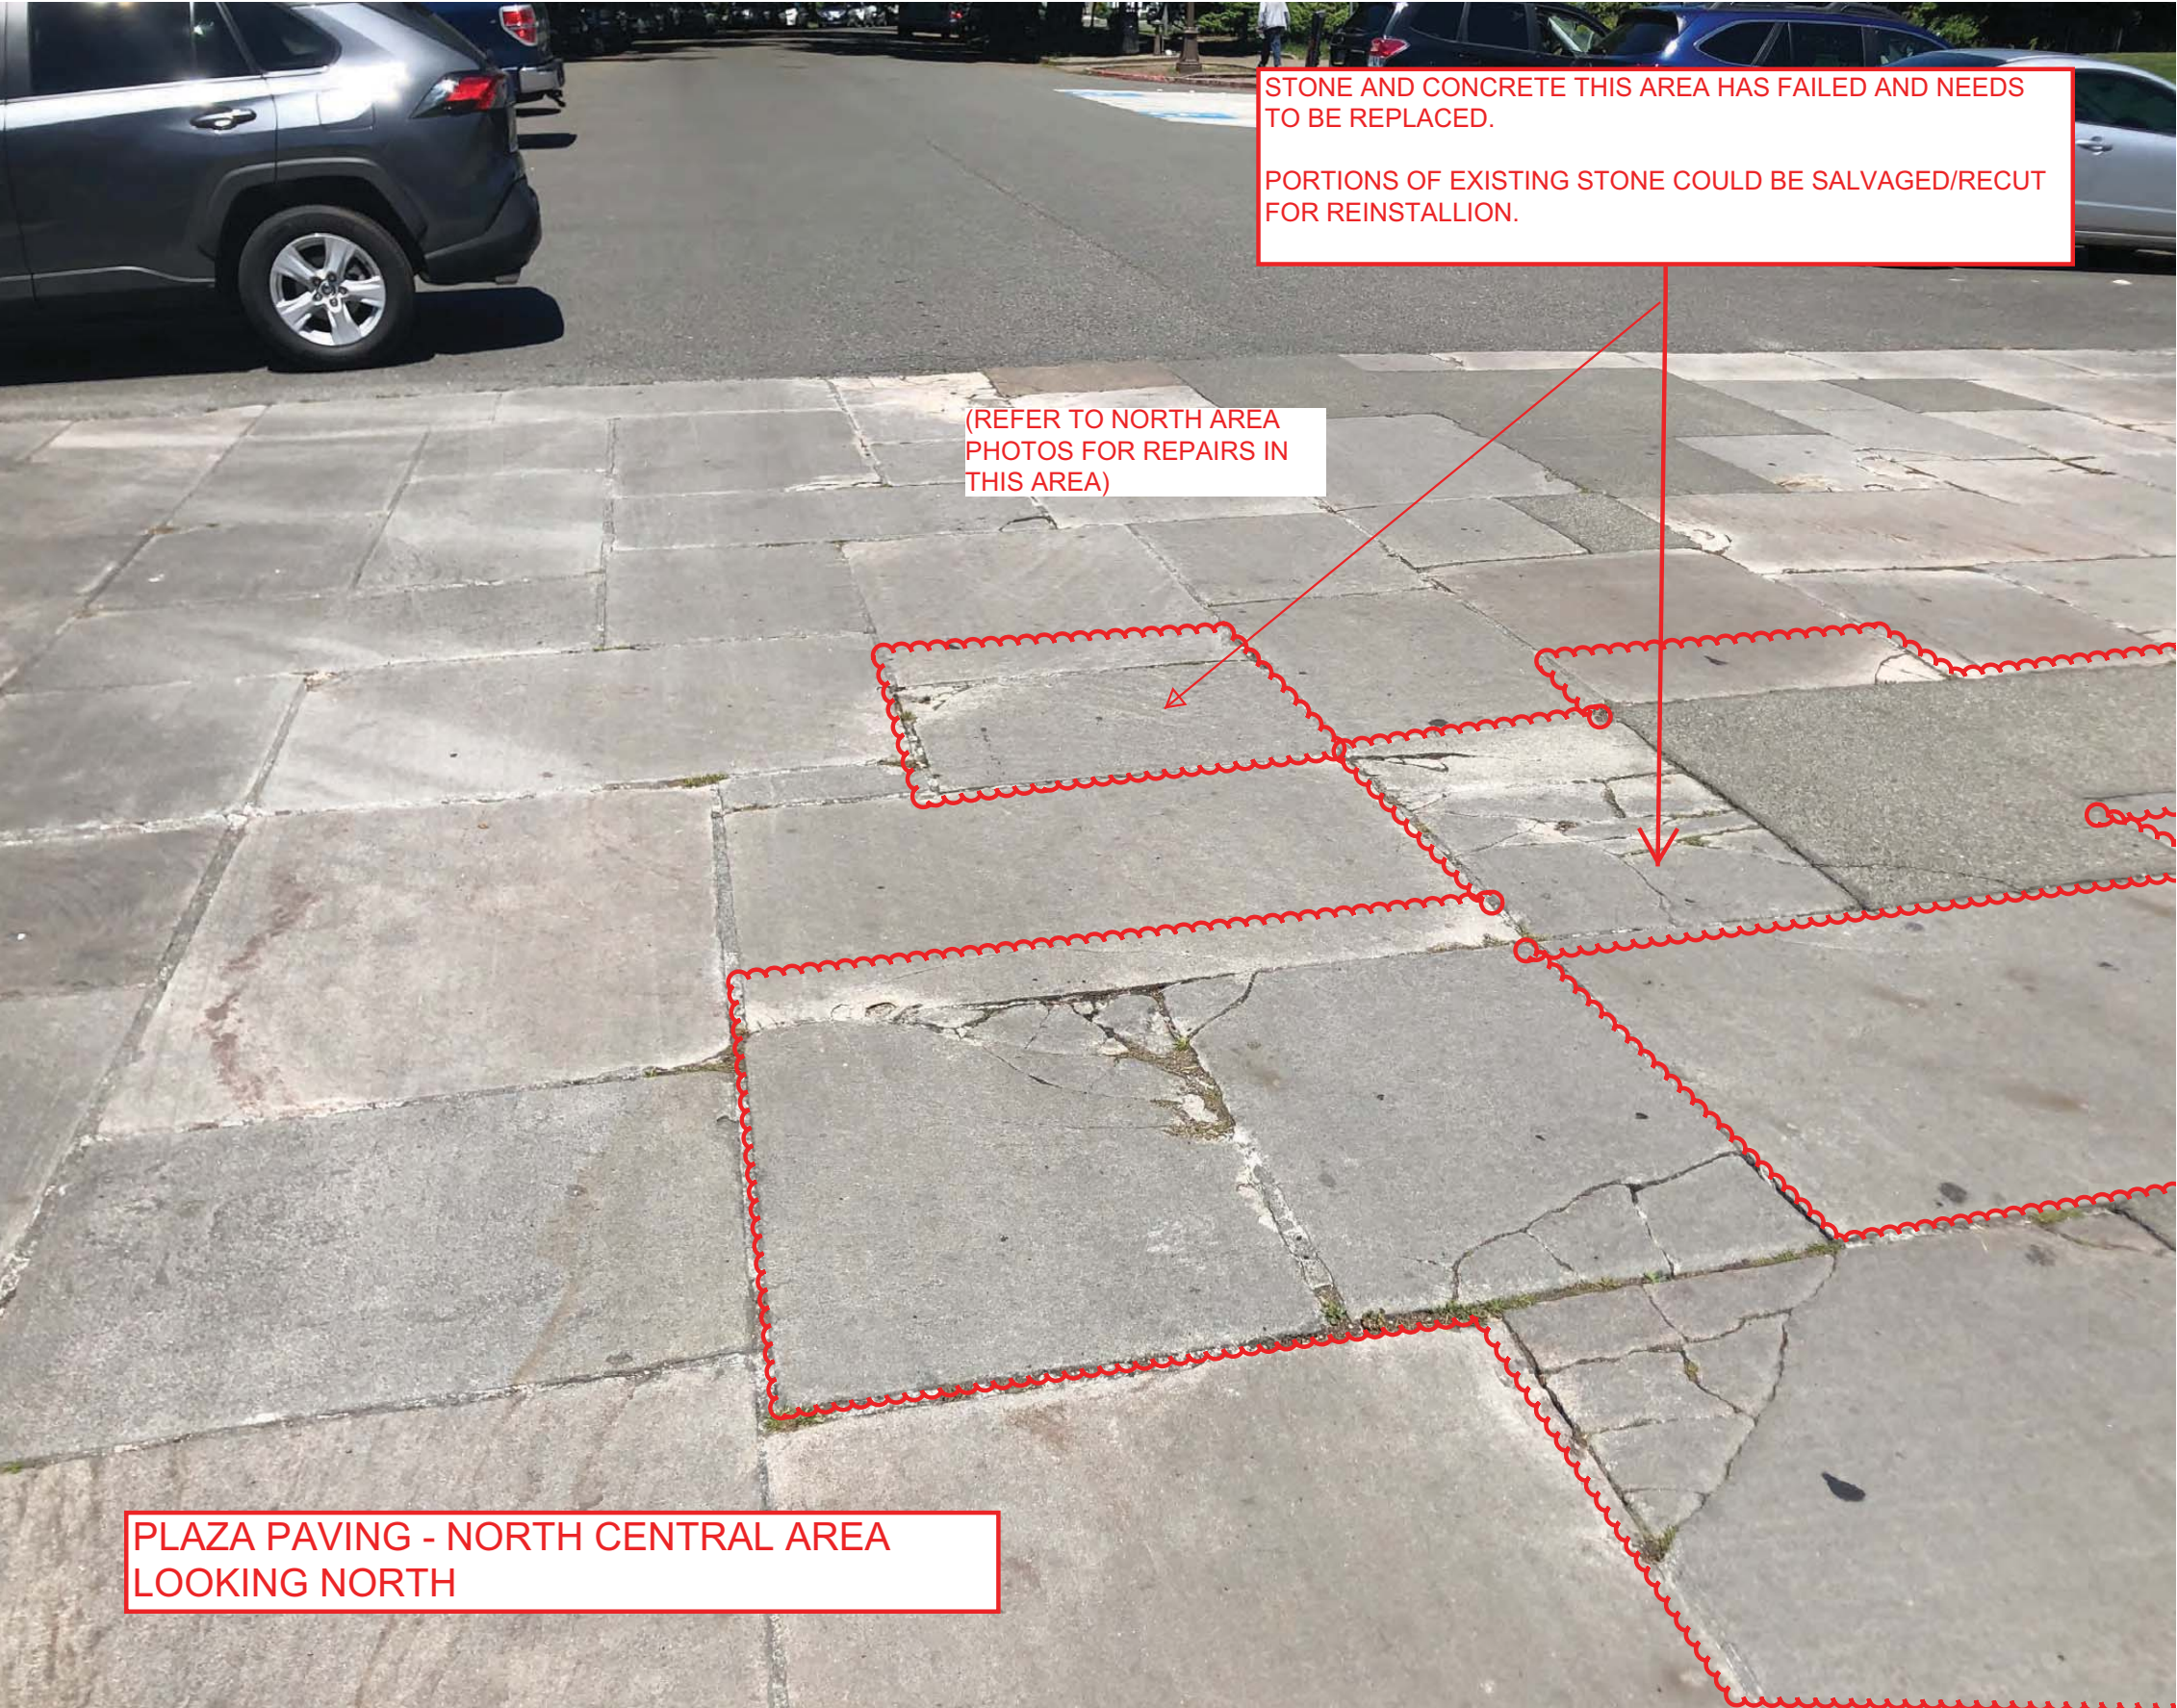
The North central plaza area also has extensive stone areas with edges and corners that have eroded or cracked to the extent that water is accumulating in the pockets and infiltrating below the stone, resulting in accelerated cracking and deterioration.

The concrete on the right-hand side of photo has some minor cracks which are not as problematic as the cracks in stone, but the concrete is proposed to be replaced here as well, if feasible within the budget.

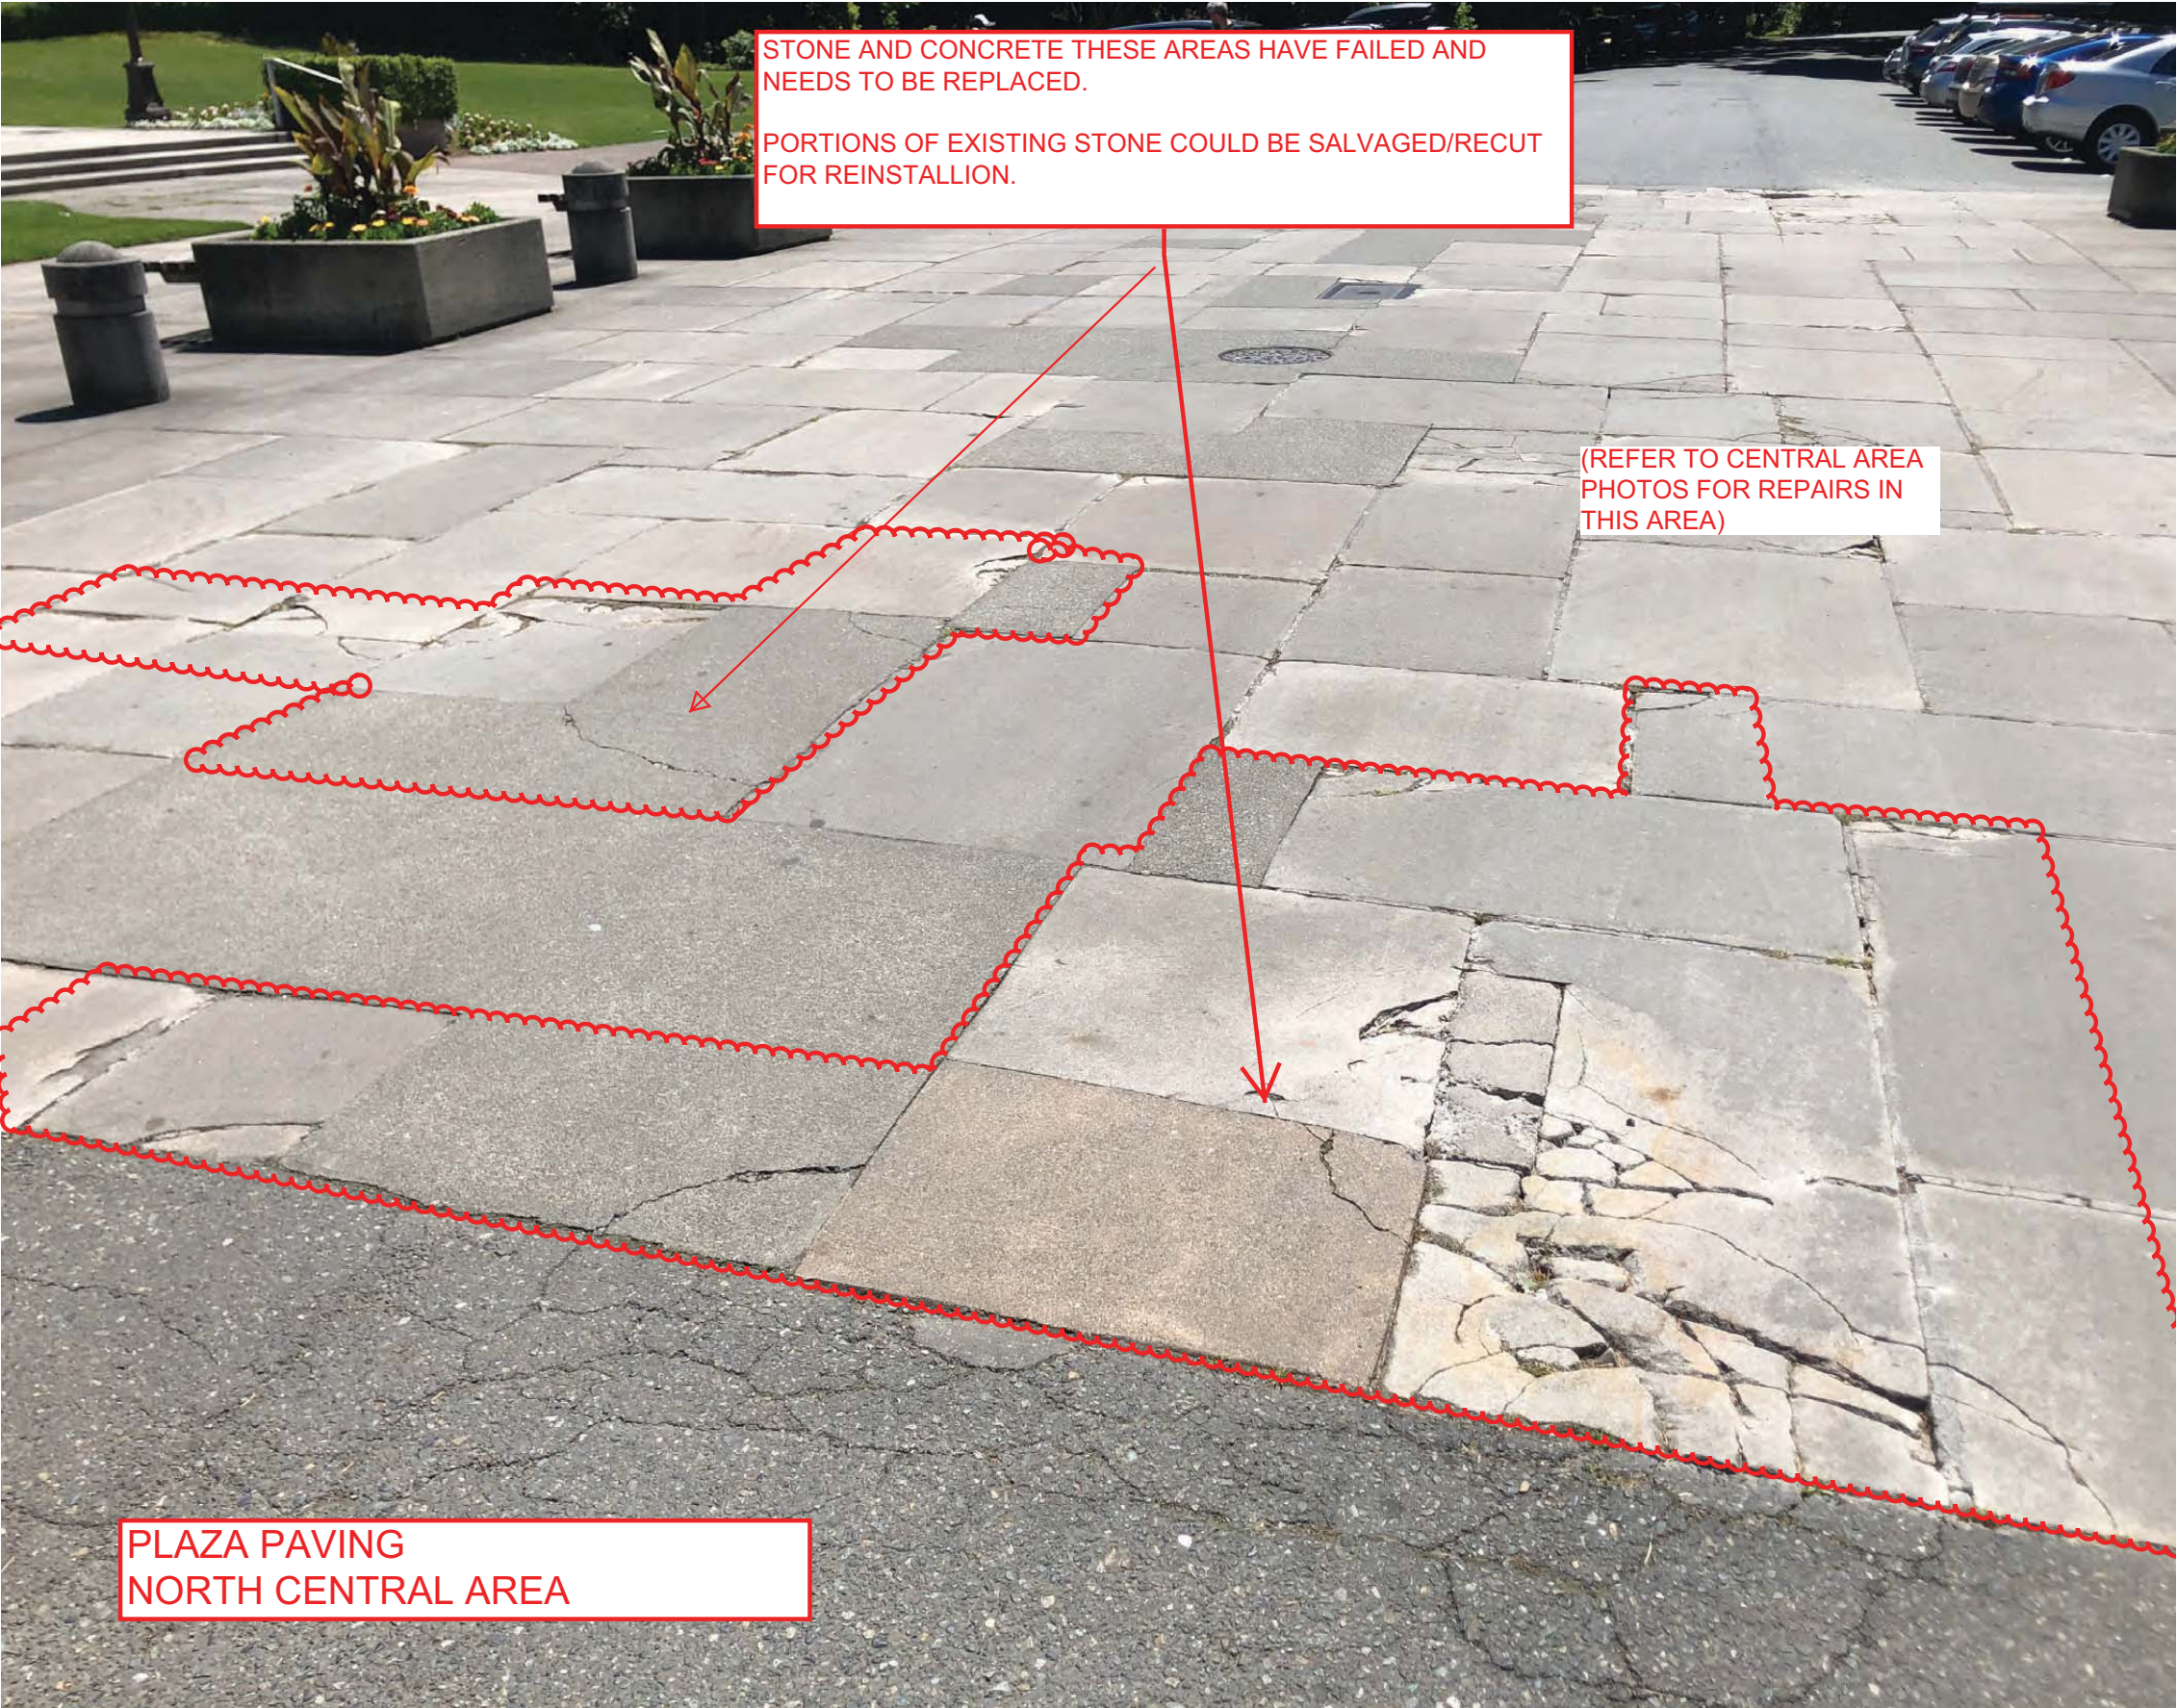
The condition of the North plaza area is similar to the south area, with more extreme deterioration at the transition from asphalt. Note the previously replaced concrete sections evidently done at different times (one portion is colored brown while the remainder is gray.)

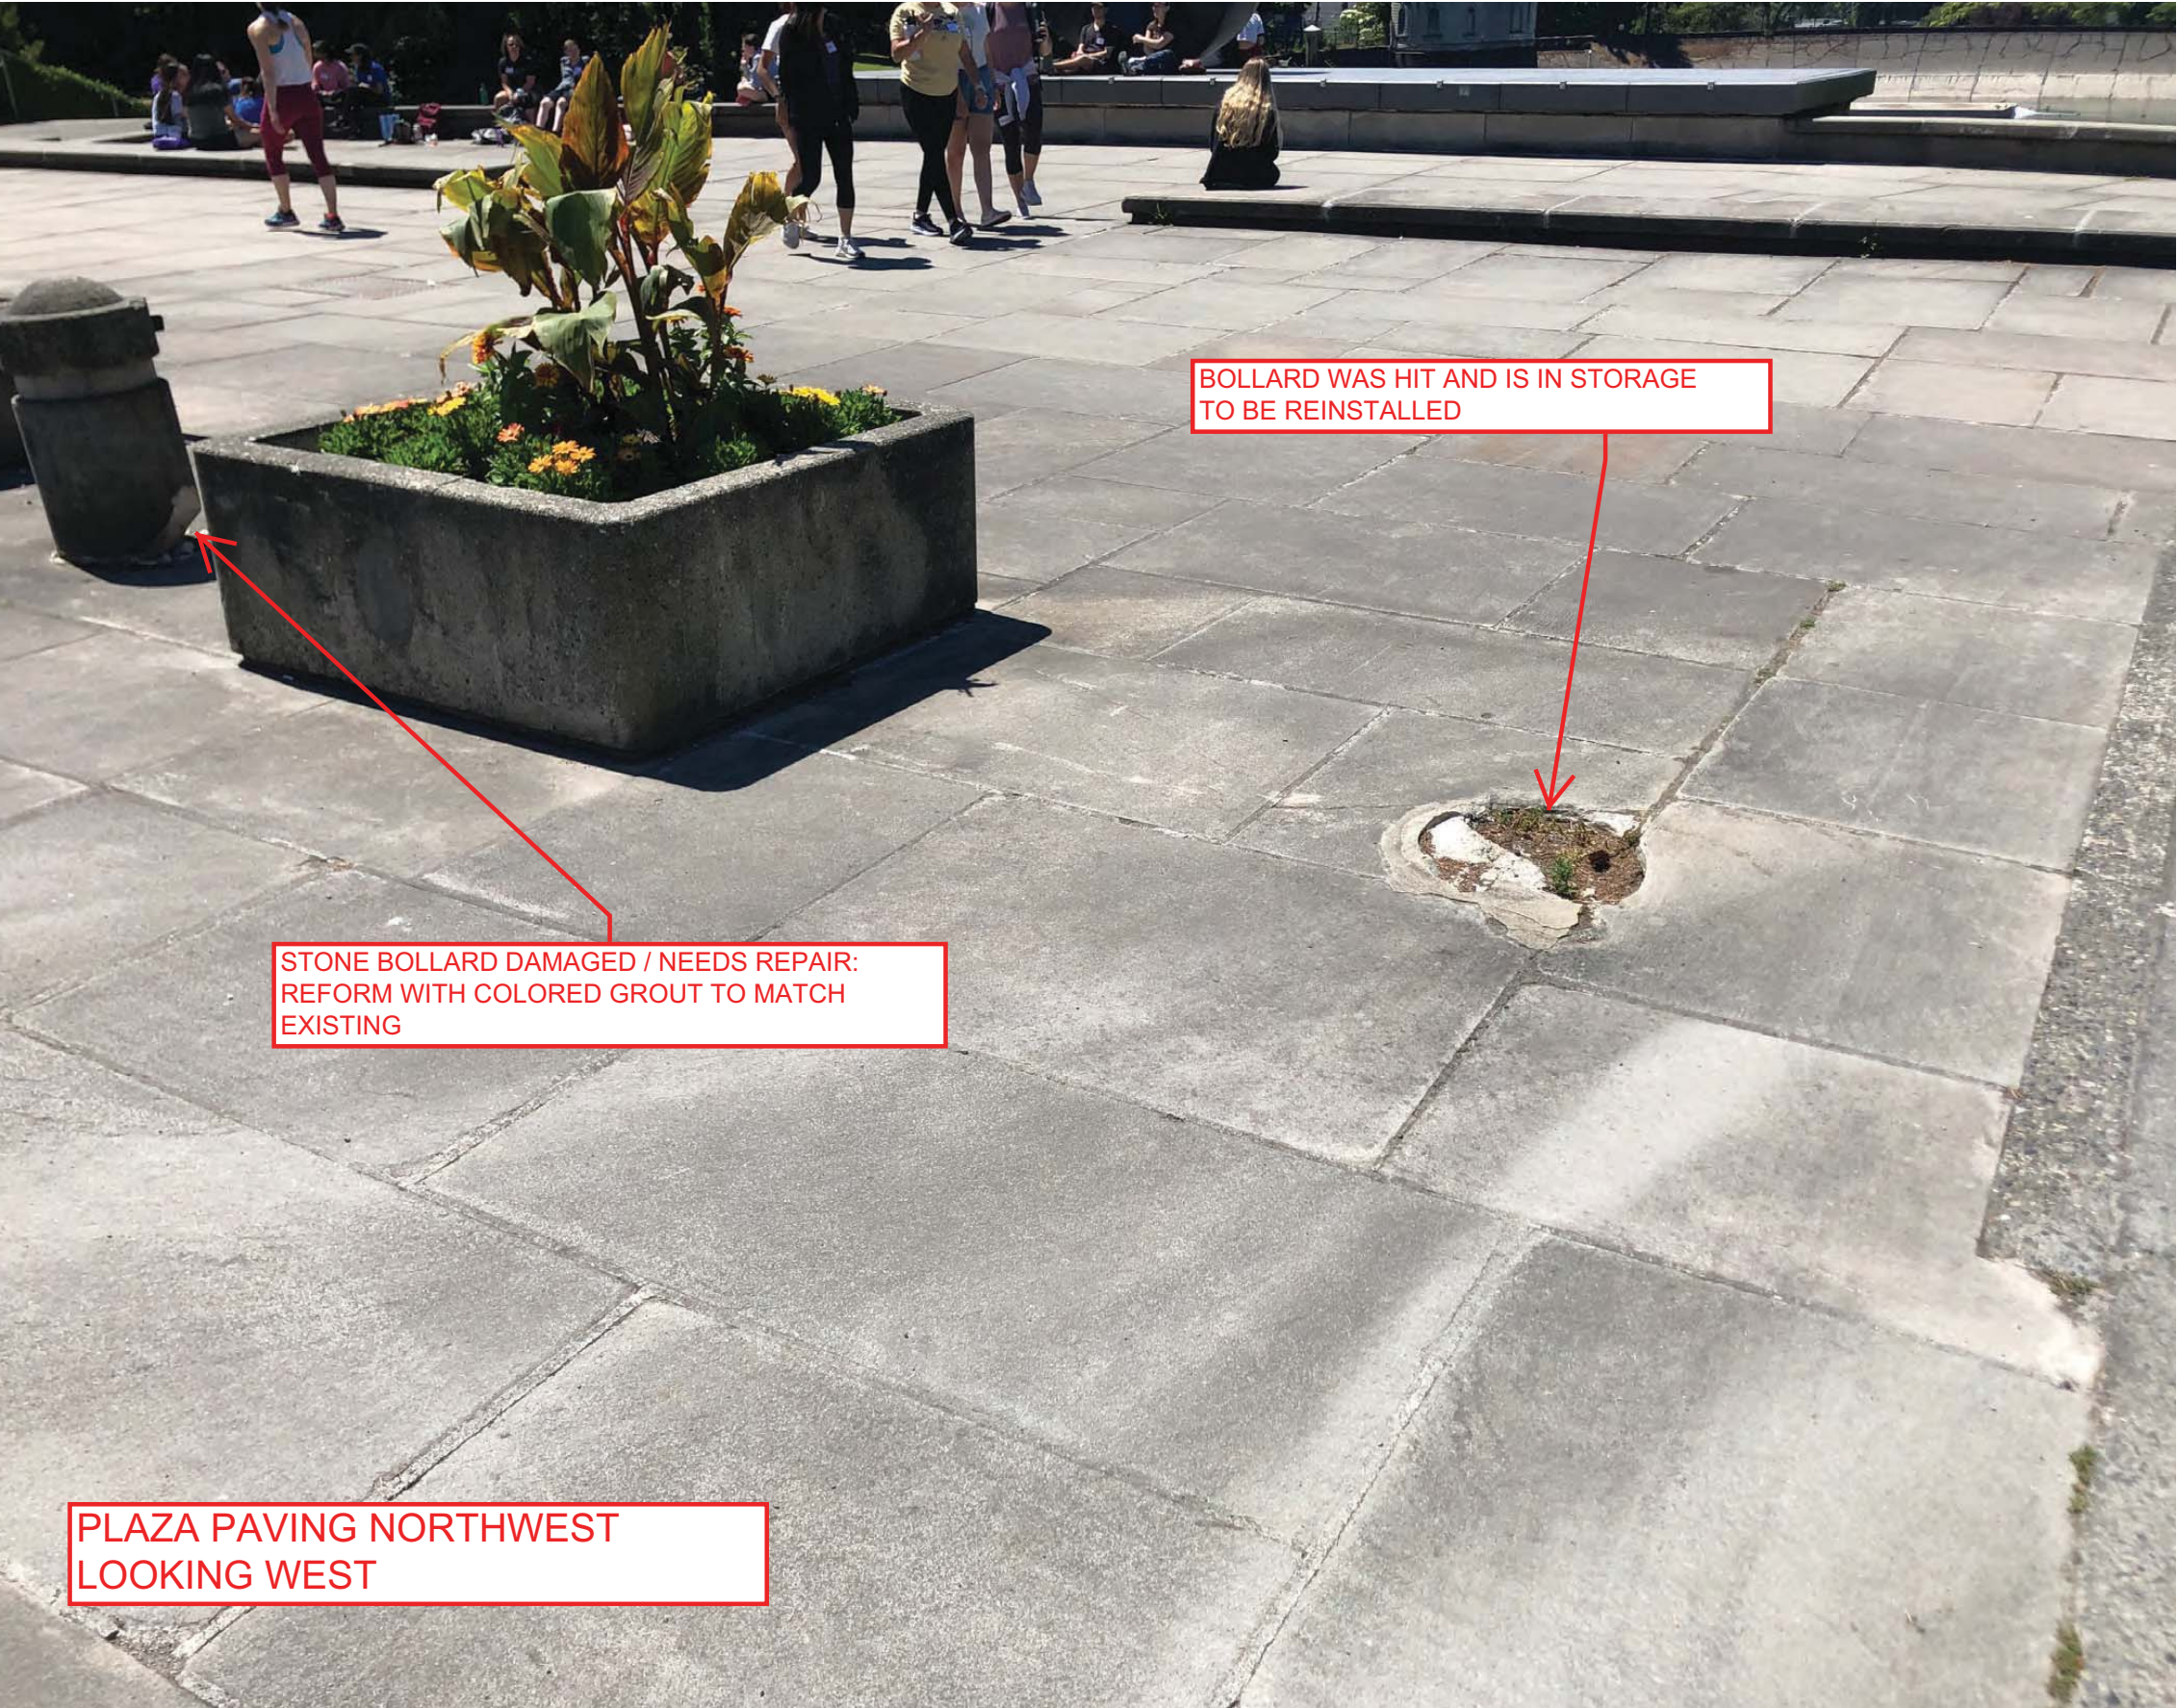
One existing bollard was knocked over by a vehicle and another was damaged by a vehicle. These will be reinstalled and restored to original condition.

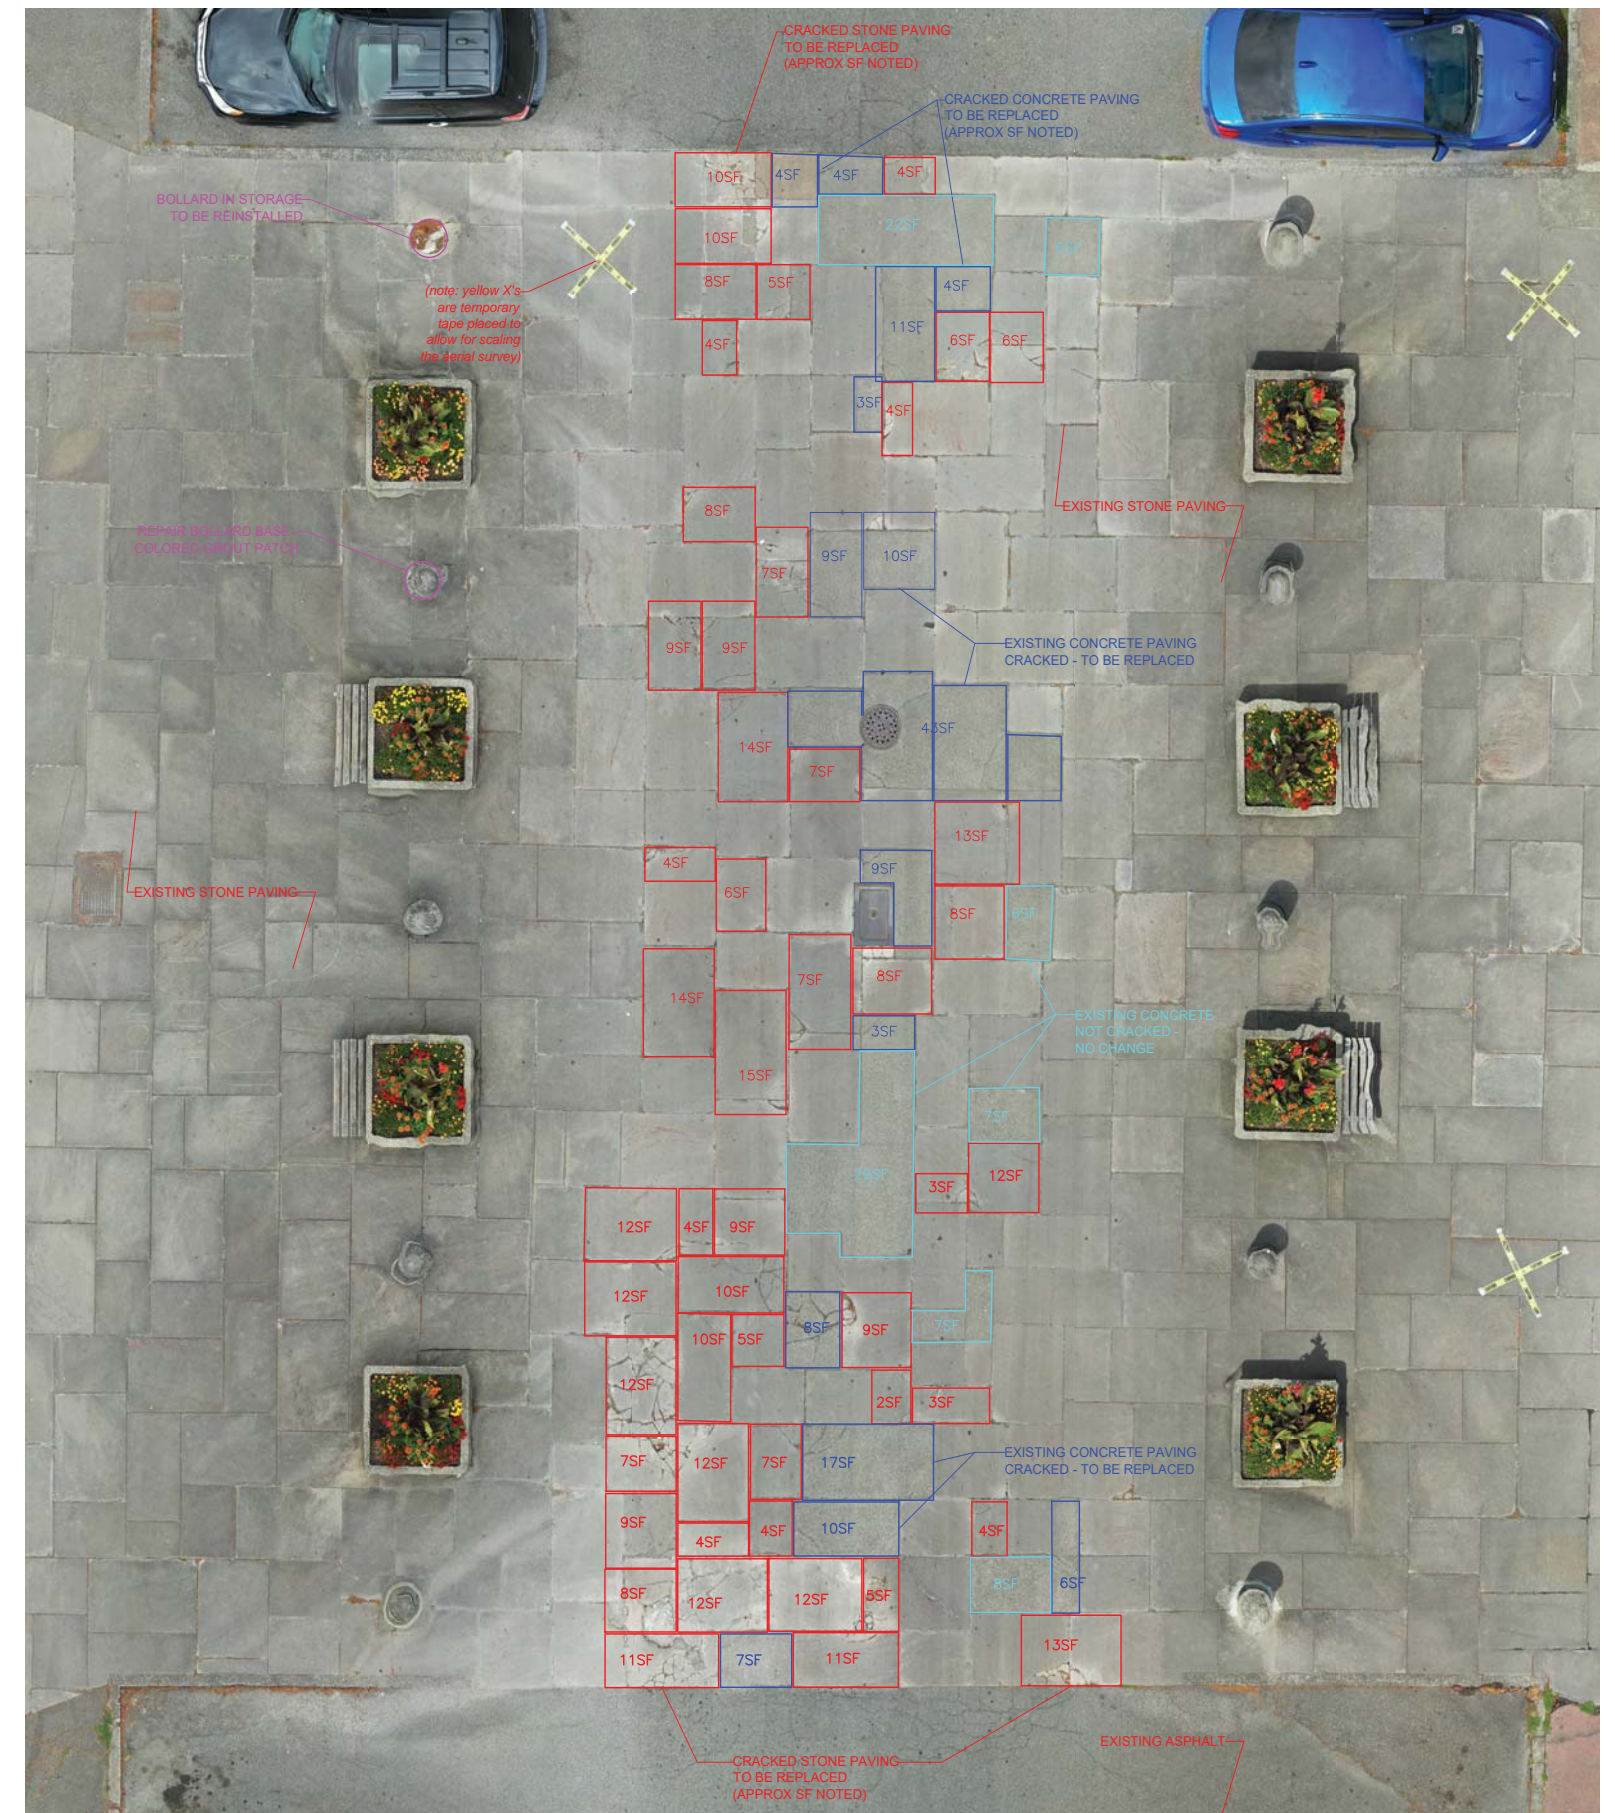
Summary of Impacted Areas:

Red: stone needing replacement: 410 sf

Dark Blue: concrete needing replacement: 150sf

Light Blue: other concrete infills with no cracks: 80sf

Drive area total area: 1950 sf

Total Plaza stone area: over 7,000 sf

1) Given the patchwork of prior concrete infills, the extent of additional deteriorated stone now needing replacement, and the poor performance of the sandstone in the primary vehicle drive area, the ARC recommended full replacement of the primary drive path with concrete constructed to maintain the scale and visual continuity of the plaza, while providing a more durable and appropriate material within the high vehicle drive areas.

2) If full concrete replacement was not feasible due to budget, the ARC indicated they would not endorse continued partial concrete replacement and would prefer limited replacement of stone with new stone.

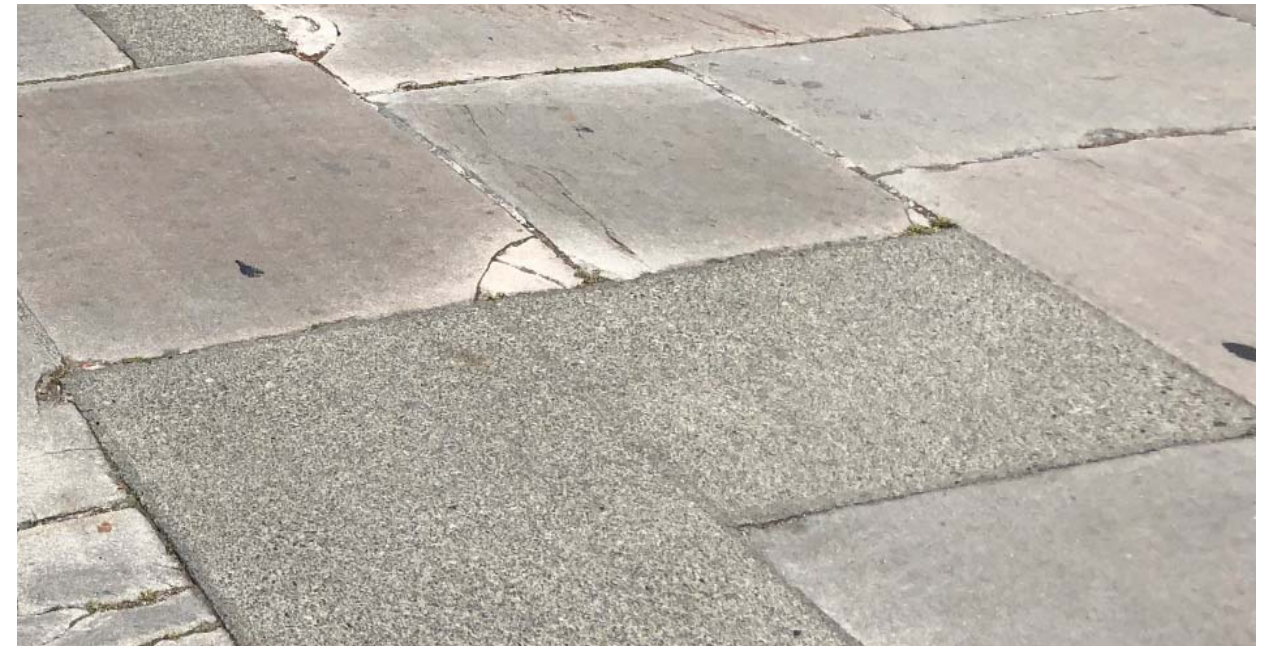
Existing Concete infill within stone paving. A slightly lighter gray color than the existing infill is proposed, with a finer grained etched finish. Note the color variation in surrounding stones.
