OVERVIEW

The stone paving in the Plaza in front of SAAM has deteriorated significantly within the primary vehicle drive areas. Seattle Department of Parks and Recreation investigated repair alternatives and conducted an initial briefing with the Architectural Review Committee on August 13, 2021 to solicit ARC guidance on repair alternatives. This submittal presents the proposed repairs incorporating the ARC recommendations for final review and approval by the ARC and full Landmarks Preservation Board.

VOLUNTEER PARK DRIVE PLAZA PAVING

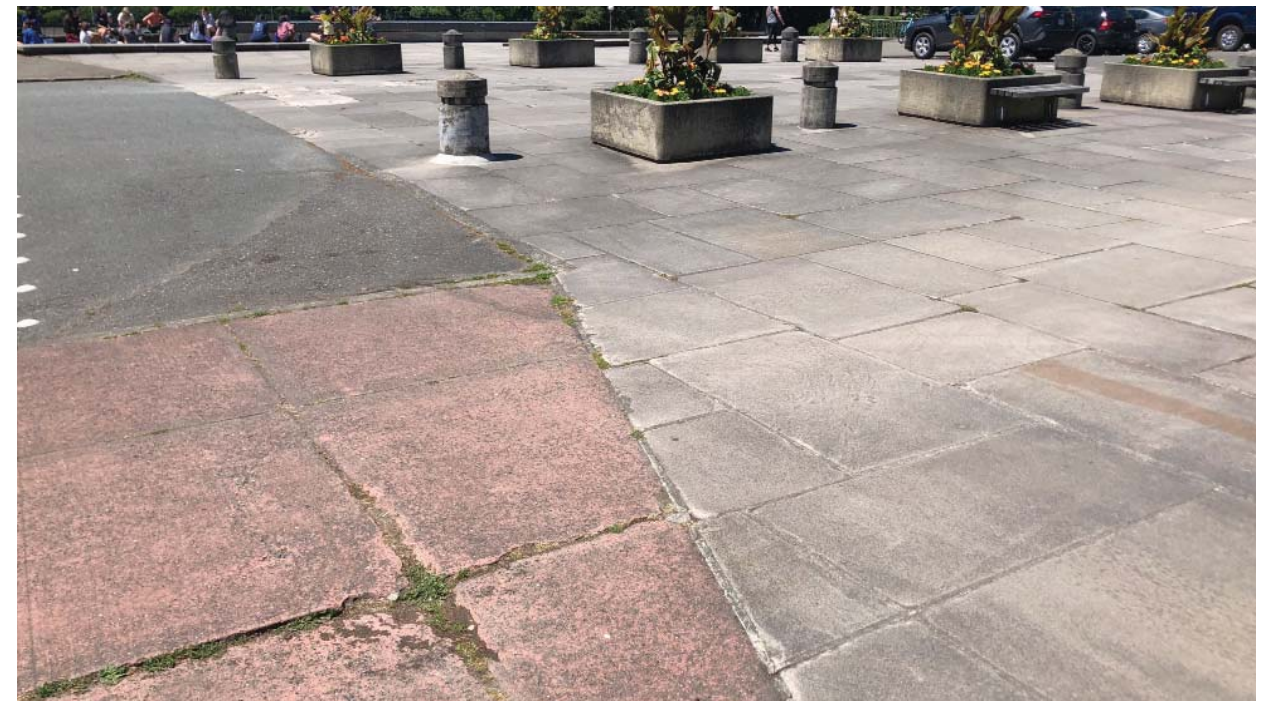
Existing pinkish concrete sidewalk at south edge of stone plaza shown as reference: apparent unsuccessful prior effort to match the pinkish cast in the stone.
