**Carkeek Park Pedestrian Bridge**

# **Feasibility Study Report**

## **Carkeek Park Pedestrian Bridge Assessment**

March 12, 2021

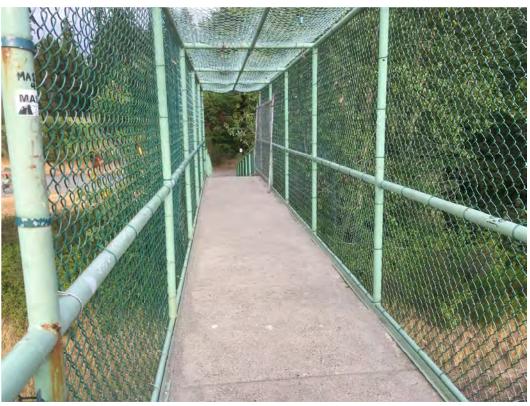
Figure 2 Deck and Fence

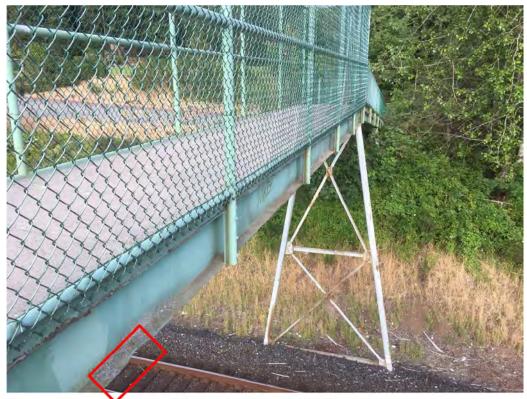
Figure 3 Bridge Steel Beam Bottom Flange Dent

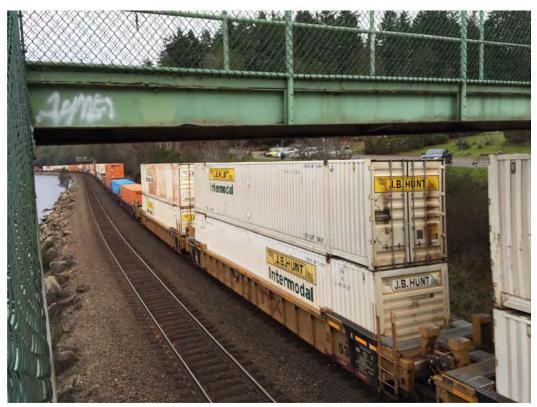
Figure 4 Bridge Low Clearance

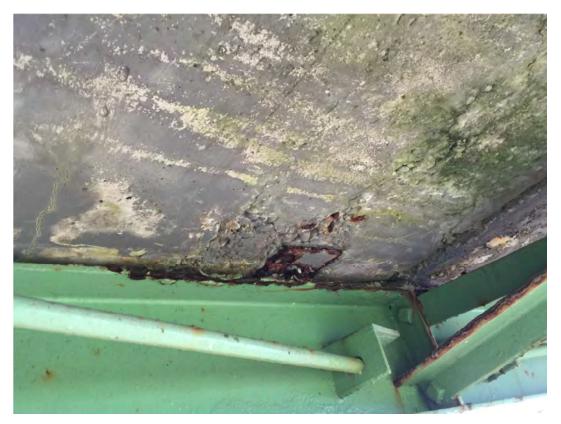
Bridge deterioration is the worst in the structural connections, where water penetration has caused significant corrosion at the concrete deck and steel beam interface, and at the steel welding between pier steel tubes and the connection plates. Figures 2 to 10 show some representative captured locations.

Figure 5 Corrosion and Spalling at Bolt Connection with Precast Slab

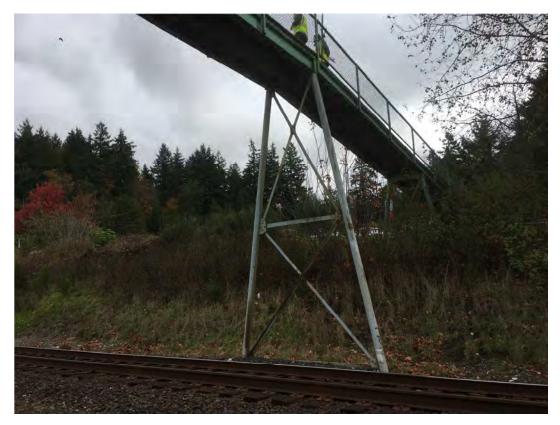
Figure 6 Pier with Corrosion Members at the Other Side of BNSF Tracks

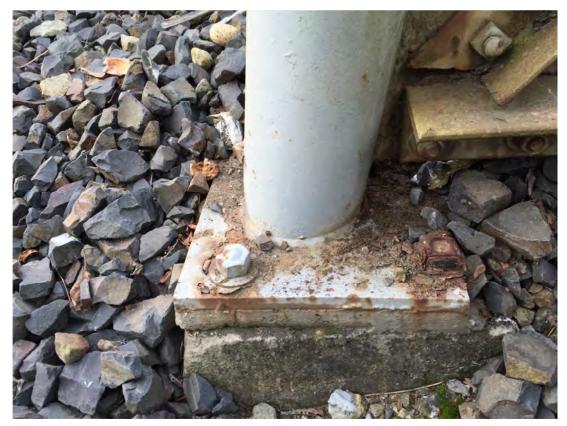
Figure 7 Corrosion at Pier Pipe Base Plate Anchor

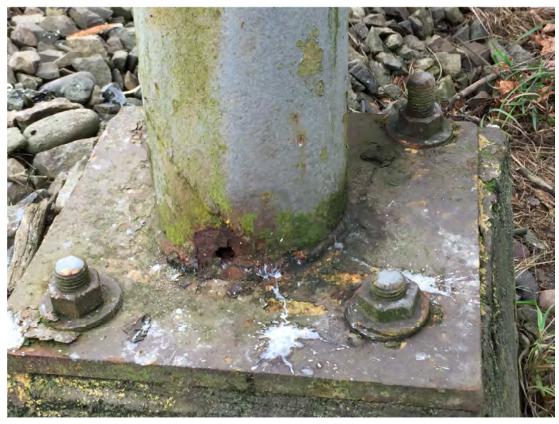
Figure 8 Corrosion at Pier Pipe Base with Visible hole

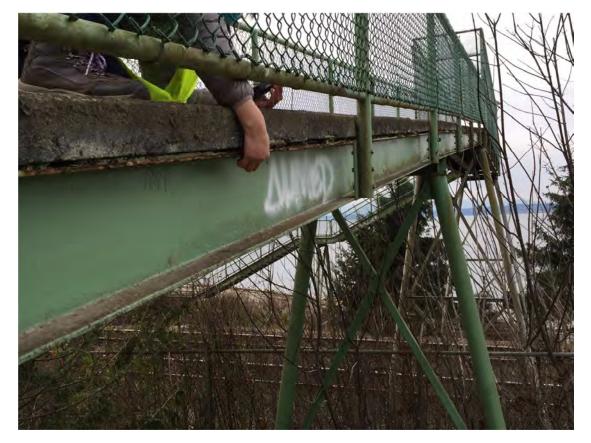
Figure 9 Corrosion at Steel Beam Top Flange

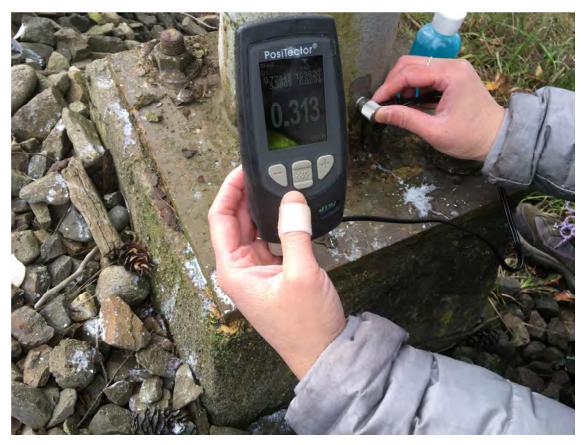
Figure 10 Field Measurement of Steel Thickness

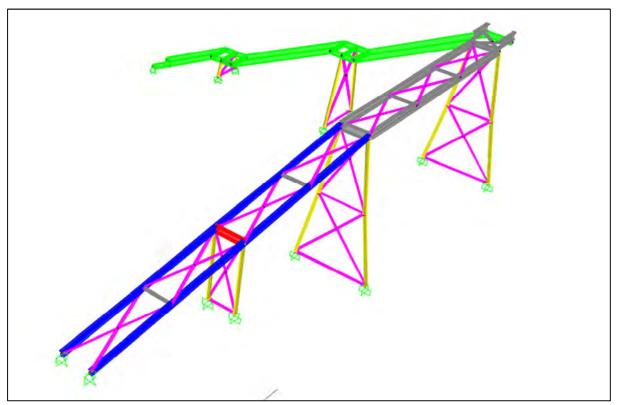
Figure 11 Existing Bridge Analysis Model

Structural analysis was performed using CSI Bridge software to evaluate the load demands. The structural analysis assumed fixed foundation conditions without considering soil responses, and the section reduction was not considered in the model. This is a reasonable assumption considering that significant corrosions occurred at isolated locations.

The structural analysis with reduced sections indicates some deficiencies in the wide flange beam at the parking side approach span, and close to deficiencies at the pipe under the bridge view platform. Both locations have moderate to severe corrosions that may further impact their capacities.

Based on the visibly deteriorated conditions at the structural members and connections, we recommend replacing the bridge within three years, although we have not found an immediate need to close the bridge. The Immediate work for safety includes Pier A-4 pipe base repair and load limitation posting at the parking side entrance.
