Unreinforced Masonry Building Seismic Hazards Study

December 2007

City of Seattle Department of
Planning and Development

ReidMiddleton

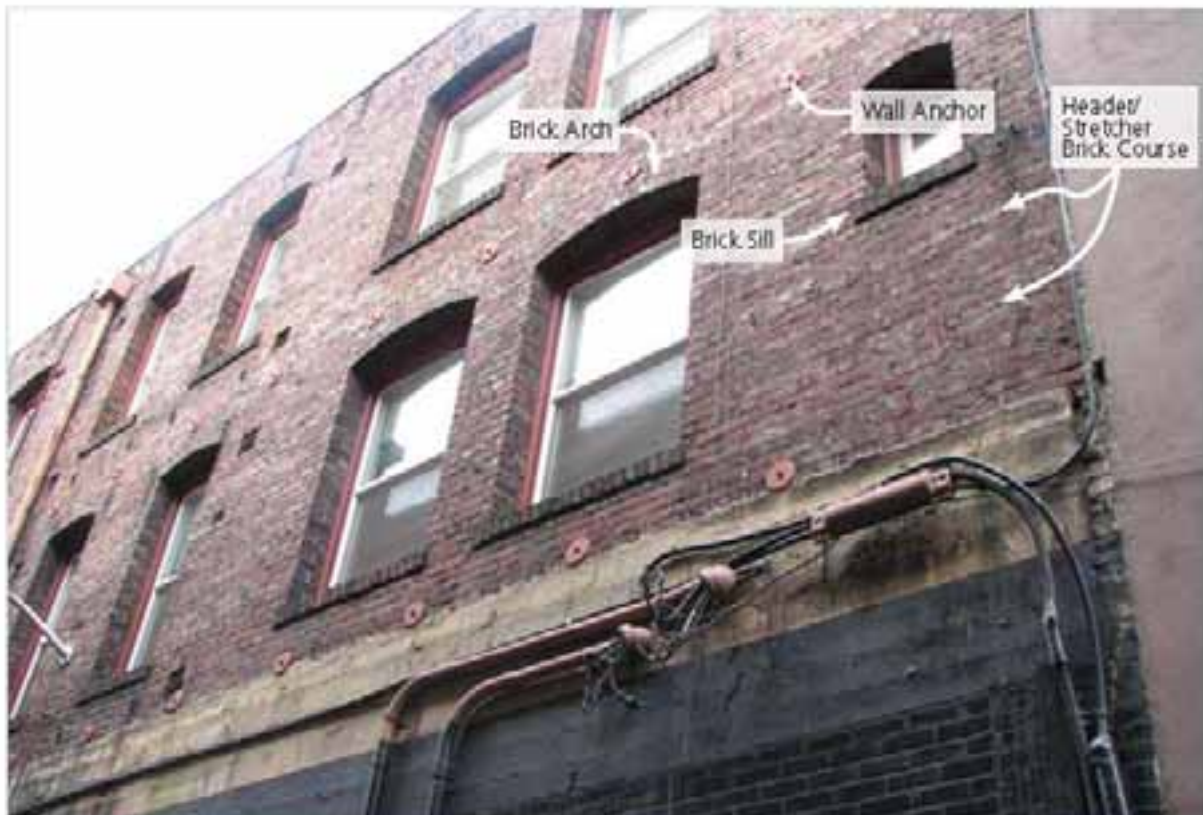
Figure 1. Typical Characteristics of a URM Building.

URM buildings were identified in the field by common characteristics, such as header bricks, brick sills, brick arches, and wall anchors, as shown in Figure 1. Buildings with these features and constructed before 1940 were included in the URM survey. Typically, West Coast building codes prohibited unreinforced masonry building construction after 1940. The year of the building's construction was usually identified through King County's GIS parcel viewer system, which lists tax records and other information about the structure. In some cases, the year was found through the date indicated on the building's cornerstone or through news articles.
