## **MAGNOLIA BRIDGE REPLACEMENT TS&L STUDY**

### **EXISTING BRIDGE CONDITION REPORT**

**April 2003**

Seattle Department of Transportation  
Agreement No. T01-34

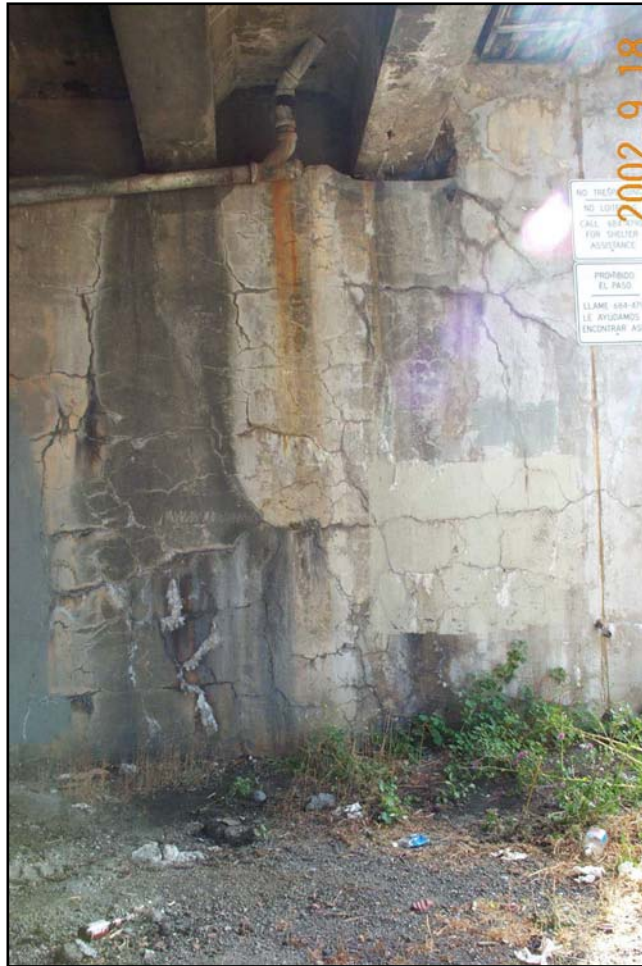
**Figure 1 - East Abutment: Station 3+81 (Reference Photograph 6)**

The east abutment has extensive cracks on the face of the abutment wall. Sounding the wall with a hammer indicates that the concrete surface is solid, suggesting the cracks are not the result of surface delaminations.

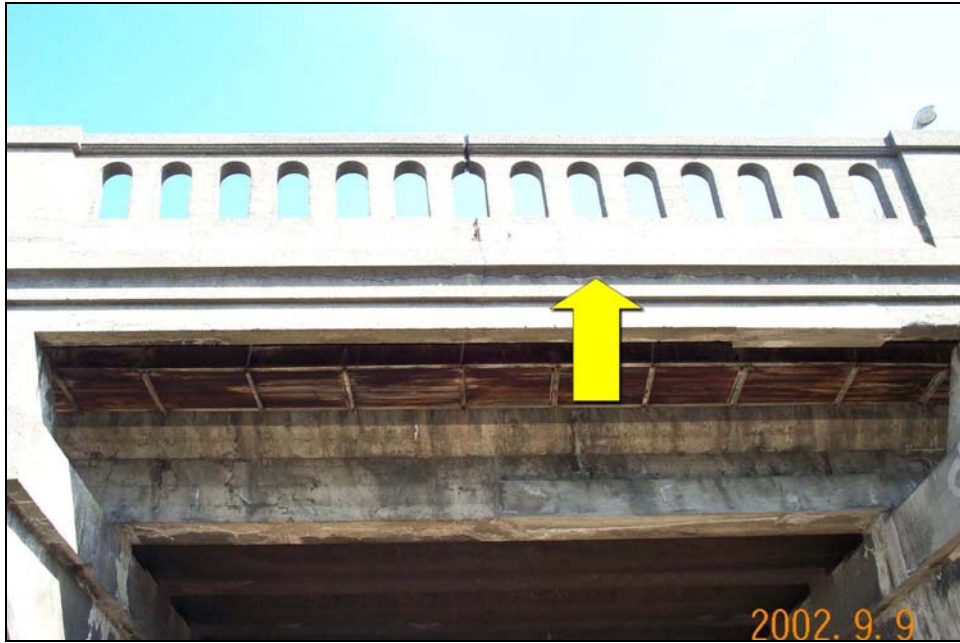
**Figure 2 - Bents 2 to 3: Station 4+29 to 4+53 (Reference Photograph 8)**

The above photo shows a horizontal crack in the slab below the guardrail.

- The horizontal crack on the south side of the bridge between Bents 2 and 5 should be checked to determine whether it adversely affects the capacity of the bridge guardrail. (See Photographs 8 and 9; Figures 2 and 3, respectively.)

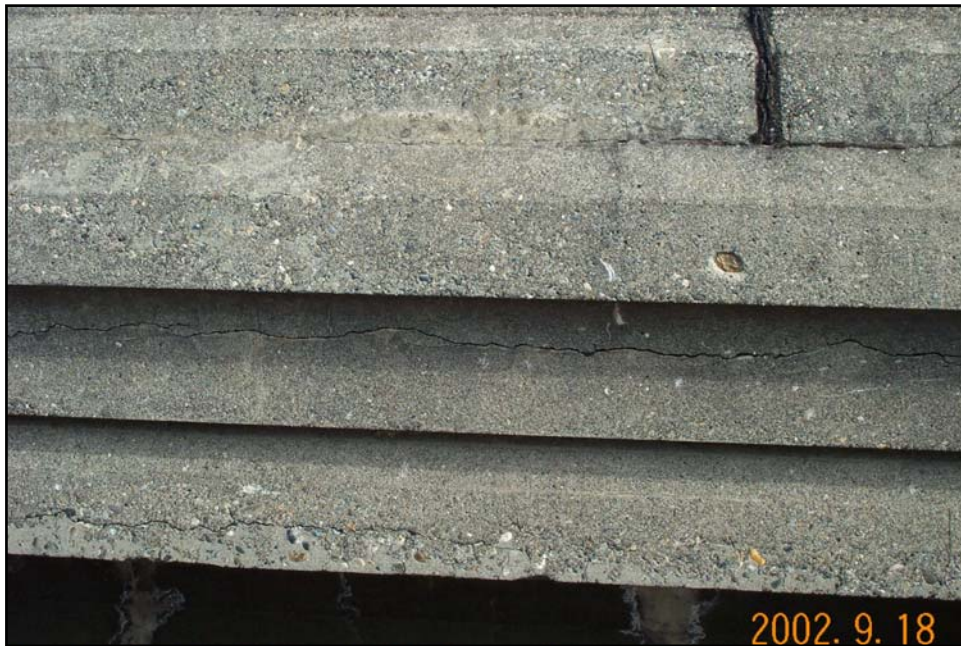
**Figure 3 - Bent 4: Station 4+77 (Reference Photograph 9)**

A close up of the same crack as shown above.

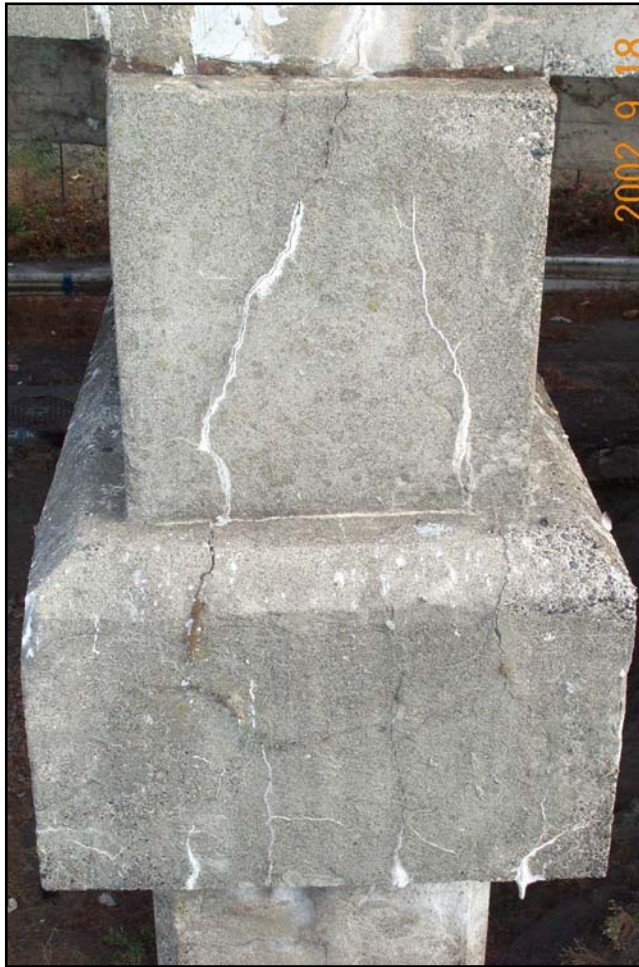
**Figure 4 - Bent 4: Station 4+77 (Reference Photograph 11)**

Cracks in the vertical end of the abutment beam. White deposits (efflorescence) indicate water migrating through the cracks.

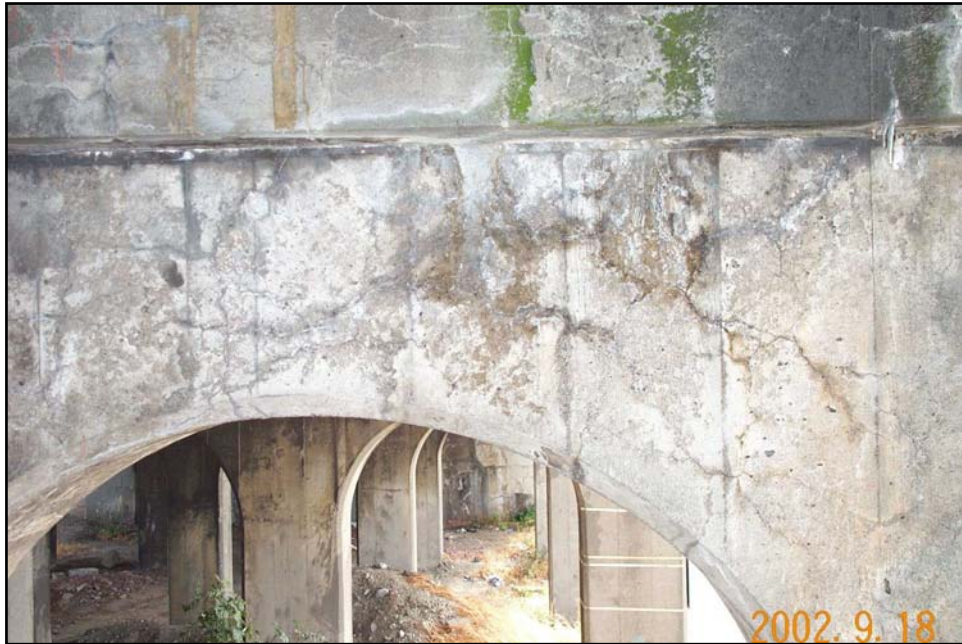
**Figure 5 - Bent 4: Station 4+77 (Reference Photograph 17)**

Cracking in the top of the arch between columns. This type of cracking appears to be relatively isolated in this section of the bridge.

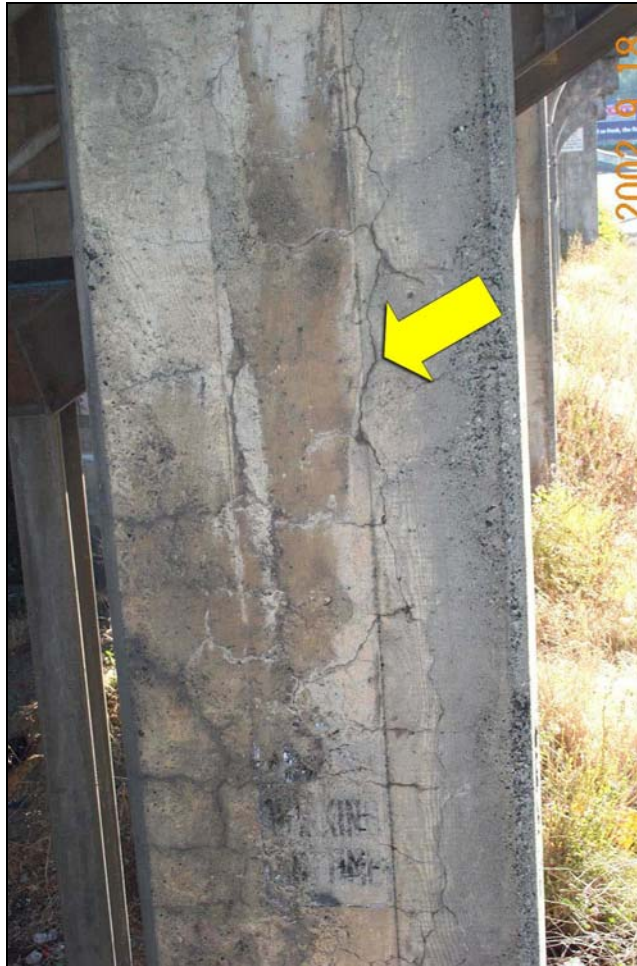
**Figure 6 - Bent 5: Station 5+01 (Reference Photograph 22)**

Vertical crack running the full height of the column.

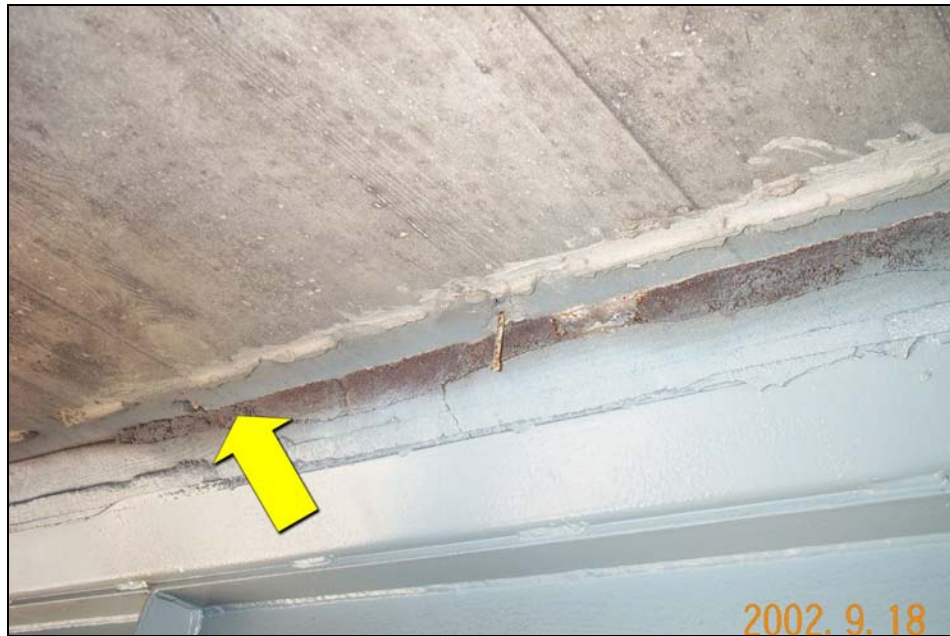
**Figure 7 - Bents 16 to 17: Station 8+70.45 to 9+03.15 (Reference Photograph 27)**

Cracked grout pad above the transverse steel beams. The crack does not extend all the way through. The black pad between the grout and the deck is deteriorated.

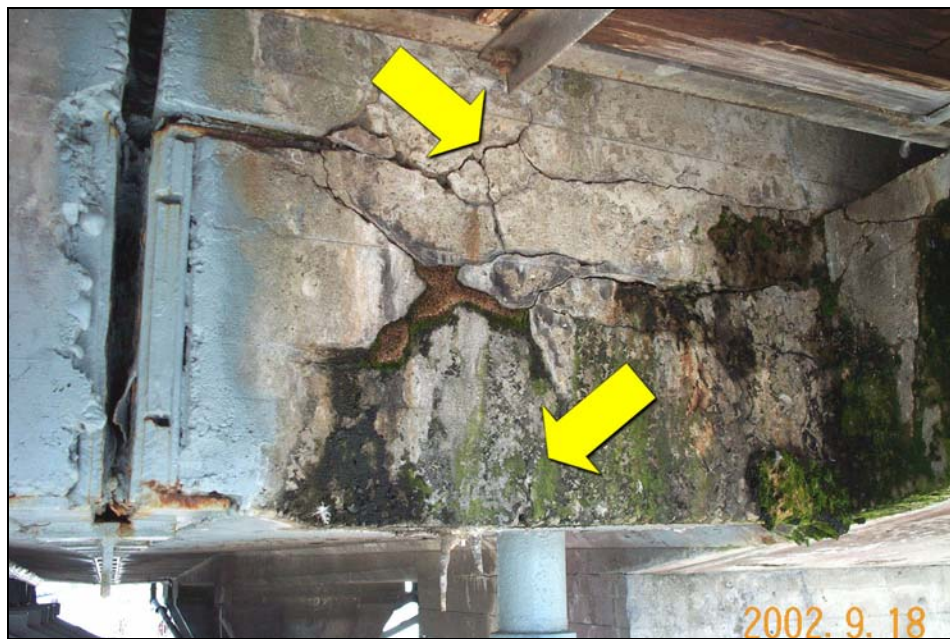
**Figure 8 - Bent 17: Station 9+03.15 (Reference Photograph 33)**

The edge beam is heavily cracked at the expansion joint west of Bent 17.

- The extent of damage to the slab on the west side of the expansion joint at Bent 17 needs to be checked further (See Photograph 33; Figure 8). Corrosion may adversely affect the structural capacity of the walkway and traffic railing.

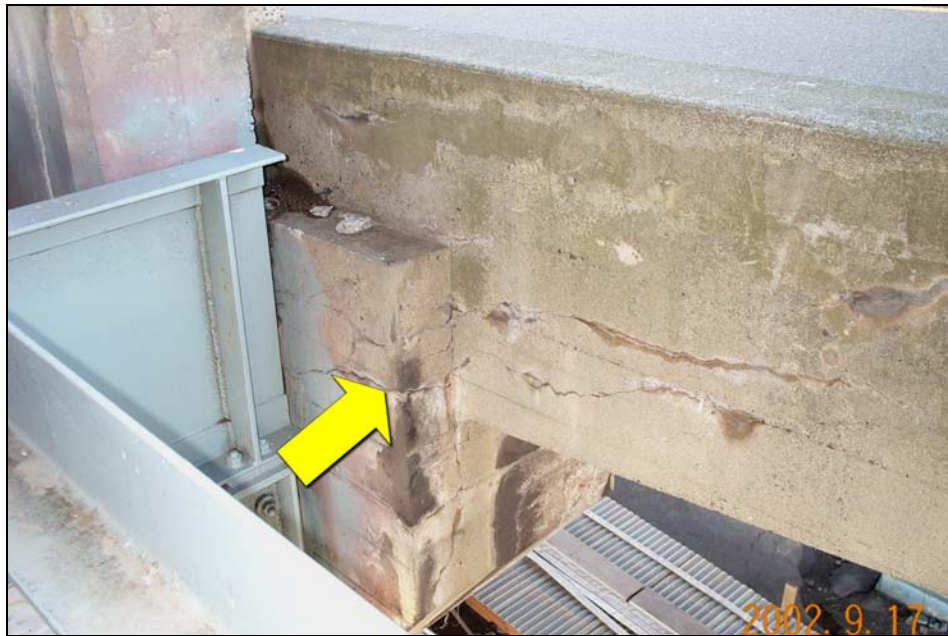
**Figure 9 - Bent 24: Station 11+32 (Reference Photograph 41)**

Cracks in the column and the edge of the beam on the south side of the center ramp at Bent 24.

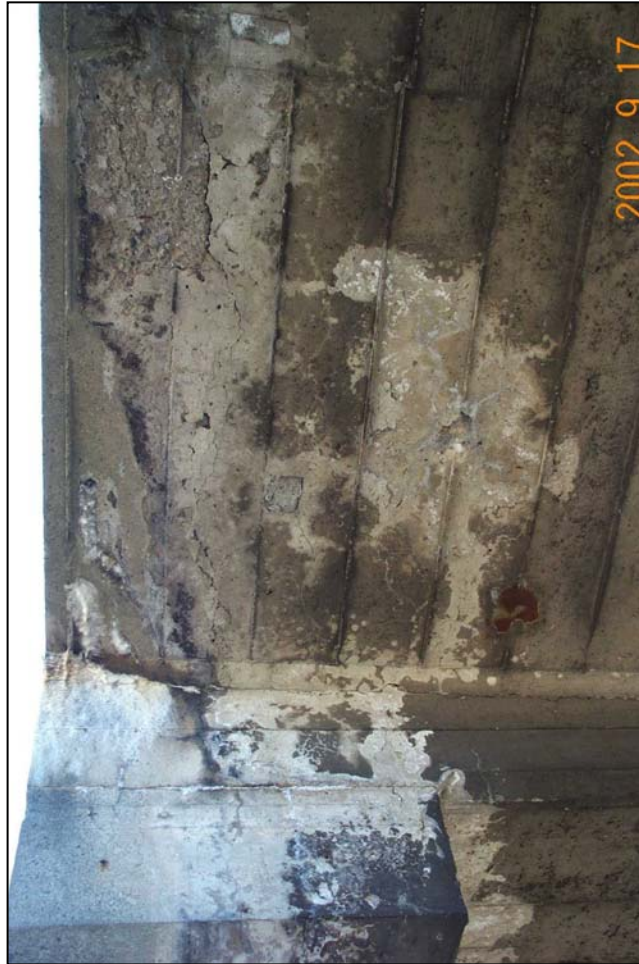
**Figure 10 - Bent 23: Station 11+00 (Reference Photograph 44)**

The underside of the slab with longitudinal crack.

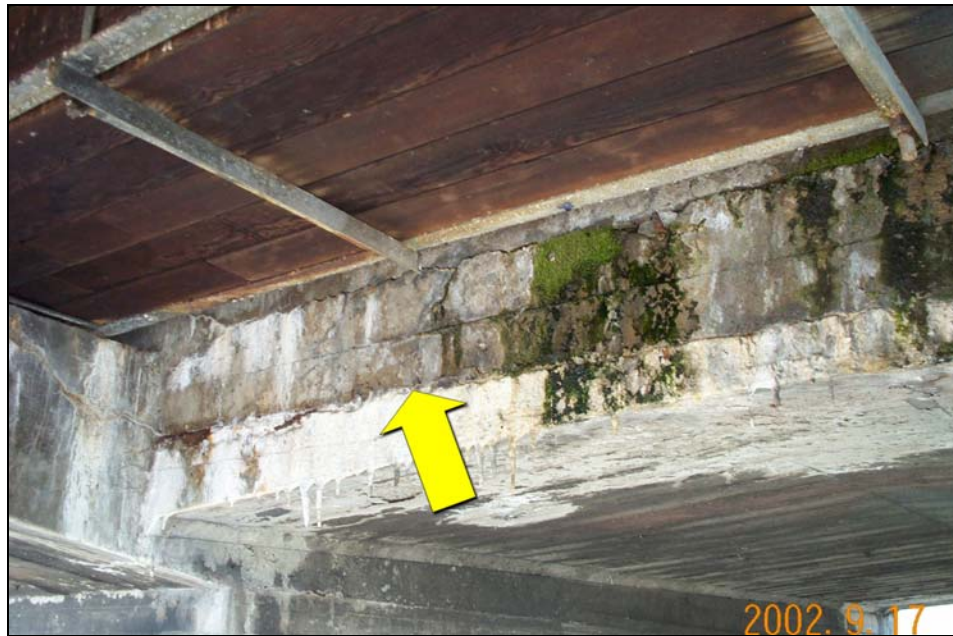
**Figure 11 - Bent 24: Station 11+32 (Reference Photograph 46)**

South side of edge beam. Bottom portion of the beam has delaminated from the upper portion. Water is leaking through the cracks.

- The extent of damage to the slab on the south side of Bent 24 needs to be checked further (See Photograph 46; Figure 11). Corrosion may adversely affect the structural capacity of the walkway and traffic railing.

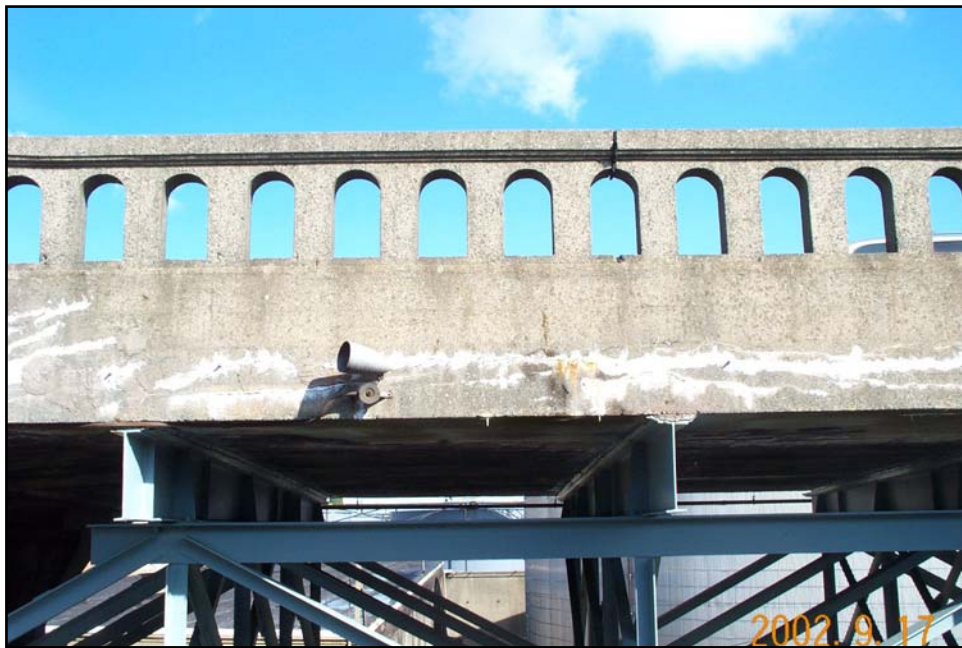
**Figure 12 - Bents 30 to 31: Station 13+32 to 13+68 (Reference Photograph 51)**

South side of the bridge showing previous repairs (epoxy injection).

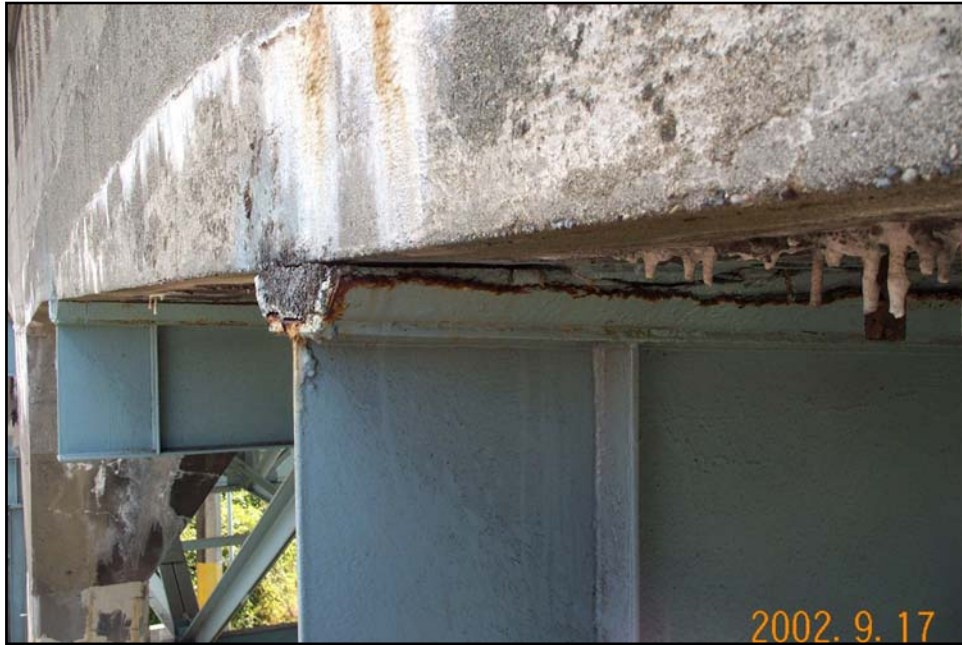
**Figure 13 - Bents 30 to 31: Station 13+32 to 13+68 (Reference Photograph 52)**

The grout pad between the steel beam and the concrete slab at the north end of the steel support beam has separated from the concrete slab.

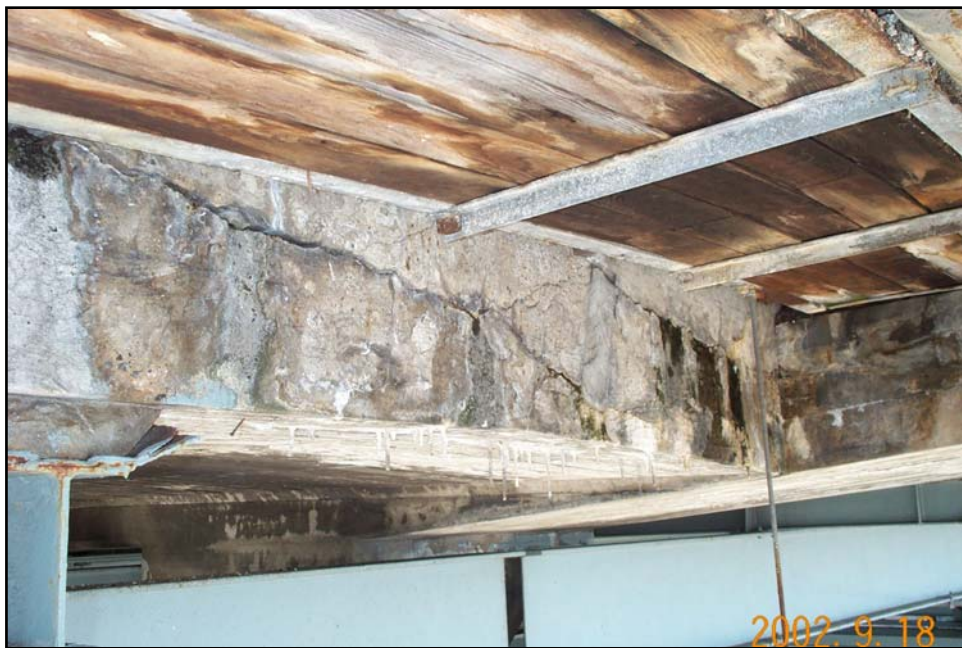
**Figure 14 - Bents 41 to 42: Station 17+07 to 17+39.50 (Reference Photograph 61)**

Cracking in the south side of the deck edge beam.

- The extent of damage to the slab on the south side between Bents 41 and 42 needs to be checked further by chipping into the existing concrete to determine the extent of damage to the reinforcing (See Photograph 61; Figure 14). Corrosion may adversely affect the structural capacity of the walkway and traffic railing.

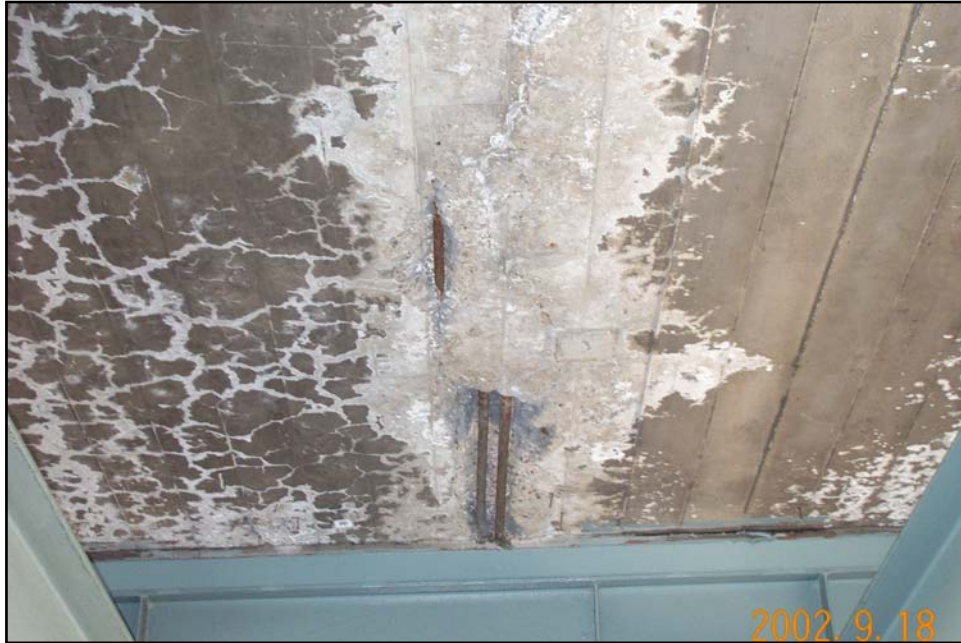
**Figure 15 - Bents 41 to 42 Station 17+07 to 17+39.50 (Reference Photograph 66)**

Spalled deck soffit with exposed reinforcing.

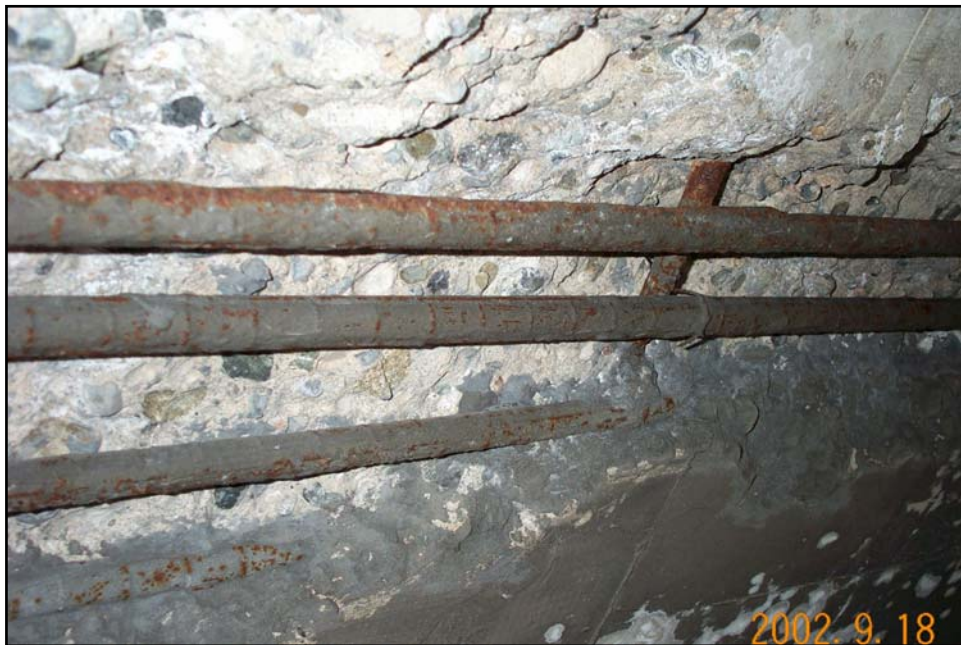
**Figure 16 - Bents 41 to 42 Station 17+07 to 17+39.50 (Reference Photograph 67)**

Exposed deck slab reinforcing in the same crack further east of Photograph 66. Bars are coated with primer.

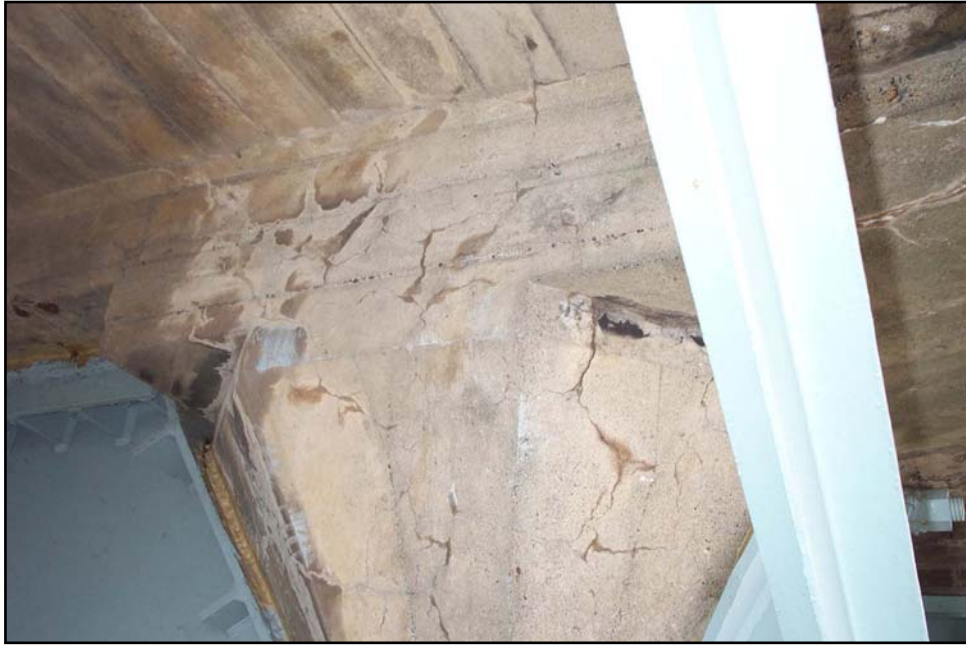
**Figure 17 - Bent 53: Station 20+95 (Reference Photograph 73)**

Cracks in the column capital on the south side of the bent.

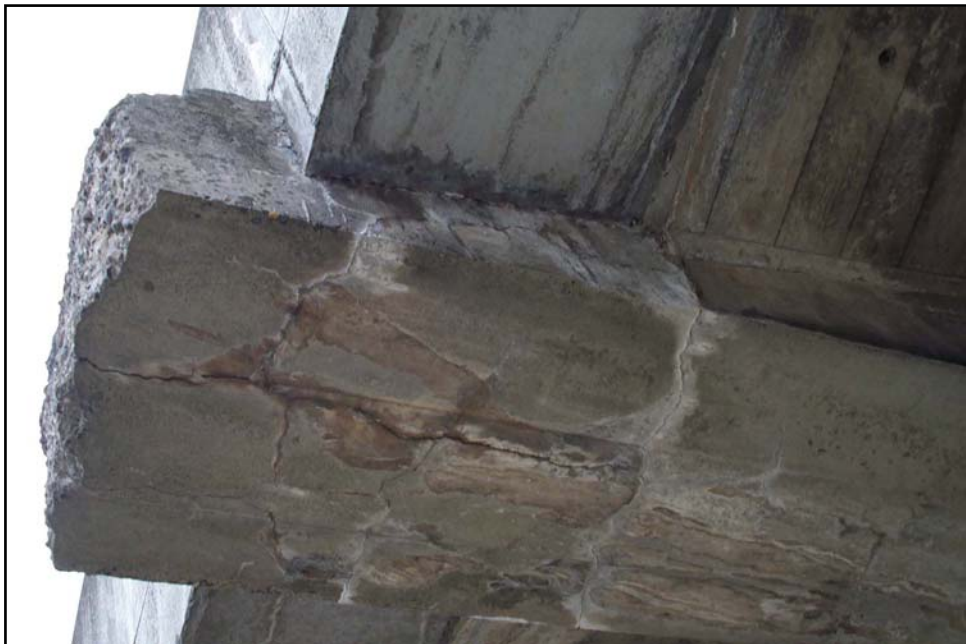
**Figure 18 - Bents 64 to 65: Station 25+58 to 26+18 (Reference Photograph 76)**

Cracks in a transverse beam along the north side of the bridge between Bents 64 and 65. This cracking is typical at the transverse beams along the north side of the bridge.

- The north ends of the transverse beam along the north side of the bridge between Bents 46 to 82 need to be checked to determine whether the condition adversely affects the bridge guardrail along the north side of the bridge (See Photograph 76; Figure 18).

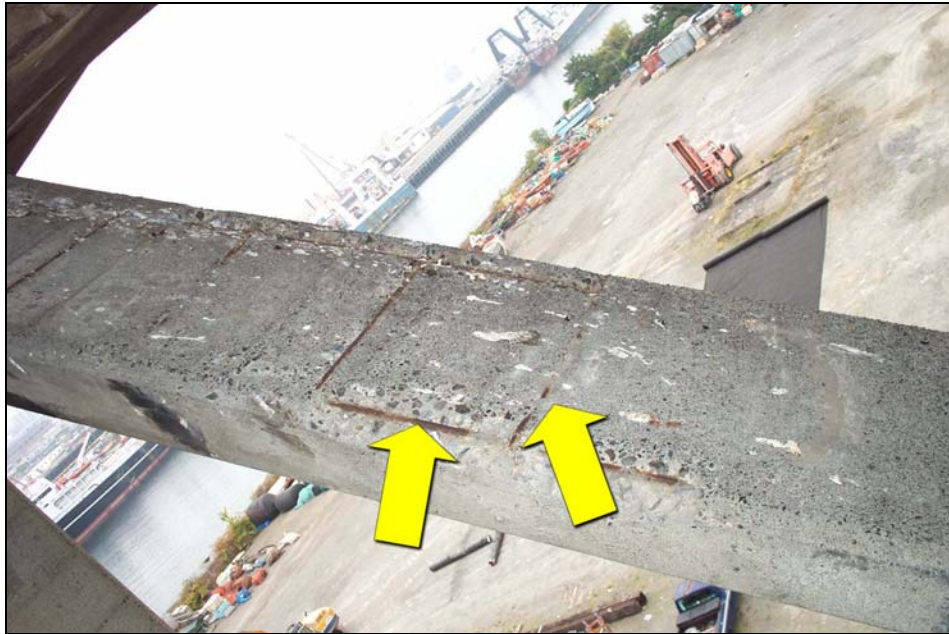
**Figure 19 - Bents 64 to 65: Station 25+58 to 26+18 (Reference Photograph 80)**

Exposed reinforcing steel on the topside of south truss Member 11.  
This condition is typical on many of the sloped truss members.

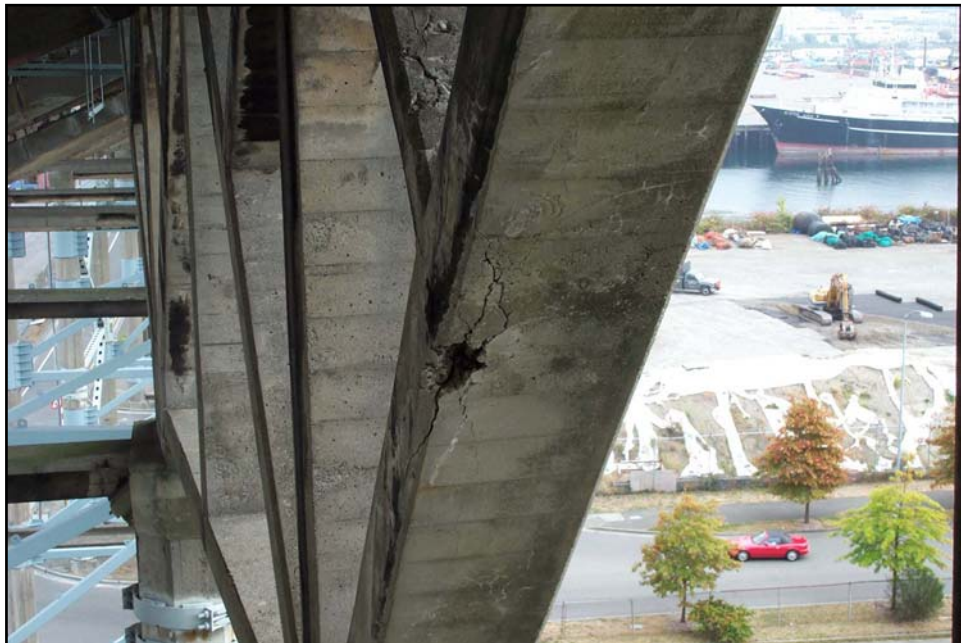
**Figure 20 - Bents 70 to 71: Station 28+67 to 29+27 (Reference Photograph 88)**

Shows cracking and spalling on Member 12 of the south truss. It appears that the reinforcing is heavily corroded at this location. Additional spalling should be expected to occur.

- The spalled concrete on Member 12 of the south truss between Bents 70 and 71 needs to be removed and the extent of reinforcing corrosion assessed (See Photograph 88; Figure 20). Corrosion may adversely affect the structural capacity of the concrete truss.

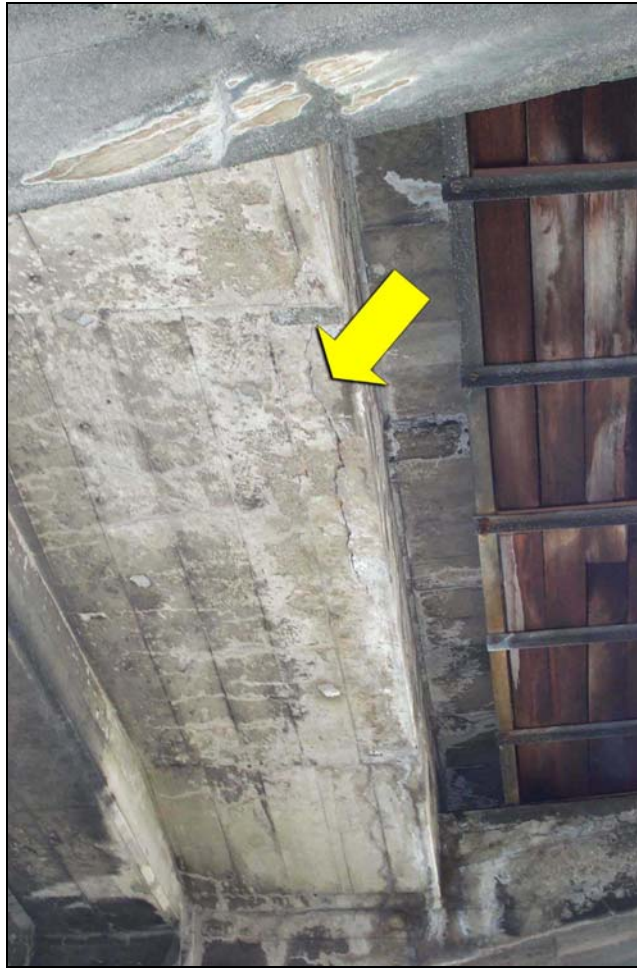
**Figure 21 - Bents 70 to 71: Station 28+67 to 29+27 (Reference Photograph 85)**

The corner of the slab is cracking along the south side of the bridge between Bents 70 to 71.

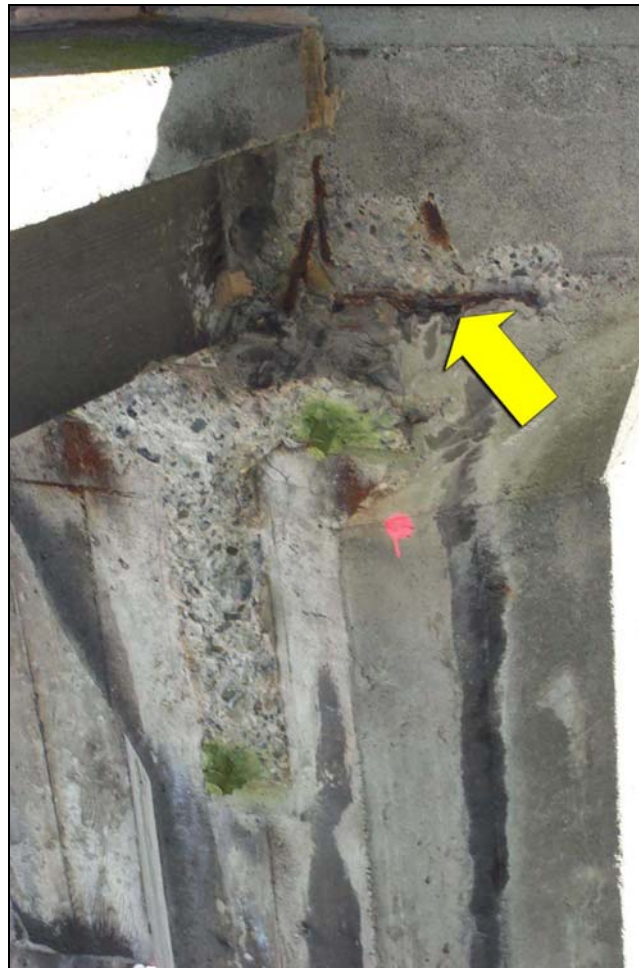
**Figure 22 - Bent 72: Station 29+70 (Reference Photograph 90)**

Exposed reinforcing bars at a column where the diagonal tees were removed for installation of the lateral seismic upgrades.

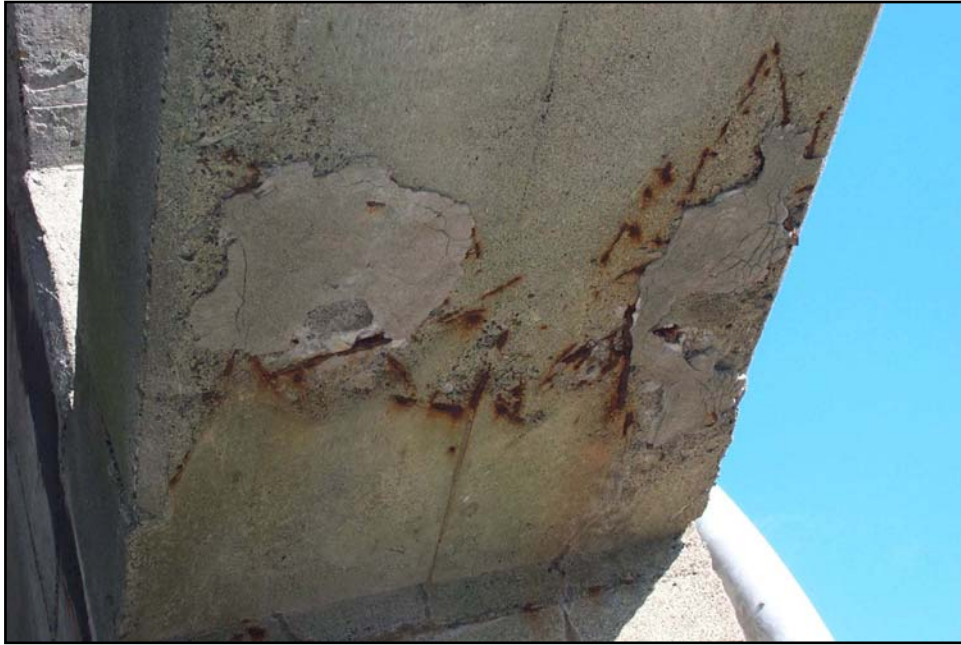
**Figure 23 - Bents 72 to 73: Station 29+70 to 30+30 (Reference Photograph 93)**

Delaminations and spalls on the soffit of Member 20 of the south truss.

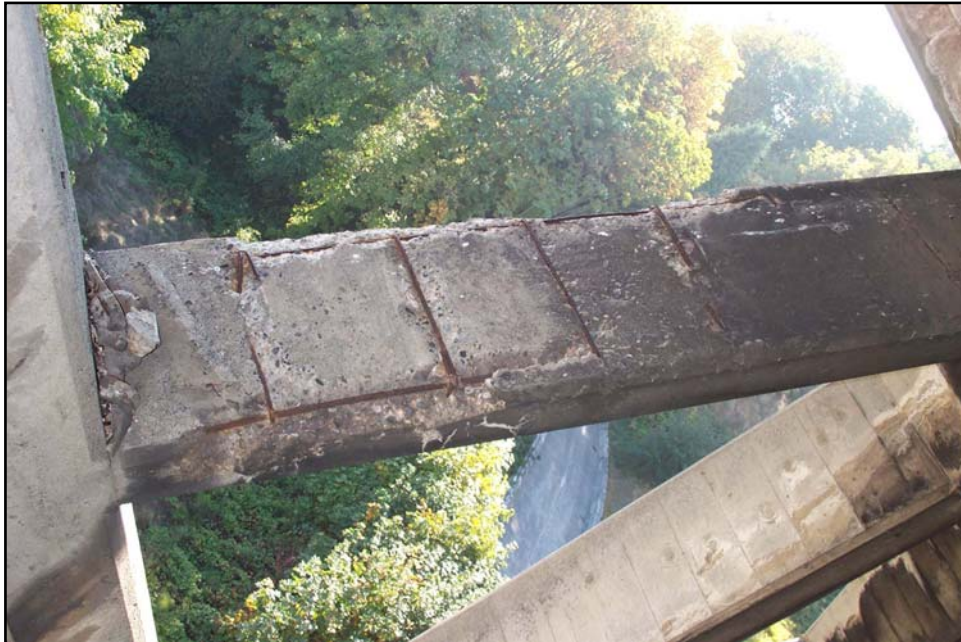
**Figure 24 - Bents 72 to 73: Station 29+70 to 30+30 (Reference Photograph 94)**

Spalling and exposed reinforcing on top of Member 9 in the south truss.

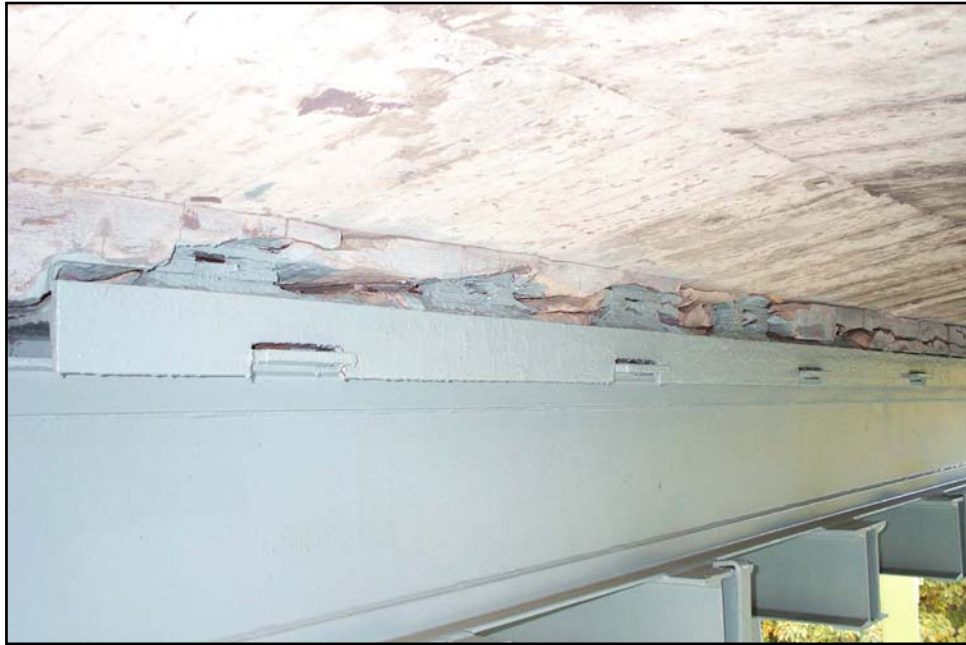
**Figure 25 - Bent 73: Station 30+30 (Reference Photograph 91)**

Severely cracked grout pad above the steel framing at the expansion joint west of Bent 73. View is looking west.

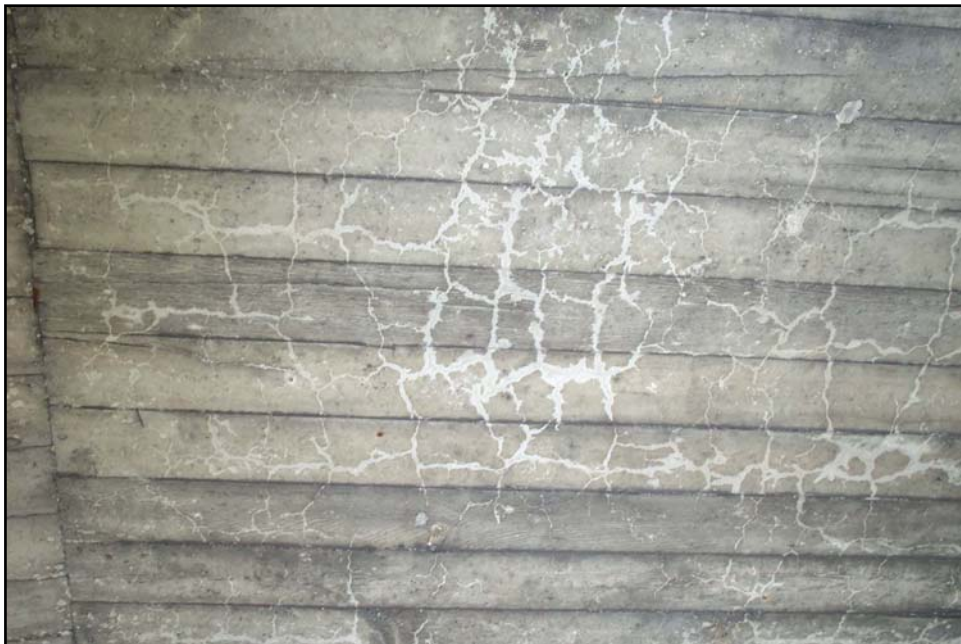
**Figure 26 - Bents 74 to 75: Station 30+73 to 31+33 (Reference Photograph 97)**

Crack pattern in the bottom of the slab between Bents 74 and 75. This pattern is typical in this area.

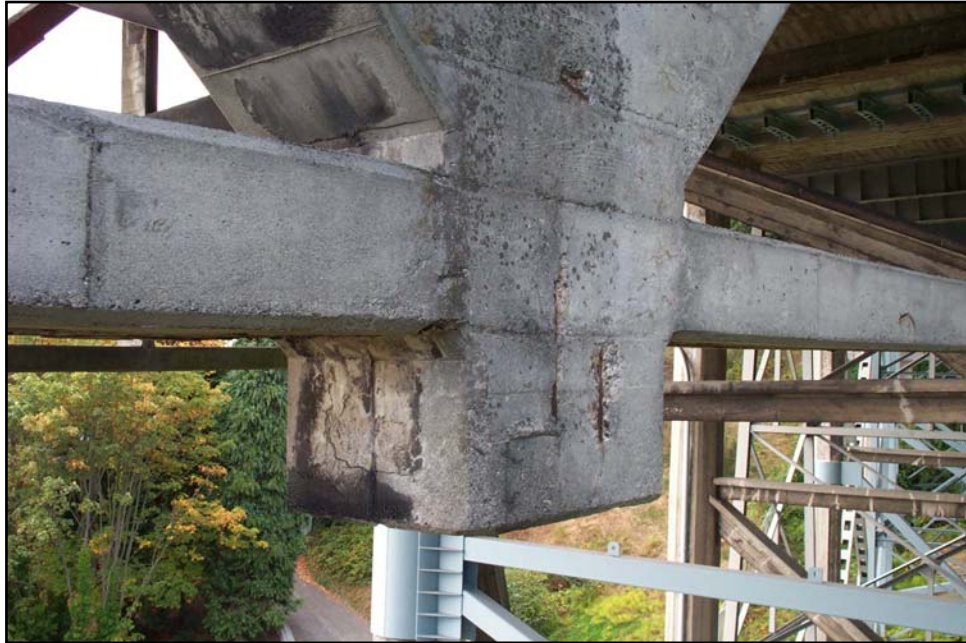
**Figure 27 - Bents 74 to 75: Station 30+73 to 31+33 (Reference Photograph 99)**

Spalling and exposed reinforcing at Member 21 on the north truss.

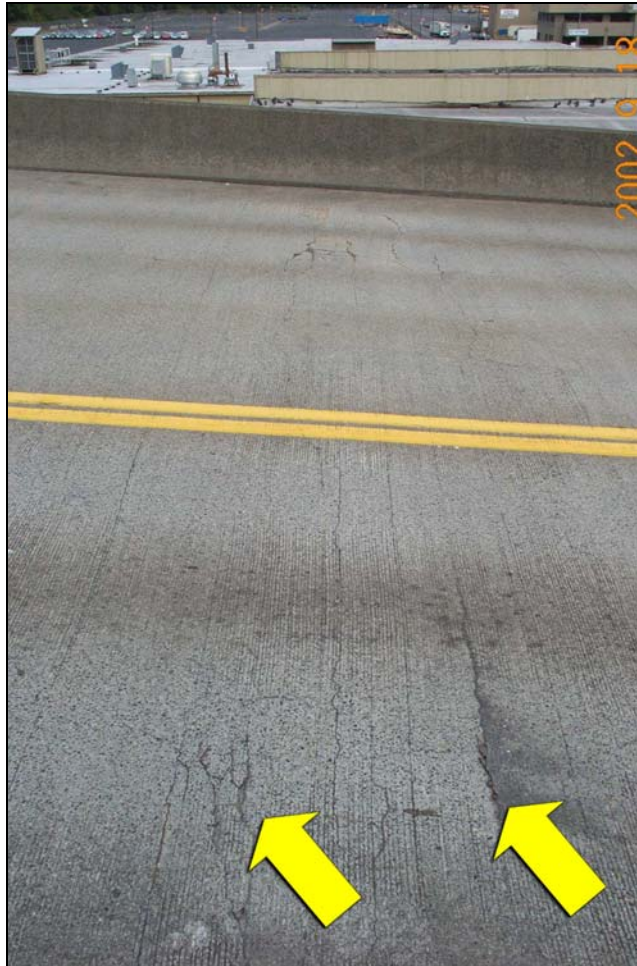
**Figure 28 - Bent 48 Station 19+31 (Reference Photograph 108)**

Cracks in the top of the deck near Bent 48.

- The extent of cracking in the slab near Bent 48 needs to be assessed. (See Photographs 108 and 109; Figures 28 and 29, respectively). The cracking illustrated in these photographs may suggest that the slab may be delaminated and may soon spall which could adversely affect the slab's structural capacity.

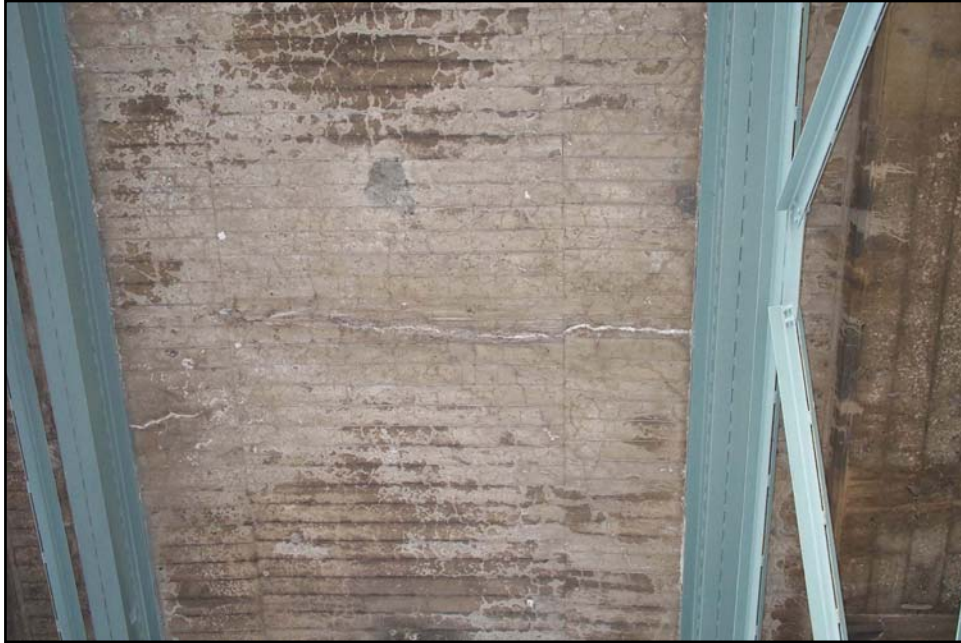
**Figure 29 - Bent 48 Station 19+31 (Reference Photograph 109)**

Cracks in the deck soffit near Bent 48 below the section of slab shown in Photograph 108 above.
