PROBLEM IDENTIFICATION TECHNICAL MEMORANDUM

Broadview Sewer Investigation Project

March 31, 2009

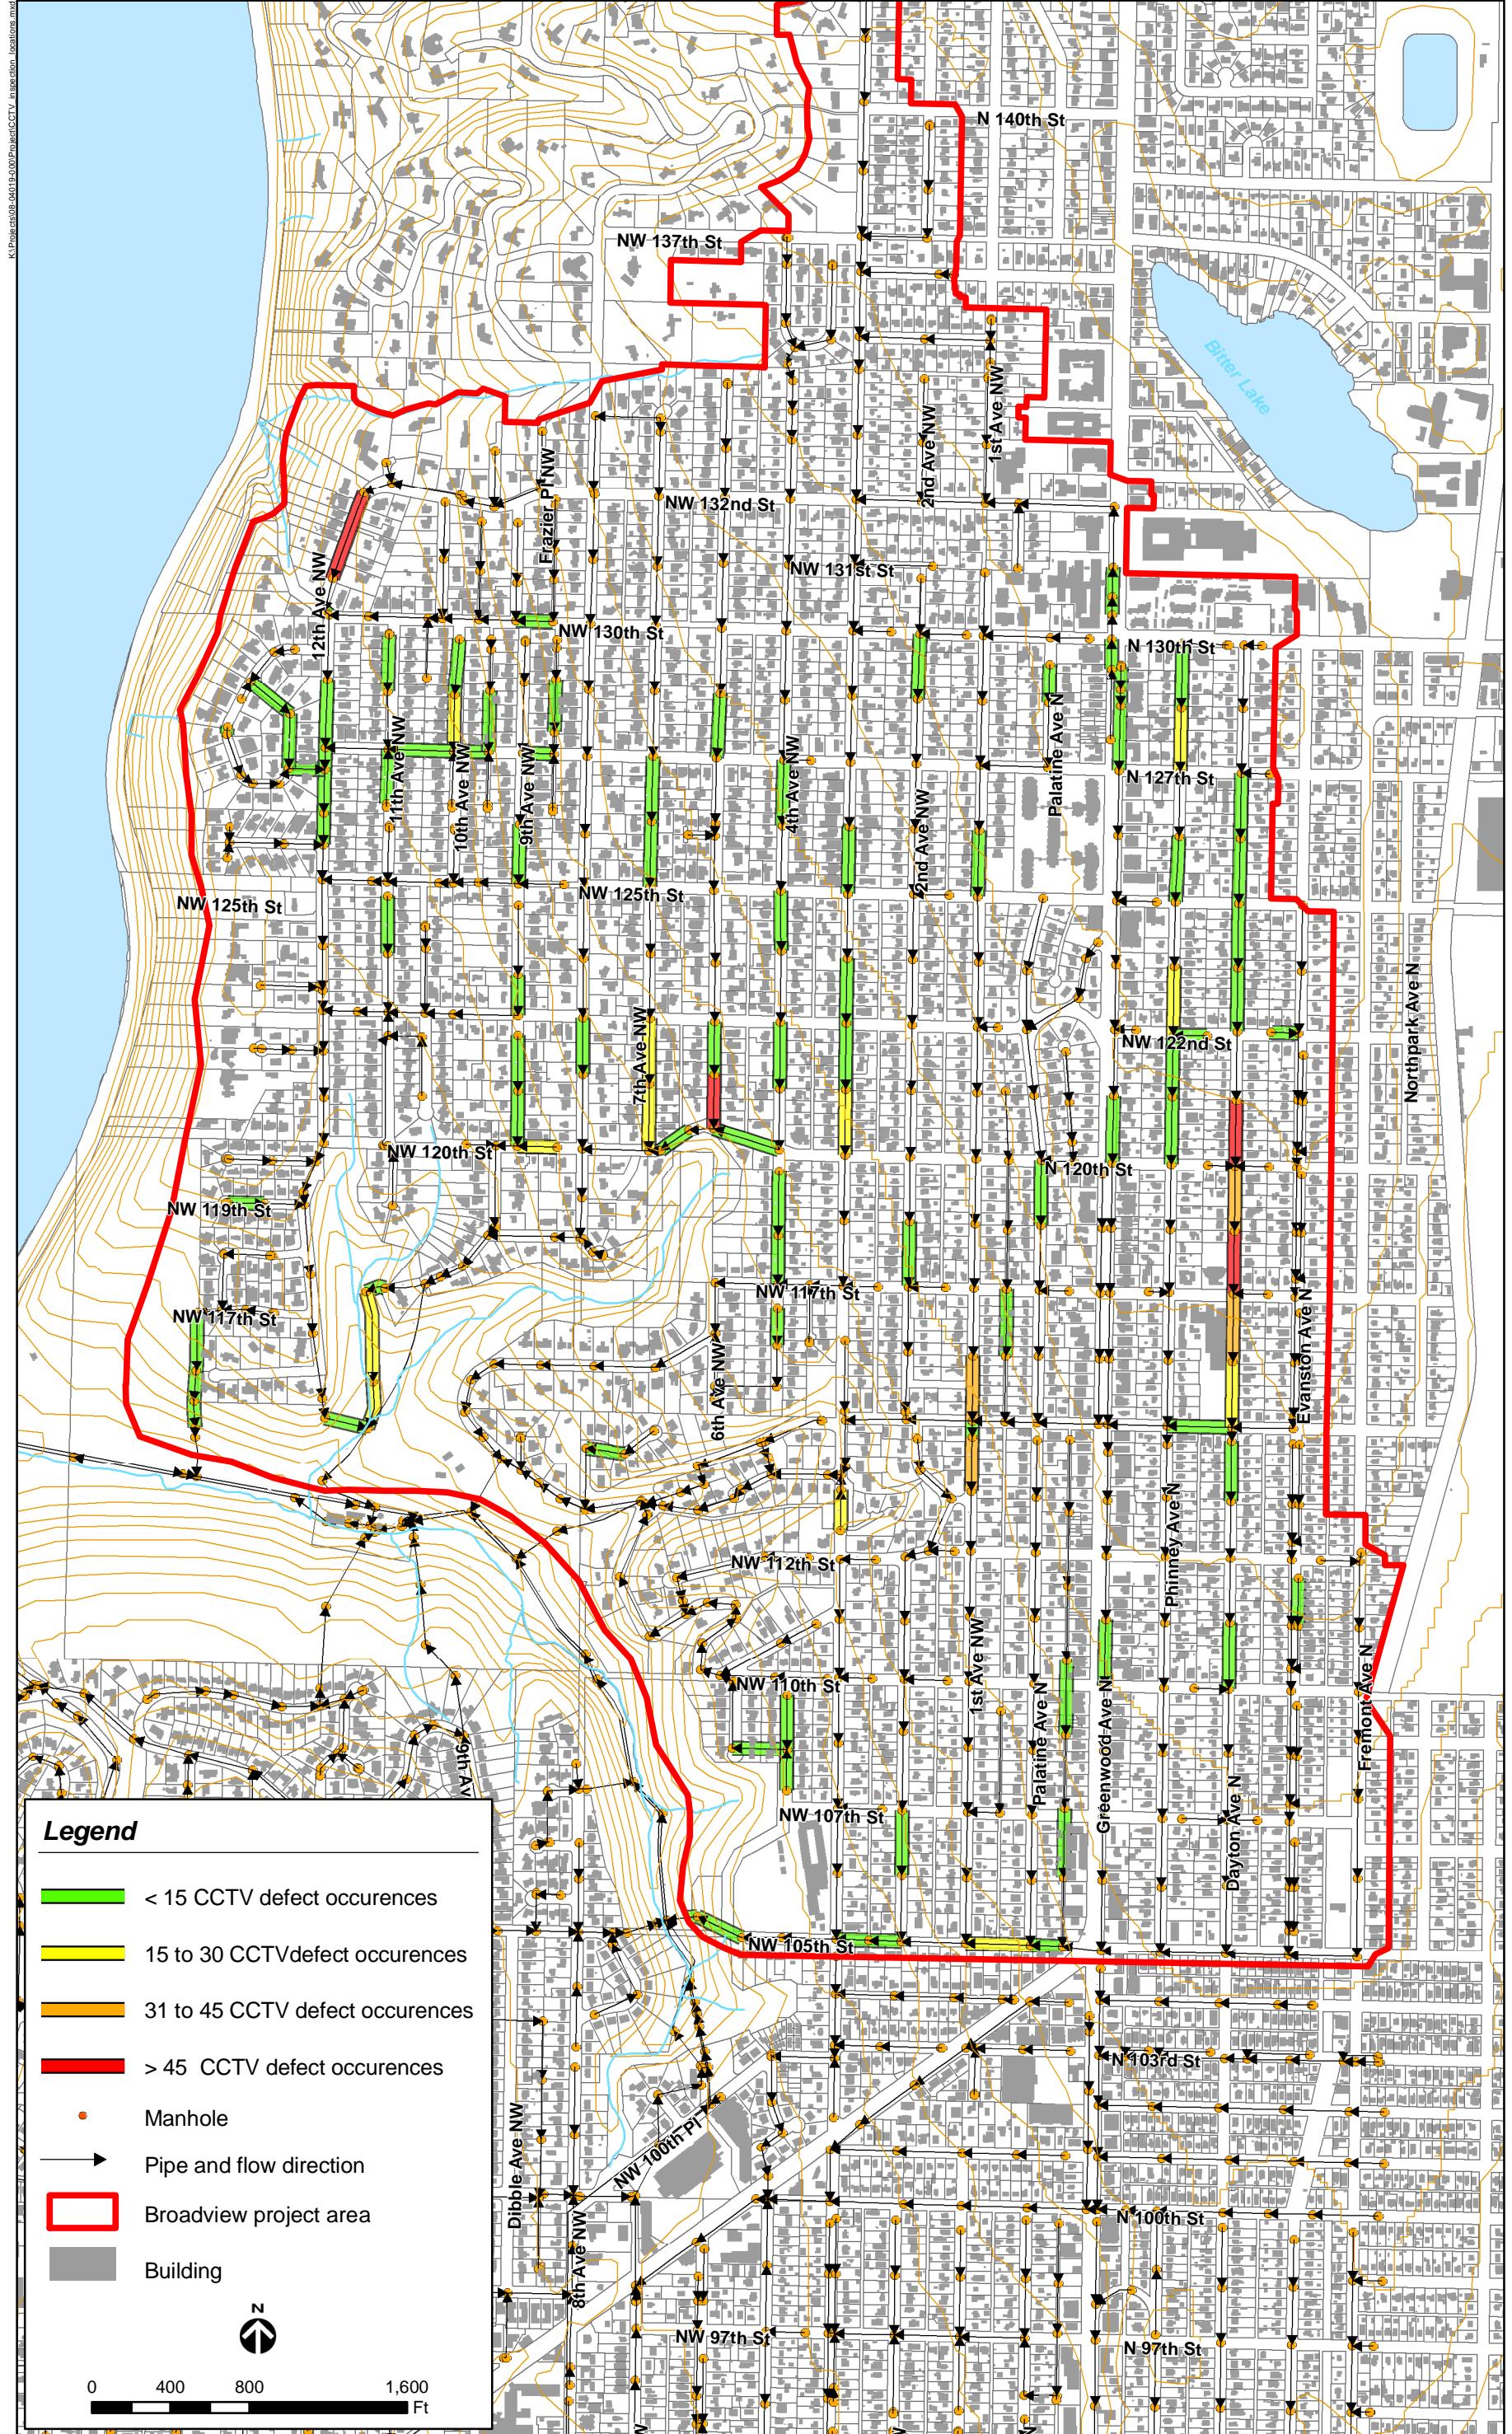
Table 2 shows the CCTV activity findings by type while Figure 4 shows the amount of CCTV occurrences reported per pipe segment. The information on Figure 4 is presented in a similar format to Figure 3 with color codes denoting certain levels of occurrence. Detail on the exact location and type of occurrence is presented in Appendix B. The data provided represents CCTV activities performed between 1997 and the end of 2008.

The single highest CCTV occurrence findings are taps, which are either active or inactive lateral connections. Of the 348 taps identified, approximately 40 were found to be cracked or defective in some manner. Root intrusion can also happen at taps; however, this is quantified under the “roots” category. The other most commonly occurrences were alignment problems (12.6 percent), root intrusion (10.6 percent), lateral problems (10.3 percent), and debris accumulation (10.3 percent). Additional CCTV work has been requested for areas that have had historic sewer backups.

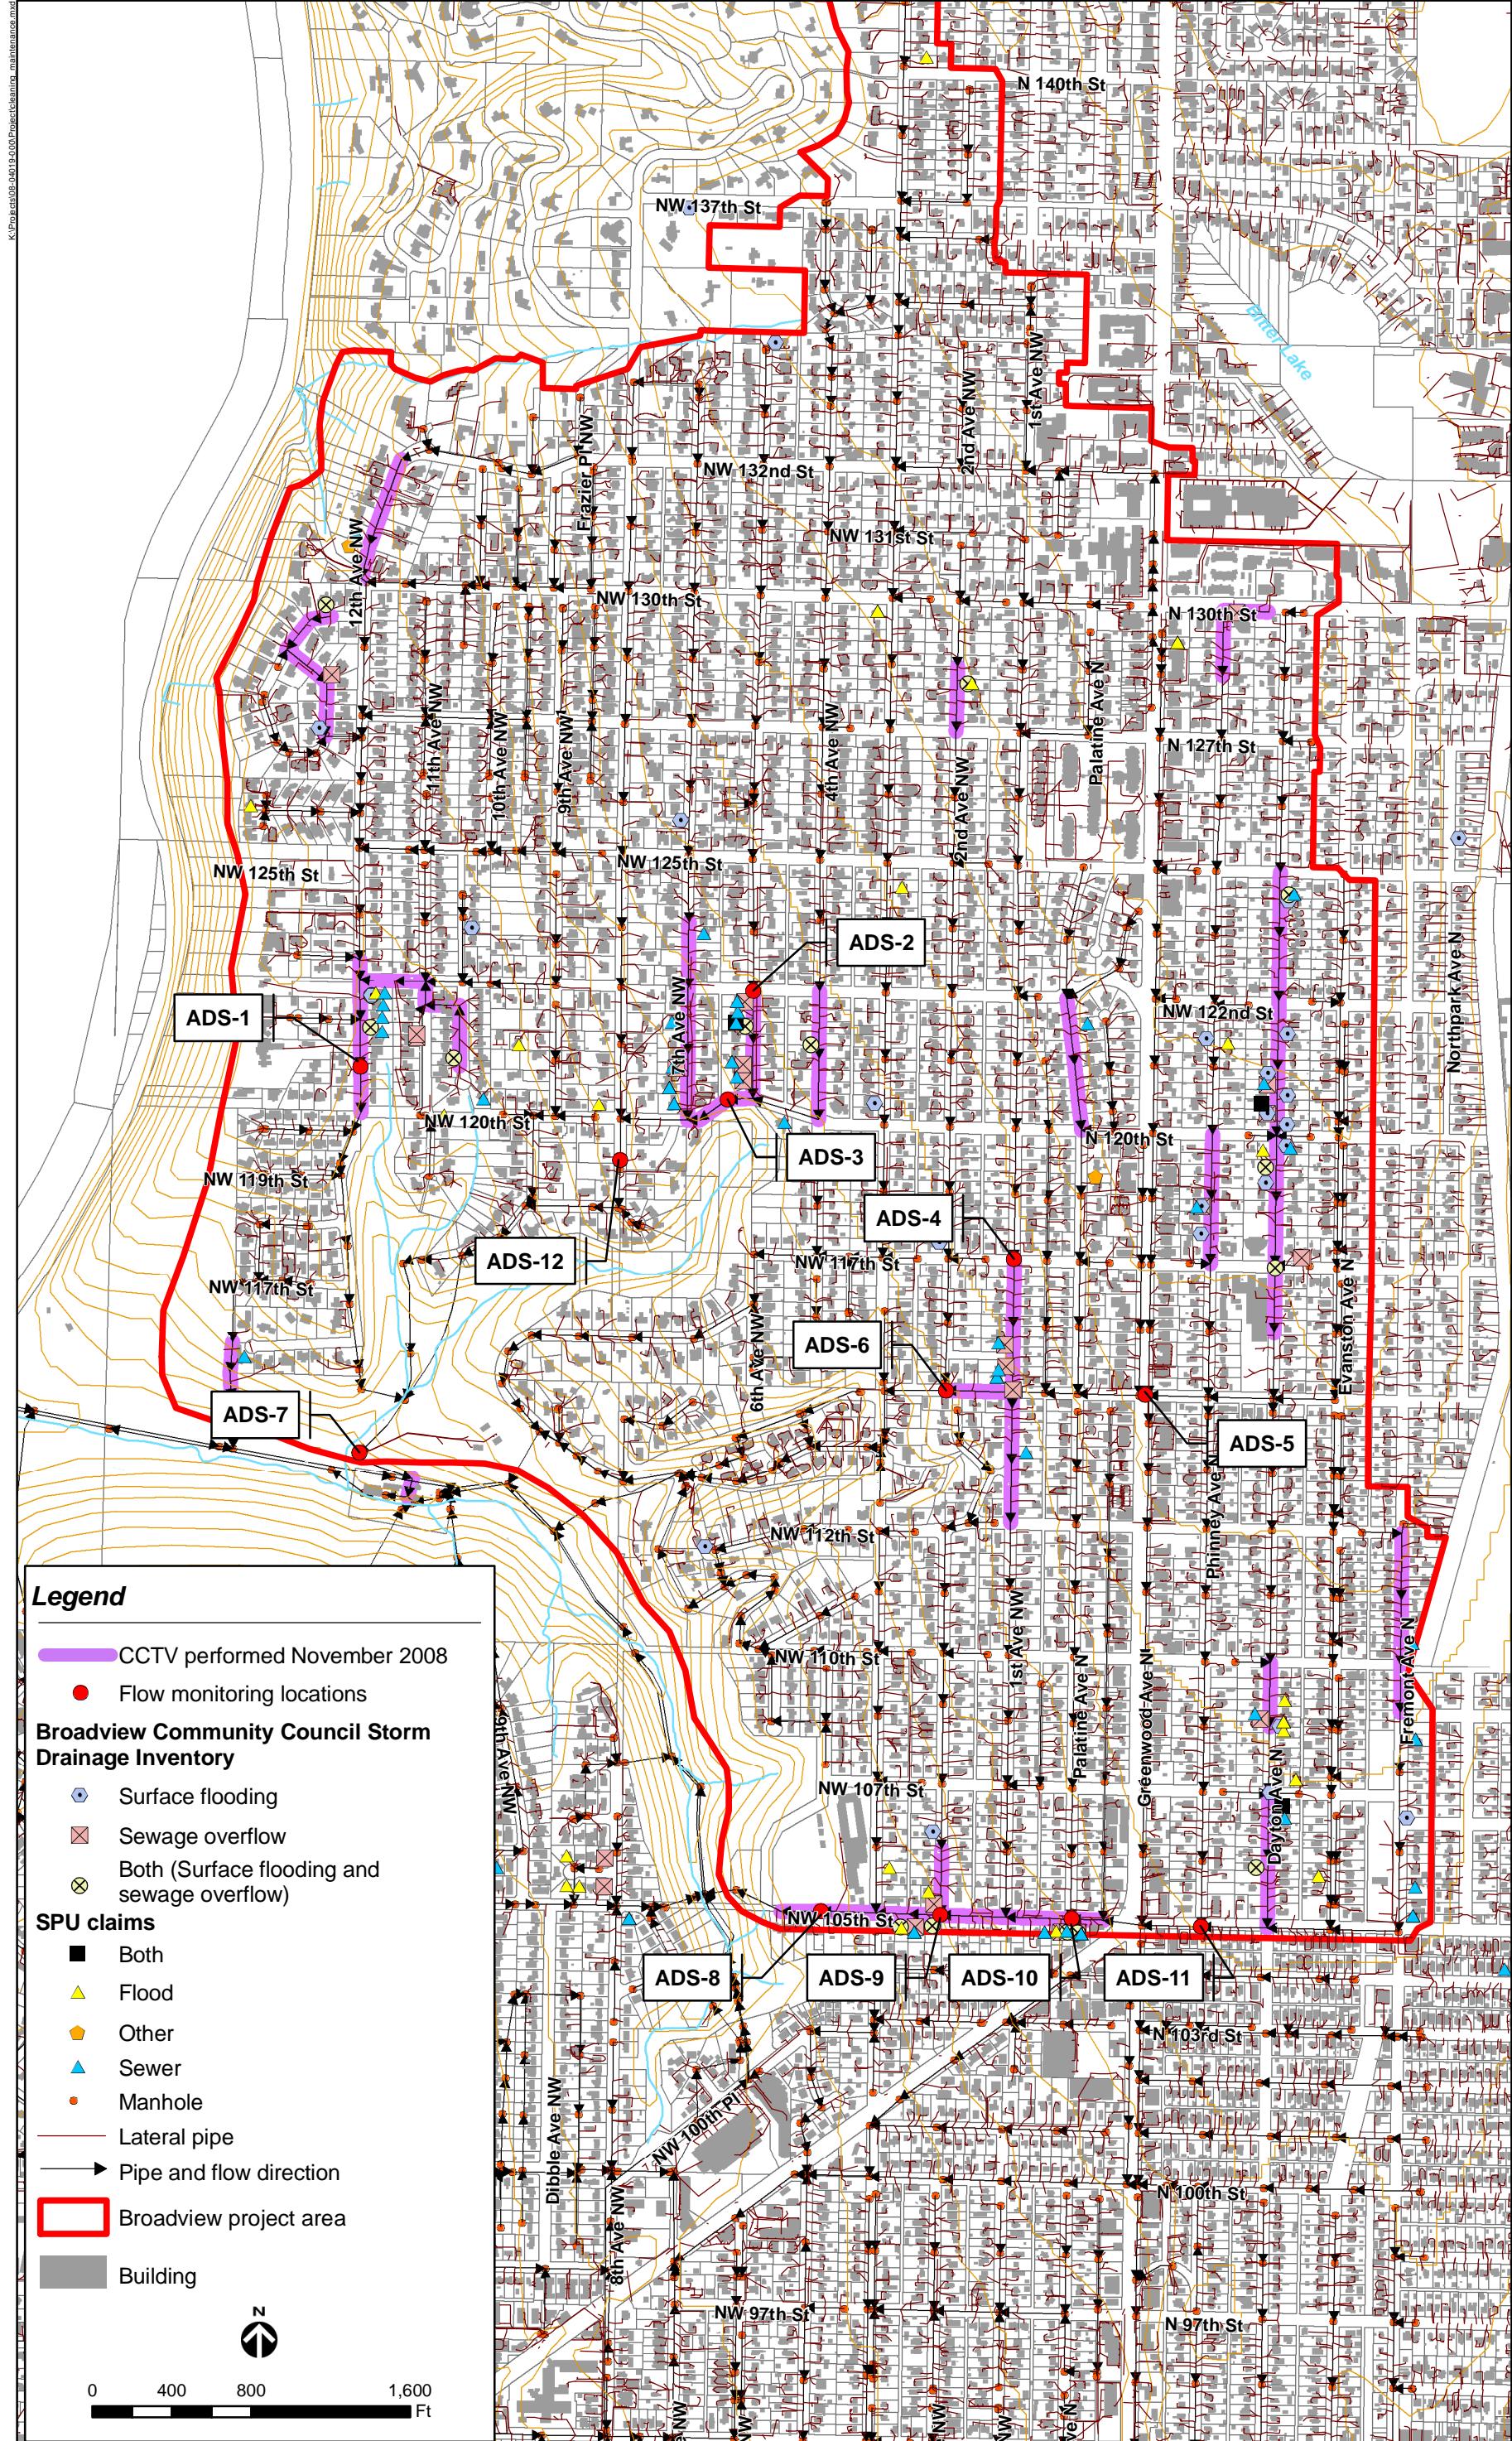
Figure 5. Locations of flow monitoring sensors and CCTV performed in November 2008.

An additional 69 pipe segments were identified to undergo further CCTV inspections based on information provided by the Broadview Community Council, SPU claim data, and historic maintenance locations. The locations of the additional CCTV activity are also presented in Figure 5 and Appendix C. These additional CCTV inspections took place in November 2008, and the data from these inspections will be used to identify any current maintenance defects. This information will be used to identify any potential spot fixes as well as calibration of the basin model.

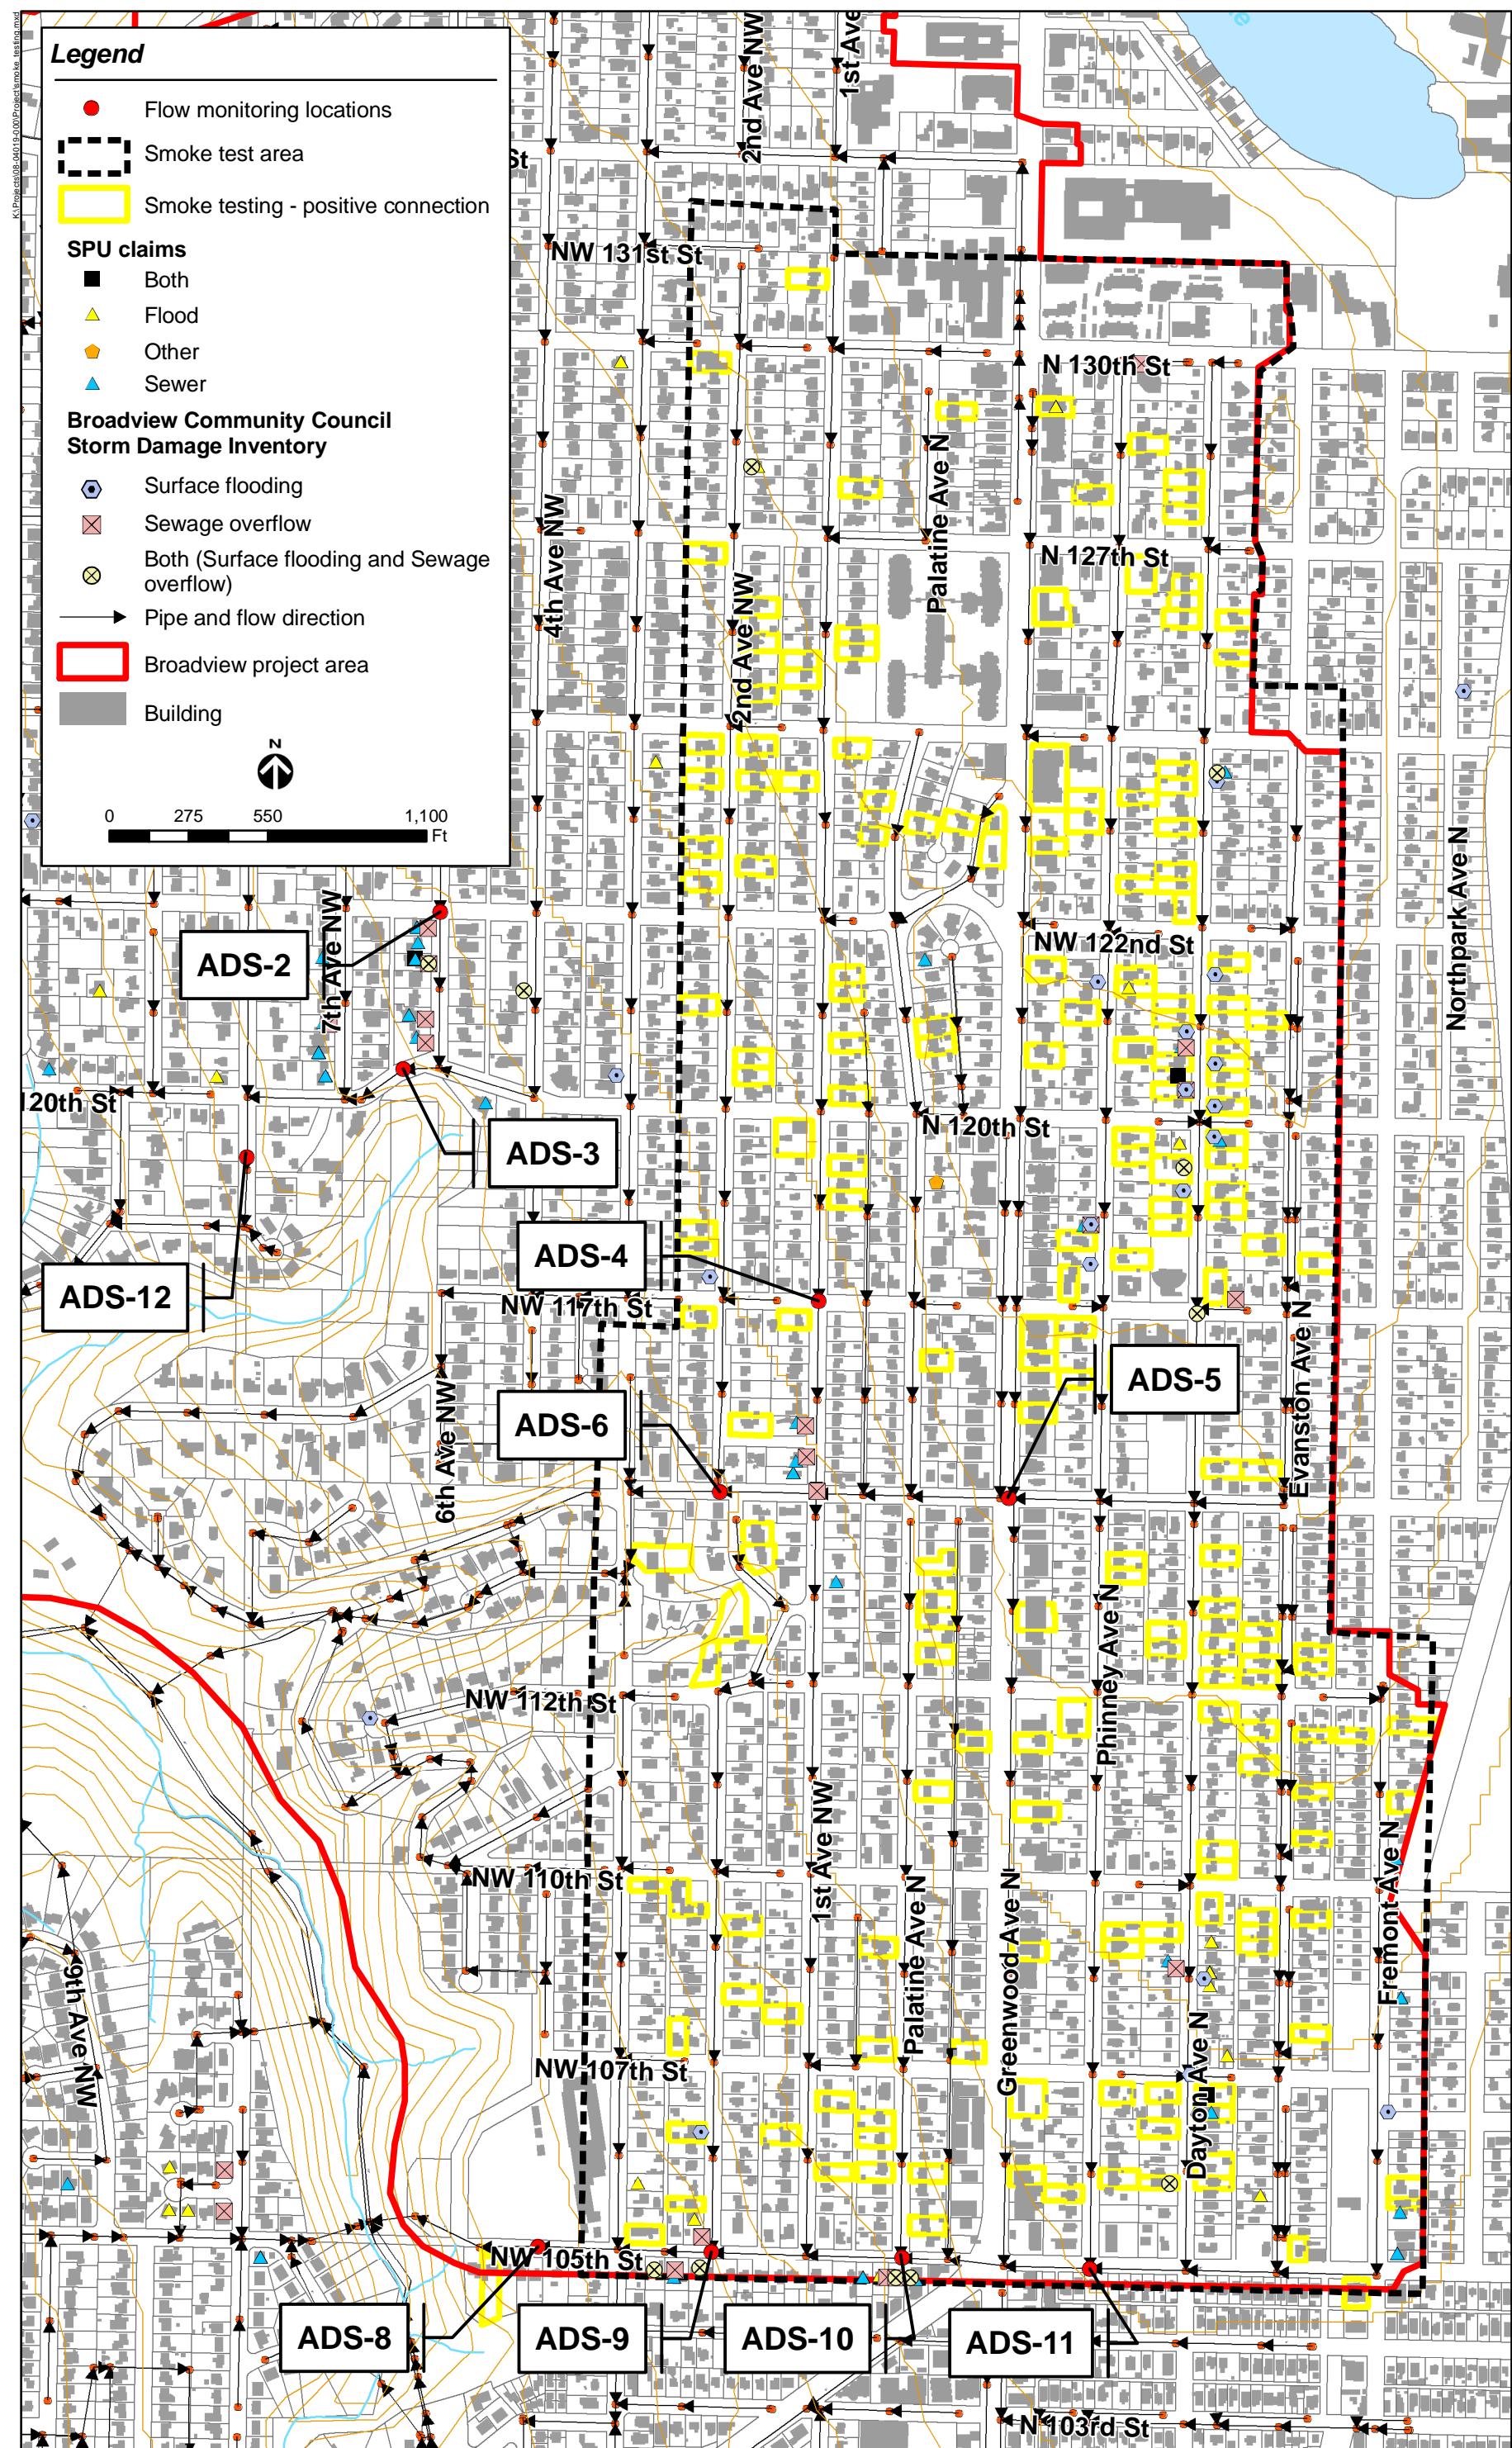
Figure 6. Smoke testing results.

Seven percent of the residences within the test area have roof drain downspout connections to the sanitary sewer. While this is not a high percent of residences, the total percent of residences with some form of non-sanitary sewer connection or broken sanitary sewer connection is about 16 percent. The smoke testing conducted in 1998 found that 20 percent of similar connections. The current results are in line with previous findings. This may represent a significant contribution to the sanitary sewer system.
