**SKAGIT RIVER HYDROELECTRIC PROJECT
(FERC PROJECT NO. 553)**

EROSION CONTROL PROGRAM

2008-2009 COMPLETION REPORT

North Cascades National Park and Seattle City Light

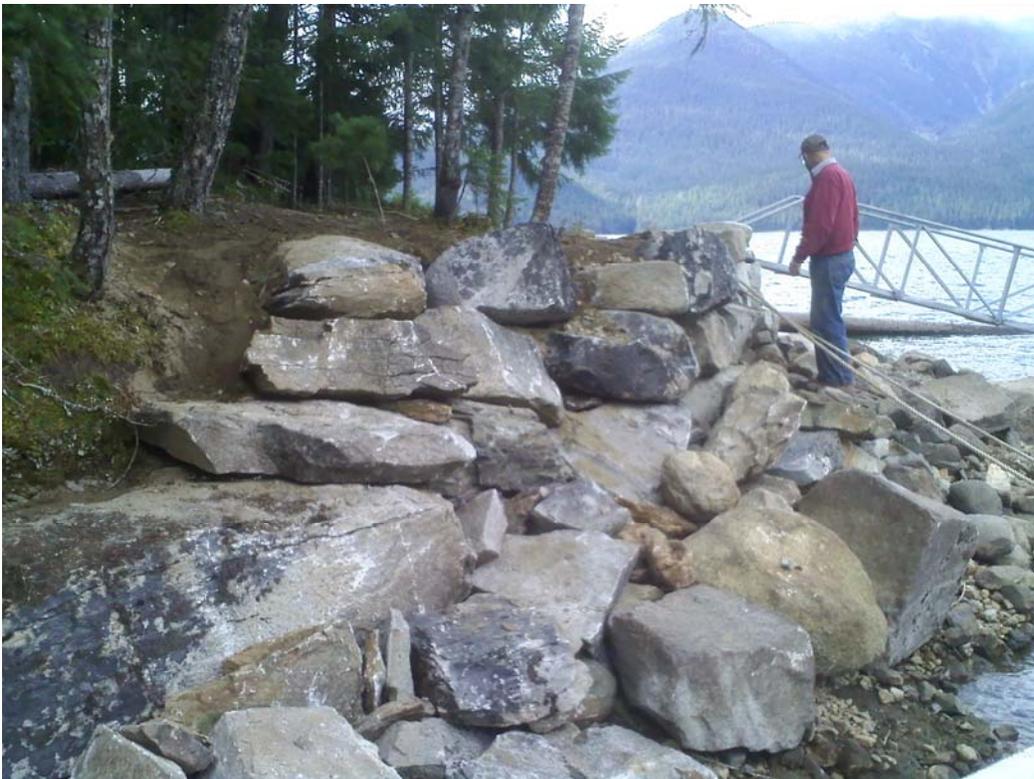
Photo 2: May Creek-after erosion control work (2009).

In 2002, NPS crews installed approximately 60 feet of dry-lay rock wall at Site E-47 per erosion control design. Over the past few years, wave activity penetrated the north end of the rock wall, threatening the structure and beginning to scour the shoreline directly below the campground's restroom facility (Photo 1). In 2009 NPS crews corrected this problem by installing an additional 30 feet of dry-lay rock wall beginning at the north end of the original structure (Photo 2).

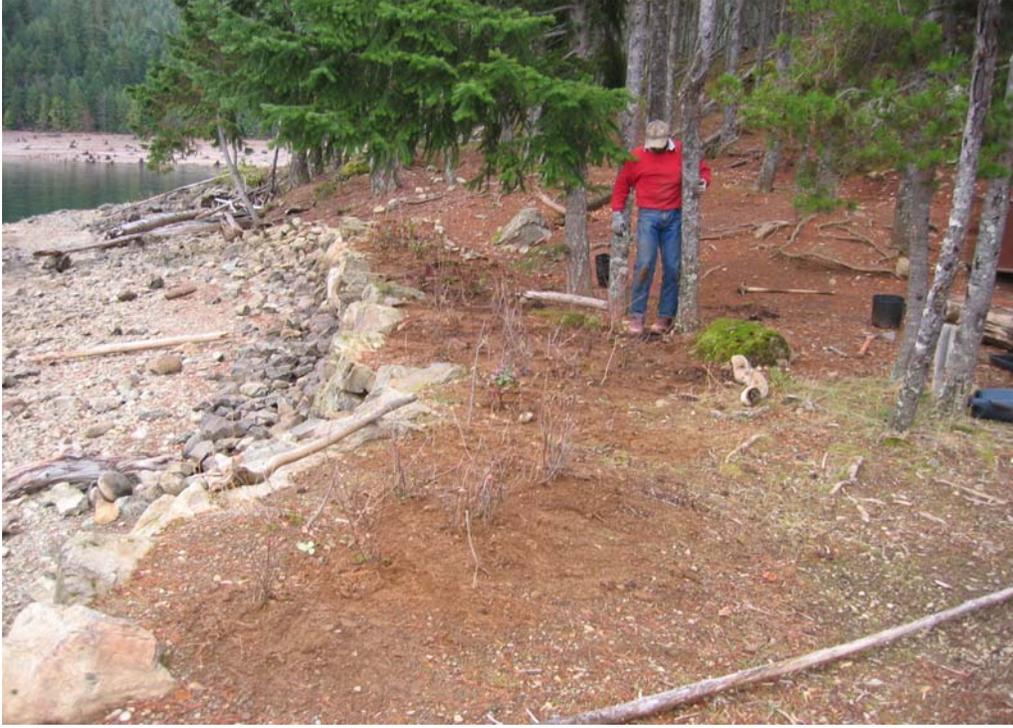
Photo 5. Planting natives at site E-103 Tenmile Island (2009).

In 2009 the NPS grew approximately 1,200 plants in the native plant nursery in Marblemount for use at erosion control sites along Ross Lake. Work included collection and propagation of native plants from seeds and cuttings (Photo 4), care for plants in the nursery, maintenance of the nursery facility, and planting in the fall. Planting work occurred at three erosion control sites in 2009. The NPS crew planted 820 native plants at erosion control sites on Tenmile Island and Dry Creek (Photo 5).
