RE: Skagit Hydroelectric Project No. 553 – 2010-2011 Erosion Control (Article 409 Report)

Erosion Control and Revegetation Completion Report 2016-2017 Skagit River Hydroelectric Project (#553)

**J. Riedel, Geologist, North Cascades National Park
Stacy McDonough, Plant Ecologist, North Cascades National Park**

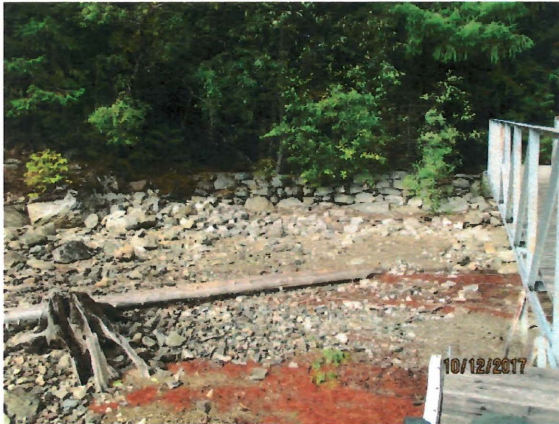
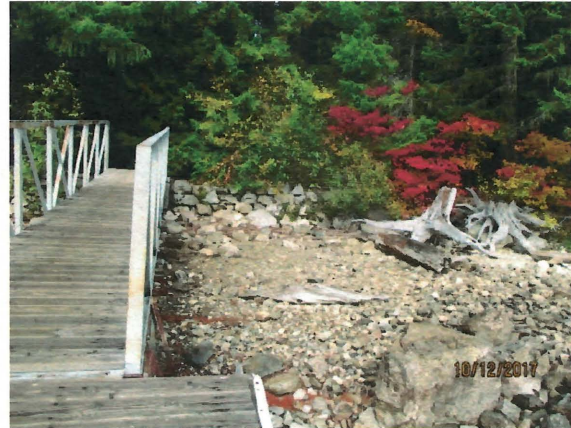
Site W-36: Big Beaver dock rock wall extends on both sides of the dock. Toe protection could use some rebuilding, approximately 10 linear feet on the north side and approximately 8 linear feet on the south side. Site ranks an 8.

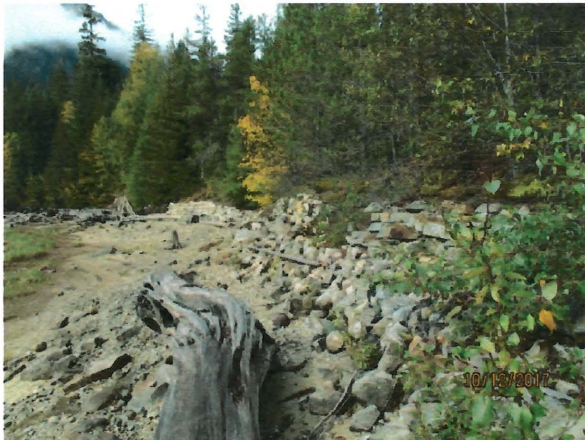
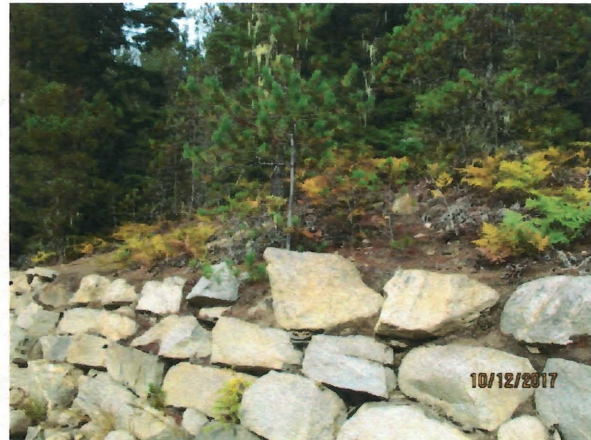
Site W-34: Site is a rock wall on an outwash terrace just south of the Big Beaver horse camp, in which approximately 5 linear feet of the east side of the wall requires toe protection maintenance. West side of the wall looks excellent; it was built originally with slightly larger toe protection. Some tree removal is necessary at this site; most are small right now and could be done with handsaws. One or two trees will require a chainsaw. Site ranks an 8/9.

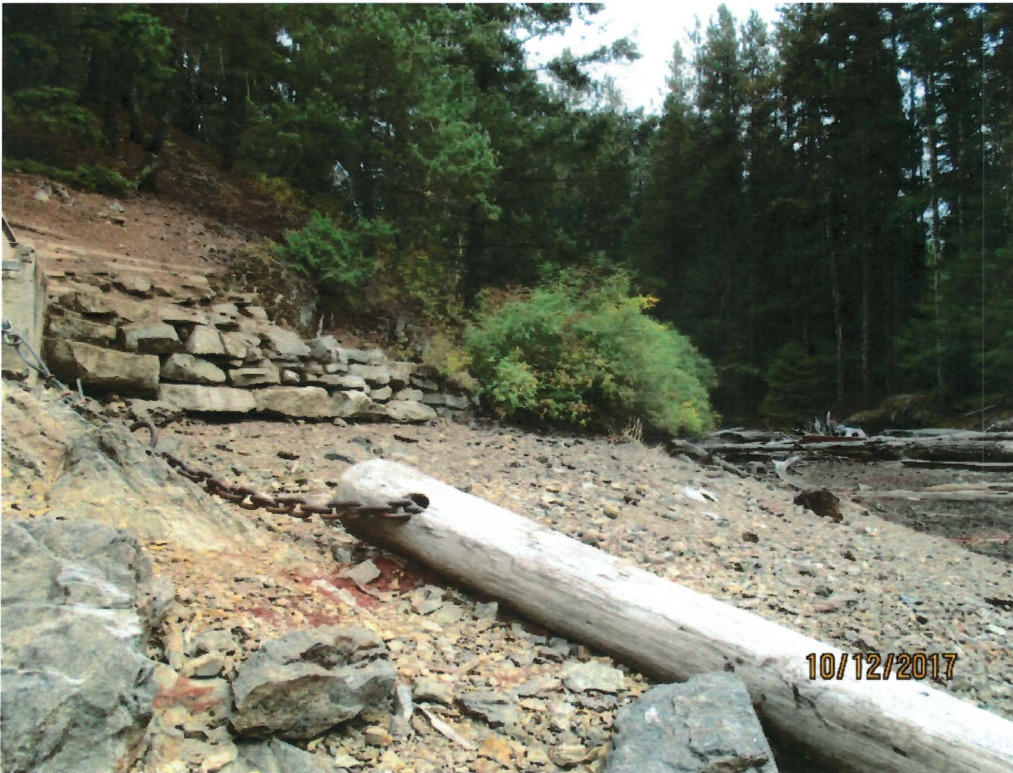
Site W-124: Site is located just above the current Little Beaver dock. Wall is in good condition but requires approximately 30 linear feet of toe protection built. Site ranks a 5.

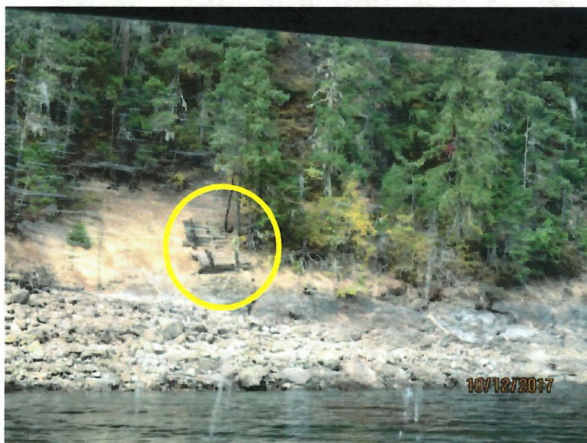
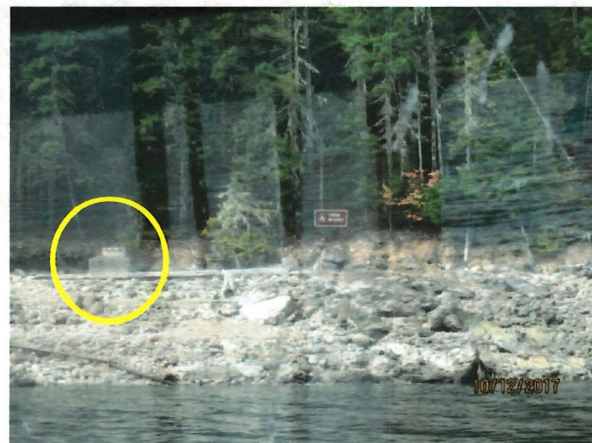
Site W-125 and W-126: This is the location of the old dock for Little Beaver. Two stacks of cribbing that are approximately 6 feet long require removal, as well as some concrete from an old bulkhead. There is no maintenance required here, just removal.

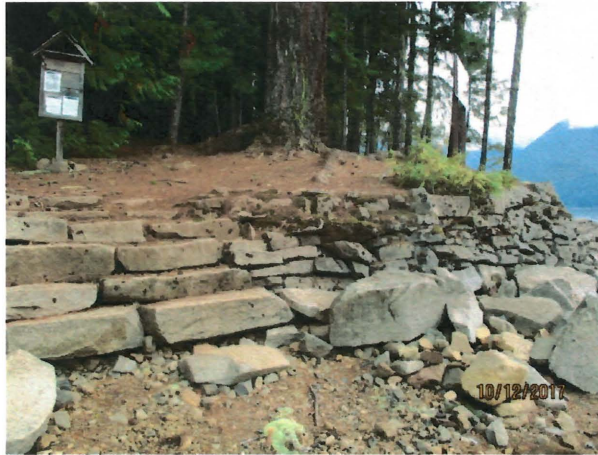
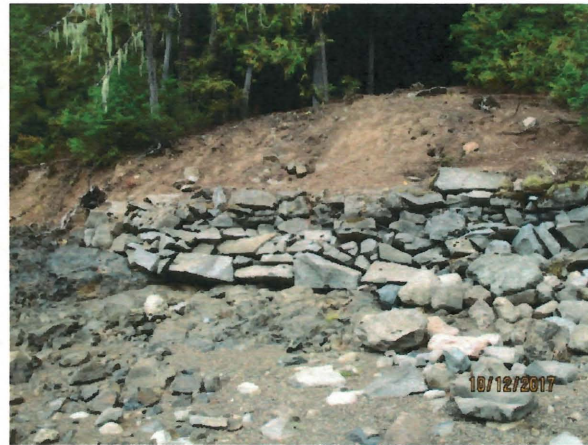
Site E-181: The Boundary Bay dock site requires ~ 60 linear feet of toe protection to be built on the north side, wall itself looks good. Toe protection is needed under the stairs as well, the large boulders by the stairs are not ideal. Excess large rock should be removed. Site ranks a 5/6.

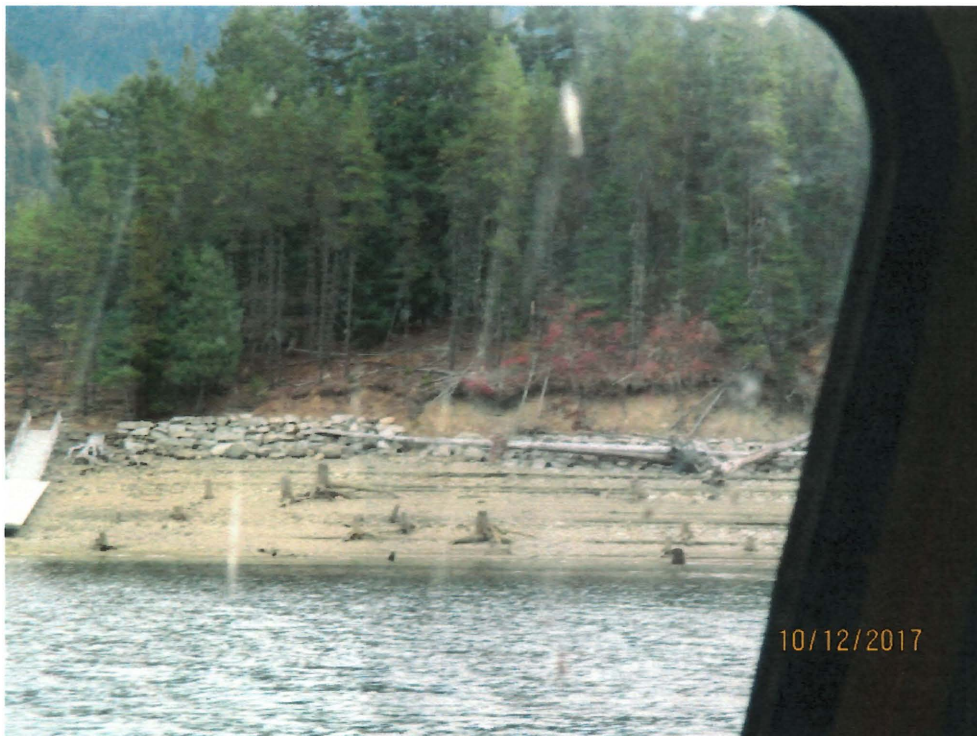
Site E-134B: Some toe protection is needed on the dock site for Cat Island. Revegetation staff could plant to prevent erosion. Site ranks a 7.

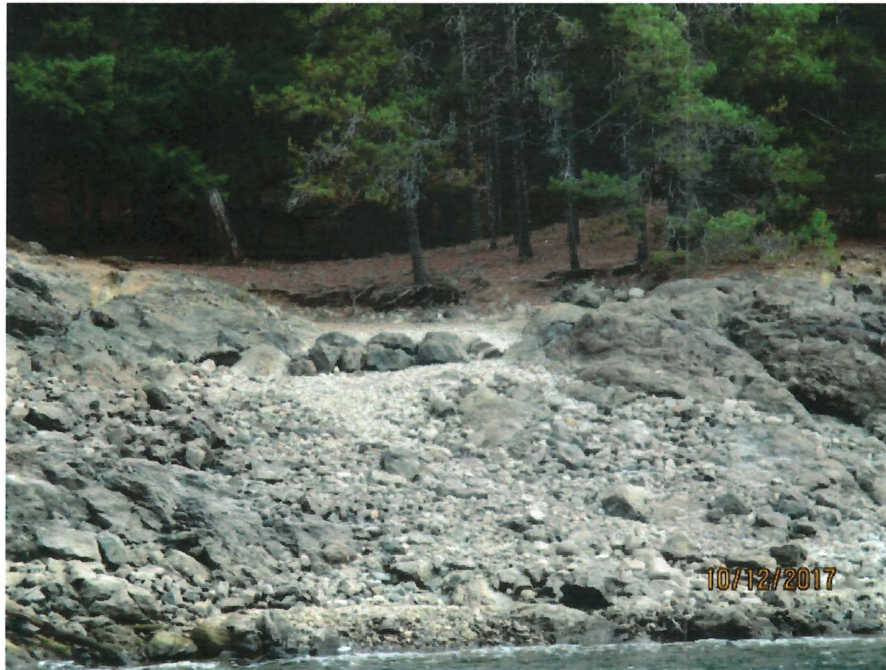
Site E-134A: Rebuild pocket beach wall on the west side of Cat Island. Site ranks a 7.

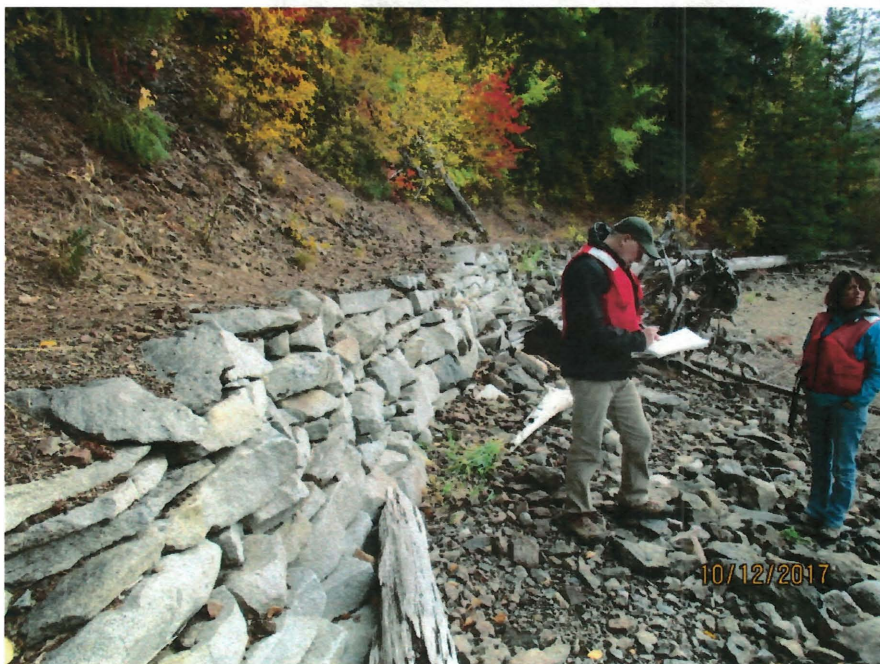
Site E-117: Site is a rock wall north of the Lightning Bridge, hiker camp. Nicely buried, no maintenance needed. There is reed canary grass along wall. Site ranks at 10.

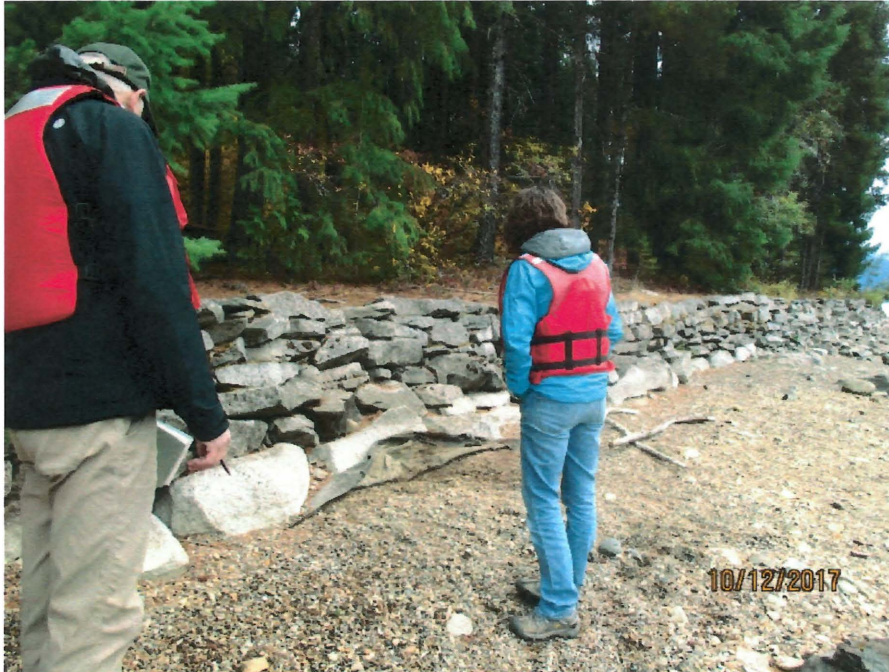
Site E-95: Site is a rock wall south of the Lightning Bridge, horse camp. Wall lacks toe protection for ~ 50 linear feet. Exposed fabric needs to be cut off and the toe protection also needs improvement at the corner. Site ranks an 8.

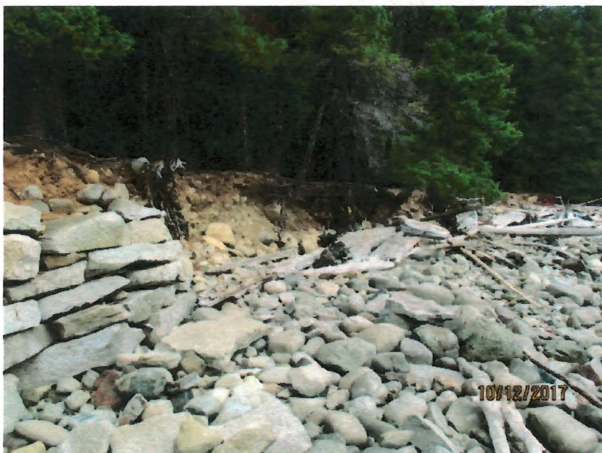
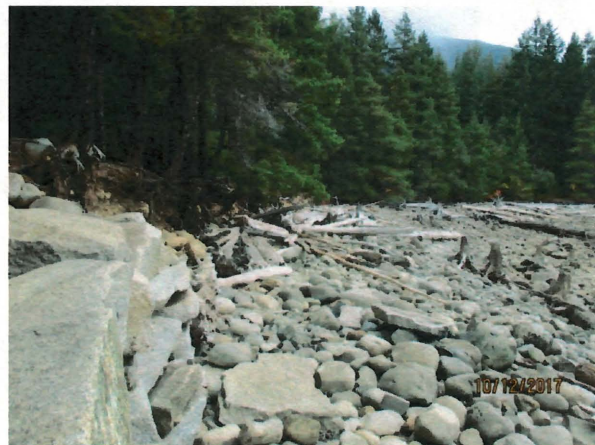
Site E-87: The Ponderosa dock site needs some toe protection at gaps, but otherwise is in good shape. Discussed the possibility of extending the wall 150 feet to the south, or as far as the stockpiled material that is on-site could take it, which might be slightly less. Site ranks an 8.

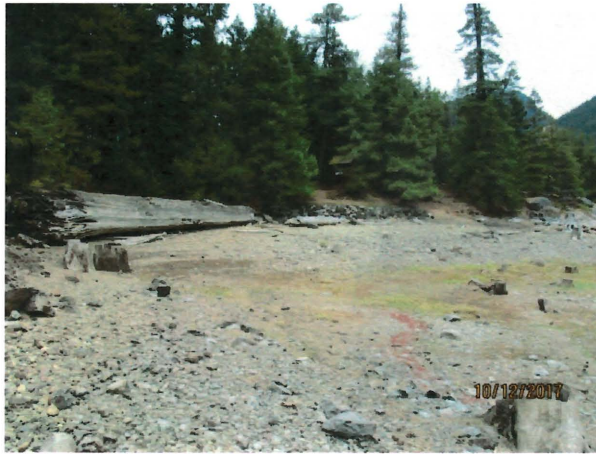
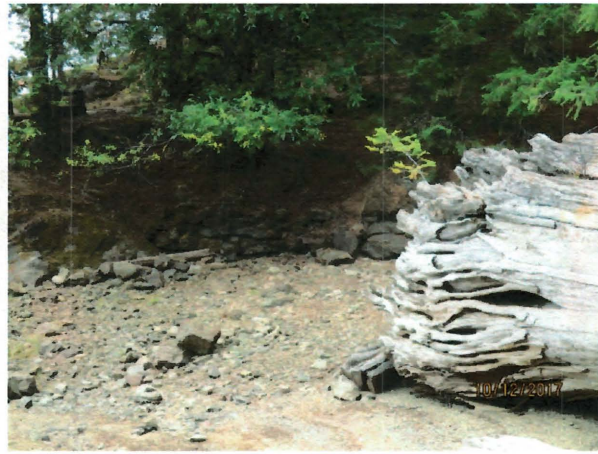
E-112: Toe protection looks good at Dry Creek dock, but work is needed on the west end. There is also a pocket beach by the large log that needs a toe protection rebuild and some maintenance of the top of the wall for ~ 10 linear feet. Site ranks a 6/7.

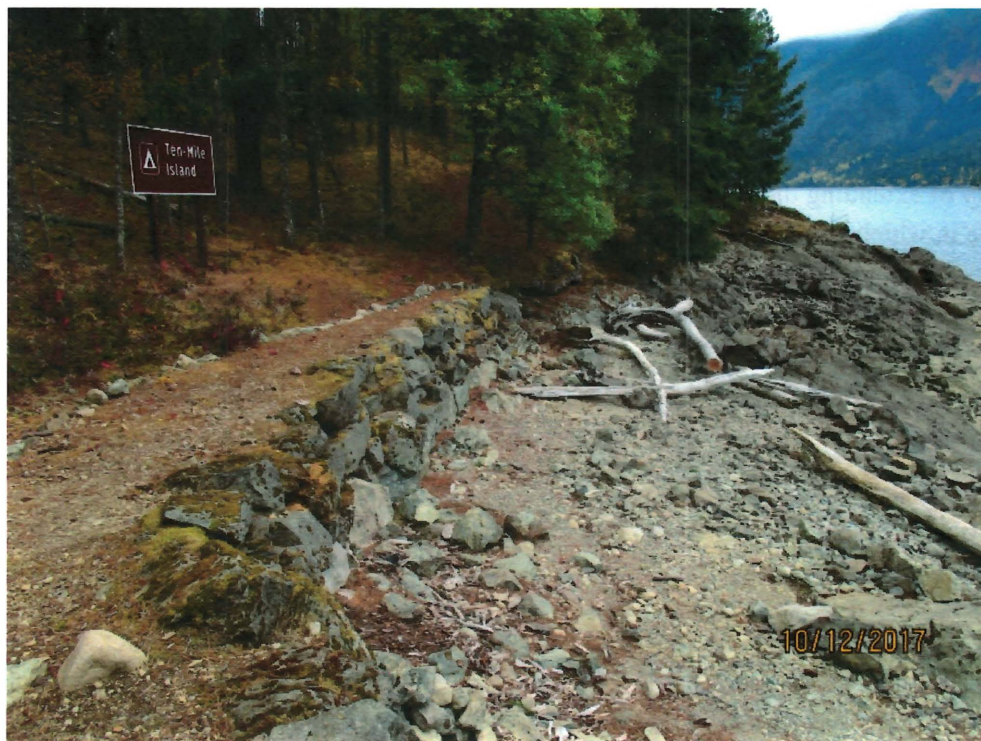
Site E-100: On north side of 10 Mile Island. Wall near sign needs ~ 20 linear feet of toe protection at the point and also for ~ 30 linear feet of the wall. Site ranks an 8.

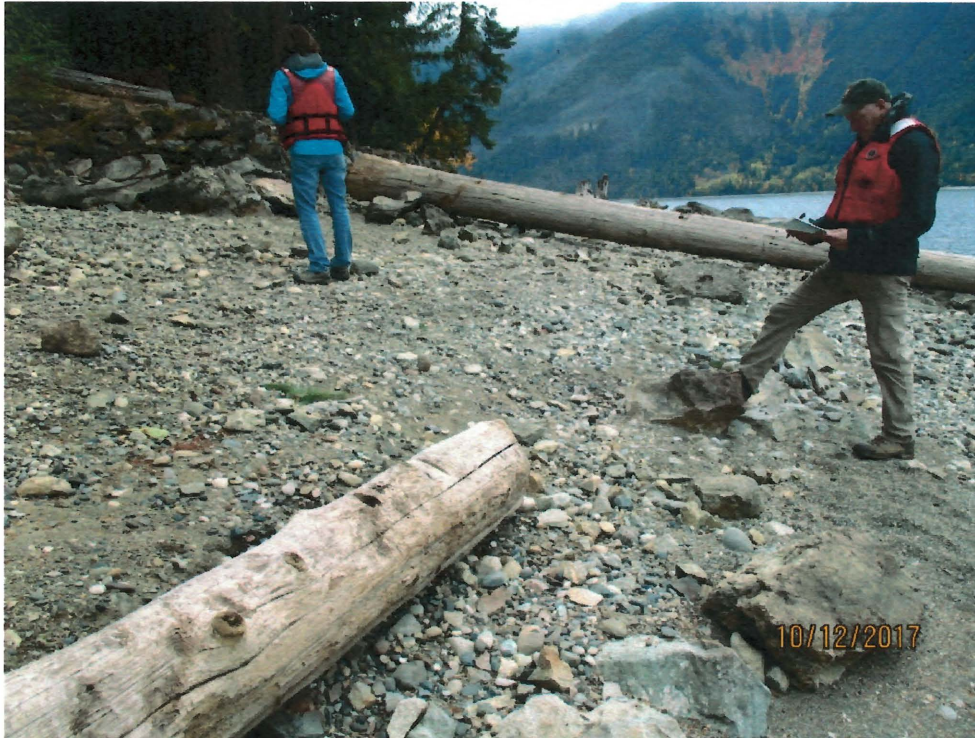
Site E-80A: The wall by the Devil's Junction dock extends to the west. Built in 1992, the wall needs ~ 75 linear feet of toe protection rebuilt. On the west side of a dock, some protection has eroded and would benefit from a log being pinned to the shore. Also, a cable has slipped off one of the trees and needs to be reattached. The large steel beam on the beach should be hauled out. Site ranks a 7.

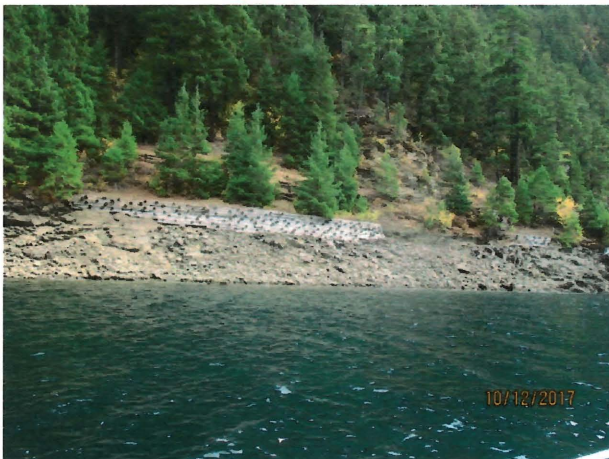
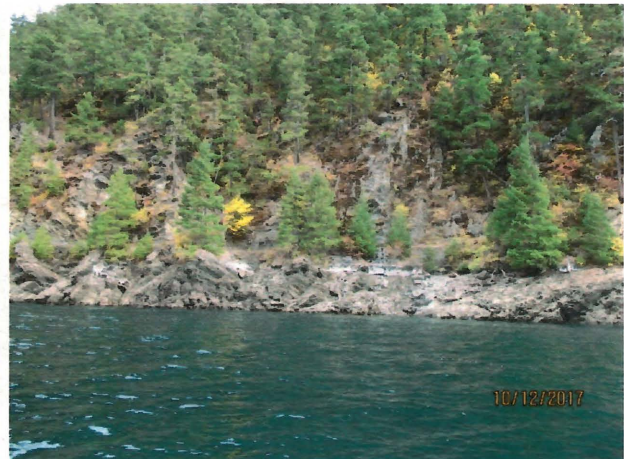
E-70 Sites: There are 9 cribbing walls here along the trail below Devil's Junction dock and have been identified as a priority for 2018. All require some amount of toe protection and all should be inspected from the trail for details, for now photographs document the conditions. Some sections have failed and needs to be repaired or rebuilt. Overall, sites rank a 6/7. Photographs are from north to south along lakeshore.

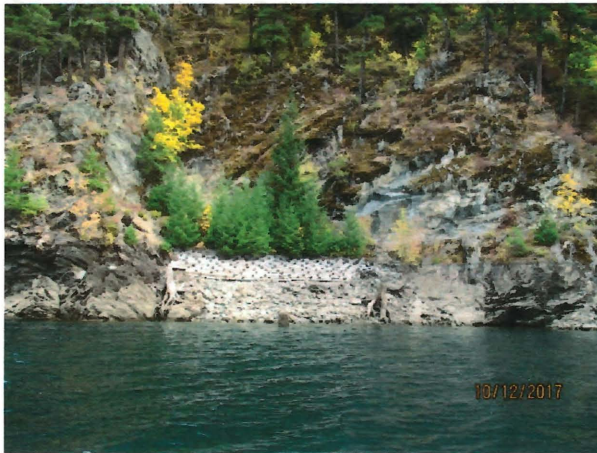
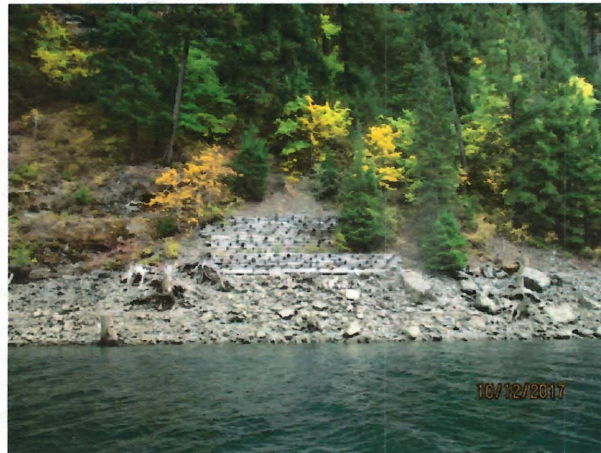
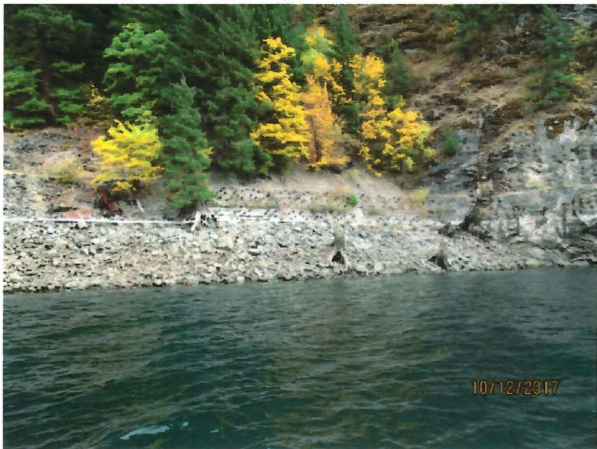
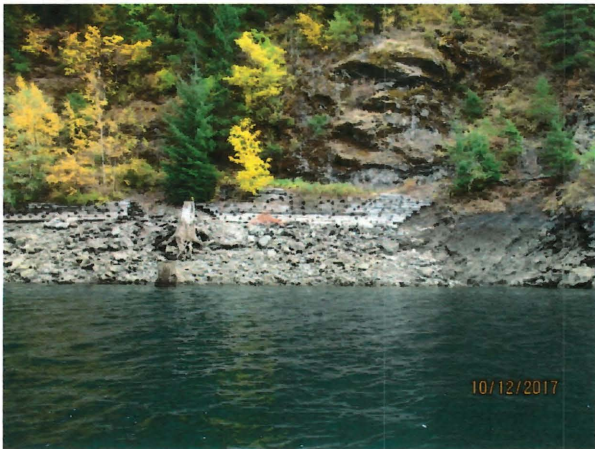
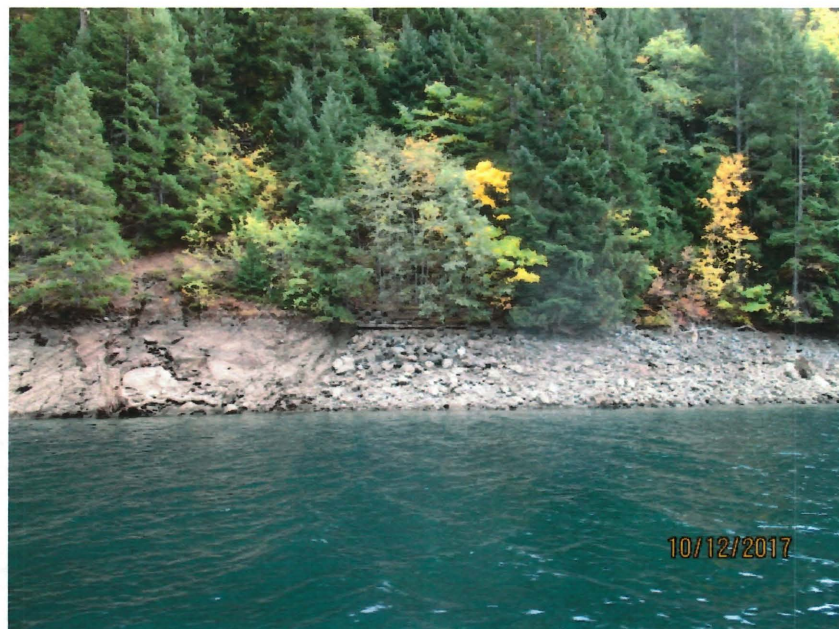
E-70 Sites: Continued photograph from north to south.

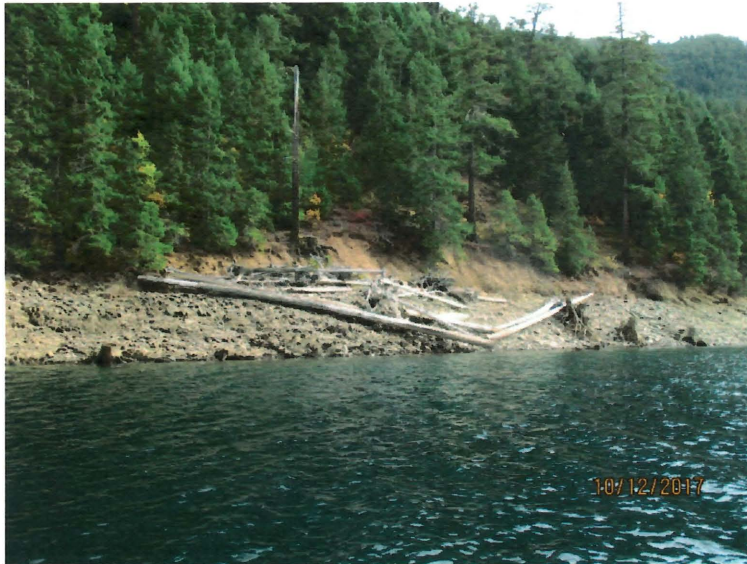
Site of log storage: This site is south of the E-70 cribbing sites. The joint is too low were the pen is connected and this should be tightened.

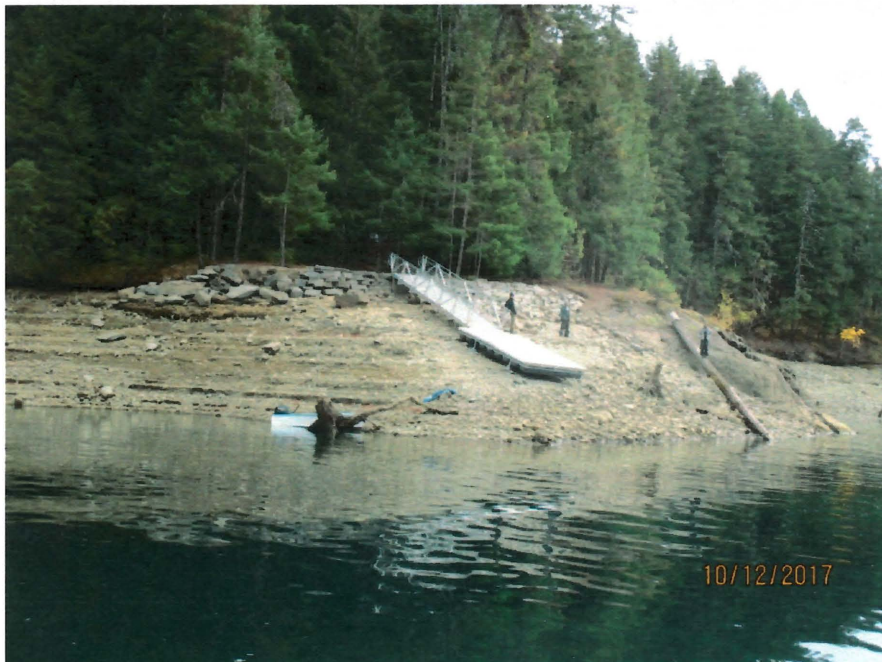
Site E-47: The rock wall at the May Creek dock needs repair and is a priority for 2018. About 15 linear feet of the rock wall built in 2002 failed because no soil filter or filter fabric was placed behind the wall, resulting in the waves removing soil from behind the wall leading to its collapse. The remaining 25 linear feet of wall is in excellent shape. Work for 2018 should be done when the lake level is about 1595 to 1600 feet so that all equipment will be in the water. Removal of the failed section will occur, along with excavating a bench below that area for the new rock wall base. Geotextile filter fabric will be placed prior to laying course rock for the base. The wall will be backfilled and toe scour protection will be rebuilt. When appropriate, revegetation will occur along the shoreline.

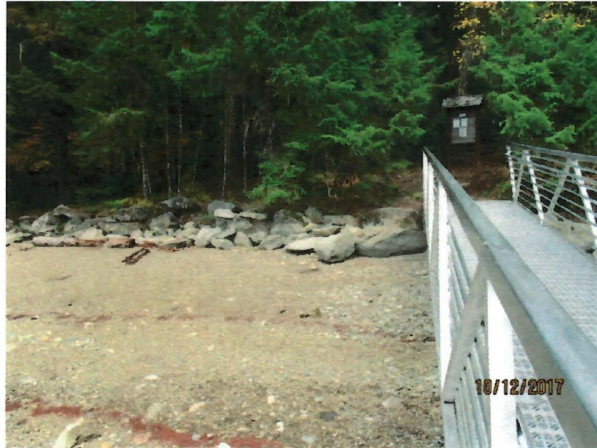
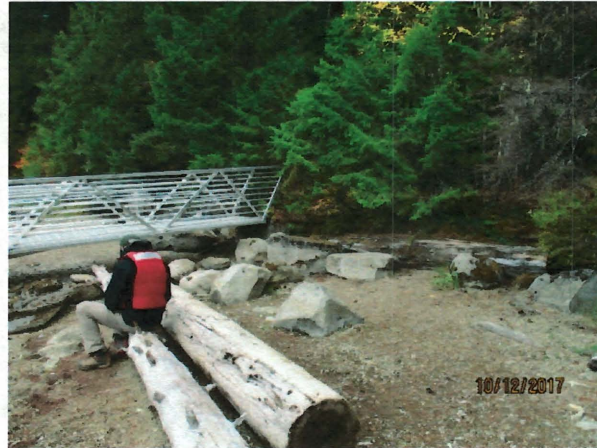
Site E-40: The dock at McMillian camp is a low priority site but needs work. The rock wall on the west side of the dock needs attention; large rocks or a 50-foot log could be installed. The log currently here is too short. Ideally, a larger log could be laid so the root wad faces the dock, with the other end on the shoreline pinned by an existing stump. It would be necessary to put rocks along the shoreline to make a bed for the log. Site ranks a 2.
