**SKAGIT RIVER GEOMORPHOLOGY BETWEEN GORGE DAM AND
THE SAUK RIVER STUDY INTERIM REPORT**

ATTACHMENT G

TRIBUTARY FISH PASSAGE ANALYSIS INVENTORY

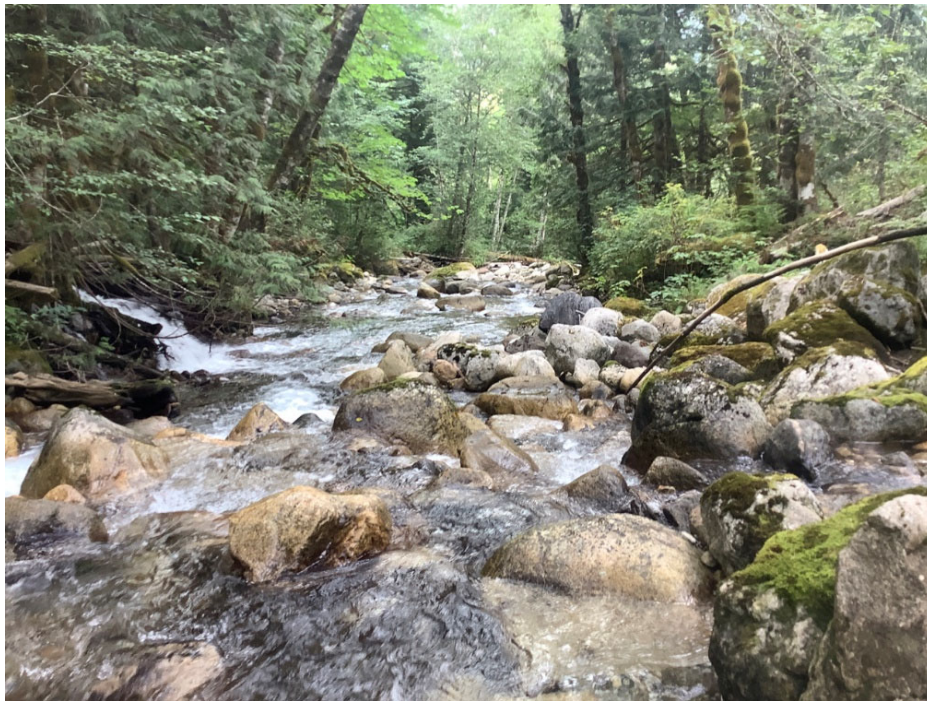
Alma Creek is characterized by a boulder cascade morphology with a predominantly cobble and boulder substrate (Figure G-1). The surveyed reach consisted predominantly of 3 percent grades with an average gradient of 5.25 percent and a wetted width of 5 ft. The average depth in the creek is 1.55 ft. The gradient is fairly consistent throughout the reach, with a series of pools between the boulder cascade sections (Figure G-2). The depth throughout the reach is also relatively consistent and there is no passage issue relative to water depth, although the gradient may be a challenge to some species (Figure G-3).

Figure G-1. Representative photo of Alma Creek habitat conditions.

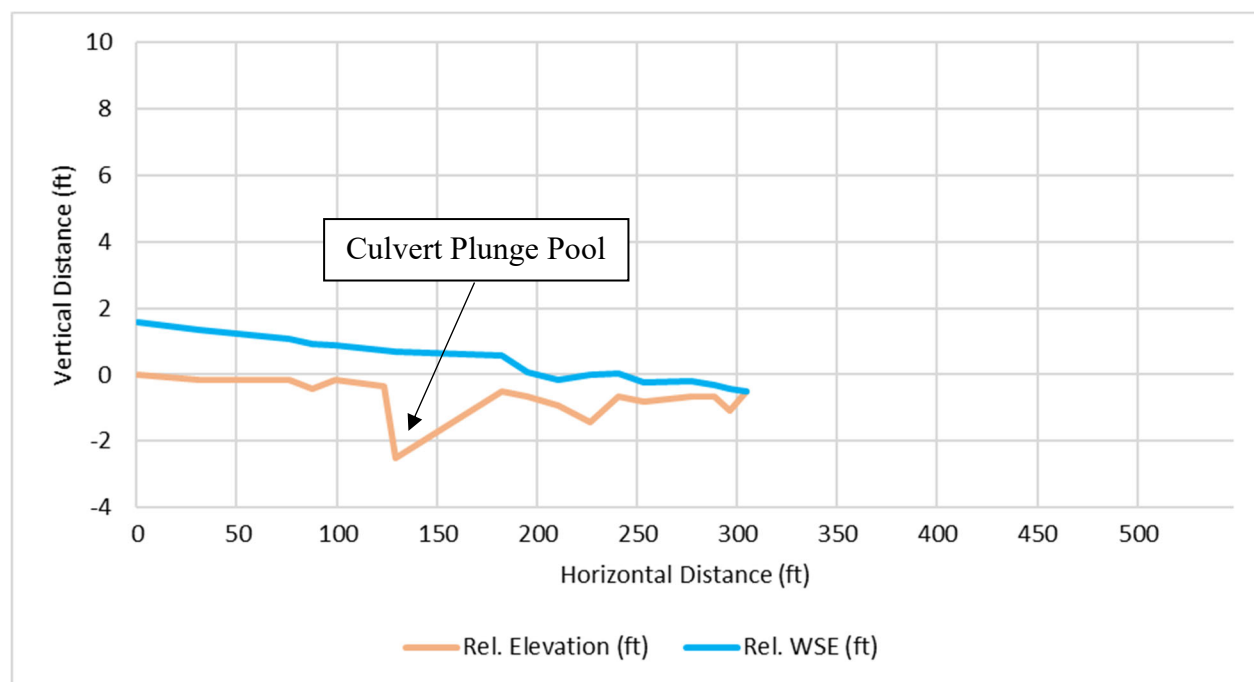
zone and the very low gradient in the lower section of the creek (Figure G-4 (left)). Based on the water depth profile and site observations, the culvert is causing scour and a plunge pool at its outlet (Figures G-5 and G-6). Approximately 304 ft upstream of the creek mouth, the stream disappears subsurface. Reed canary grass and blackberry are very dense along the stream and throughout the channel itself, preventing the survey of the entire 500 ft (Figure G-4 (right)). There is little tree canopy upstream of the culvert and the channel appears to be incised on the upstream end of the culvert by more than two vertical ft. Much of the water present below the culvert is backwatered from the Skagit River contributing to sandy substrate and a negative overall gradient of -0.21 percent throughout the reach.

Figure G-5. Relative bed elevation and water surface elevation for Babcock Creek from mouth upstream 500 linear ft.

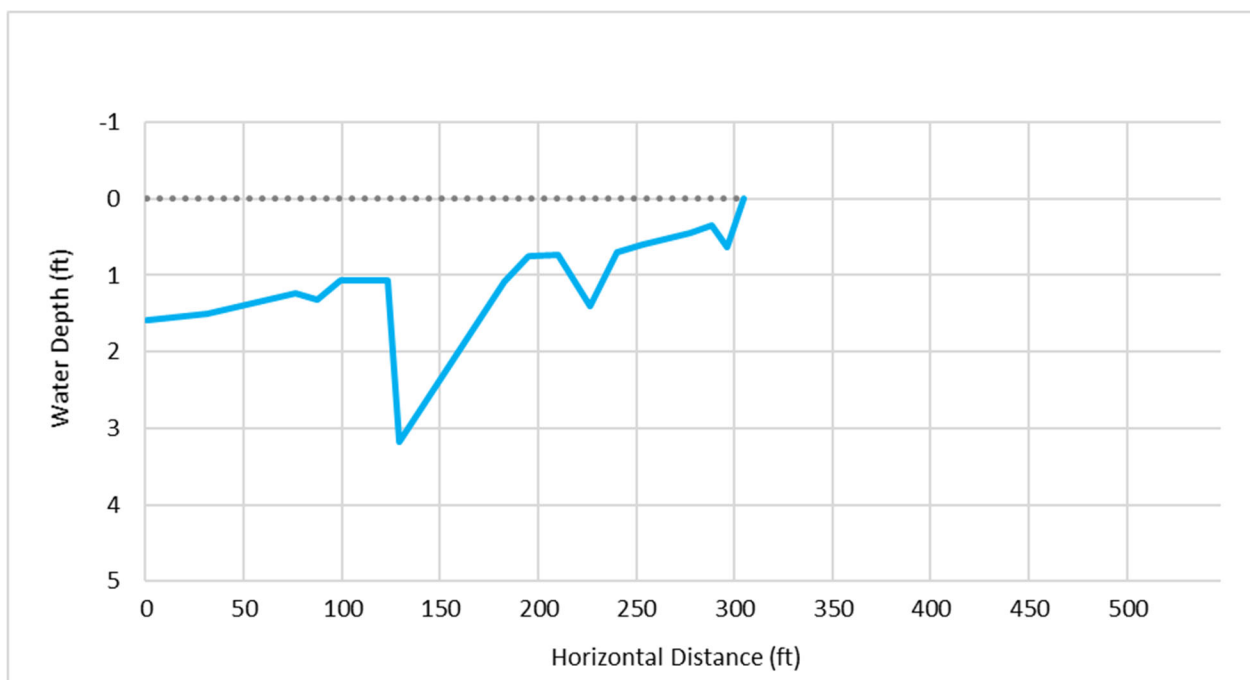
Figure G-6. Water depth profile for Babcock Creek on August 6, 2021 from the mouth upstream 500 linear ft.

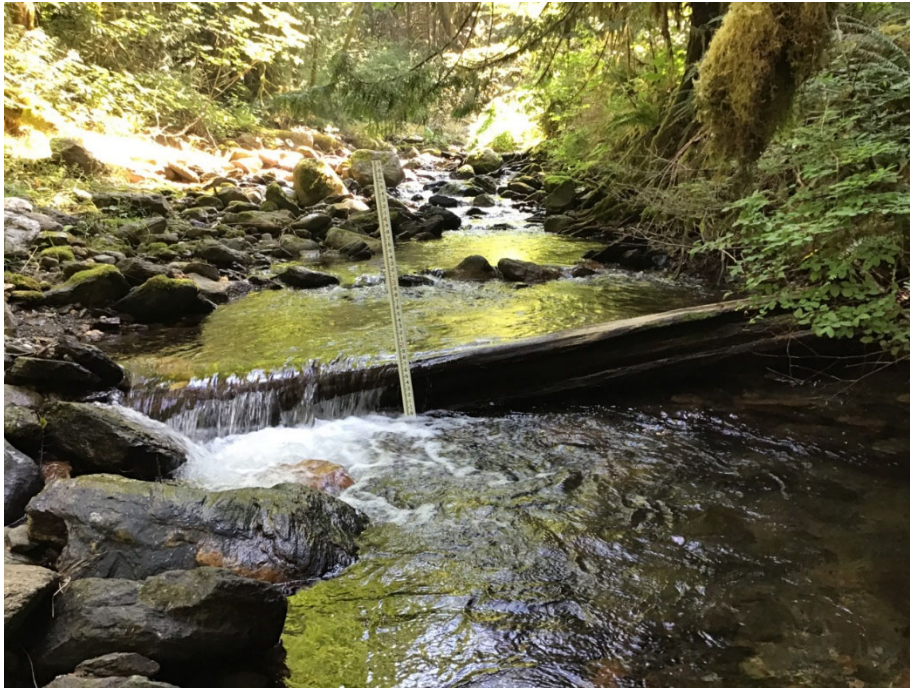
Figure G-14. Looking upstream approximately 300 ft upstream of creek mouth on Copper Creek.

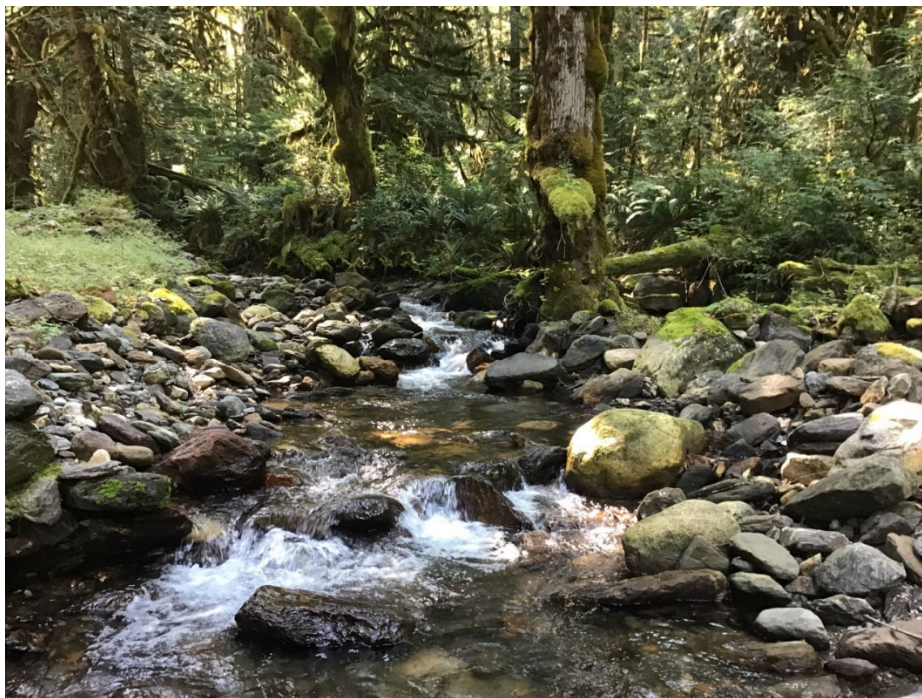
Figure G-15. Looking upstream approximately 320 ft upstream of creek mouth on Copper Creek.

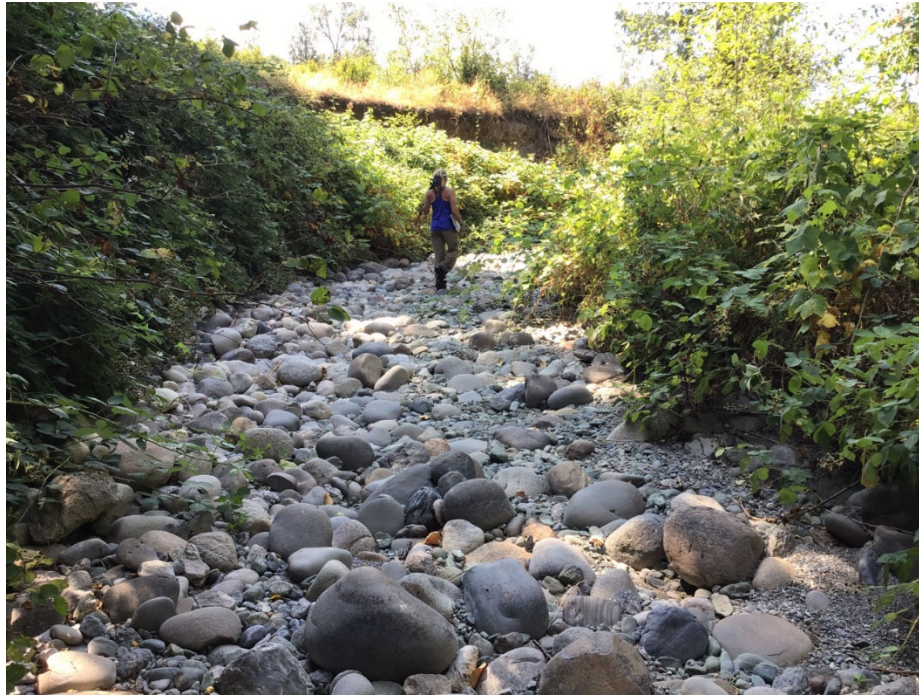
Corkindale Creek was dry at the time of site visit (Figure G-18). The average bed gradient is 2.07 percent with a bankfull width (BFW) of approximately 16 ft (Figures G-19 and G-20). Channel

substrate consists predominantly of large cobbles. Both banks showed signs of incision with banks obscured by a dense layer of Himalayan blackberry.

Figure G-18. Looking downstream approximately 280 ft upstream from the mouth of Corkindale Creek.

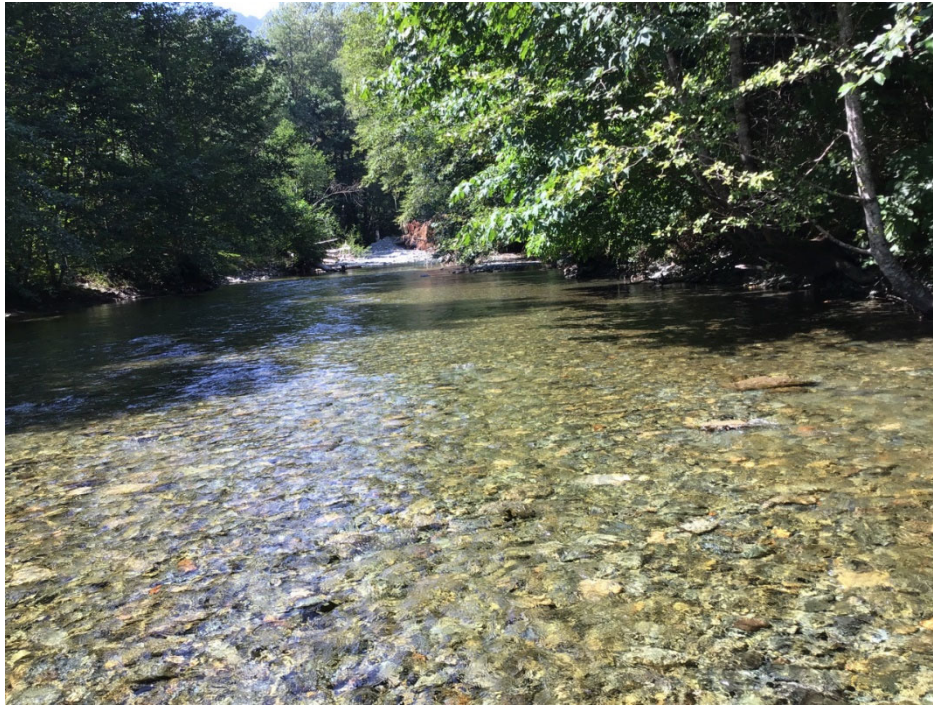
Figure G-24. View of the plane bed morphology of Diobsud Creek.

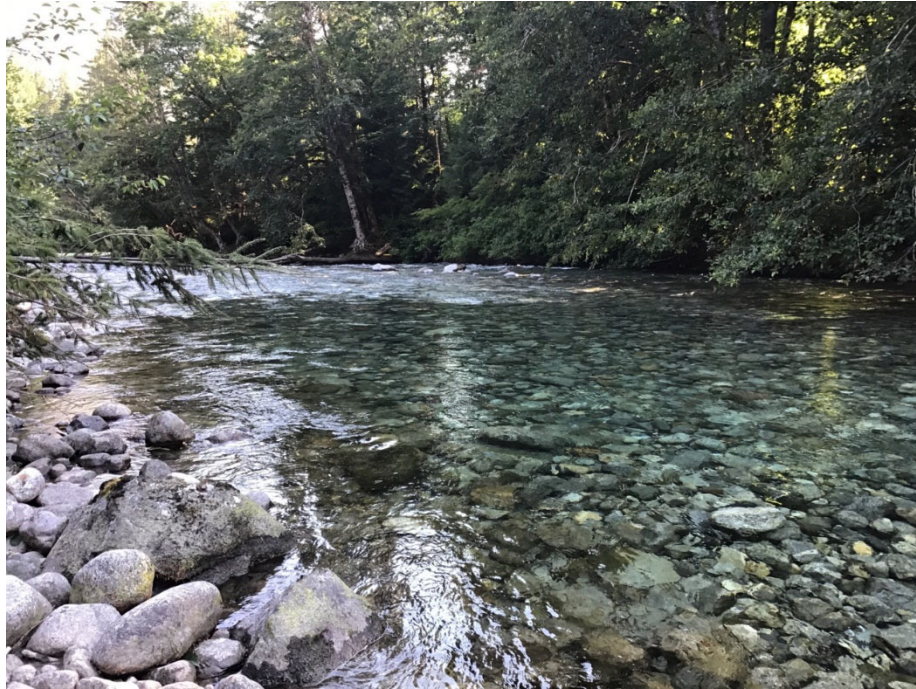
mouth due to a highly erosive, steep right bank preventing a water depth profile from being conducted. Approximately 500 ft upstream of the mouth by the bridge crossing, waters slowed but were consistently too deep to wade for survey. Water depth was approximated to be 3 to 5 ft deep throughout reach, with deeper slower waters further upstream near the bridge (Figure G-28). A visual inspection concluded that fish passage was not a problem at the mouth of Goodell Creek.

Figure G-28. View of Goodell Creek from the bank.

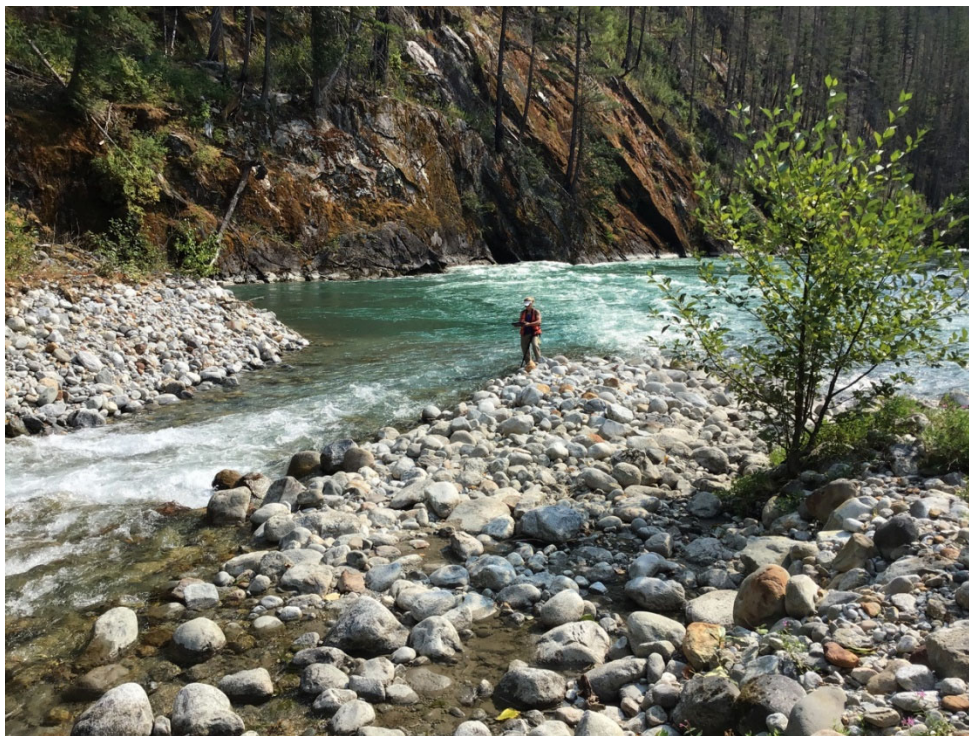
The mouth of Ladder Creek is comprised predominantly of large boulders with cobble substrate (Figure G-32). A series of cascades occur beginning approximately 300 ft upstream of the mouth with the first of several large, fish blocking waterfalls (over 3.7 meters according to Washington Department of Fish and Wildlife [WDFW] 2019) occurring approximately 50 ft further upstream. A large plunge pool exists at the base of the falls. Downstream of the falls, the average slope is 2.68 percent where surveyable. The thalweg of the river was too deep and swift to survey at time of field visit, so an elevation profile was conducted along right bank. The water depth along right bank averaged 2.27 ft deep and wetted width was approximated at 16 to 20 ft wide.

Figure G-32. A surveyor stands on the right bank at the mouth of Ladder Creek.

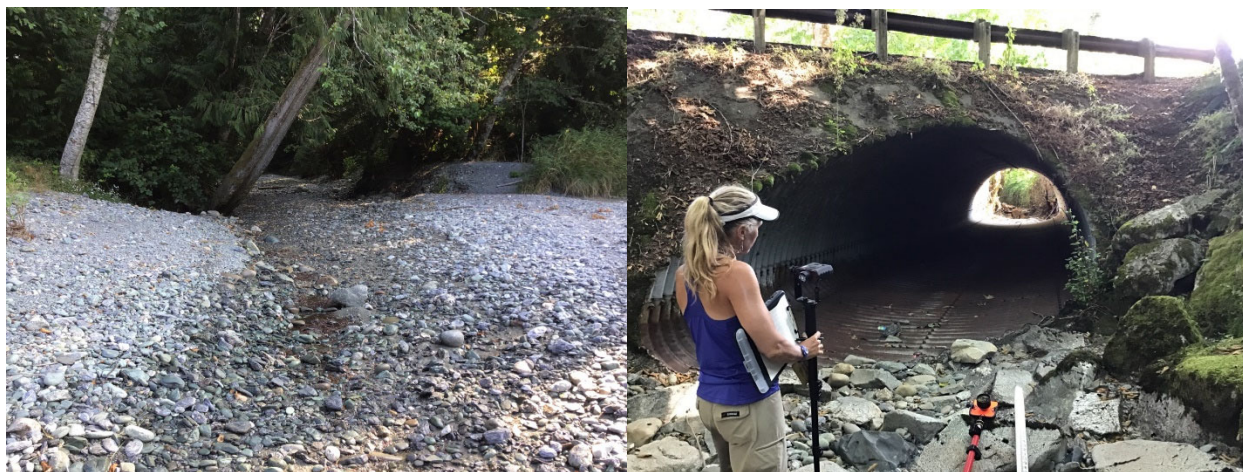
Olsen Creek was dry at the time of site visit, except for two isolated pools within shallow depressions (Figure G-44). Approximately 300 ft upstream from the creek mouth, Olsen Creek runs through a squashed corrugated metal pipe (CMP) beneath State Rt. 20 that is documented as a total fish barrier (0 percent passable) due to having a slope over 3 percent according to the WDFW Fish Passage Inventory (WDFW 2021). Upstream of the culvert, the channel is constricted by failing gabion basket walls approximately 8 ft tall that are contributing angular aggregate to the streambed and confining the creek within a width of 13 ft. The gabion basket walls continue until about 500 ft upstream of the channel's mouth, at which point, the channel widens again. The riparian zone throughout the surveyed reach is heavily impacted and dominated by Himalayan blackberry. The average bed gradient throughout the surveyed reach is 1.67 percent (Figure G-45) and the BFW is 39 ft downstream of the road crossing (Figure G-46).

Figure G-44. Standing at mouth of Olsen Creek looking upstream (left). A surveyor stands at the downstream end of the squashed CMP beneath State Rt. 20 (right).

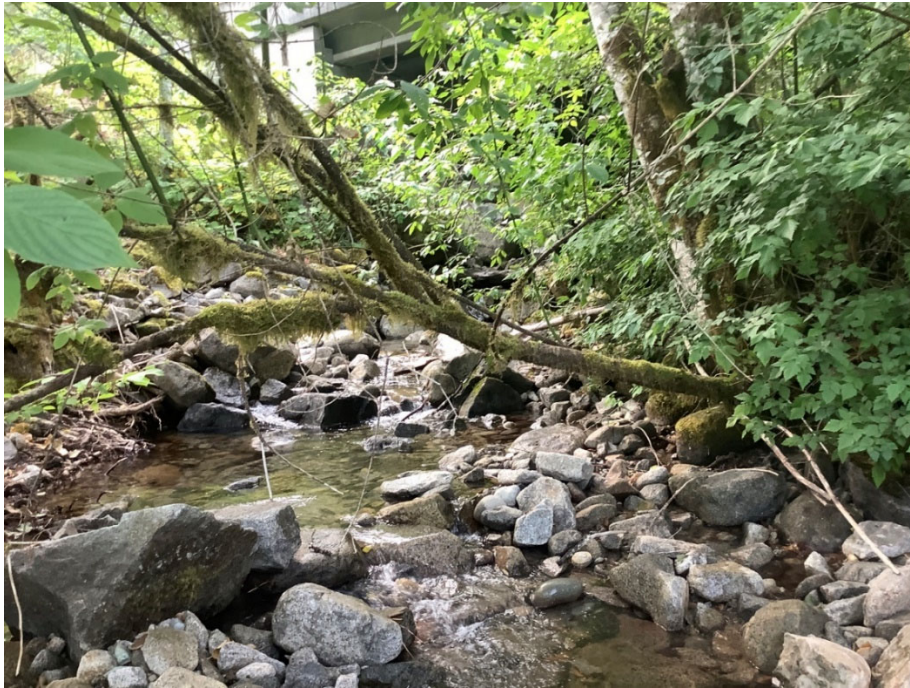
Sky Creek is a steep, boulder dominated channel with multiple vertical hydraulic drops that act as natural fish barriers (Figure G-53). At 110 ft upstream of the channel mouth, the first hydraulic

Figure G-53. Looking upstream at the mouth of Sky Creek.

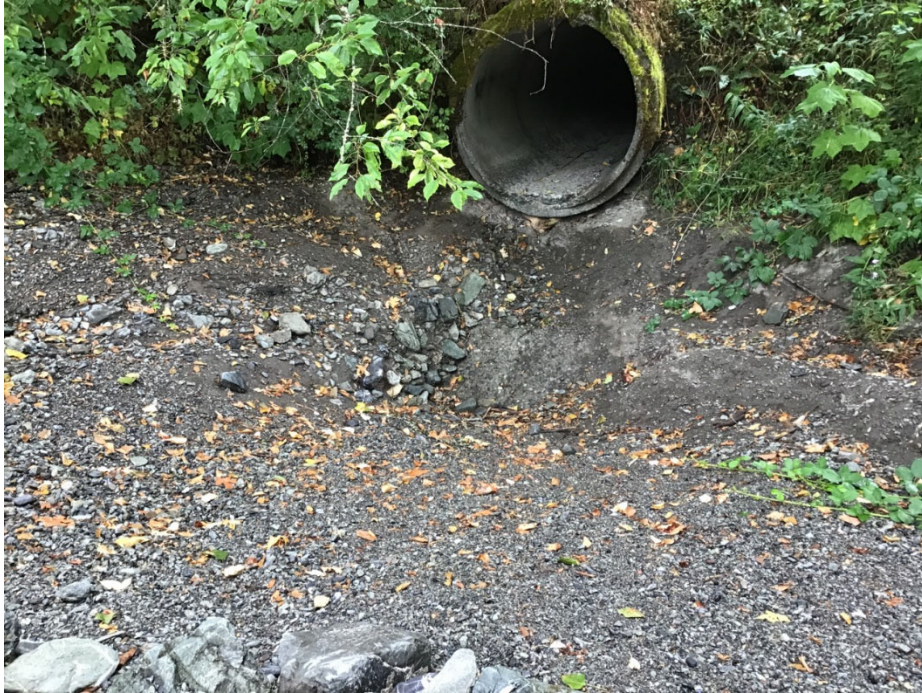
Figure G-57. Looking upstream at the outlet of the PCC culvert beneath State Rt. 20 that acts as a total fish barrier (WDFW 2021) on Sutter Creek.

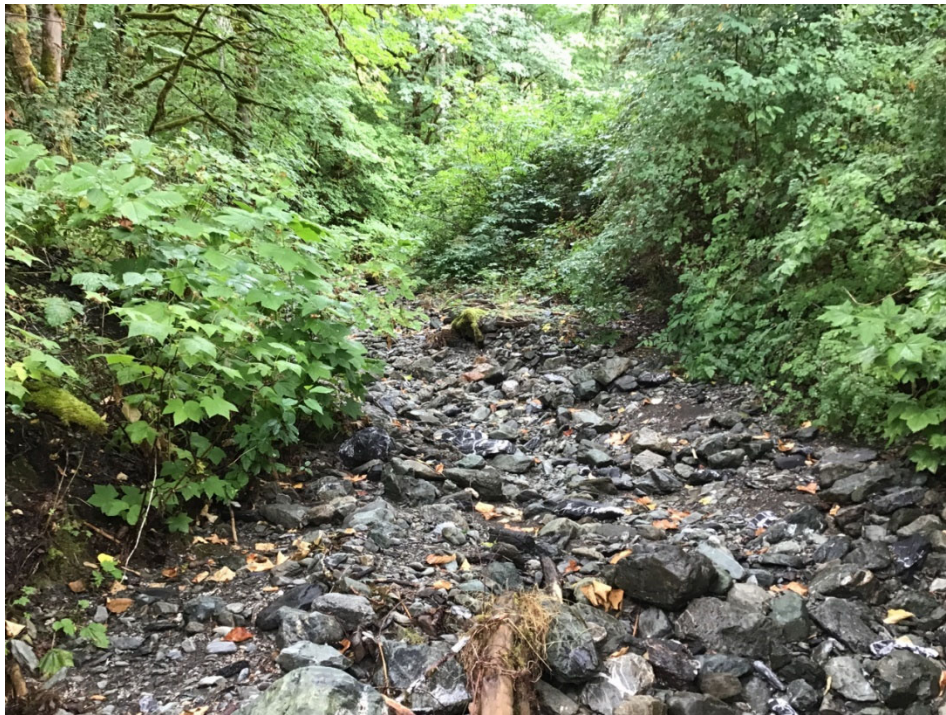
Sutter Creek was dry at the time of the field visit. The mouth of Sutter Creek occurs at a popular boat launch, which has contributed to widening of the stream channel, erosion, and a lack of riparian vegetation. Approximately 80-ft upstream of the mouth, a 5-foot diameter plain cement concrete (PCC) culvert occurs at the crossing with State Rt. 20 (Figure G-57). This culvert is identified as a total fish barrier (0 percent passability) by the WDFW Fish Passage Inventory (WDFW 2021). Downstream of the culvert, substrate consists predominantly of gravel, while upstream of the culvert substrate becomes coarser (Figure G-58). The average slope of the surveyed reach was 4.3 percent while the average BFW was 17 ft (Figures G-59 and G-60).

Figure G-58. Standing in channel center looking upstream, approximately 500-ft upstream of channel mouth.

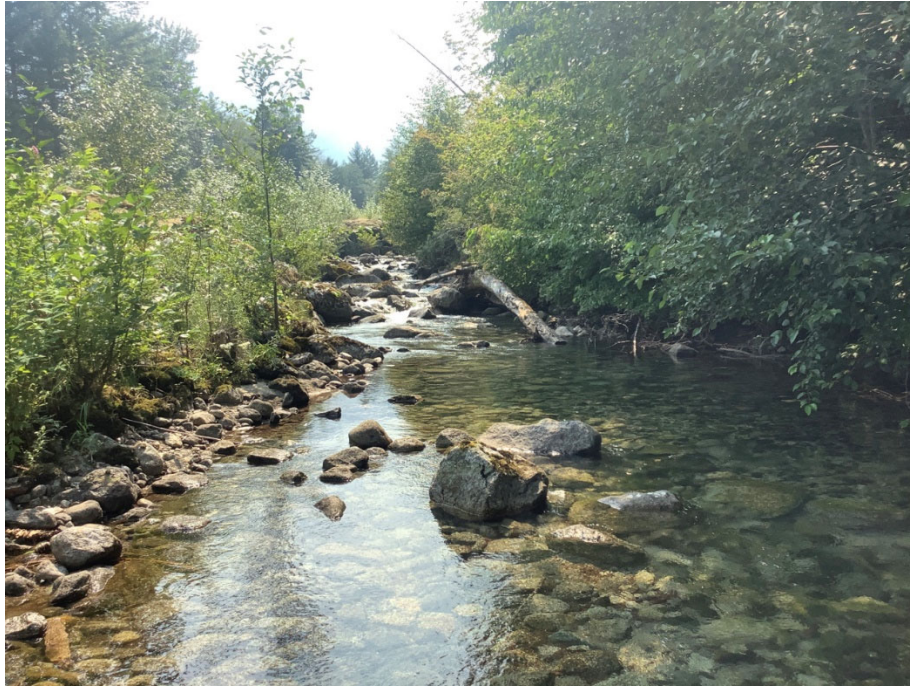
Figure G-61. Standing in channel center looking upstream approximately 400 ft upstream from channel mouth on Thornton Creek.

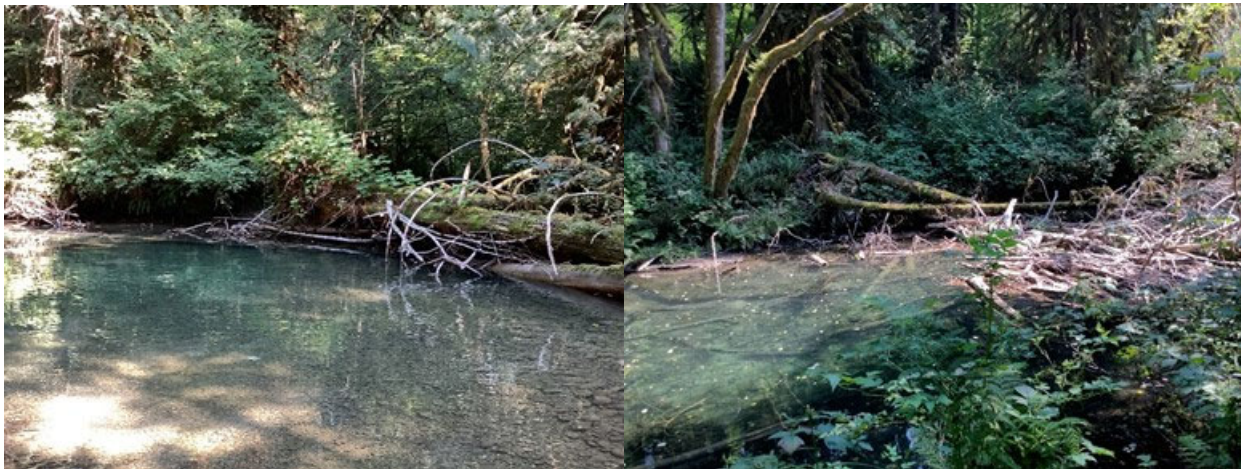
Branching off of the Thornton Side Channel is a secondary side channel at PRM 90.25. The channel is perennial and contains juvenile salmonid rearing habitat elements including shelter from mainstem flows, large wood and vegetation cover, and large wood formed pools, along with stretches of spawning gravels (Figure H-1). The channel is low gradient with an average slope of 0.25 percent and has two notable log jams. The first log jam is at the meander just downstream from the inlet and forms a pool >4 ft deep. The other log jam is channel spanning forms a pool >4 ft deep has accumulated large amounts of smaller wood that form a continuous rack of woody cover above the channel.

Figure H-1. Notable log jams creating deep pools with cover within the smaller side channel at PRM 90.25 that splits off of the Thornton Side Channel.

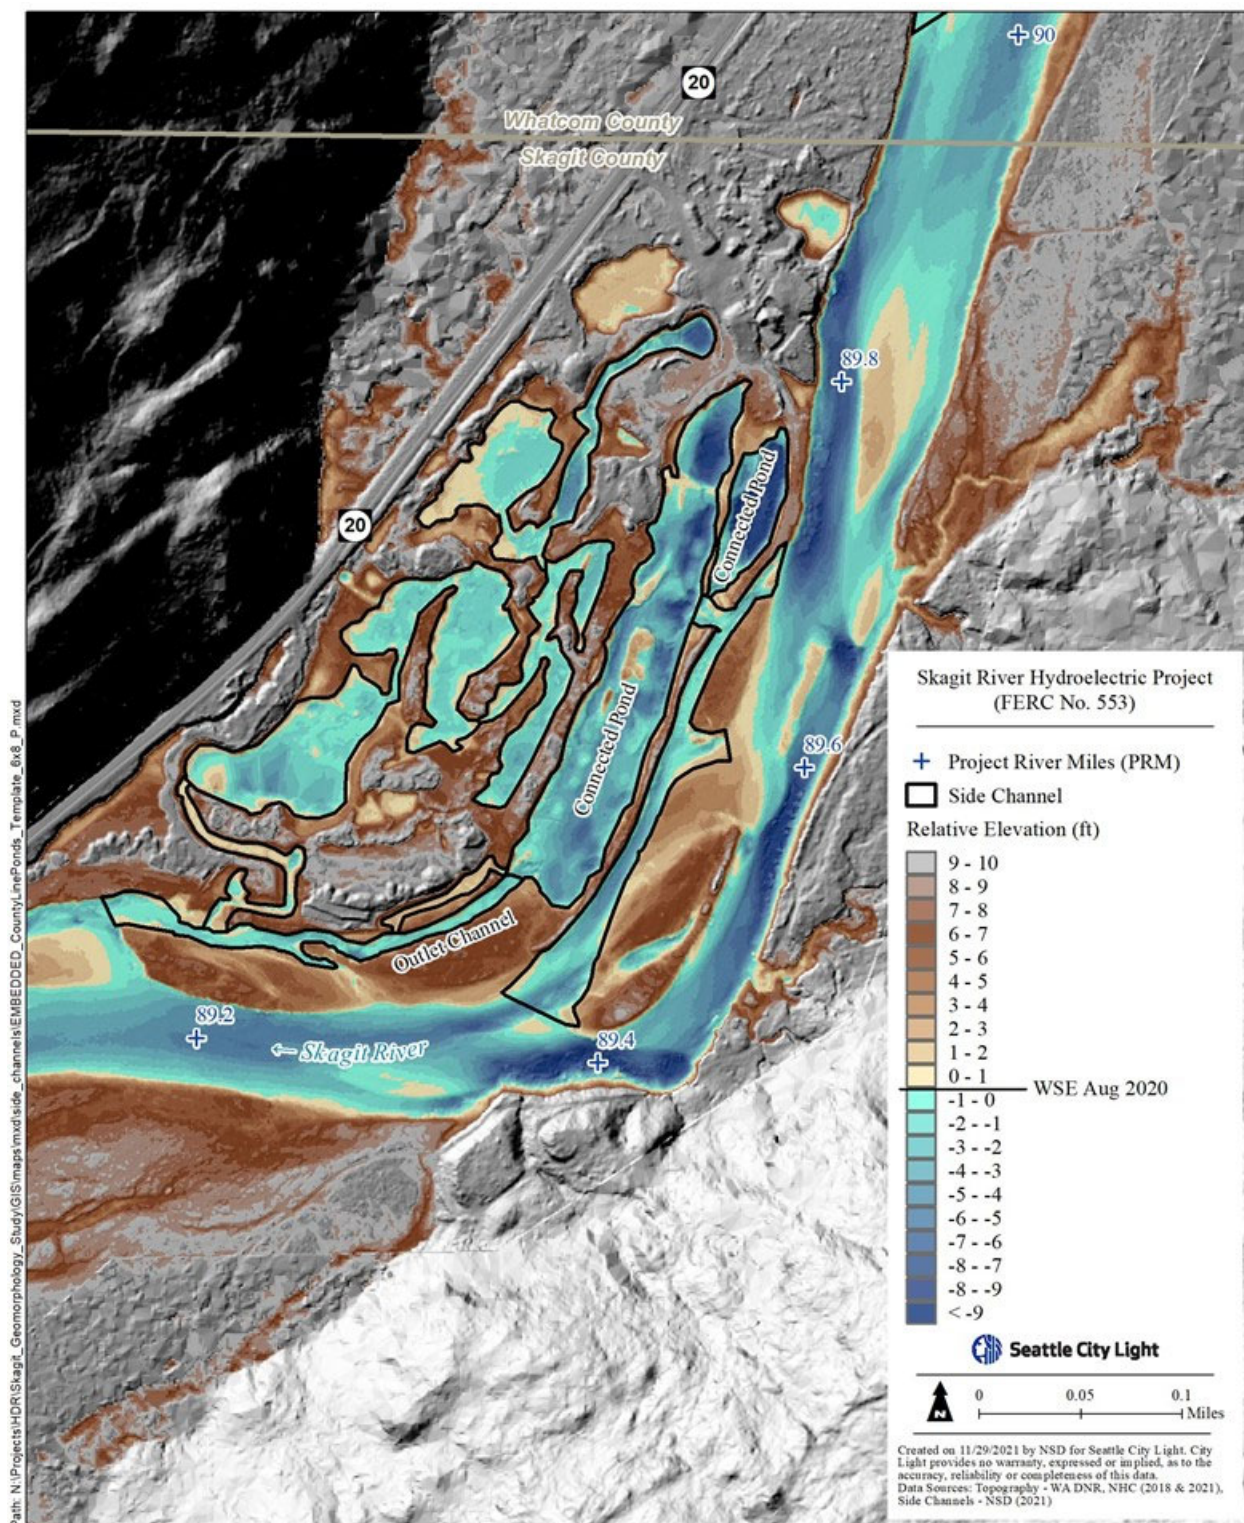
two ponds that are perennially connected to the river, and a series of ponds that are less connected. The largest side channel, near the upstream end of the County Line Ponds, begins where the river eroded through a bank separating one of the ponds from the river. The channel splits with a portion of the flow going through a large pond and out into a side channel downstream of the pond. The other portion of the side channel flows parallel to the pond and around an island before rejoining the Skagit. This channel is wide and lacks complexity or woody debris, aside from a few wood pieces in the upper portion of the channel. At the downstream end of the pond with the side channel flowing through it a large floating mat of woody debris has formed, and the outlet forms a deep and fast side channel that is widening as indicated by significant bank erosion. The widening is likely due to an increased amount of flow coming into the pond and outlet channel from the river in recent years. Near the downstream end of the outlet channel is a constructed side channel that connects one of the large ponds to the outlet channel. The constructed channel was dry during the August 2021 survey, but appears to be seasonally inundated, although the frequency of connection to the pond is currently unknown.

Figure H-2. County Line Ponds in Reach 2B relative elevation model (REM) showing side channels.

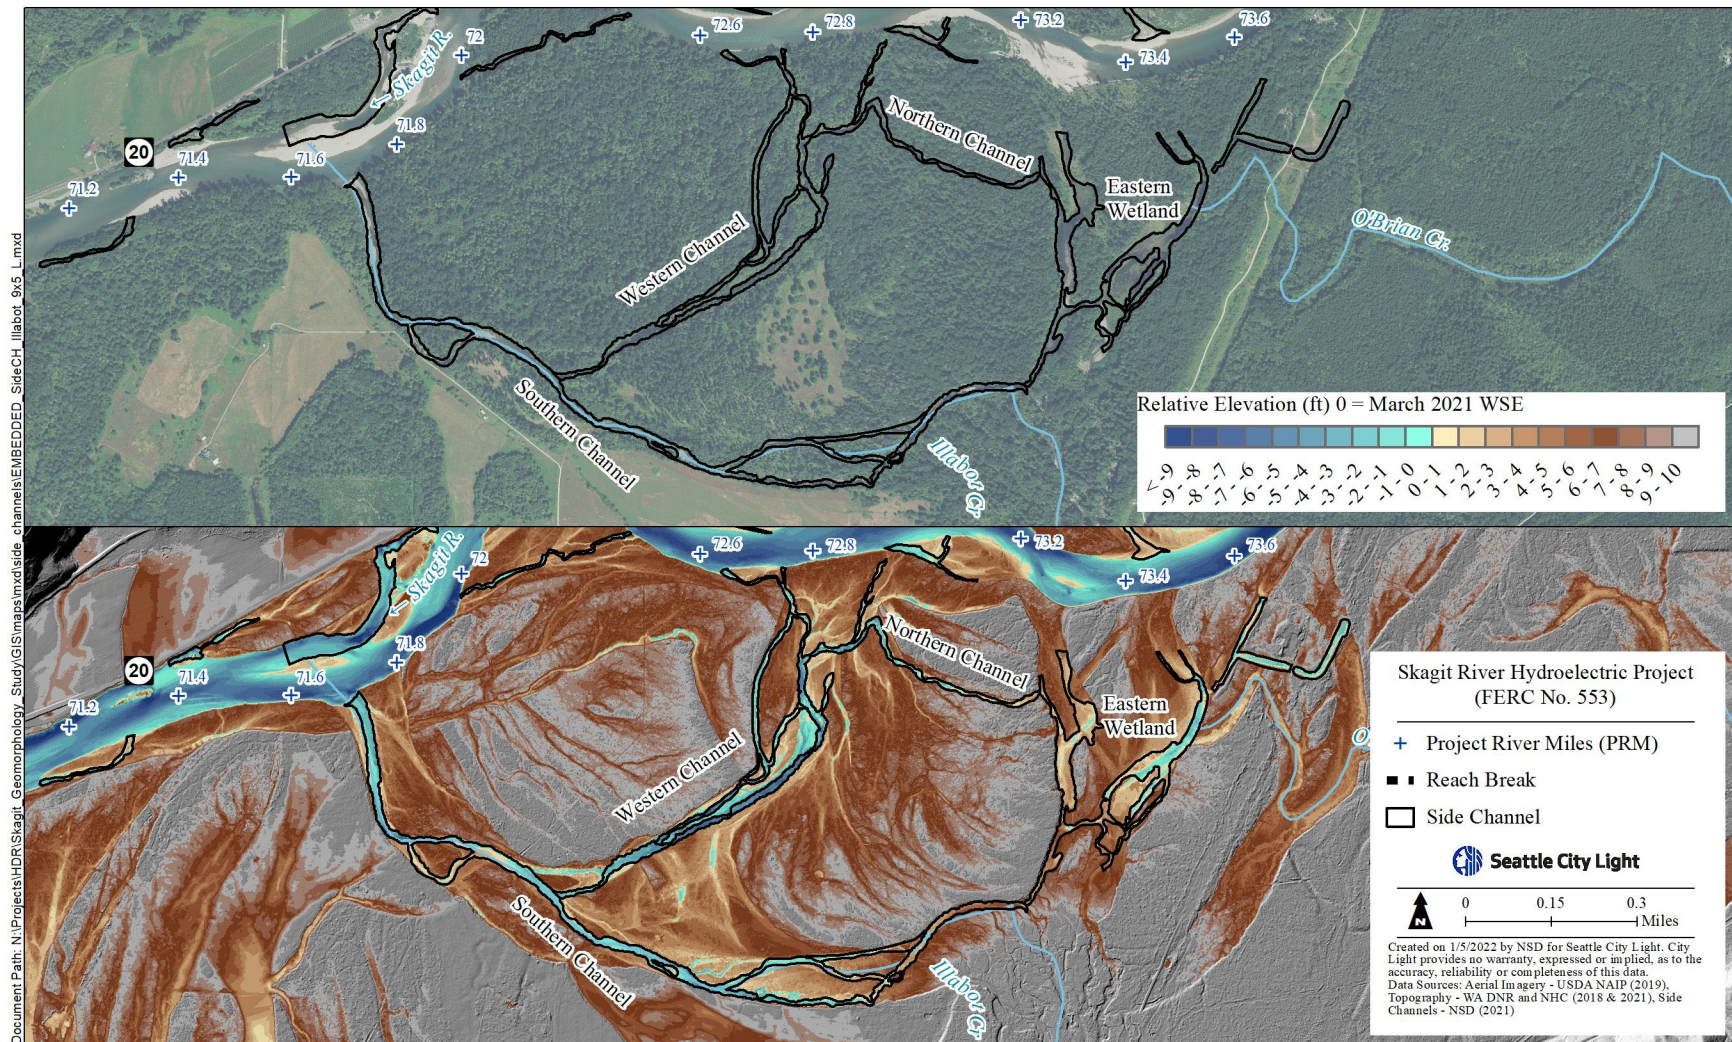
There are four main sections to the side channel network: southern channels, northern channels, western channels, and eastern wetland (Figure H-7). The southern channel is the outlet of the complex, and Illabot Creek also flows into the southern channel. The northern channel flows out of the eastern wetland and contains large wood and several channel-spanning log jams. The western channels contain one main perennial channel and several seasonal channels. The western channel has significant ground water input as evidenced by active areas of groundwater upwelling and water noticeably colder to the touch than the other areas in the Illabot Complex. The eastern wetland is a large off channel wetland. The wetland is a series of open water areas of full of aquatic vegetation and depths were 2+ ft deep in the center during the August 2021 survey.

Figure H-7. Illabot Side Channel Complex.

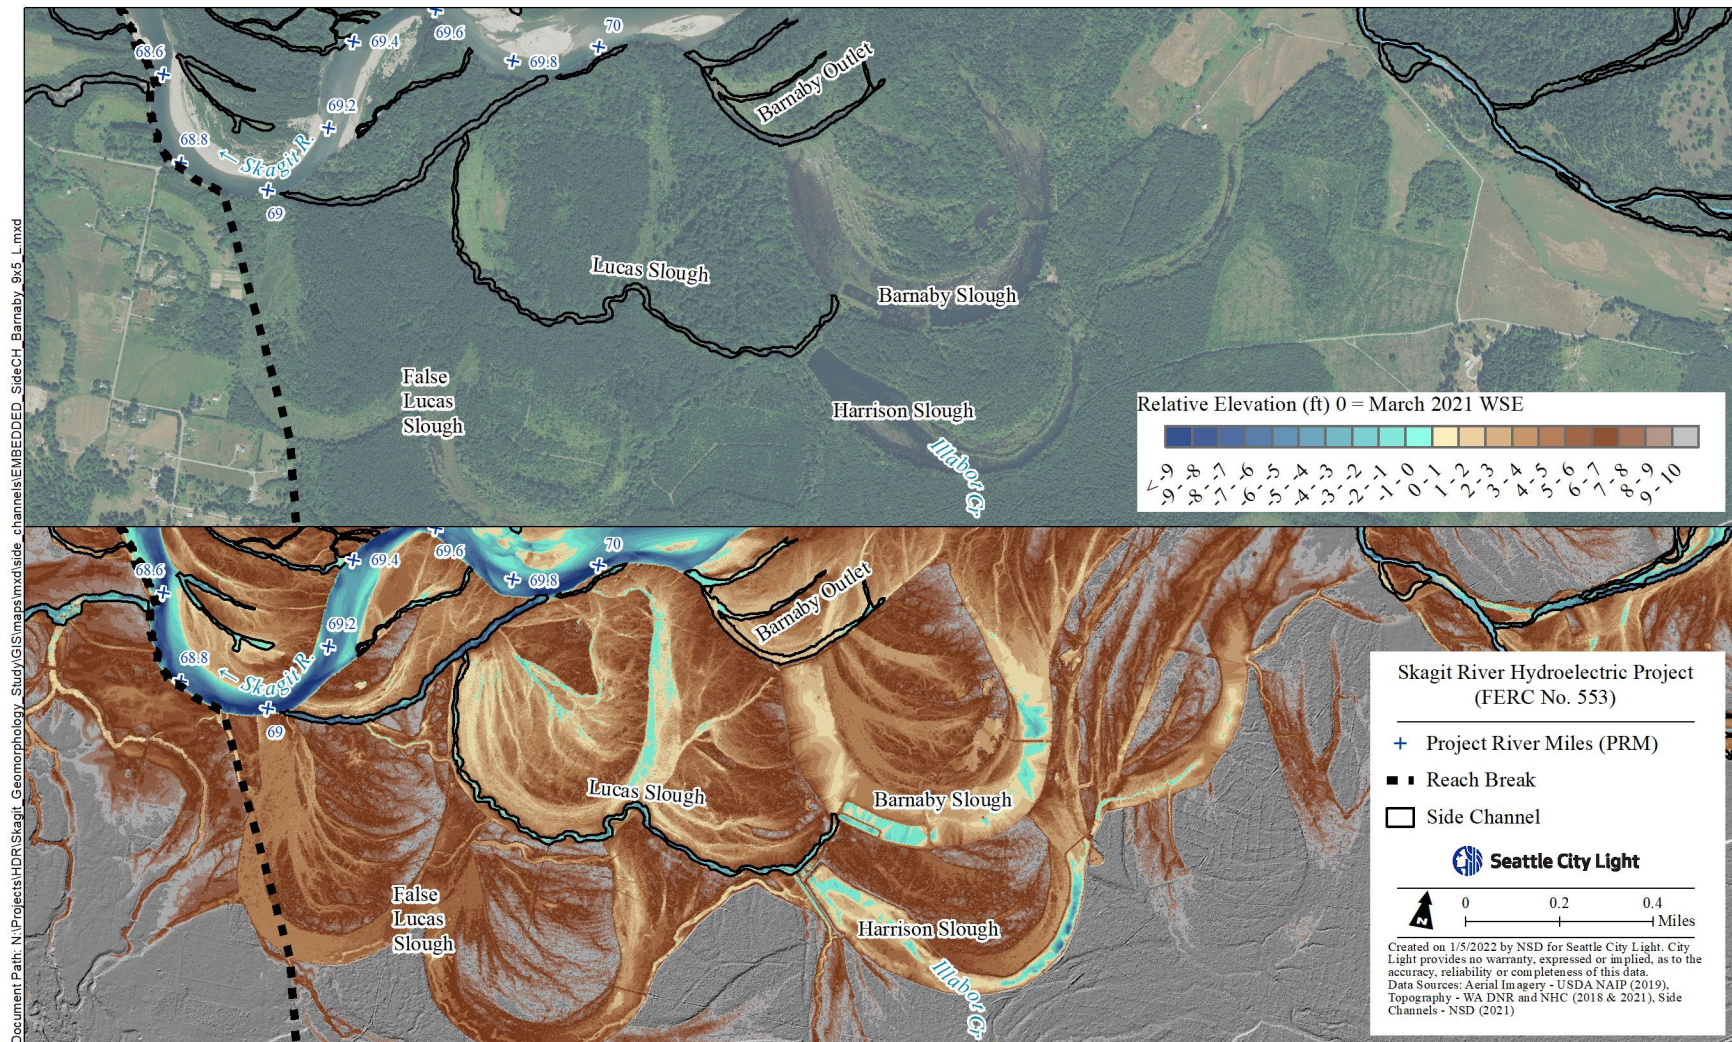
Within the Barnaby area floodplain is another large off channel wetland oxbow—False Lucas Slough (Figure H-8). False Lucas Slough was not visited during August 2021 surveys, but information from aerial imagery, the TR-02 Wetland Assessment, and REM provide some information. False Lucas Slough is more shallow and vegetated than Barnaby Slough or Harrison Slough. False Lucas Slough is not perennially connected to the Skagit River. The March 2021 REM show the outlet several feet higher than the mainstem water surface, and hydraulic modeling performed for the Barnaby Restoration Project show it connected at a 2-year flow via a perched outlet at PRM 69.

Figure H-8. Barnaby area.
