**GE-01 RESERVOIR SHORELINE EROSION STUDY  
INTERIM REPORT**

**SKAGIT RIVER HYDROELECTRIC PROJECT  
FERC NO. 553**

**Seattle City Light**

**March 2022  
Initial Study Report**

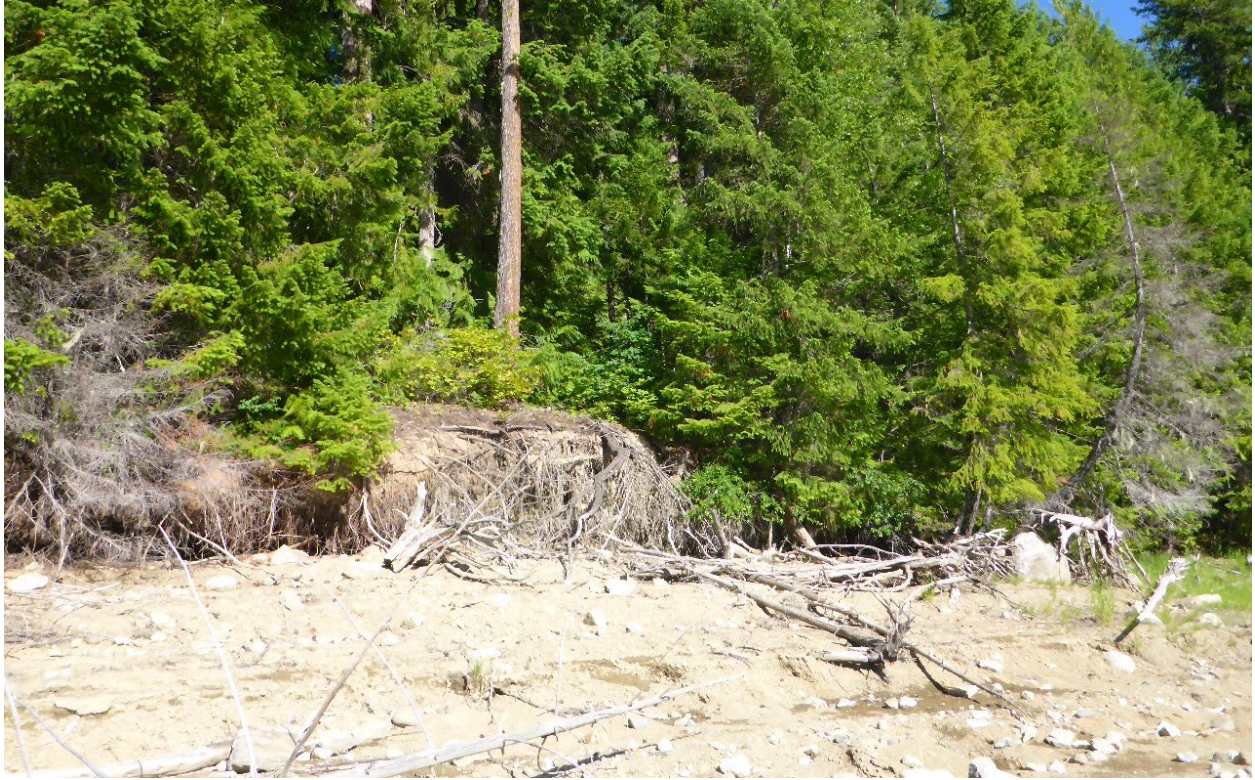
**Figure 5.1-3. Undercut bank erosion observed at Project reservoirs.**

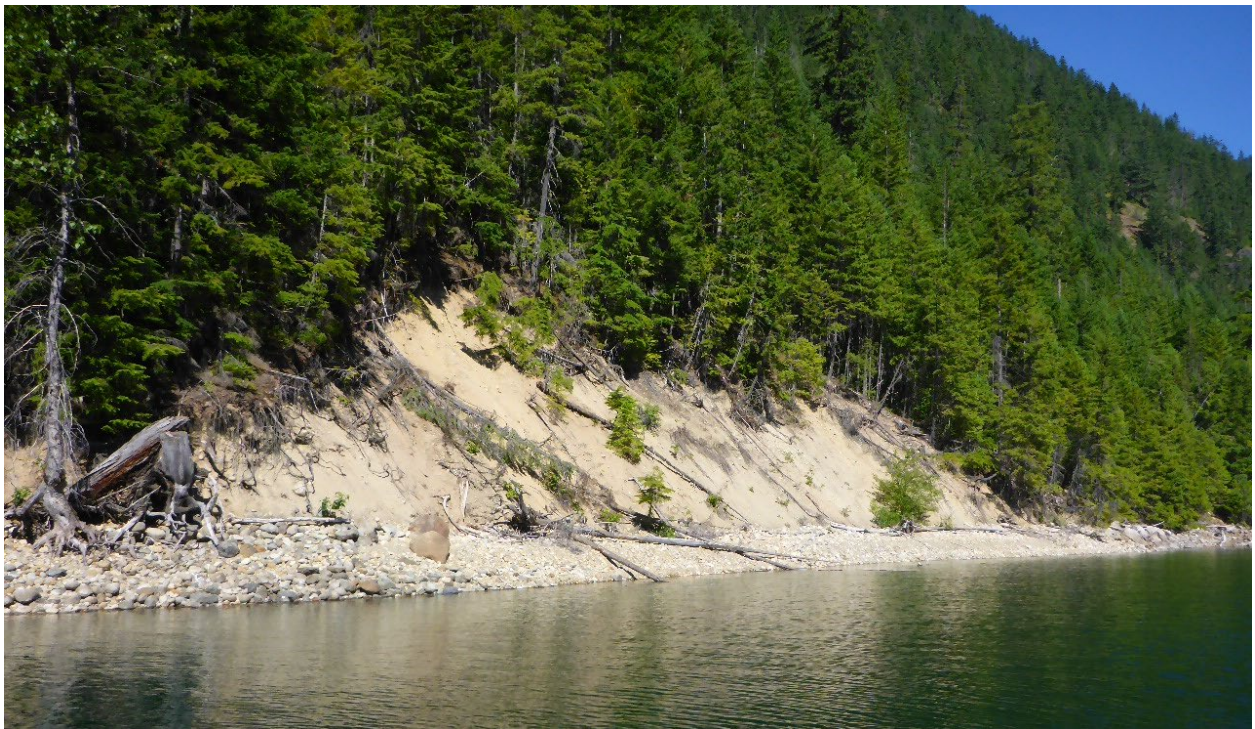
**Figure 5.1-4. Shallow translational slide with raveling surface erosion observed at Project reservoirs.**

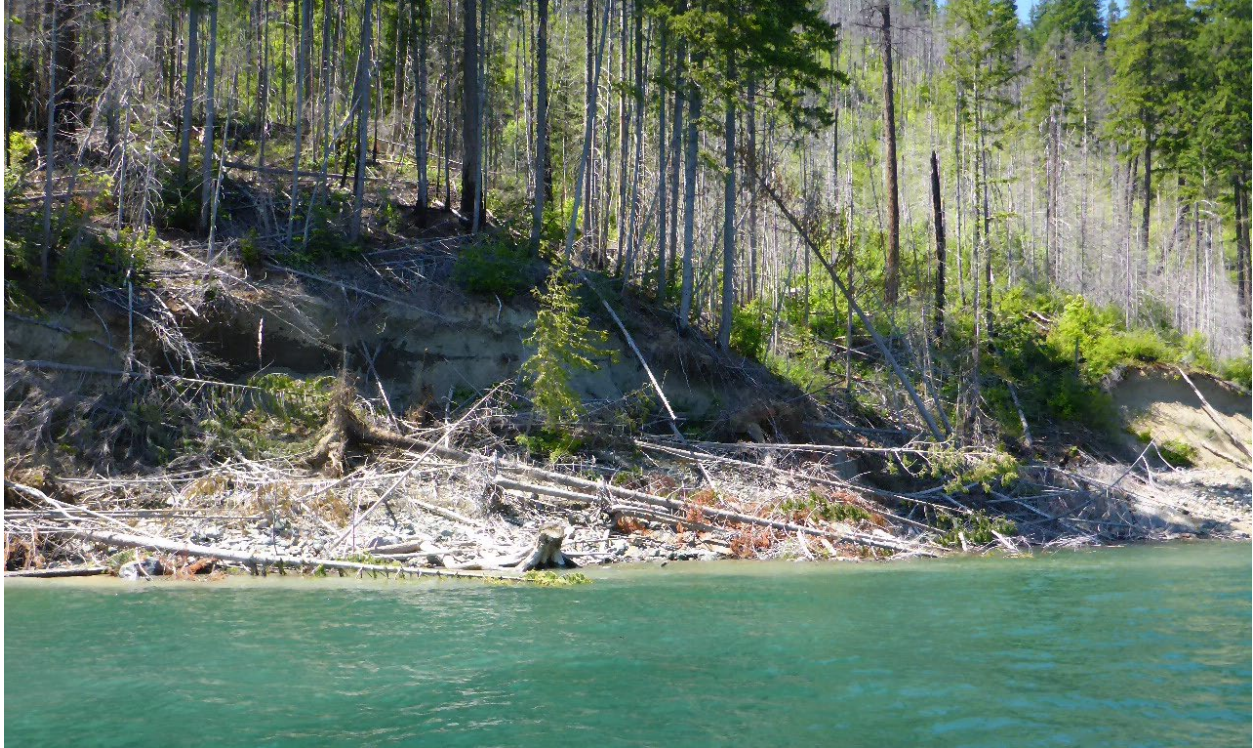
**Figure 5.1-5. Slumping erosion covered by trees that have slid observed at Project reservoirs.**

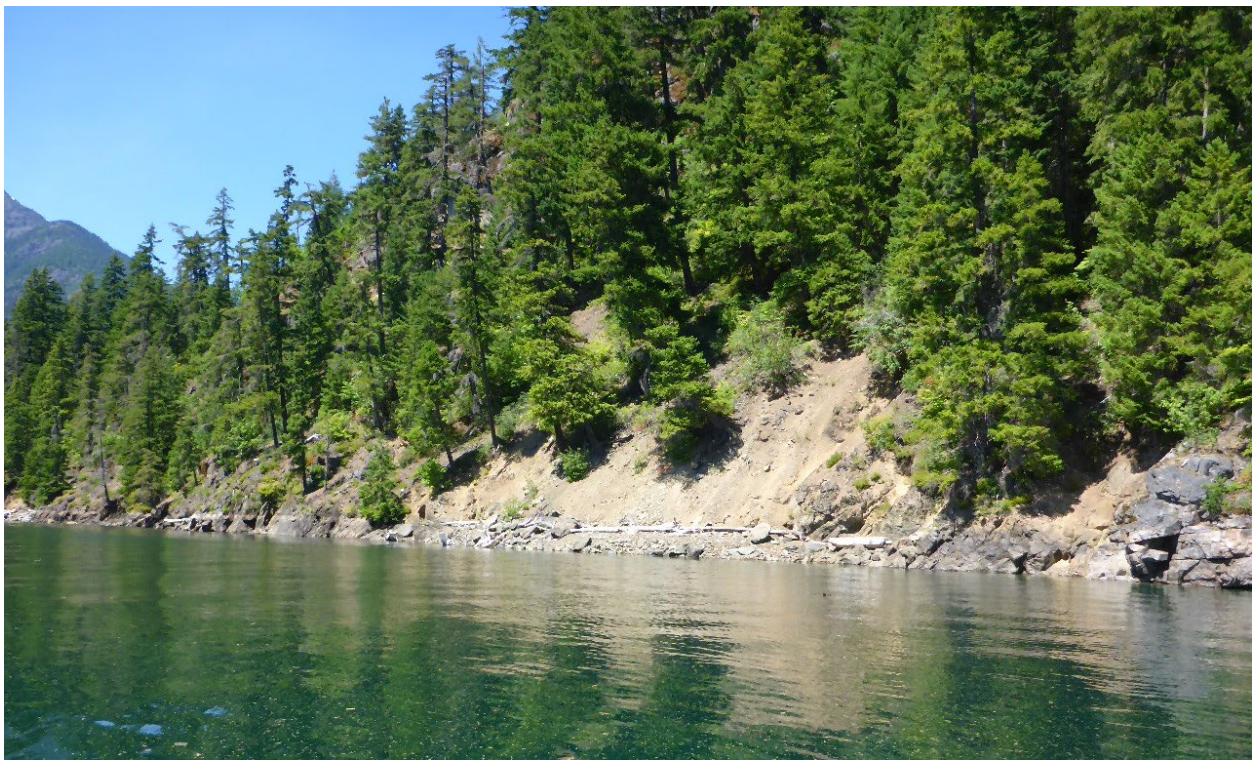
**Figure 5.1-6. Raveling colluvium/till mix erosion observed at Project reservoirs.**

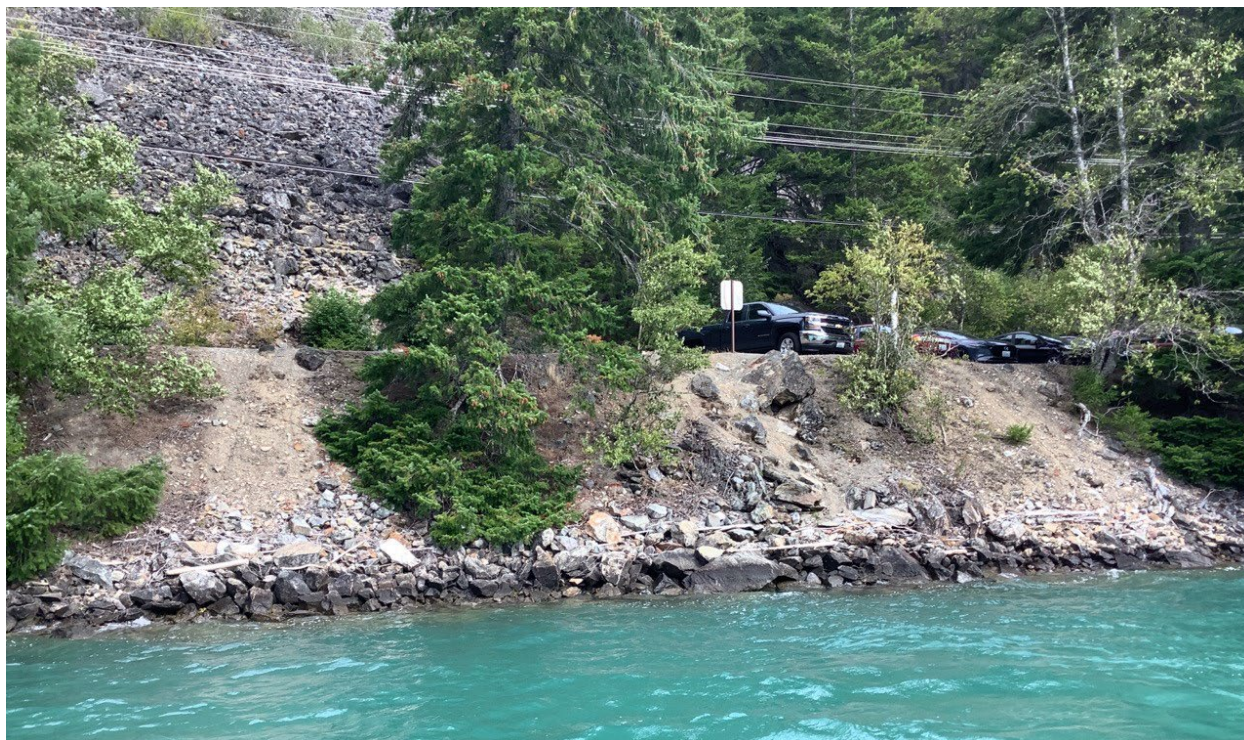
**Figure 5.1-7. Erosion and rilling from road runoff observed at Project reservoirs.**

Concentrated road runoff was observed at several locations in Diablo Lake and Ross Lake where the reservoir shoreline parallels roadways. Road runoff can cause gullyng in unconsolidated deposits.

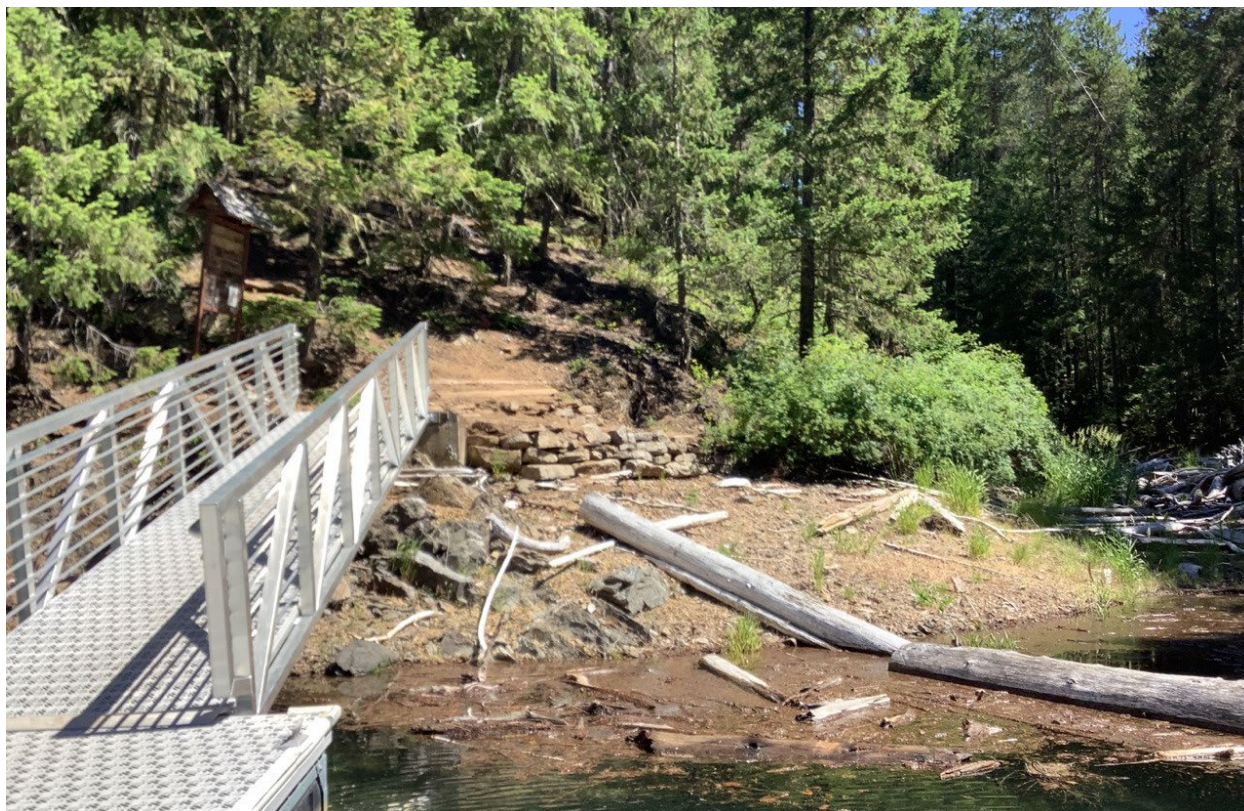
**Figure 5.1-8. Trampling erosion at a camping area observed at Project reservoirs.**

Foot traffic on reservoir banks can cause removal of stabilizing vegetation and disturbance of soil and rocks on the banks as people access the shoreline at campsites, docks, or dispersed use sites.

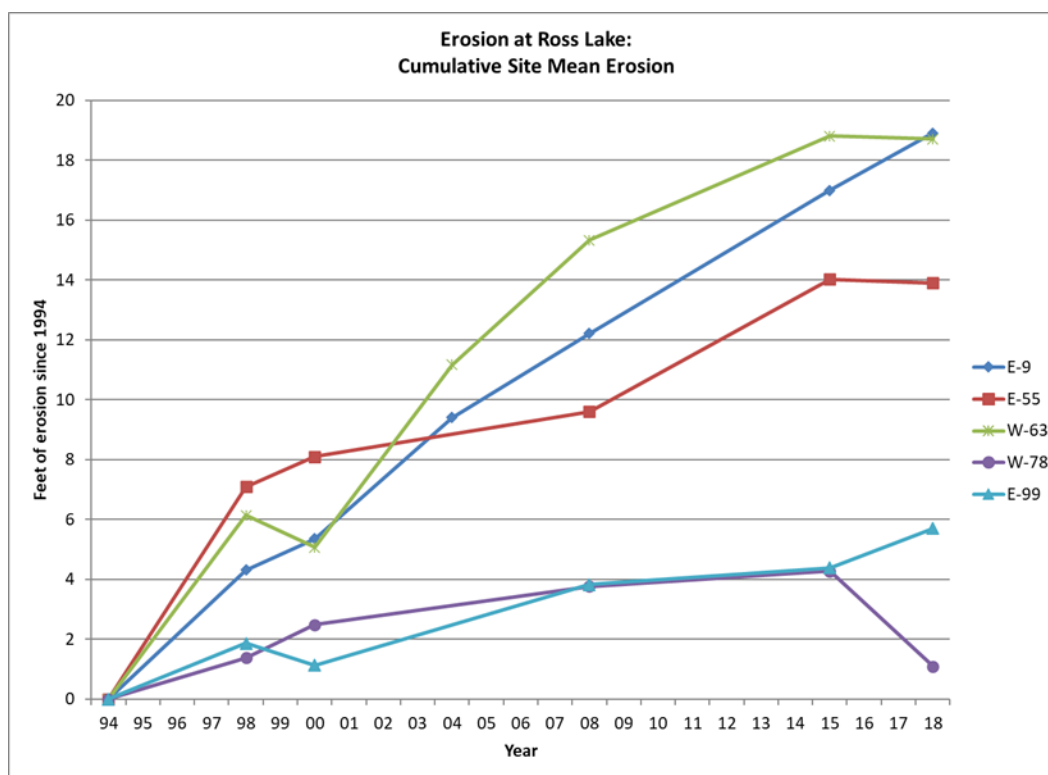
**Figure 5.4-1. Total mean distance of bank recession 1994–2018 at Ross Lake monitoring sites.**

The greatest total amount of bank recession is at three sites with thick, unconsolidated glacial deposits (E9, E55, and W63), where erosion has a mean of 14 to 19 feet of bank retreat in 24 years. Relatively low rates of erosion were observed at the other two sites (sites E99 and W78) with a mean of less than 6 feet of erosion in 24 years. Site E99 is a rocky slope with colluvial soils, while site W78 has a shoreline composed of consolidated glacial till.

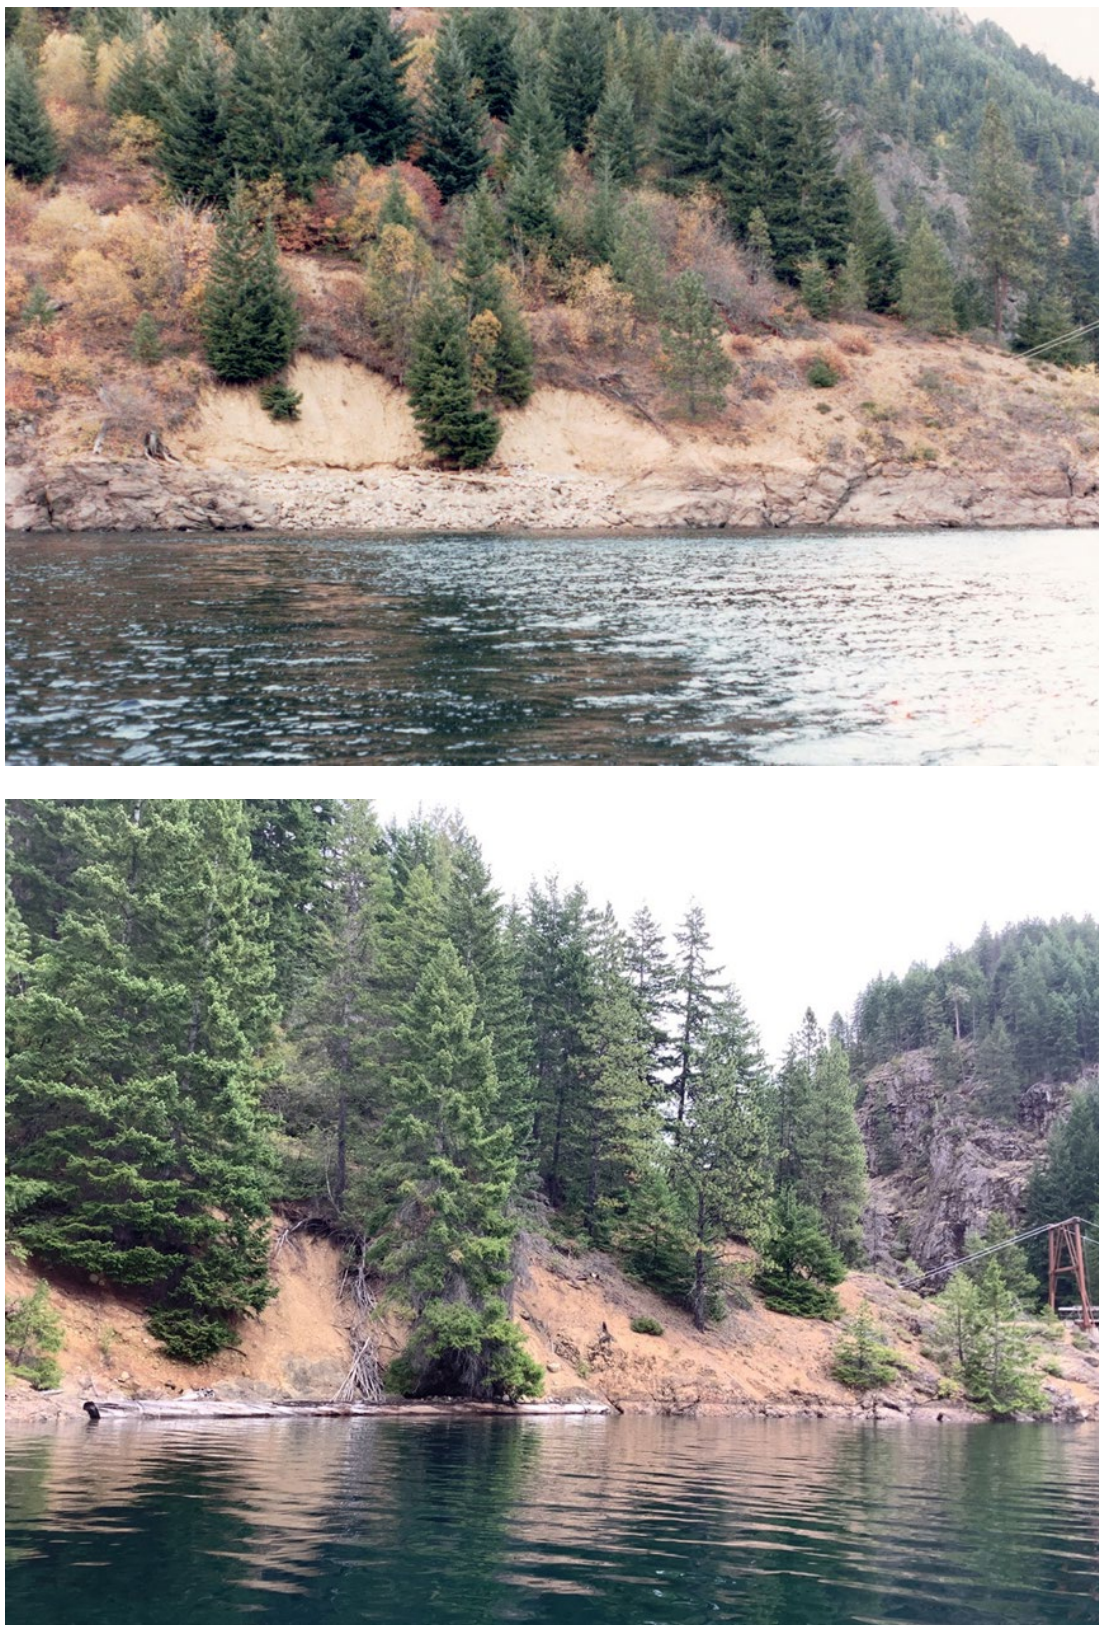
**Figure 5.4-2. Ross Lake Site E-116 in 1989 (top photo) and 2021 (bottom photo).**

Comparison of 1990 and 2021 field photographs of reservoir erosion locations yielded only one site where a definitive comparison could be made (Figure 5.4-2) since few of the 1990 photographs were labeled with site number. Comparison of Ross Lake site E-116, just north of Lightning Creek, showed evidence of a few feet of bank retreat based on root exposure. There did not appear to be any loss of trees at this site; trees in the 1990 photograph can be seen as larger trees on the 2021 photograph.
