**Sand Point
Potential Partnership Study**

**Building Cost
Estimates**

September, 2003

**Building No. 12
Steam Plant**

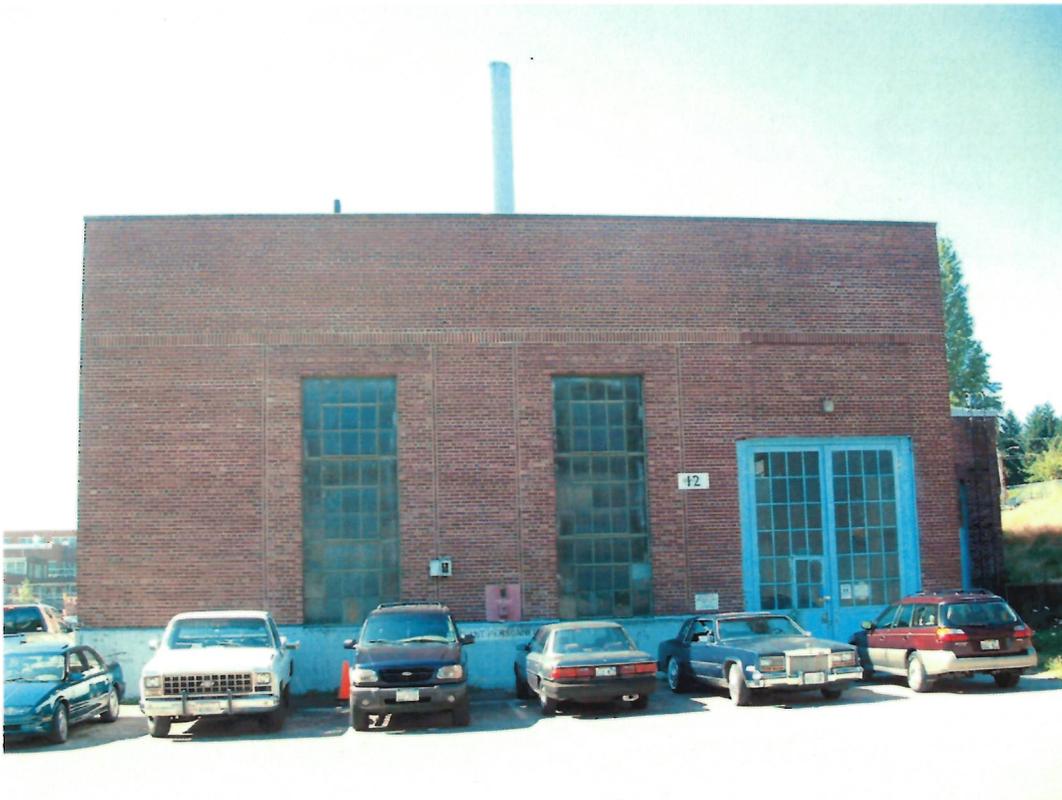
The exterior of the building is in poor shape with cracks in the brick at the sough elevation, and the doors and windows in serious need of repair. The roofing and flashing are also in a deteriorated condition and need replacement.

The steam was distributed to the base through a series of utilidors. The pit leading into this system, appears to be flooded and will need to be cleaned out, and the utilidor opening sealed.

The interior finish of much of the building was simply a coat of paint over the steel or brick. This paint is peeling. Where the roof deck paint has peeled, there are signs of corrosion of the metal.

- n/a
 - Restrooms
 - Add men and women, 1 stall each.
 - Signage
 - Allowance for code signage only
- **Exterior Envelope**
 - Façade
 - Masonry
 - Clean and point

- Repair S. wall
 - Steel
 - Replace windows and doors.

- Repair and renovate exterior roof access ladder
 - Wood
 - Repair or replace main swinging entry door system.
 - Exterior walls
 - Furr and insulate
 - Cleaning and Painting
 - Windows and Frames
 - Doors and Frames
 - Roof top exhaust vents
 - Roof
 - Roofing and Flashing – complete replacement
 - Rigid insulation with roof installation
 - Exterior walls
 - Furr and insulate all walls
- Miscellaneous
 - Remove protruding anchor bolts from previous tank farm.
