SEATTLE PUBLIC LIBRARIES UNIVERSITY BRANCH

TREE REMOVAL

APPLICATION FOR CERTIFICATE OF APPROVAL

**Arborist Report
DRAFT**

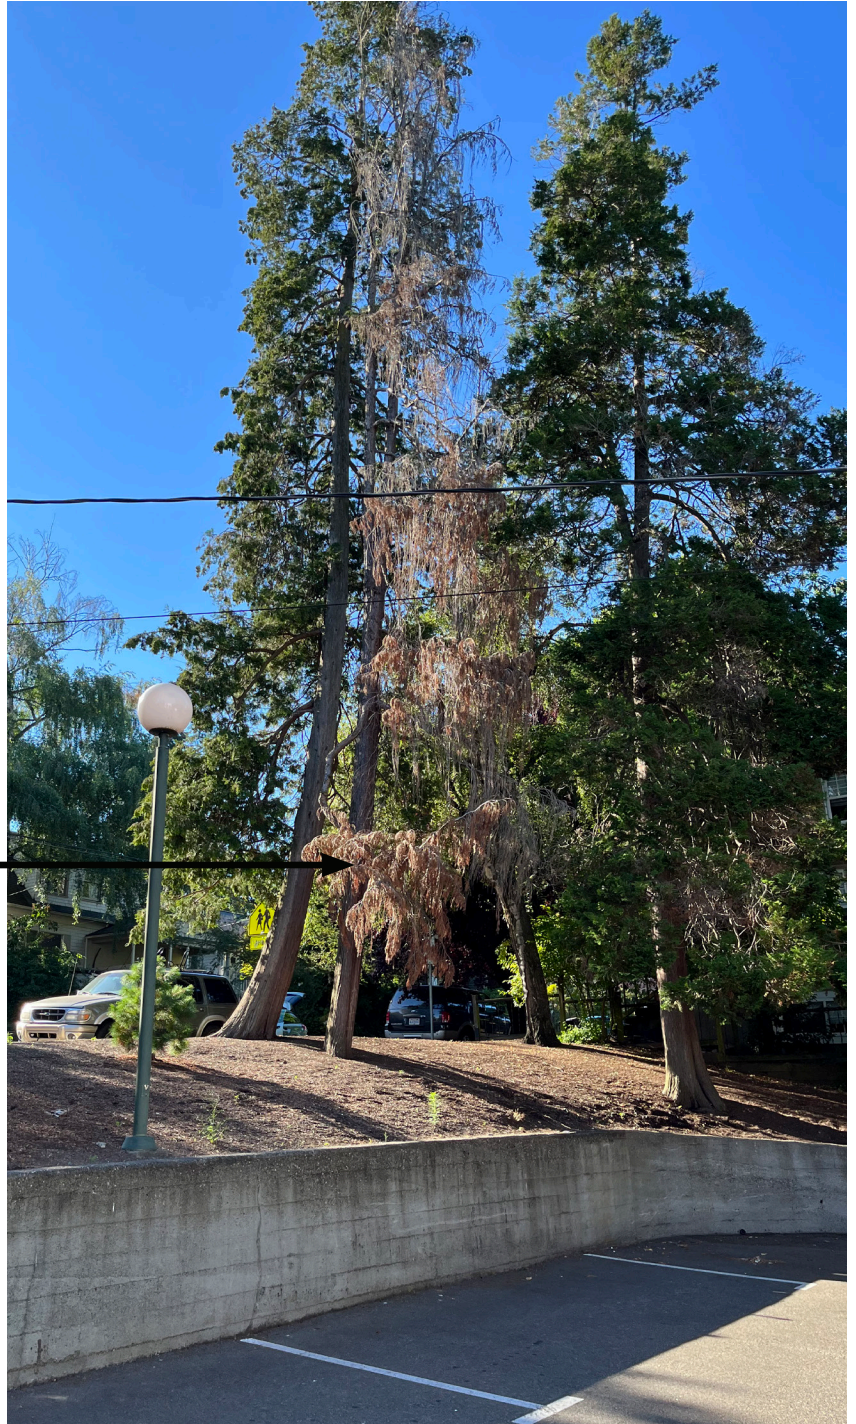
One large Lawson Cypress tree west of the rear parking lot is dead and poses a moderate threat to adjacent trees, patrons, and Library property. The dead tree has been evaluated by a certified arborist who noted several deficiencies. The Arborist recommends removal of the dying tree. A copy of the arborist's findings and recommendations is attached to this application

Existing tree *Chamaecyparis Lawsoniana* "Lawson Cypress". Proposal includes removal of this tree in 2022. See attached arborist report for site photos and condition assessment.

There is a dead Lawson cypress immediately adjacent to tree 269. This tree should be removed or reduced to a 20-foot wildlife snag before it becomes unstable due to decay.

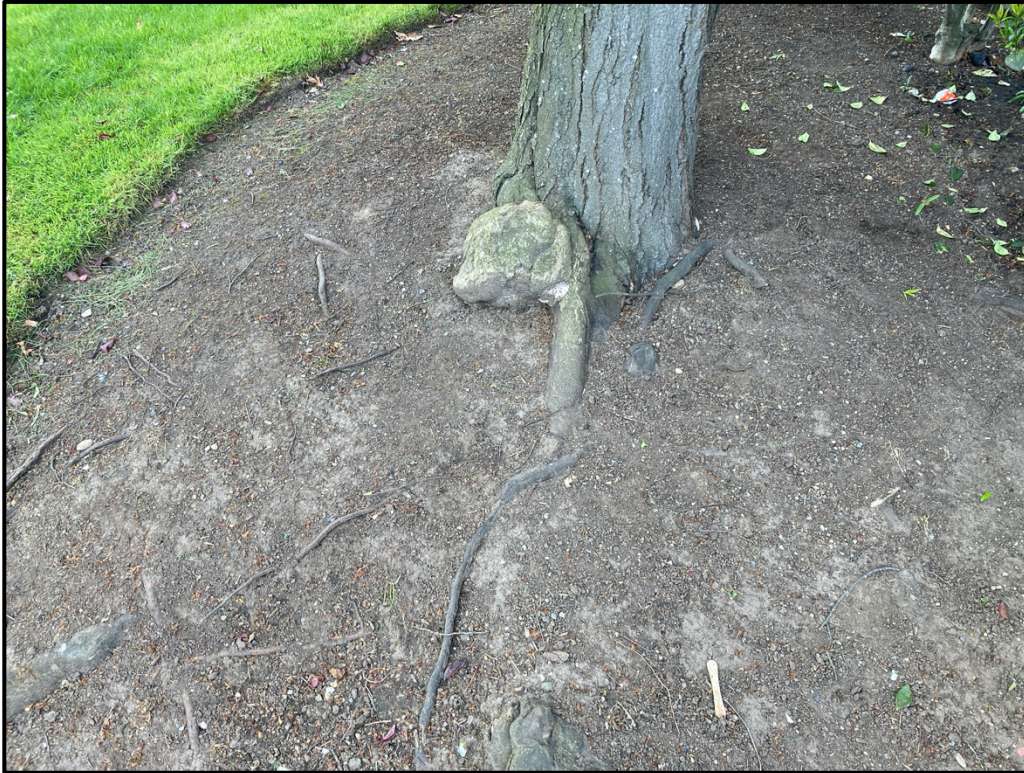
The soil across the site appears somewhat stripped from the management practice of consistently removing organic debris from the landscape using rakes and leaf blowers. In a few instances this has exposed surface roots (Photo 1). The addition of woodchip mulch across the root zones of these trees would improve growing conditions.

Photo 1. Exposed surface roots at the base of tree 278.

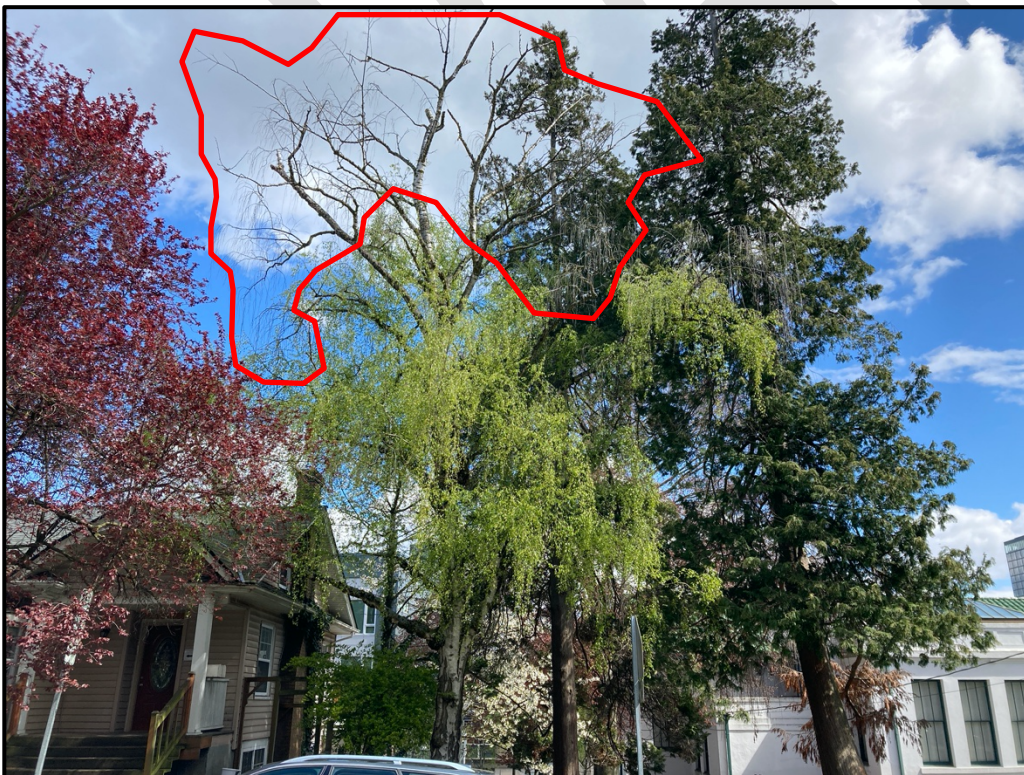
Trees 267, 277, and 282 are European white birches, in various stages of decline due to a bronze birch borer (*Agrilus anxius*) infestation. Bronze birch borer (BBB) is a common pest that is affecting birches citywide. BBB generally causes the trees to die back slowly from the top down. There are insecticide treatments available to prevent further infestation, but they must be combined with other plant healthcare strategies such as mulching and providing supplemental irrigation. Out of these three trees, tree 267 is by far the worst affected and is very unlikely to recover (Photo 2).

Photo 2. Tree 267, a birch with significant dieback from Bronze Birch Borer (Outlined in red).

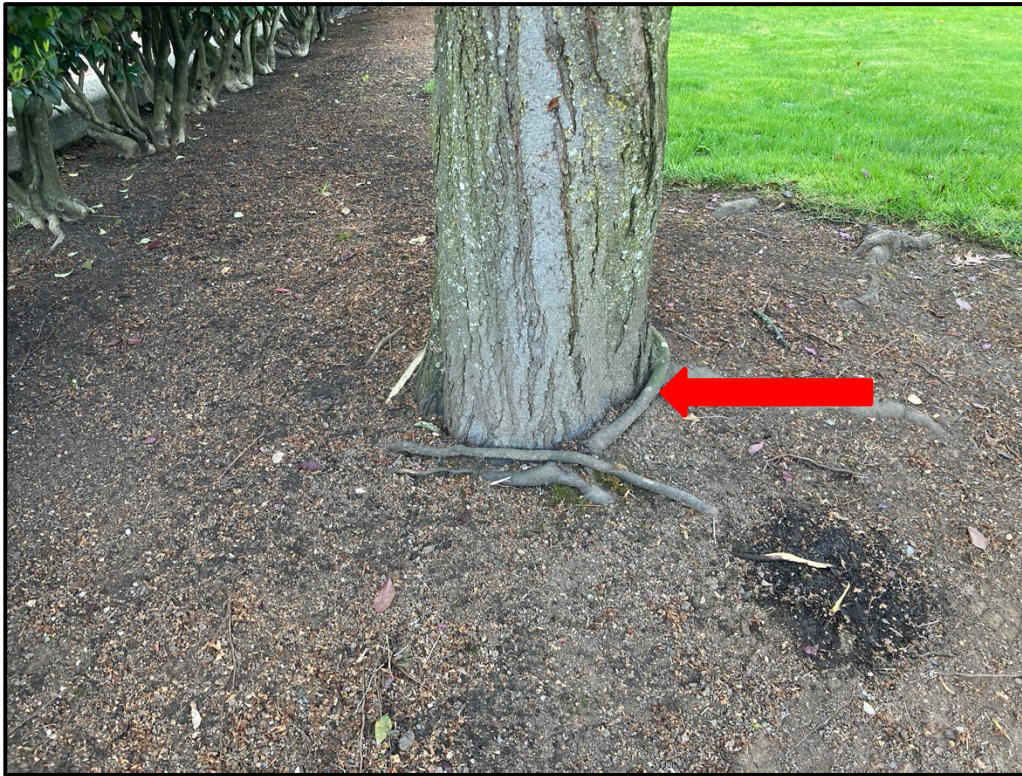
Tree 280 is a flowering plum with a prominent girdling root (Photo 3). This root should be cut using a hammer and chisel to prevent future issues. If left unchecked, this root can lead to the eventual decline of the tree.

Photo 3. A prominent girdling root at the base of tree 280 (Indicated by red arrow).

- Site planning around exceptional trees must follow the requirements outlined in SMC 25.11.050.¹
- Add the locations and driplines of all significant trees in relation to proposed structures to all pertinent plan sets using the data in the attached Table of Trees.
- All pruning should be conducted by an ISA certified arborist and following ANSI A300 specifications.²
- Obtain permits from the Seattle Department of Transportation for the removal or pruning of any street trees.
- Add a 4-inch layer of woodchip mulch under the driplines of retained trees to improve growing conditions.
- Remove or reduce the dead tree adjacent to tree 269.
- Consider treatment of trees 277 and 282 for bronze birch borer.
- Use a chisel to sever the prominent girdling root at the base of tree 280.

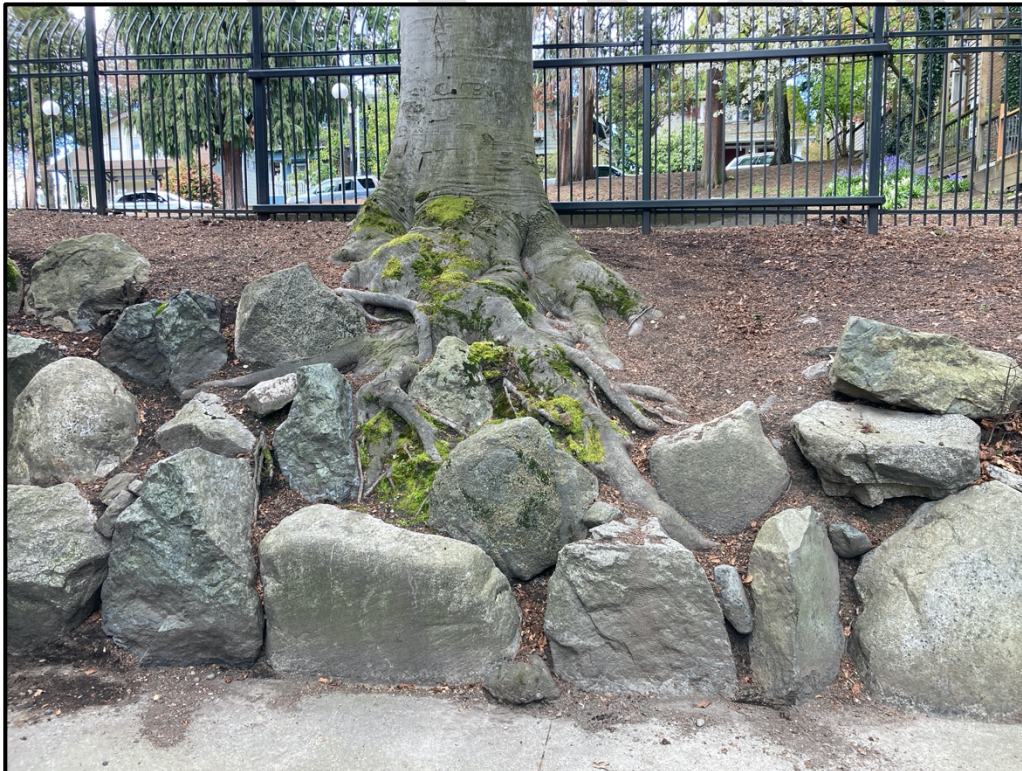
Tree 275 is an exceptional copper beech located on the north side of the library building. The roots of this tree are intertwined in the adjacent rockery (Photo 4). The rockery must remain in place if this tree is to be retained.

Photo 4. Roots from tree 283 that have become intertwined in the existing rockery
