Gorge 2nd Tunnel

Appendix F: G2T Portal Evaluation Technical Memorandum

PROJECT MEMORANDUM

To: John Owen, Seattle City Light
cc: Gregg Davidson, Jacobs Associates
From: Mark Havekost and Sue Bednarz, Jacobs Associates
Job No.: 4087.1
Date: April 3, 2009
Subject: Gorge 2nd Tunnel: Portal Alternative Evaluation

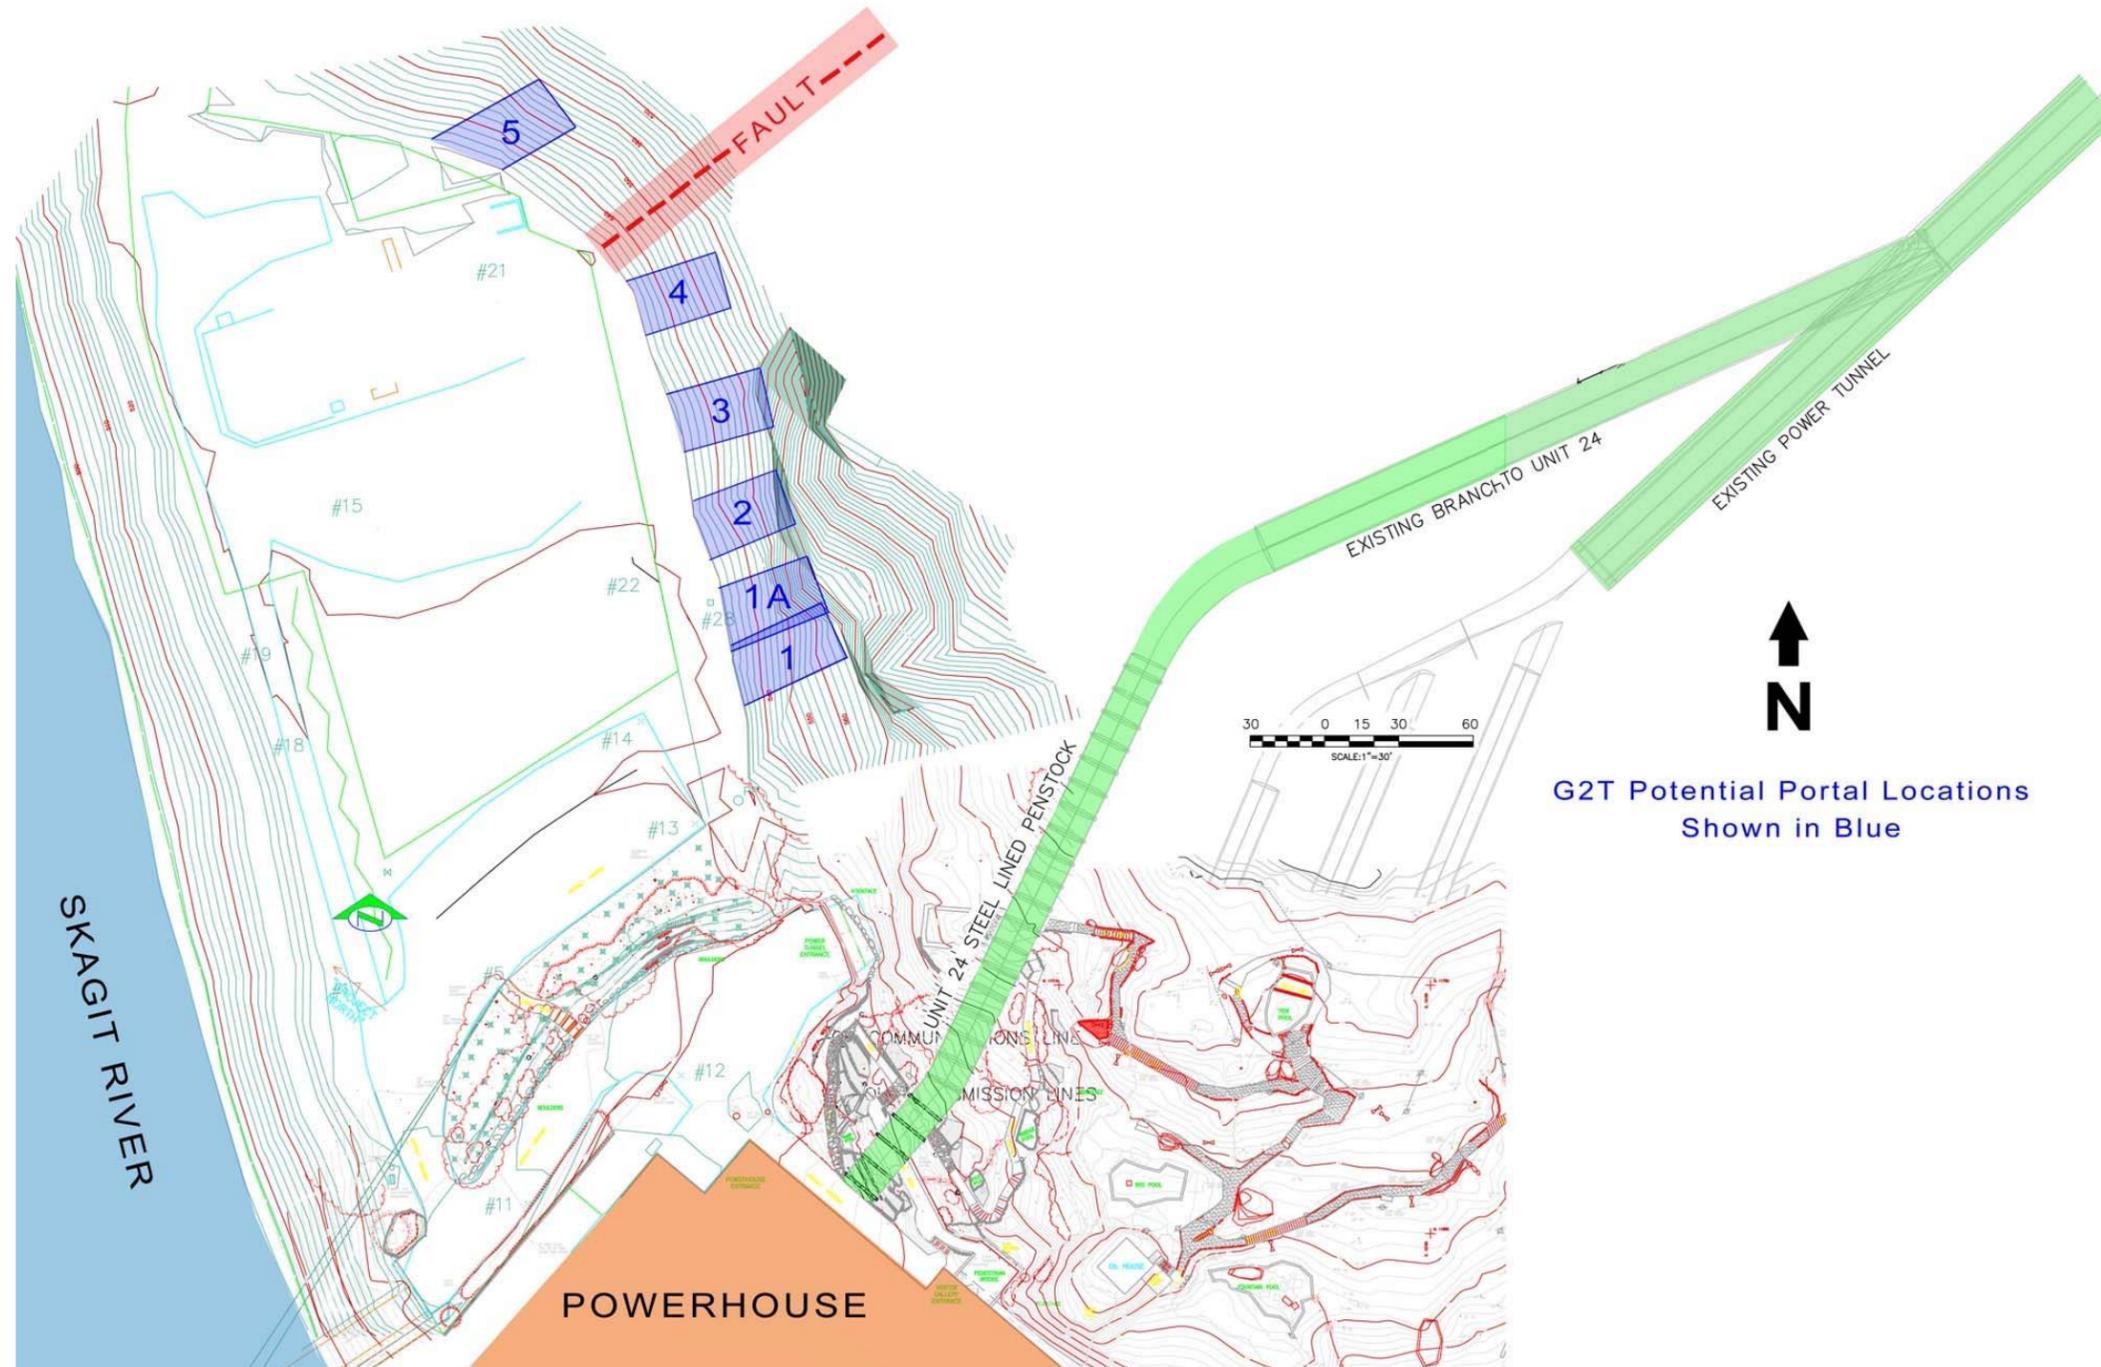
Figure 1. G2T potential portal locations

On March 10, 2009, a geologic reconnaissance was conducted across the portal area by geologists from Jacobs Associates and Aspect Consulting to identify potential portal locations. Six potential portal alternatives were identified (1, 1A, 2, 3, 4, 5) between the existing tunnel adit and the north end of the Skagit River (on the north end of the field). Figure 1 shows the location of these alternative portal sites. At each location, rock slope stability was evaluated, potentially unstable blocks were identified, and site impacts such as tree removal were assessed.

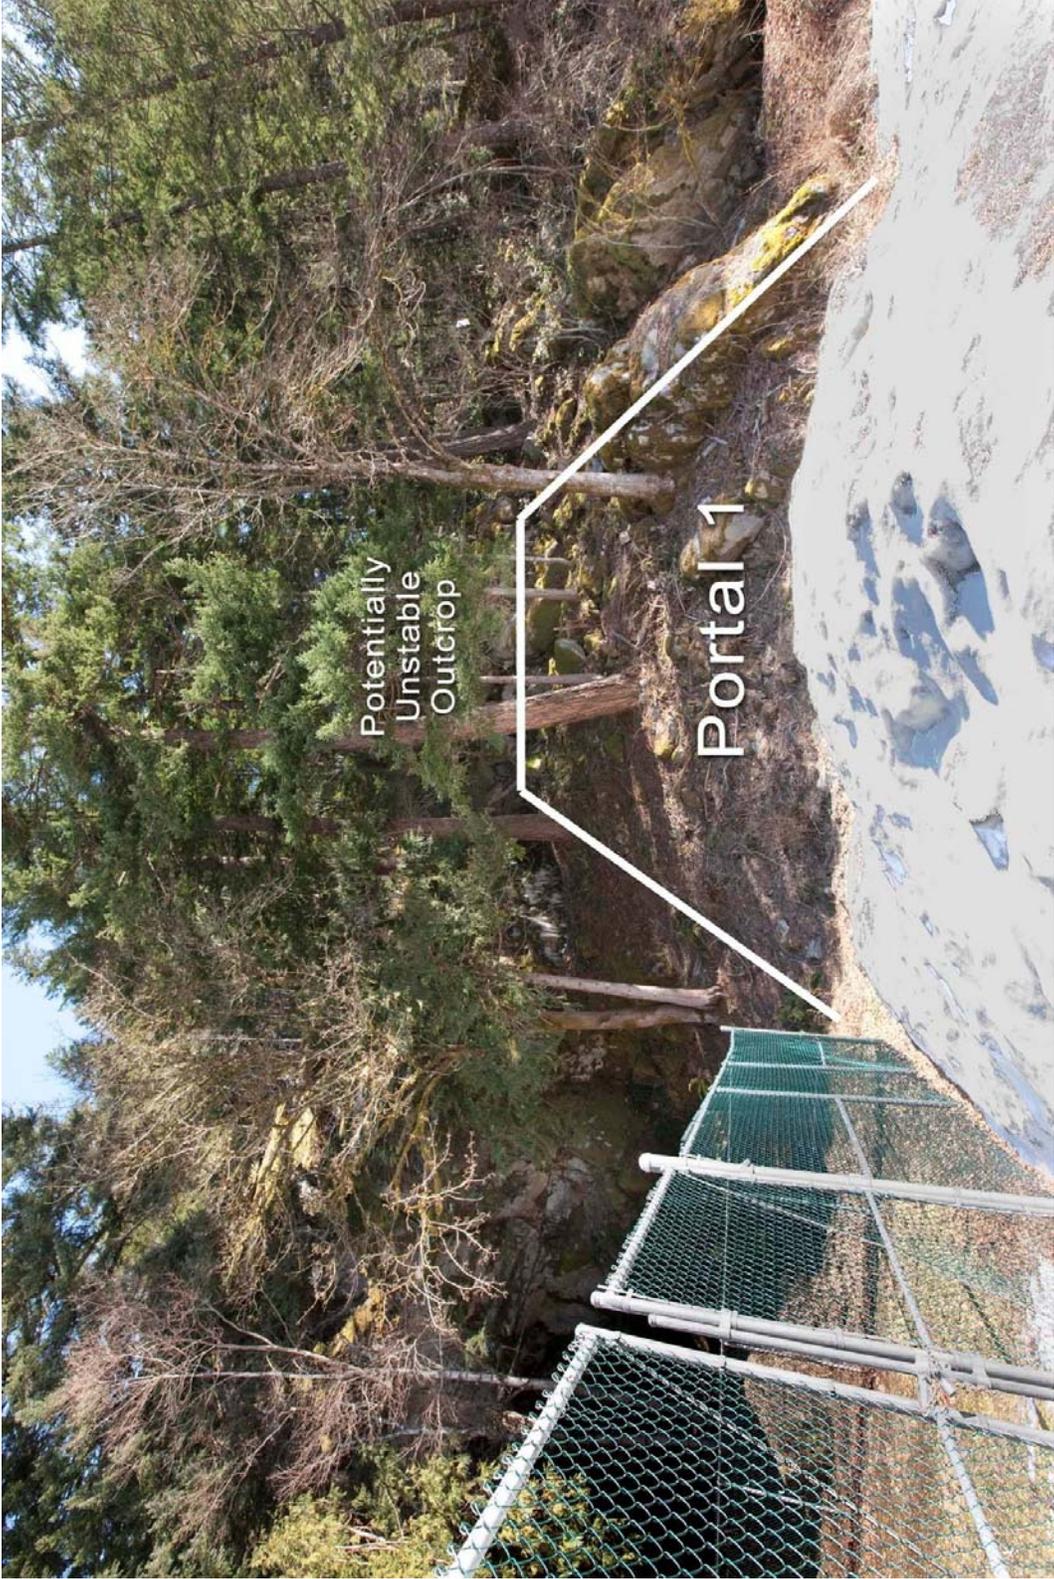
Figure 2. Portal 1 location

Portal 1 is located in the slope directly east of the existing Gorge Powerhouse upper parking lot (Figures 1 and 2).

The critical feature of Portal 1 is the extremely large (30-ft high and 50-ft wide) unstable outcrop block that is located directly upslope of the portal. The outcrop has a 30-degree sloping overhang that ranges from 10 to 20 feet in length. Figures 3 and 4 include photographs of this outcrop block. Although the block is still connected to the underlying rock, the significant downslope overhang makes this block susceptible to sliding or rolling downhill into the portal. Vibrations created during the excavation of the starter tunnel could cause this block to fail.

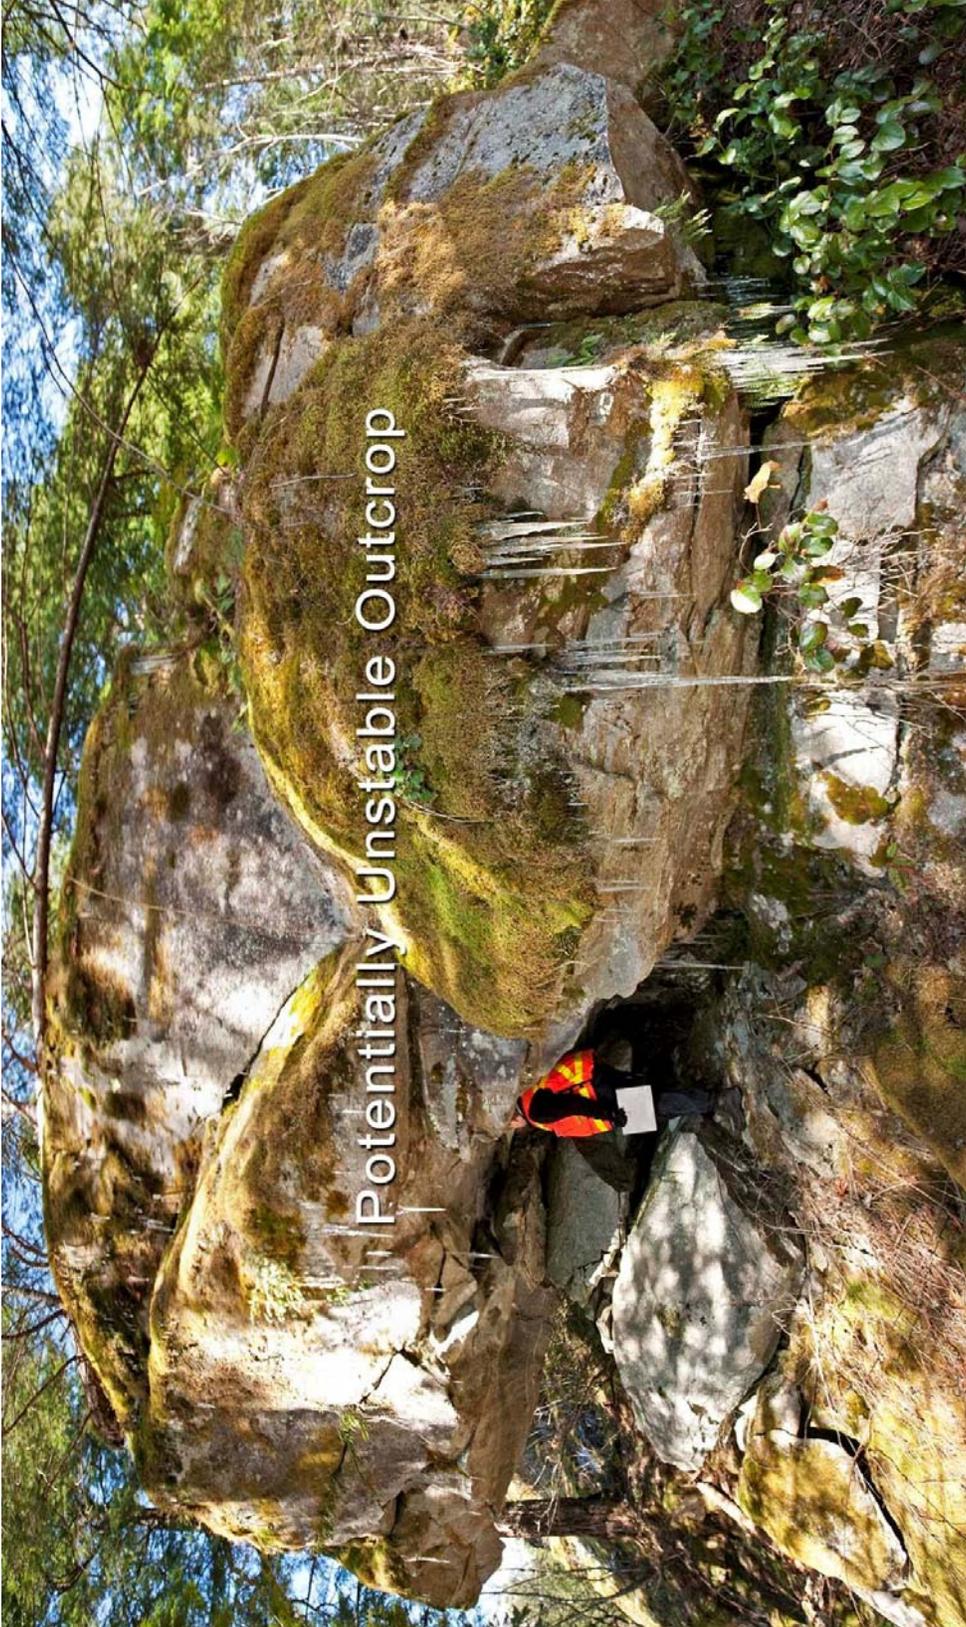
Large, potentially unstable blocks, some with a significant overhang, were also observed above Portals 1 and 1A and the Gorge Powerhouse Extension. The blocks above the Gorge Powerhouse Extension have been stabilized with large steel cables; however, the large blocks above the proposed G2T portal area have not been stabilized. It is speculated that undercutting of these large blocks was formed by freeze-thaw action.

Figure 3. Overhanging potentially unstable rock outcrop above Portal 1

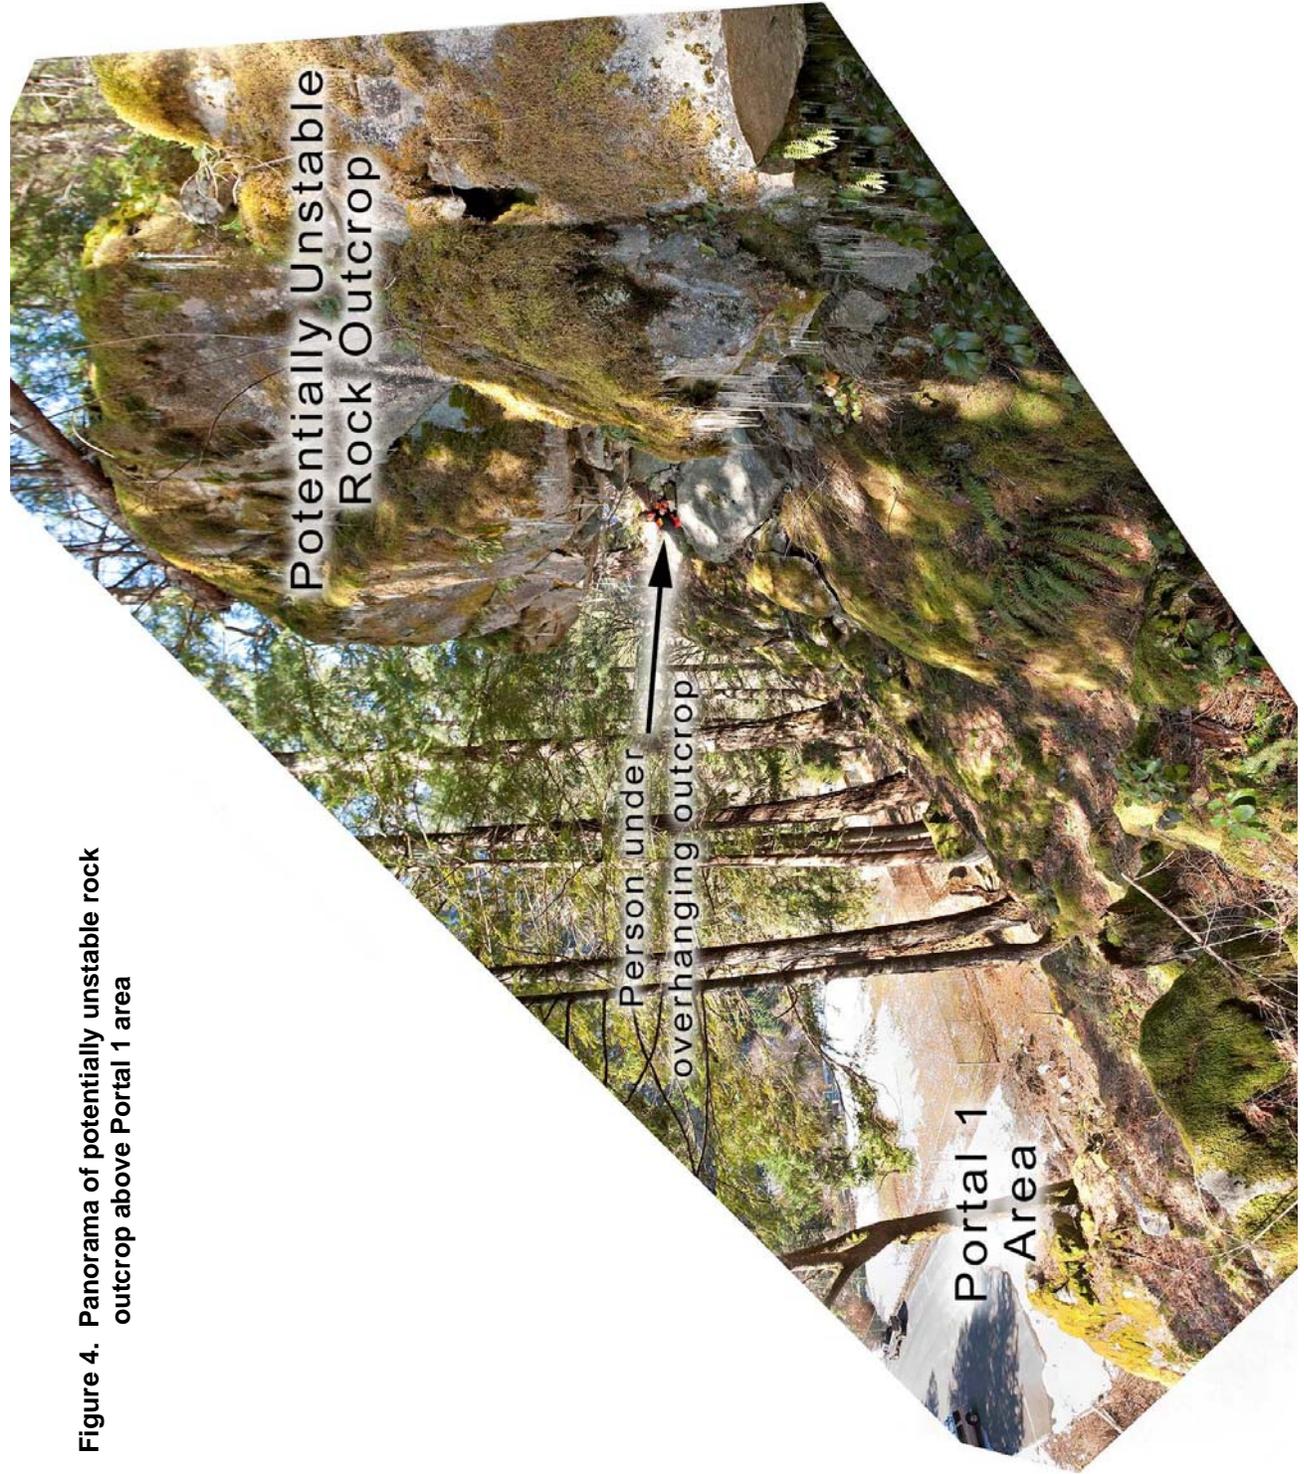
Figure 4. Panorama of potentially unstable rock outcrop above Portal 1 area

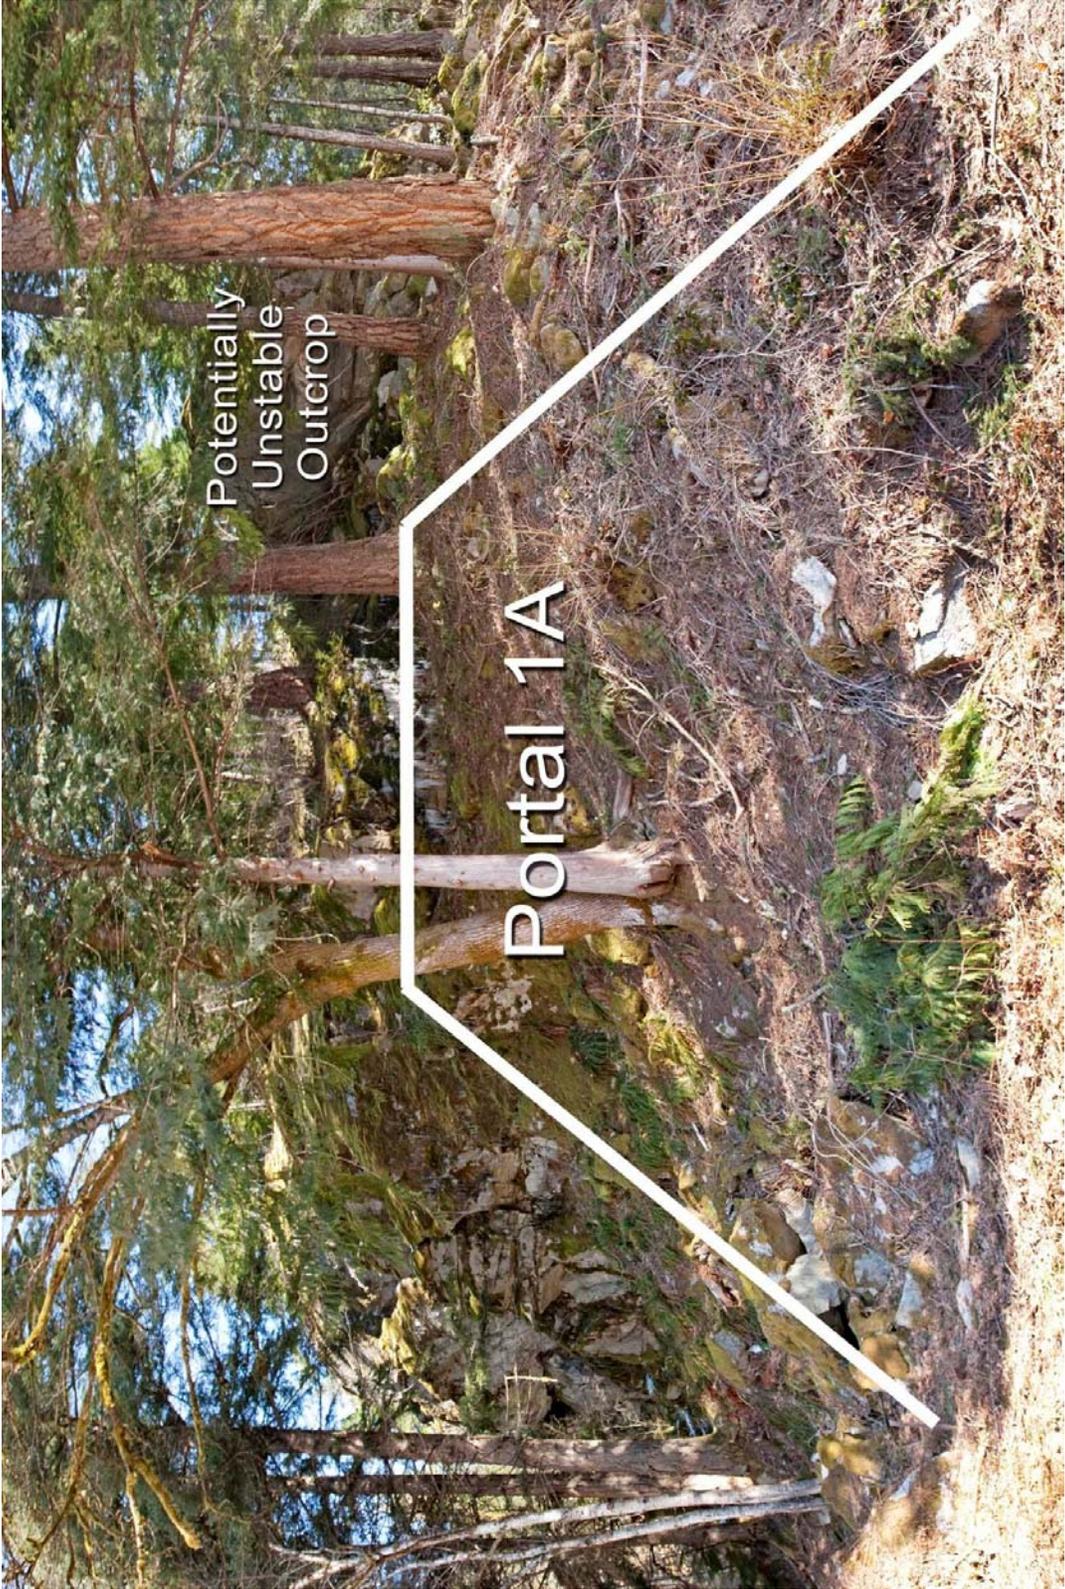
Figure 5. Portal 1A location

Portal 1A, which partially overlaps Portal 1 (Figures 1 and 5), will require less tree removal during construction than Portal 1. Portal 1A is still located within the trajectory of the extremely large, potentially unstable block discussed in Section 3.1.

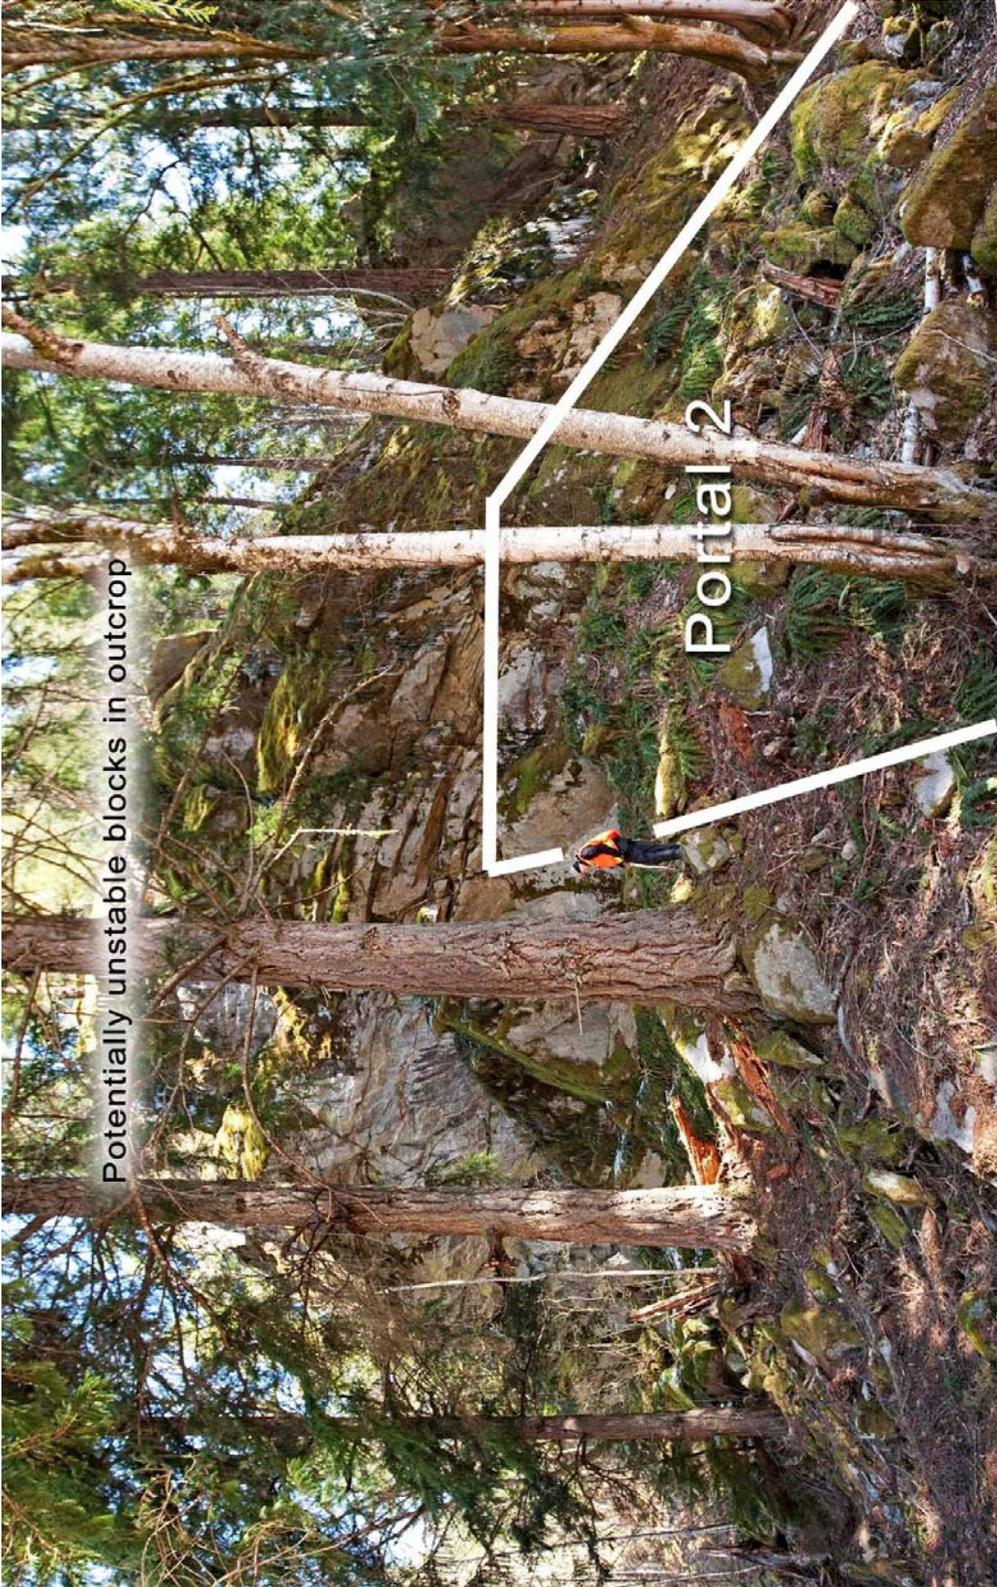
Figure 6. Portal 2 location

Portal 2 is located in the slope north of Portal 1A, beneath a large, near-vertical rock outcrop (Figures 1 and 6).

Relatively closely spaced jointing within the outcrop forms moderately sized blocks that are generally less than 8 ft in maximum length. The majority of these blocks could be stabilized using rock bolts and welded wire mesh. One approximately 8 x 10 ft block that appears to be resting on the sloped upper surface of the outcrop would either require stabilization or removal.

Rockfall mitigation for the outcrop in the slope above Portal 2, while still required, is significantly less than any mitigation that would be required to stabilize blocks above Portals 1, 1A, and 3. Since Portal 2 is located significantly south and to the side of the portal area fault, sheared rock is not expected within the portal excavation.

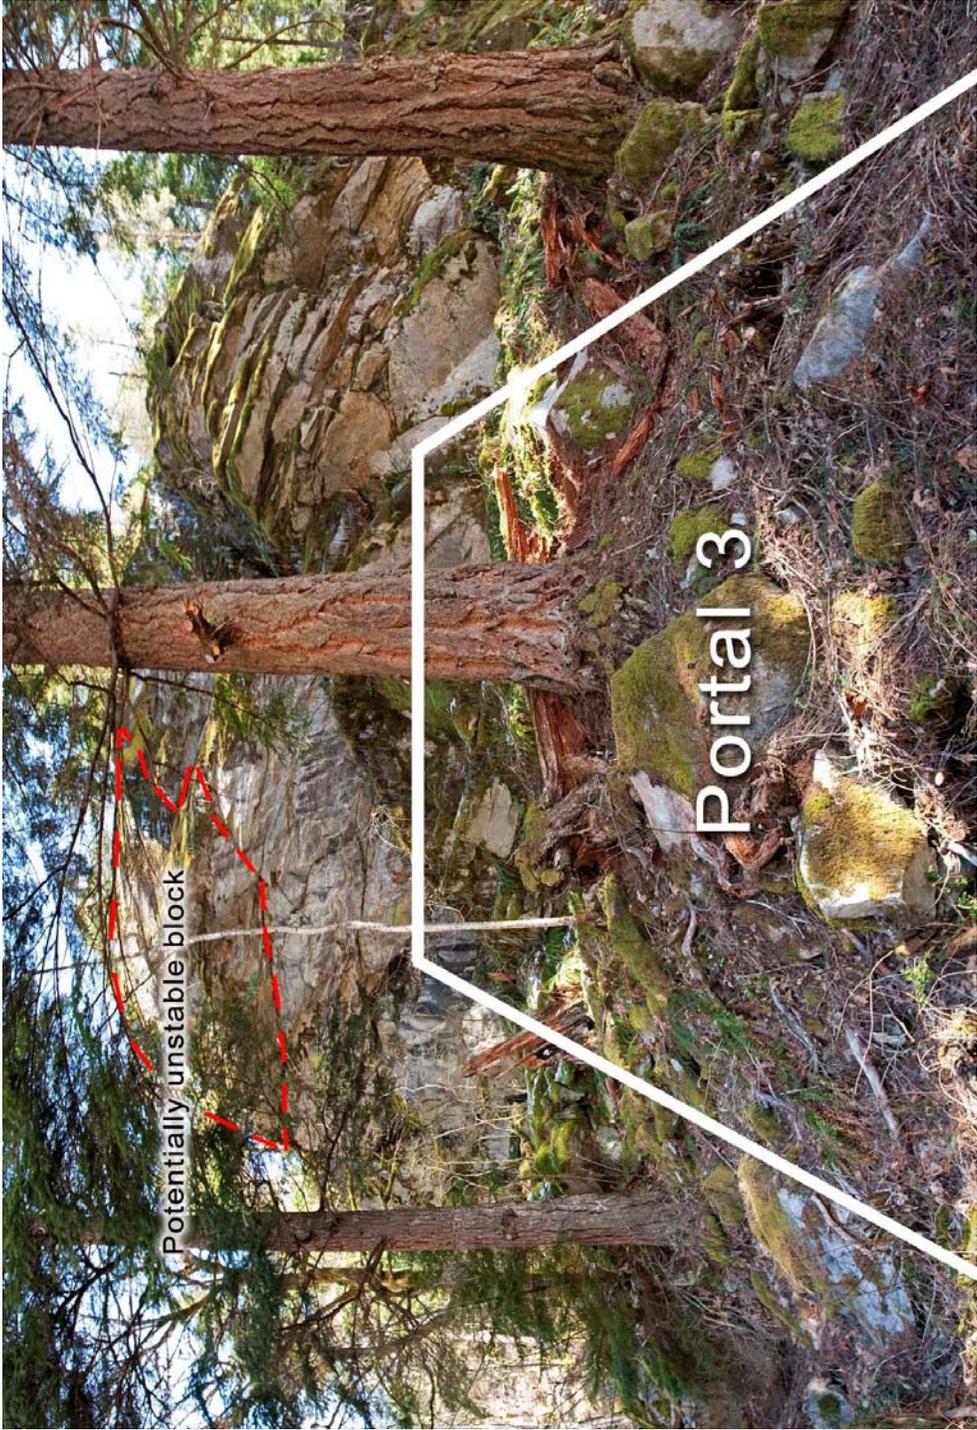
Figure 7. Portal 3 location

Portal 3 is located beneath a nearly 120-ft-high rock outcrop to the north of Portal 2 (Figures 1 and 7).

Although the joint spacing is generally greater than in the outcrop above Portal 2, one large block (15 ft high x 25 ft wide) is exposed in the upper portion of the outcrop above the portal. Open joints that surround this block indicate that it is potentially unstable and would require stabilization or removal prior to portal construction in this area.

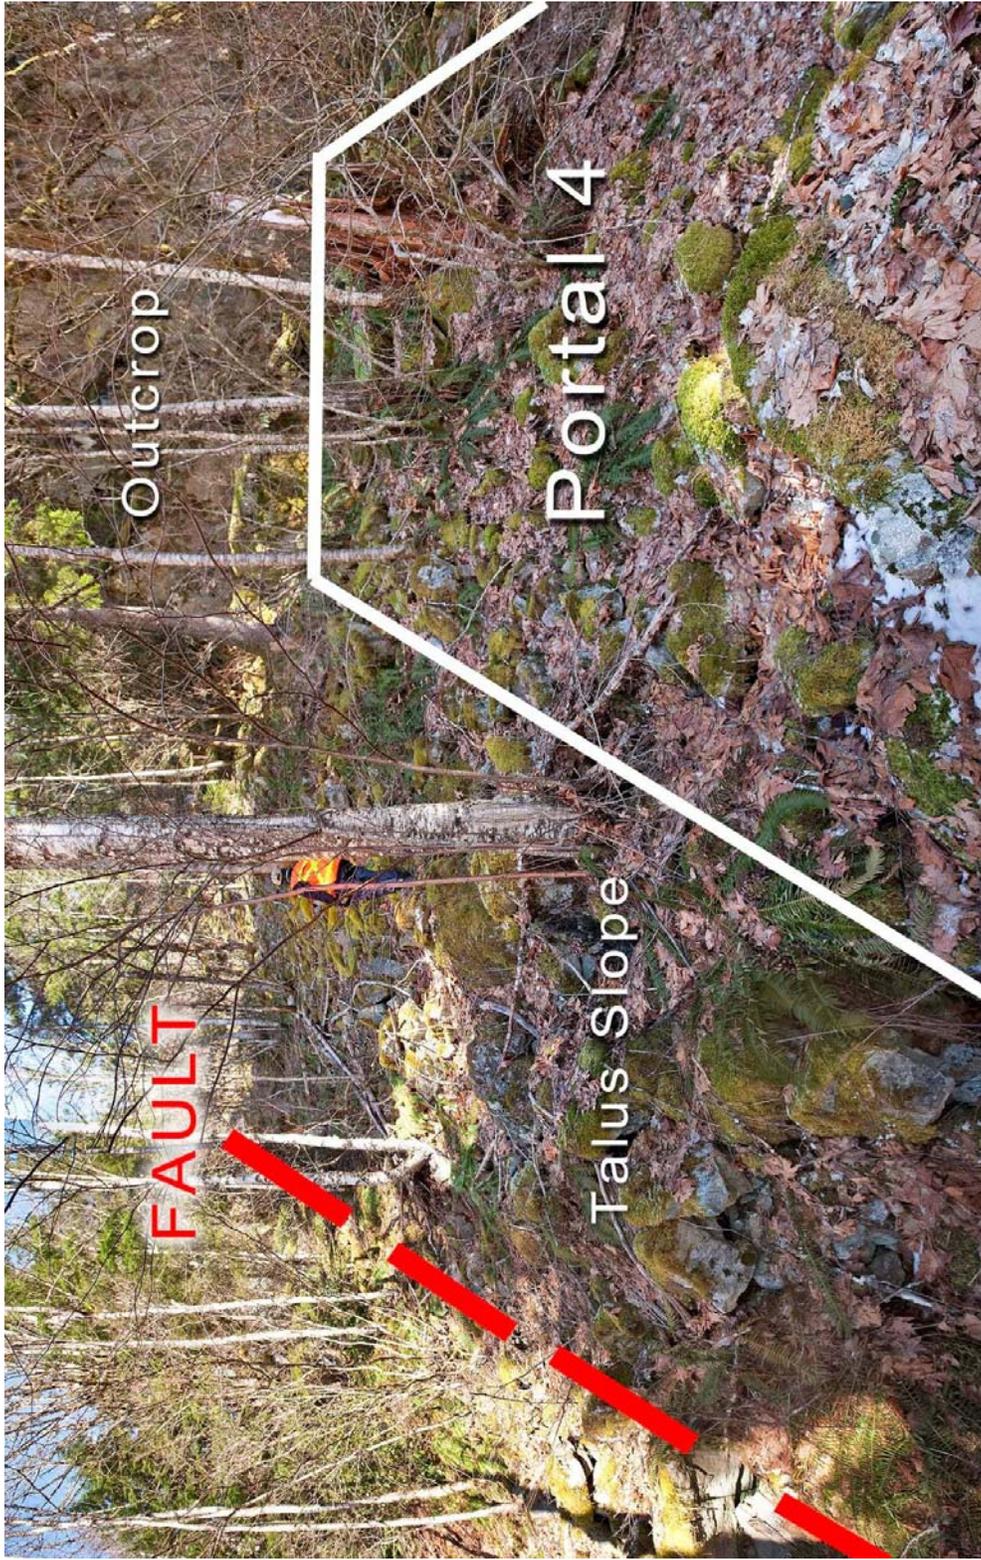
Figure 8. Portal 4 location

Portal 4 is located within a talus slope on the north side of the outcrop above Portals 2 and 3 (Figures 1 and 8). This slope is covered with an unknown thickness of boulder and cobble-sized angular blocks.

While this location is devoid of large, unstable blocks that could fall into the portal area, portal excavation could destabilize the talus slope above the portal. Additionally, the talus slope overlies a large fault that cuts approximately north-south across the

mountainside (beneath the transmission lines). Bedrock in the vicinity of this fault is expected to be highly fractured and potentially sheared.

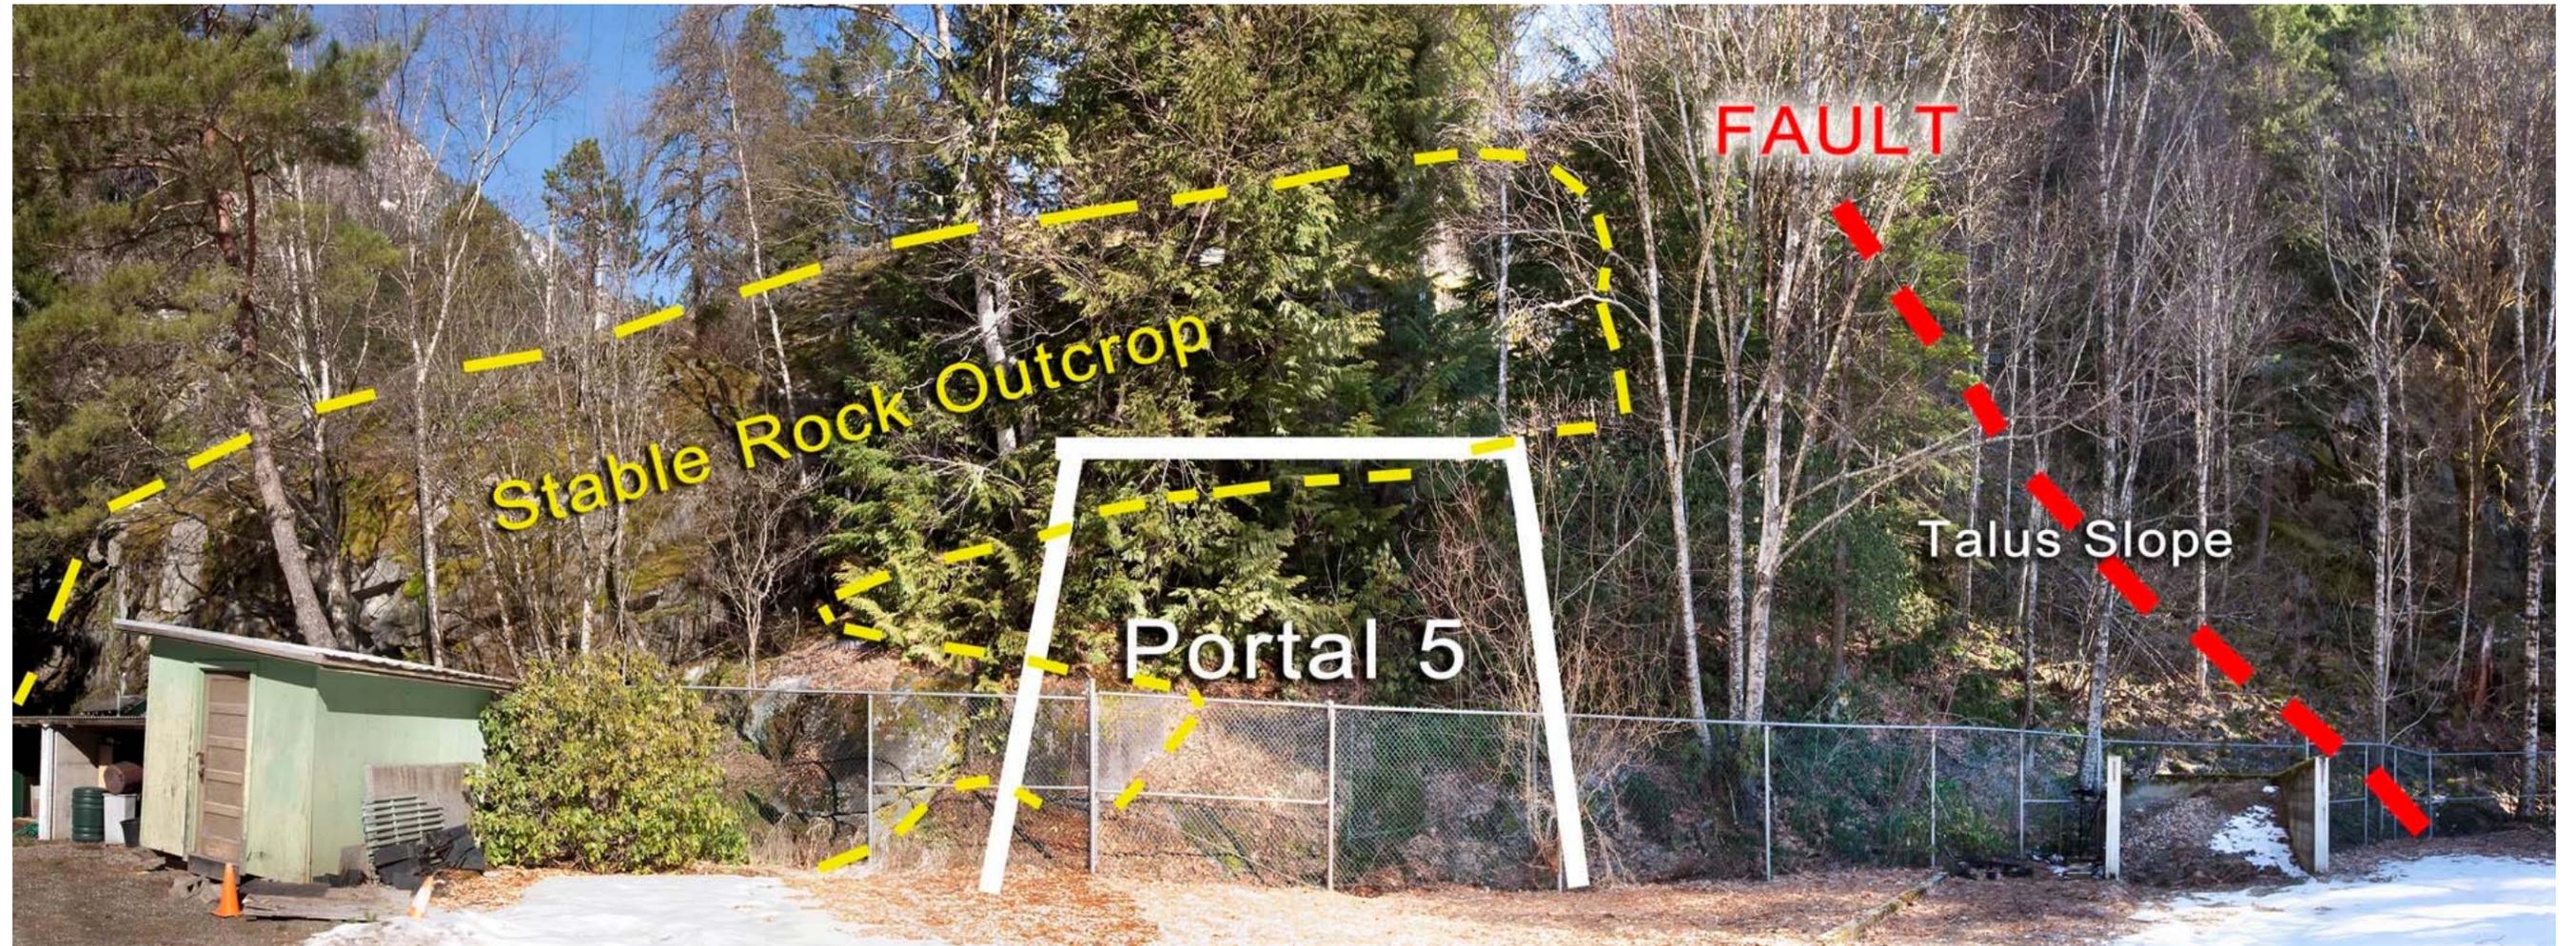
Figure 9. Portal 5 location

Portal 5 is located on the north side of the large field at the base of the hillside and also northwest of the large fault (Figures 1 and 9).

The portal is situated in stable orthogneiss bedrock, and no talus removal or rock-slope stabilization is required; however, the alignment crosses the large fault in an area of limited tunnel cover. This will complicate construction of the starter tunnel.
