## 2003 Streamside Revegetation Final Report

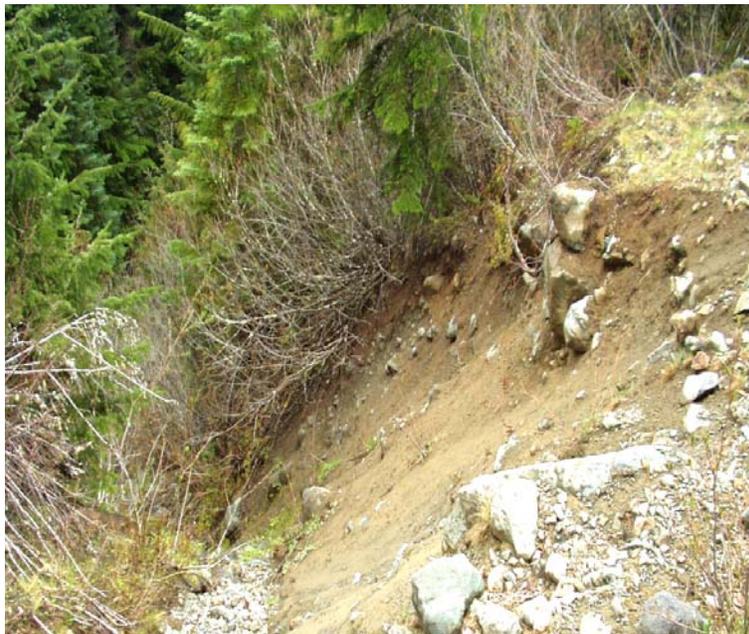
Photo 1: Chronically eroding fill on the 126 road above McClellan Creek. Restoration site number 10

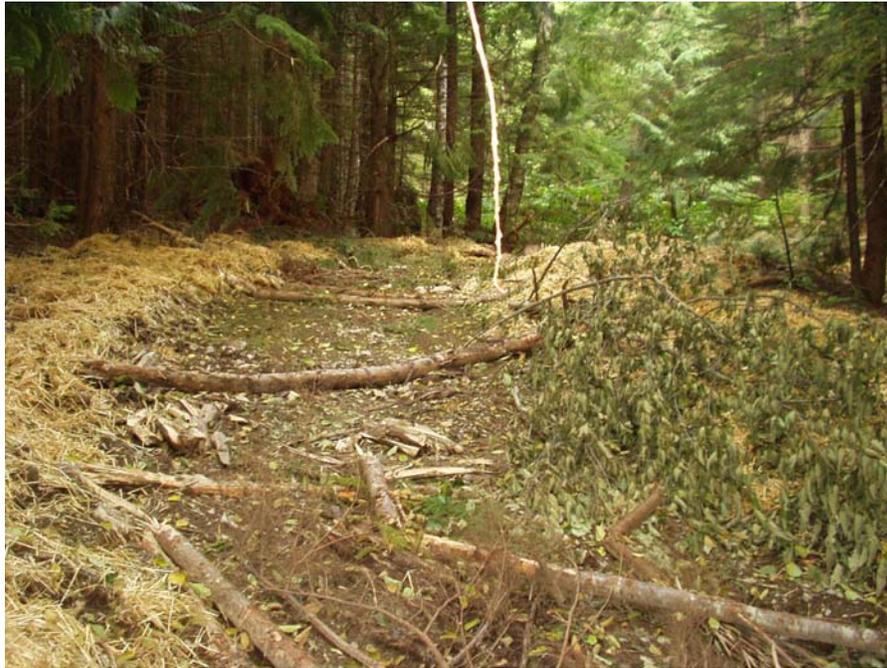
Photo 2: 64.1 road stream crossing restoration prior to planting. Site number 17.

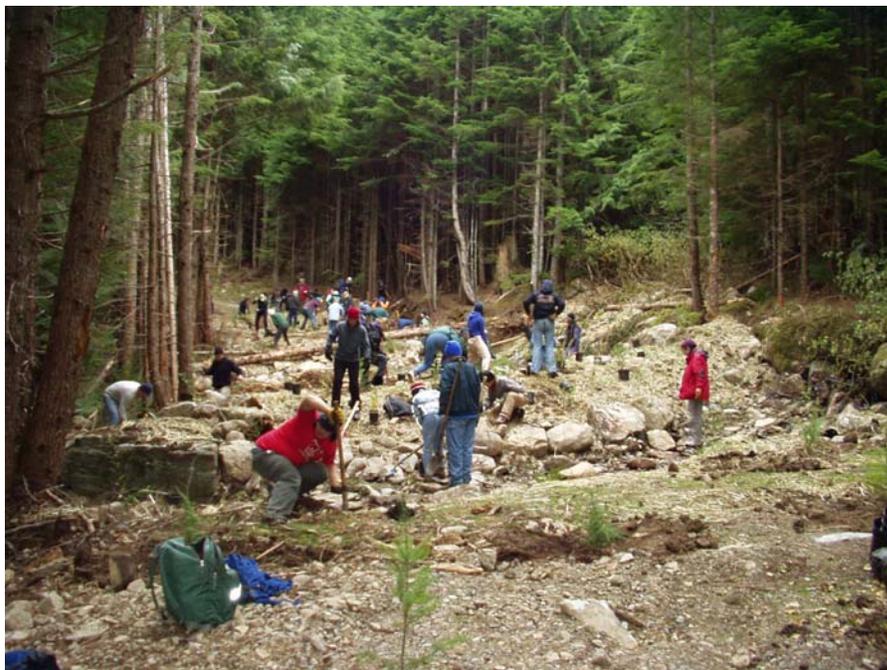
Photo 3: Volunteers planting trees and shrubs at a stream crossing on the 64.2 road. Restoration site number 13.
