**City of Seattle**  
Seattle Public Utilities

**SUBJECT:** Addendum to the Meadowbrook Pond Dredging and Improvements Project SEPA  
Determination of Non-significance

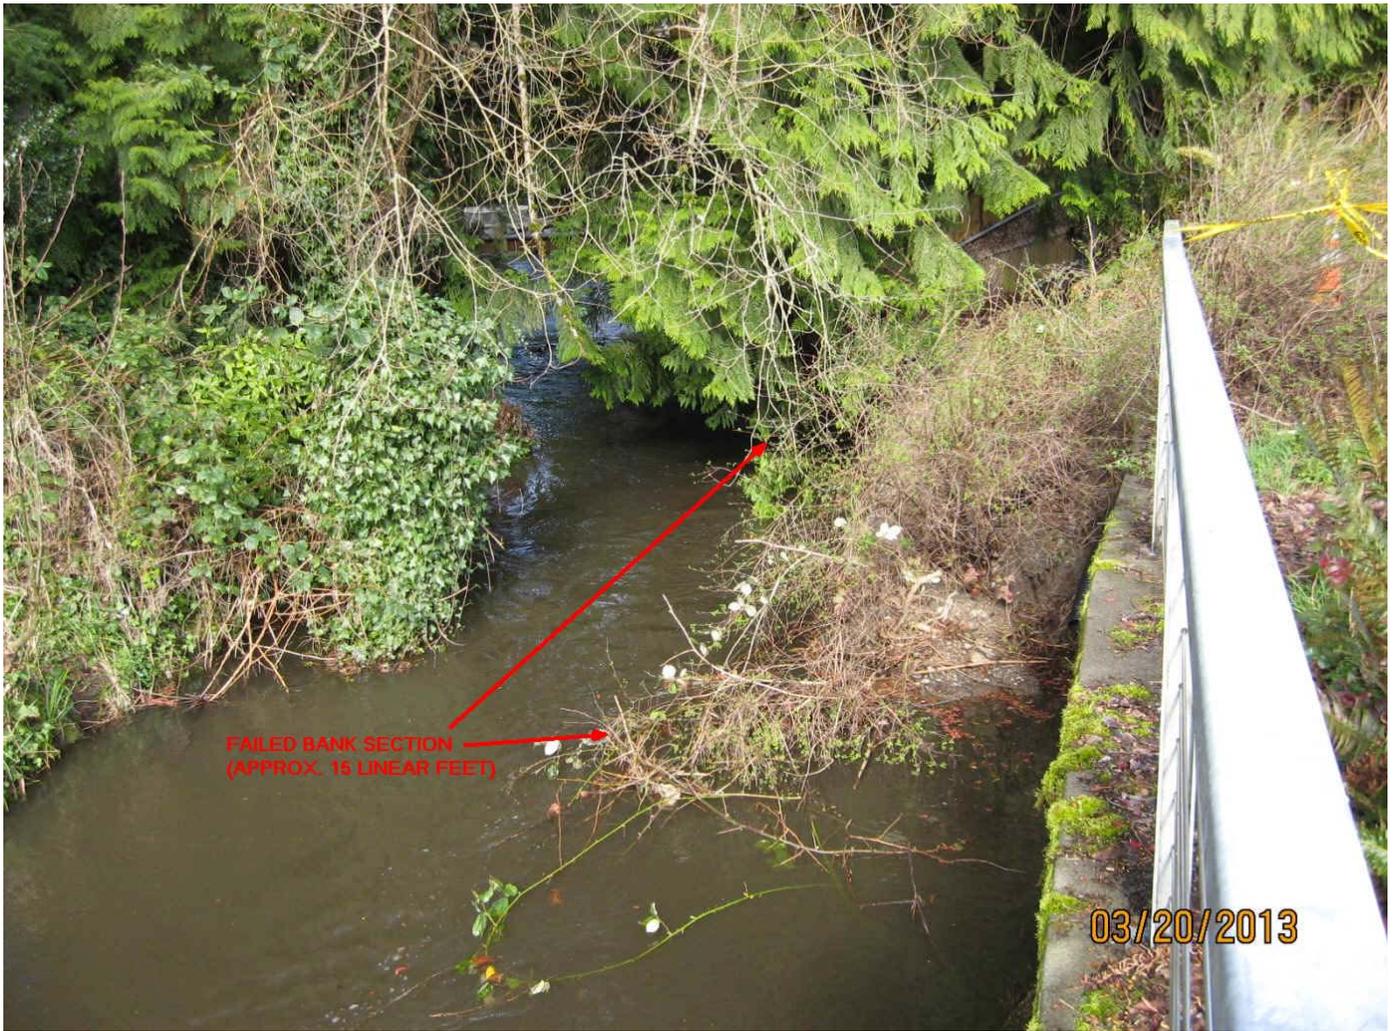
In February 2013, SPU staff discovered that approximately 15 linear feet of Thornton Creek stream bank had failed immediately upstream of the existing High Flow Bypass Inlet and Trash Rack at Meadowbrook Pond, sloughing 20 to 30 cubic yards of previously compacted soil and rock into the creek (Photo 1). Although the bank failure does not pose an apparent immediate threat to public safety or downstream property, the sloughed material should be removed and the bank restored to prevent further erosion during future storms. In addition, the bank must be restored in order to construct the SPU maintenance vehicle access improvements planned as part of the Meadowbrook Dredging and Improvements Project. Those improvements require a stable bank to accommodate the access road and vehicular traffic.

Photo 1. Failed bank, looking upstream. The High Flow Bypass Inlet and Trash Rack are shown at right.

SPU has subsequently identified a bank repair (Figures 1, 2, and 3). This repair would require bypassing flow away from the affected reach of Thornton Creek for approximately 2 to 3 weeks. To minimize the number of Creek bypasses, SPU is proposing to conduct the bank repair at the same time (July and August 2013) that the affected reach of Thornton Creek is dewatered to construct some elements of the Meadowbrook Pond Dredging and Improvements Project. SPU would add the bank repair to the current scope of work of the contractor constructing that project.

The bank repair would use an excavator to remove approximately 20 to 30 cubic yards of sloughed soil and rock from Thornton Creek and the adjacent bank. The bank would then be rebuilt using 4-man (36 inch by 48 inch) rocks keyed 18 inches into the streambed. The top of these base rocks would be at the same elevation as the Ordinary High Water Mark (OHWM) of Thornton Creek in this reach. The next two layers would be comprised of 3-man (24 inch by 36 inch) rocks. Soil lifts (native soils mixed with compost) would be used between the rock layers and planted with a total of approximately 25 shrubs and approximately 25 vine maples or willows. Specific plant species to be used would be determined in the field during construction. All rocks and soil would be installed using an excavator.
