Phase 2B

Glass Canopies Installed

December 6, 2012

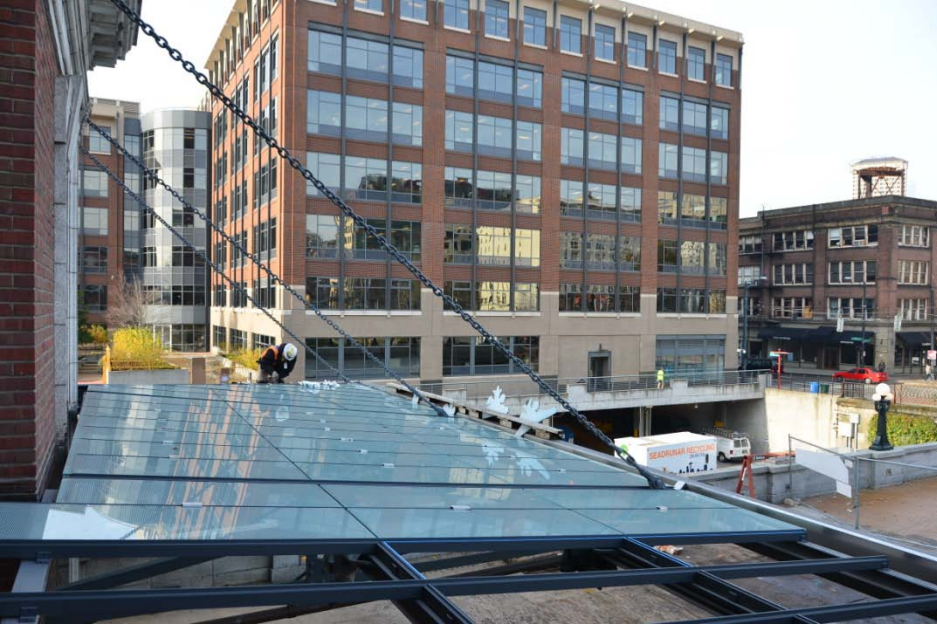
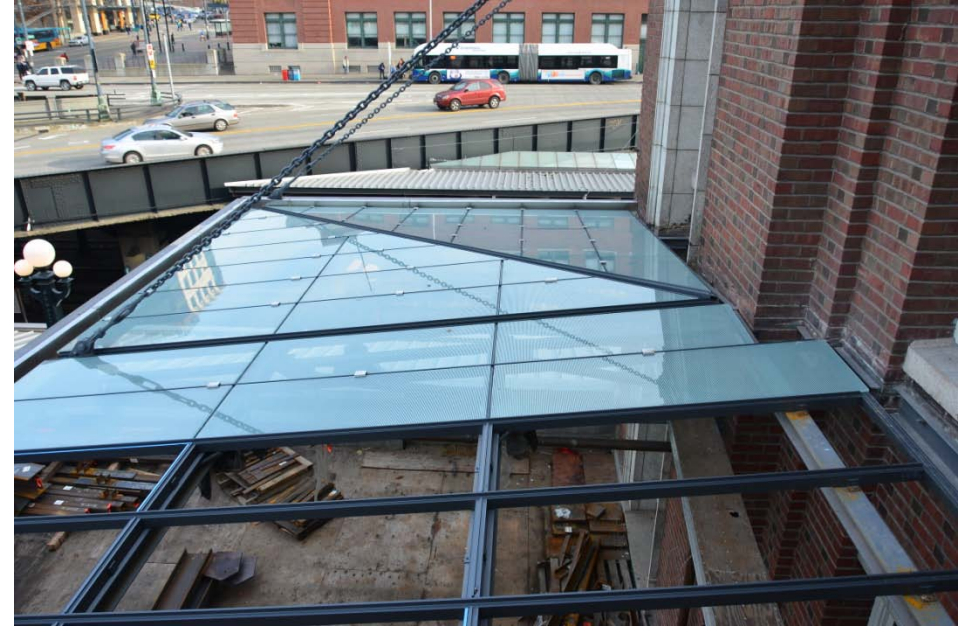
The north canopy gets a new glass roof. The strong $\frac{1}{4}$ " safety tempered glass is strong enough to hold an average weight adult. New efficient lighting had been installed in a previous phase. Ornamental copper fascia and crestring will also be installed along the perimeter of this canopy.

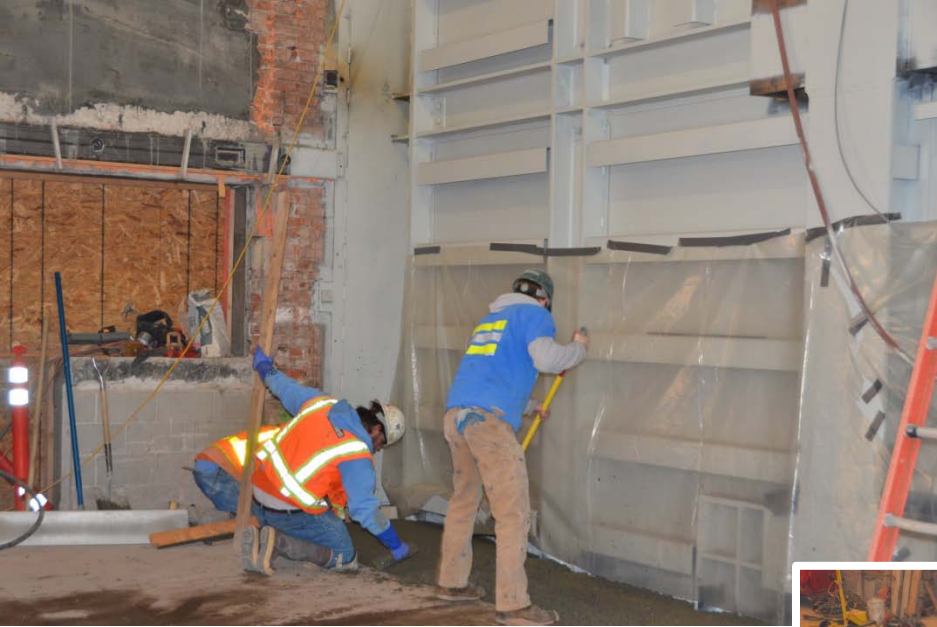
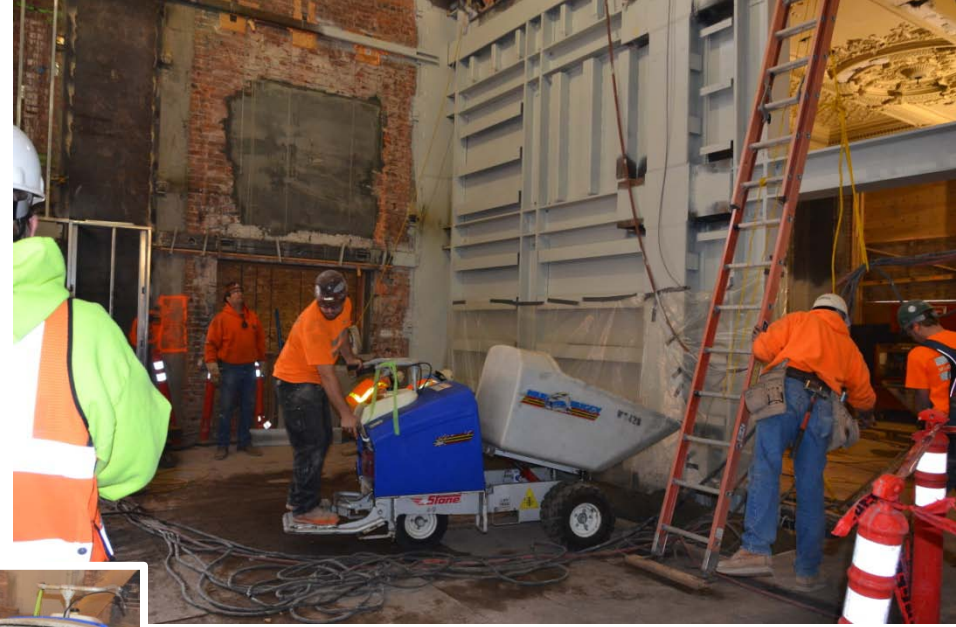
Grade beam for the shear wall outside the original Women's Waiting room was casted on site.

Both the grade beam and shear wall are tied to the reinforced concrete piles for stability/anchorage.

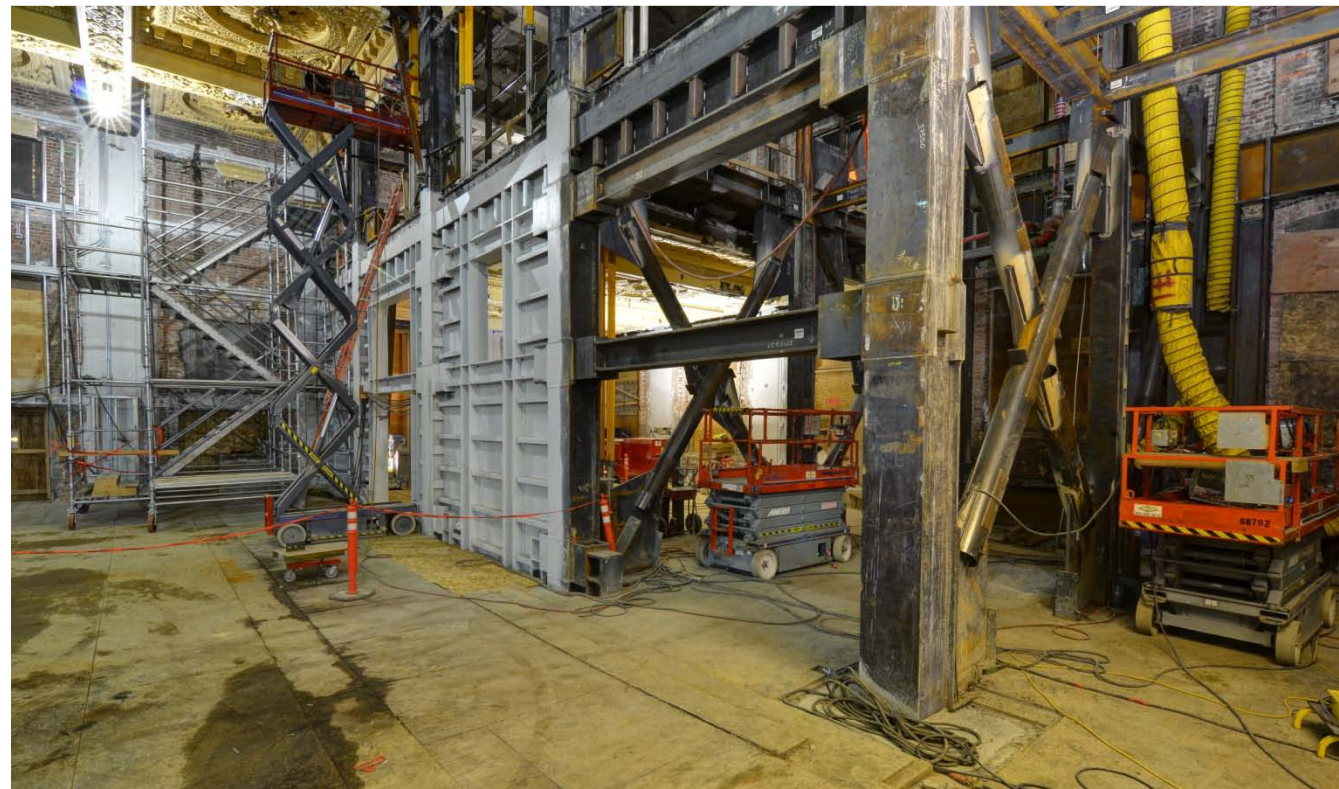
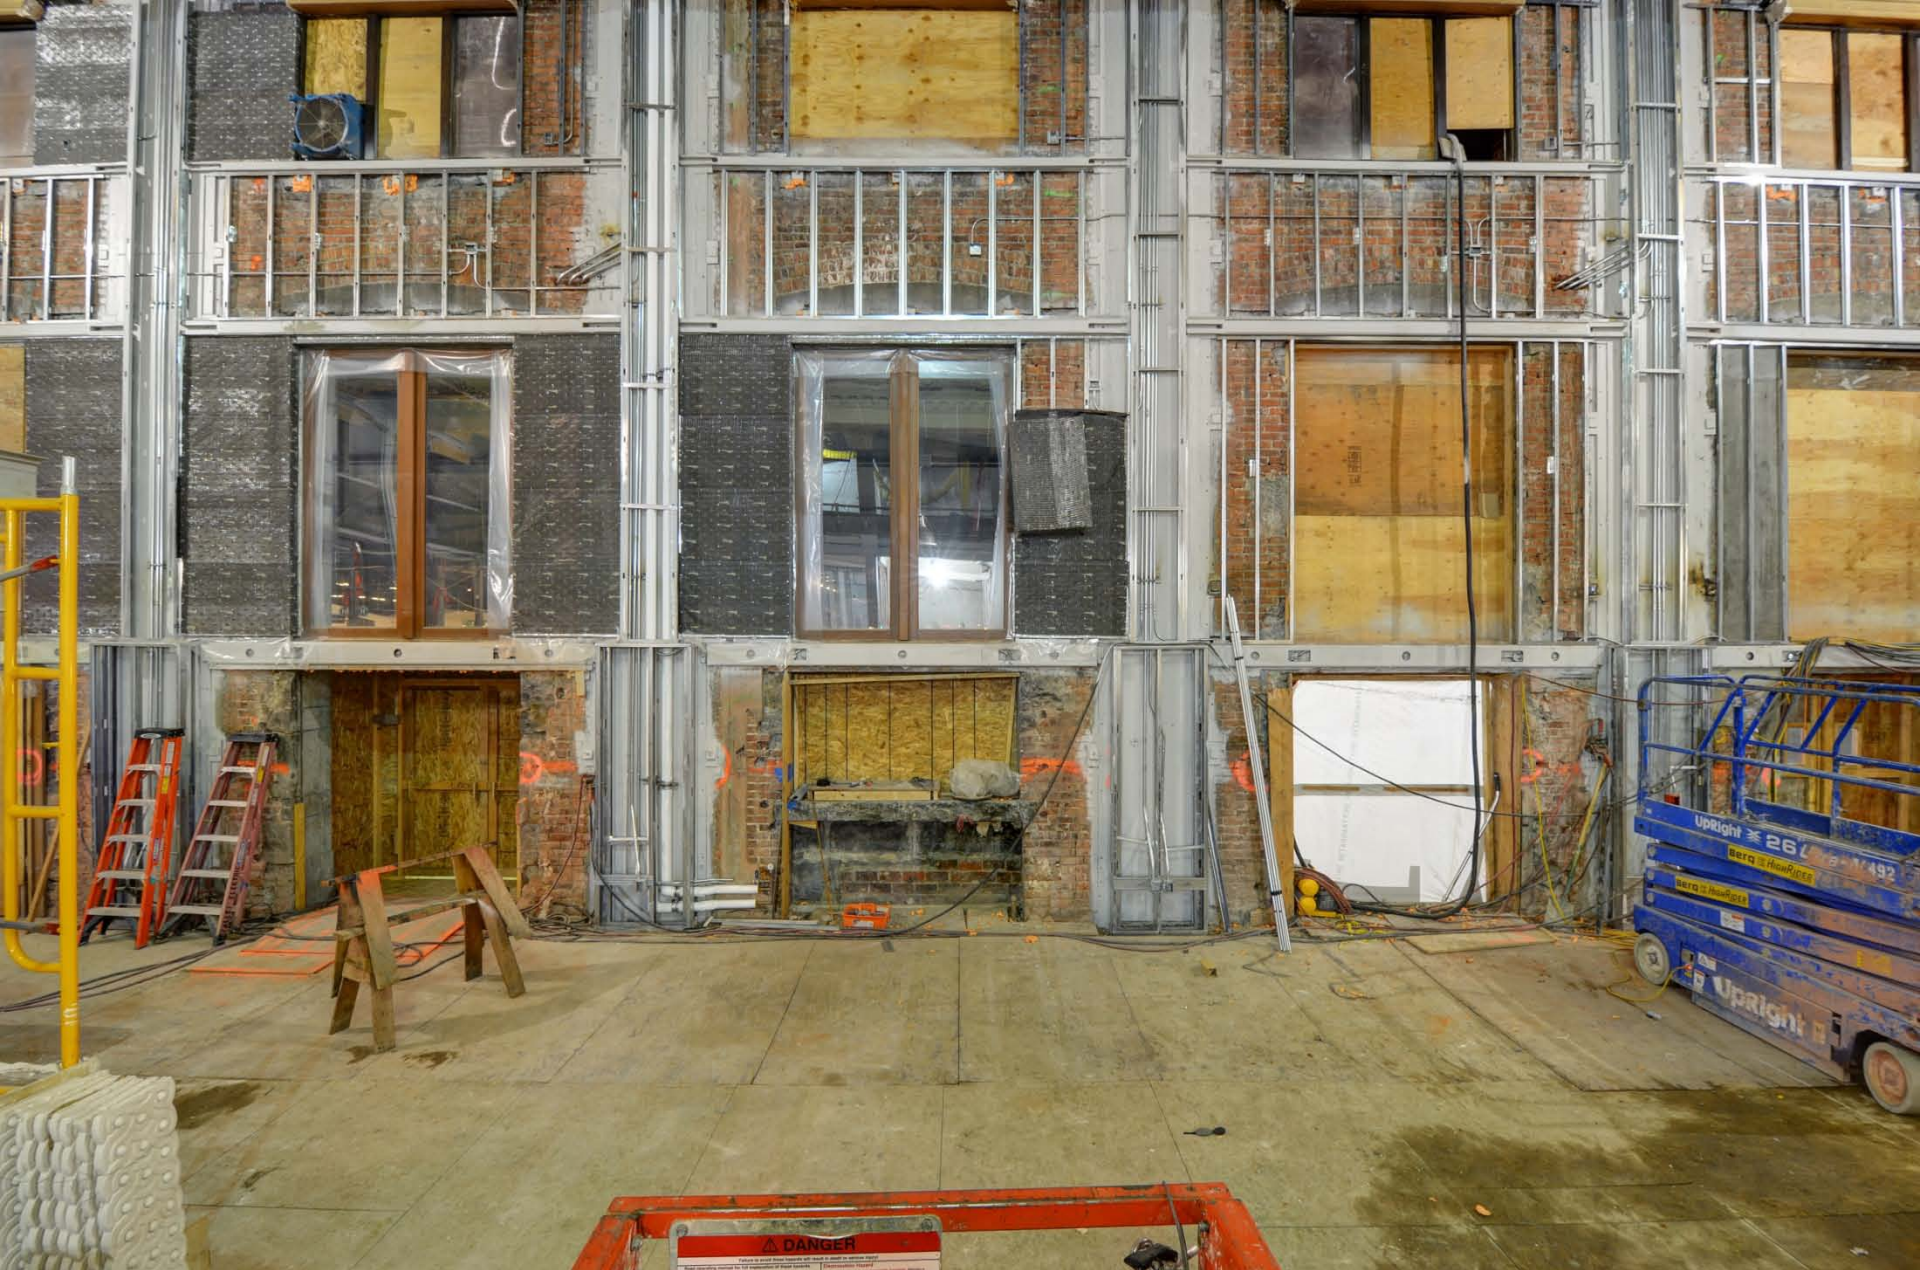
Vertical bracings above the window are installed for plaster mounting. The 8' tall windows shown are restored originals. Some of the old glass in the original window looks rippled due to the handmade process which is very different from the machine reproduction nowadays.

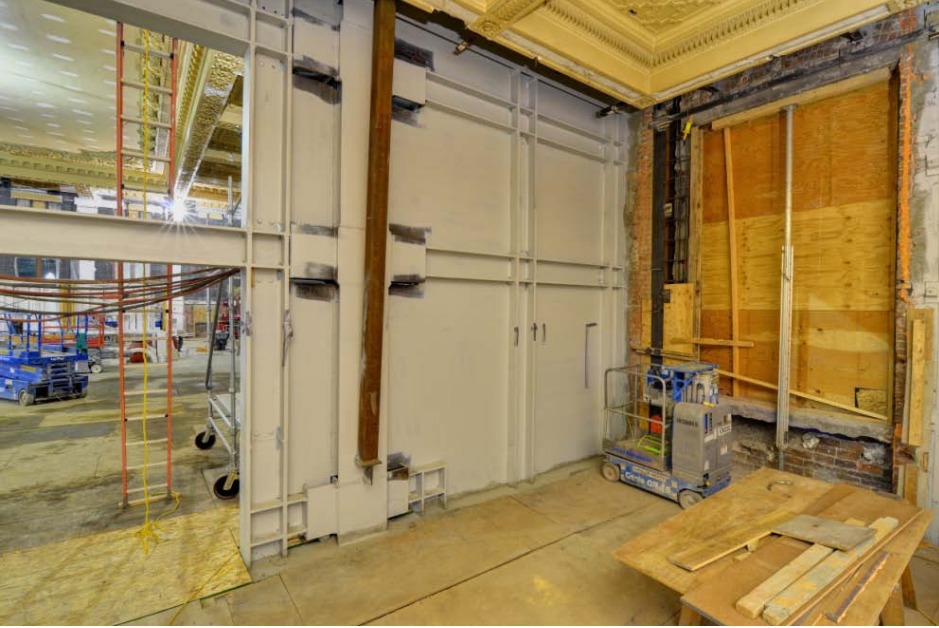
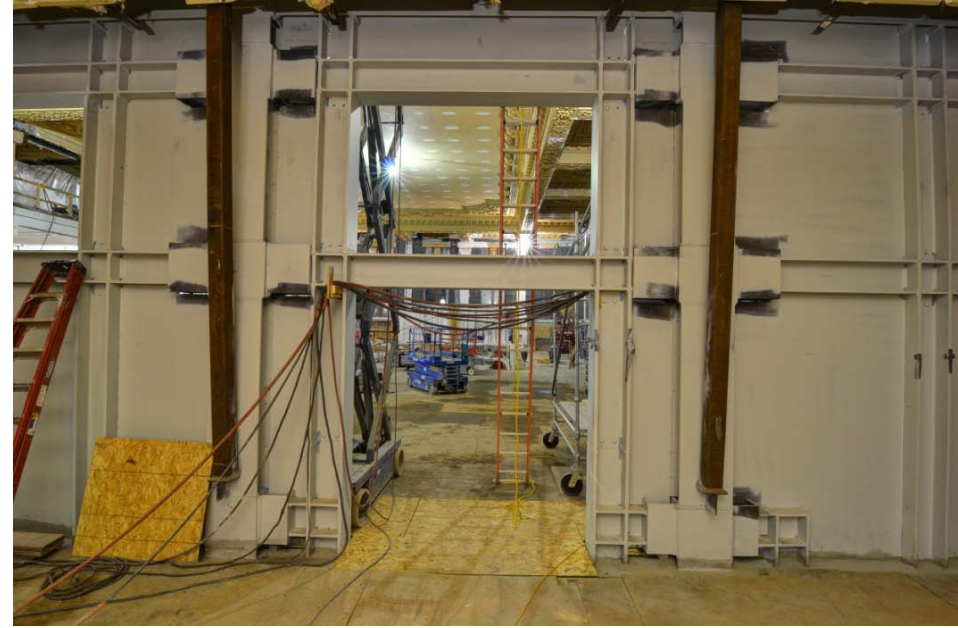
A new steel shear wall separates the intimate women's waiting room from the lofty main waiting room.

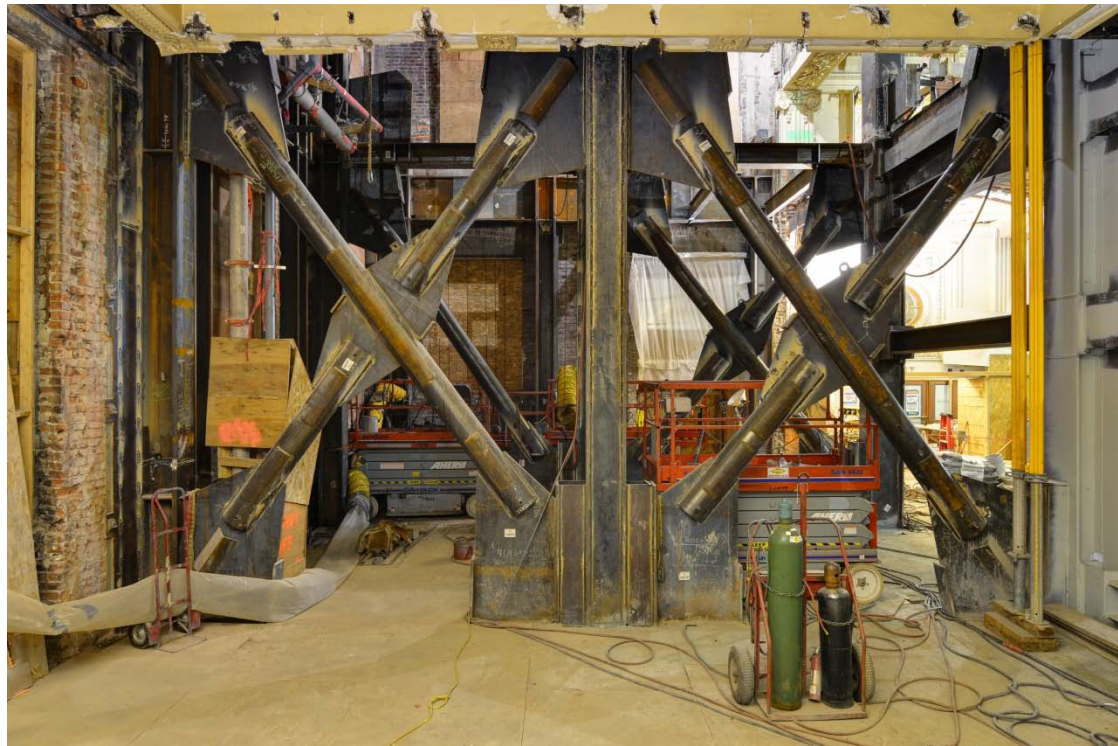
New brace frame

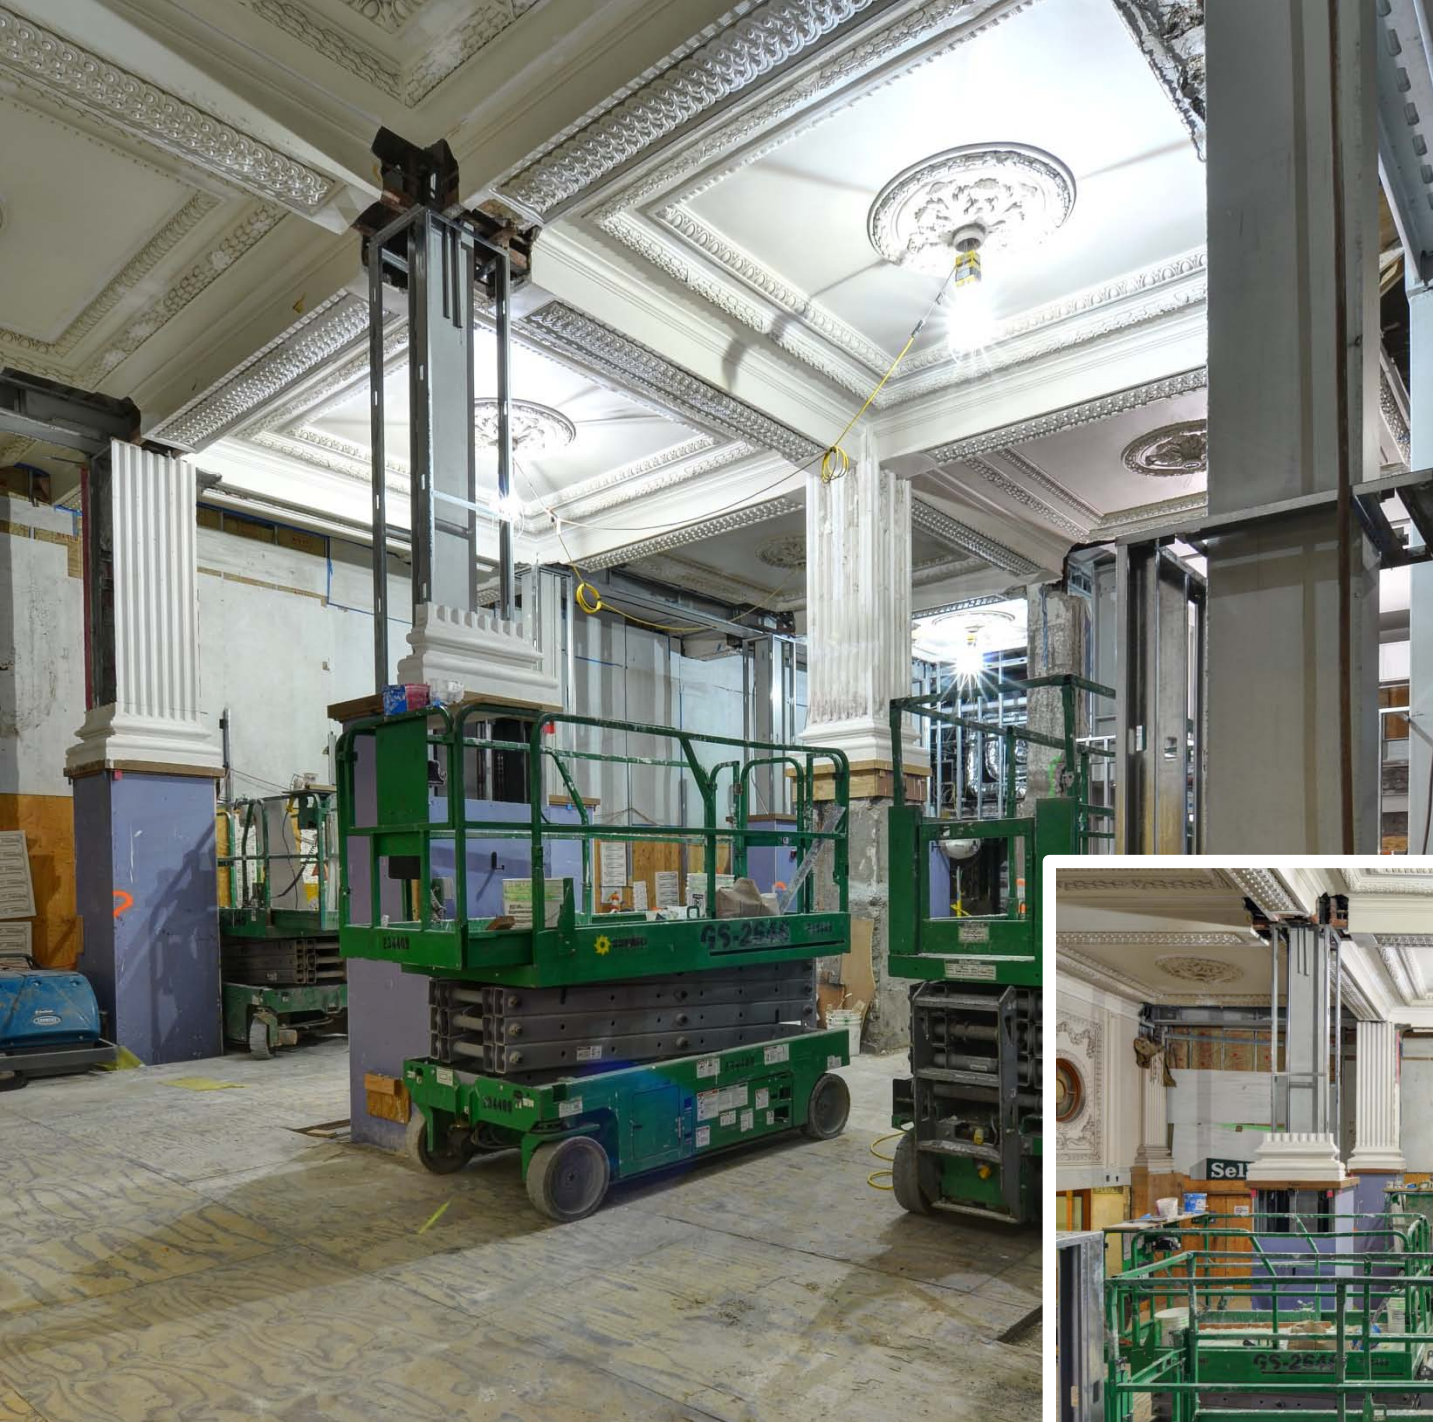
Columns in various states of restoration are shown in the left photo. The original column on the far right was similar in size to the small steel column in the middle. New seismic steel pieces now surround the column on all sides. All other columns will be wrapped this way.
