**DPD Project# 3015522**  
**Project Address: 901 W McGraw St**

Re: Final Tree Report – Seattle Children's Home

## 1. Exceptional Tree Risk Assessments

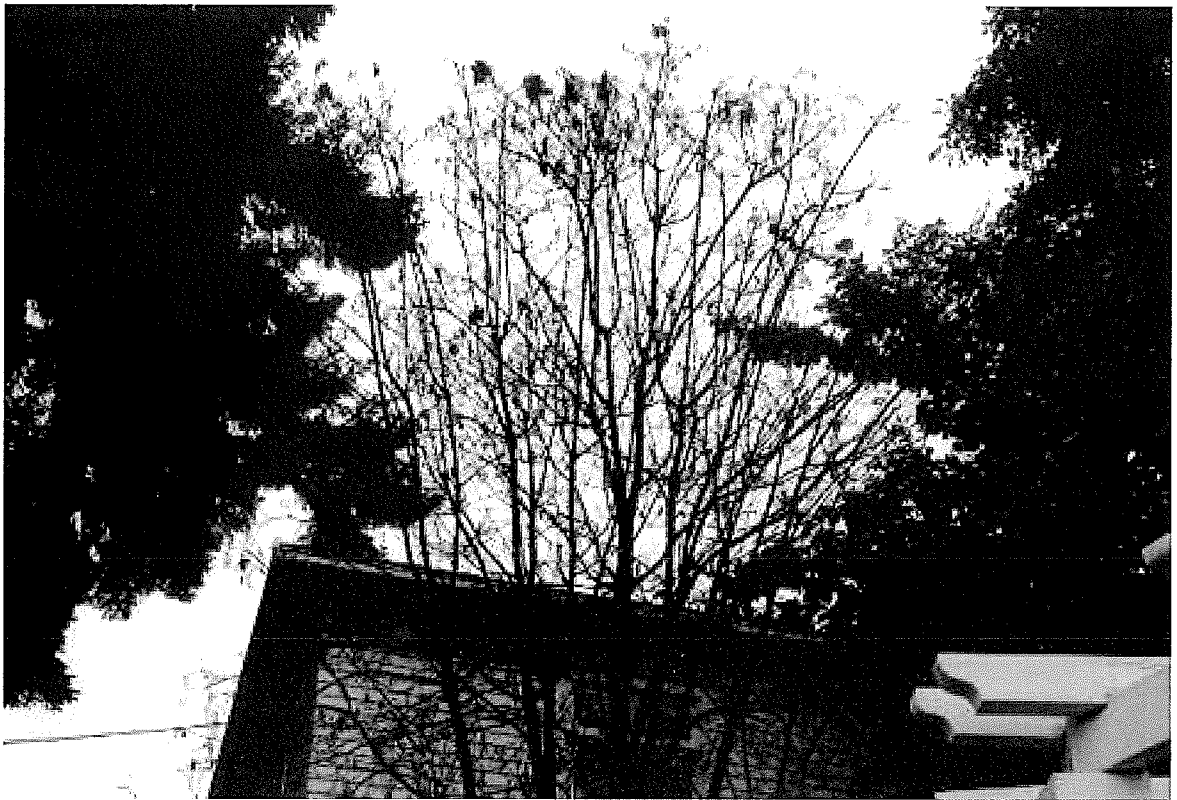
Tree #770 - This tree is a Pacific madrone measuring 8" dbh that was in fair condition and health at the time of my initial assessment back in the late fall of 2013. This tree is dead and no longer viable and no longer classified as Exceptional.

Size of Defective Part (8") - 2 points  
The Target Area (Building) - High, 4 points  
Probability of Failure - Dead tree, Extreme, 5 points  
Overall Risk Rating - 11 points  
Risk Category - High3

Figure 1. Tree #770 - Dead Pacific Madrone

Clearly, the trees with the High 3 risk category warrant removal at this time (770 and 776) and 792 does not.

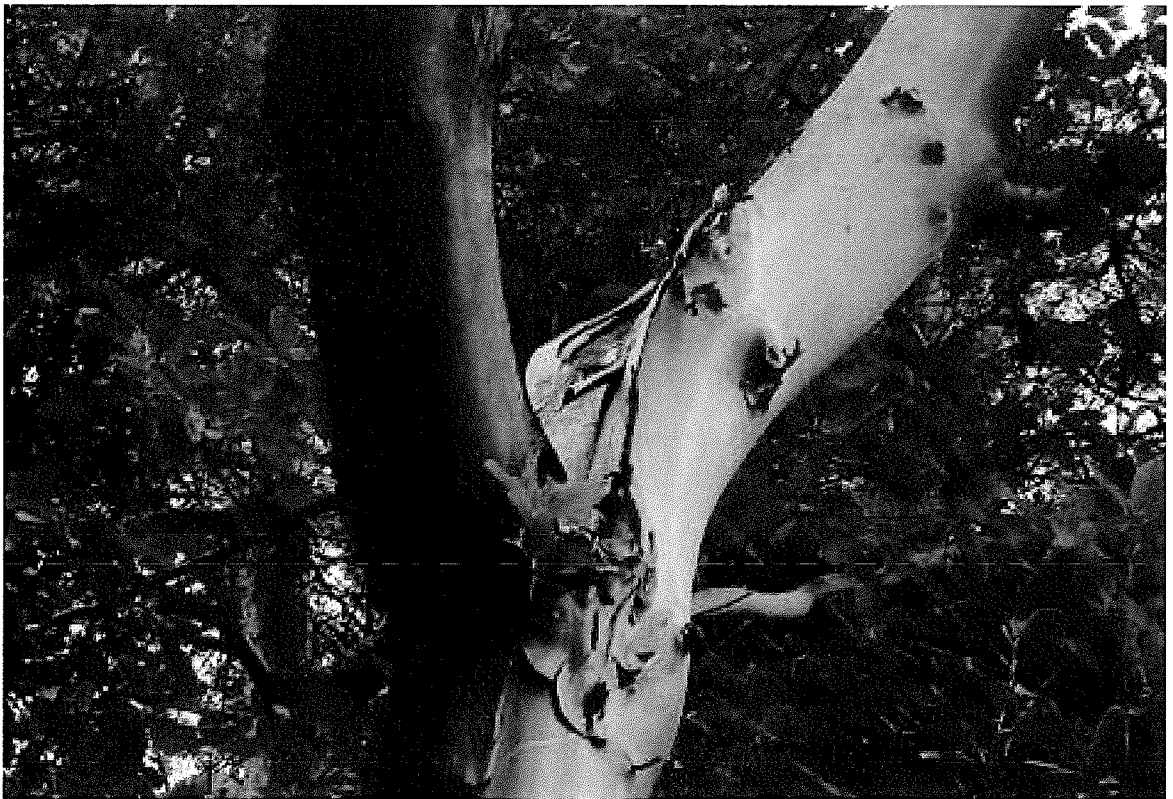
Tree #776 This tree is a Pacific madrone measuring 14" dbh that was in good condition and health at the time of the initial assessment. Since that time, a large codominant leader failed at a connection with the other co-dominant leader leaving a large scar and reducing the width of the trunk by approximately 1/2 its diameter in that location. This defect presents a considerably weakened portion of the trunk presenting a point of potential failure. In addition, the wound renders the tree susceptible to decay and as a highly sensitive species,

the wound will more than likely lead to the tree's early death. Therefore this tree is no longer classified as Exceptional and is recommended to be removed. (see figure 2)

Size of Defective Part (14") - 2 points  
The Target Area (Building) - High, 4 points  
Probability of Failure - Previous failure, Extreme, 5 points  
Overall Risk Rating - 11 points  
Risk Category - High3

Figure 2. Tree #776 - Damaged Pacific Madrone

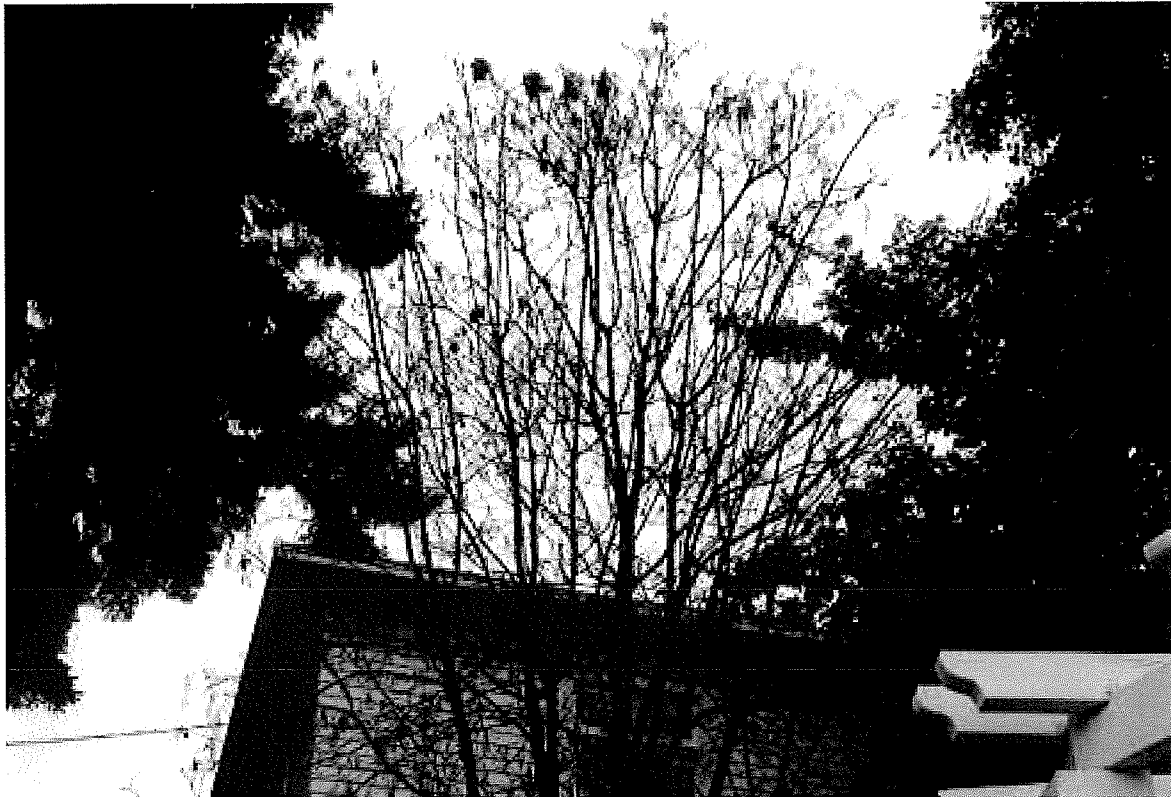
minimum size threshold for their species to be classified as Exceptional, one of which is confirmed as dead (see Figure 1) and another has suffered a significant failure and therefore is classified as a High3 level overall risk rating. Therefore, both of these trees are declassified as Exceptional per SMC 25.11.030.B, for a total of 13 Exceptional trees on the project site.

Tree #770 - This tree is a Pacific madrone measuring 8" dbh that was in fair condition and health at the time of my initial assessment back in the late fall of 2013. This tree is dead and no longer viable and no longer classified as Exceptional. (see figure 1)

Figure 1. Tree #770 - Dead Pacific Madrone

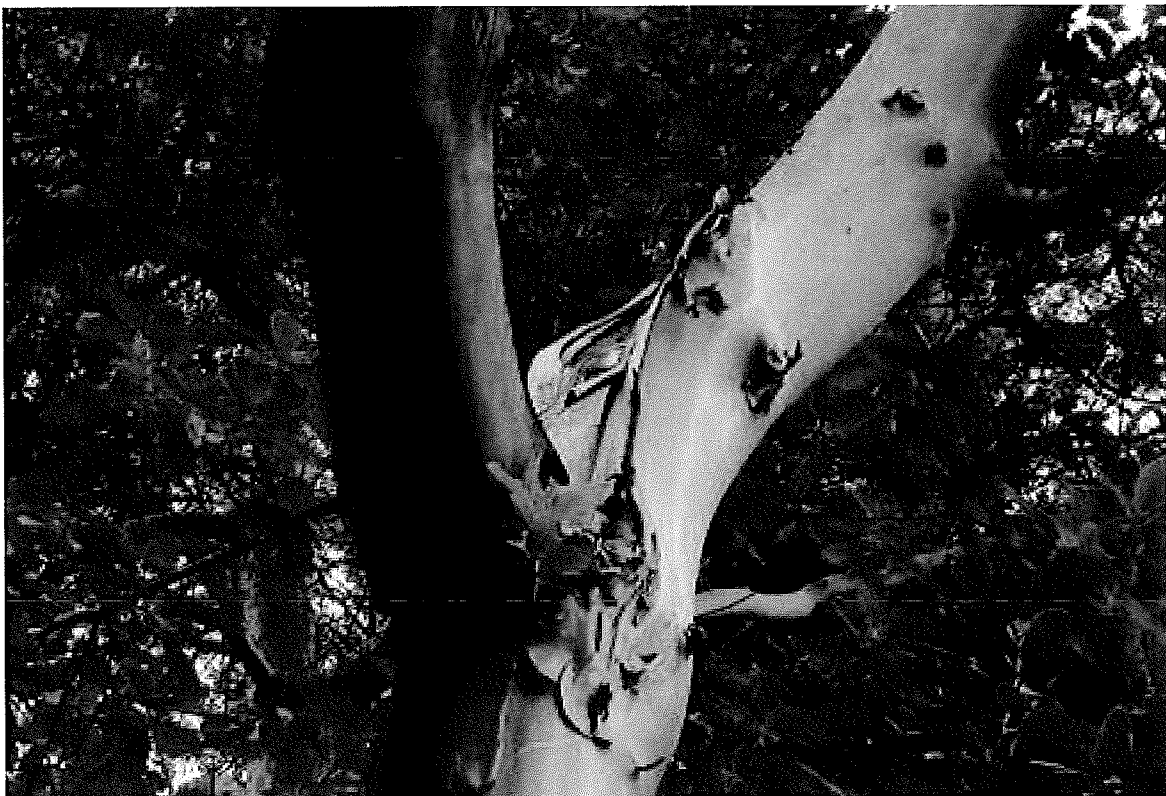
Tree #776 This tree is a Pacific madrone measuring 14" dbh that was in good condition and health at the time of the initial assessment. Since that time, a large codominant leader failed at a connection with the other co-dominant leader leaving a large scar and reducing the width of the trunk by approximately 1/2 its diameter in that location. This defect presents a considerably weakened portion of the trunk presenting a point of potential failure. In addition, the wound renders the tree susceptible to decay and as a highly sensitive species, the wound will more than likely lead to the tree's early death. In terms of a risk assessment, this tree is given a Probability of Failure rating of Extreme for 5 points as it satisfies the criteria of "Dead branches hung up or partly failed", and "Any partly failed component or whole tree". The size of the defective part is between 4 and 20 inches for a value of 2 points. the Target area is a high use building and walkway for a High rating of 4 points. The Overall Risk Rating is 11 points for a High3 calling for action to mitigate the risk within

weeks rather than days. Therefore this tree is no longer classified as Exceptional and is recommended to be removed. (see figure 2)

Figure 2. Tree #776 - Damaged Pacific Madrone
