## MERIDIAN PLAYGROUND

## PLAY AREA RENOVATION

**MERIDIAN PLAY AREA RENOVATION & ADA MERIDIAN RR DESIGN**

**Table of Trees**  
 4920 Meridian Ave N, Seattle, WA  
 Arborist: Charlie Vogelheim, Julian Garcia  
 Date of Inventory: 2/15/2024, 5/23/25  
 Table Updated: 6/4/25

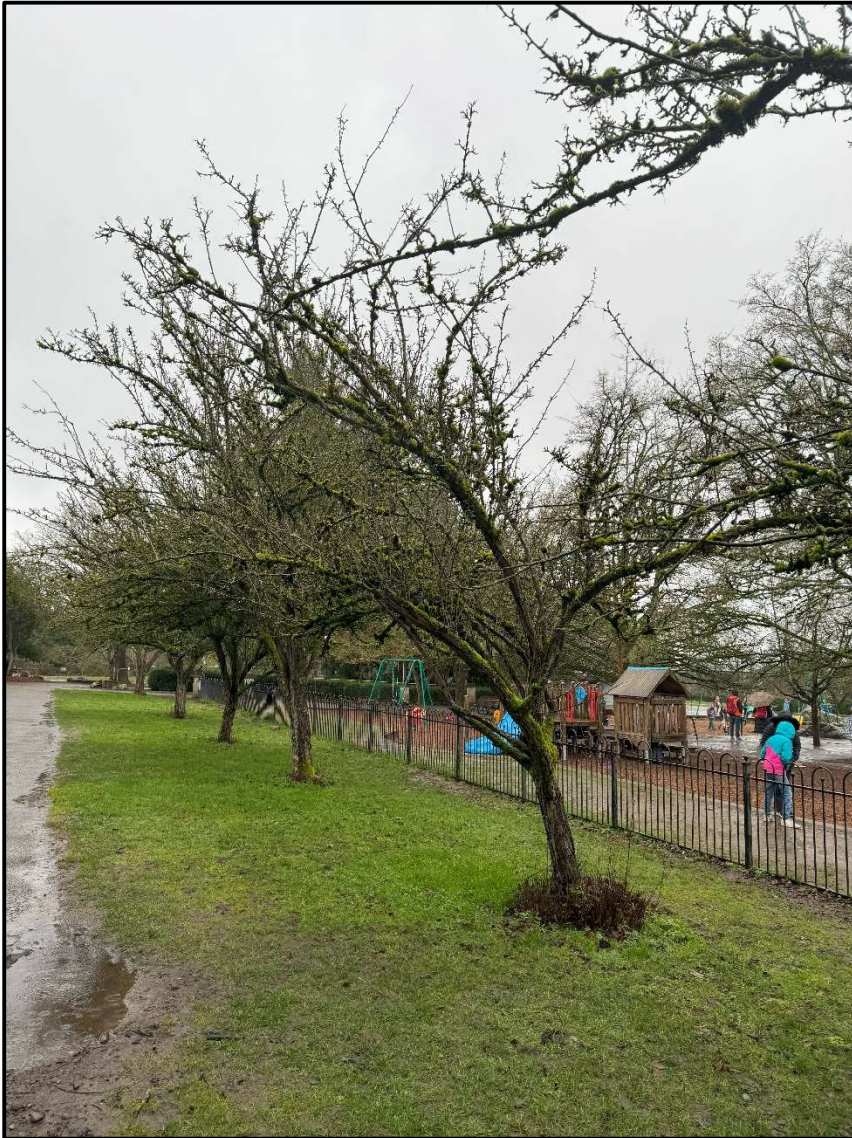
**Photo 1.** Crabapple tree 442 in a line of similar species. This tree is the typical size and structure of the other trees of this species onsite.

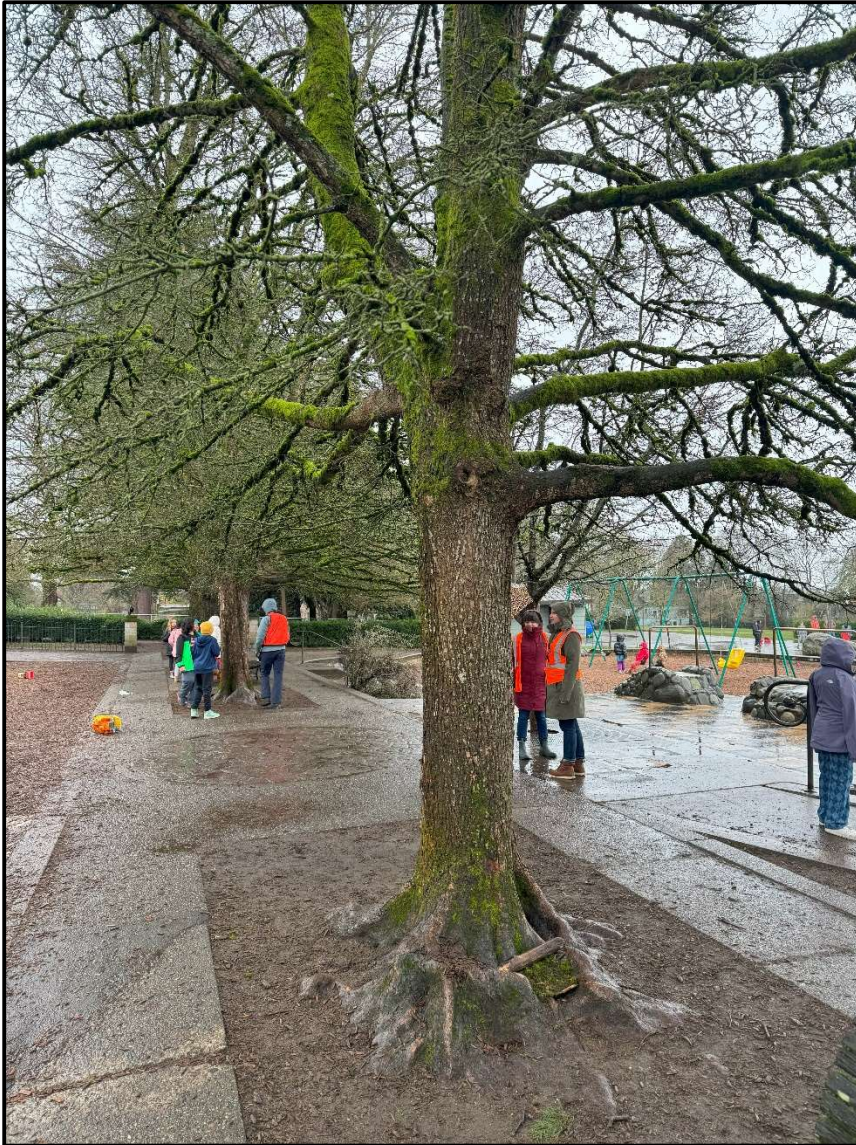
Plans call for the removal and replacement of concrete around the six hedge maples in the middle of the playground. These maples had surface roots and the existing concrete around these maples was showing uplift. It is likely that roots of these trees are in contact with the pavement and so removal of the existing pavement will need to be done carefully to reduce wounding to the roots.

**Photo 2.** Hedge maple tree 448, with surface roots and compacted soil. This is typical for trees of similar species within the play area. Removal of adjacent pavement should be done carefully and under arborist supervision.

Details for replacement pavement notes that 4 inches of concrete will be placed on top of 3 inches of subgrade. Any necessary excavation for the subgrade should be done by hand or with pneumatic air and/or vac-truck as to not injure the roots. Encountered roots should be retained and if possible be included in sub grade. Roots may be shaved down if necessary. Bolting a steel plate to the top of the root beneath the sidewalk will prevent the root from causing further uplift. Attached are specifications for this method. An arborist should be present to monitor demolition and excavation within the TPAs of these trees.

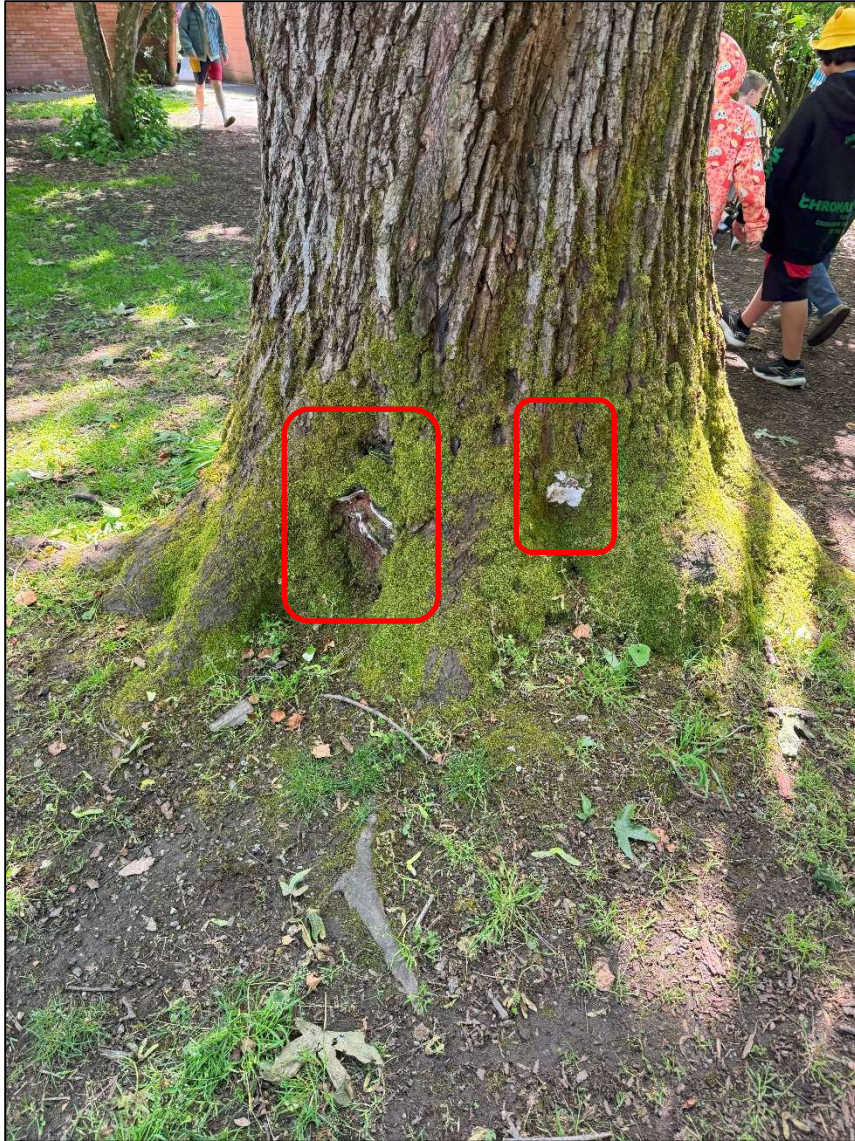
Tree 490 is a 42.1 inch DSH tier 2 bigleaf maple (*Acer macrophyllum*) in fair health and structural condition. I observed artist's conks (*Ganoderma sp.*) on the northwest and southeast sides, which indicate that internal decay is present inside the trunk. There were also dead branches up to 4-inches diameter in the canopy. Since this tree is adjacent to the building and areas where people frequently congregate, I recommend having the tree assessed for risk with advanced assessment such as a micro-resistance drill. Tree Solutions Inc. can provide these services upon request.

**Photo 3.** Bigleaf maple tree 490 has *Ganoderma* conks on the northwest and southeast sides of the trunk, which are a sign of internal decay in the trunk. I recommend an advanced assessment to determine its structural condition and safety.
