SDCI GIS Web Map - 901 Harvard Ave East Seattle 98101 parcel #547950-0090

TO: Sterling Malcomson, Bartlett Tree Experts
SITE: 901 Harvard Ave East, Seattle WA 98101 Parcel #547950-0090
RE: Tree Replacement Plan
DATE: May 5, 2025
PROJECT ARBORIST: Scott Selby
ASCA Registered Consulting Arborist #749
ISA Board Certified Master Arborist #PN-1775B
ISA Qualified Tree Risk Assessor

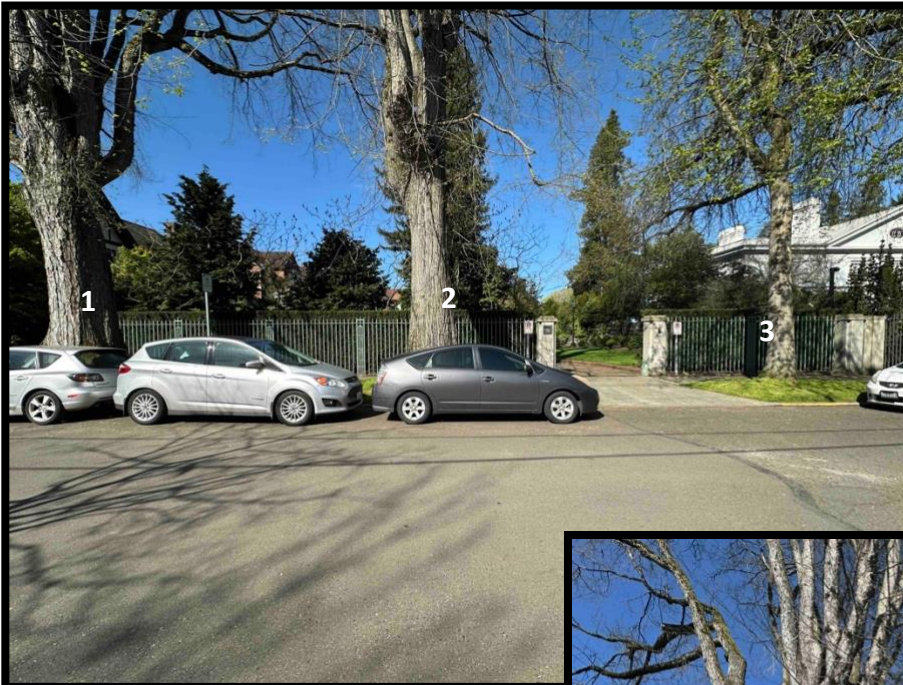
Photo 1. Image of all 3 trees looking west from street.

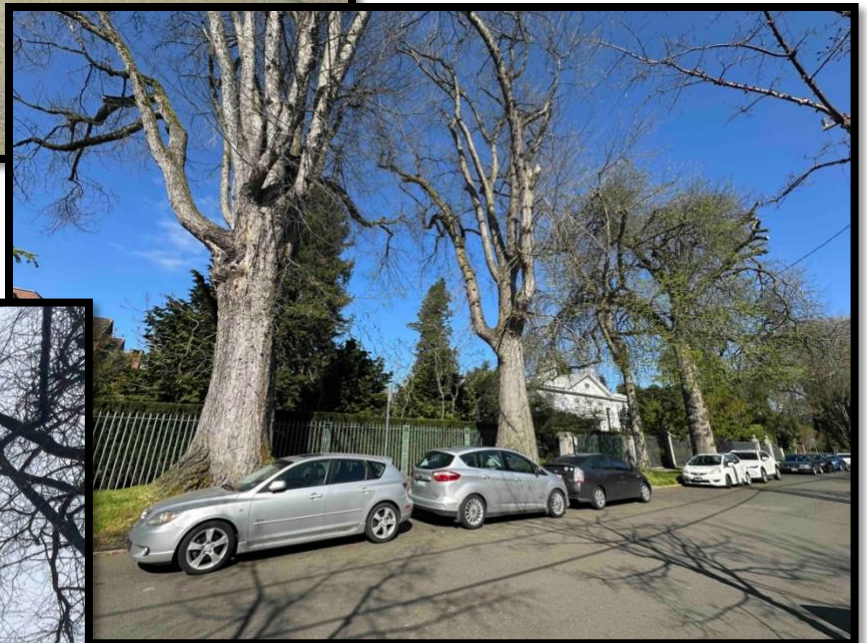
Photo 2. Another image of all 3 trees in the context of other street trees.

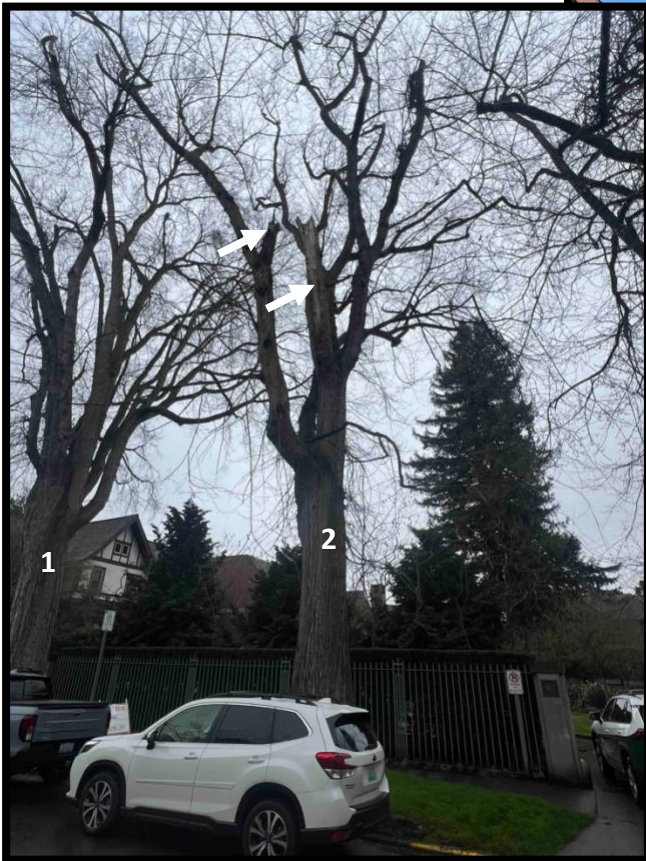
Photo 3. Trees 1 and 2. White arrows indicate where branch tear-outs have occurred.

The three removed trees will be replaced on a 1:1 basis with Garry Oak (*Quercus garryana*) with locations as identified on the provided site map. Replacement trees will be a minimum of 1.5 inches in diameter, measured 6 inches above the ground.

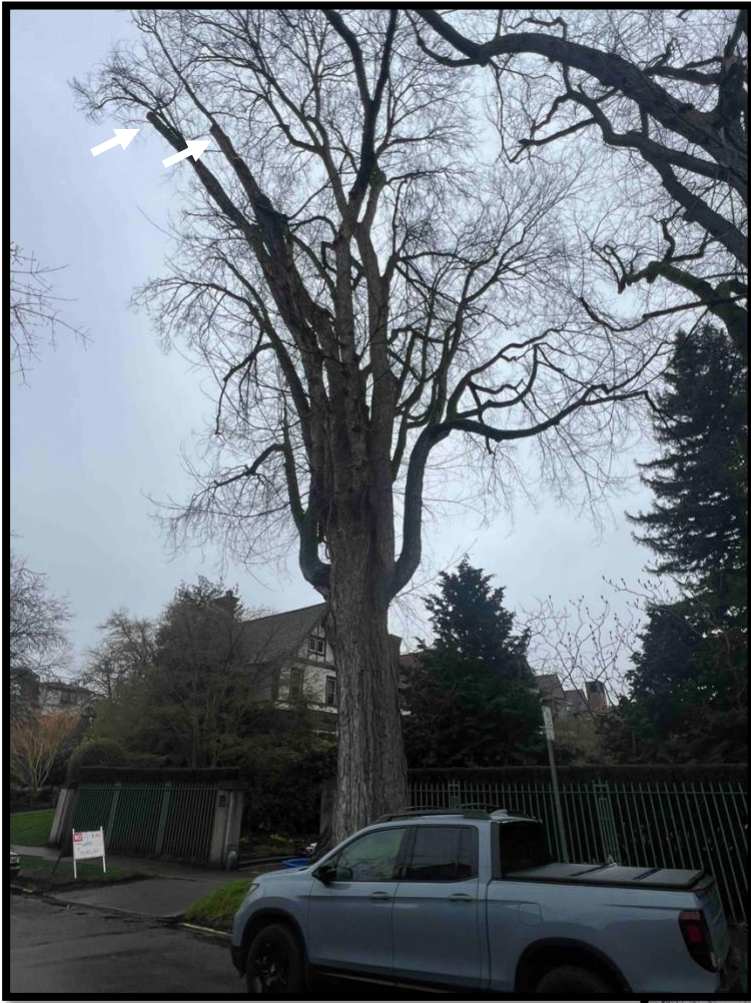
Photo 4. Tree 1. White arrows point out areas where branch tear-outs have occurred.
