Kanti C. Ramamurti, Application and Certification of Special Valuation on Improvements to Historic Property. Stewart House, 10455 Maplewood PL SW, Seattle, WA 98146

Detailed Description of Rehabilitation Work.

BEFORE
REHABILITATION
PHOTOGRAPHS

AFTER REHABILITATION
PHOTOGRAPHS ALONG WITH
HISTORIC PHOTOGRAPHS TO
SHOW ORIGINAL DESIGN.

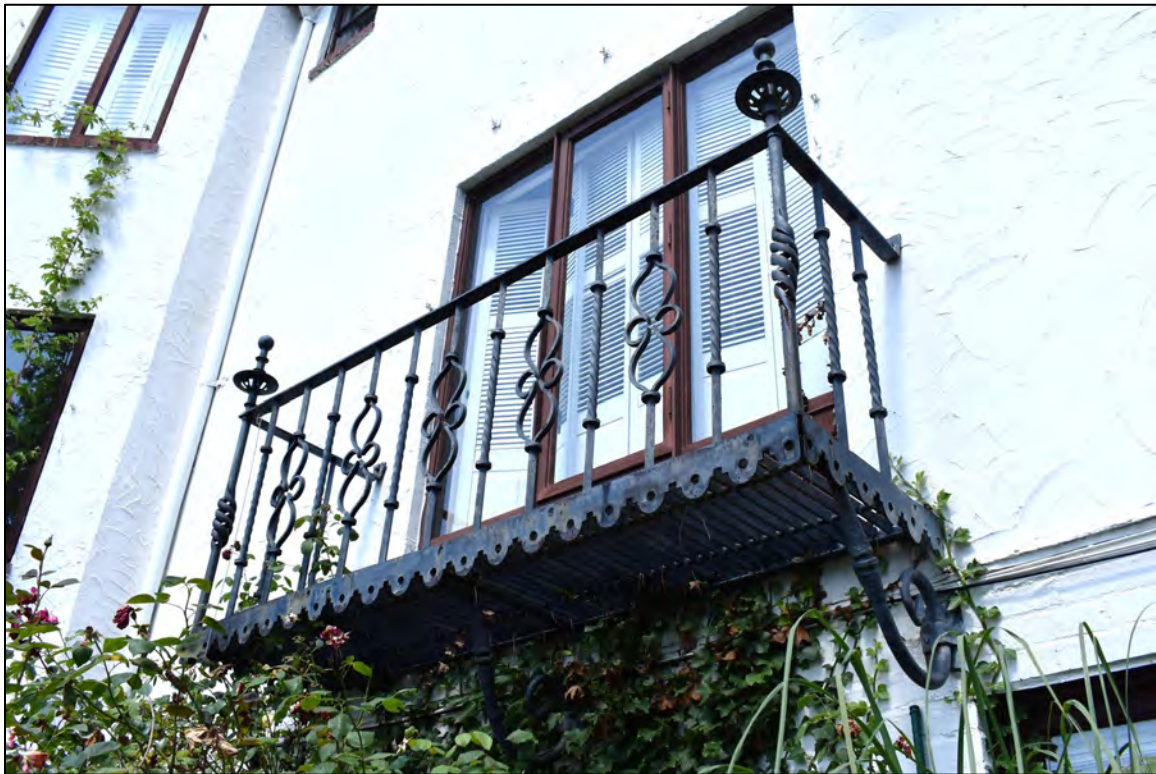
Fig. 12 – West facade, south part, detail of first floor wrought iron balcony.

July 19, 2024-September 7, 2024. Stucco repair, Paint Main House after new window installation and refurbish/paint iron balconies. Dakasi PMC.
