Early Guidance Meeting for
'Certificate of Approval'
JCCCW // Building 3 // Roof Replacement

Japanese Community and Cultural Center of Washington

1414 S. Weller Street, Seattle, WA 98144

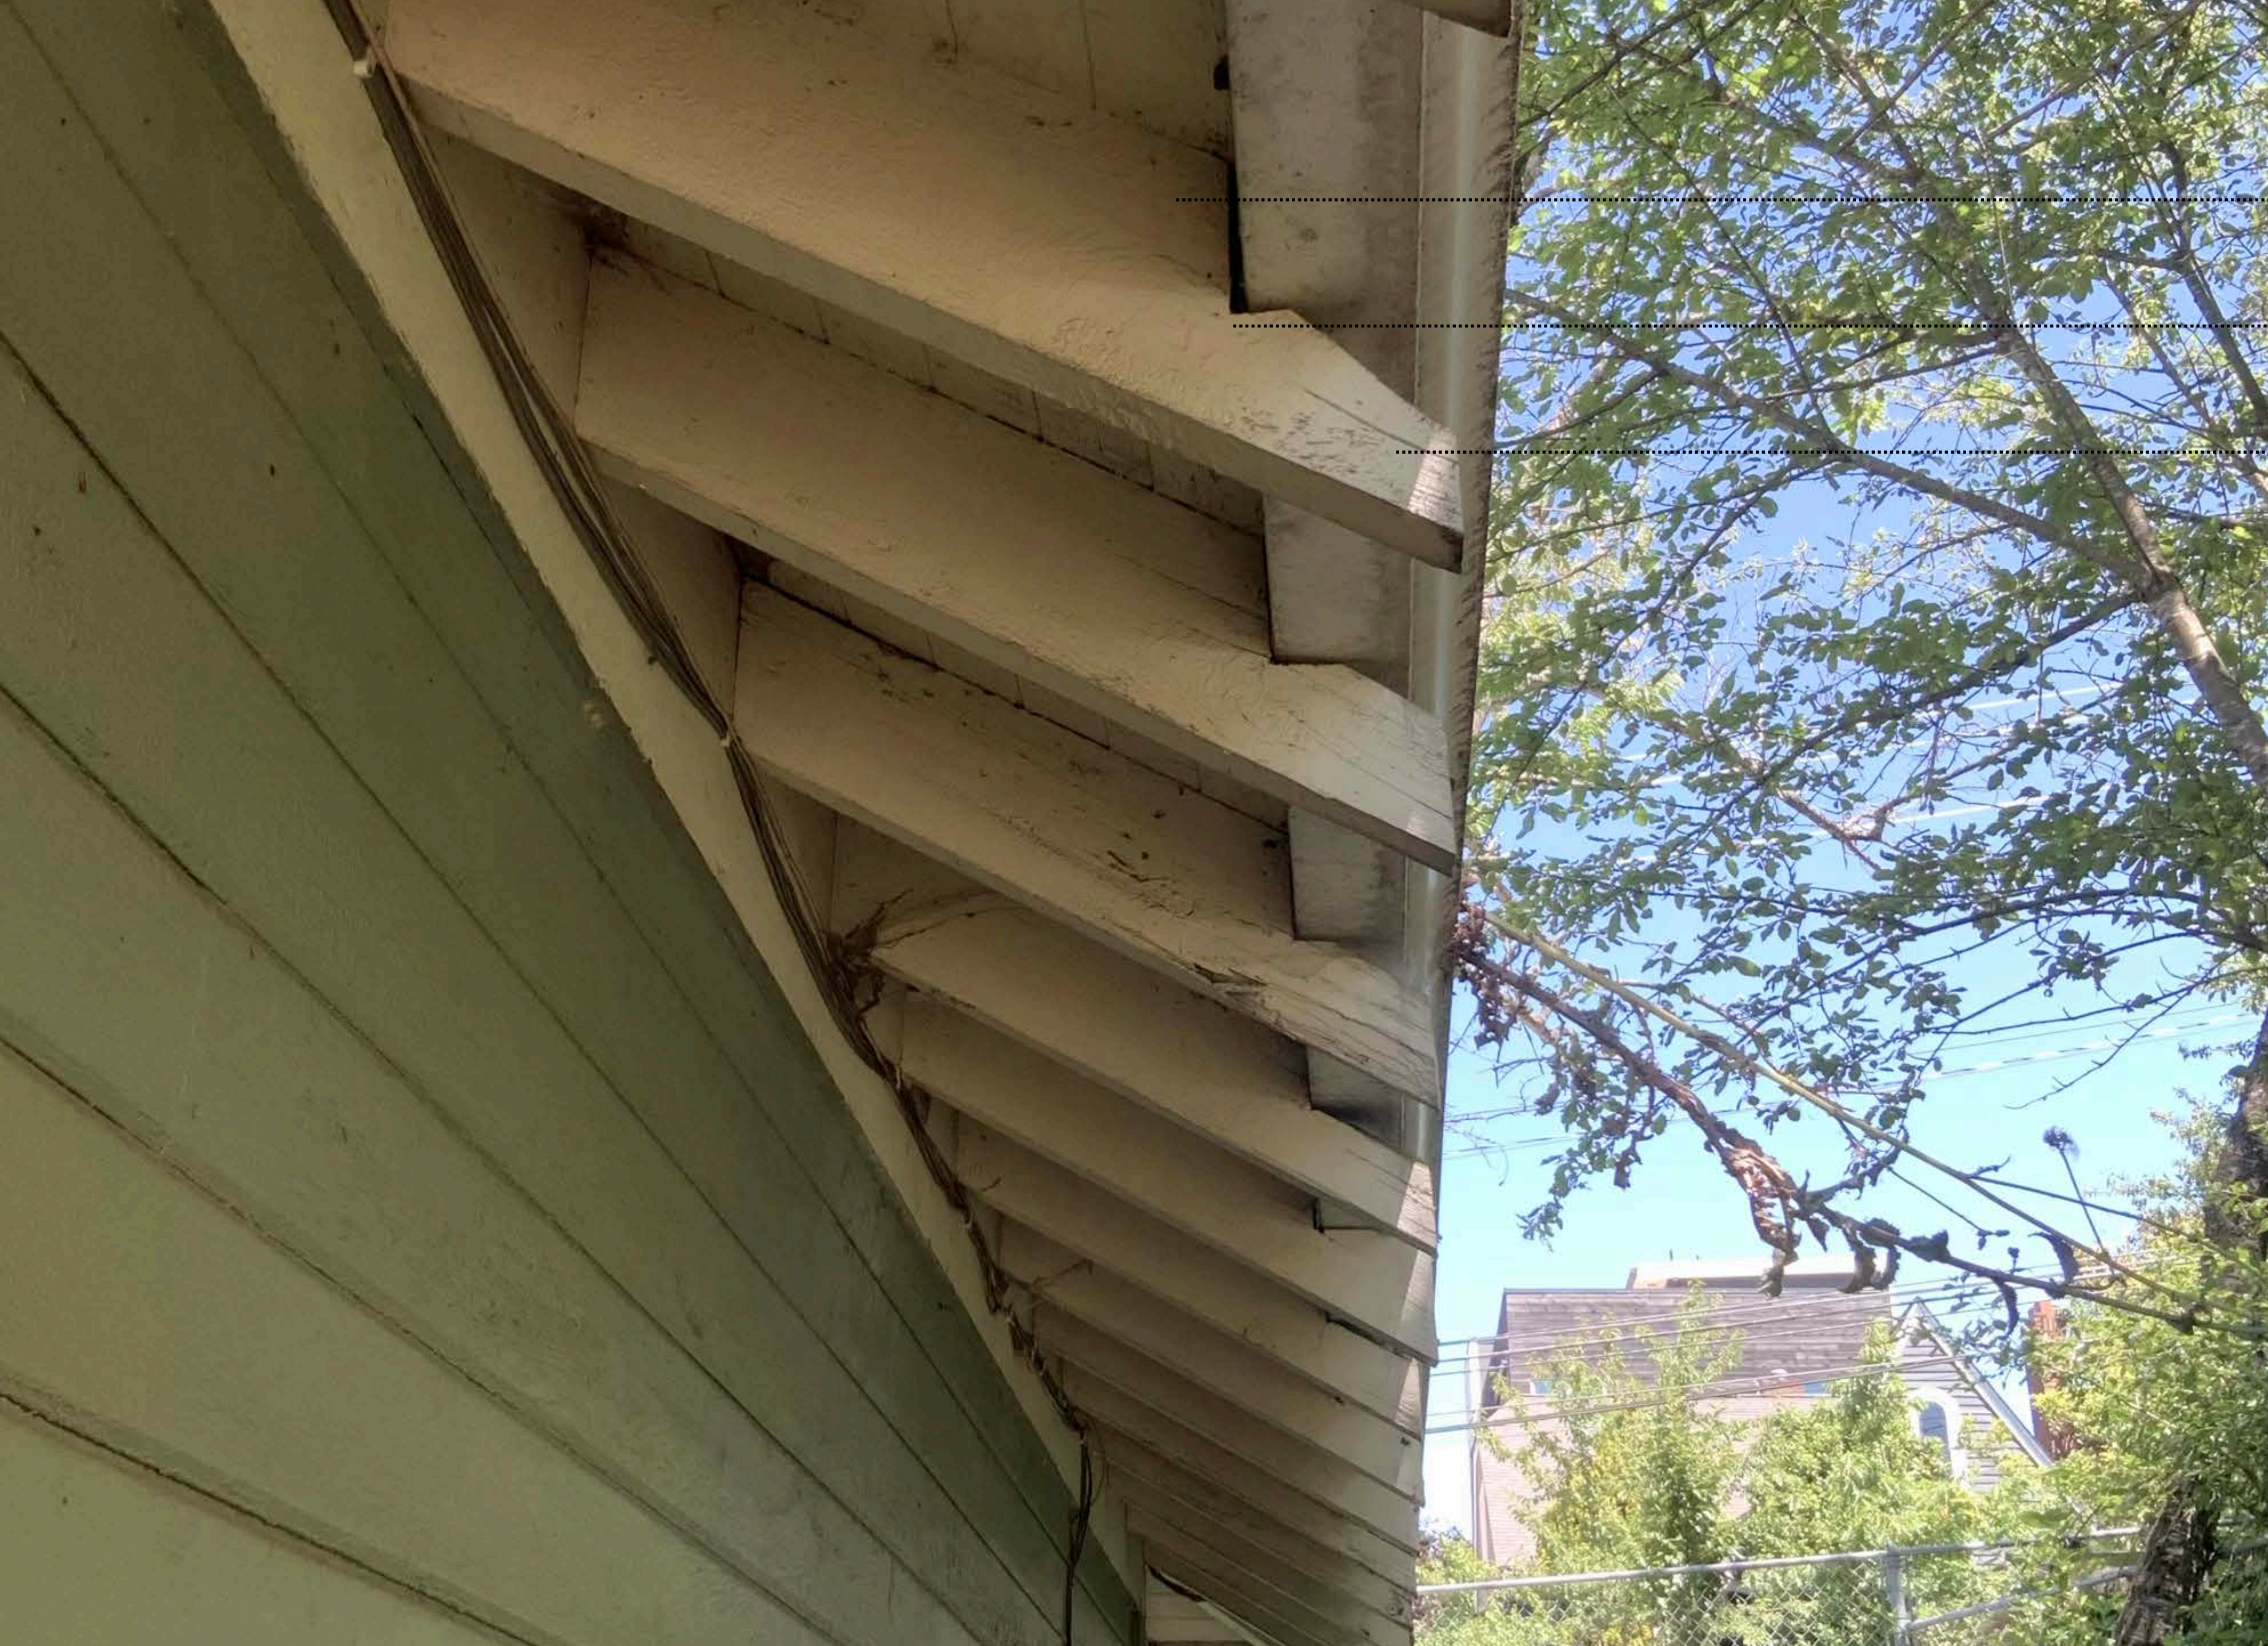
Rafter Tail / Gutter Detail

..... Gutter sits on 2x6" Rafter Tail

..... Flawed detail leading to water retention
..... between the base of the gutter and the
..... rafter tail cut to allocate it.

..... End grain face exposed to rain

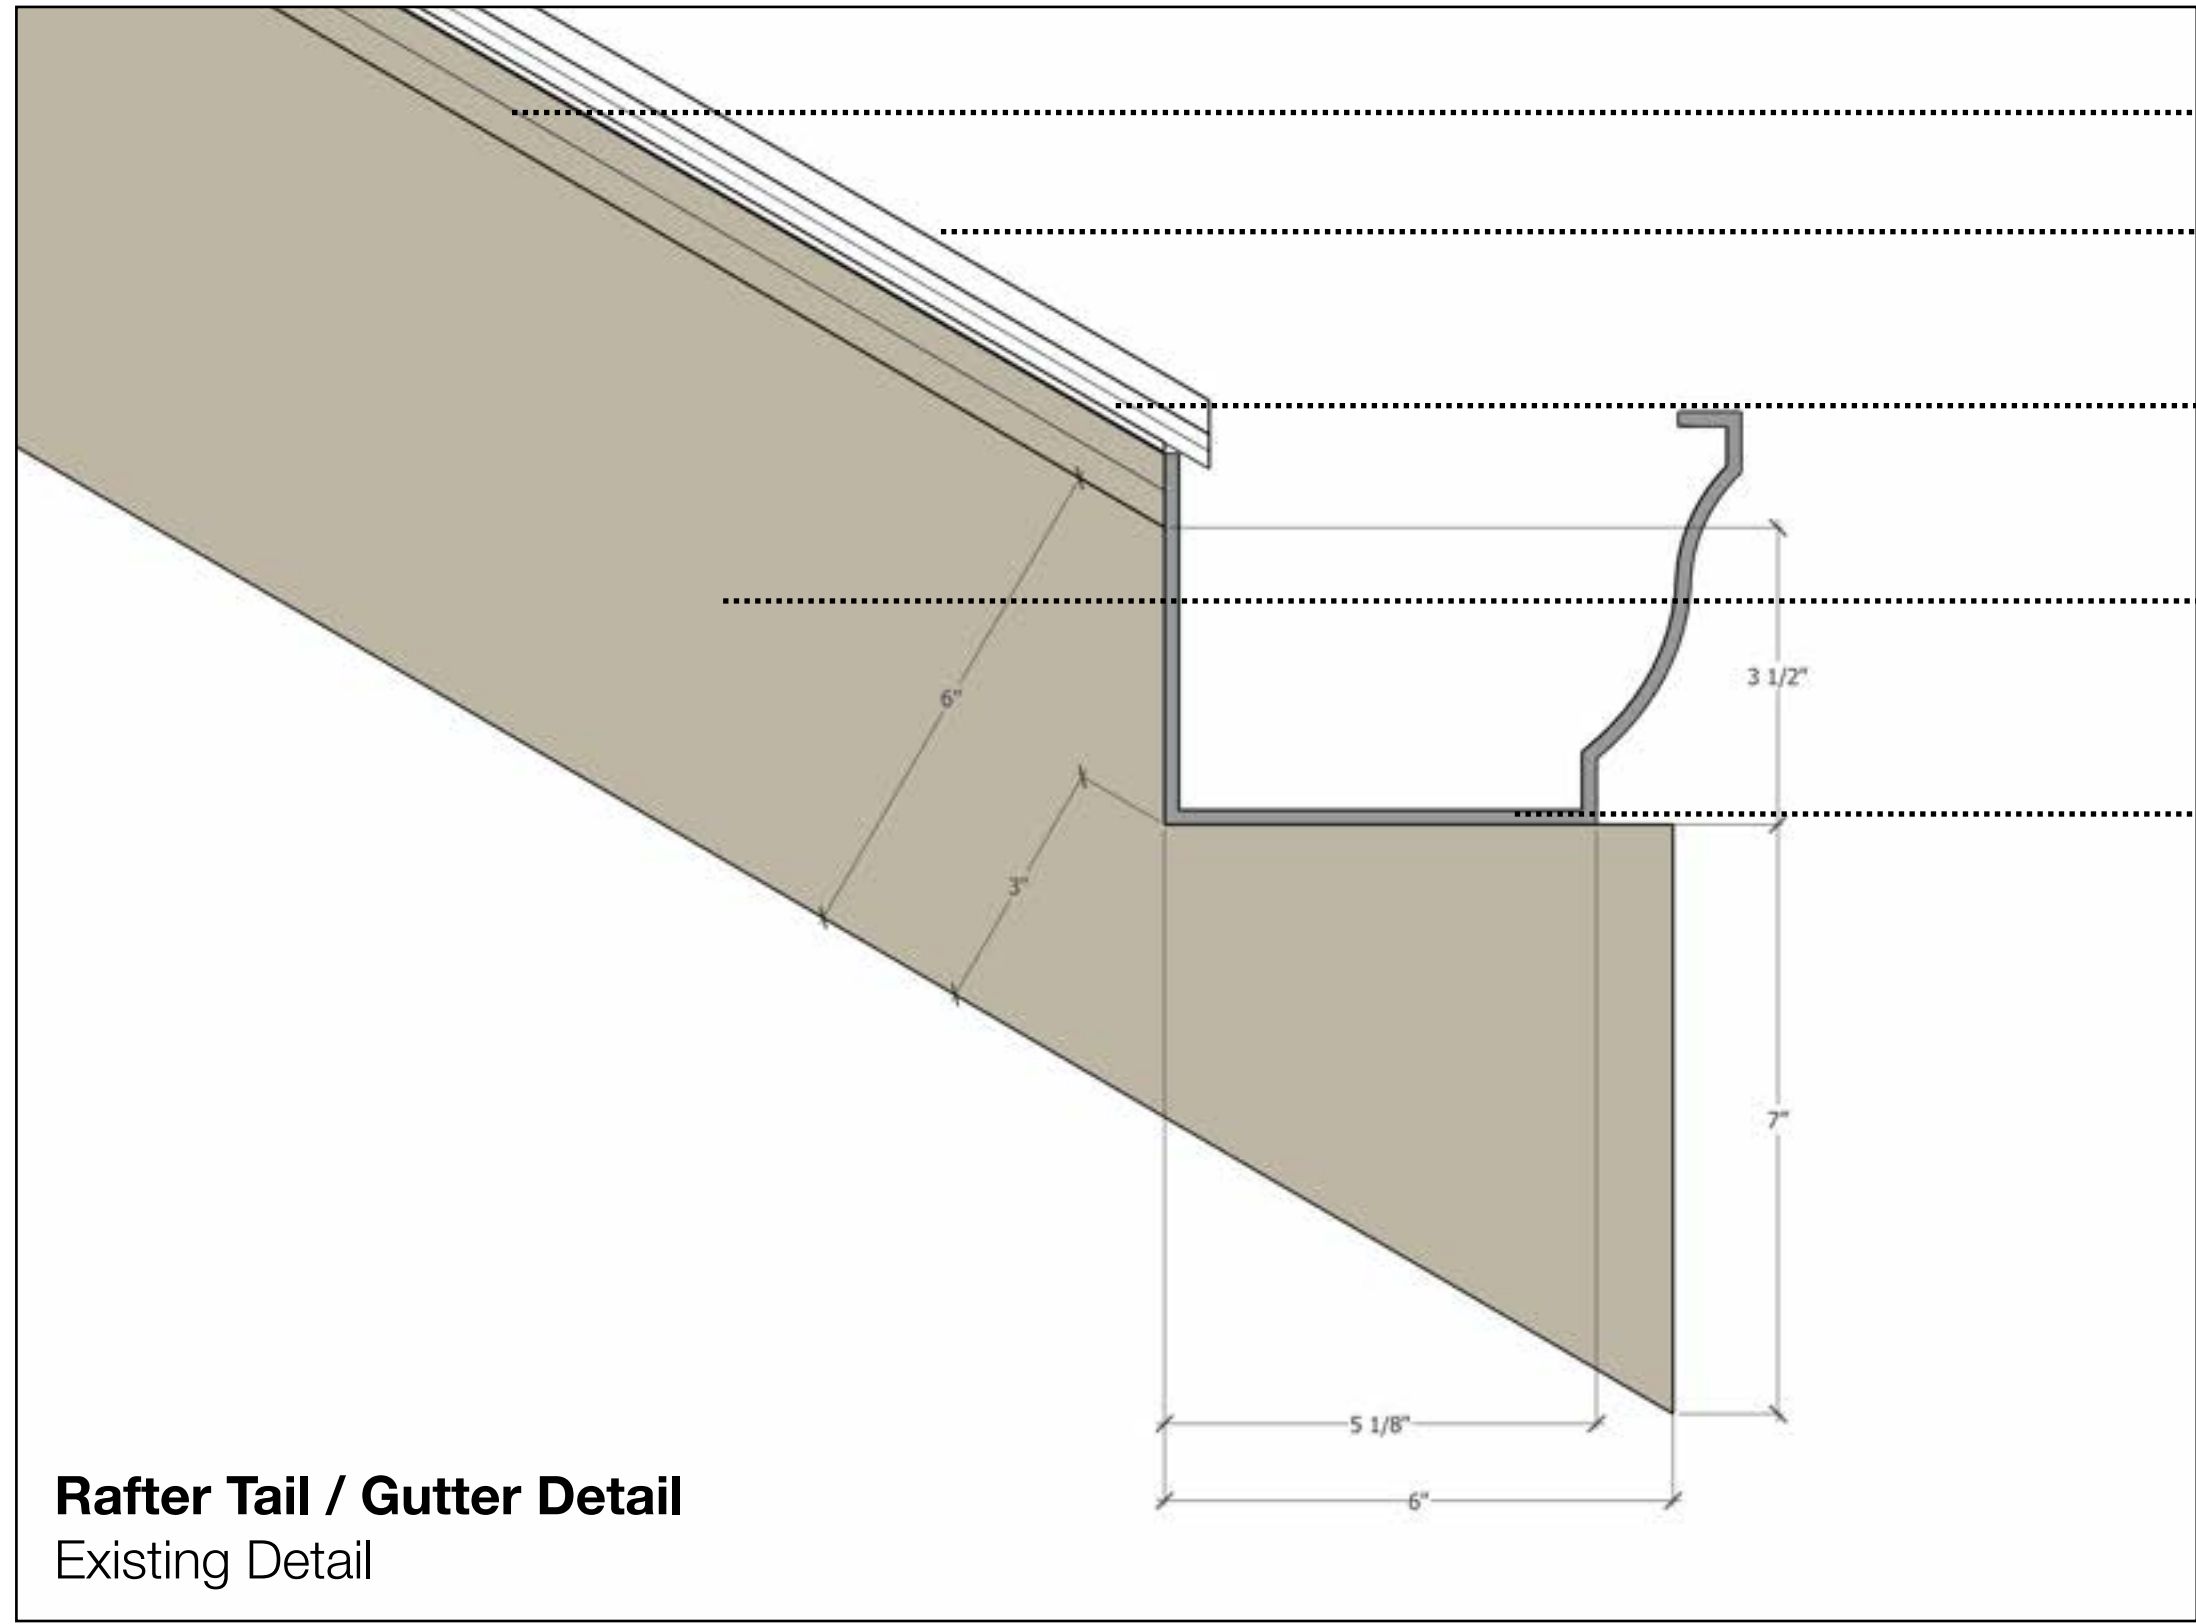
Rafter Tail / Gutter Detail
Existing Detail

..... exi. original fir planks + 1/2" plywood

..... 3 layers of asphalt shingles

..... exi. waterproof paper

..... 2"x6" rafter tail 16" o.c.

..... aluminum gutter in contact with the notched portion of the rafter tail

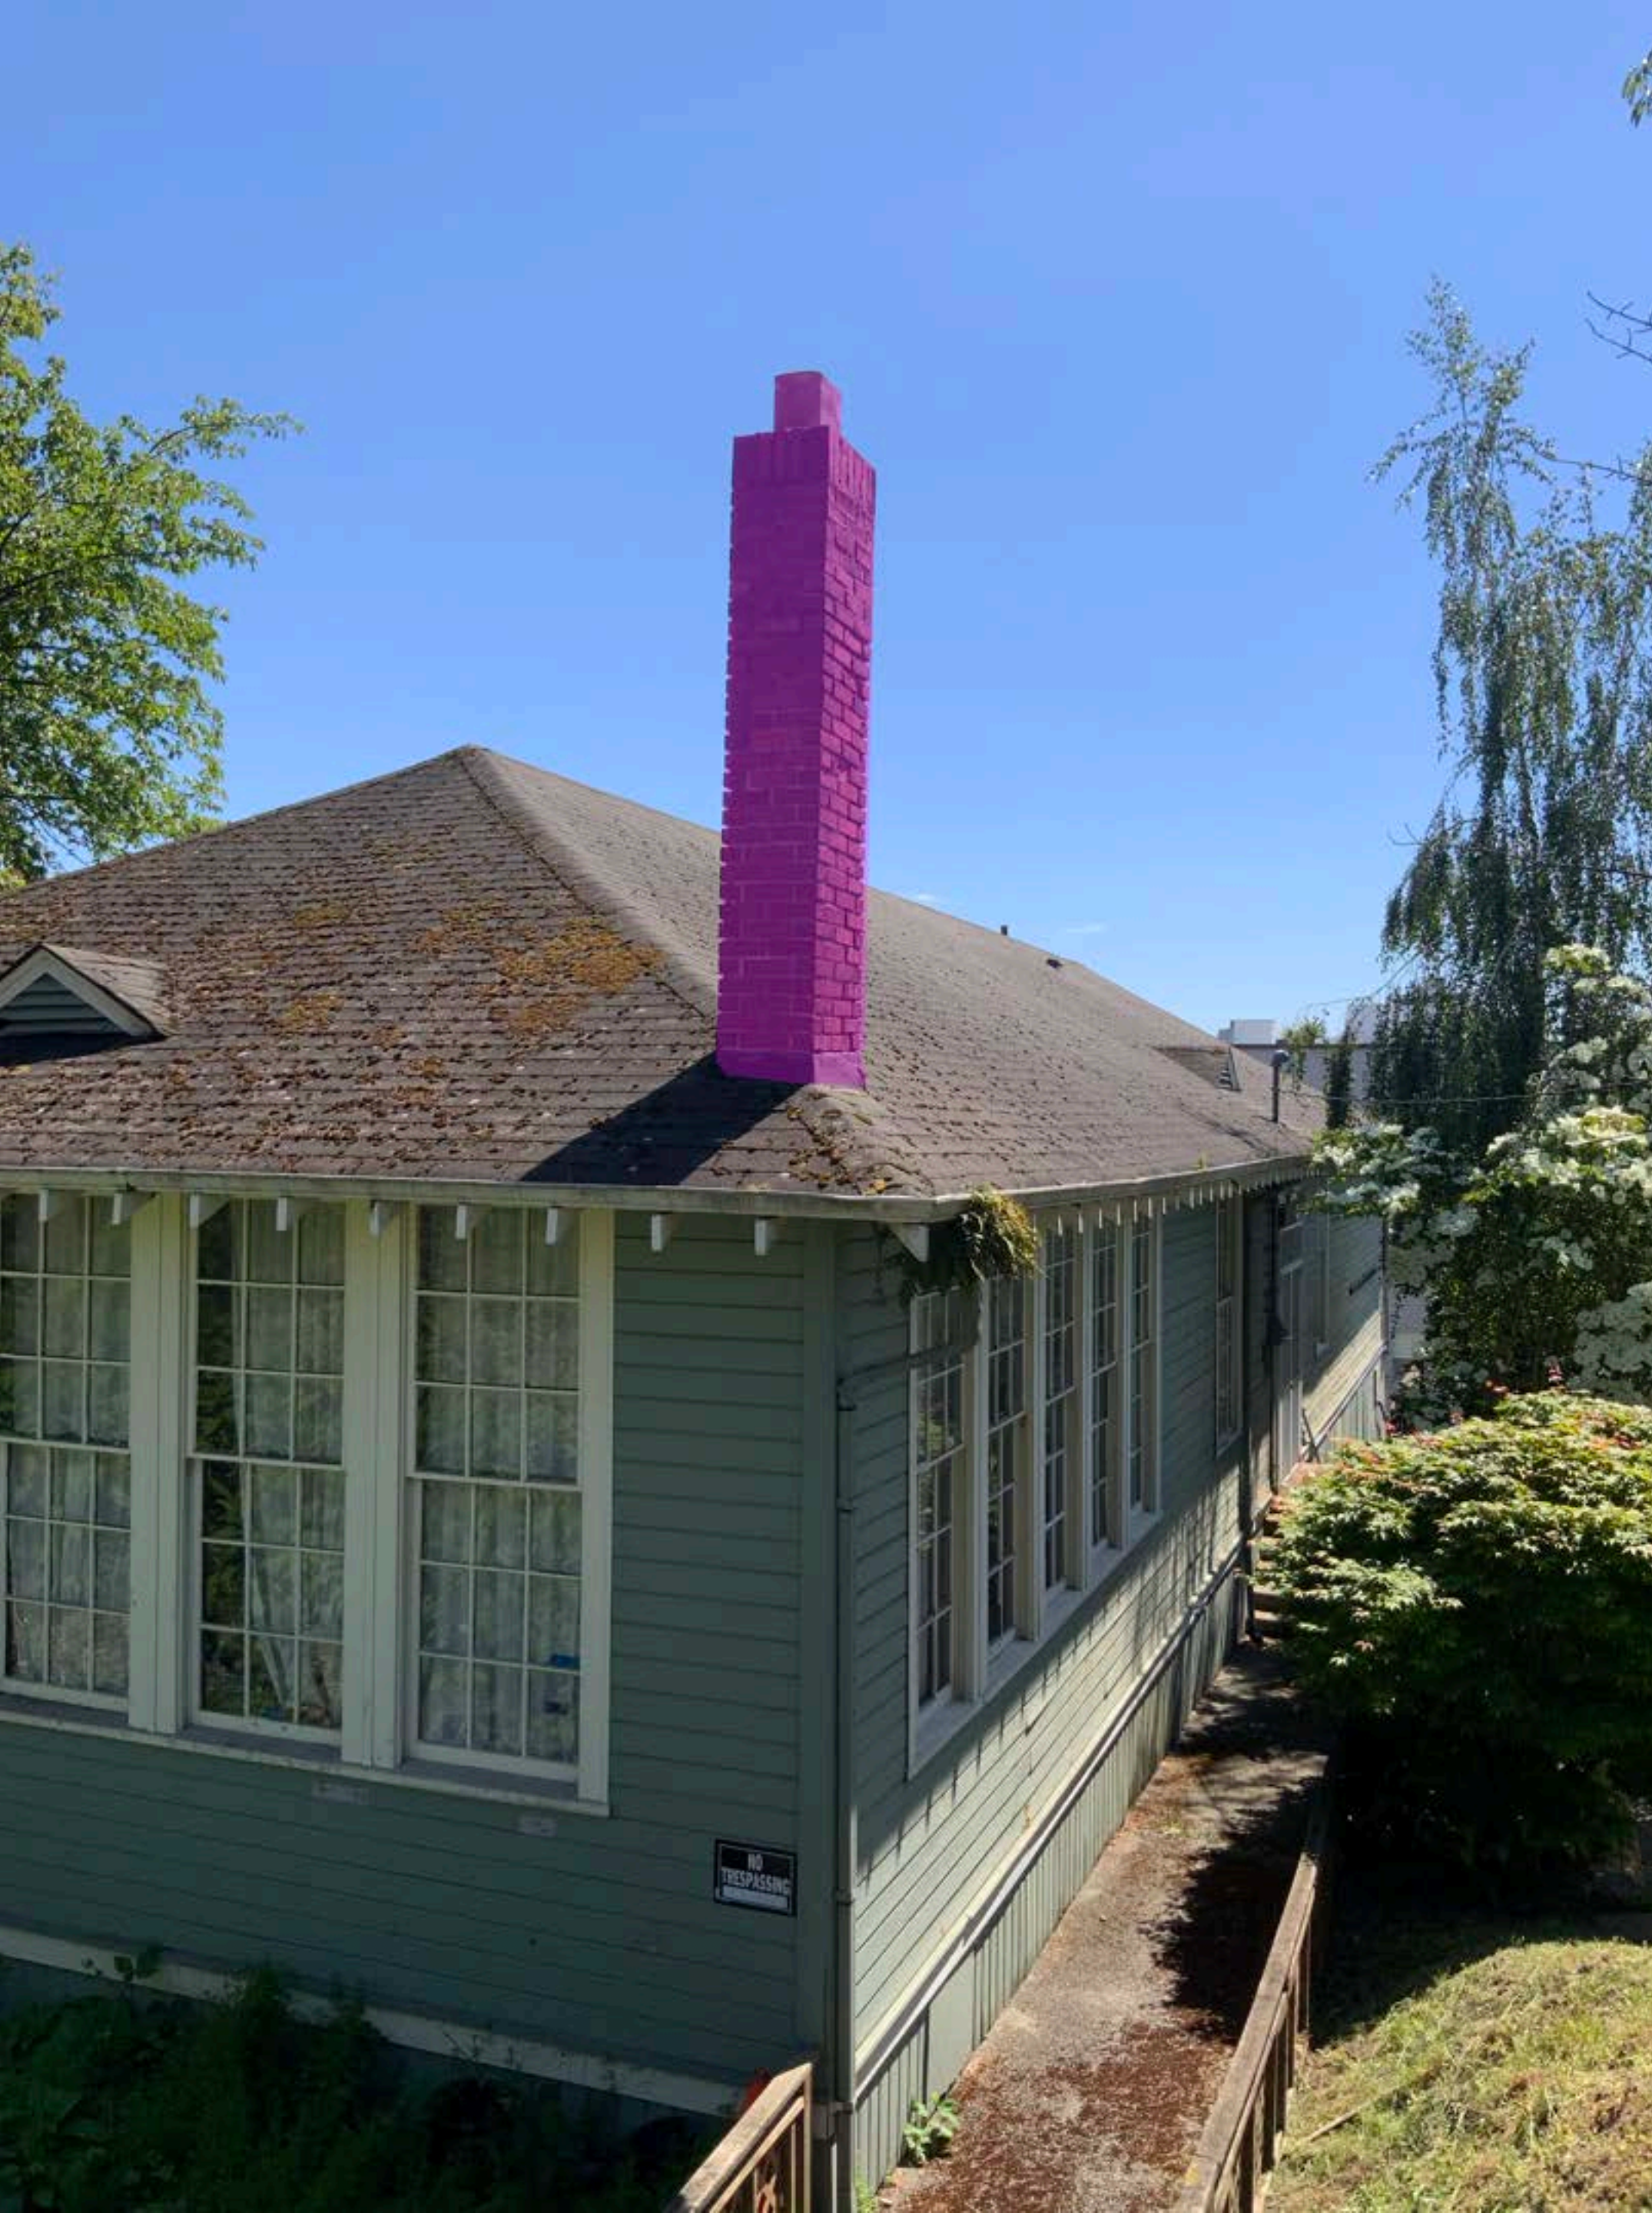
Of the three original chimney flues, only two remain. These flues, made of 4" bricks and measuring 8" x 12", are currently unbraced and show significant signs of deterioration. This deterioration is the primary cause of water intrusion in the classrooms below and poses a safety hazard for the building, as well as for the students attending classes and the children playing outside on the deck.

Numerous previous attempts to address the issue, including patches of drywall below the lath and plaster ceiling, have been unsuccessful. The Roof Replacement Intervention proposes a full plywood re-sheeting and proposes either eliminating or reducing the size of these deteriorating flues.

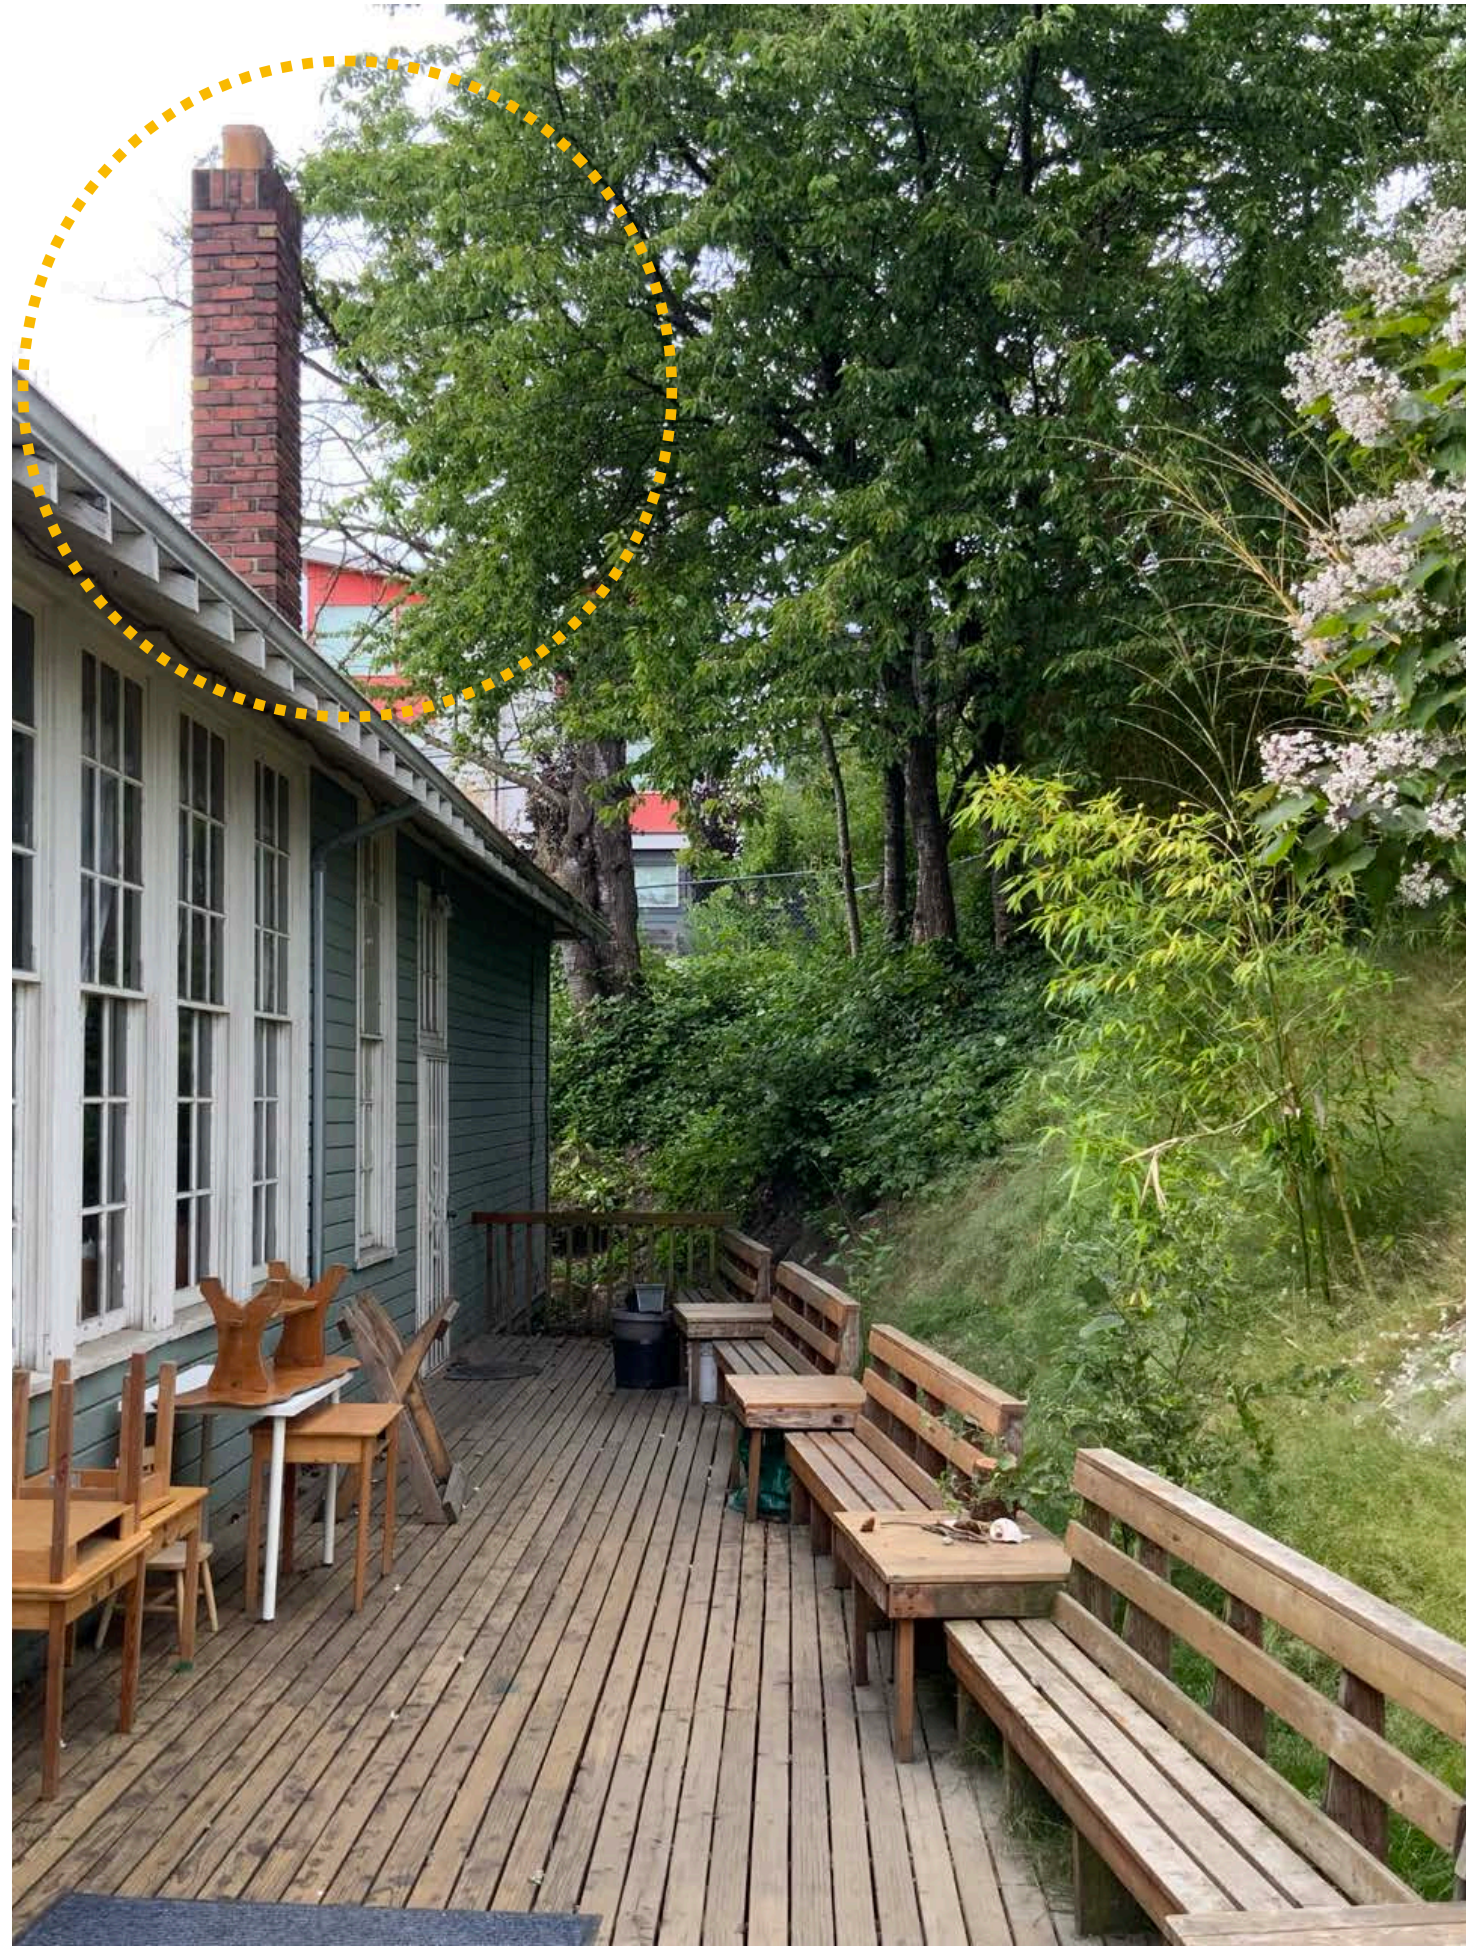
Hazard for students playing outside on the outdoor deck

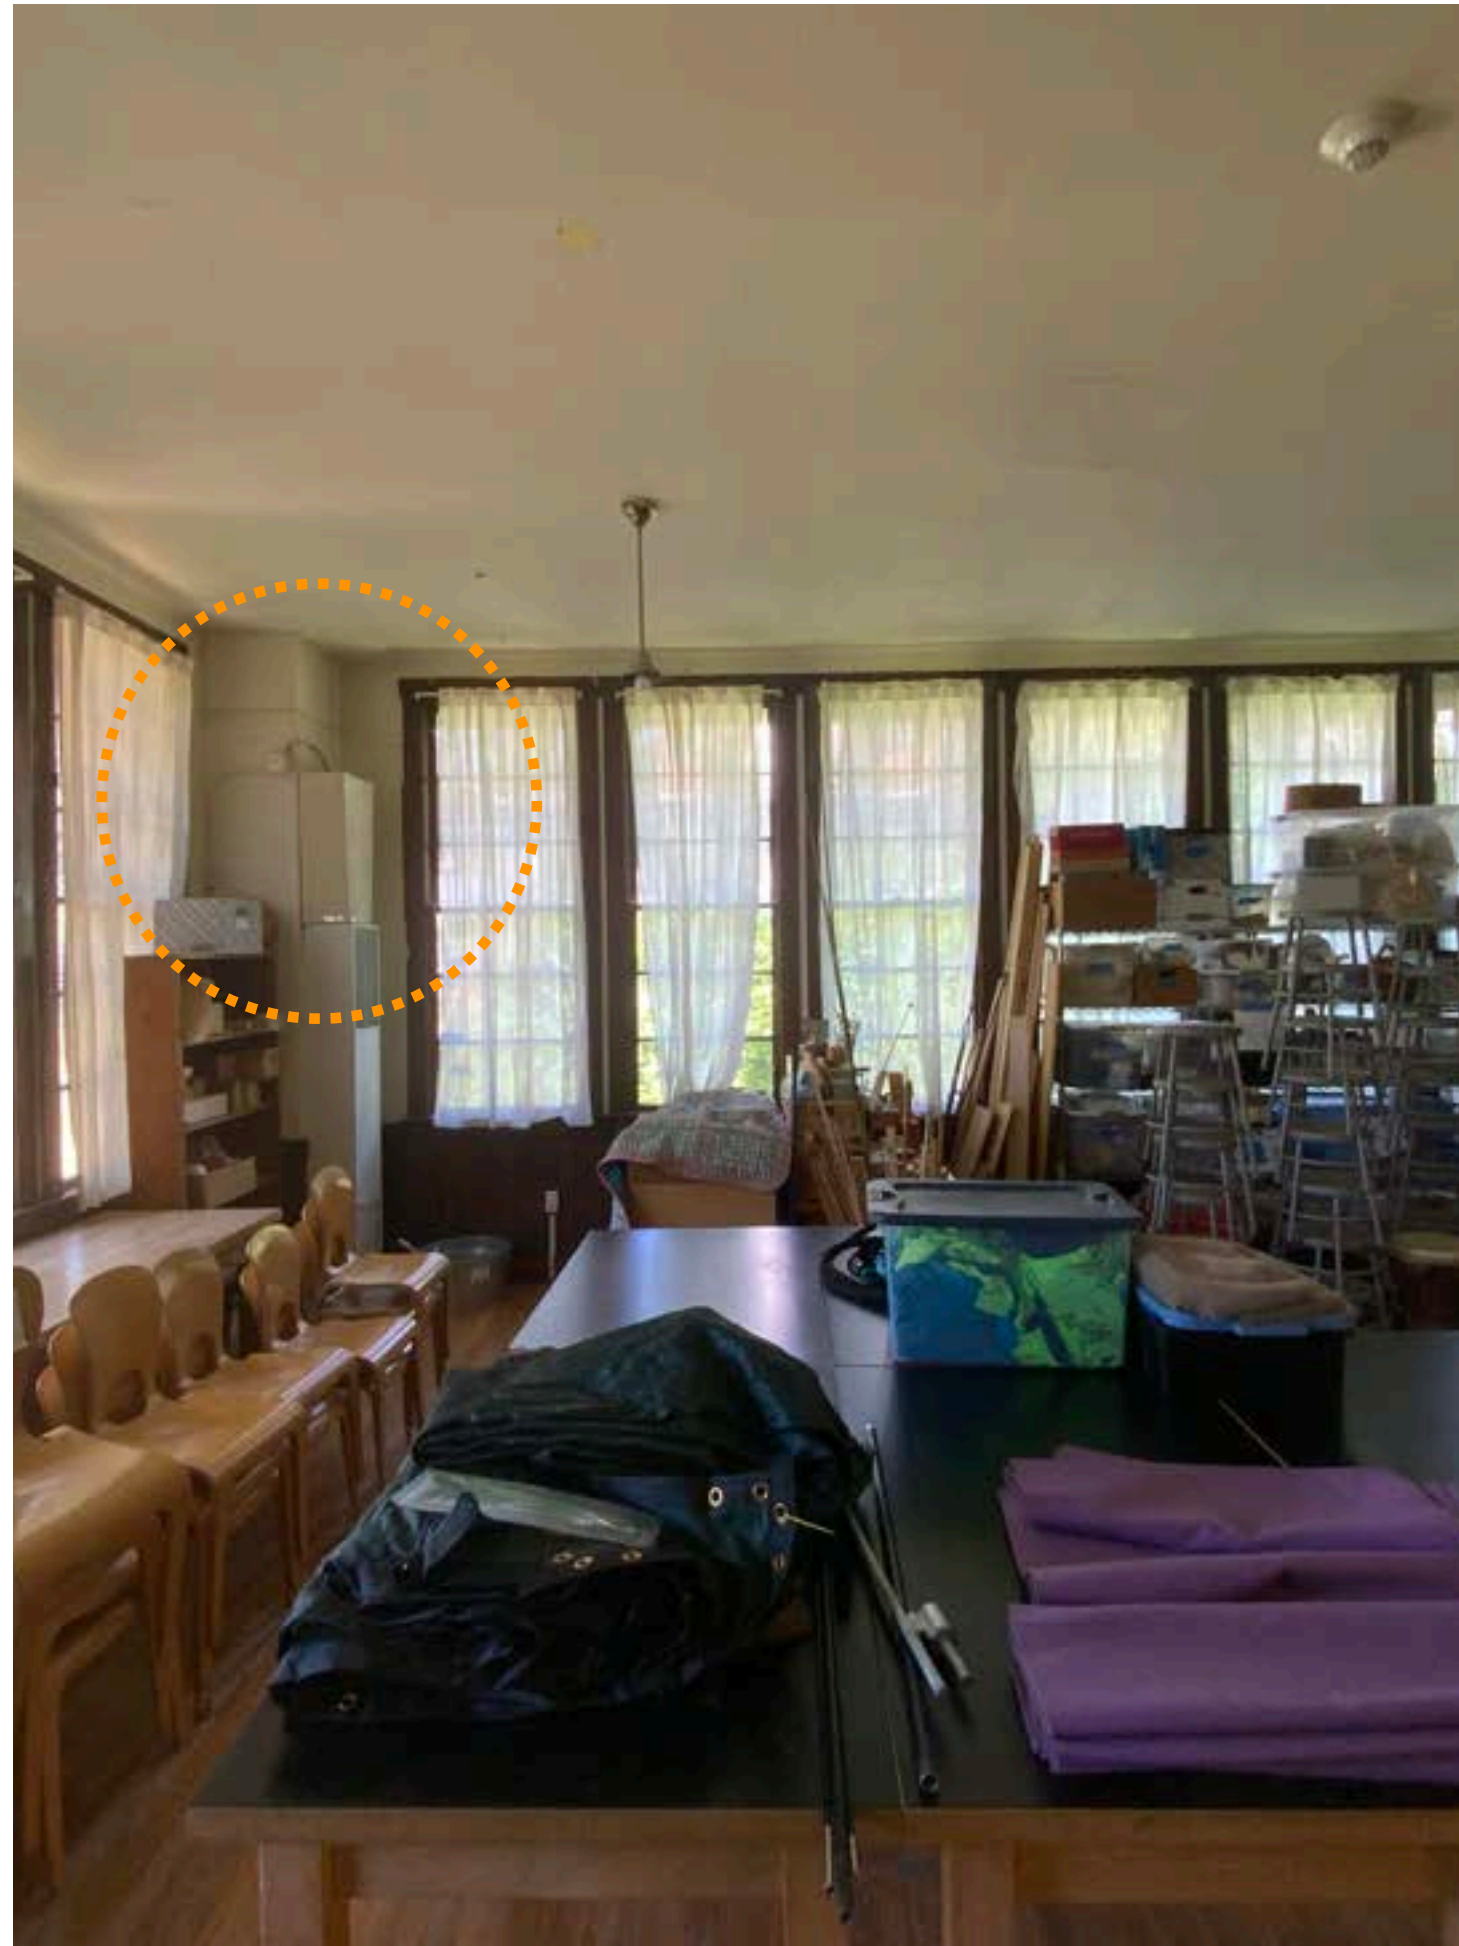
Hazard for students attending the classes

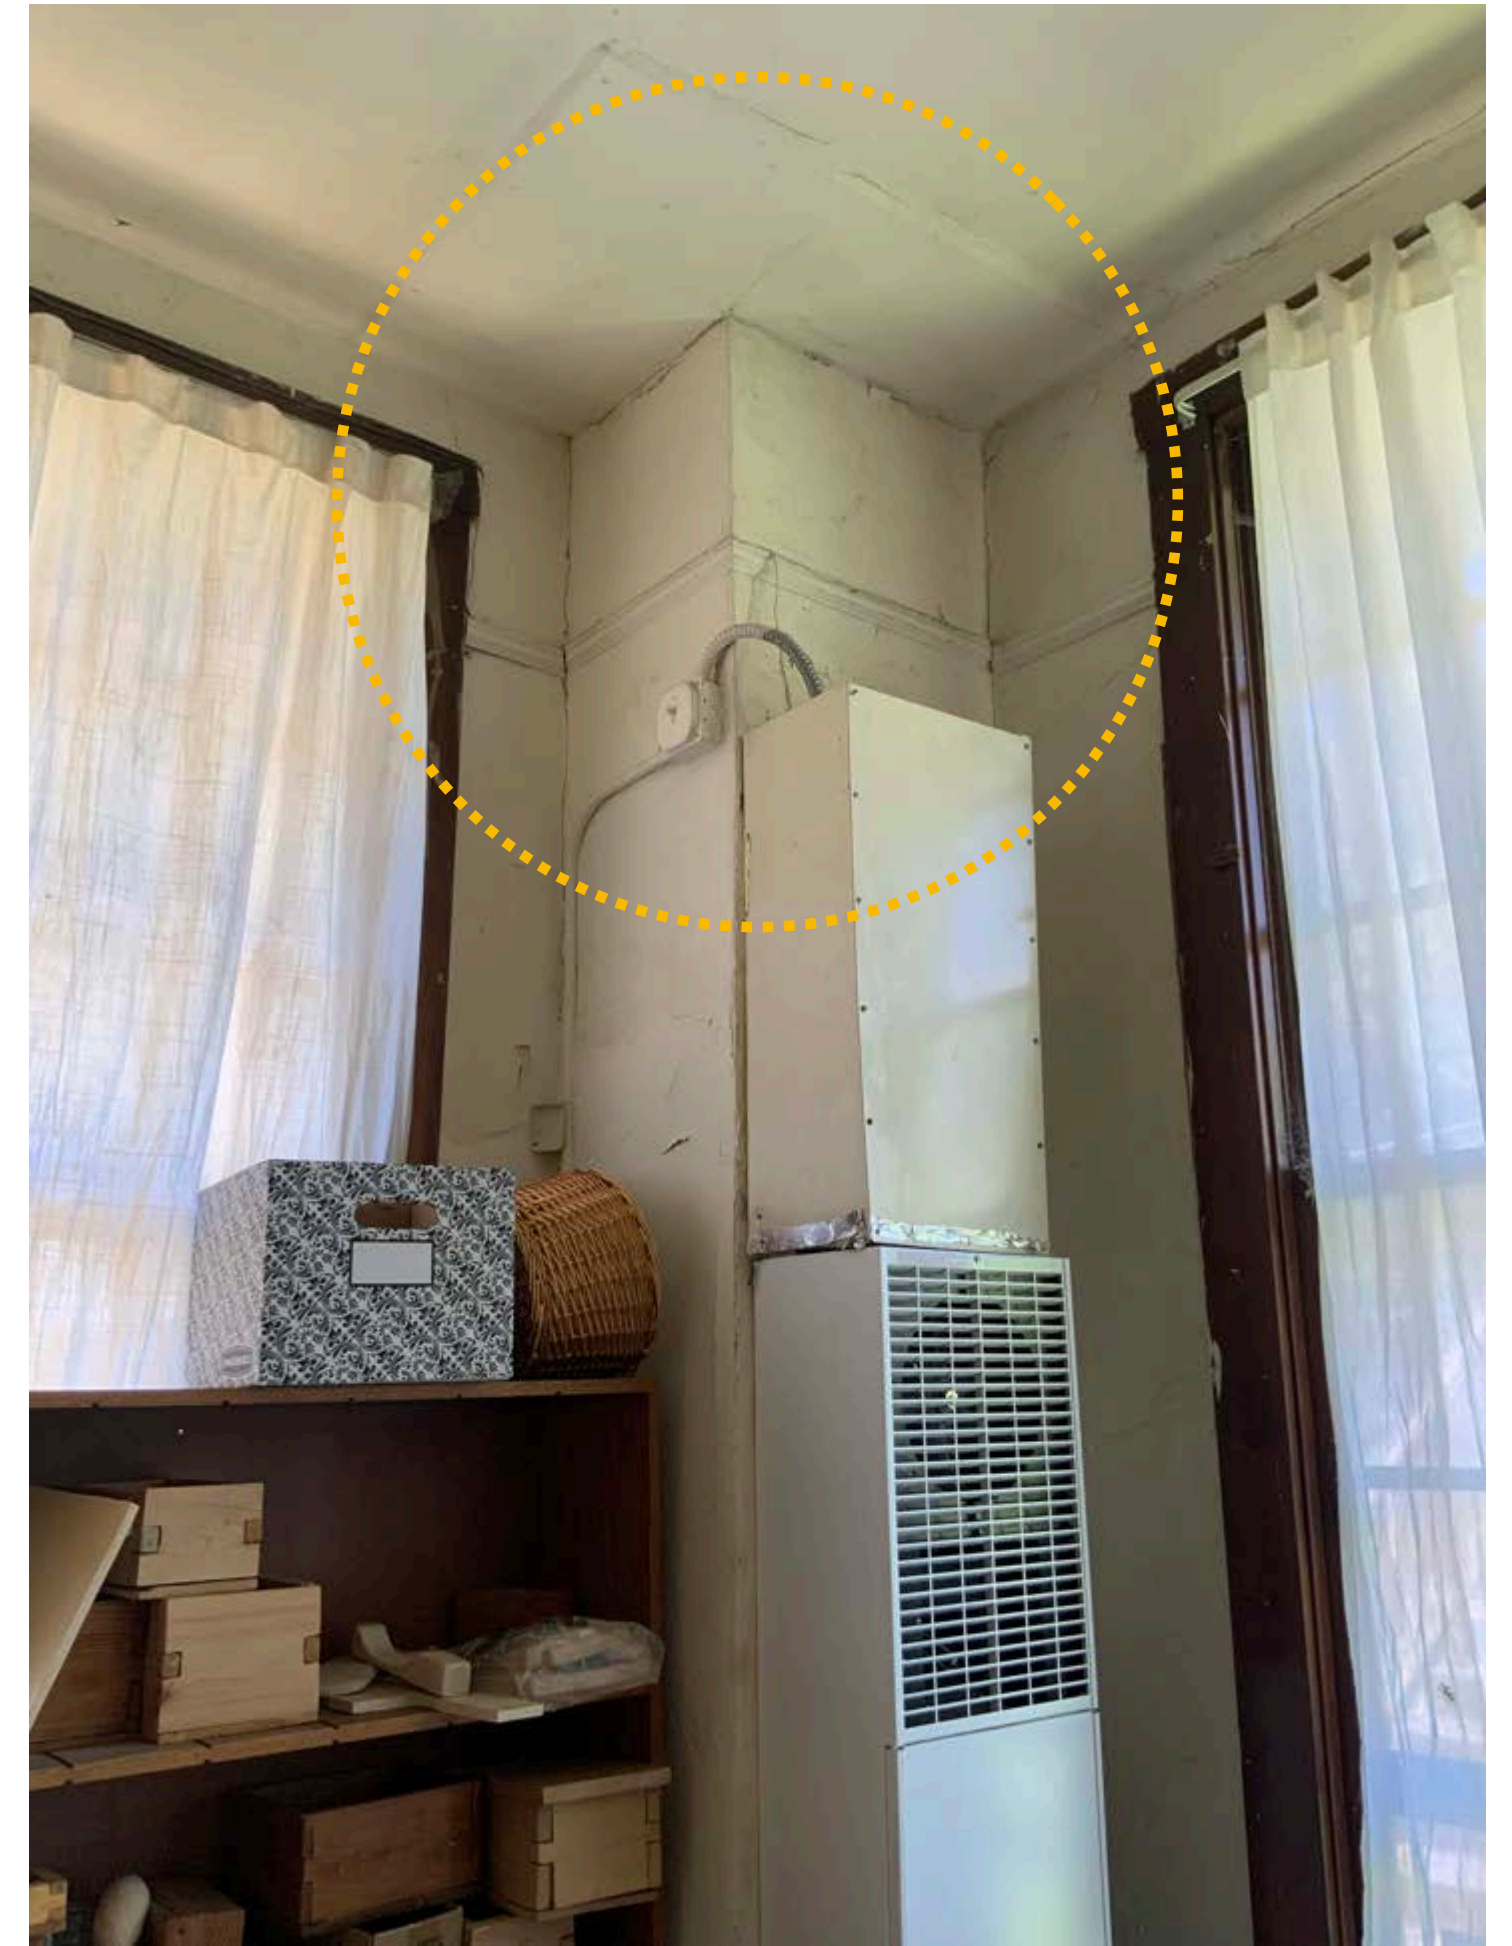
Sign of previous patches and water intrusion
