Early Guidance Meeting for
'Certificate of Approval'
JCCCW // Building 3 // Roof Replacement

Japanese Community and Cultural Center of Washington

1414 S. Weller Street, Seattle, WA 98144

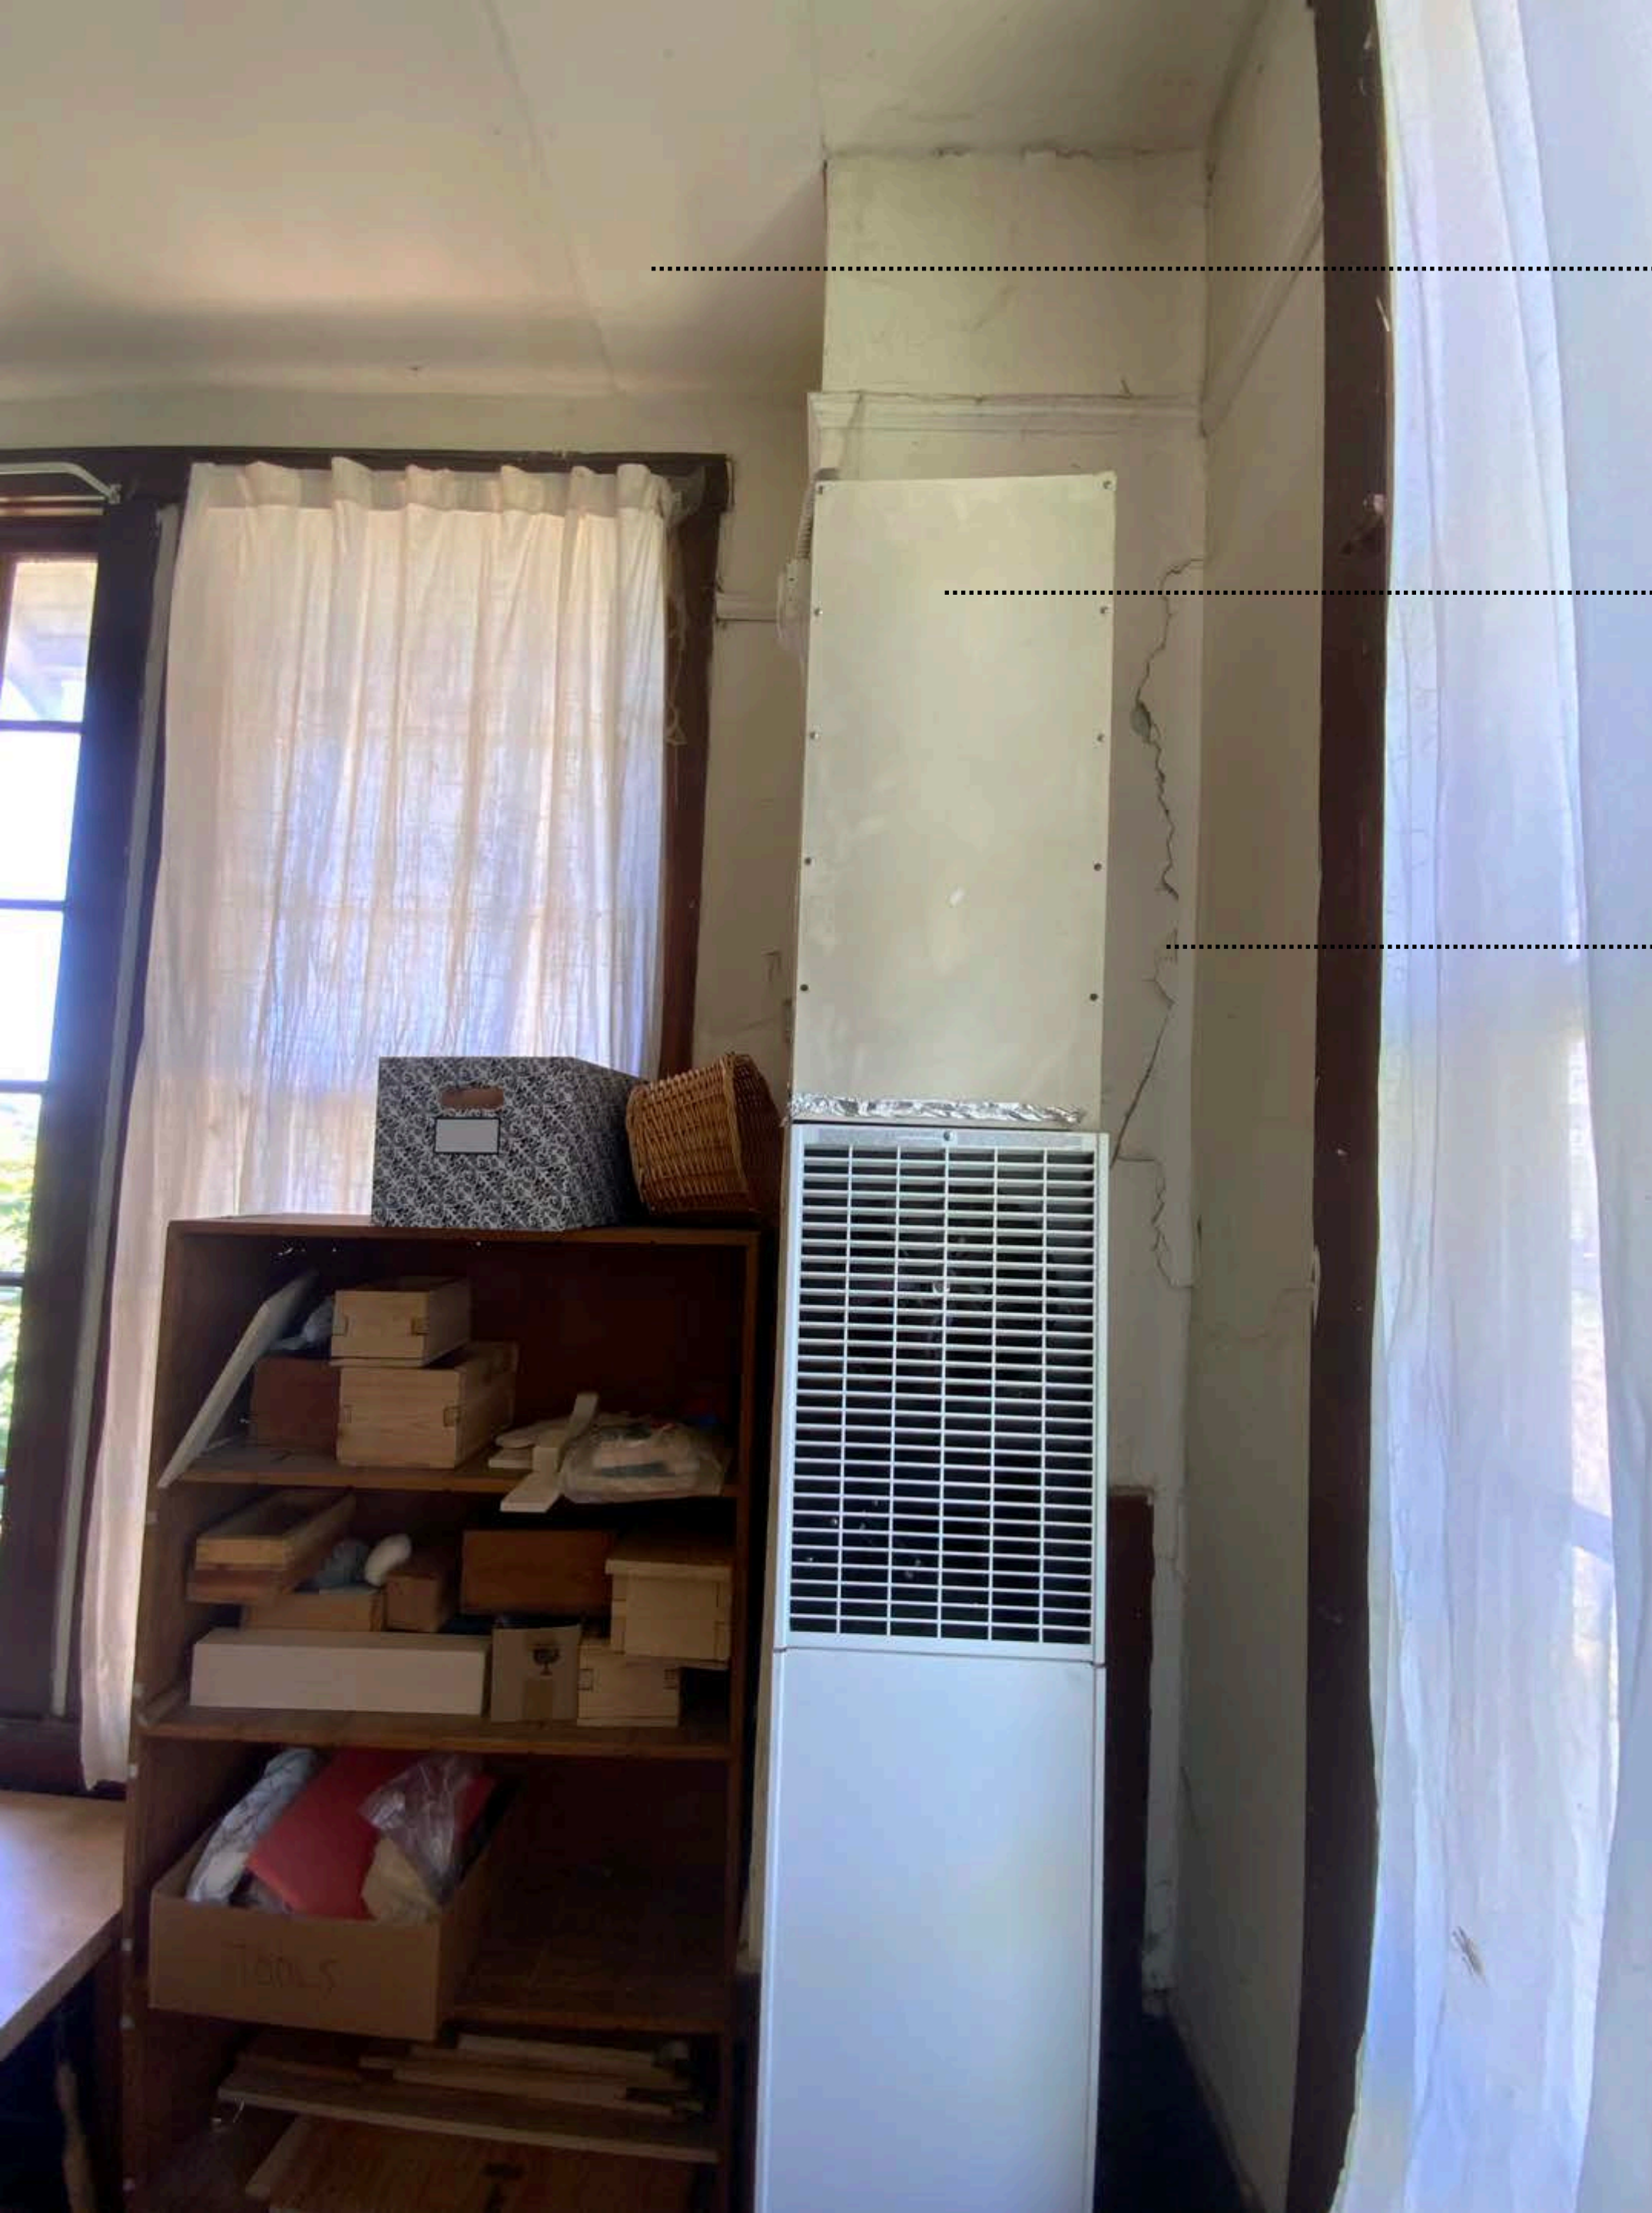
Previous unsuccessful ceiling patch

Structural crack sign of detachment from main structure

Obsolete HVAC units are set to be replaced in the fall by a new Heat Pump system for the entire building, with ducts running in the crawlspace

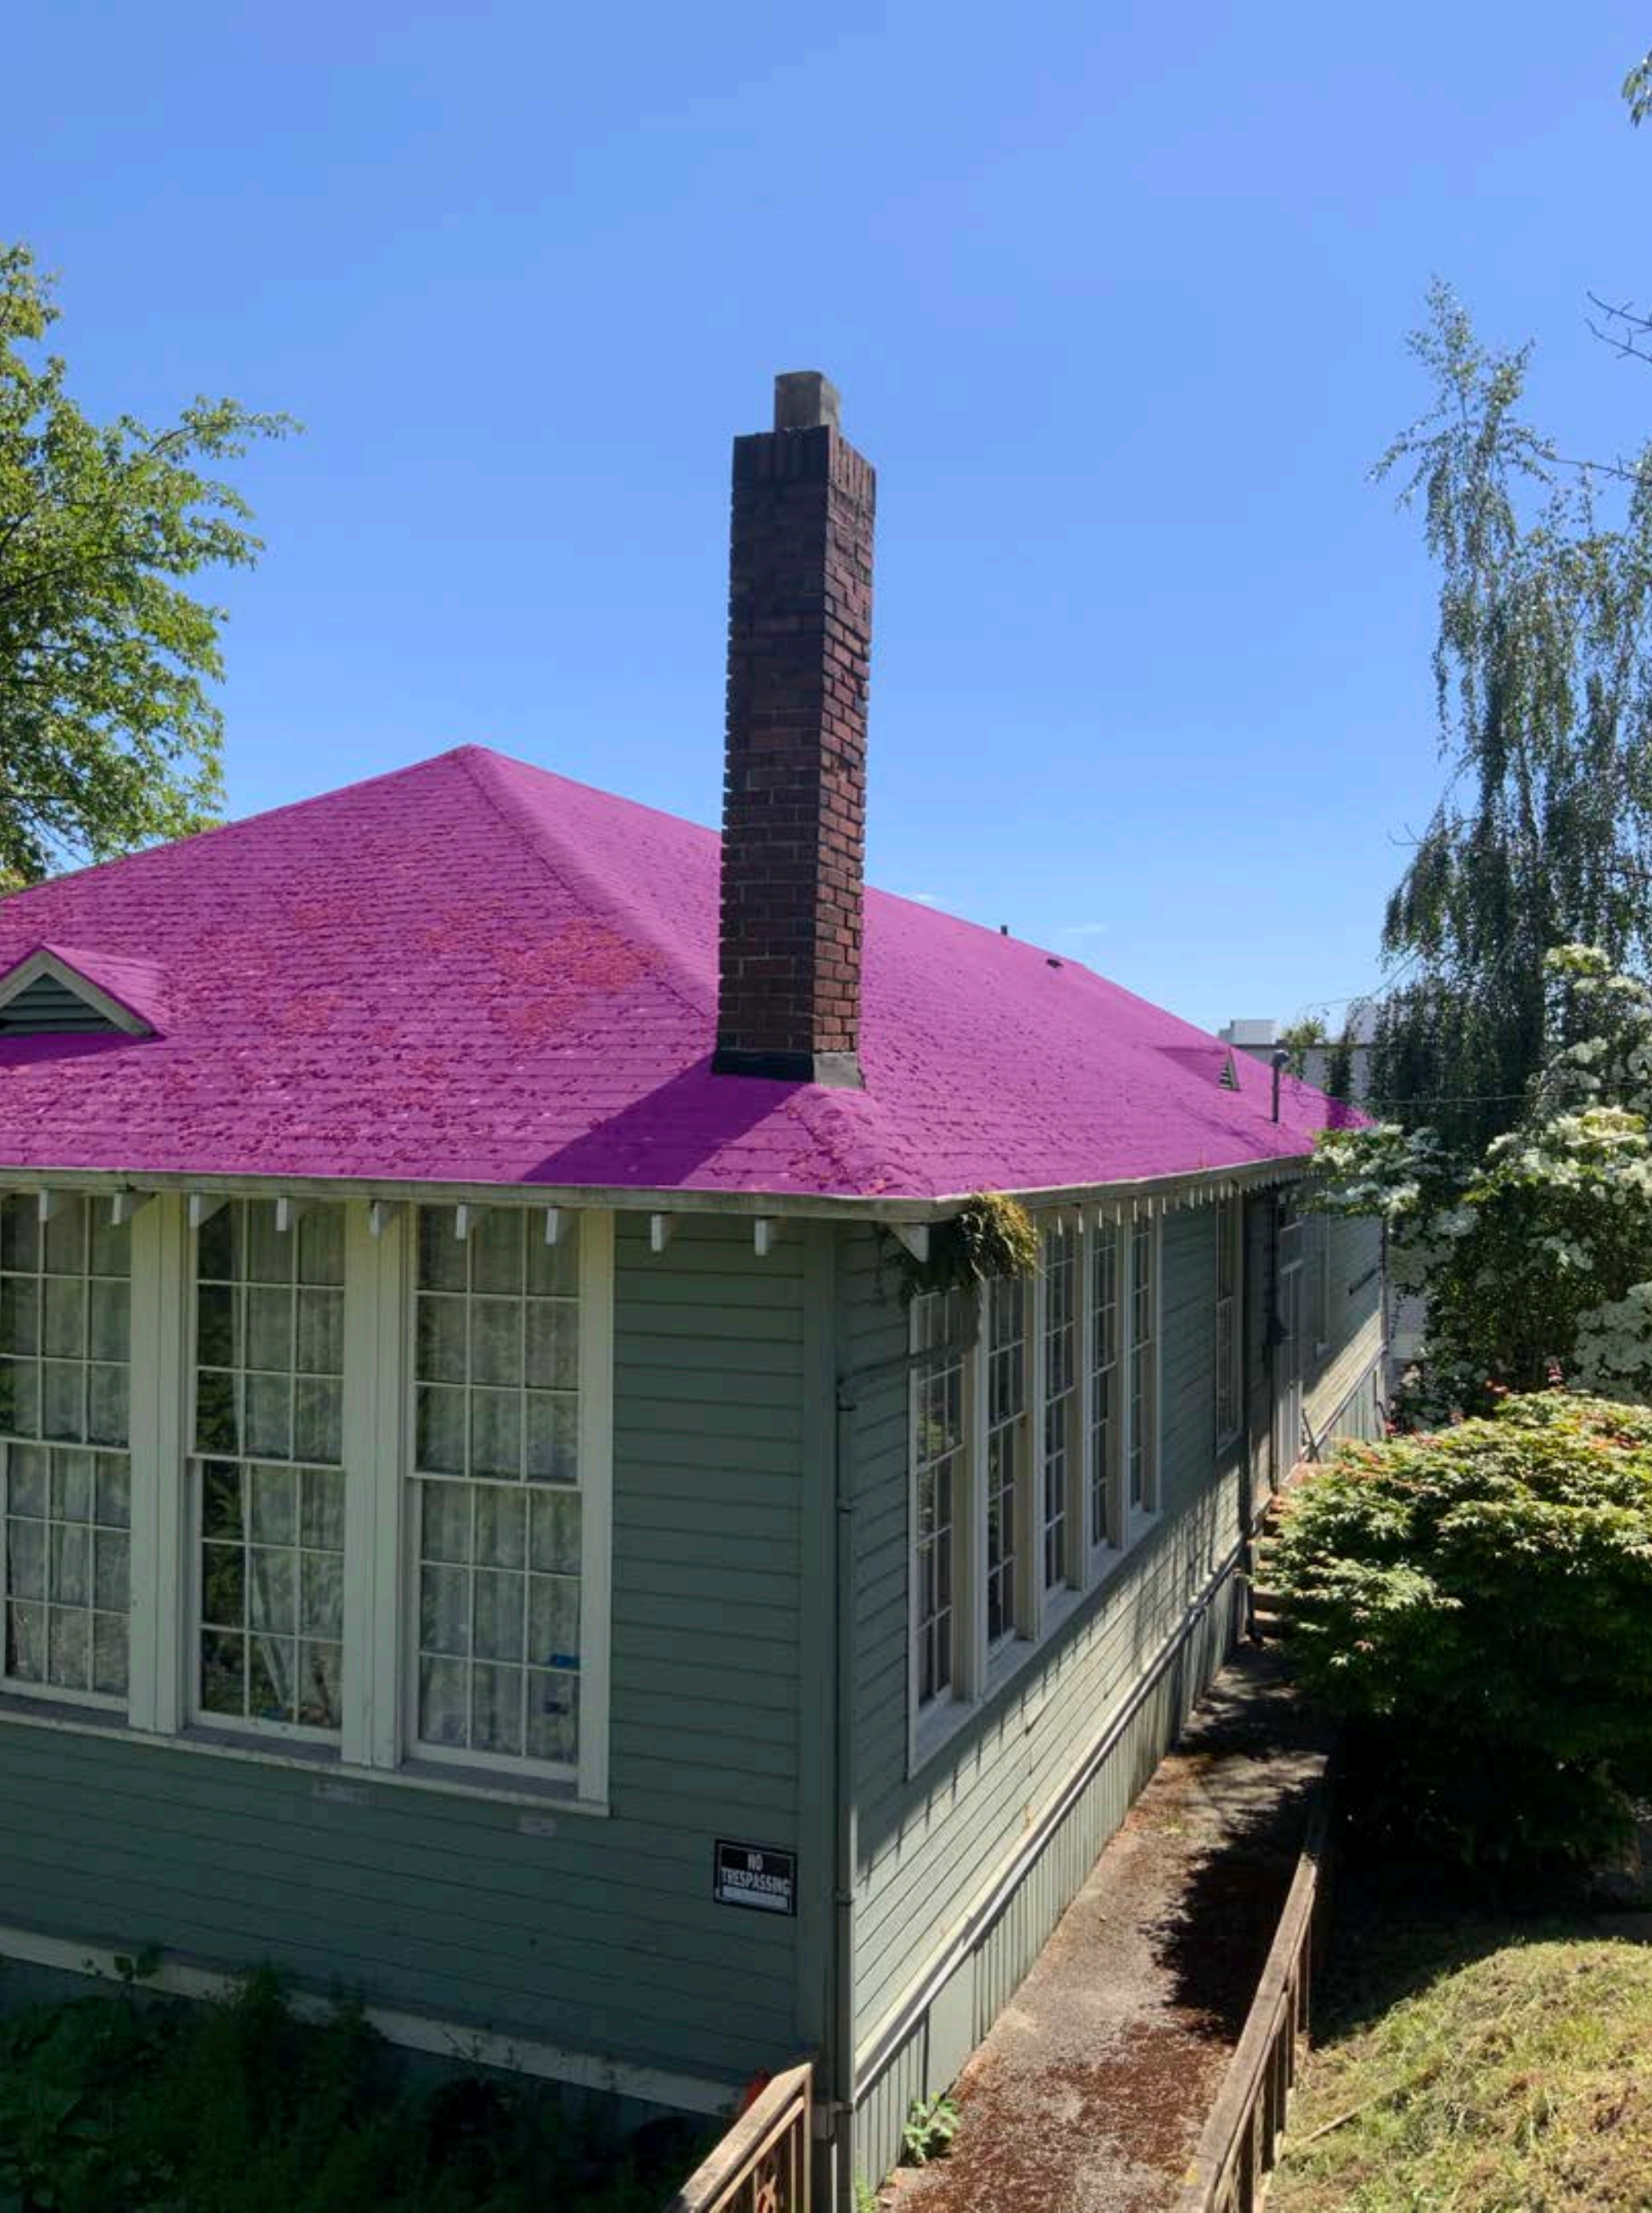
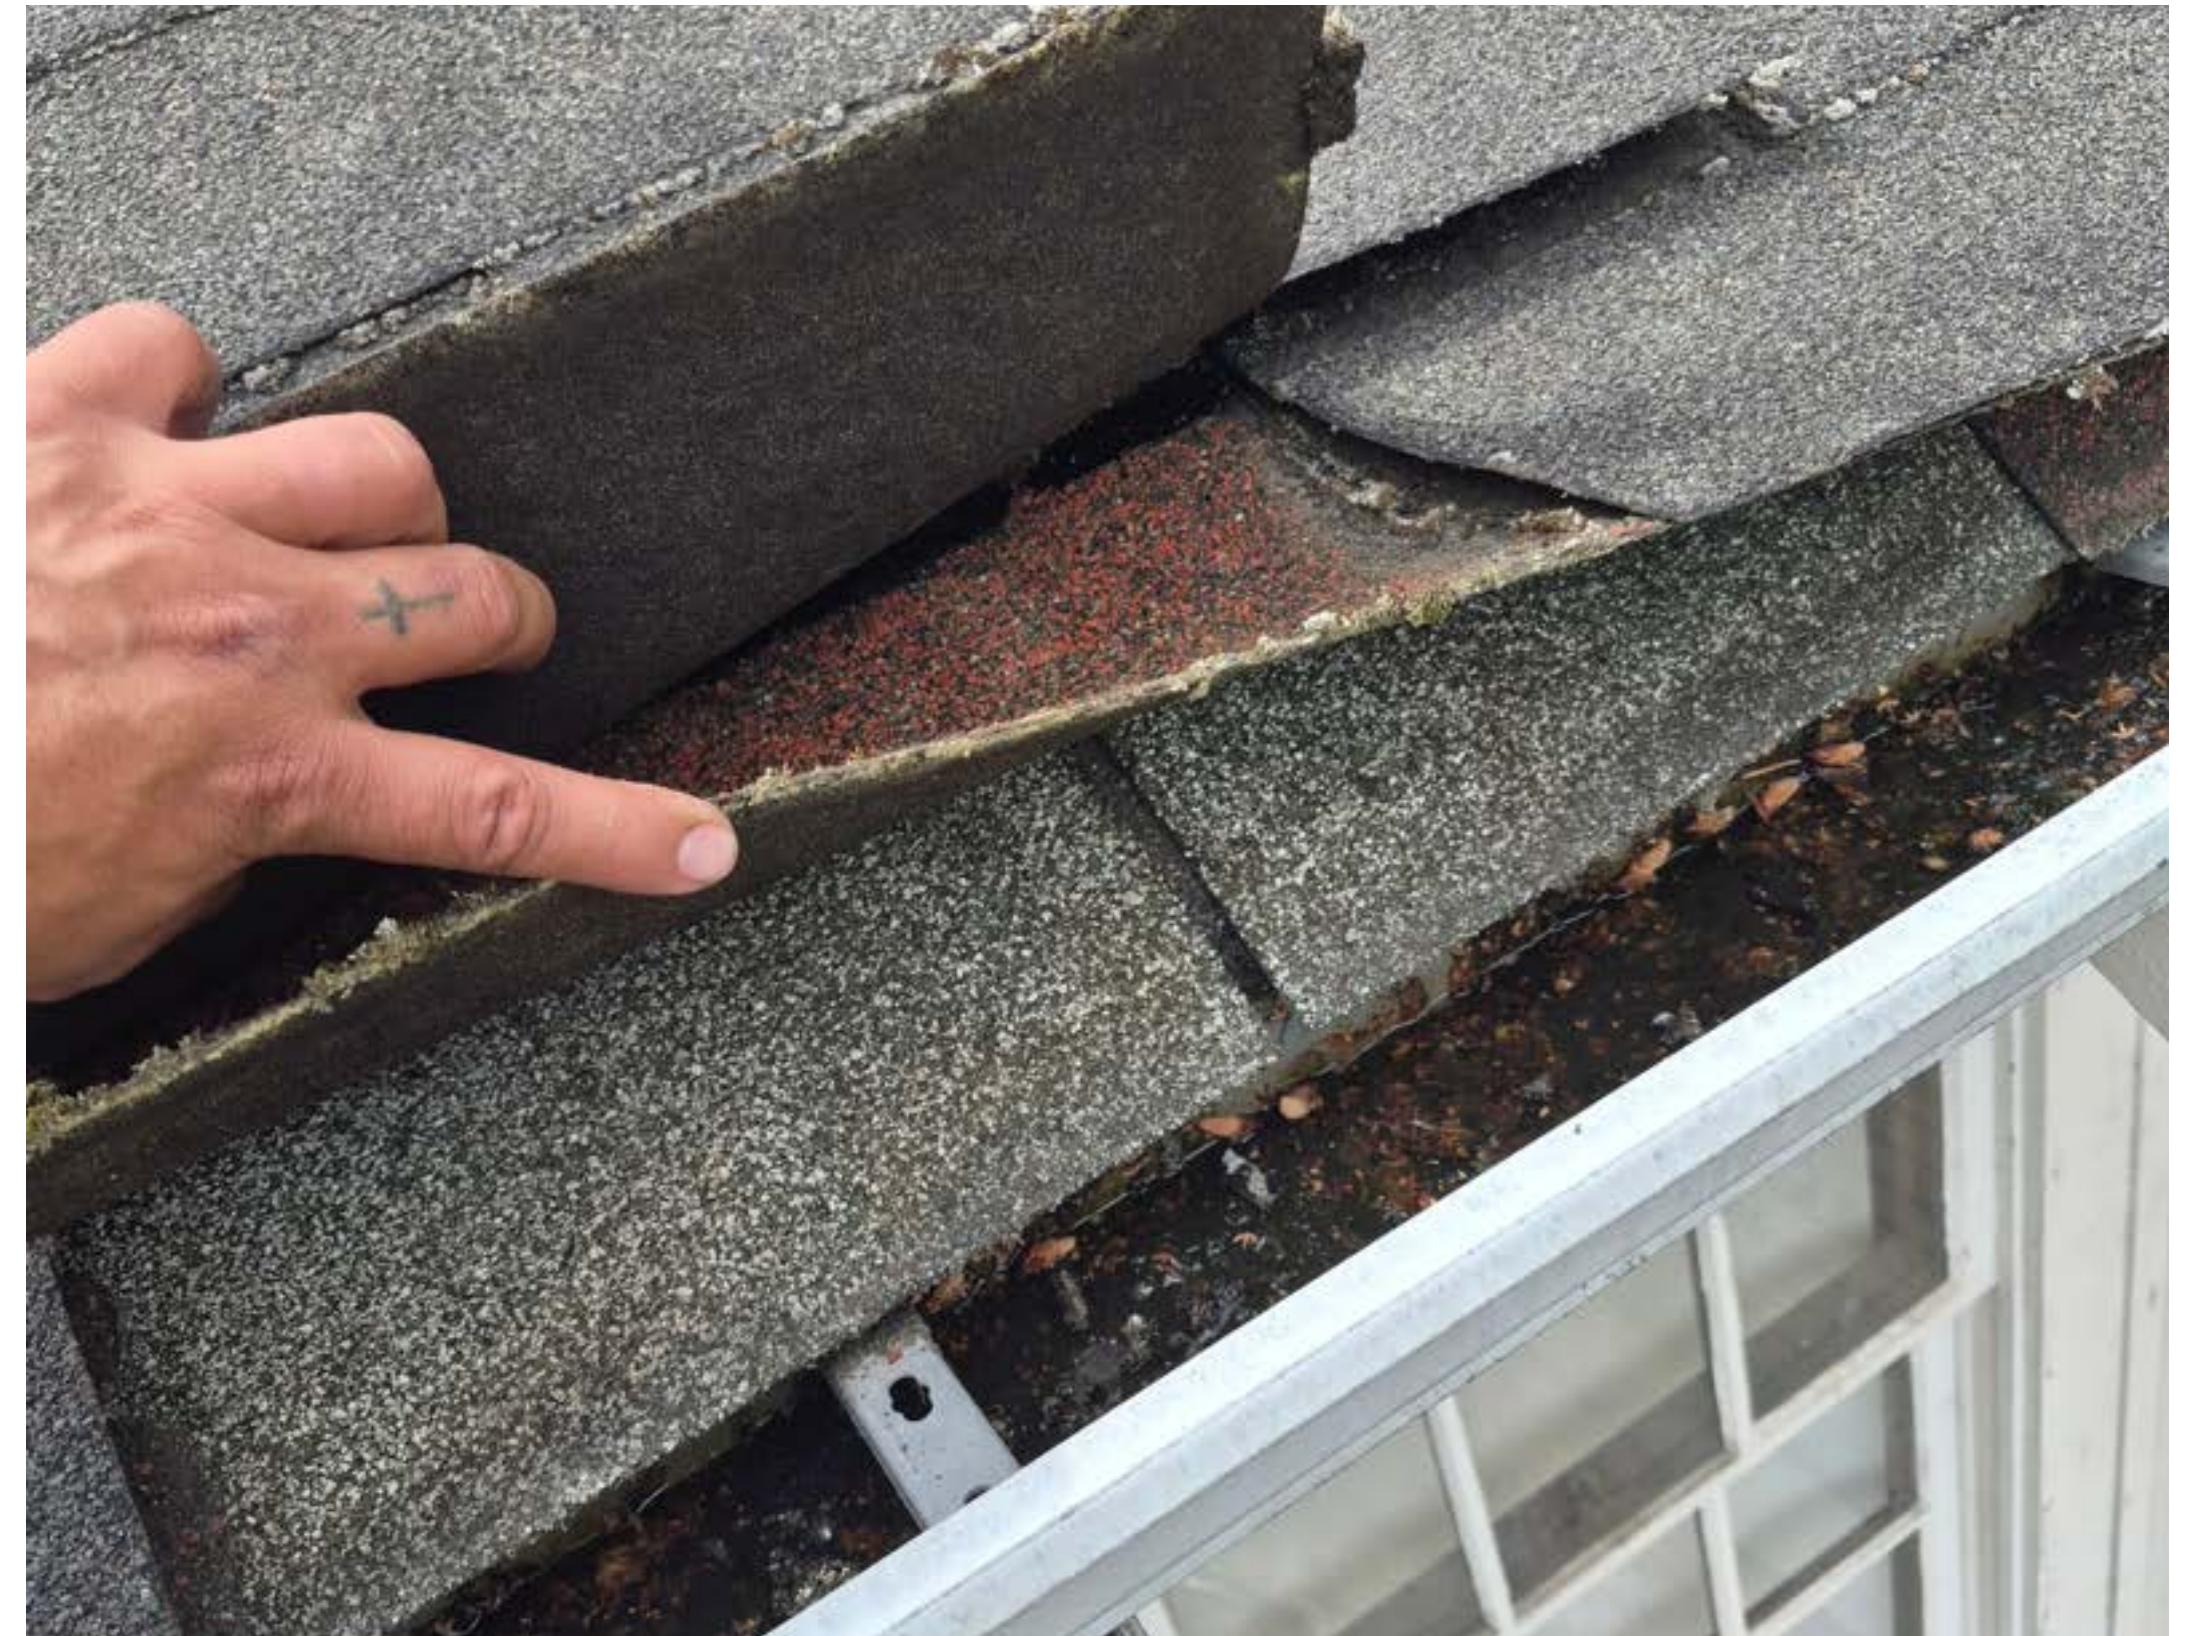
The existing roof, as shown in the photo above, consists of three layers of asphalt shingles. Each layer weighs approximately 4 pounds per square foot, resulting in a total weight of 12 pounds per square foot on the underlying structure. This roof was designed and engineered for only one layer of asphalt shingles, and the excessive weight is likely the primary cause of the visible cracks in the lath and plaster ceiling. Additionally, the short lifespan of asphalt shingles leads to constant maintenance and financial burden.

Our proposal suggests replacing the current roofing material with metal roofing, which weighs only 2 pounds per square foot and lasts five times longer than asphalt shingles. Furthermore, this change will significantly reduce maintenance and financial requirements.
