***‘Certificate of Approval’***  
***JCCCW // Building 3 // Roof Replacement***

*Update 08/04/2026*

Japanese Community and Cultural Center of Washington

1414 S. Weller Street, Seattle, WA 98144

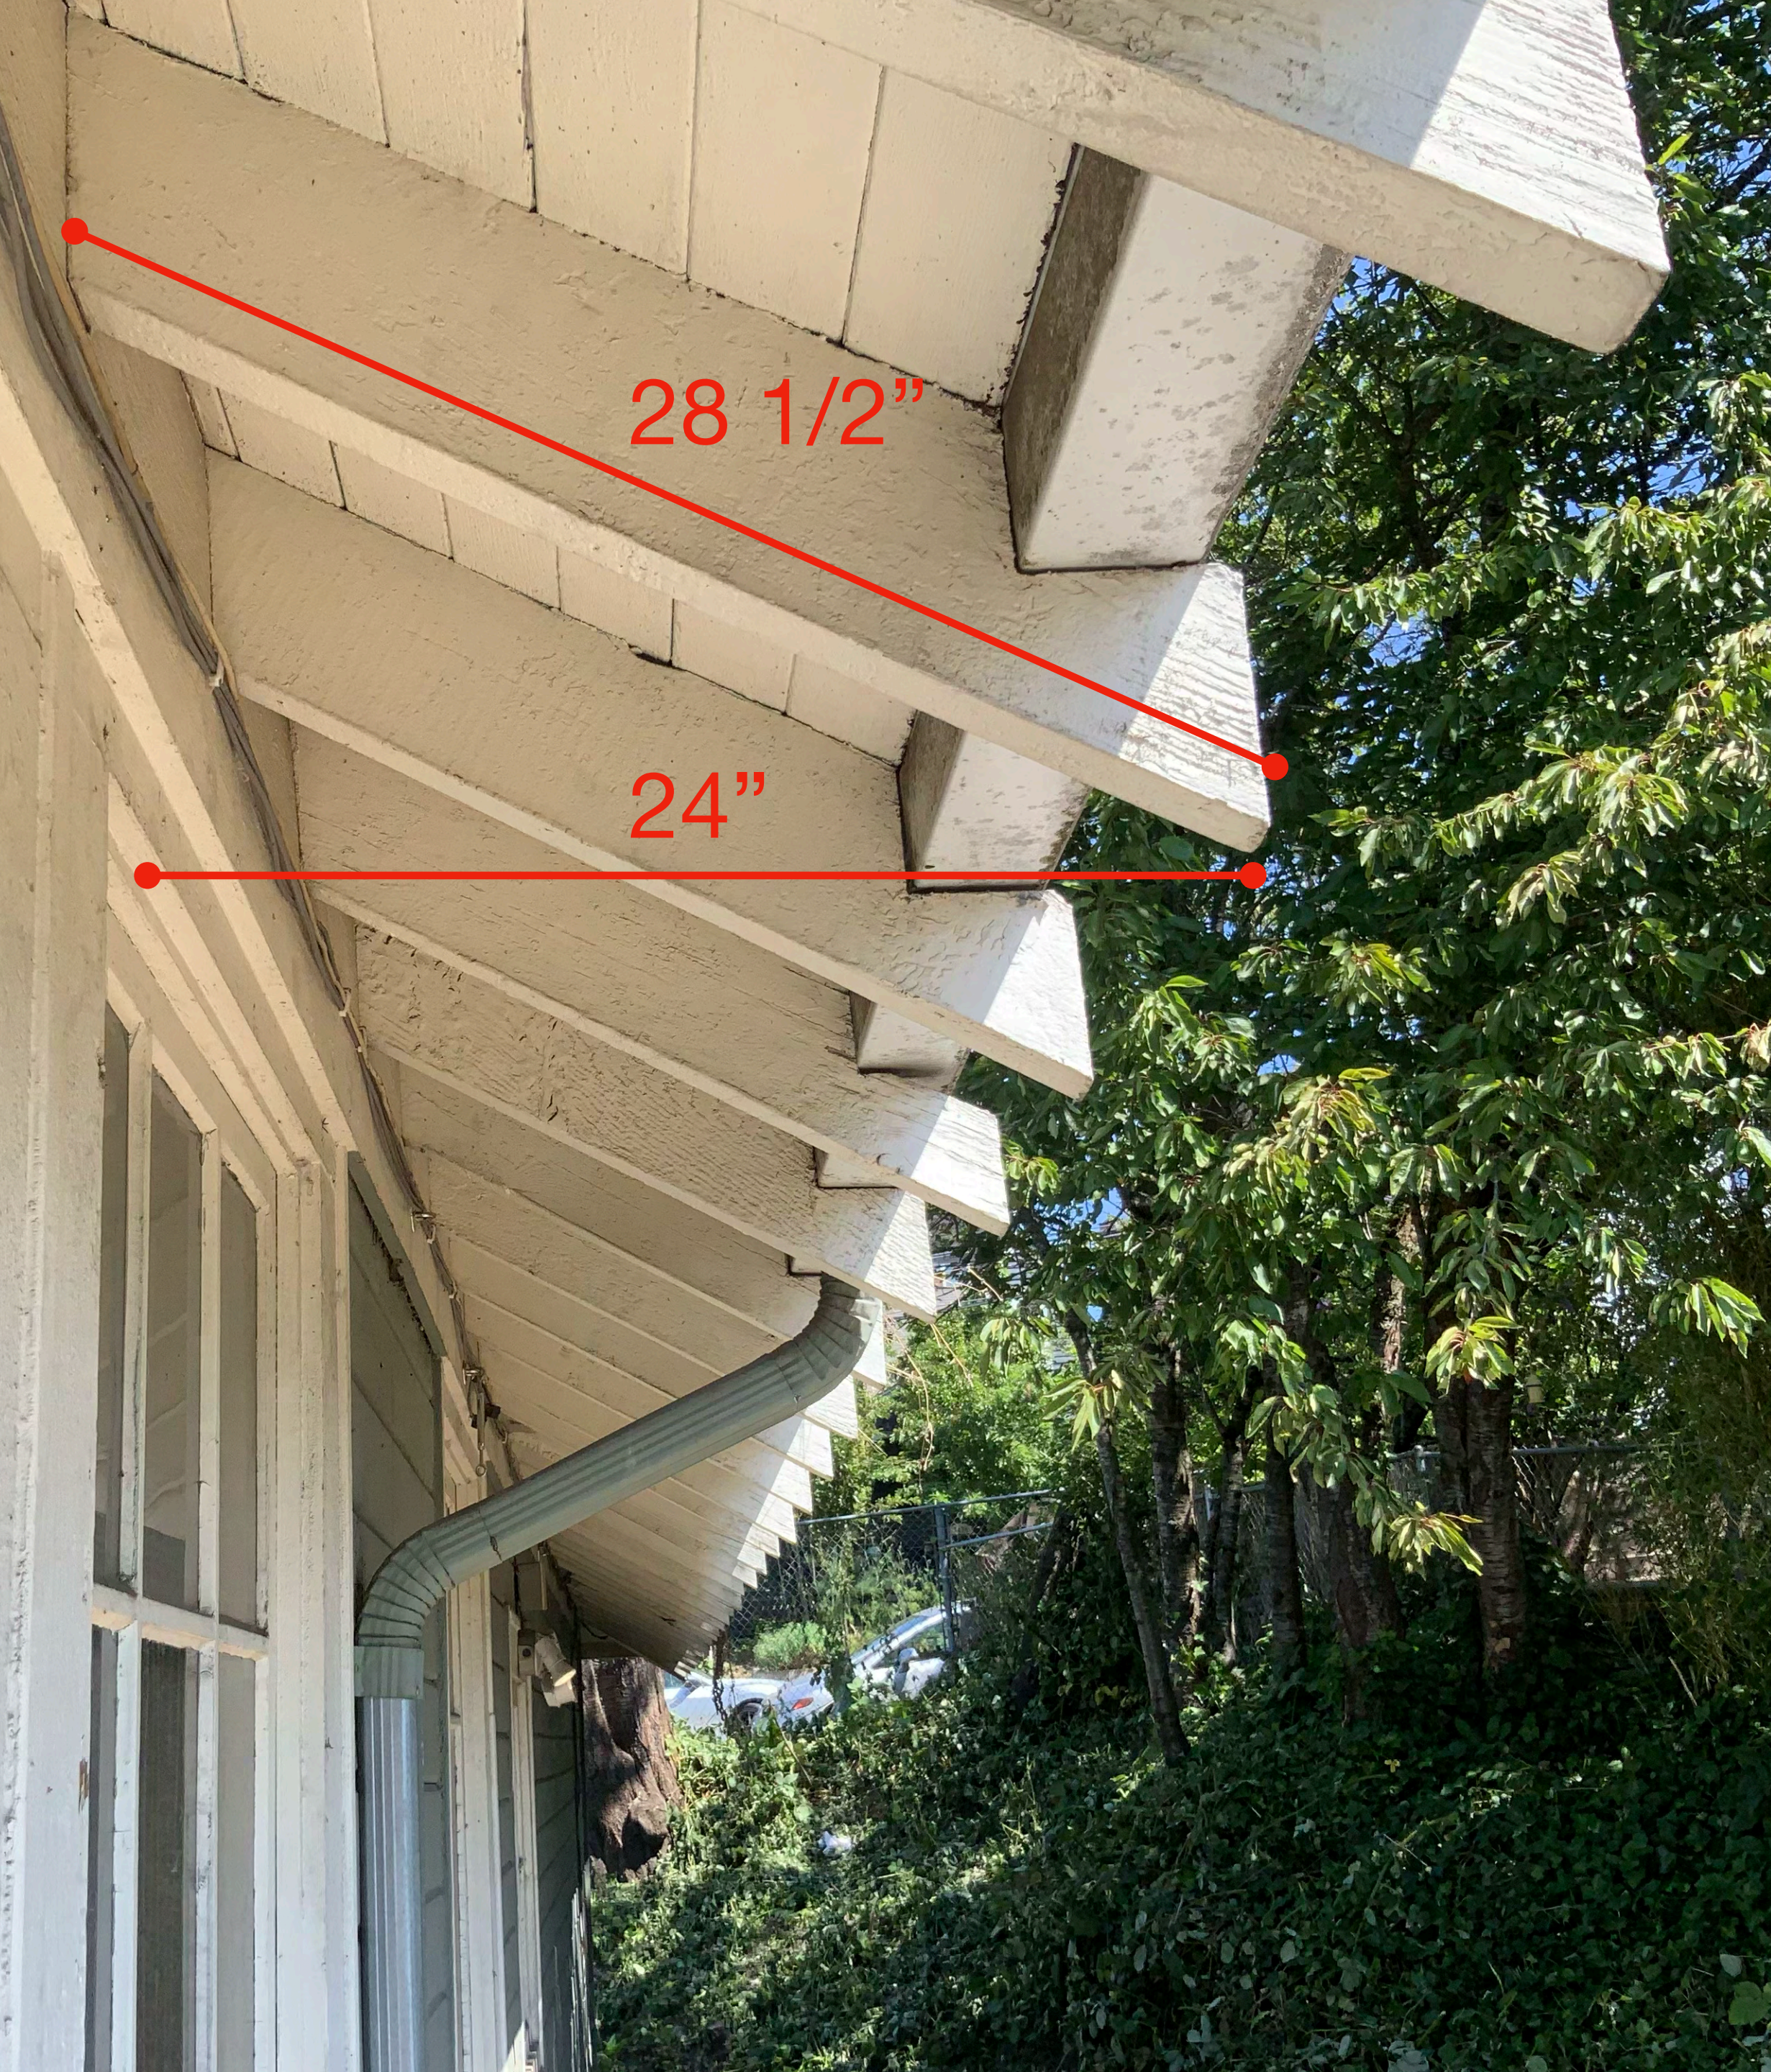
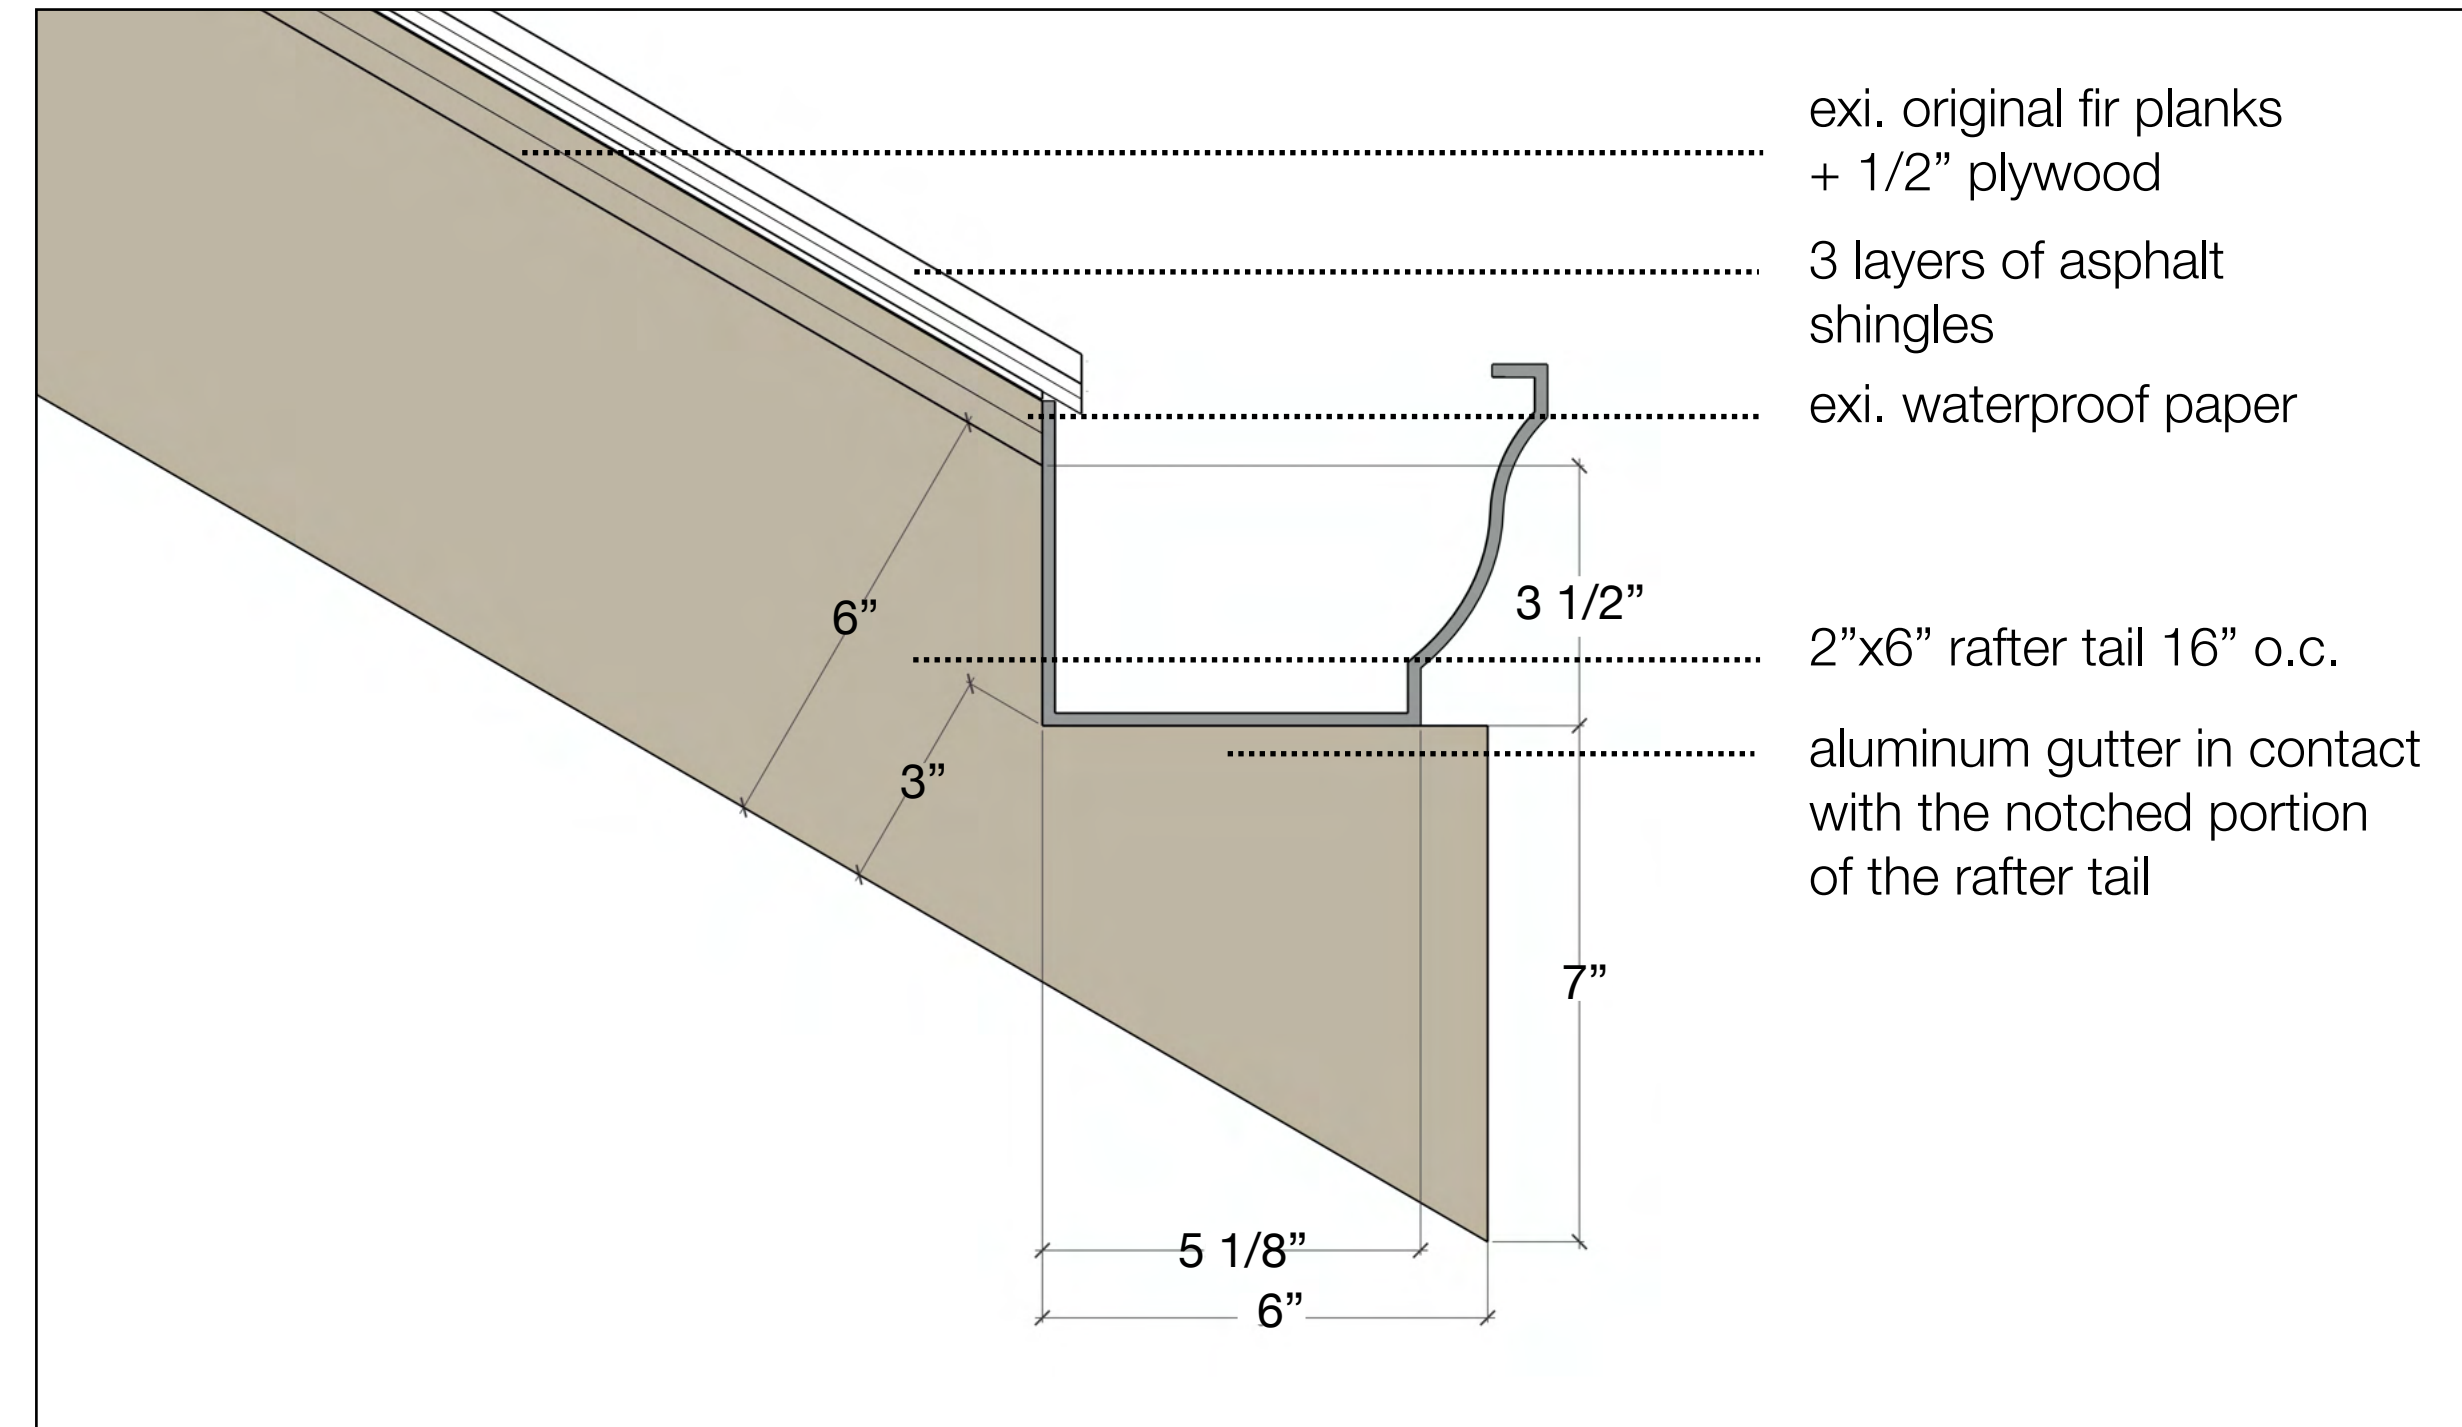
**Rafter Tail / Gutter Detail**  
Existing Detail

The rafter tail is the portion of the roof rafter system that extends beyond the building envelope. According to the original blueprints, the gutters were initially made of 4"x5" wood, likely cedar, and the rafter tails had a specific angular design, probably altered during construction. However, during a roof resurfacing in the 70s, the wooden gutters were replaced with aluminum ones. This change has led to a critical design flaw, characterized by water condensation between the base of the aluminum gutter and the exposed cut on the rafter tail to allocate it, see next page.

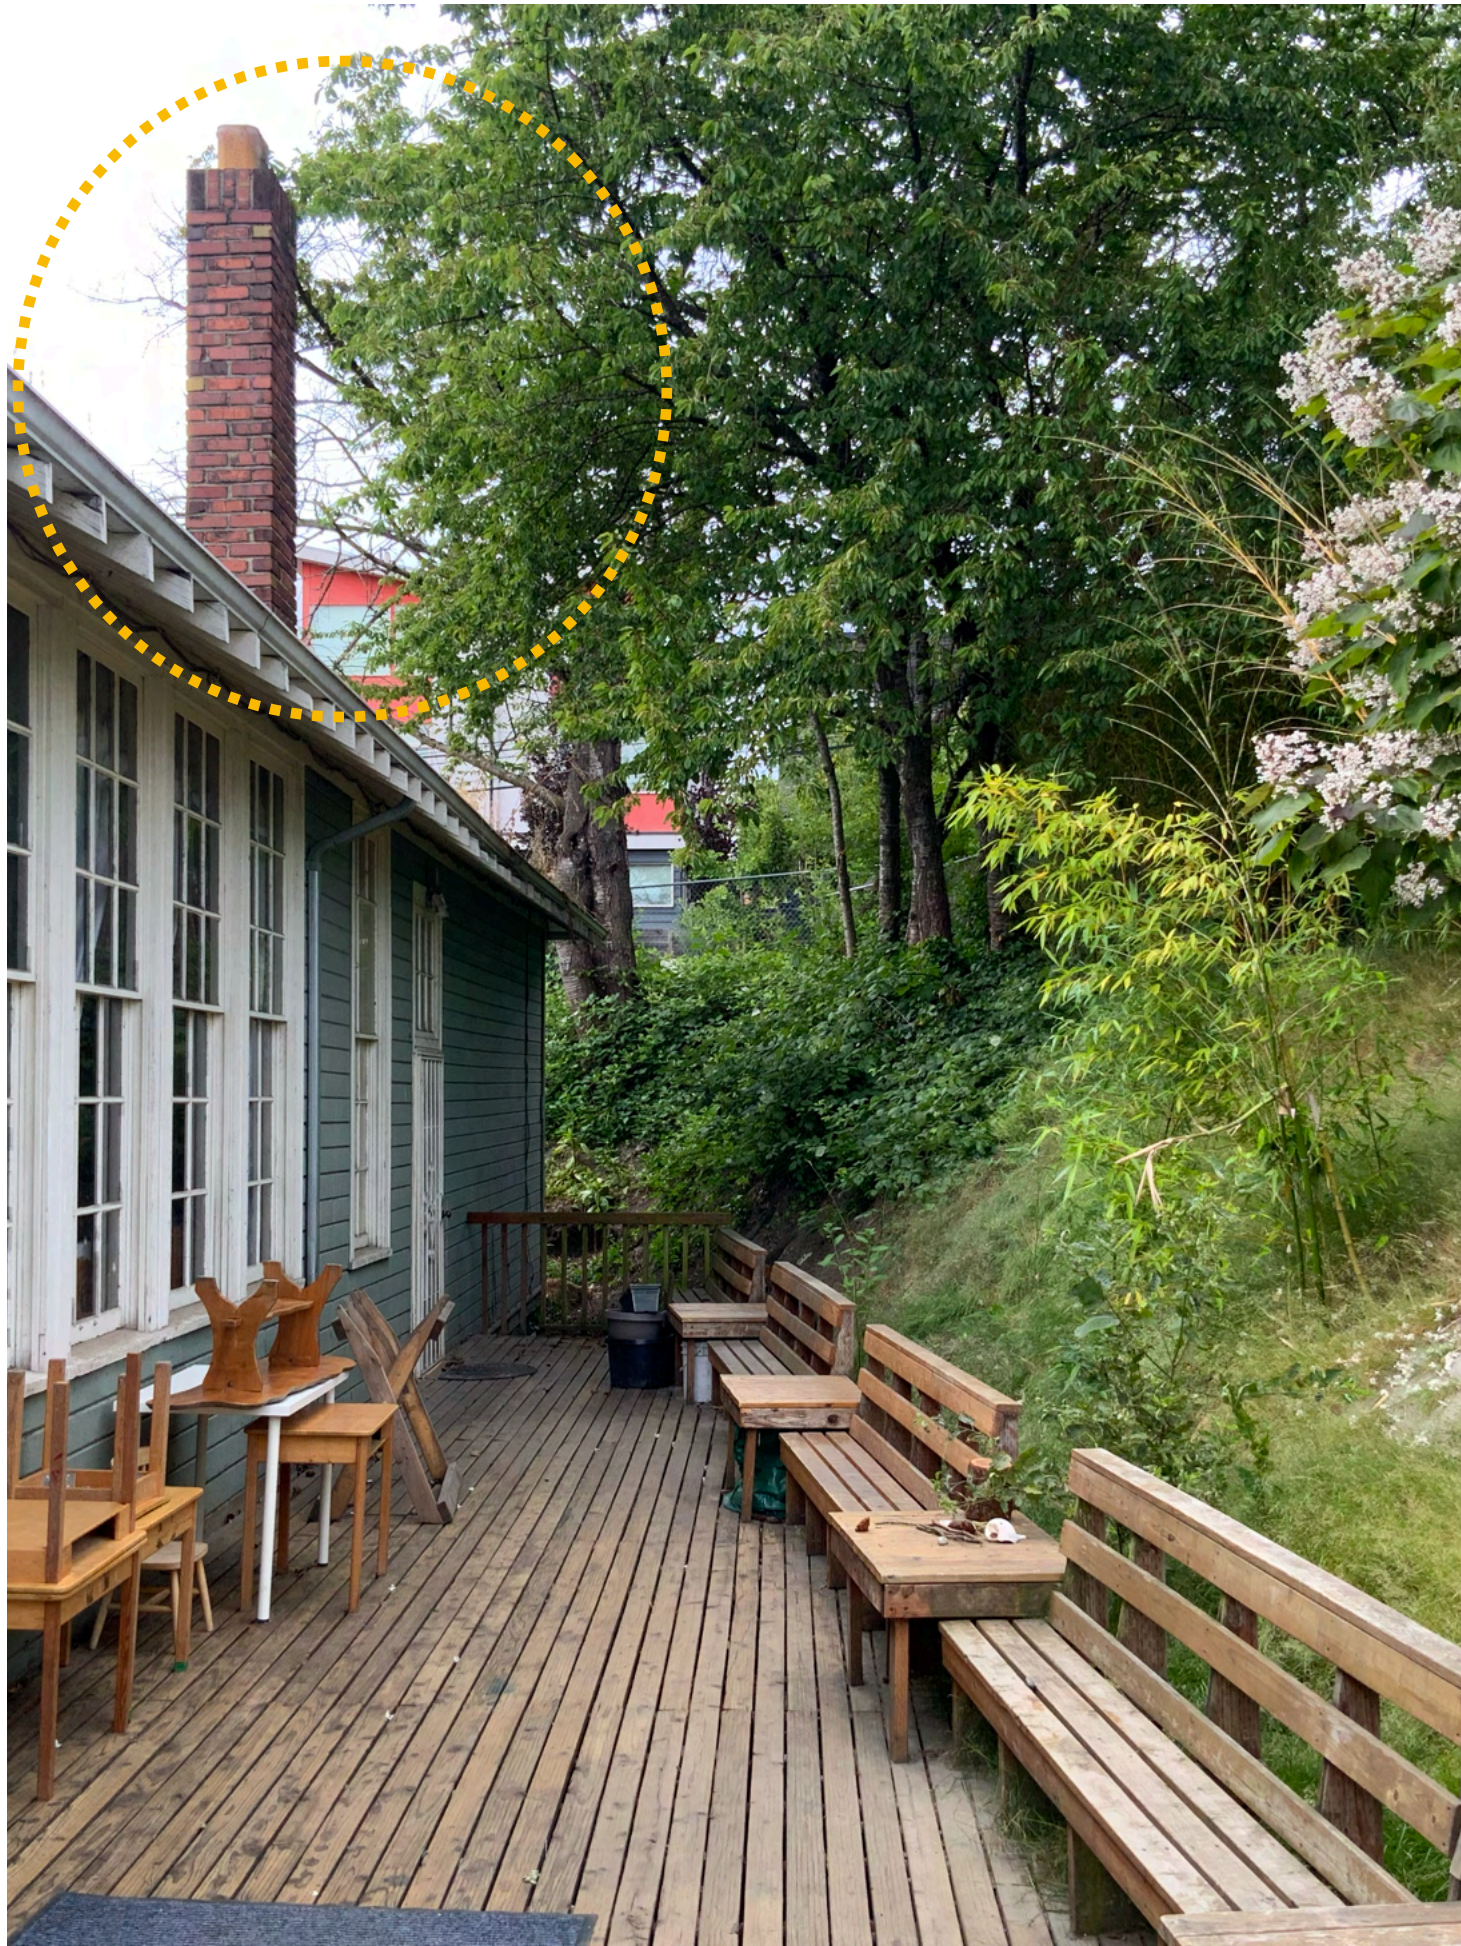
Of the three original chimney flues, only two remain. These flues, made of 4" bricks and measuring 8" x 12", are currently unbraced and show significant signs of deterioration. This deterioration is the primary cause of water intrusion in the classrooms below and poses a safety hazard for the building, as well as for the students attending classes and the children playing outside on the deck.

Hazard for students playing outside on the outdoor deck

Numerous previous attempts to address the issue, including patches of drywall below the lath and plaster ceiling, have been unsuccessful. The Roof Replacement Intervention proposes a full plywood re-sheeting and proposes either eliminating or reducing the size of these deteriorating flues.

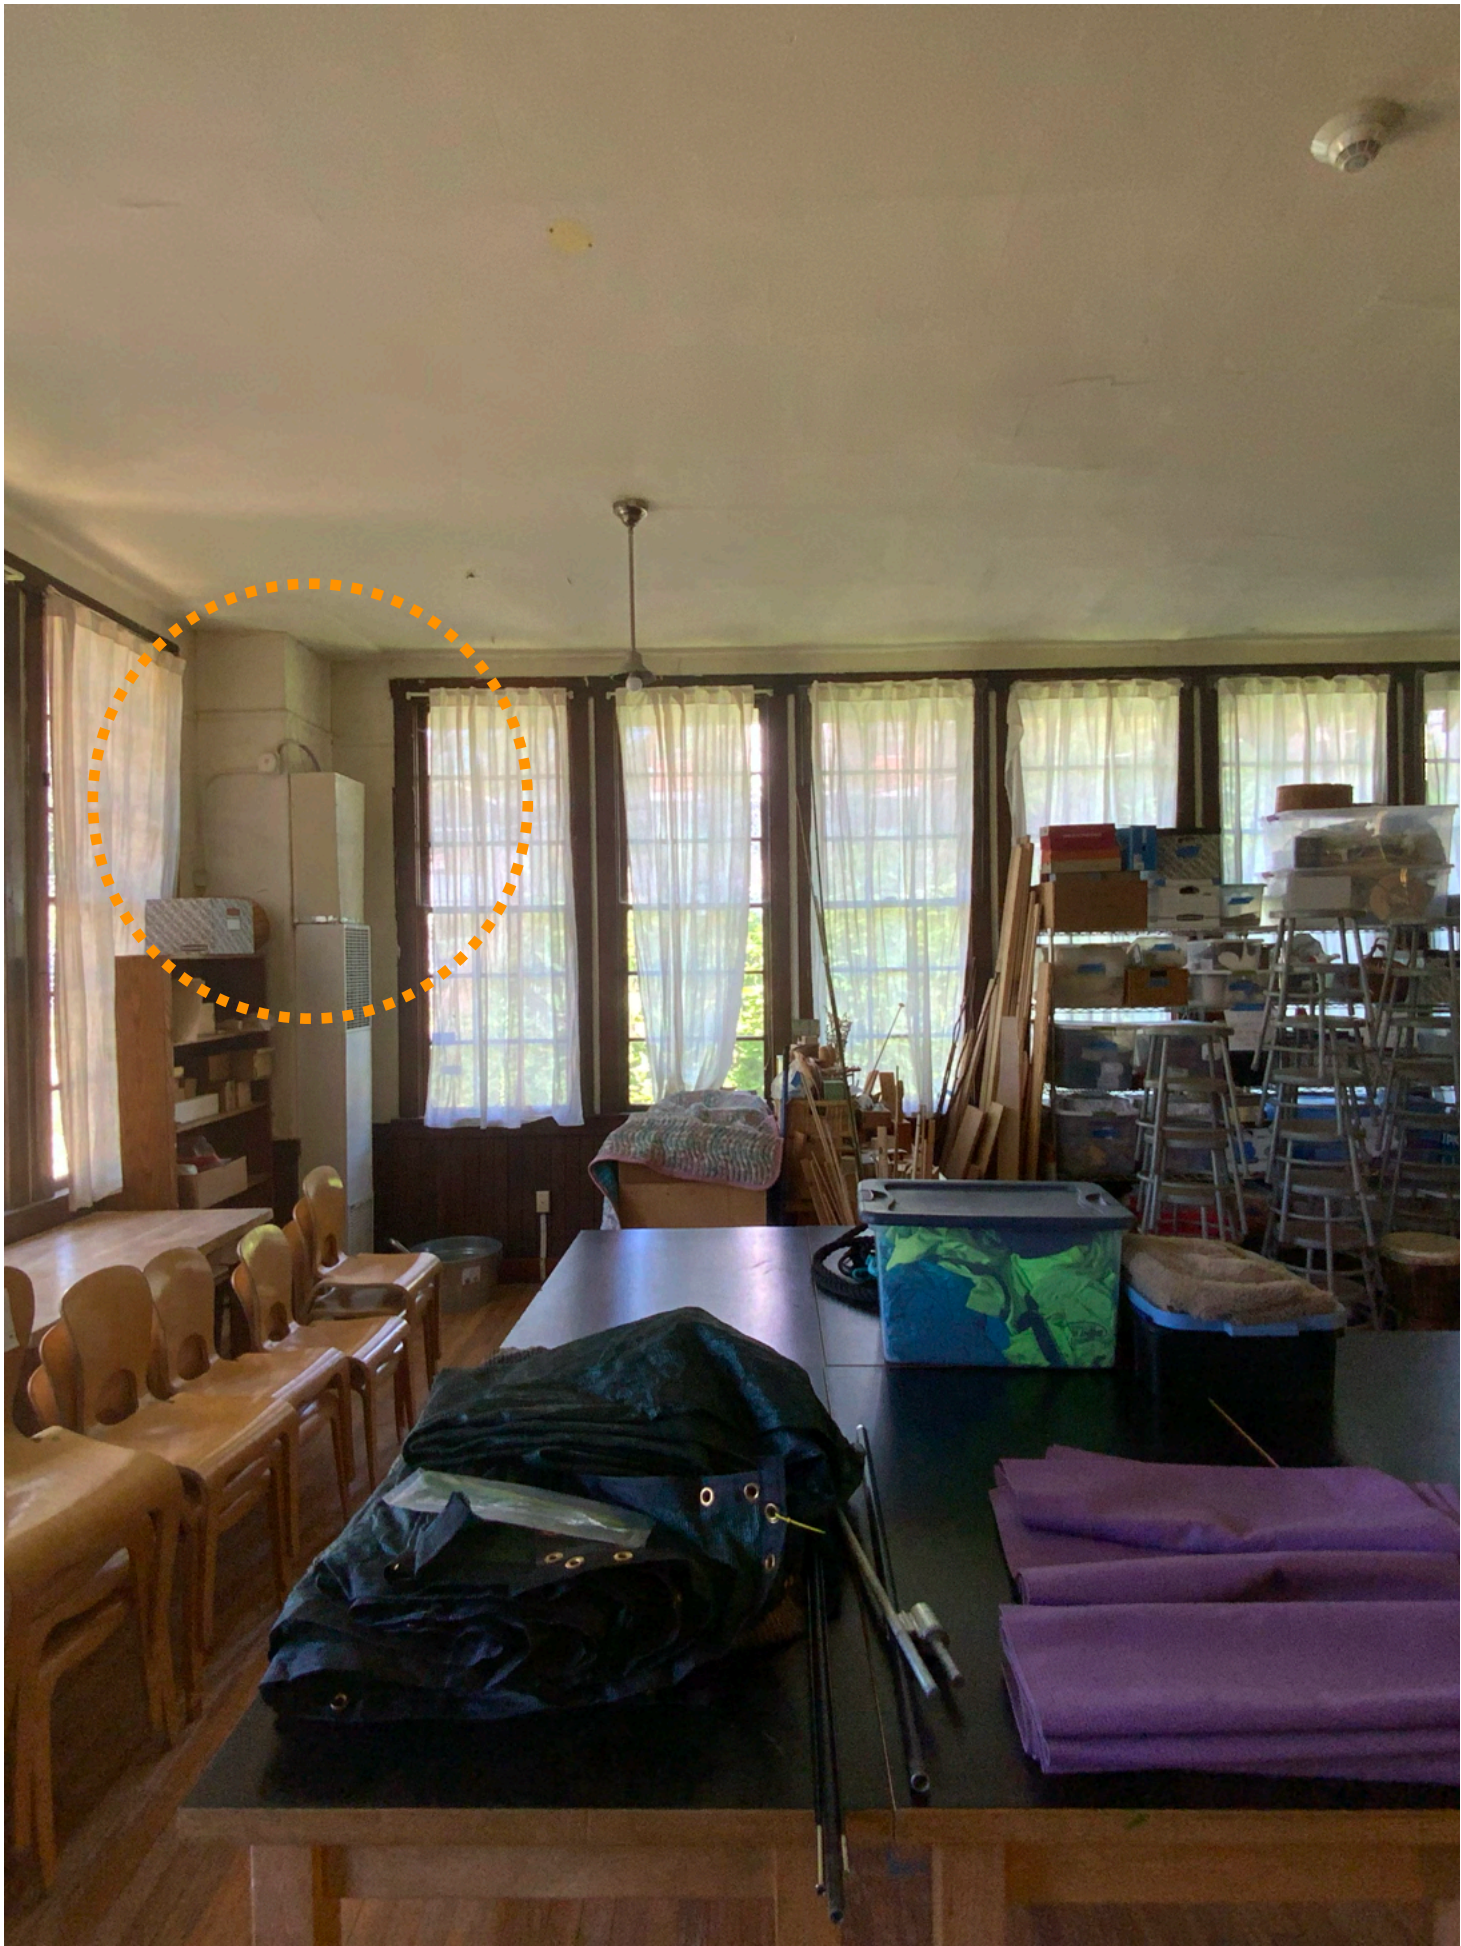
Hazard for students attending the classes

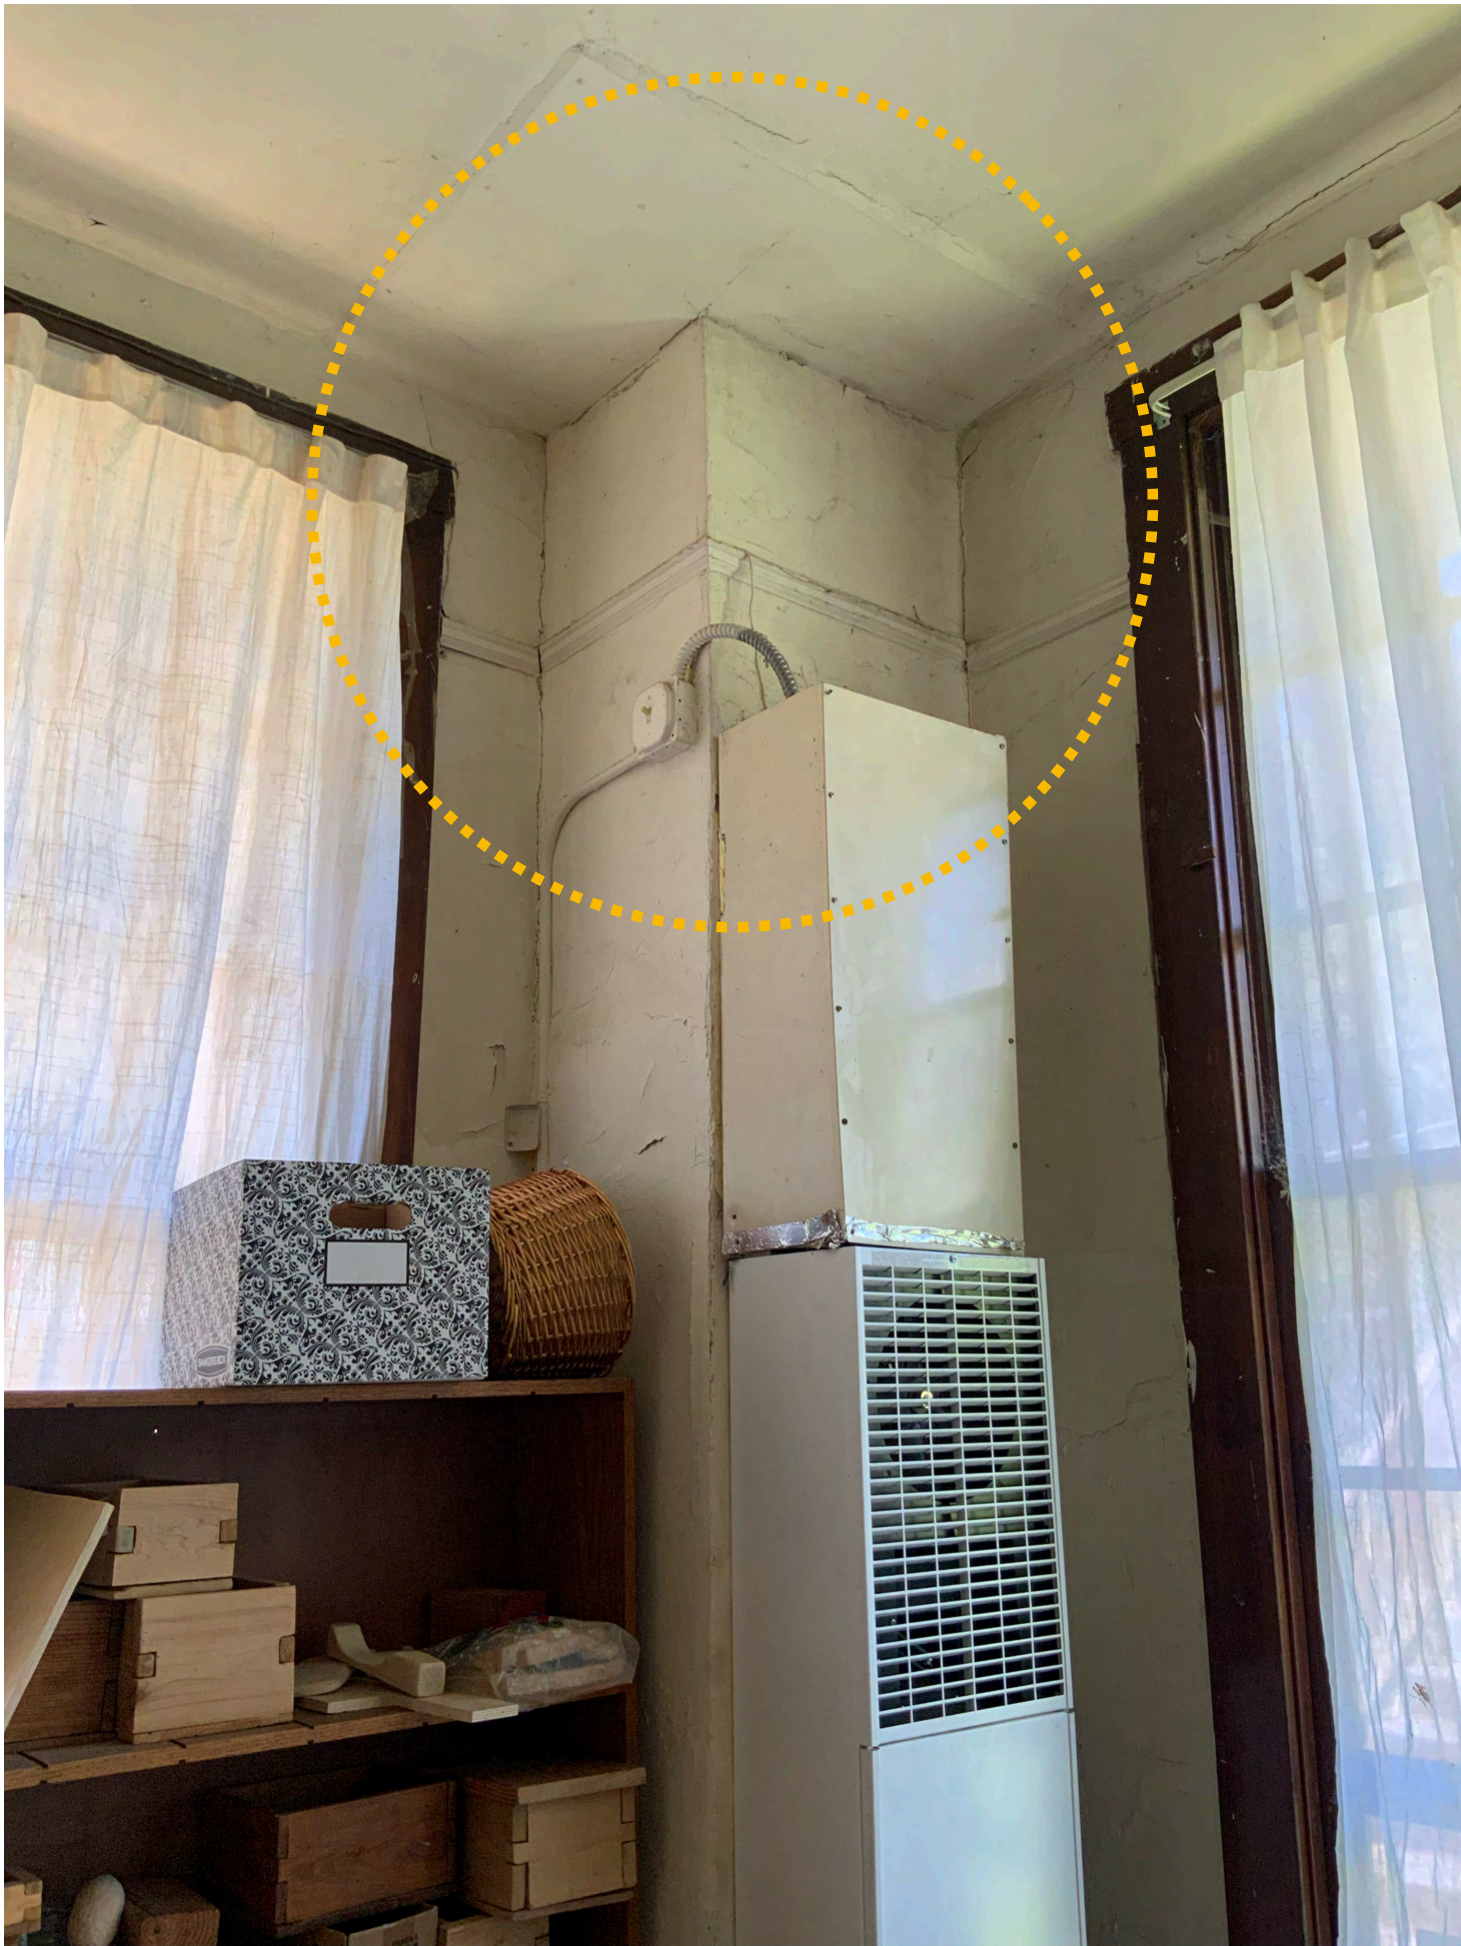
Sign of previous patches and water intrusion

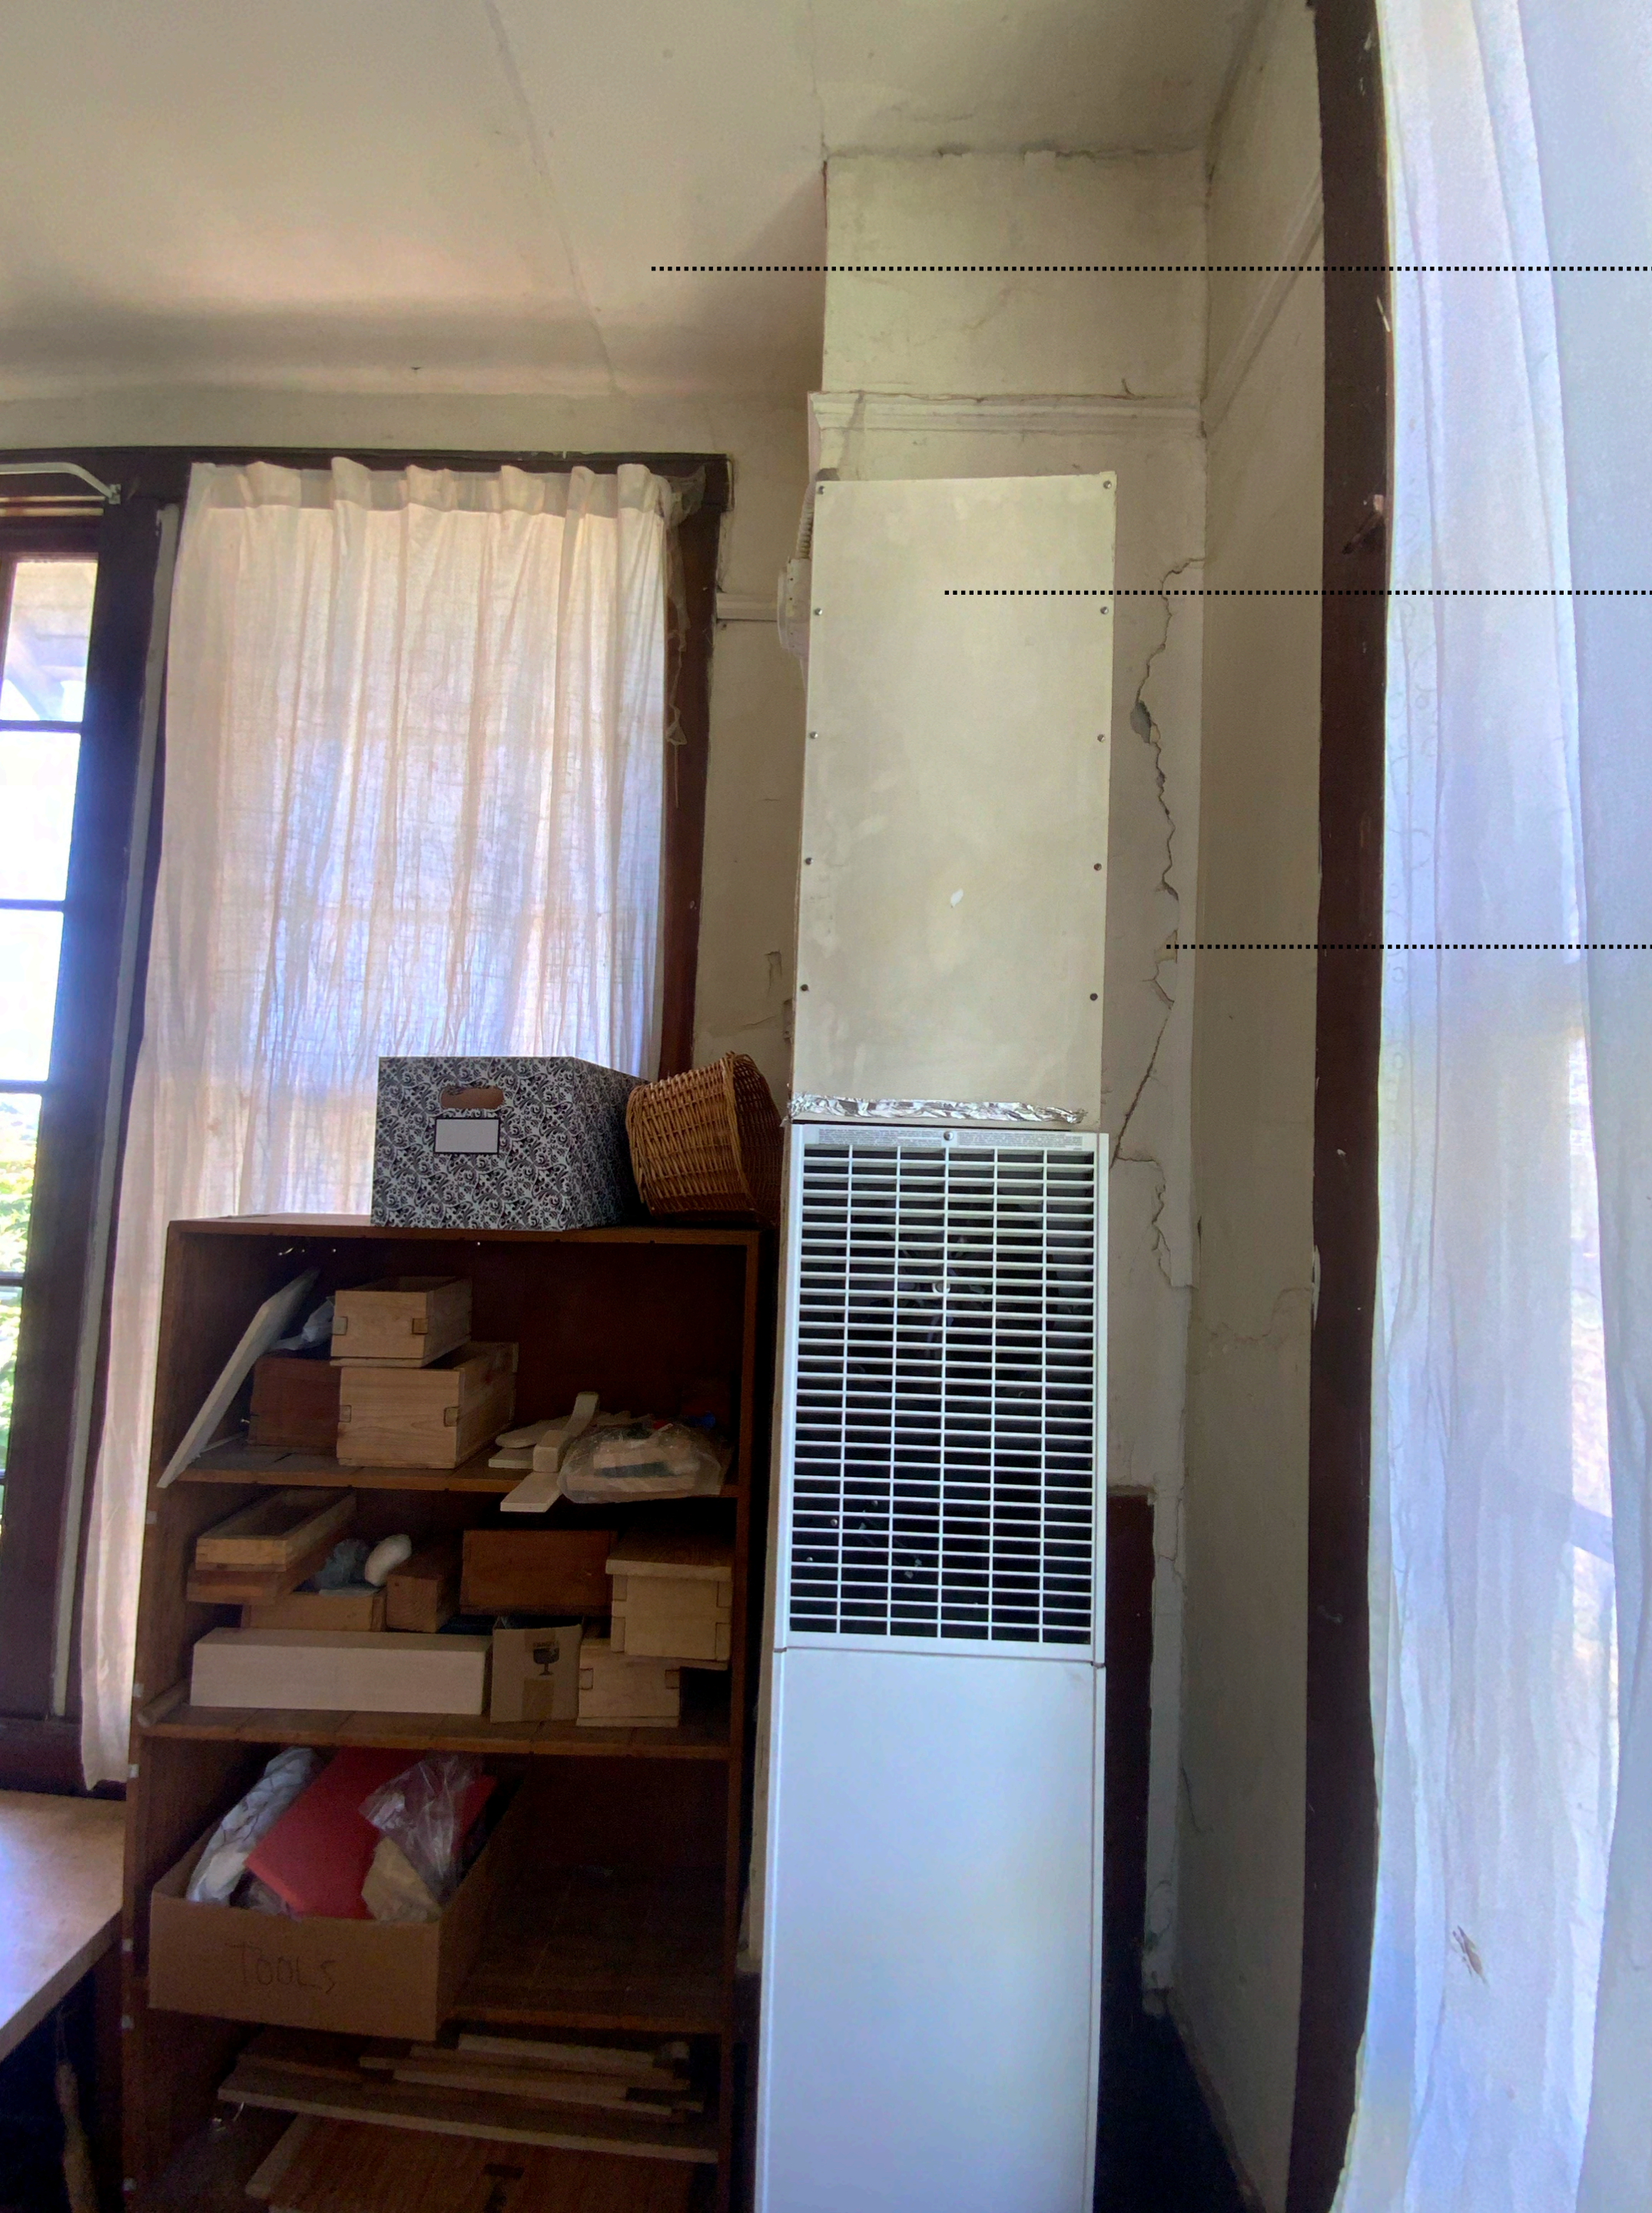
Previous unsuccessful ceiling patch

Structural crack sign of detachment from main structure
