***‘Certificate of Approval’***  
***JCCCW // Building 3 // Roof Replacement***

*Update 08/04/2026*

Japanese Community and Cultural Center of Washington

1414 S. Weller Street, Seattle, WA 98144

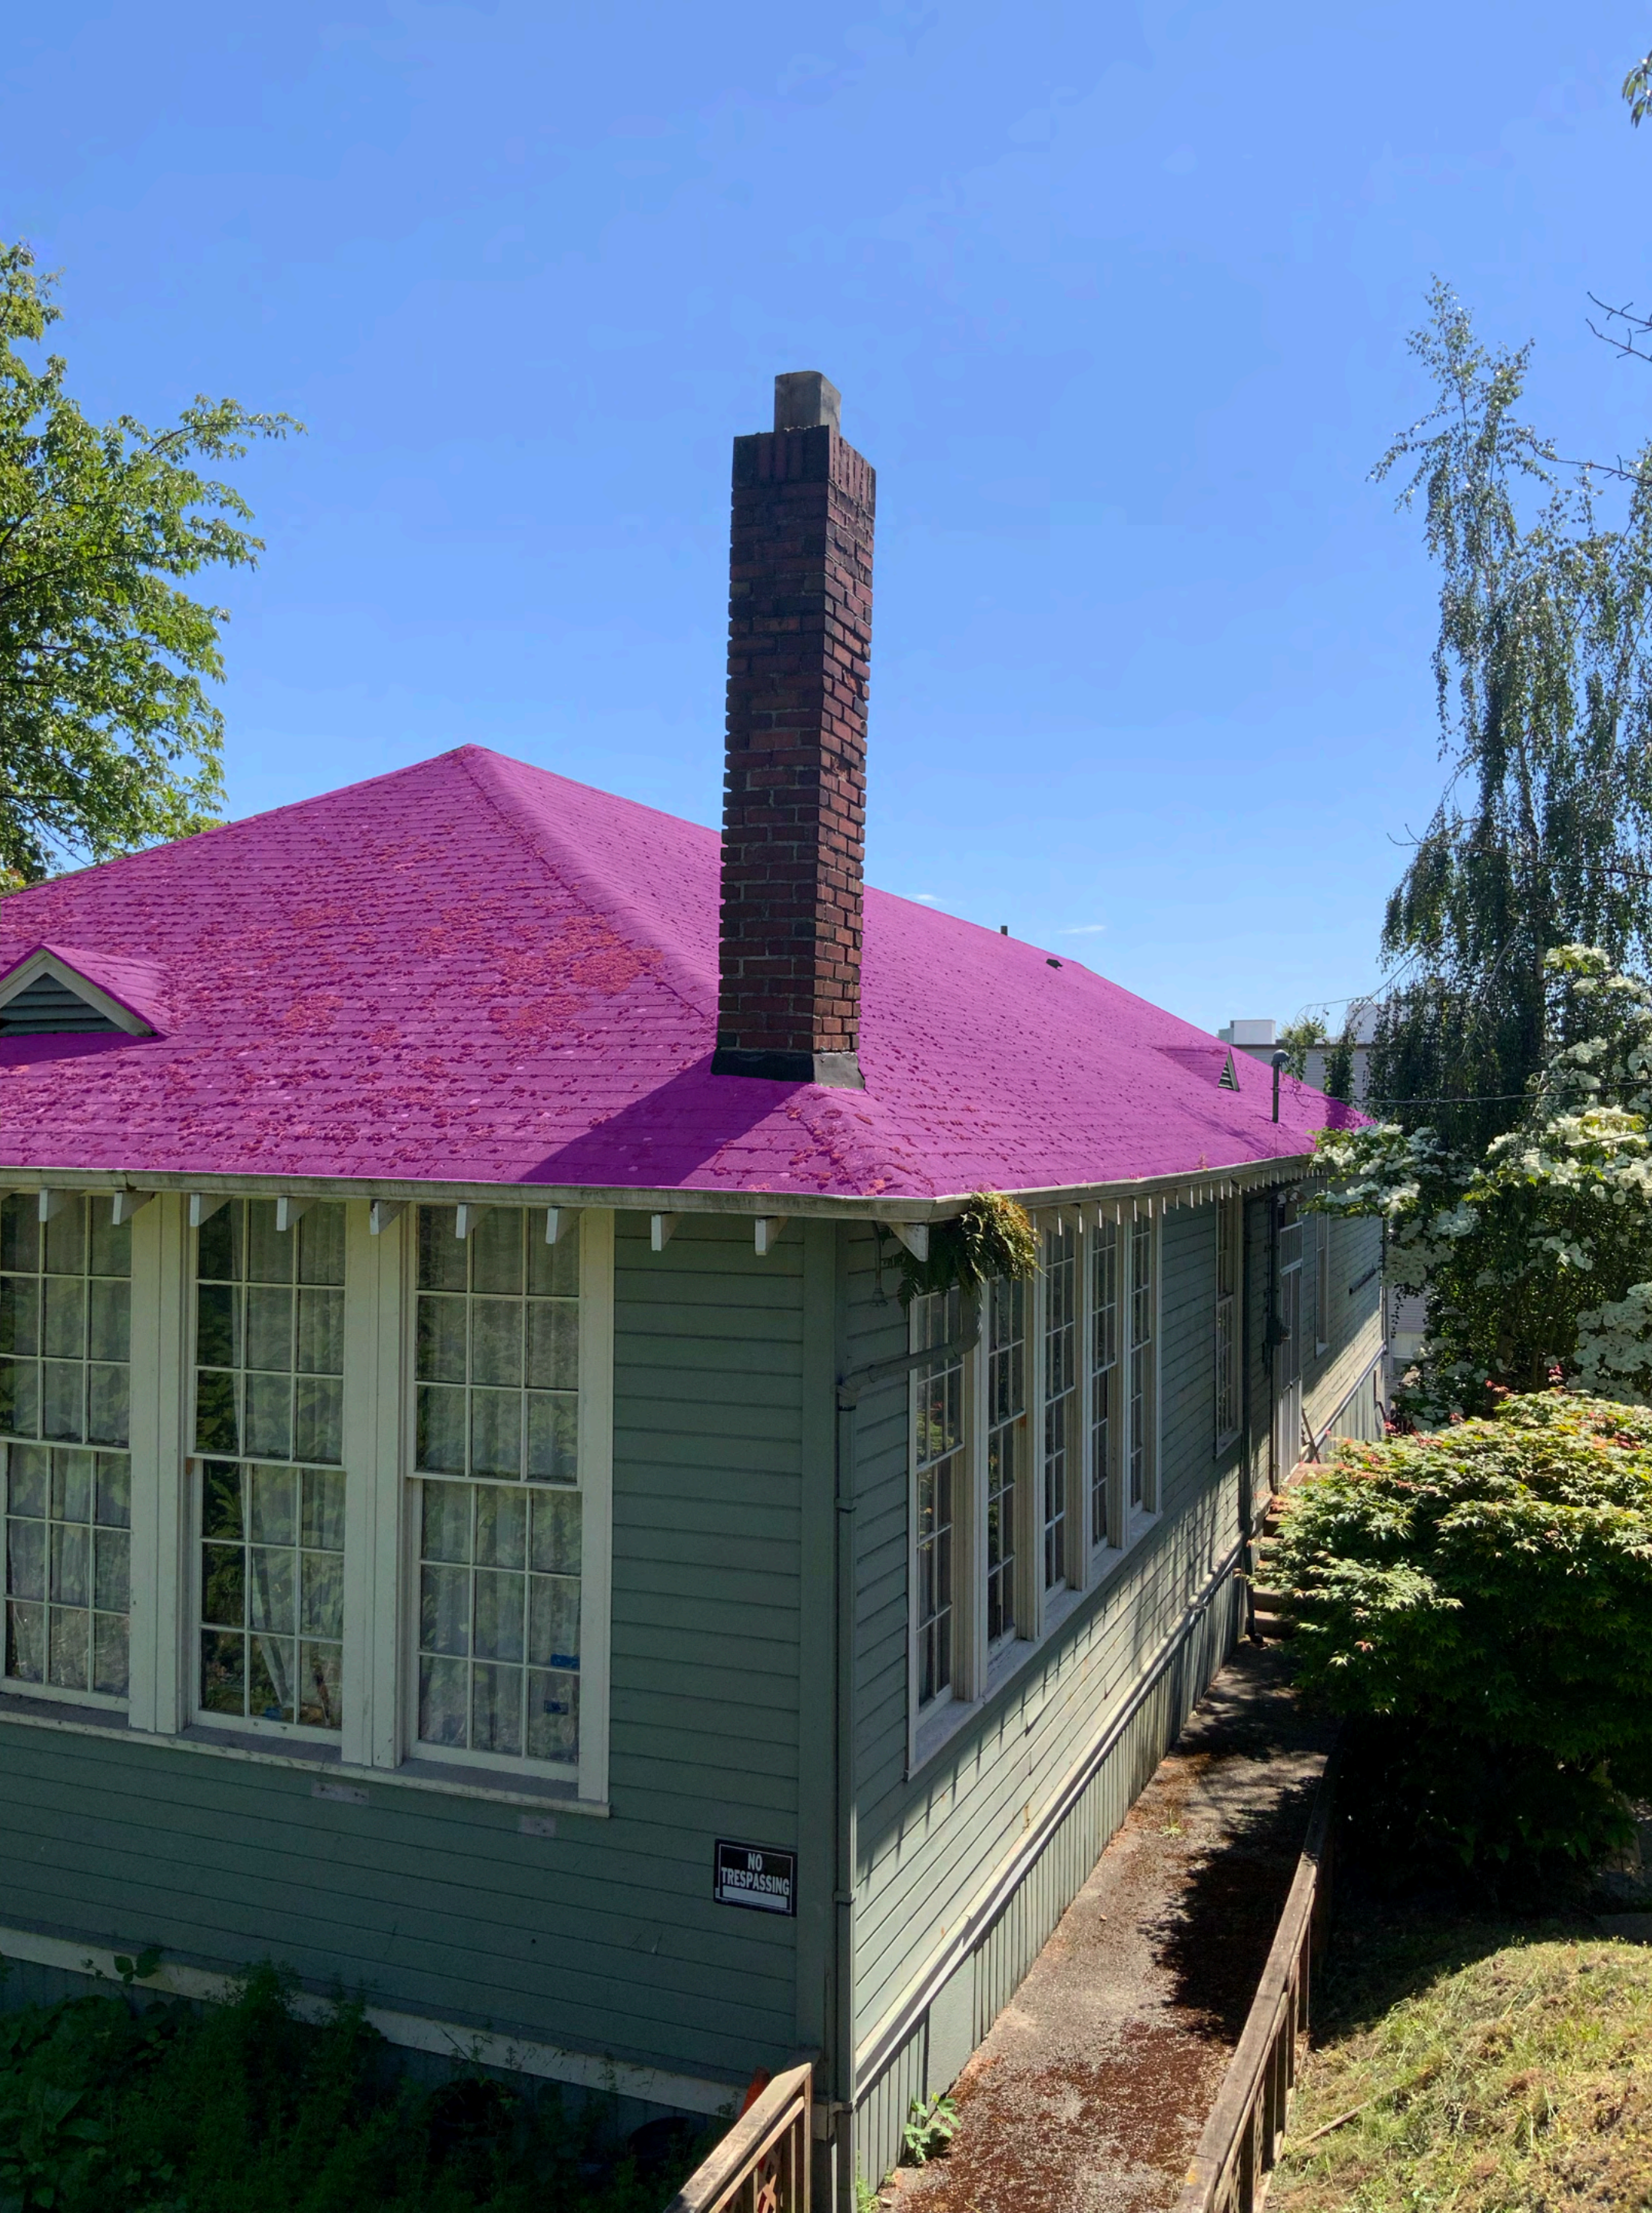
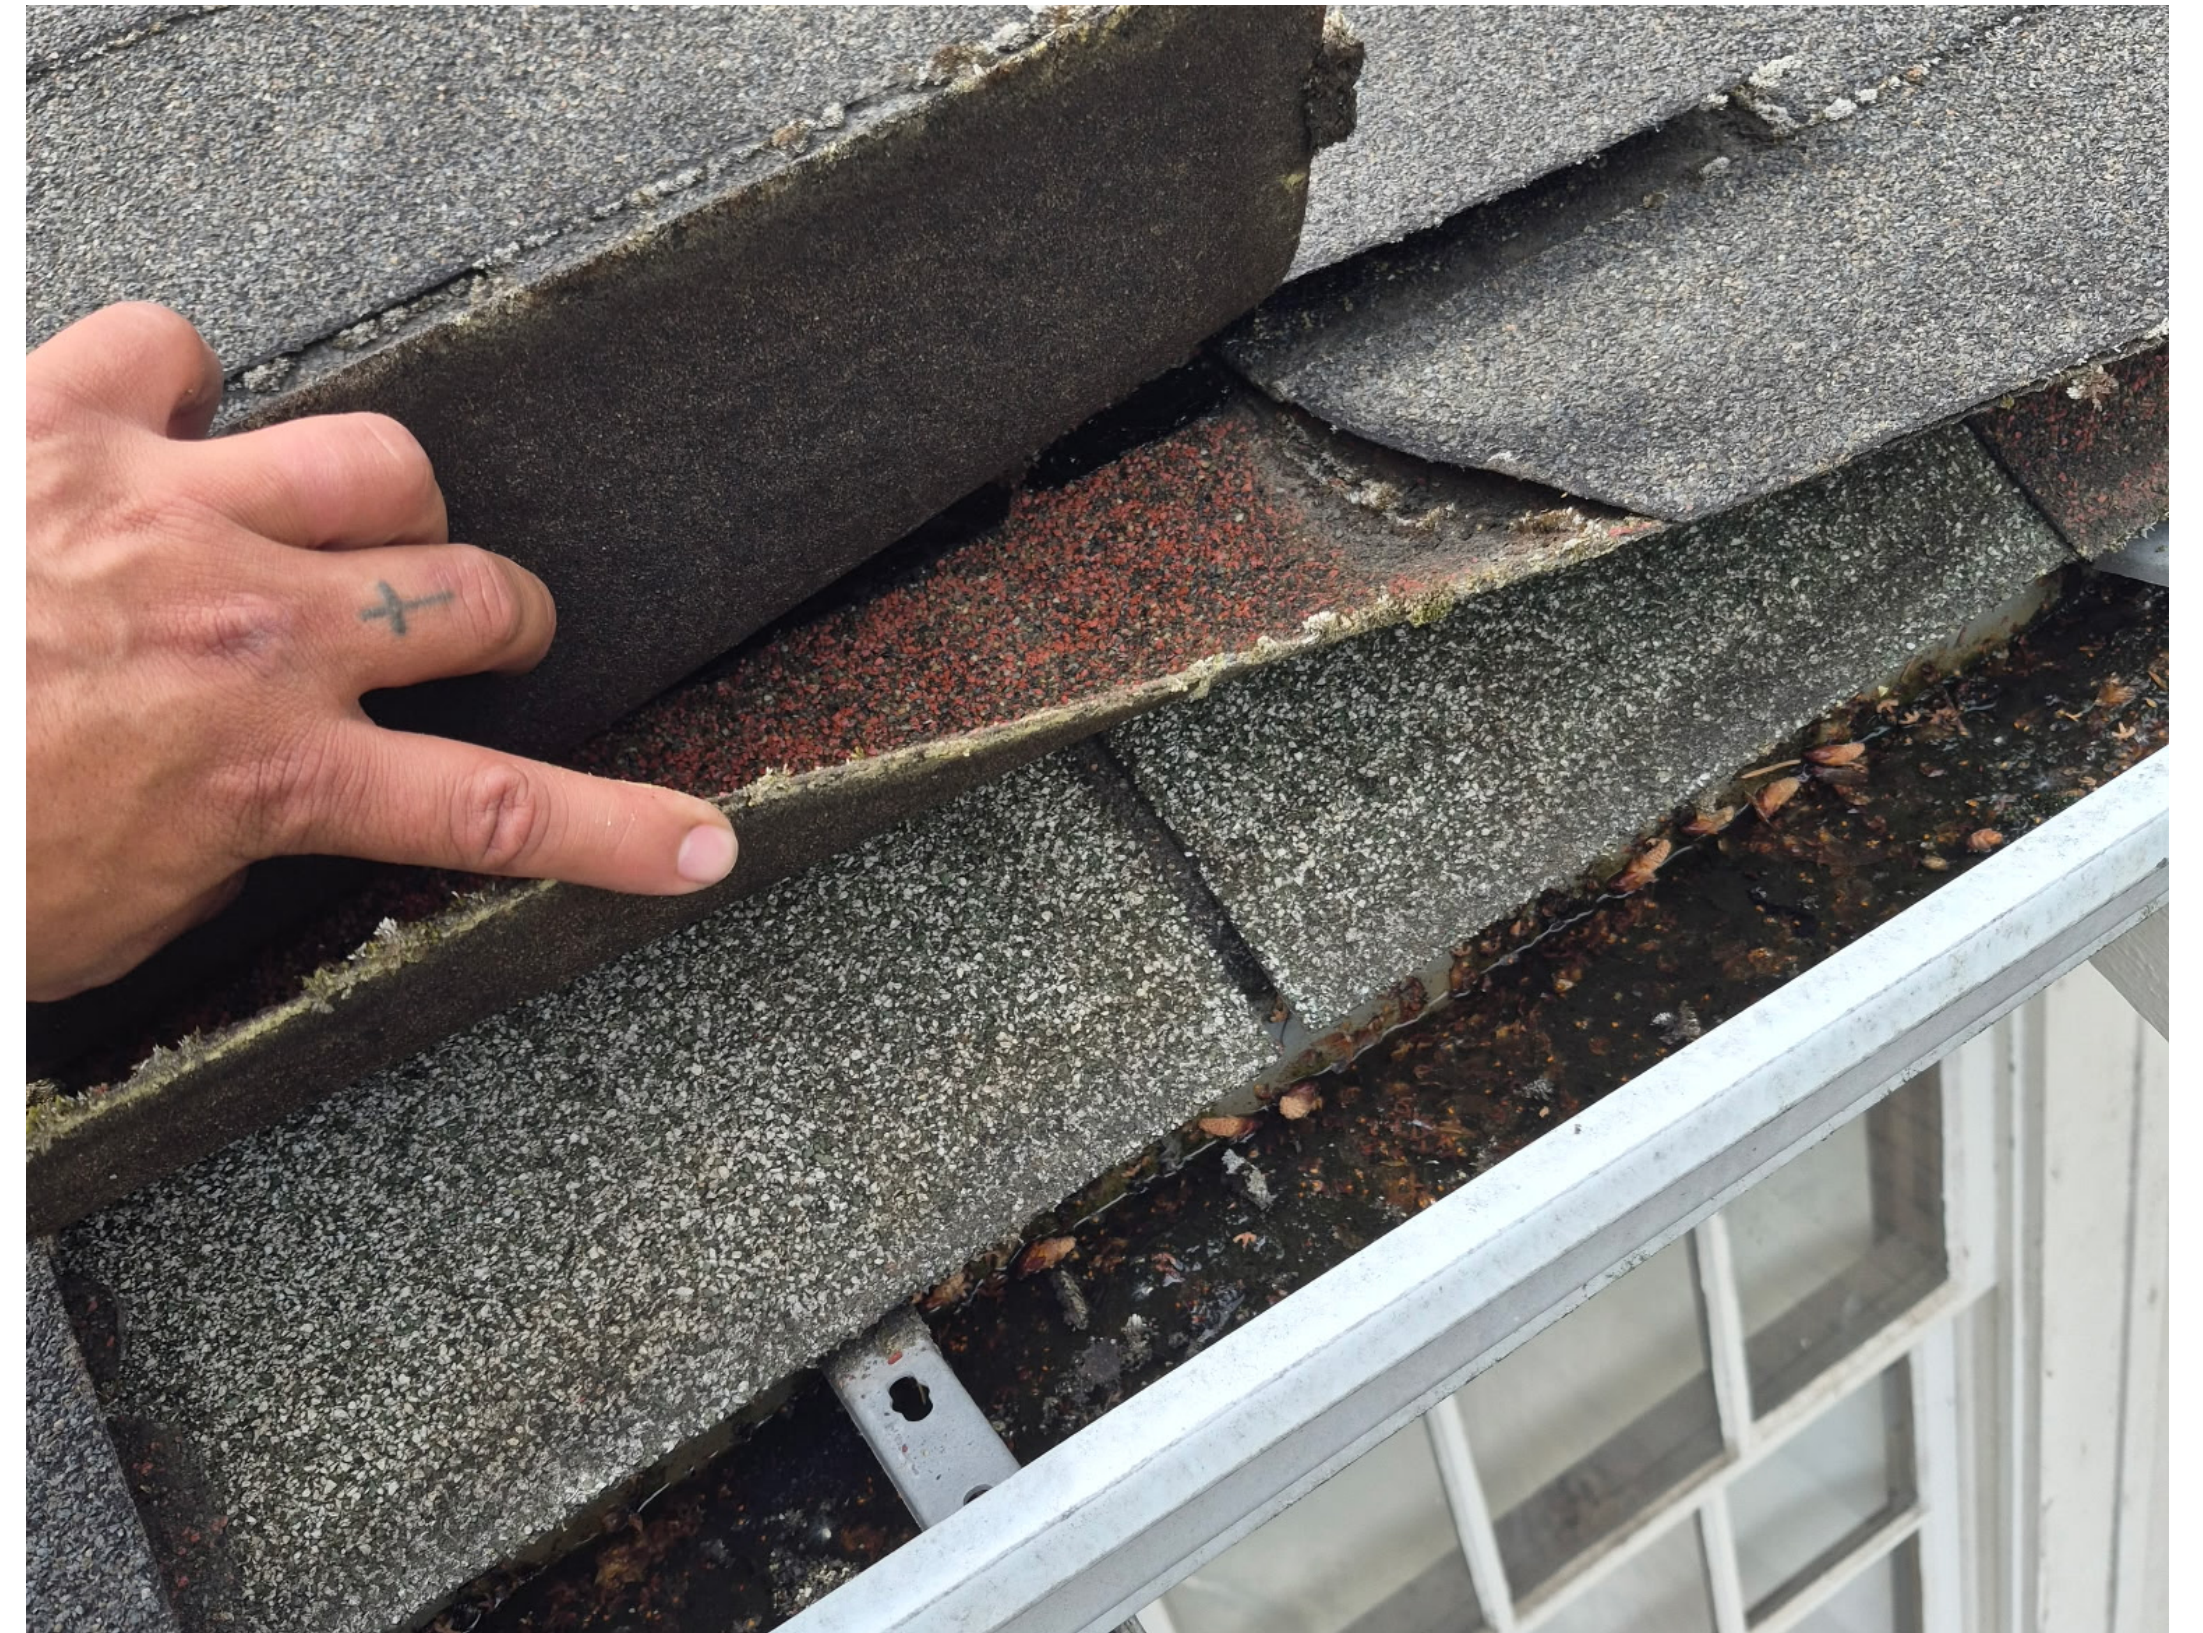
The existing roof, as shown in the photo above, consists of three layers of asphalt shingles. Each layer weighs approximately 4 pounds per square foot, resulting in a total weight of 12 pounds per square foot on the underlying structure. This roof was designed and engineered for only one layer of asphalt shingles, and the excessive weight is likely the primary cause of the visible cracks in the lath and plaster ceiling. Additionally, the short lifespan of asphalt shingles leads to constant maintenance and financial burden.

Our proposal suggests replacing the current roofing material with metal roofing, which weighs only 2 pounds per square foot and lasts five times longer than asphalt shingles. Furthermore, this change will significantly reduce maintenance and financial requirements.
