Seattle Public Utilities, Lakeridge Park

Taylor Creek Restoration Project Tree Impact Assessment

PREPARED FOR:

Cody Nelson
Seattle Public Utilities
Seattle, WA 98026

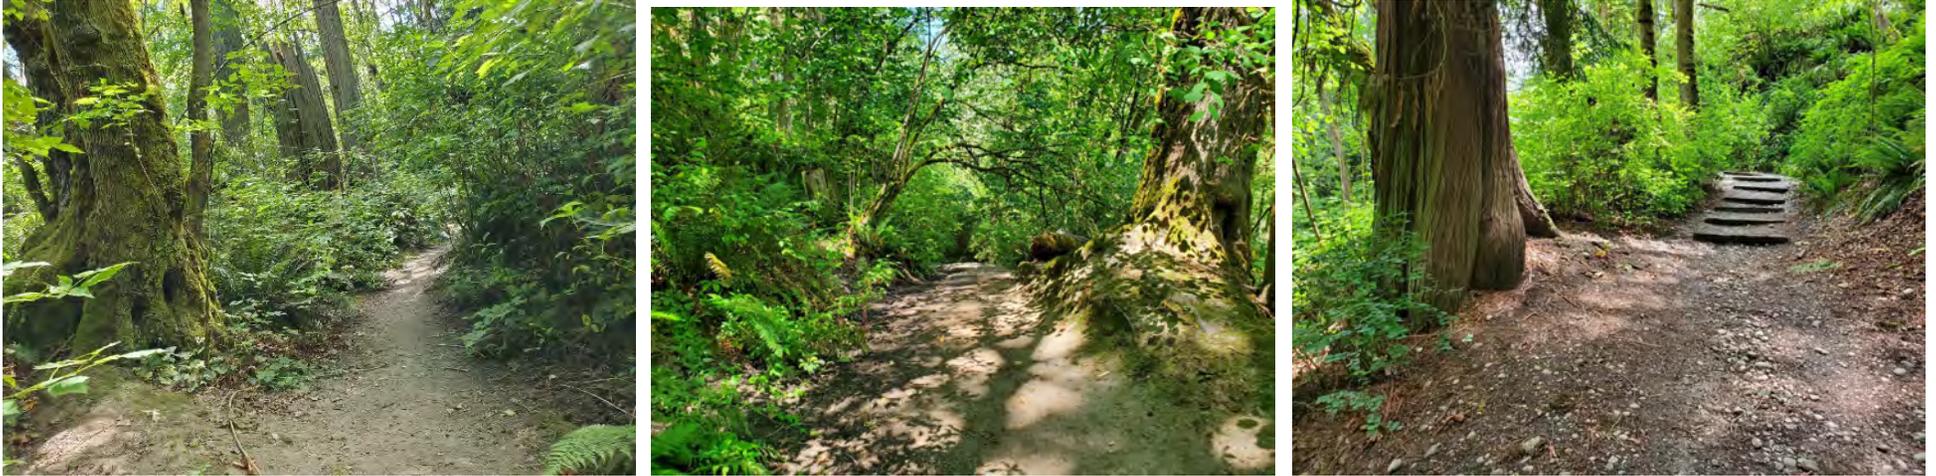
Photo 1-3: The large, bigleaf maples and cedar tree 3065 are located on the downhill side of the trail. These trees have significant root systems that support the slope and are recommended for retention if possible. Trees with this form also provide the sense of a mature forest.

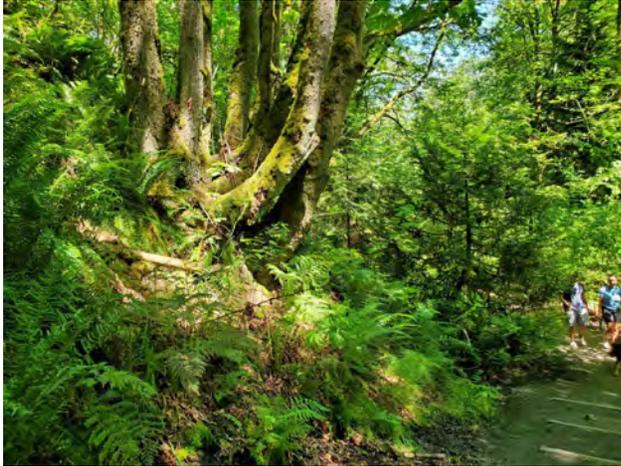
Photo 4. Maple tree 3040 has 10 stems. One stem (tree 3046) is closest to the trail. If management is needed for construction remove the tops of the stems but do not remove root systems.

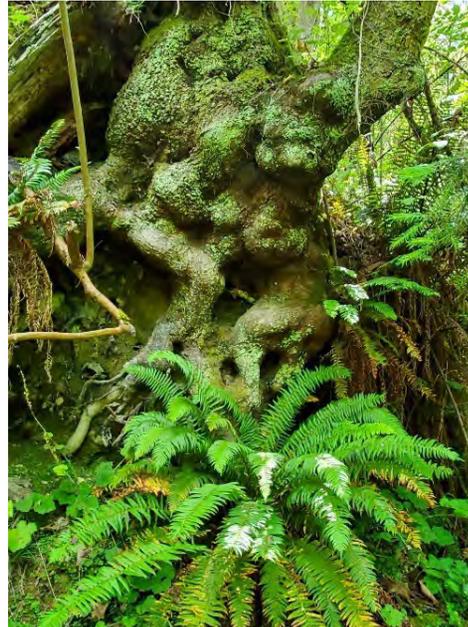
Photo 5. Tree 3527 has a unique root system and is holding up the bank.

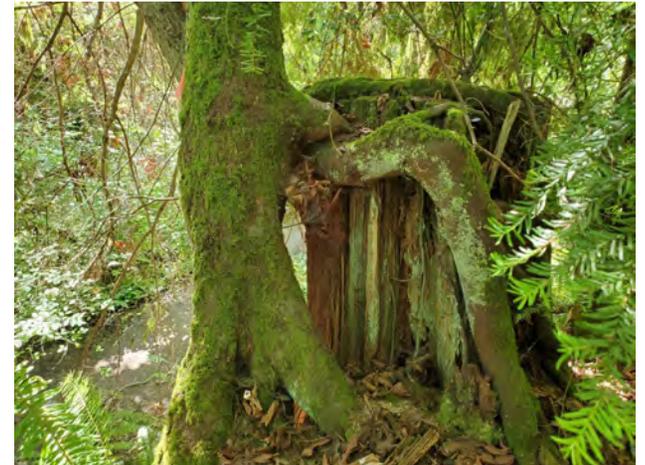
Photo 6. This hemlock is above the trail and has unusual form. Snag only if management is needed.

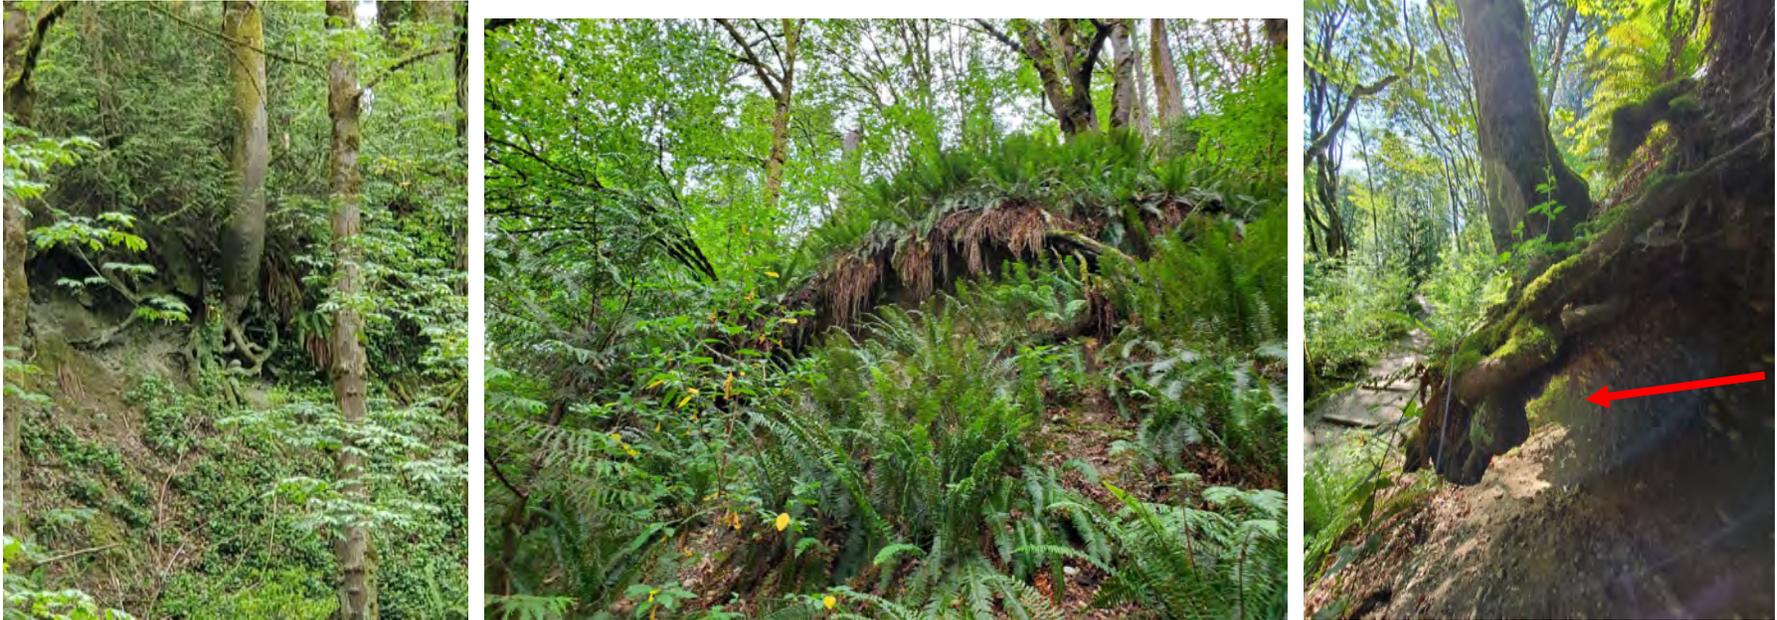
Photo 7-9. Examples where soil erosion above the trail is undercutting the bank and destabilizing trees. The untagged maple (UM ACMA) is undercut (arrow) beneath the trunk and is hanging in midair attached to the slope by a few roots.

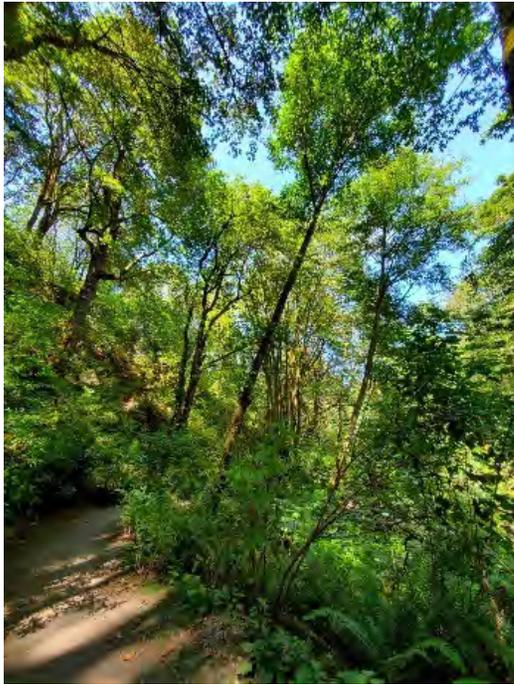
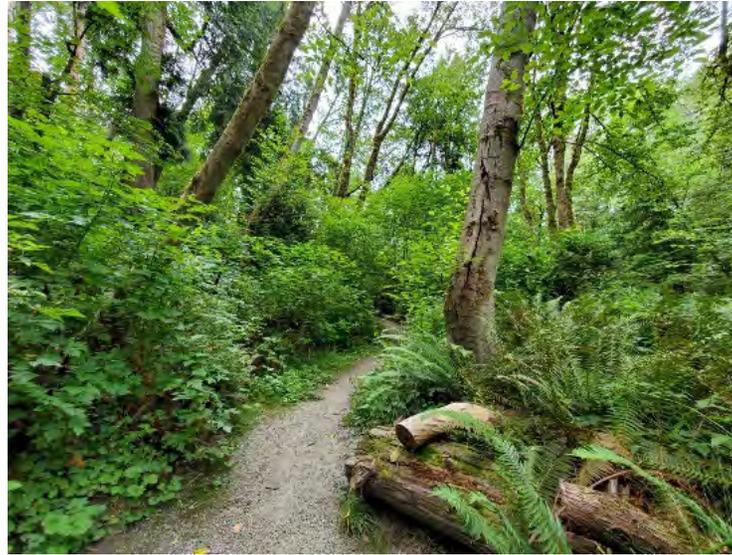
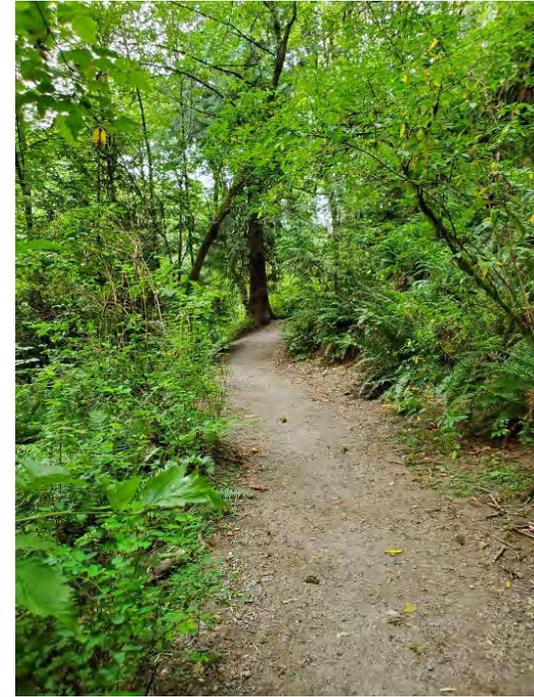
Photo 10-12: Tall and skinny trees with leans over the trail, or with root plate failures that will impact the trail were recommended for removal even if they were not located in the proposed roadbed.

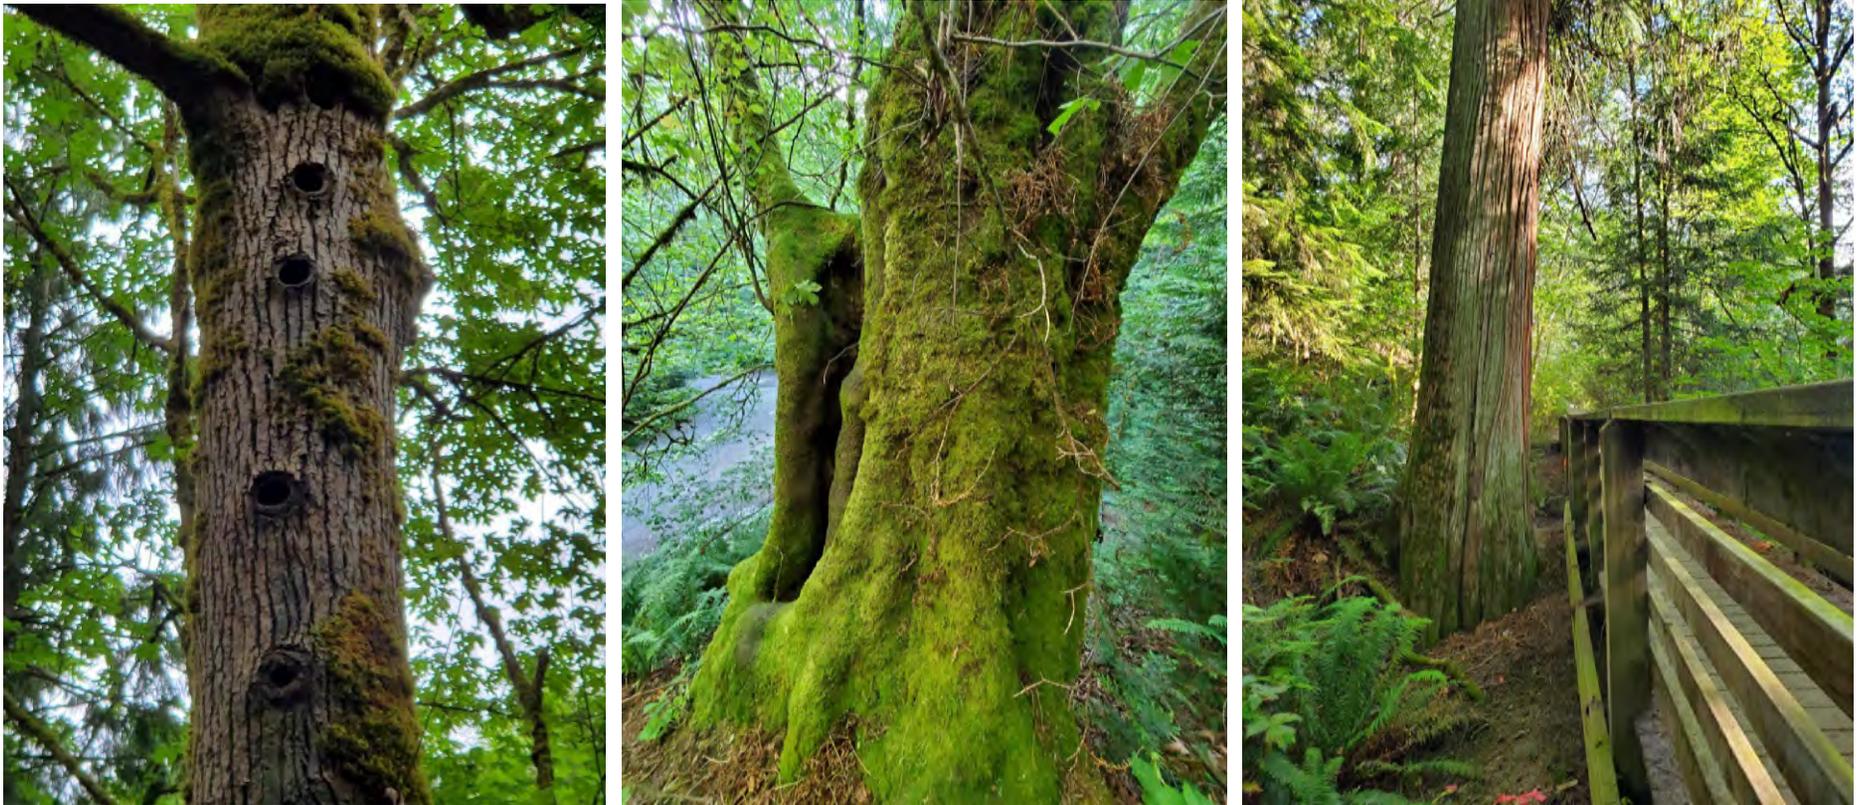
Photo 13-15. Habitat trees can be living or dead snags. Some have hollow cavities or unique branching patterns. Many large western hemlock, bigleaf maple and western redcedars have high habitat value.

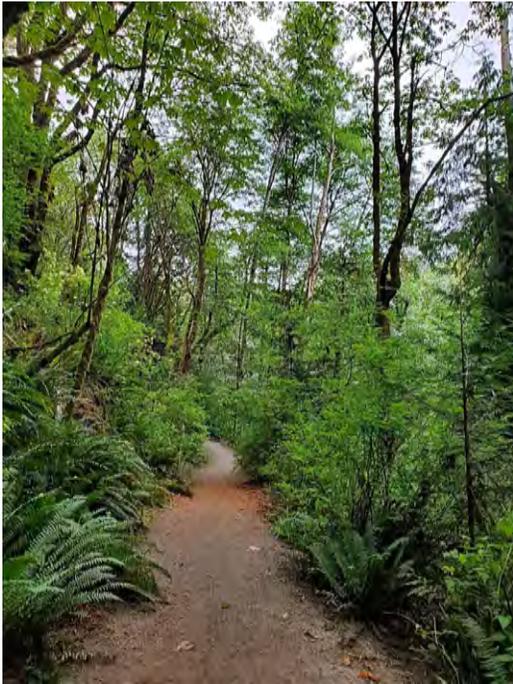
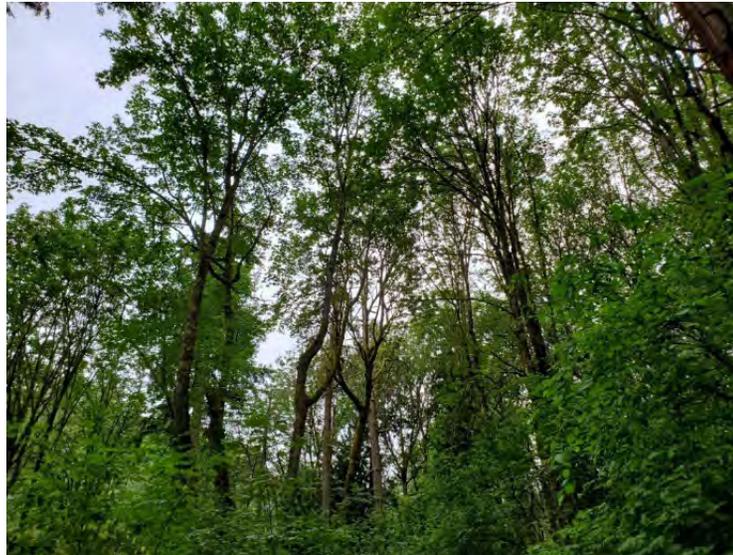
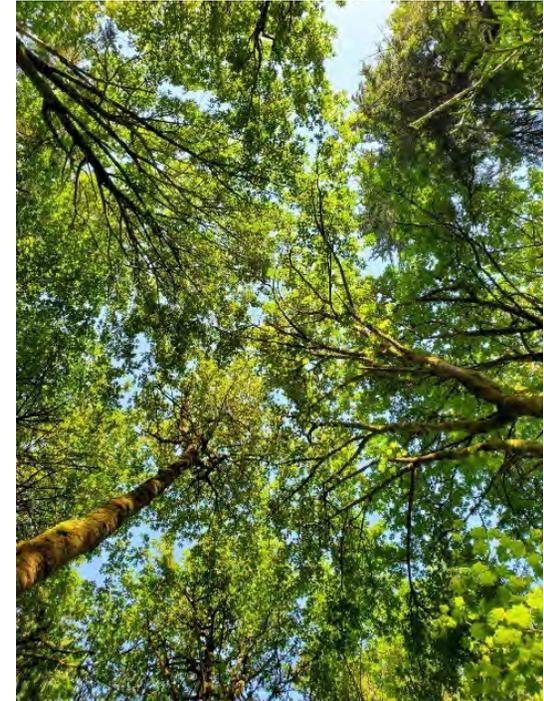
Photo 16-18: The forest canopy through the project area is deciduous, dominated by bigleaf maple and primarily one thin canopy layer 80 to 100 feet tall. The canopy during summer has many openings and light gaps and in the winter after leaf fall is very open. Tree canopies are small in width and very uneven relative to single open grown trees.
