Seattle  
Public  
Utilities

# Shape Our Water

Technical Memo  
**Seismic Risk Assessment**  
February 17, 2022

Deliverable title: Drainage and Wastewater Seismic Risk Assessment

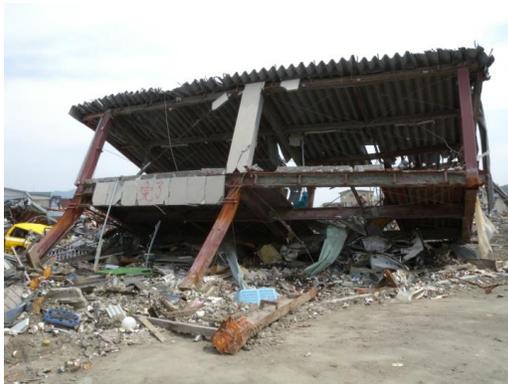
(a) Collapsed building

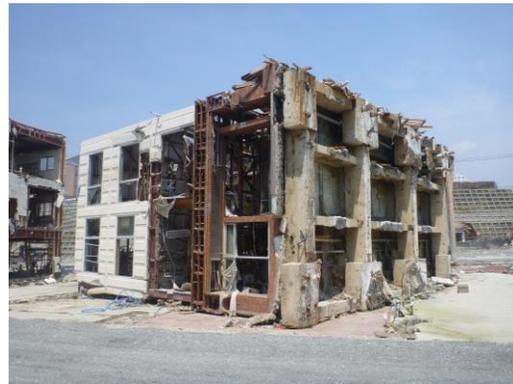
(b) Overturned building

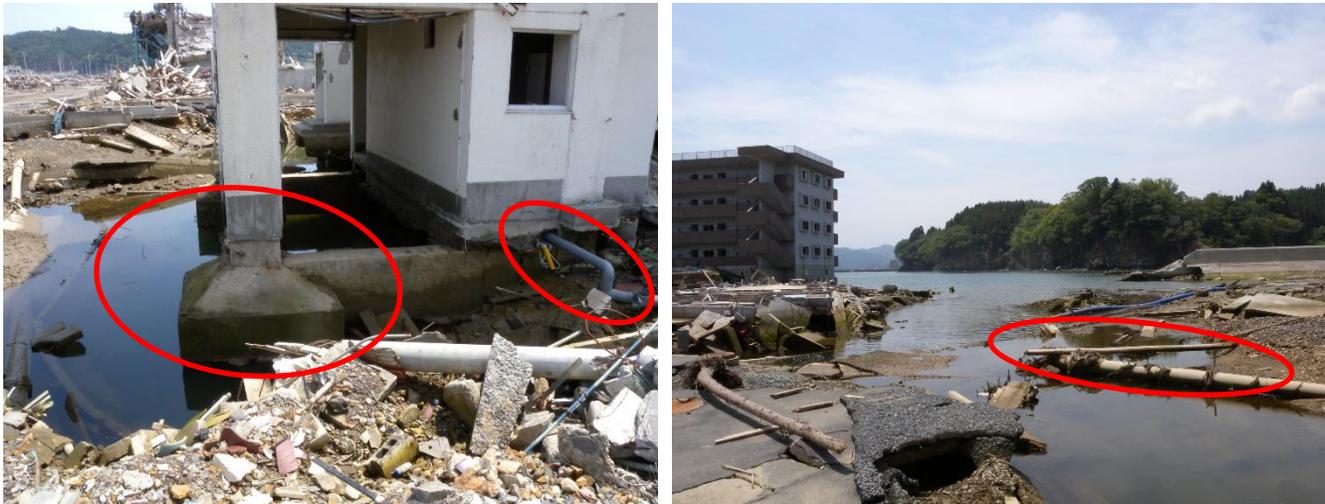
(a) Foundation and pipelines exposed adjacent to buildings

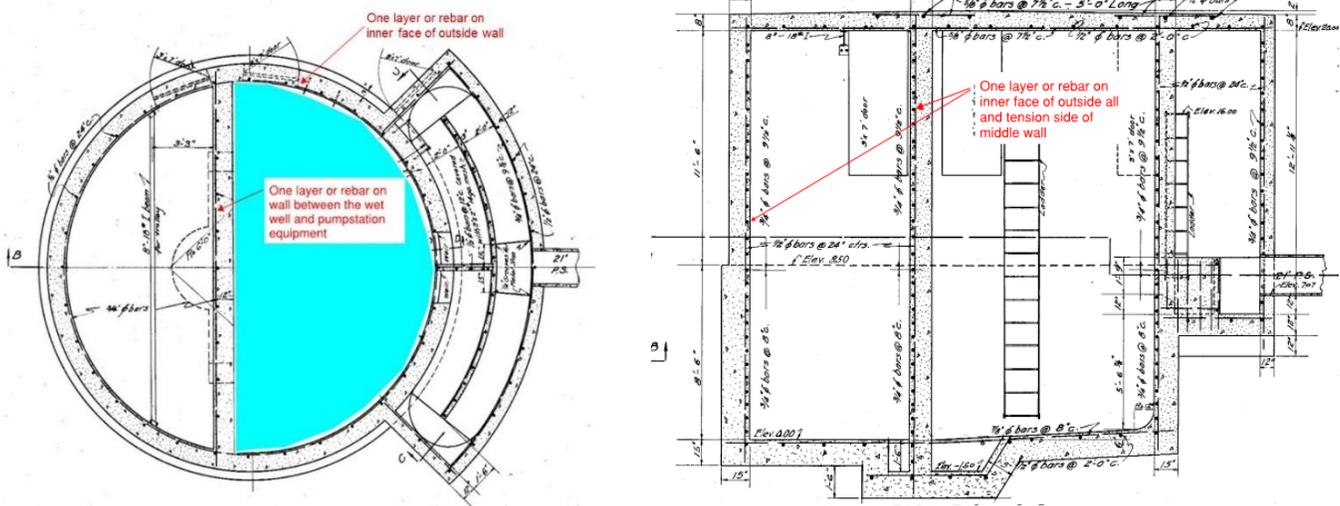
**Pump Stations 02, 05, 07, 09, 10, 13, and 20.** Built in the 1930s or '40s, these pump stations are circular in plan and each have a wet well. PS 02, 05, and 13 have only one layer of rebar in the perimeter walls designed to resist external pressure. There is just one layer of rebar on the tension face of the interior wall separating the wet well from the equipment room of the pump stations. Additionally, the length of lap splices for rebar of this era is typically insufficient. All of these pump stations lack ductility and potentially lack adequate strength (when unreinforced faces experience tension) and could result in pump station damage due to shaking. See Figures E-1 and E-2.

Figure E-1. Plan and section views of PS 05 showing the rebar placement within the outer and center wall

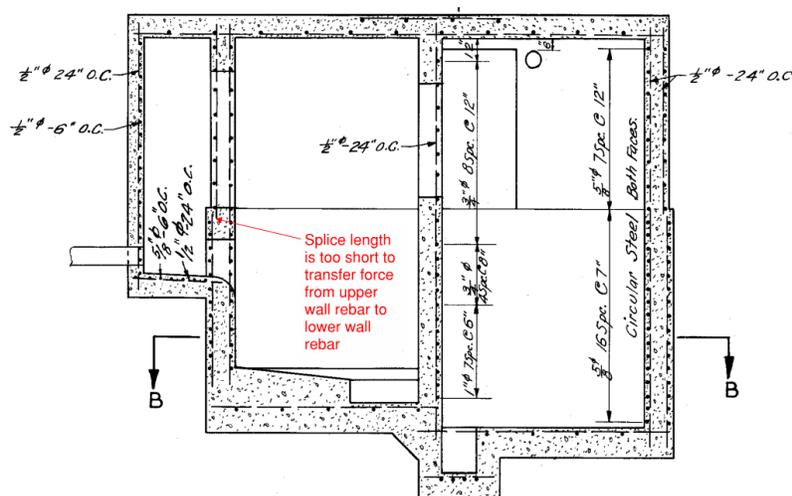
Pump Stations 09 and 13 are especially vulnerable because they also are in liquefaction zones. The amount of movement they may experience is listed in Appendix G. Moreover, Pump Station 09 is also at risk of failure due to floatation. Thus, the piping and structures are at risk of being severely damaged by the earthquake scenarios described in Section 3. There is no splice between the upper wall and lower wall in PS 20. This significantly reduces the pump station's wall ductility and makes it vulnerable to cracking and separation between the wall segments. This pump station is at risk of being severely damaged by the earthquakes considered in Section 3. See Figure E-2.

Figure E-2. Section view of PS 20 showing little or no splice where wall thickness changes between lower and upper wall

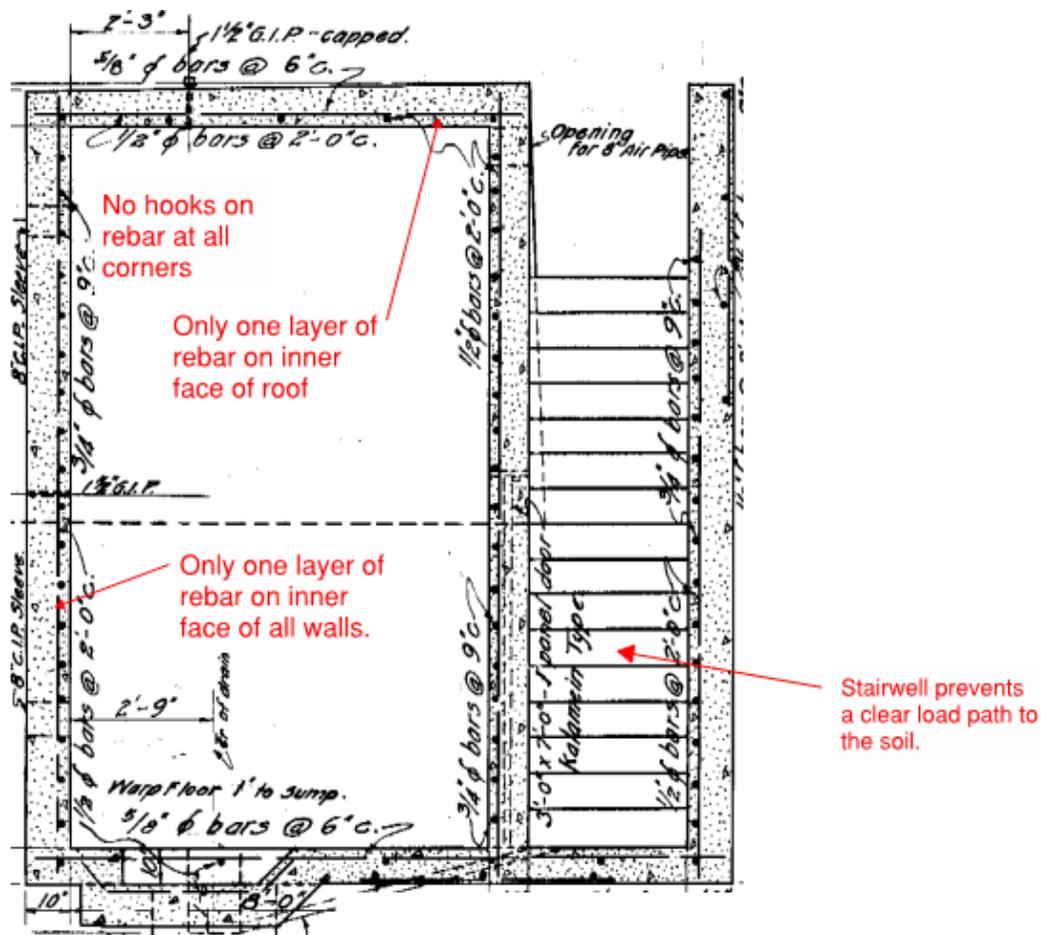
**Pump Station 06.** Built in 1930, this pump station is rectangular in plan, and has only one layer of rebar on the inner face of the perimeter walls. The horizontal rebar does not terminate with hooks at the wall corners. One wall is adjacent to a stairwell. The stairwell will prevent the adjacent tank wall from transferring its load to the soil making the load unbalanced and significantly increasing the risk this structure will be severely damaged by the earthquake scenarios described in Section 2. The structure potentially lacks adequate strength (when unreinforced faces experience tension) and a clear load path to transfer the load to the adjacent soil. See Figure E-3.

Figure E-3. Section view of PS 06 showing the rebar placement within perimeter walls of the structure

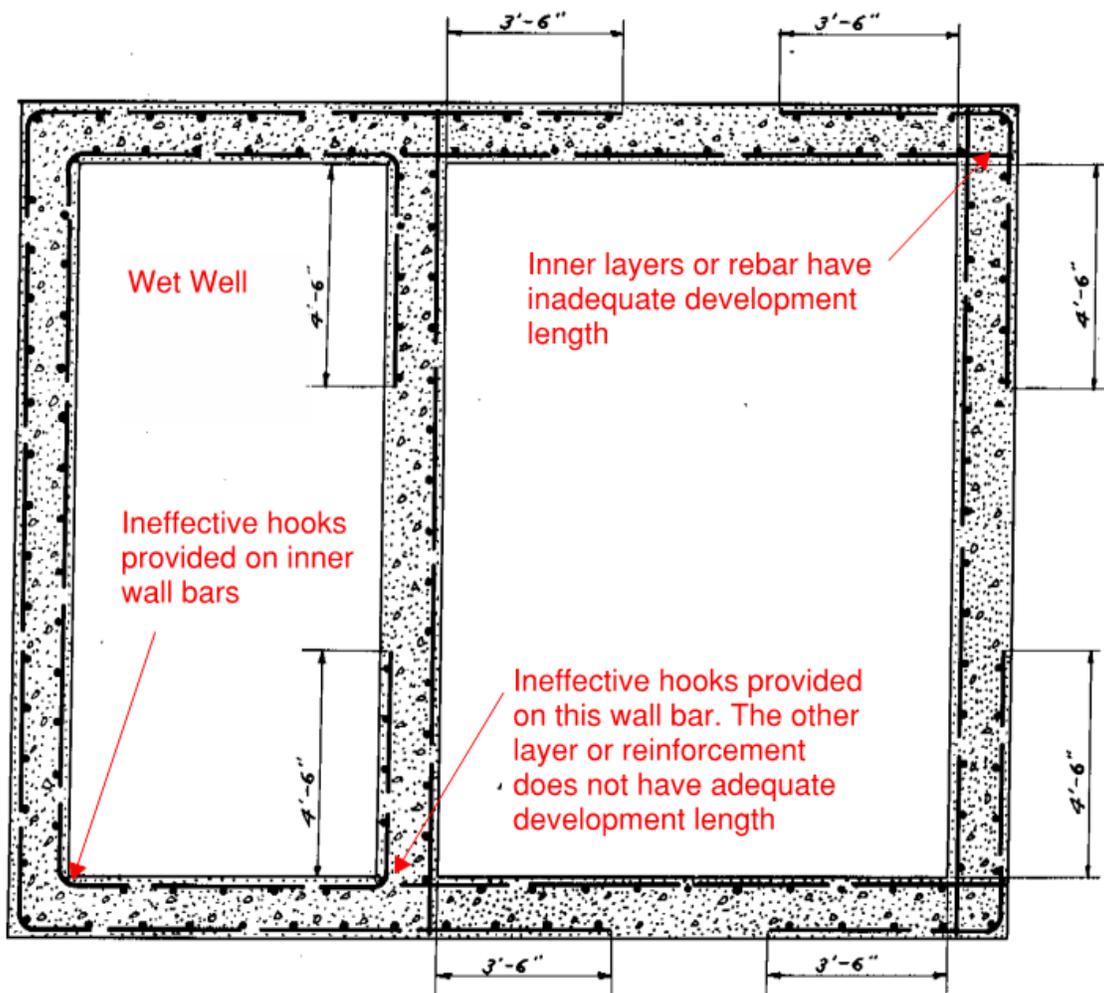
Overall, the structure does not have adequate strength and ductility and is at risk of being severely damaged by the earthquakes considered in Section 3. See Figure E-4.

Figure E-4. Plan view of PS 22 showing ineffective hook at inner wall corners of the structure

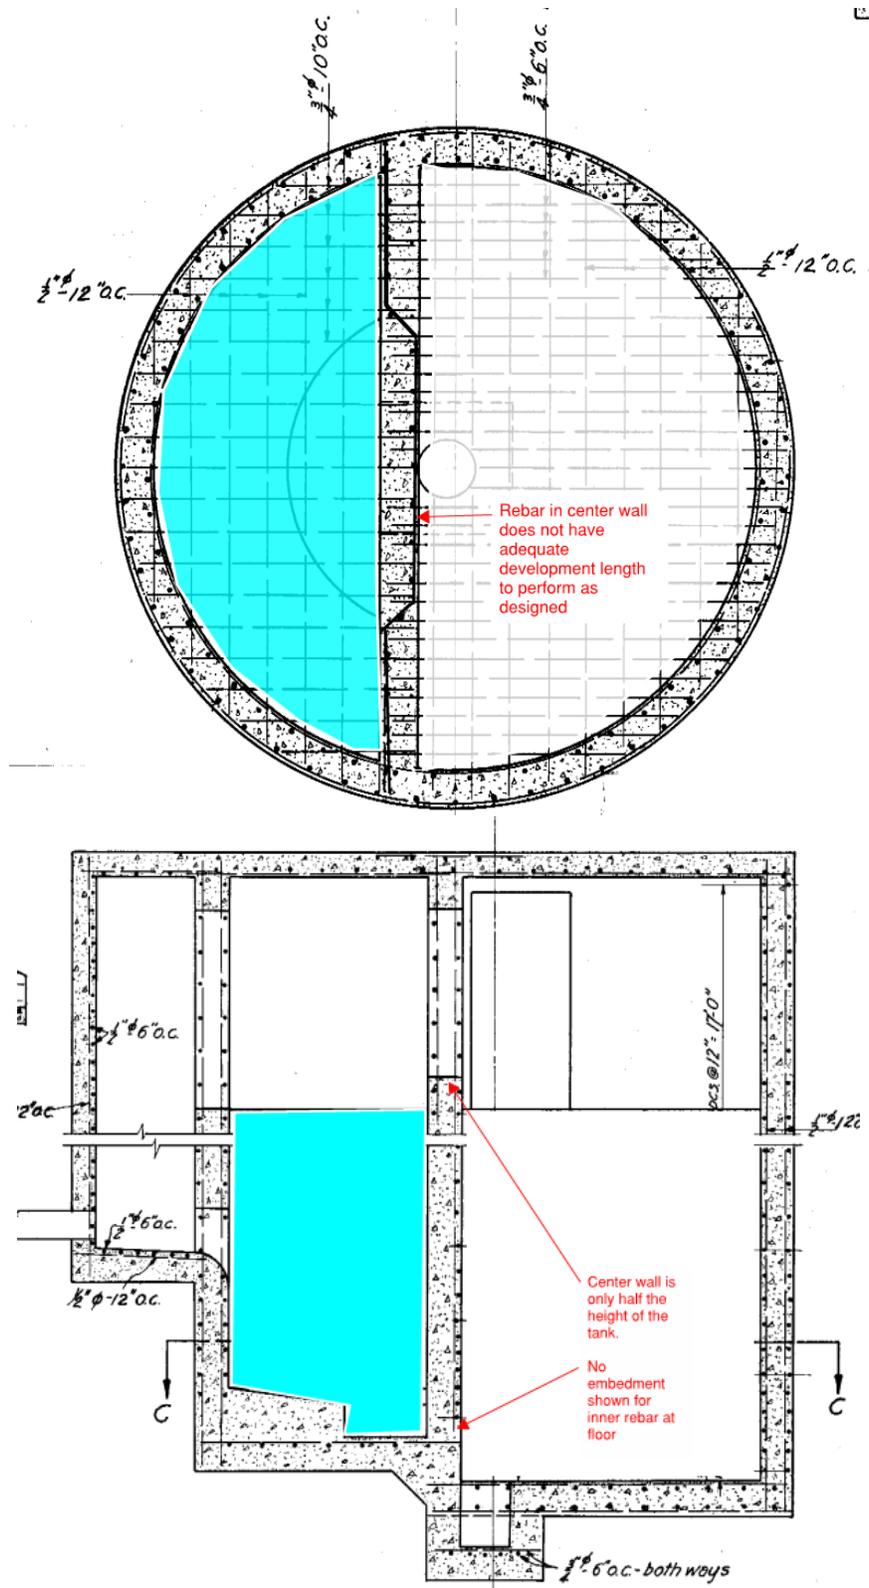
**Pump Station 25.** Constructed in 1952, Pump Station 25 is a cast-in-place concrete storage tank with an inside diameter of 16 feet. An interior concrete wall divides the tank between its wet well and equipment room. The structure has two layers of rebar on the perimeter walls. The rebar in the interior wall is detailed to resist the wet well loads using a moment connection at the tank wall, however, the rebar does not have adequate embedment length to be a moment connection. The wall is improperly designed and is at severe risk of damage under the earthquake scenarios considered in Section 3. This structure will likely perform poorly due to its lack of adequate strength and ductility in the interior wall. See Figure E-5.

Figure E-5. Plan and section views of PS 25 showing the rebar placement of the interior wall

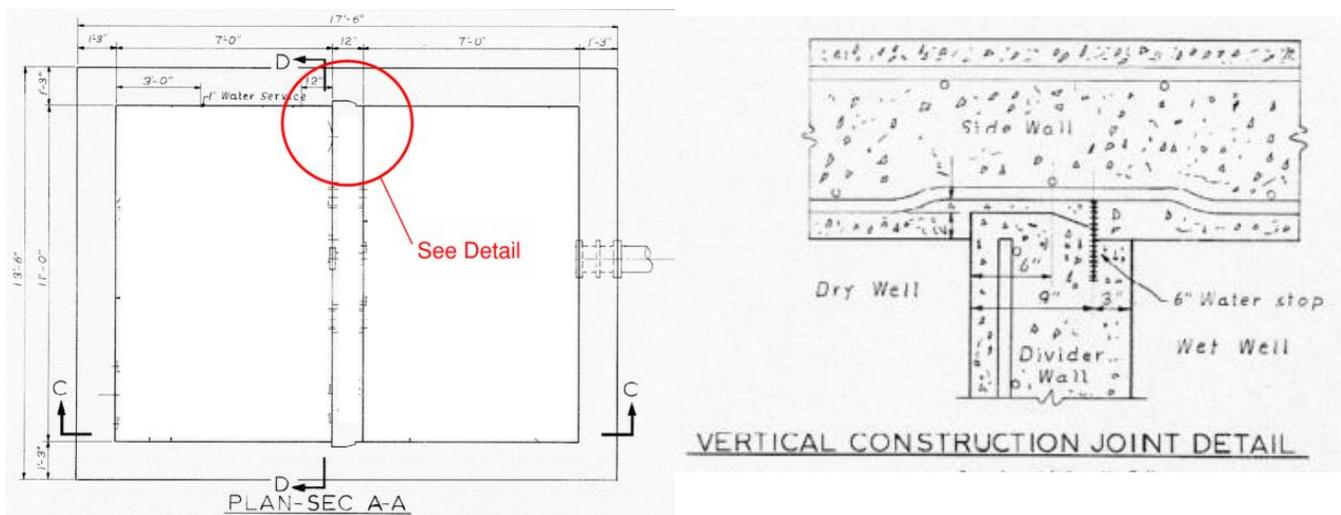
Figure E-6. Plan view of PS 54

Built in 1960, Pump Station 49 is also rectangular in plan with approximate dimensions of 10 ft by 12 ft and an overall height of approximately 18 feet. Similar to Pump Station 54, the interior wall separates the wet well from the equipment room. The interior wall is not attached to the tank perimeter walls, roof, or floor with rebar. Only a key connects the interior wall to the walls and floor. Although this pump station is not located in a liquefaction zone. The middle wall could still perform poorly under the earthquakes considered in this report. See Figures E-6 and E-7.

*The center wall is connected to the outer walls with only a key.*

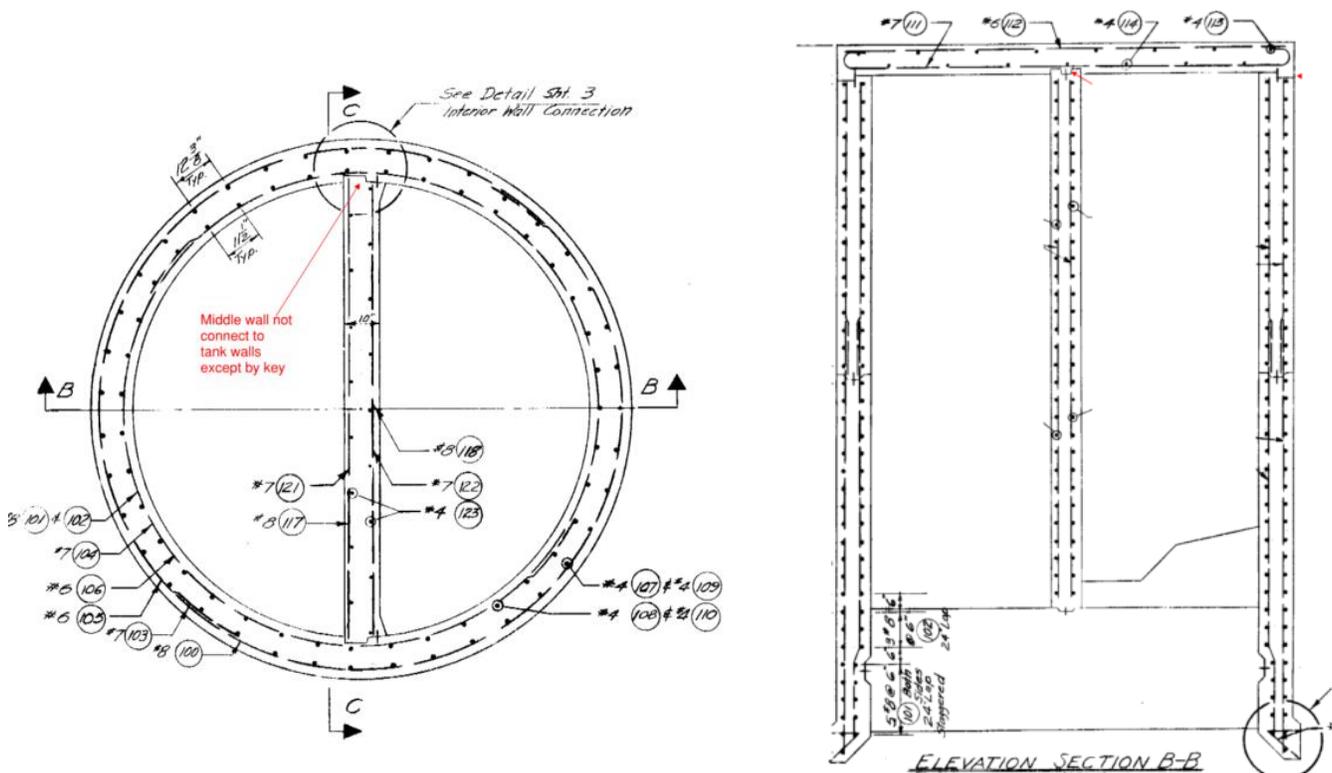
Figure E-8. Plan view of PS 71

**Pump Station 71** Built in 1963, this pump station is about 20 feet deep with an inside diameter of 13 feet. An interior wall separates the wet well from the equipment room. The interior wall is not attached to tank perimeter walls, roof, or floor with rebar. Only a concrete key connects the interior wall to the perimeter walls and floor. This pump station is also located in a liquefaction zone with an anticipated PGD of 26 inches. The roof is not connected to the walls with rebar. There is no rebar in the 3'-6" thick base slab. Tank perimeter walls have no connection to base slab except for a concrete key. The span is short but the interior wall could experience damage in the earthquake scenarios considered in Section 3 of this report. The anticipated ground movement could easily move the roof making it possible for soil or debris to enter the structure. See Figure E-8.

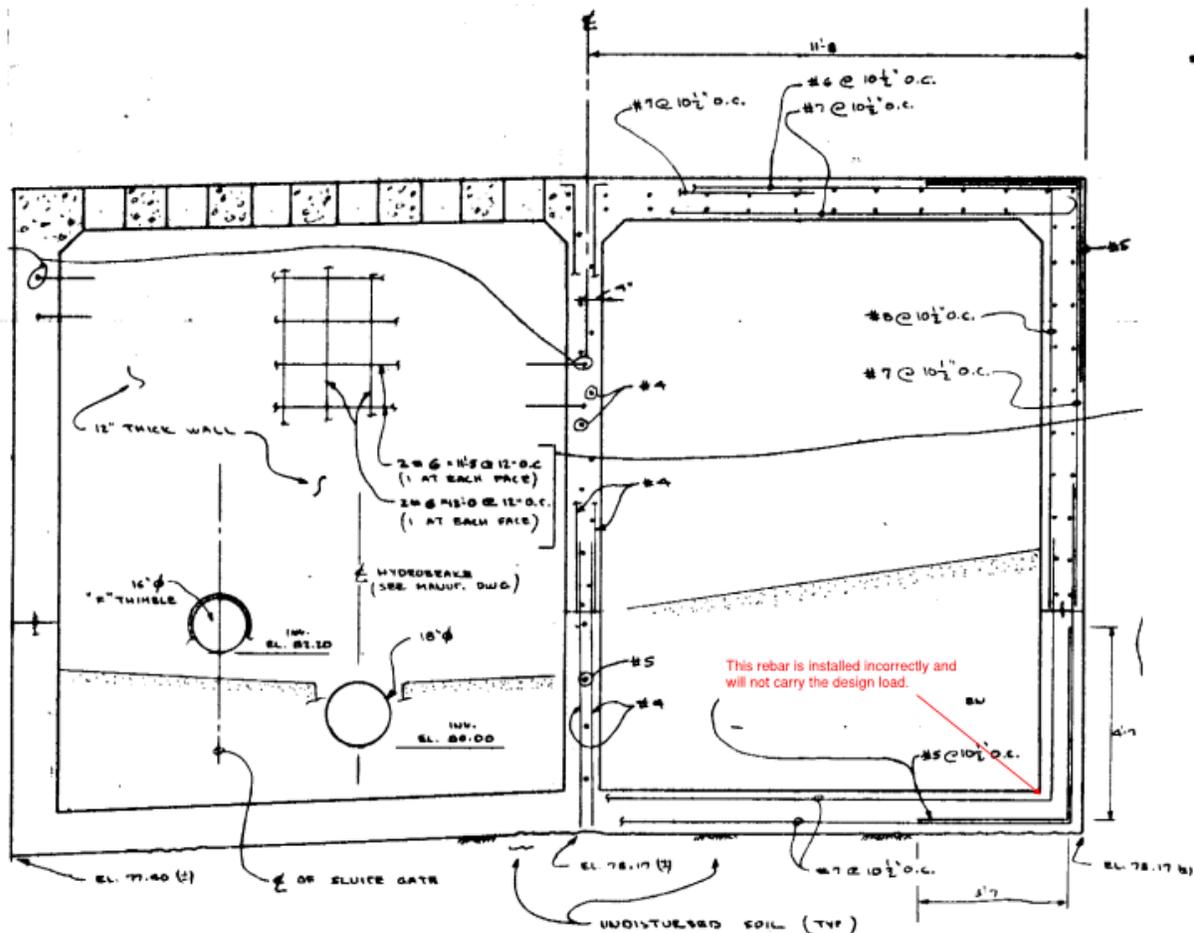
Figure E-13. Box conduit with wall to floor corner rebar shown to have hooks detailed improperly
