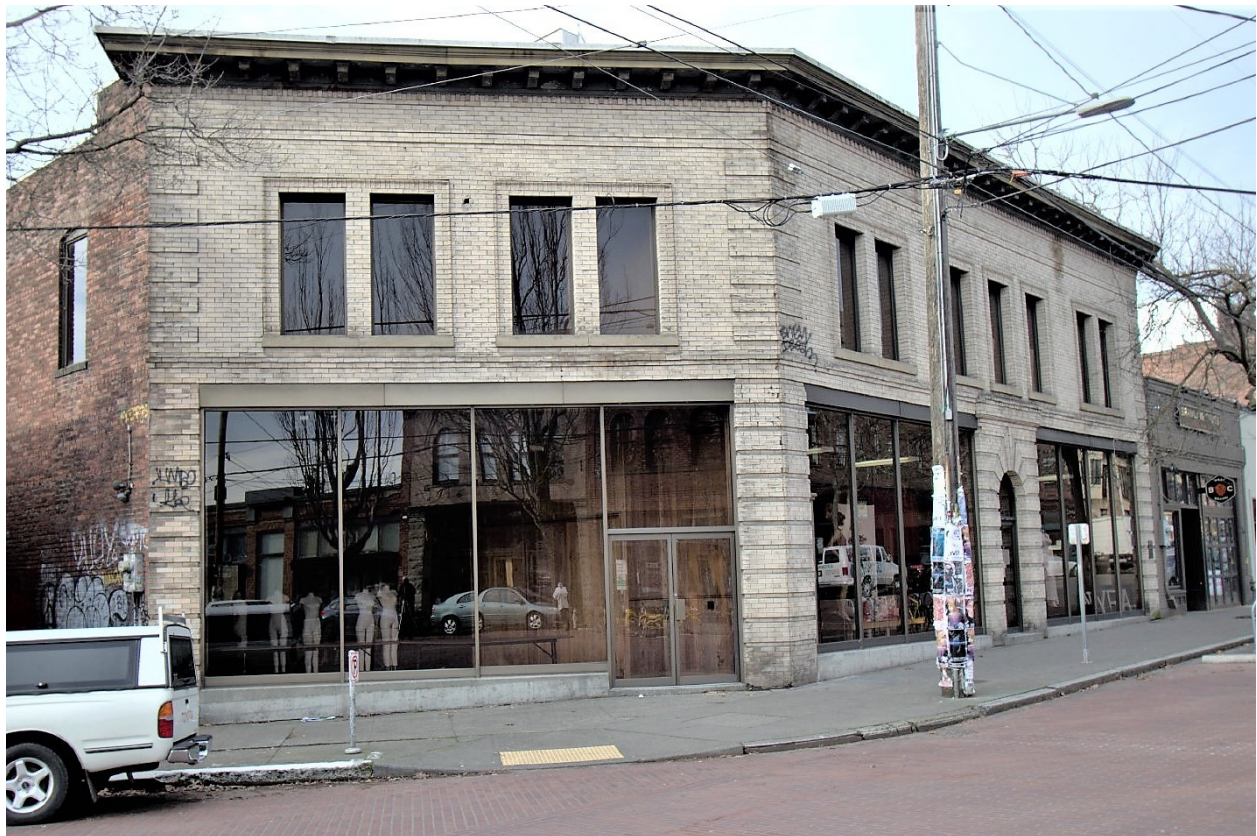
Building prior to renovation – 2018.

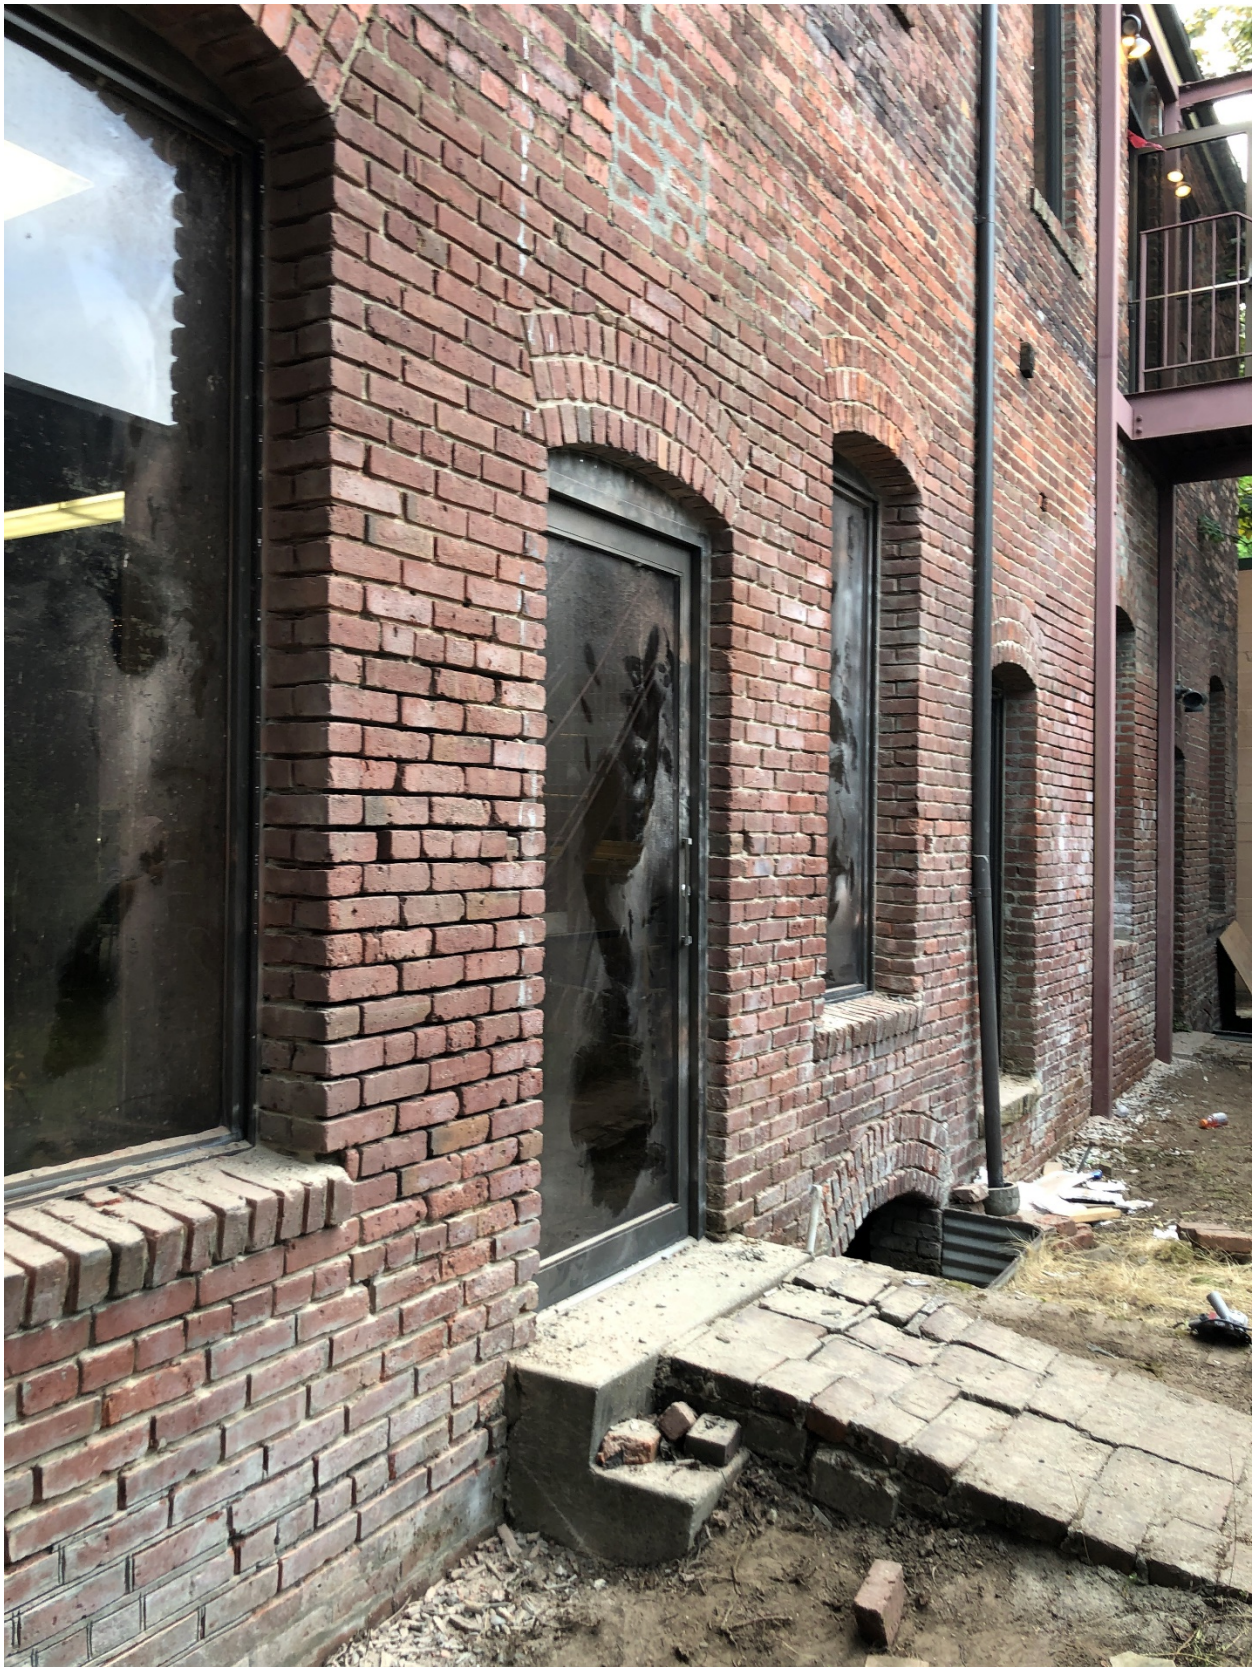
Exterior rear wall prior to tuck pointing.
