## **FIRE STATION 13: SELECTIVE WINDOW REPLACEMENT**

Seattle Landmarks Preservation Board Briefing Packet  
November 30, 2022

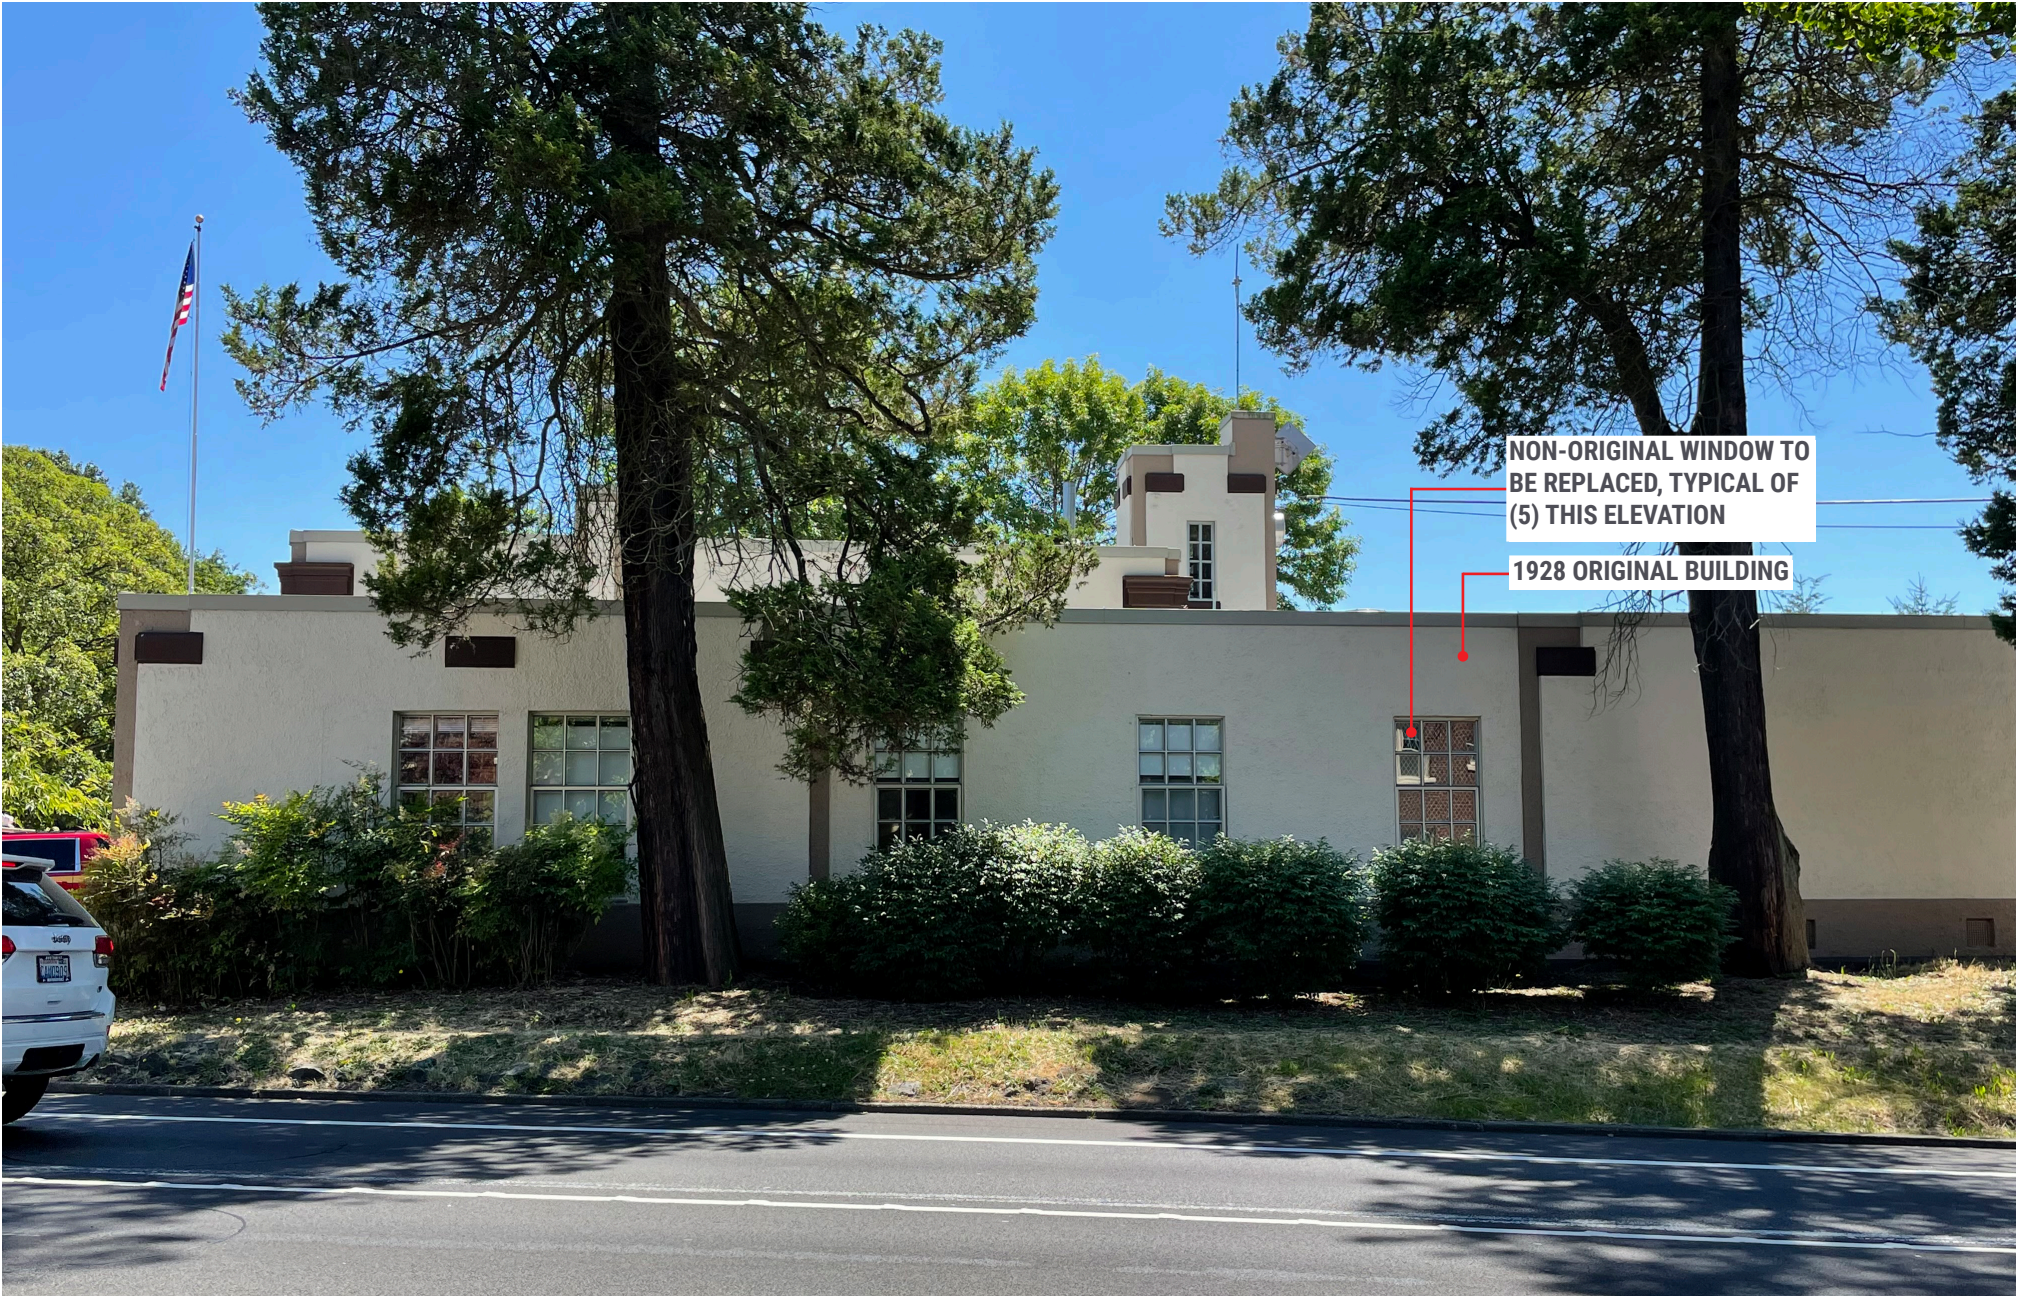
View at North facade of Fire Station 13, taken from S Spokane St.

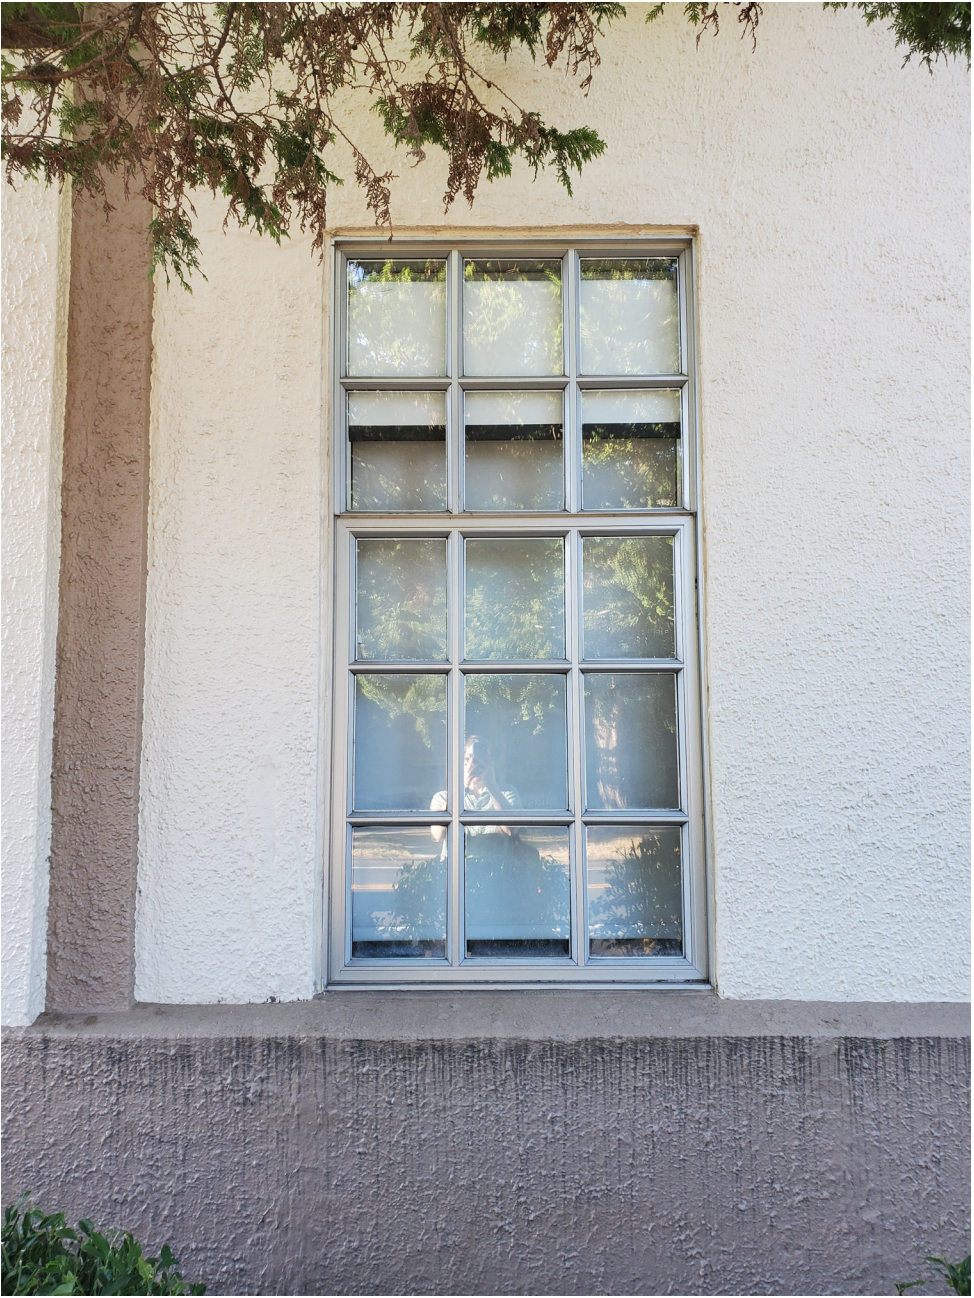
Close-up of a typical non-original window to be replaced.

This project proposes replacement of five non-original aluminum windows on the north elevation at street level with new high-performance fiberglass windows manufactured by Cascadia Windows and Doors. Four of the selected windows have failed; they no longer perform adequately for thermal or acoustic properties and have condensation inside the insulated glass units. For aesthetic consistency, this project will also replace a fifth window immediately adjacent to the four failed windows.

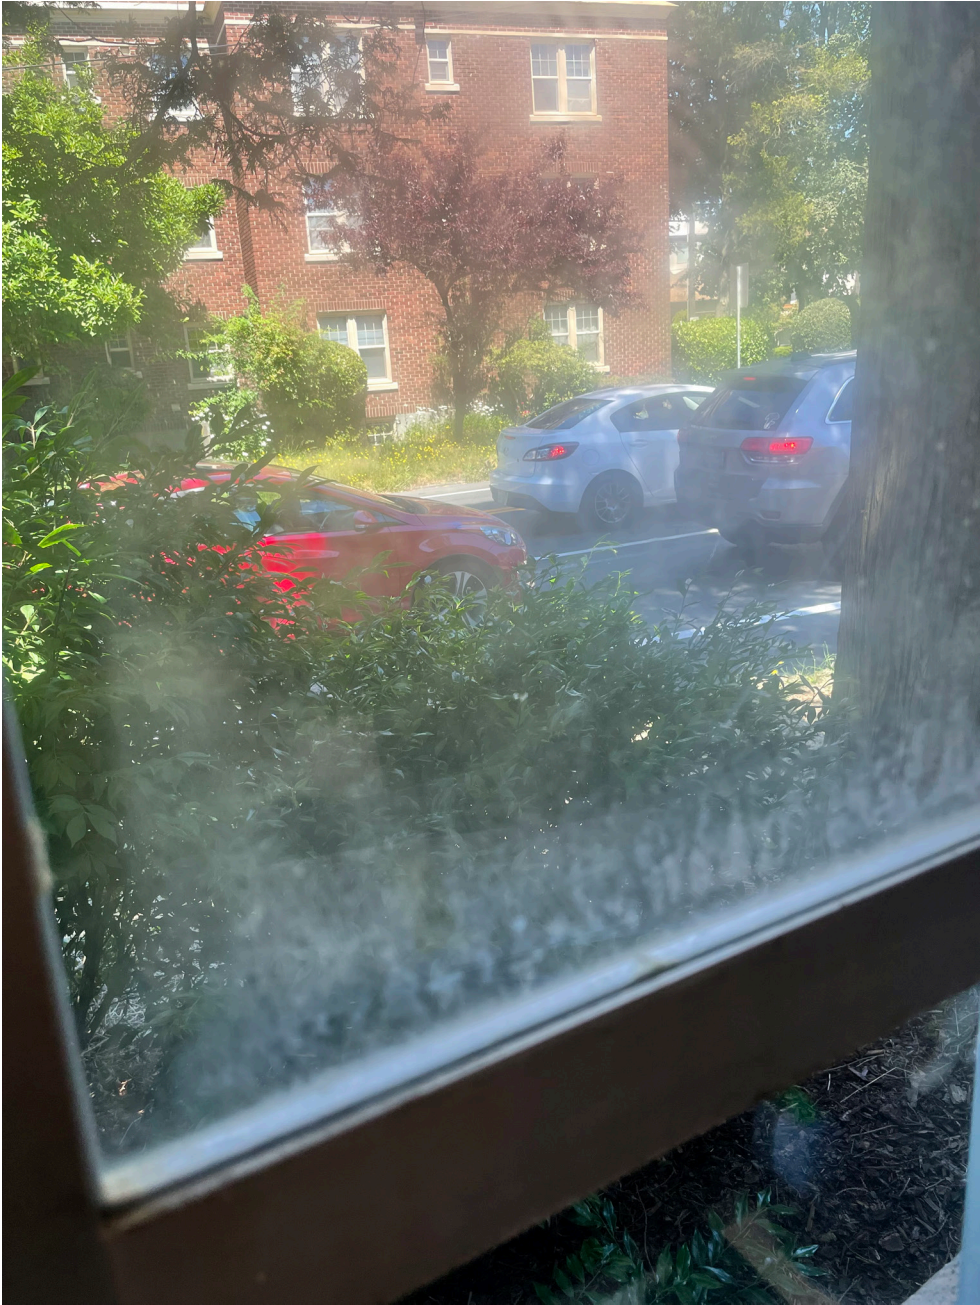
Building integrity: Since the seals have failed in several windows, we anticipate the windows will continue to experience regular internal condensation. This additional moisture will degrade the windows over time and the window performance likely will continue to worsen. If air and vapor infiltration continue unabated, and the windows continue to degrade, damage to the building wall assembly may occur. This is especially concerning for a designated landmark building.

Example of condensation between panes of an existing non-original window.

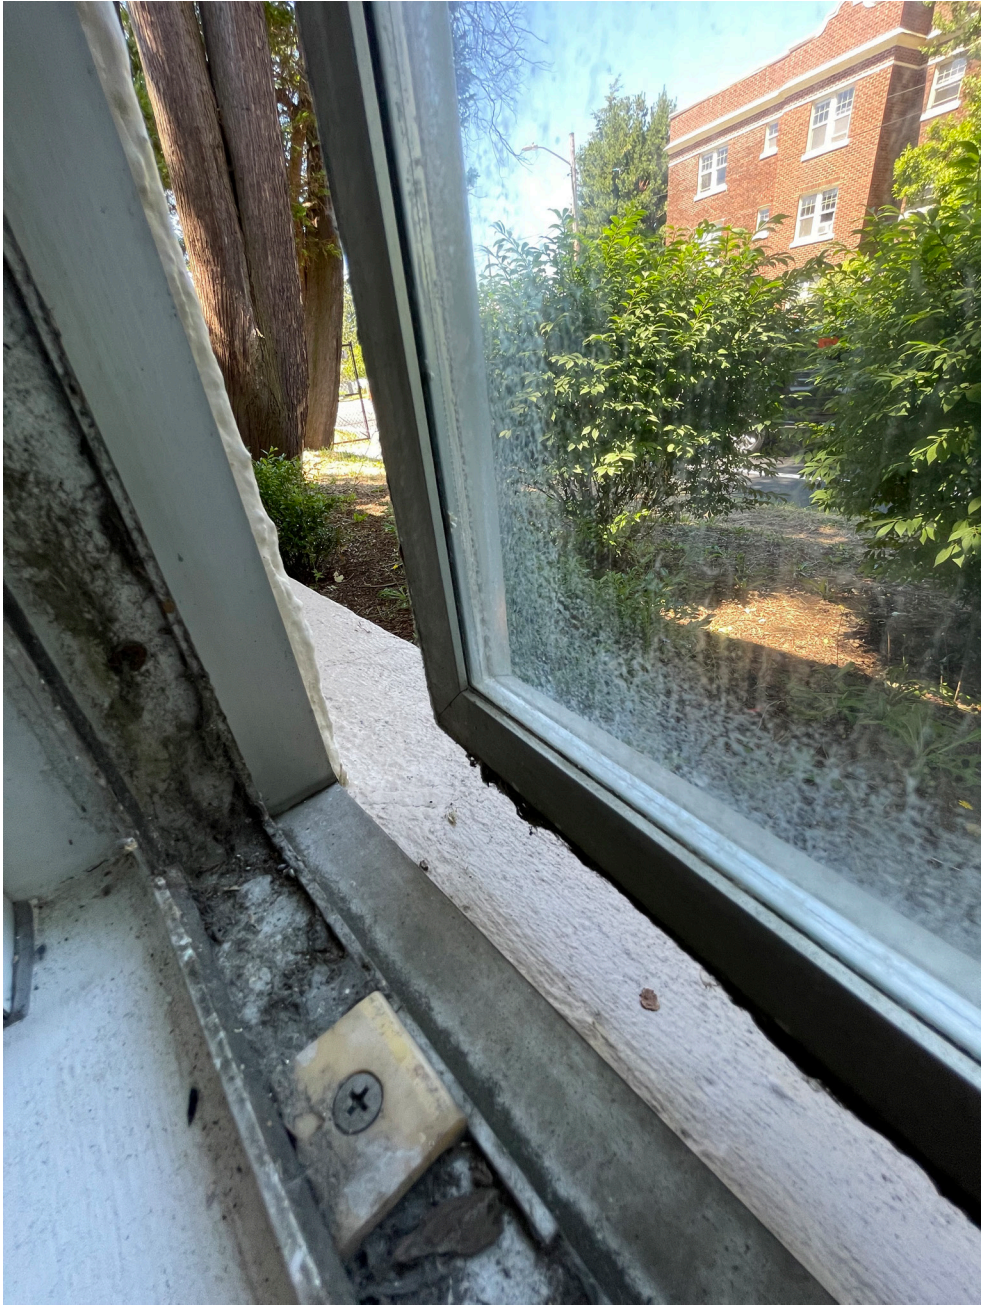
Example of degraded frame condition at an existing non-original window.

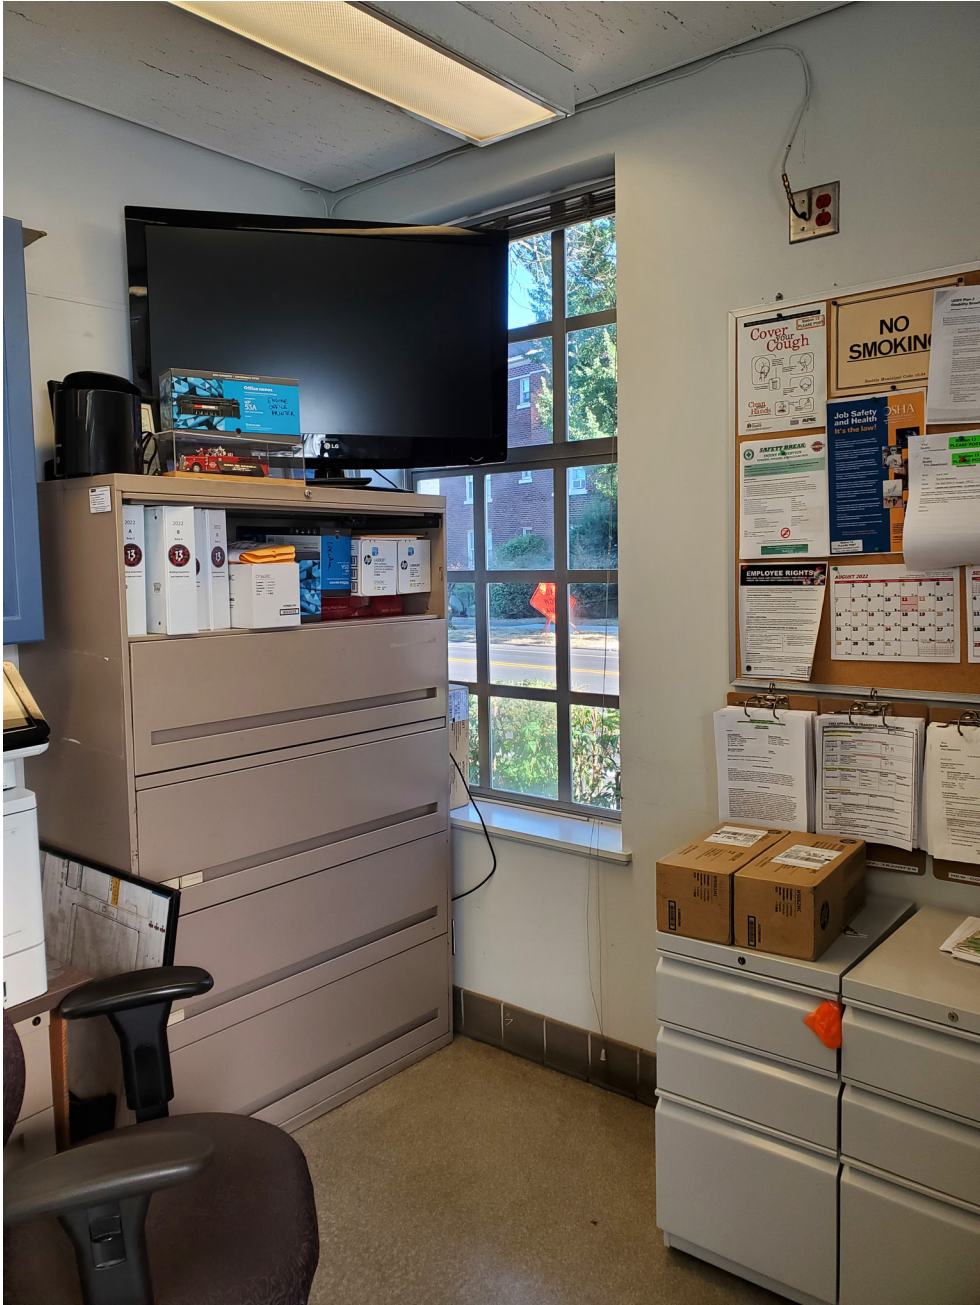
Interior view of one of the existing non-original windows to be replaced.
