Lowman & Hanford Printing and Binding Building (Washington Park)
68 S Washington Street, Seattle WA 98104

2022 Special Valuation on Improvements | Supporting Documentation

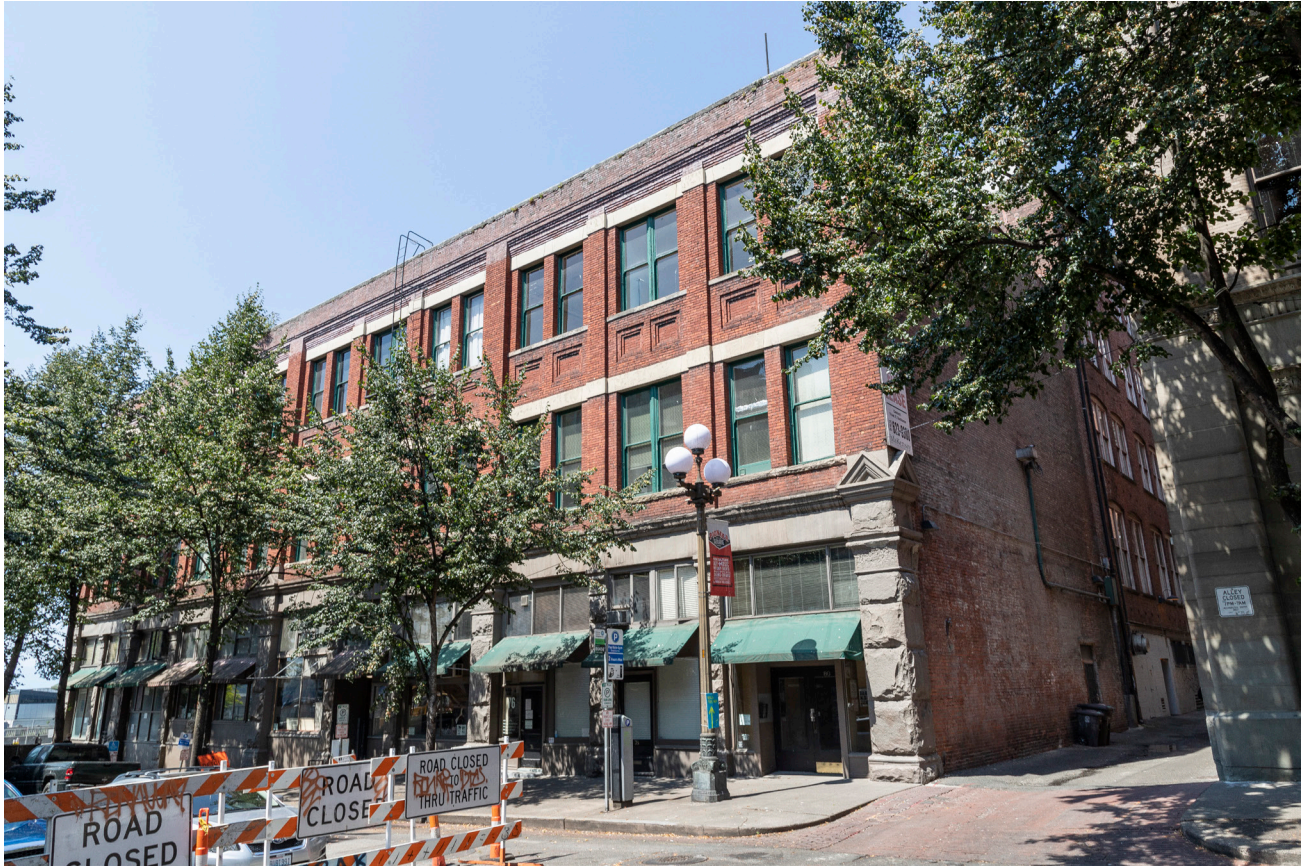
PHOTO 1. Before: 2020 site, southeast corner looking northwest across S Washington Street. Alley at right.

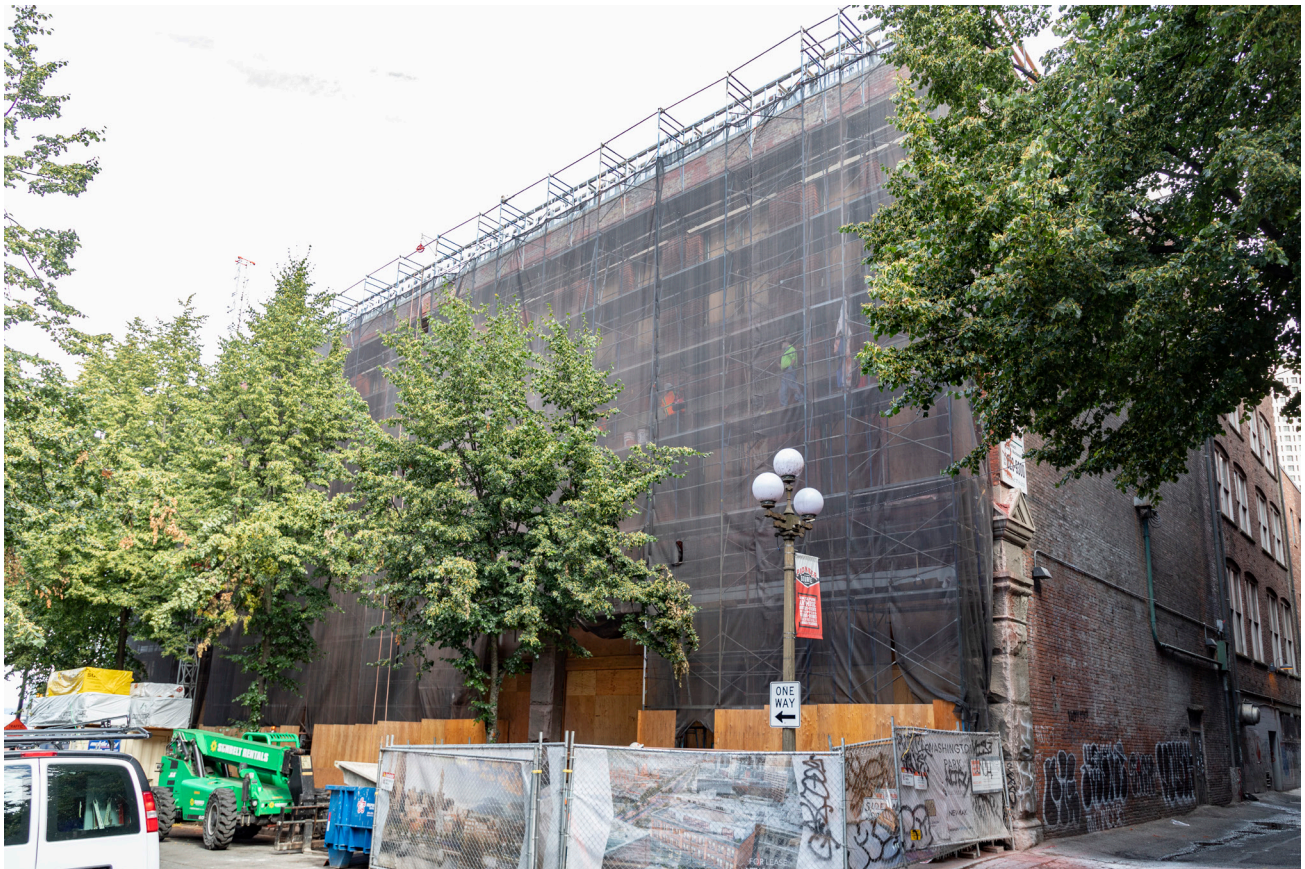
PHOTO 2. After: 2022 site, showing construction fencing, temporary protection at the storefronts, and repointing work under way.

8. **Exterior walls (Phase 2):** Clean and re-point the masonry, including removal of the painted signage on the west facade (third story).
 - » Wash walls with Sure Klean 600 Detergent, warm water, not exceeding 900psi. Remove mortar to 3/4-inch depth and re-point with a premixed type O mortar. Clean off re-pointed areas using ProSoCo’s Sure Klean 600 detergent and low pressure rinse. Remove paint at broken, chipped, and gouged areas in the sandstone.

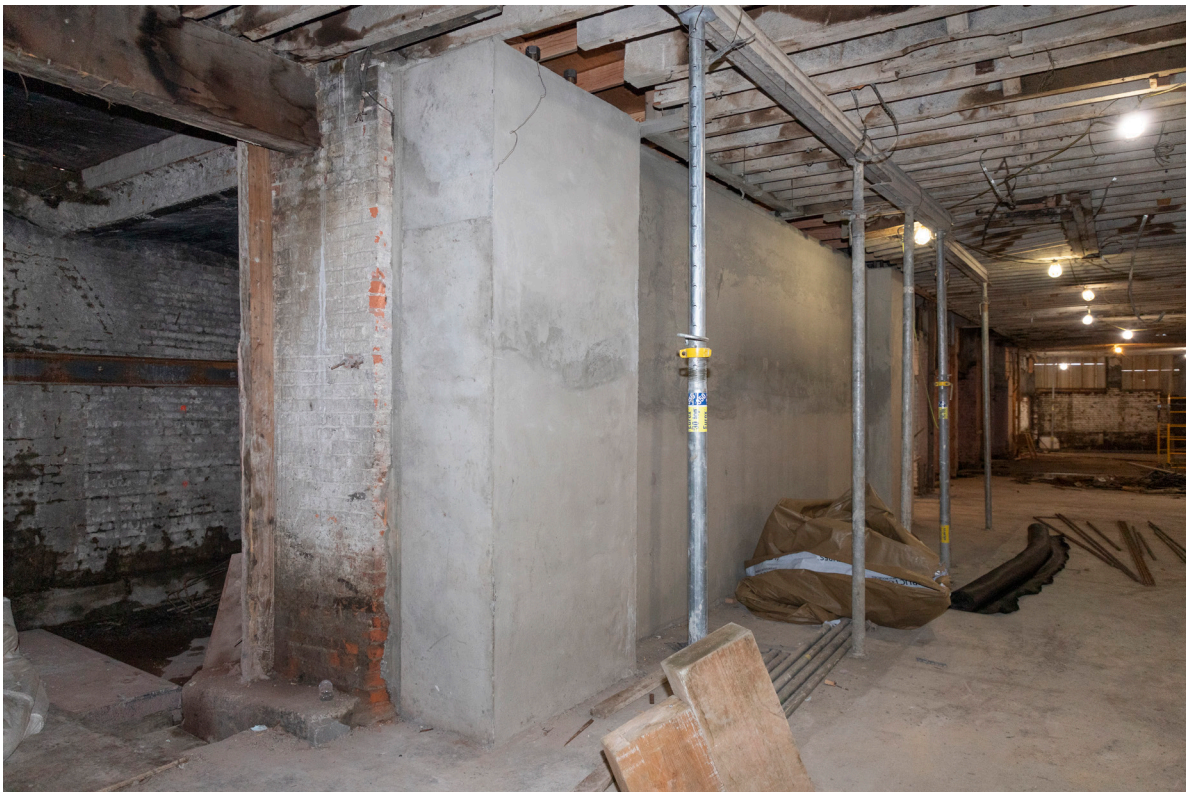
PHOTO 5. After: 2022 basement, Braced Frame 1, concrete portion completed.

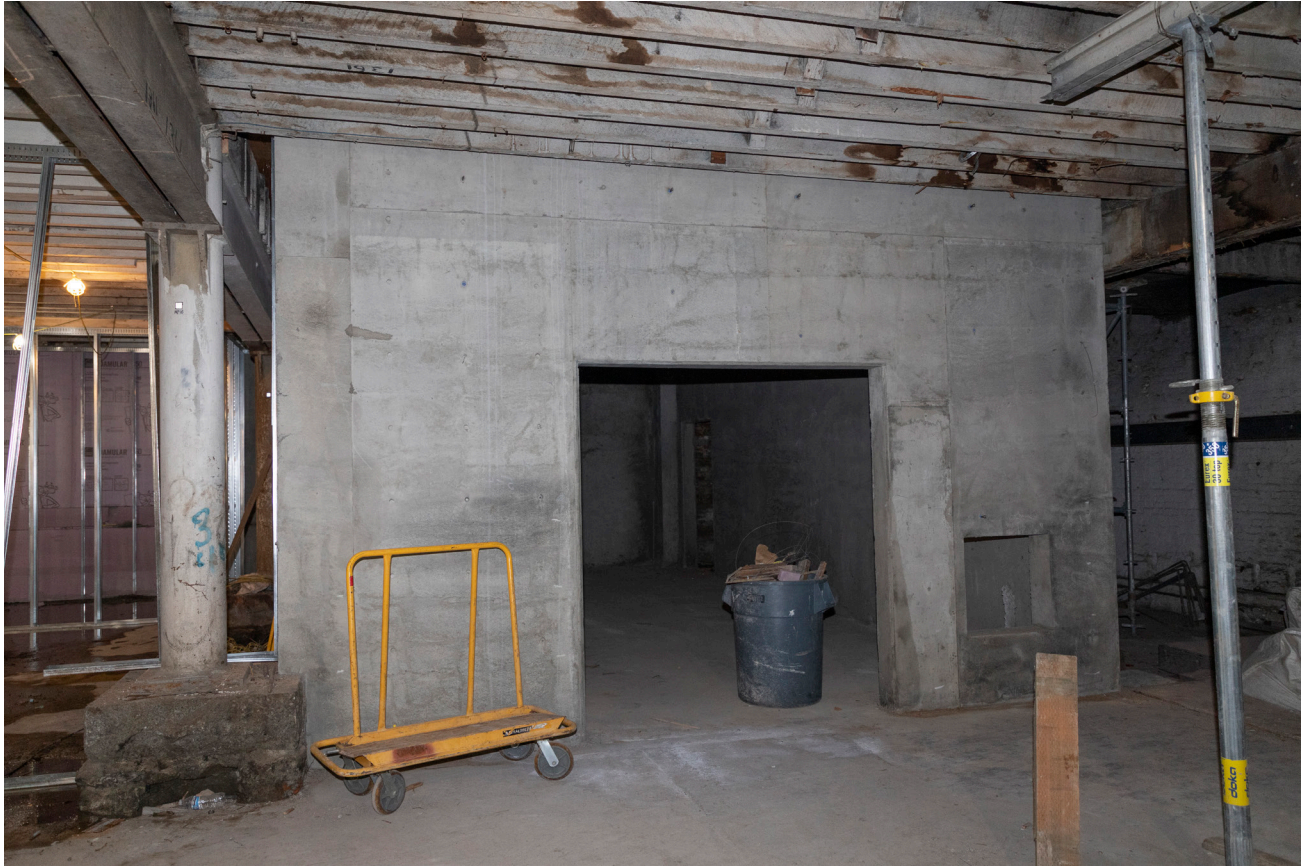
PHOTO 6. After: 2022 basement, electrical vault complete.

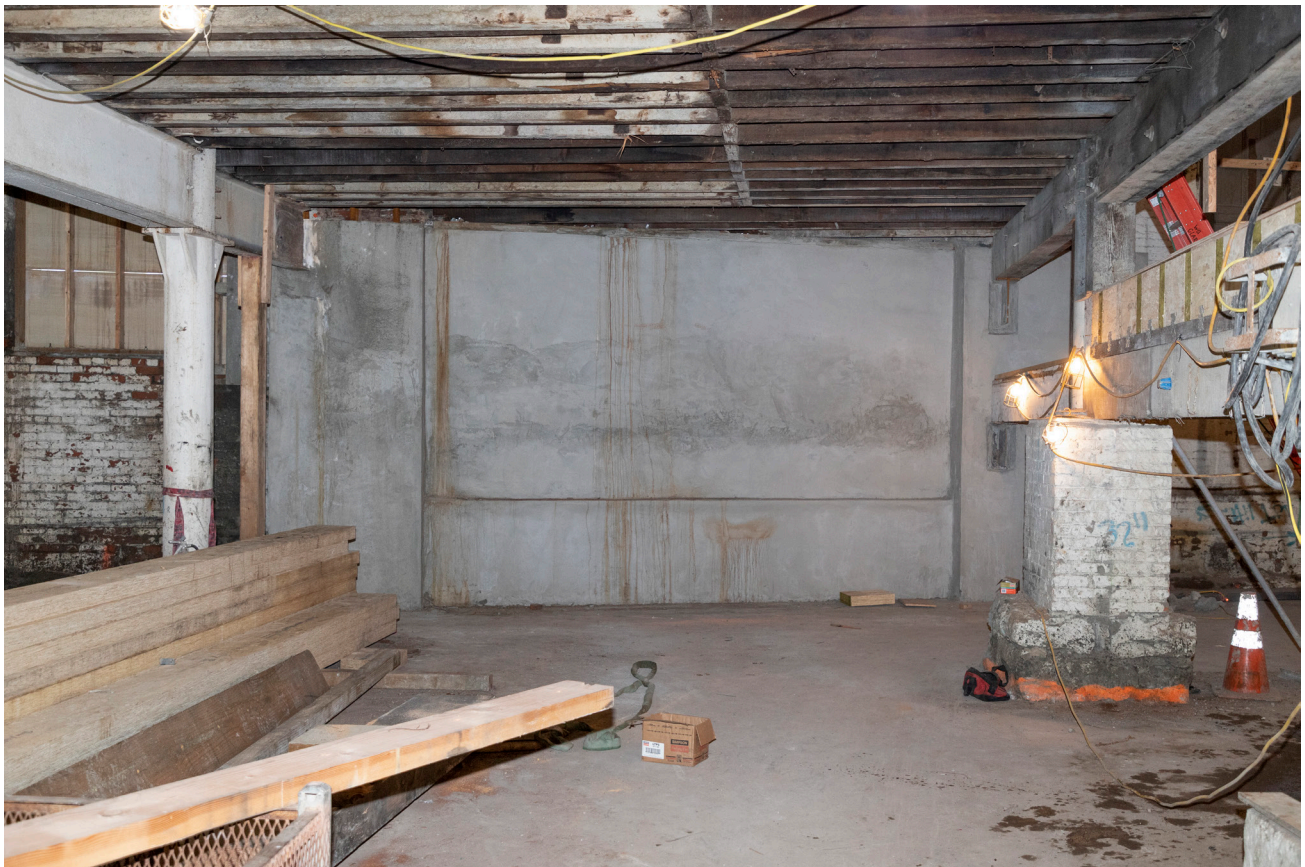
PHOTO 7. After: 2022 basement, Braced Frame 2, concrete portion complete.

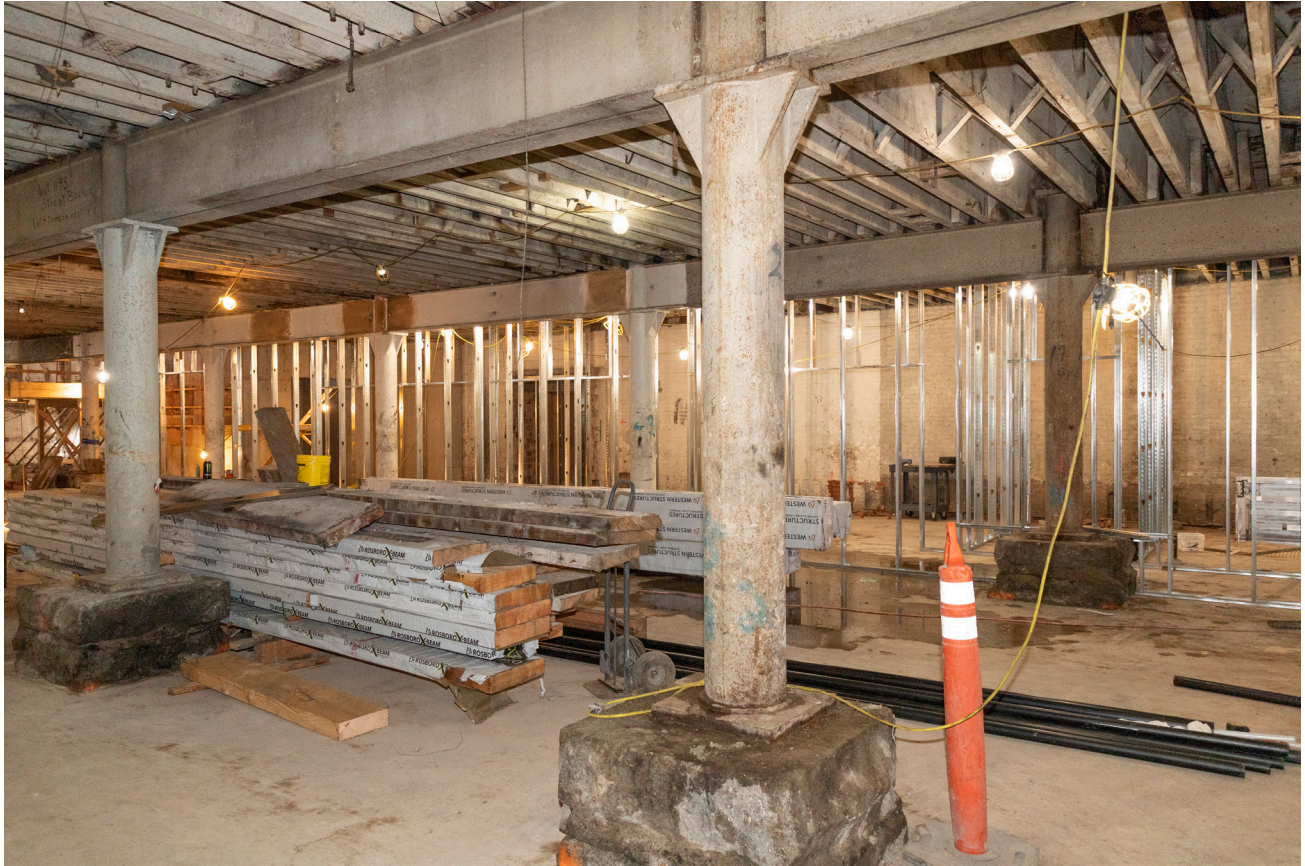
PHOTO 8. After: 2022 basement, selective demolition complete, interior framing in progress.

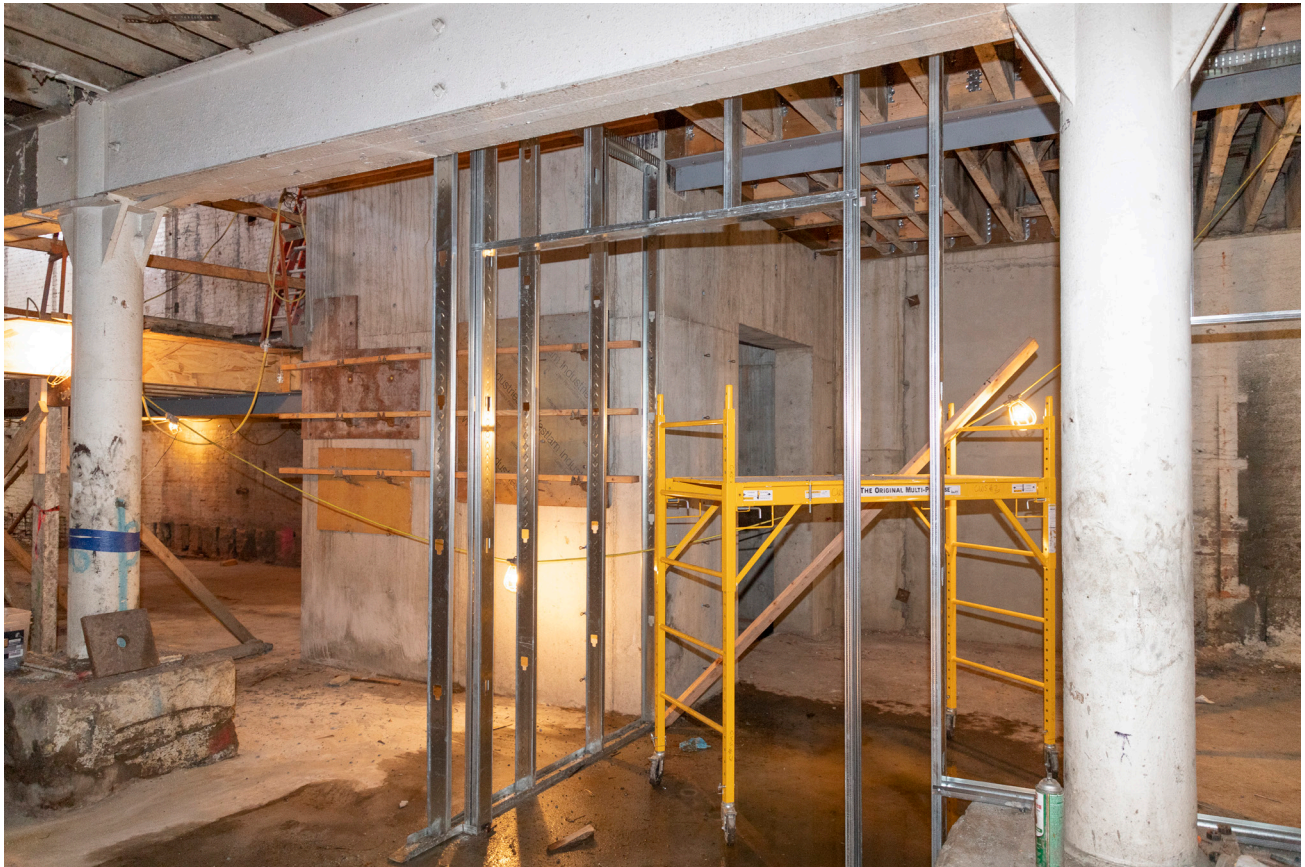
PHOTO 9. After: 2022 basement, elevator core and shear walls 3-6, concrete completed.

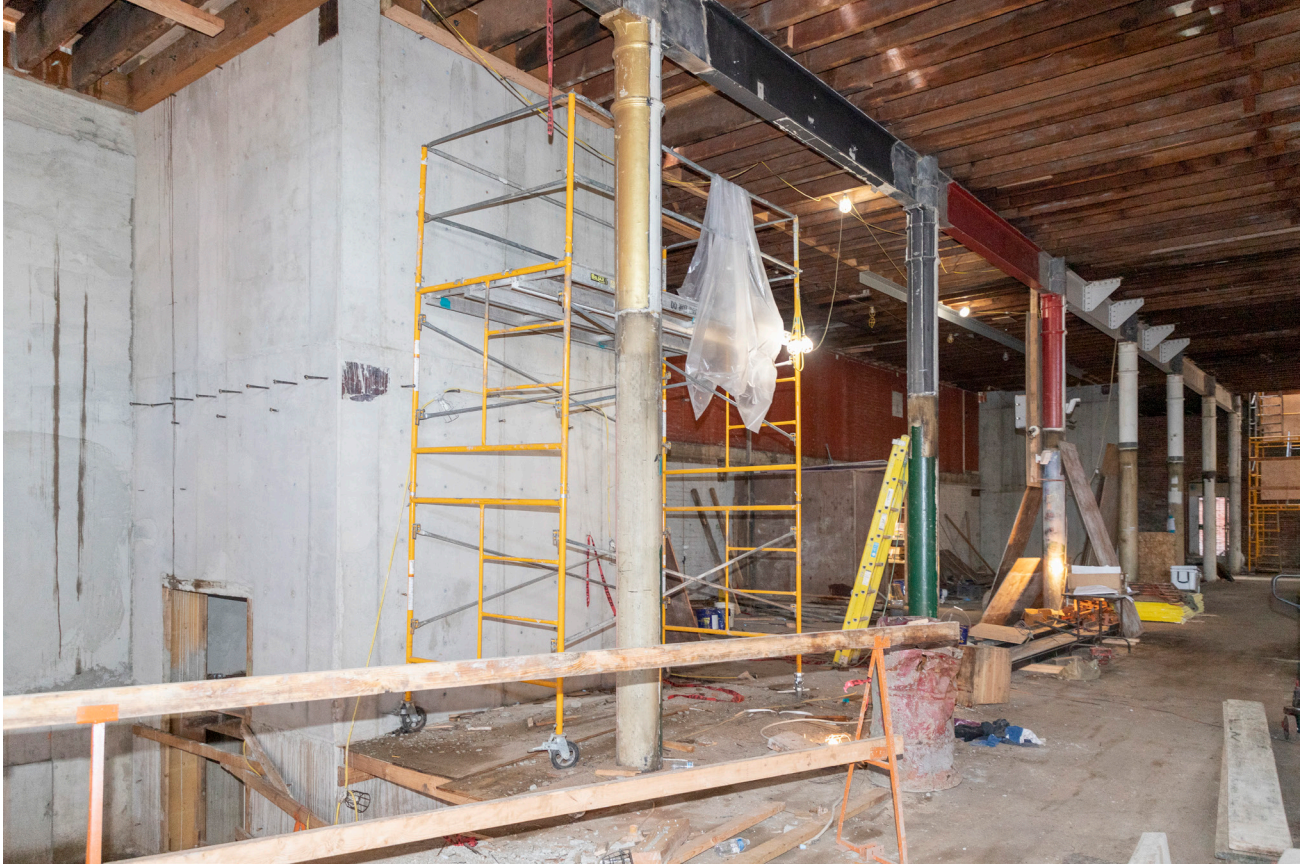
PHOTO 12. After: first floor, 2022, elevator core and completed concrete work for Shear Walls 3-6.

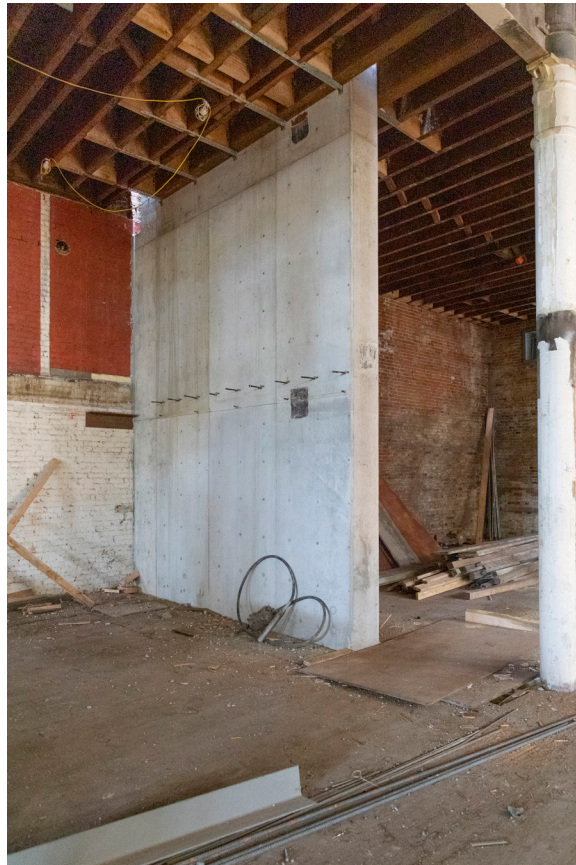
PHOTO 13. After: first floor, 2022, completed Shear Wall 2.

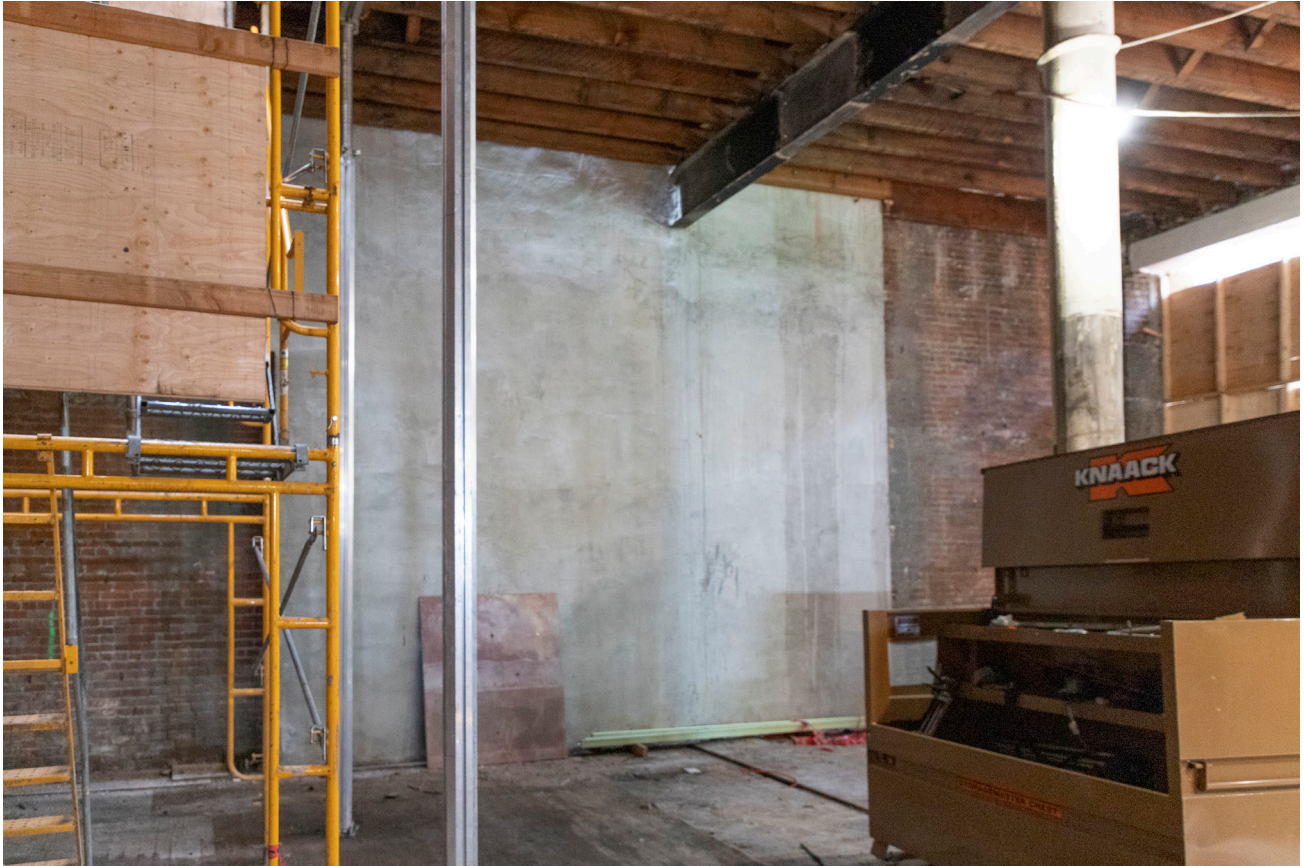
PHOTO 14. After: first floor, 2022, completed Shear Wall 1.

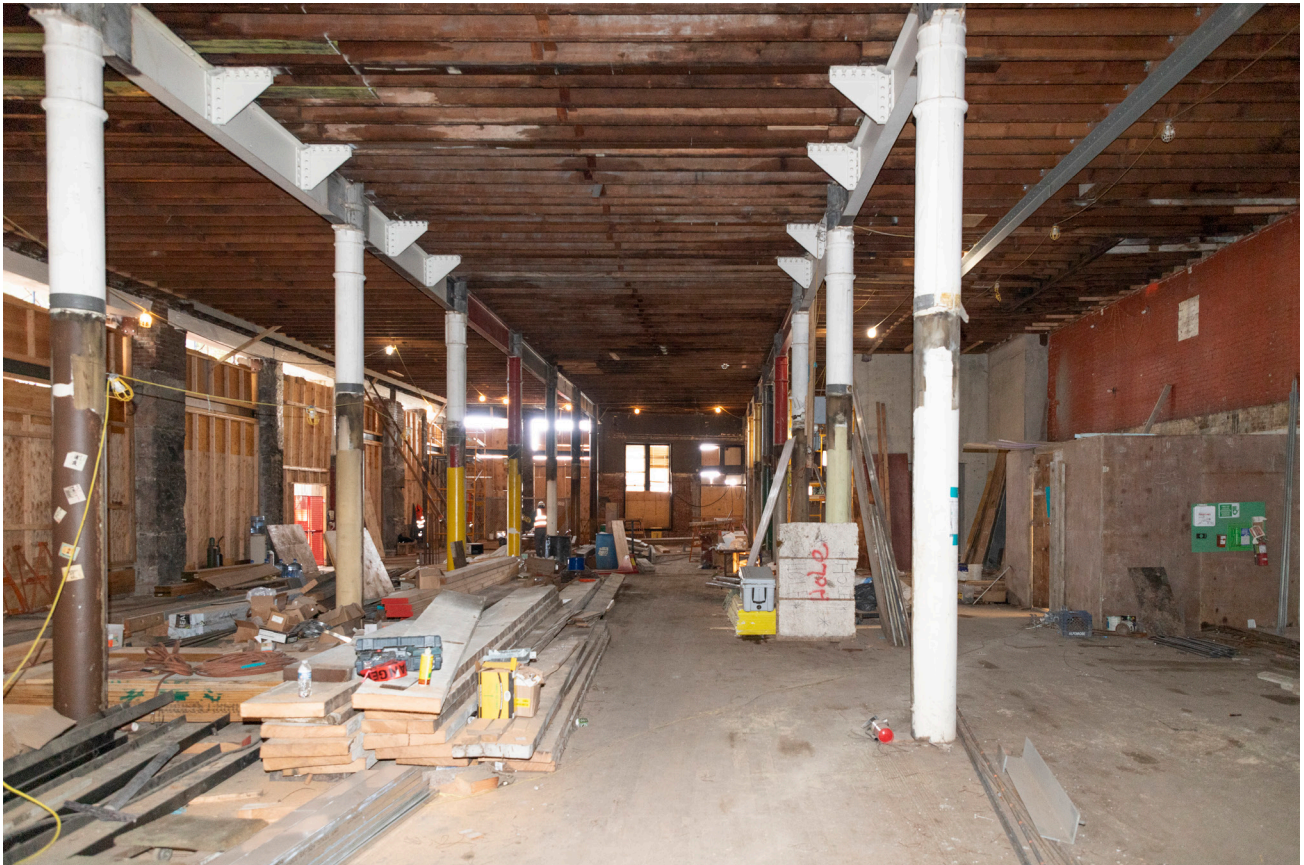
PHOTO 15. After: first floor, 2022, looking through the space with the mezzanine removed and intumescent paint applied to steel.

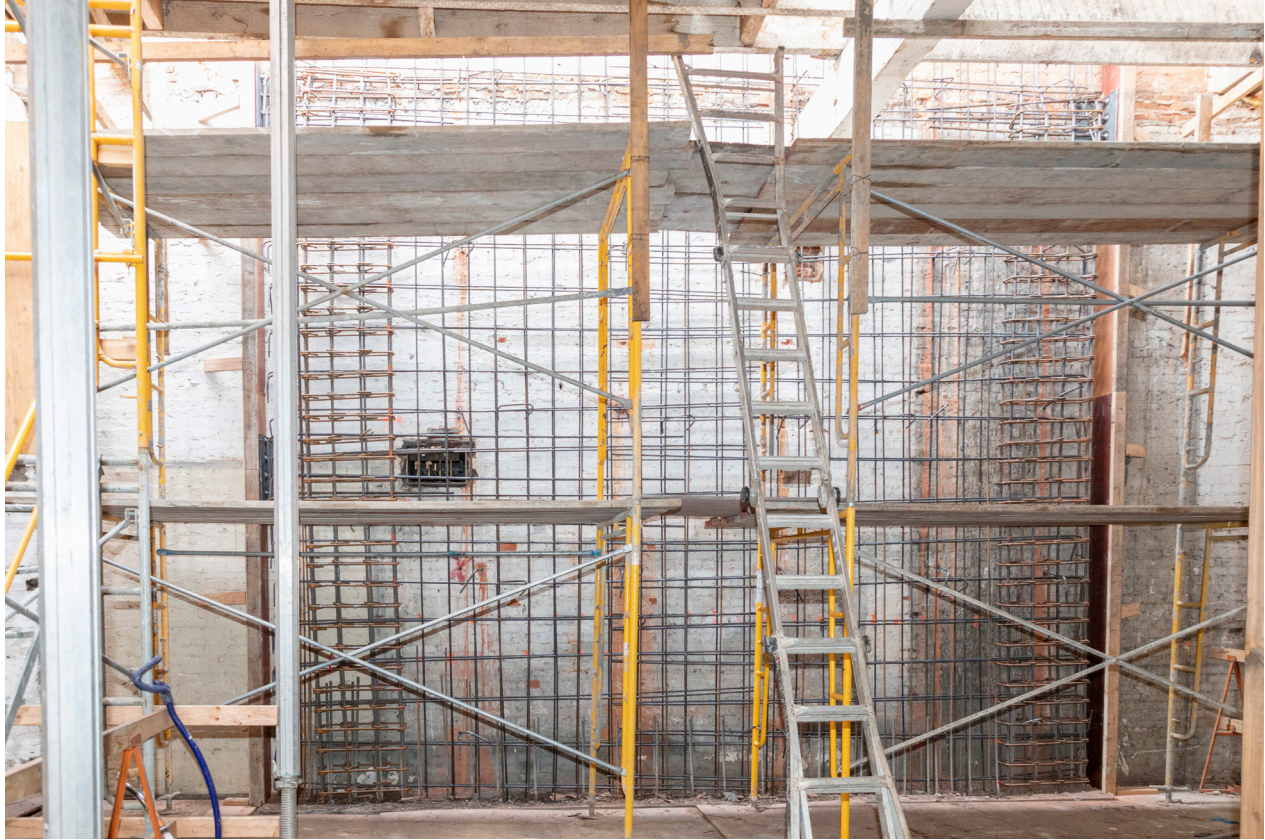
PHOTO 20. After: 2022 second floor, Shear Wall 1 steel placed.

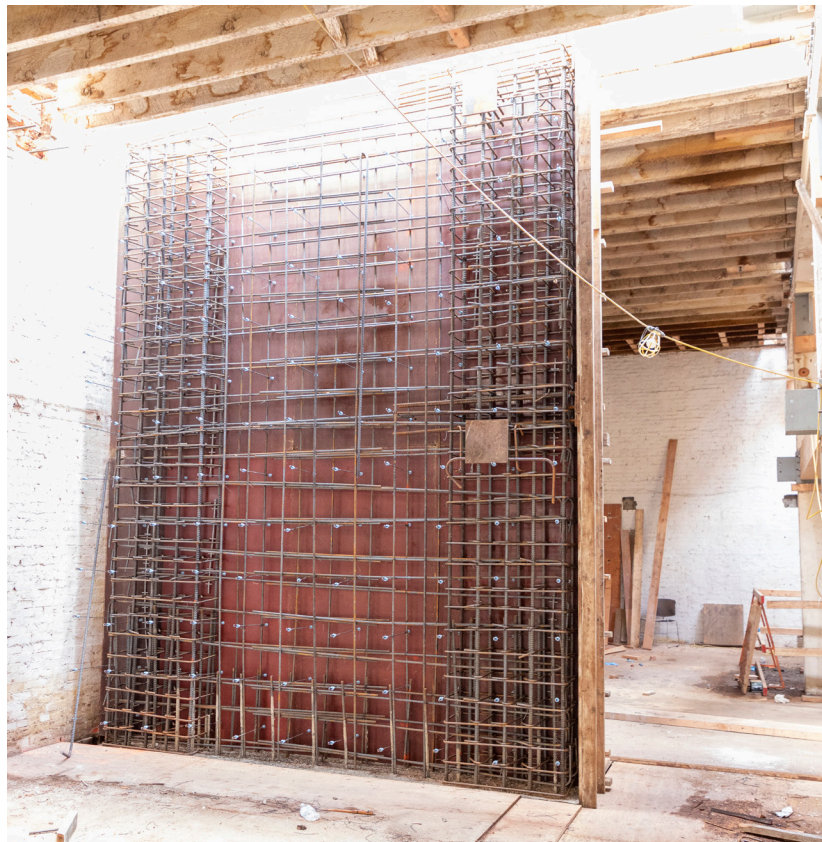
PHOTO 21. After: 2022 second floor, Shear Wall 2 steel placed.

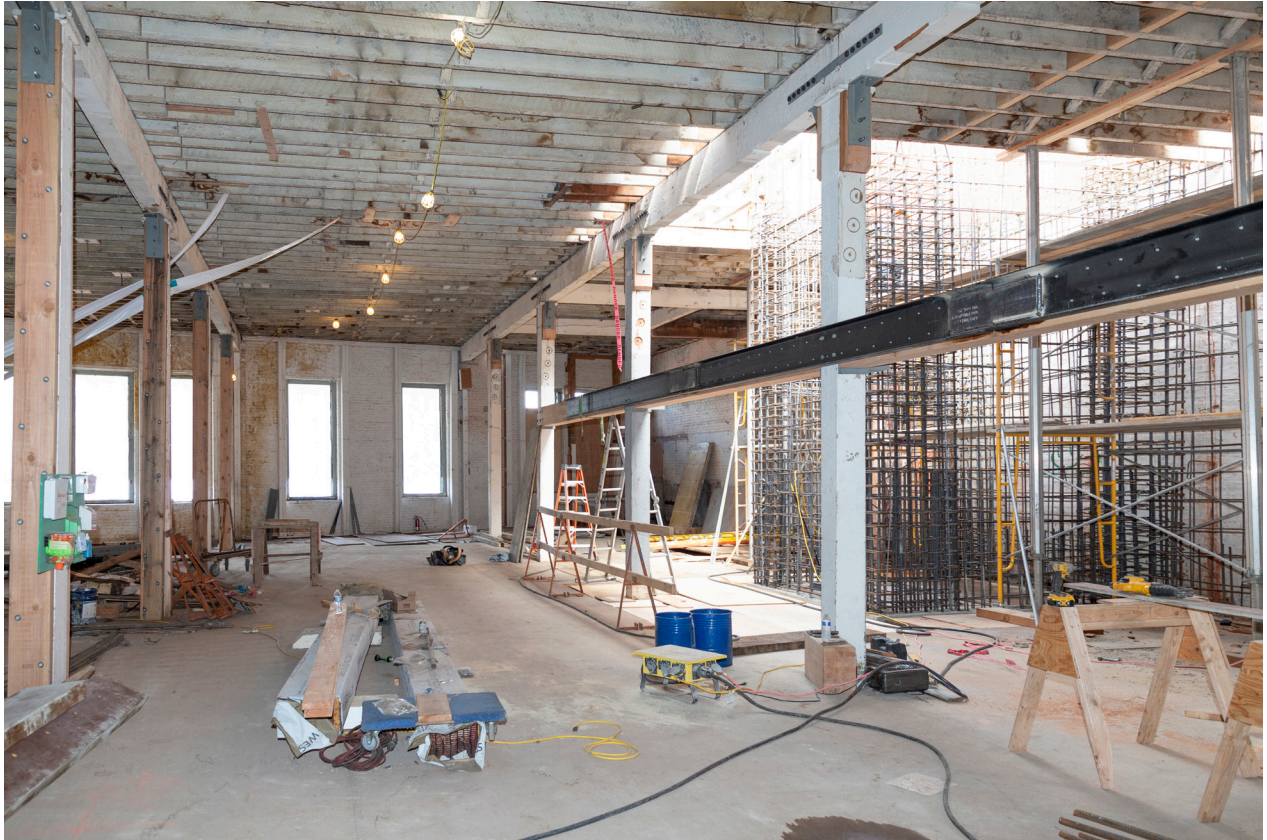
PHOTO 22. After: 2022 second floor, elevator core and Shear Walls 3-6 steel placed..

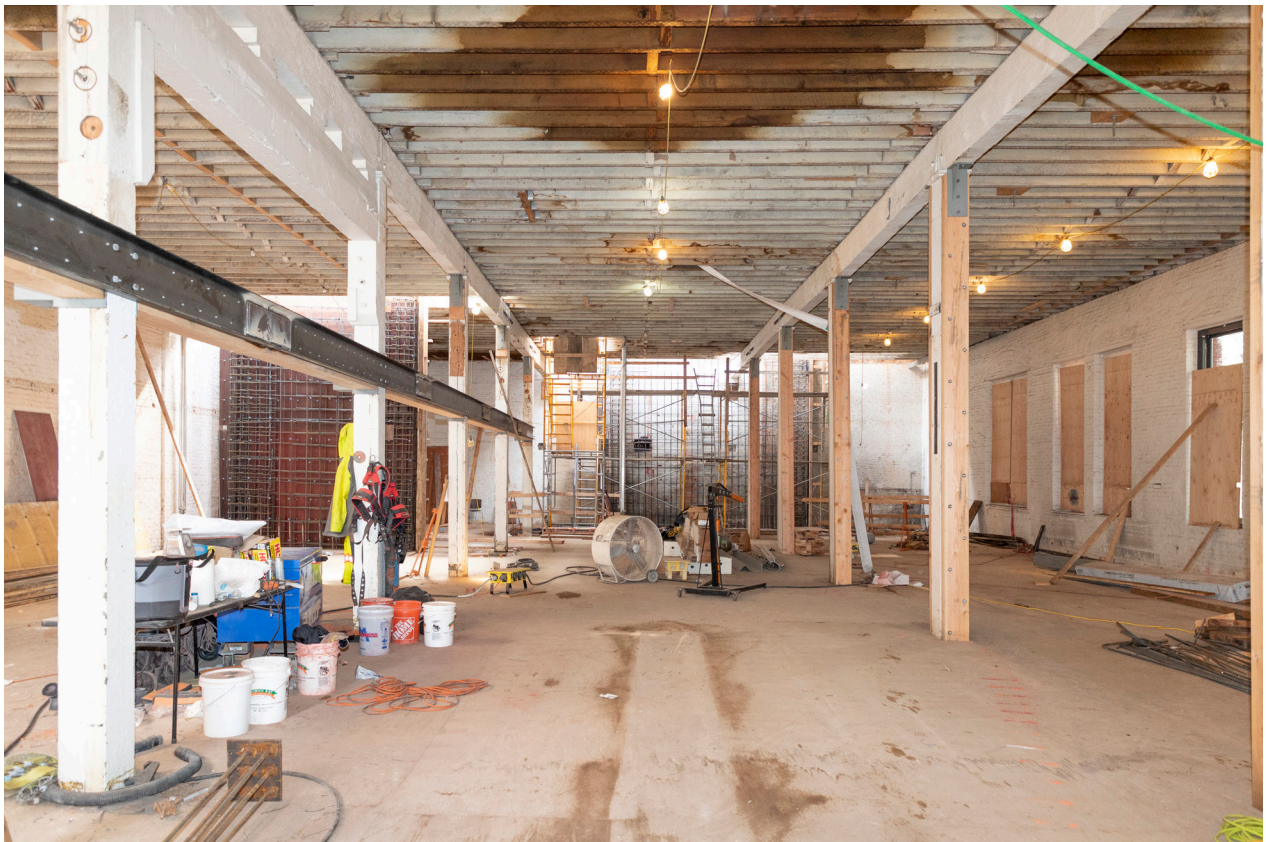
PHOTO 23. After: 2022 second floor, steel seismic reinforcing attached to columns.

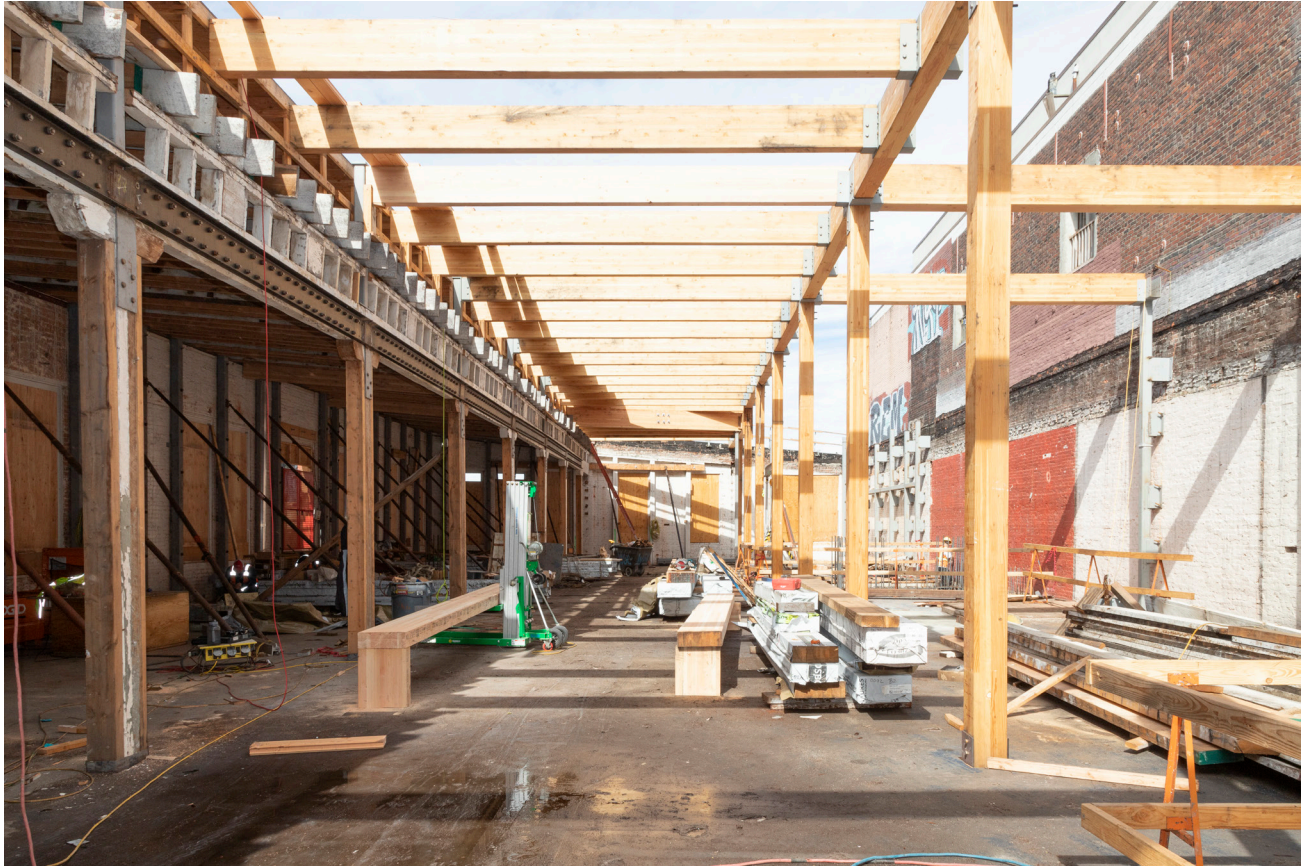
PHOTO 26. After: 2022 third floor, showing roof framing in progress.

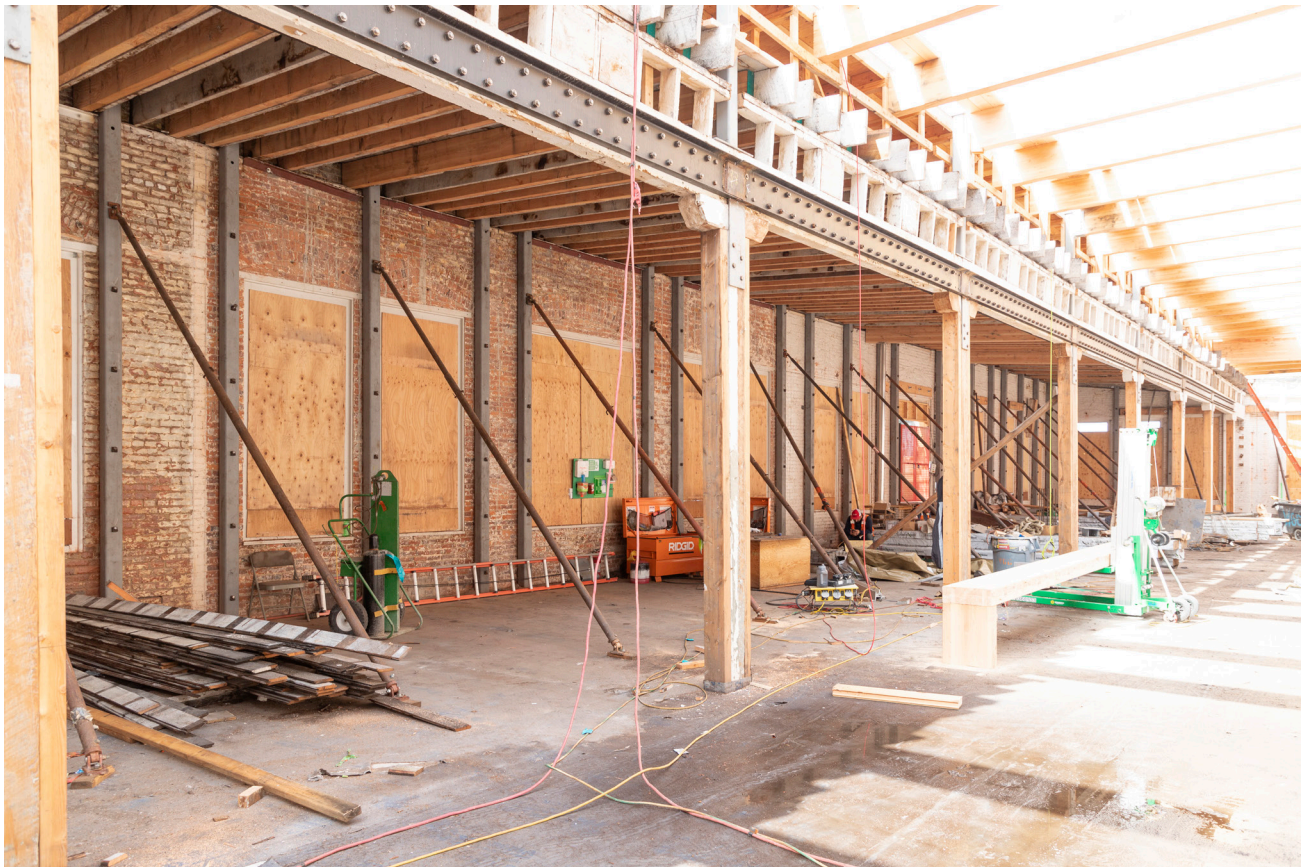
PHOTO 27. After: 2022 third floor, showing seismic retrofit steel at columns and strong backing at brick completed.

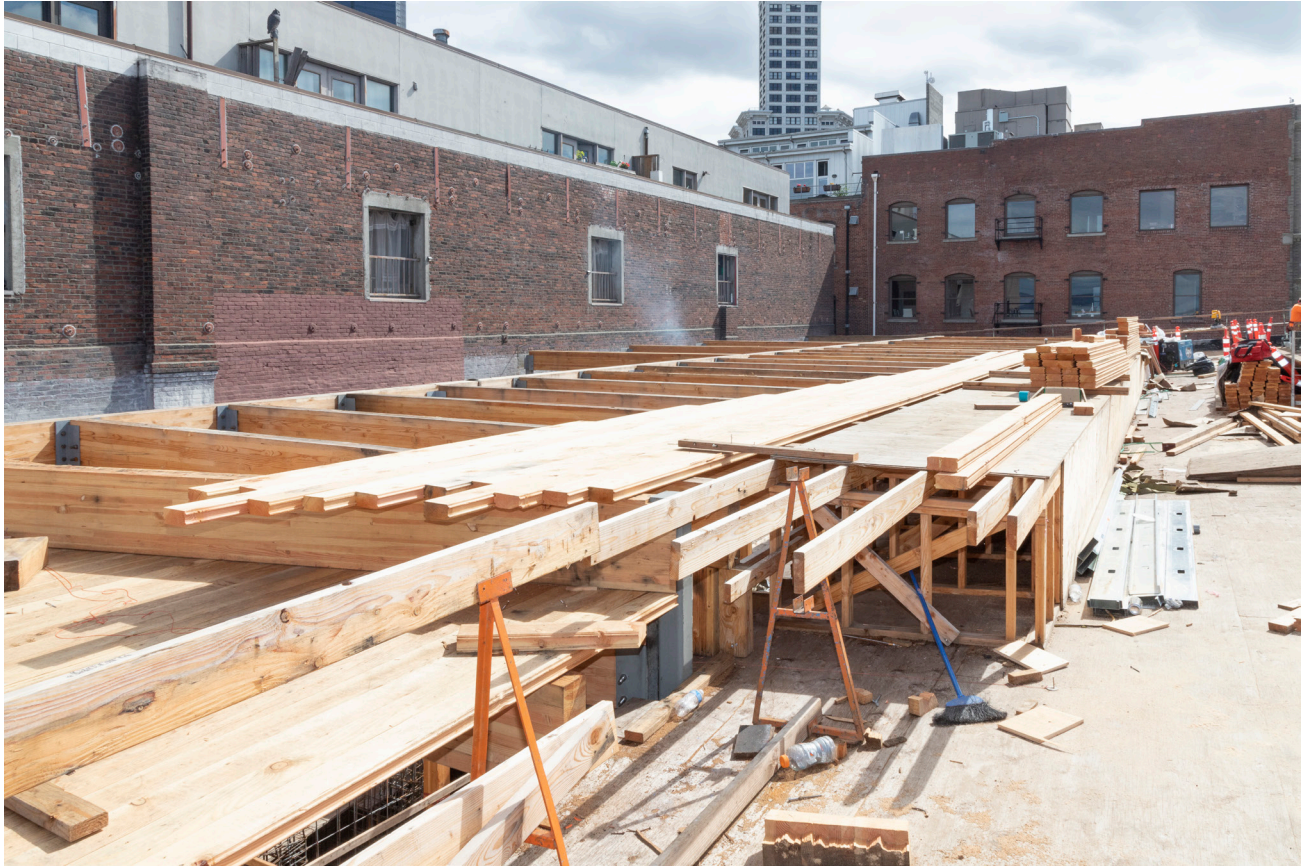
PHOTO 28. After: 2022 roof, showing roof portion removal and roof framing in progress.

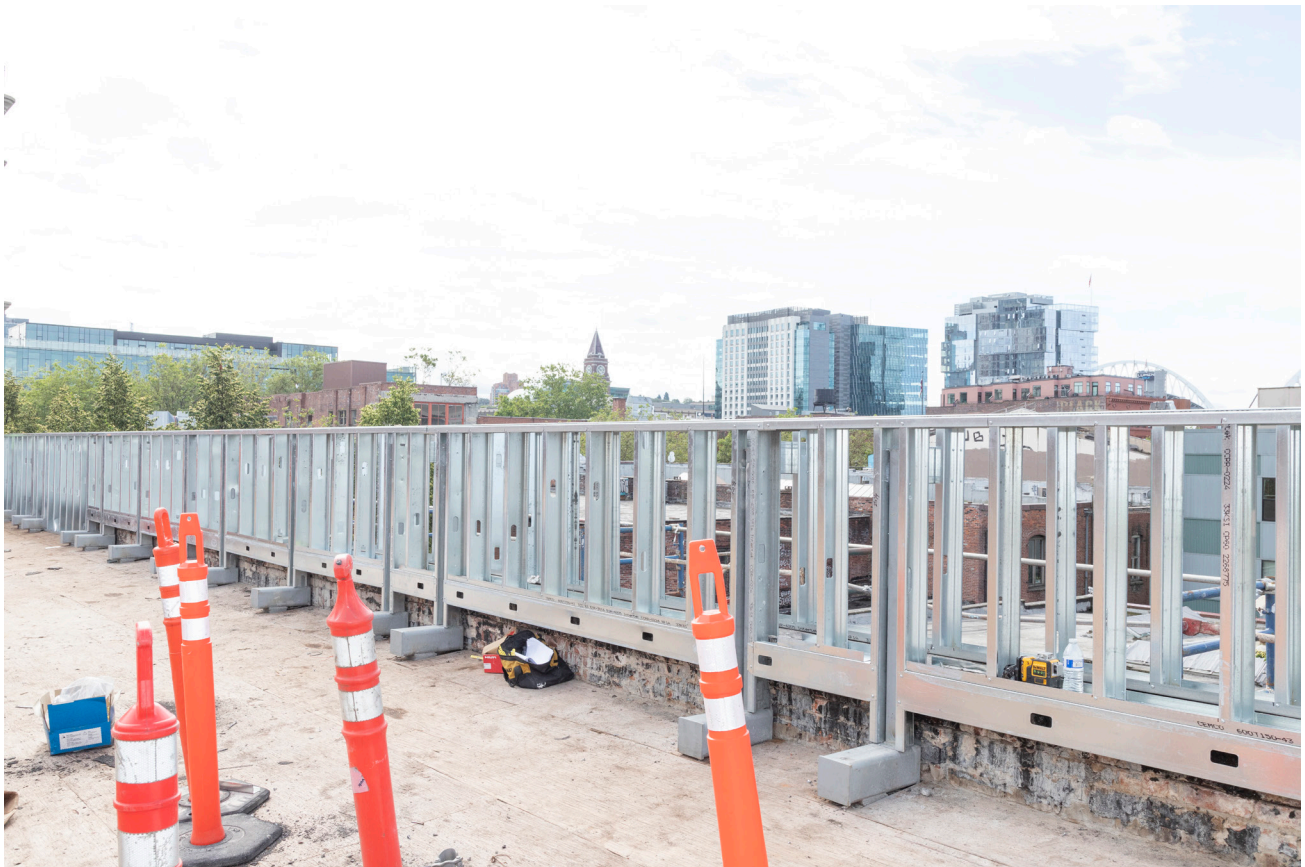
PHOTO 29. After: 2022 roof, showing metal framing completed for parapet reconstruction.

- » Remove all parapet brick down to the roof line and reconstruct the parapet and associated original cornice based on historic photographs and physical evidence on the building. Use brick veneer with structural backing, and inner metal panel finish. Match brick to existing either through use of salvaged brick from interior wall locations where being removed for structural access or with new brick. Upper cornice elements to consist of painted polymer-modified glass fiber reinforced gypsum (PGRG) supported by a steel structure anchored to the masonry walls and steel strong backing at the third floor.
