BROADVIEW SEWER INVESTIGATION

Project Summary Report

Seattle Public Utilities

July 2010

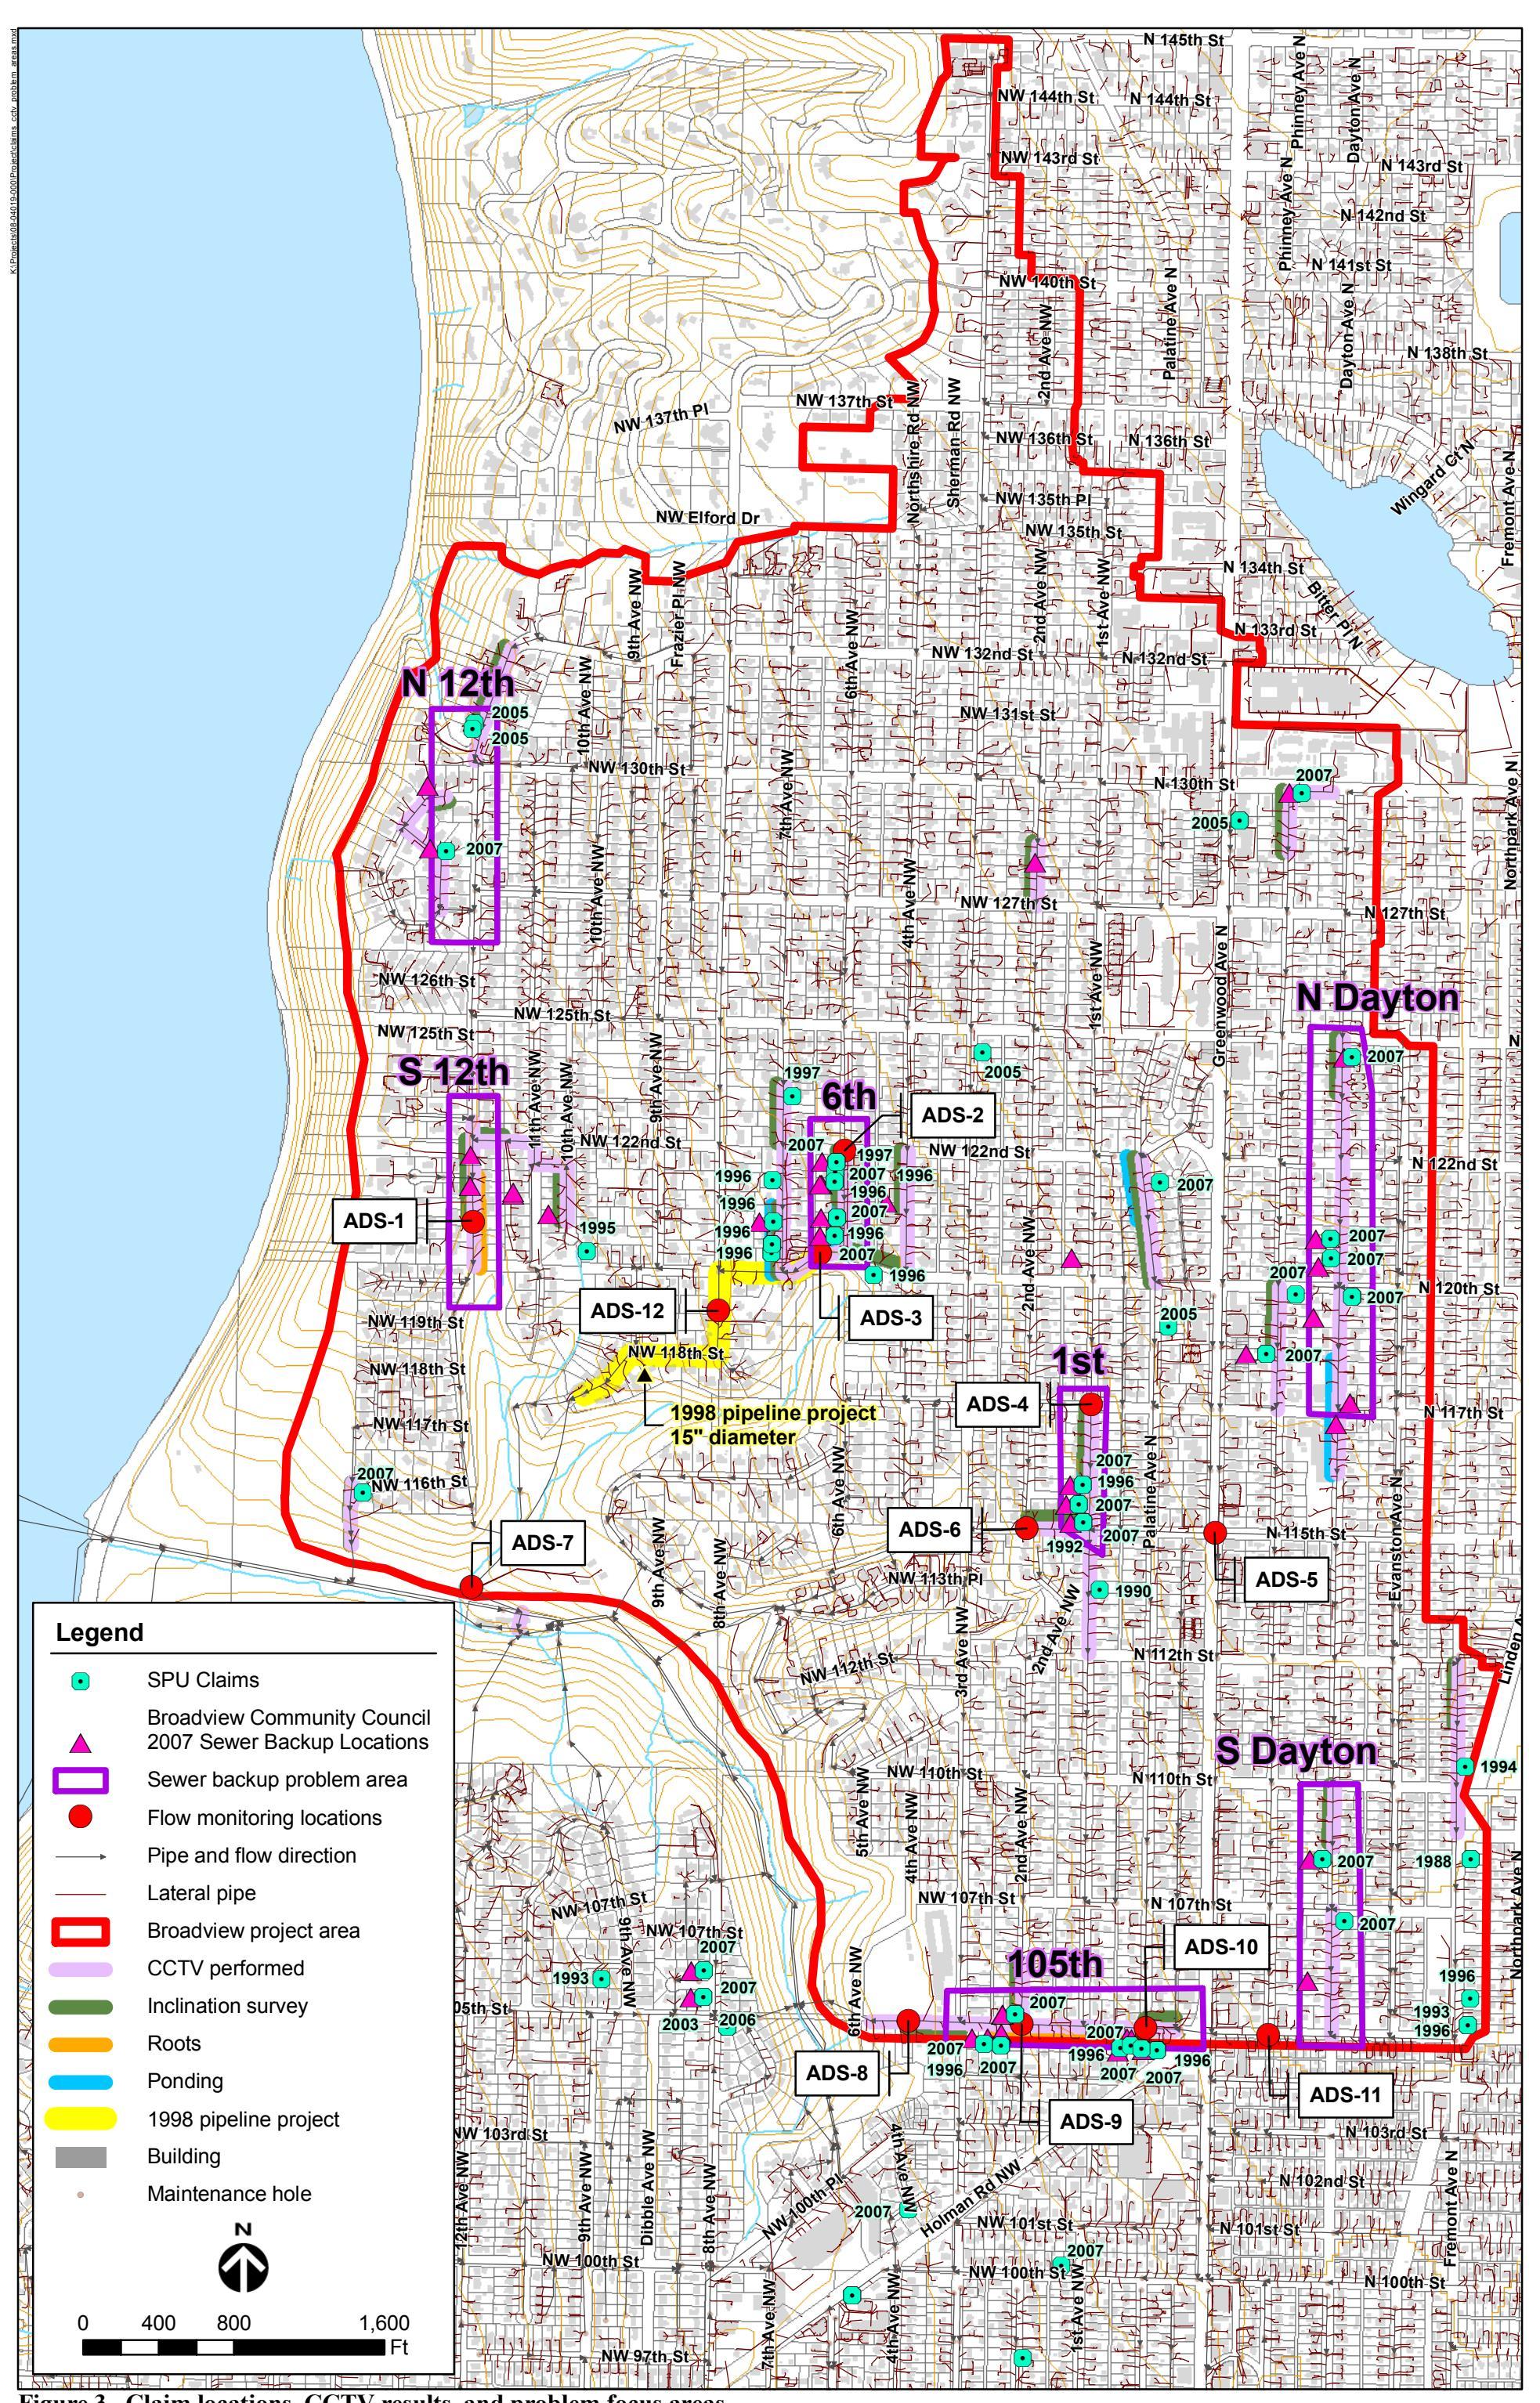
Figure 3. Claim locations, CCTV results, and problem focus areas.

The majority of sanitary sewers in Broadview are between 6 and 12 inches in diameter. The sanitary sewers are concrete and were constructed in the 1950s. The majority of maintenance holes are brick and mortar. Figure 3 shows a sanitary sewer project constructed in 1998 that included replacement of sanitary sewer lines along 9th Avenue NW, NW 118th Street, 8th Avenue NW, and NW 120th Street. This project included a new mainline sanitary sewer and was constructed to alleviate sanitary sewer backups in the area of NW 120th Street and 7th Avenue NW. Figure 4 shows the same information in a large format and includes maintenance hole numbers.

Herrera conducted a site visit on August 13, 2008 to assess conditions of the known problem areas. As part of this effort and to evaluate conditions for flow meter installation, a general maintenance hole condition assessment was conducted. The assessment included visual observations only and the maintenance hole was not entered as part of the assessment. No significant rainfall had occurred within days of investigation. The majority of the maintenance holes were brick and mortar and were generally in fair condition and showed evidence of infiltration at several locations.

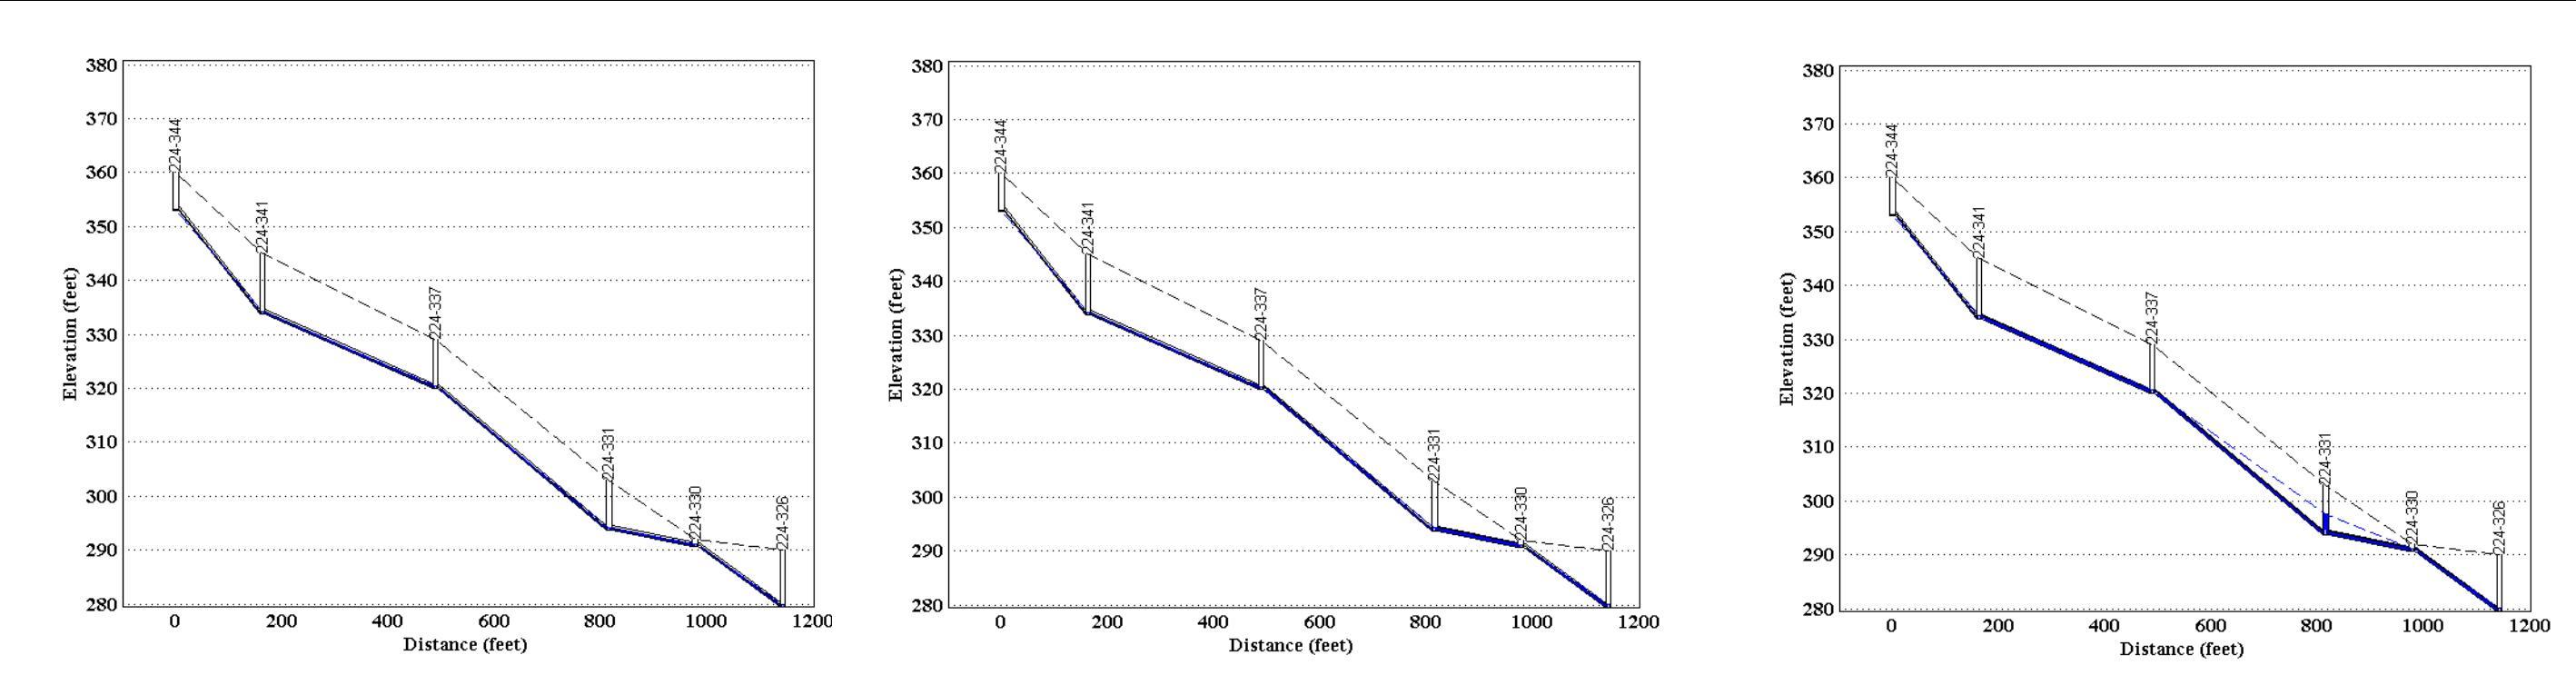
The existing sewer line along N and NW 105th Street is a 10 inch diameter concrete pipe with 3 foot pipe segments. The capacity of the pipe segments through this area are presented in Table 5. Table 5 shows that segment 224-330 to 224-331 has a capacity less than the adjoining pipe. The observed discharge in the pipe segments during the 1/7/2009 storm event, the 100-year modeled discharge, and the 100-year modeled discharge as a percent of capacity are also shown in Table 5. The pipe segment with the lowest capacity is segment 224-331 to 224-330 and has a capacity lower than the 100-year modeled discharge which makes it function as a bottleneck in the system. The 100-year modeled discharge is 128 percent of the Manning's capacity in this pipe segment.

Profile plots of the peak water surface elevation during the 2-, 25-, 100-year, and December 3, 2007 events are presented in Appendix B (Figures B-3 and B-4). Surcharge of the pipe system first occurs during the 100-year event Appendix B (Figure B-3) which approximately corresponds to the level of storm that caused sewer backups in December 1996.

Figure B-3. Water surface elevation profiles on N 105th Street between Greenwood Avenue N and 3rd Avenue NW for the 2-year (left), 25-year (middle), and 100-year (right) storms under existing conditions.

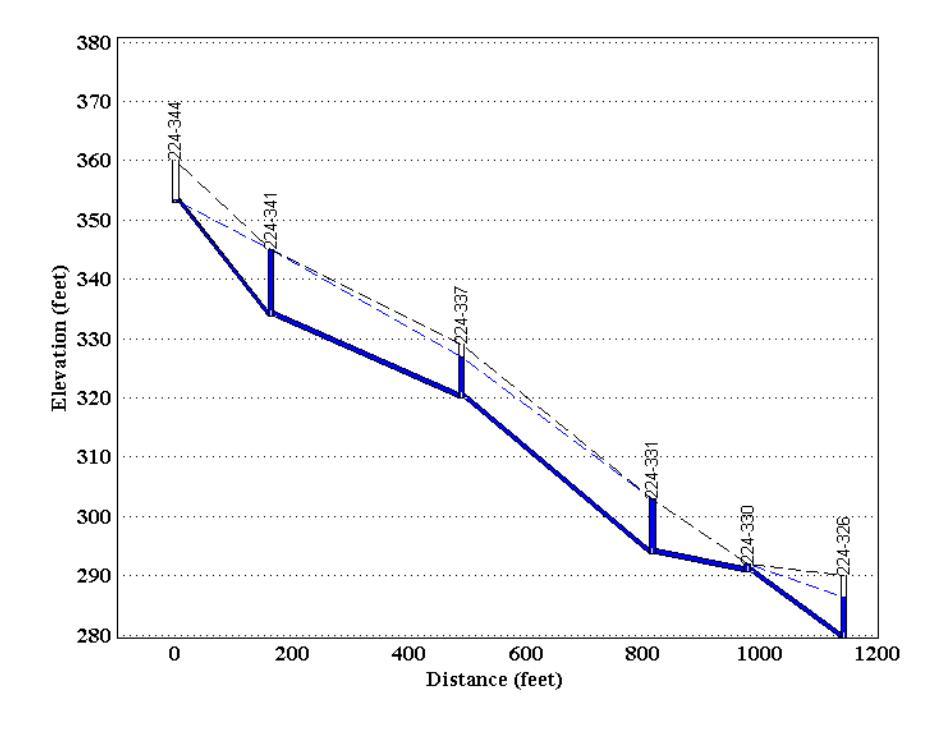
Figure B-4. Water surface elevation profile on N 105th Street between Greenwood Avenue N and 3rd Avenue NW for the December 3, 2007 storm under existing conditions.

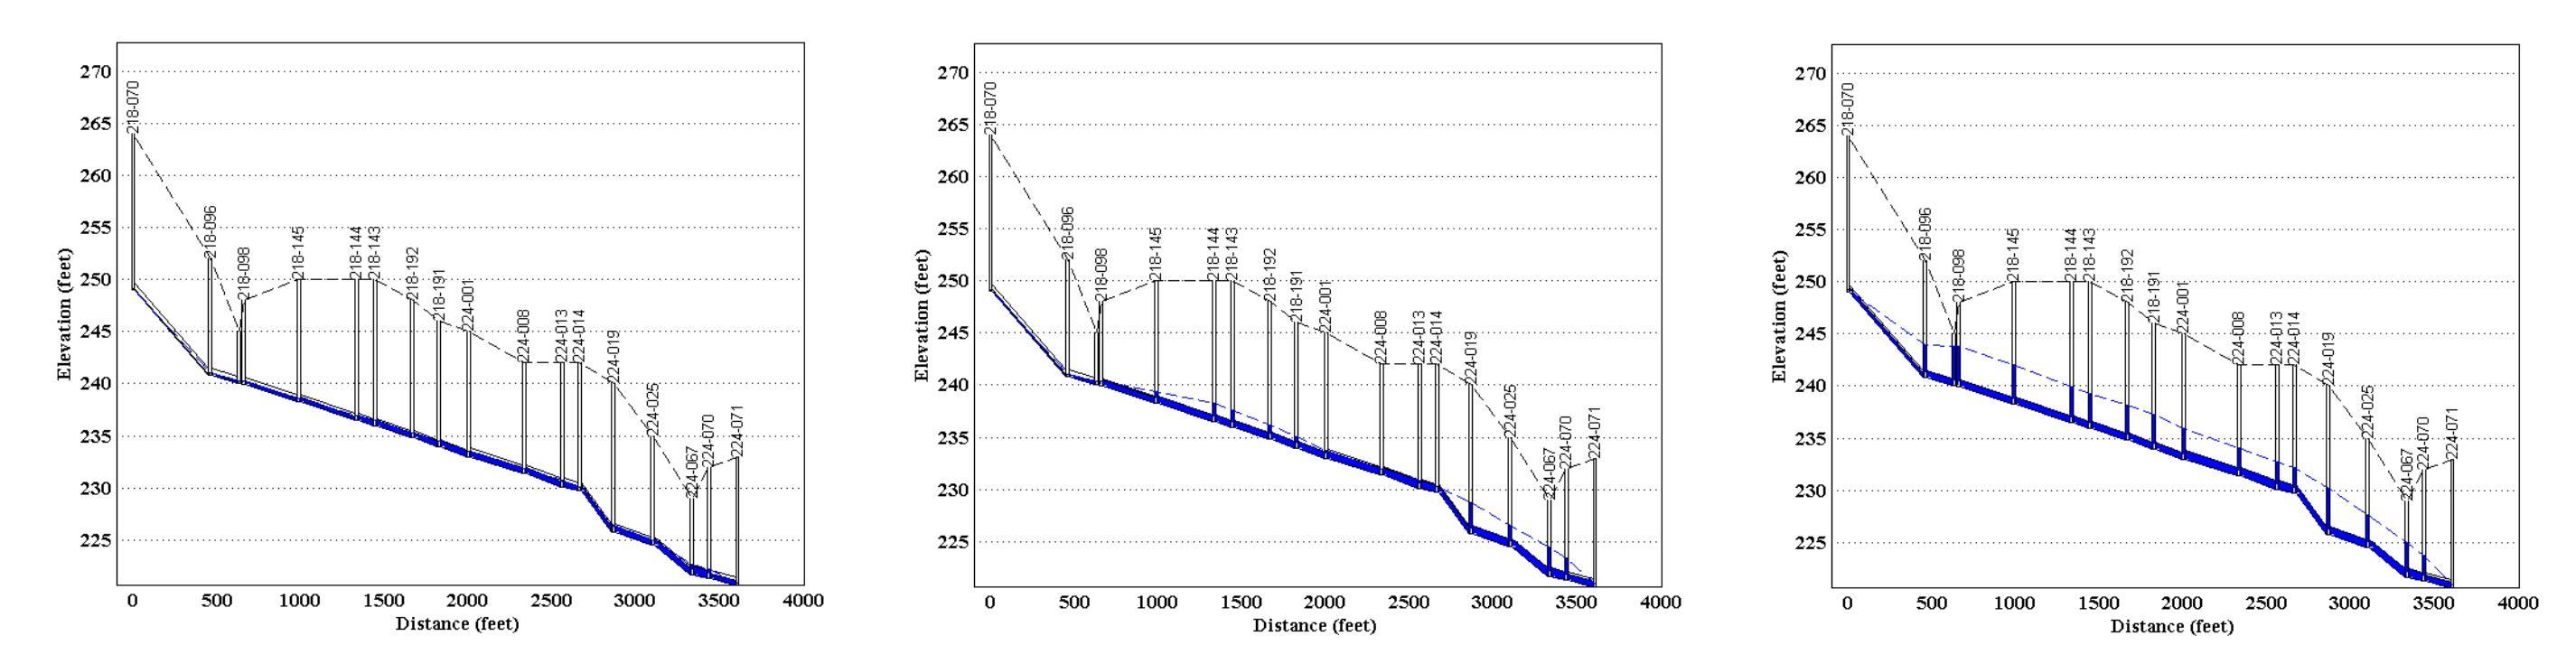
Modeling of existing conditions indicates that 12th Avenue NW from NW 117th Street to north of NW 130th Street surcharges during large storm events. However, SPU sewer backup claims include only two residences near NW 122nd Street, two residences near NW Blakely Court, and two residences north of NW 130th Street. The sewer backups at four residences occurred during the December 3, 2007 storm while the remaining residences experienced backups during a period of no rain.

Figure B-5. Water surface elevation profiles on 12th Avenue NW between NW 132nd Street and NW 119th Street for the 2-year (left), 25-year (middle), and 100-year (right) storms under existing conditions.
