Phase I Environmental Site Assessment Final Report

Vacant Residential Parcels South Irving Street & Yakima Avenue South Seattle, WA 98144

EHSI Project #10737e-04

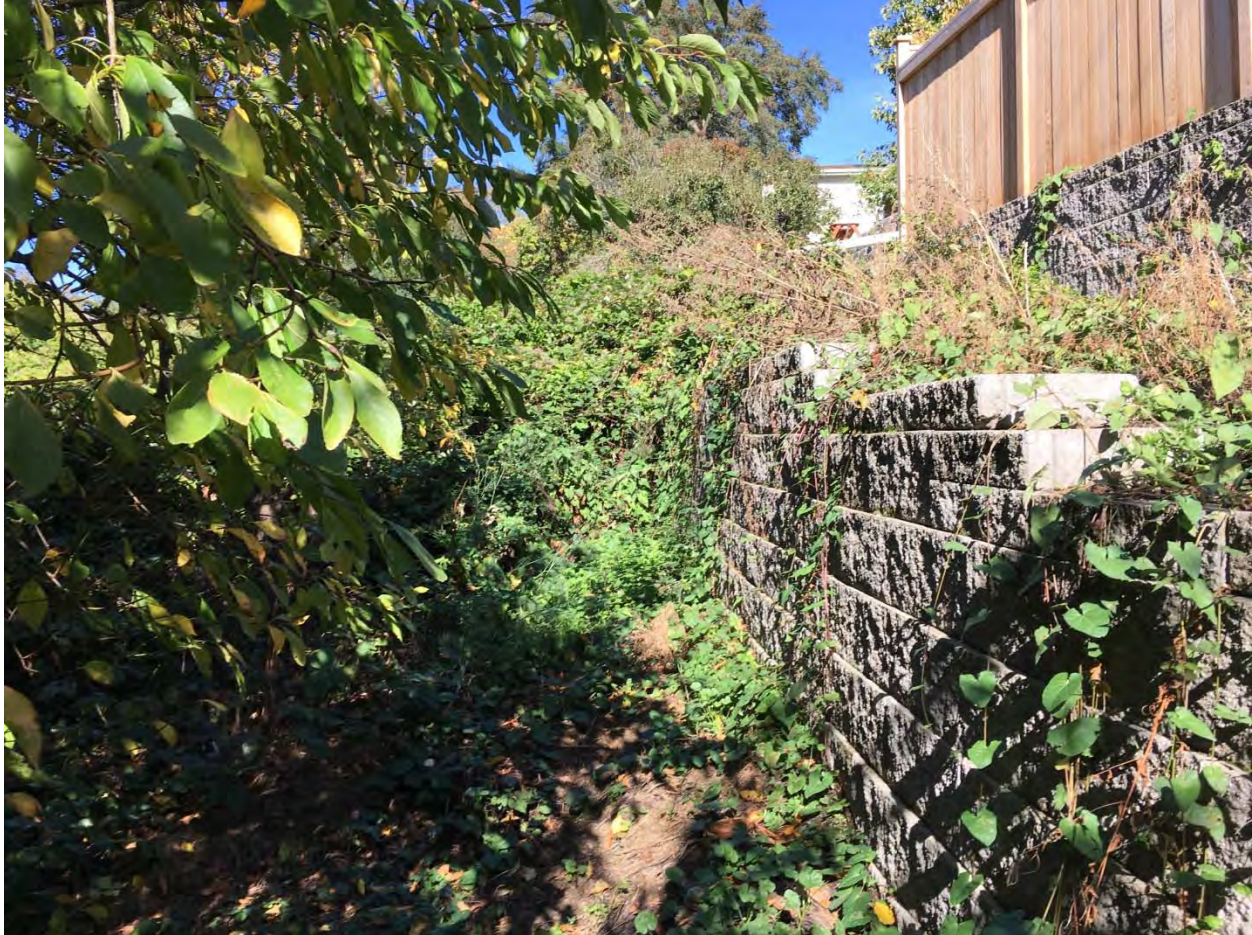
Southeast Corner of Subject Property, Viewing North. Retaining Wall (Front Right) and Rubble Fill Soils (Front Left) Encroach on Subject Property (Assuming the Fence Corresponds to the Approximate Property Line)

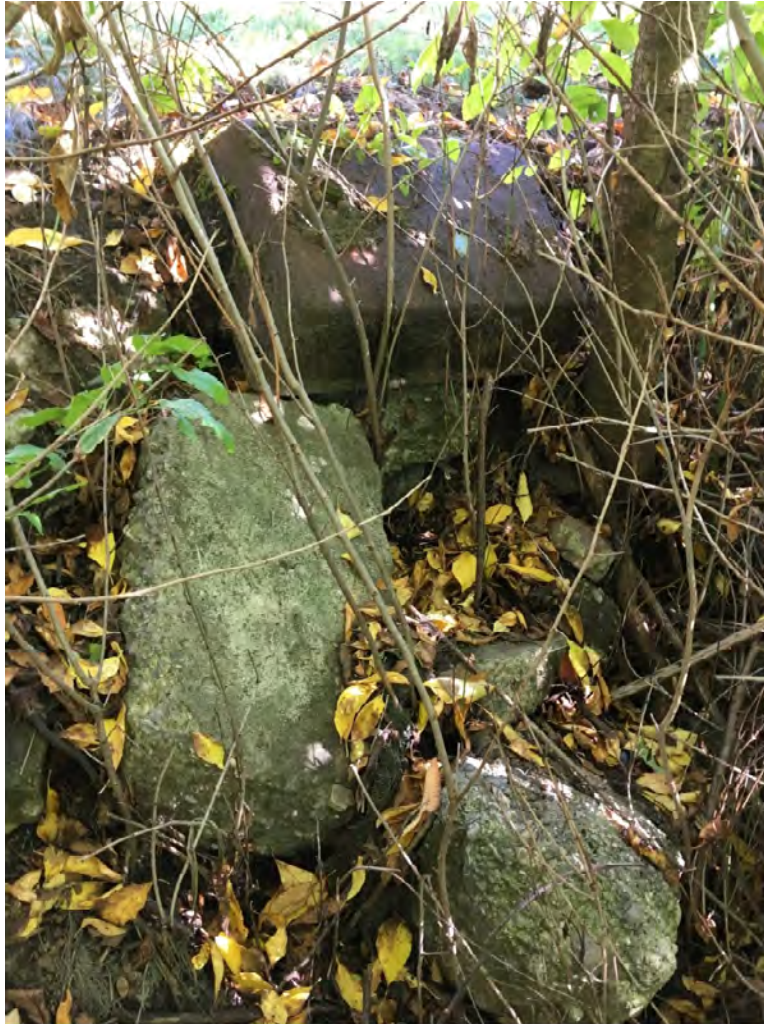
- Debris fill is present on the southern portions of the subject property. The fill material is of unknown origin, thickness, and composition; construction debris observed at the surface of the fill layer includes brick, concrete rubble, guy wire, pipe, and suspected asbestos-coated pipe.

**Rubble Fill and Debris on Southwest Portion of Subject Property
West of and Below Retaining Wall**

Physical access to the subject property for the purposes of conducting a Phase II ESA is extremely poor, and may not be safe for drill rig access without significant grading and/or clearing. EHSI recommends the following sequence of activities:

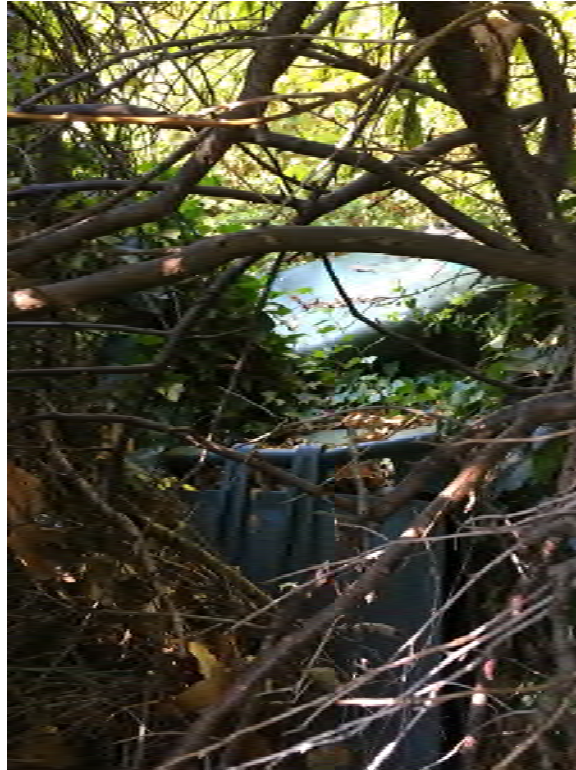
Yard Waste Bins Discarded in North Central Portion of Subject Site, Viewing Northwest

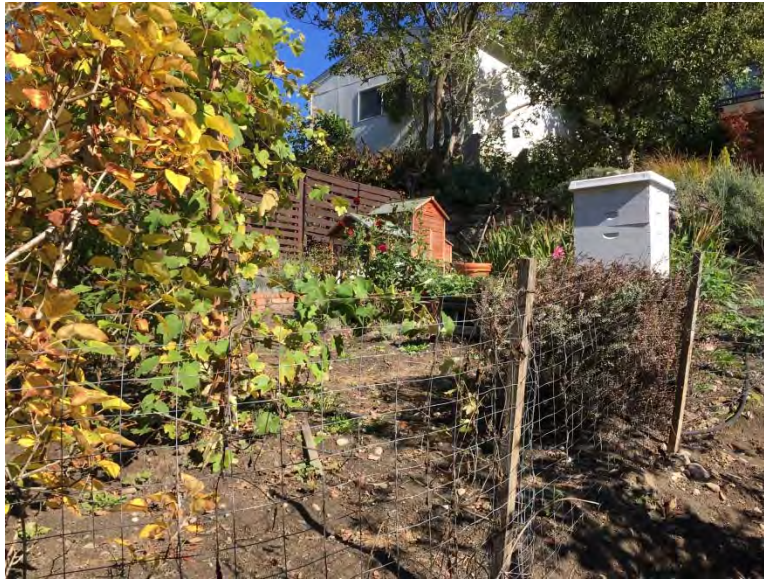
Estimated 400 Square Foot Area on Subject Property Cleared for Gardening, Beehive, and Chicken Coop, Viewing Northeast (Area Located West-Adjacent to Single-Family Residence at 1319 30th Avenue South)

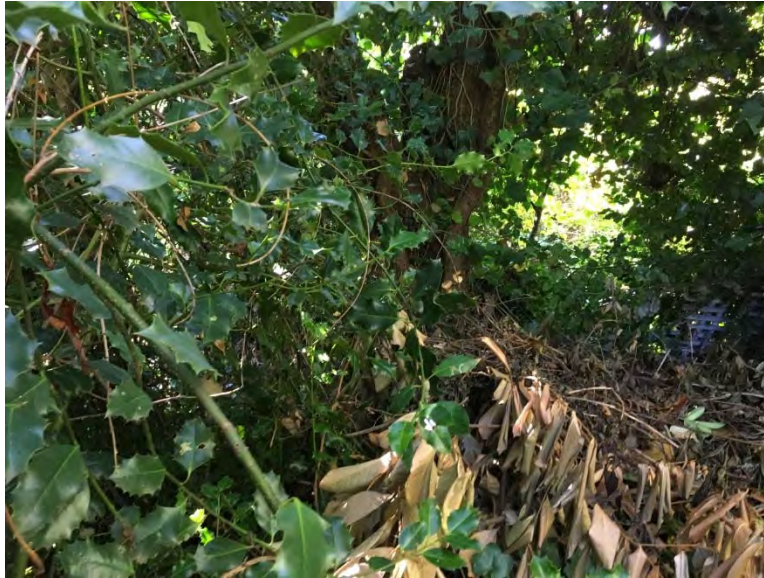
Typical Vegetation and Discarded Landscaping Materials, South-Central Portion of Subject Property, Viewing Southwest

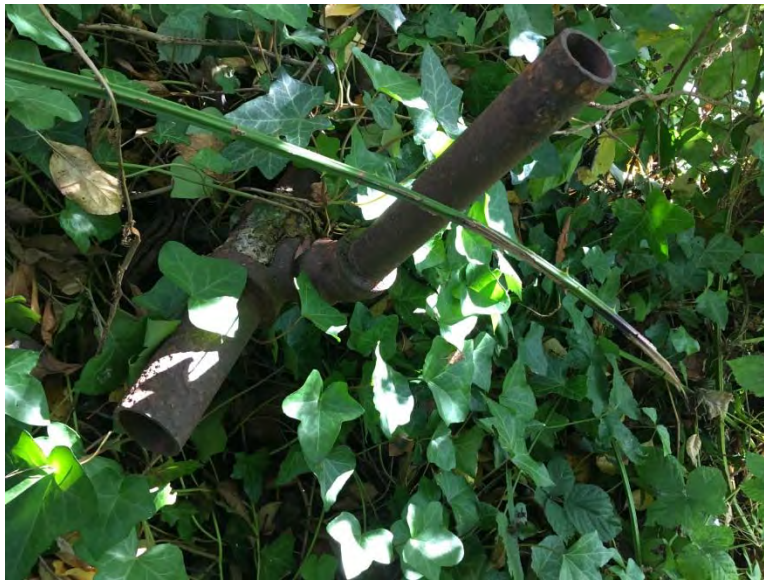
Discarded Sewer Plumbing Associated with Southwest Rubble Fill, Viewing South
