# UST DECOMMISSIONING AND SITE REMEDIATION REPORT

Queen Anne Storage Building  
1529 – 4<sup>th</sup> Avenue West  
Seattle, Washington 98119

Project Number 12-11002

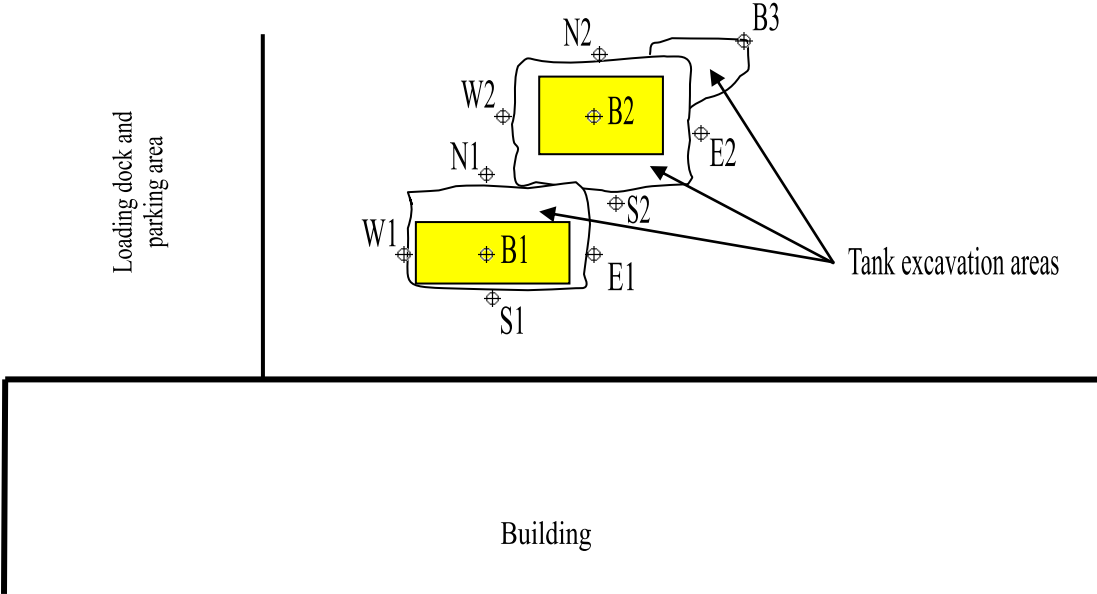
Figure 3. Approximate UST soil sampling locations. 1529 – 4<sup>th</sup> Avenue West, Seattle.

The tank closest to the building was removed on Monday, August 31, 2015. An area approximately 18 feet from west-to-east and 7 feet from north-to-south was excavated (Figure 3). The tank was removed from the pit and disposed of by Marine Vacuum Service. A copy of the disposal receipt for the tank is attached as Appendix E.

Once the extent of contaminated soil was believed to have been reached, a total of 5 soil samples were collected from the tank excavation area (samples N1, S1, W1, E1 and B1) (see Figure 3).

The tank furthest from the building was removed on Tuesday, September 1, 2015. An area approximately 17 feet from west-to-east and 10 feet from north-to-south was excavated (see Figure 3). The southwest portion of this excavation pit bordered the northeast portion of the excavation pit for the other exterior UST (see Figure 3).

Once the extent of contaminated soil was believed to have been reached, samples were collected from the excavation area (samples N2, S2, W2, E2, B2 and B3) (see Figure 3). One sample was also collected of the contaminated soil disposed of offsite (sample St1).

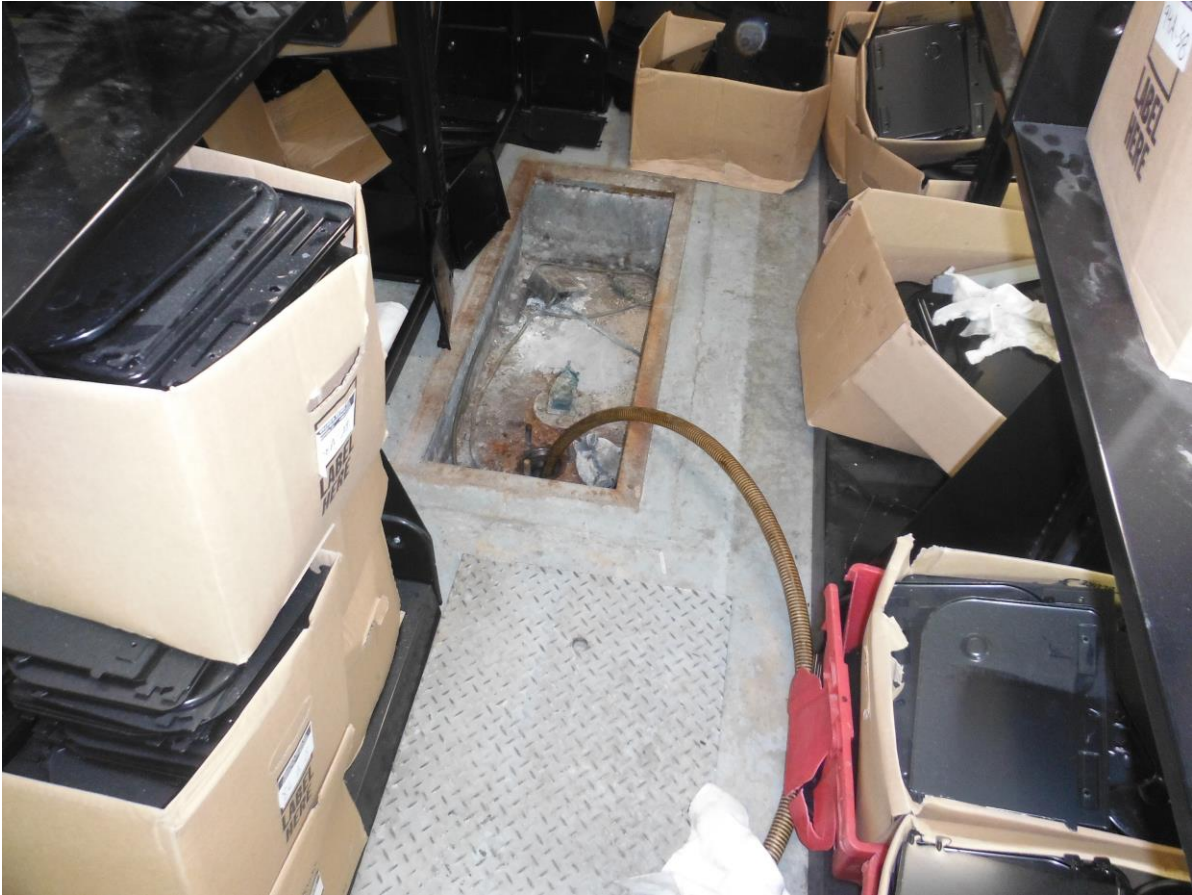
The UST in the southwest corner of the basement of the building was emptied and rinsed. Approximately 200 gallons of liquid was removed from the tank and disposed of by Marine Vacuum Service in Seattle. A copy of the disposal receipt for the tank contents is attached as Appendix B.

Pumping and cleaning of UST in southwest corner of basement of building.

The UST located beneath the concrete slab floor in the southwest corner of the basement of the subject Queen Anne storage building was emptied and rinsed. There were no soil samples collected from this tank area. The tank was not removed or filled-in-place. Future plans call for the sale of the building. The current owner, the Seattle Public Library, will ask the future buyer what they want done with the tank before performing any further work. It is unlikely that the tank will be removed due to its presence inside the building.

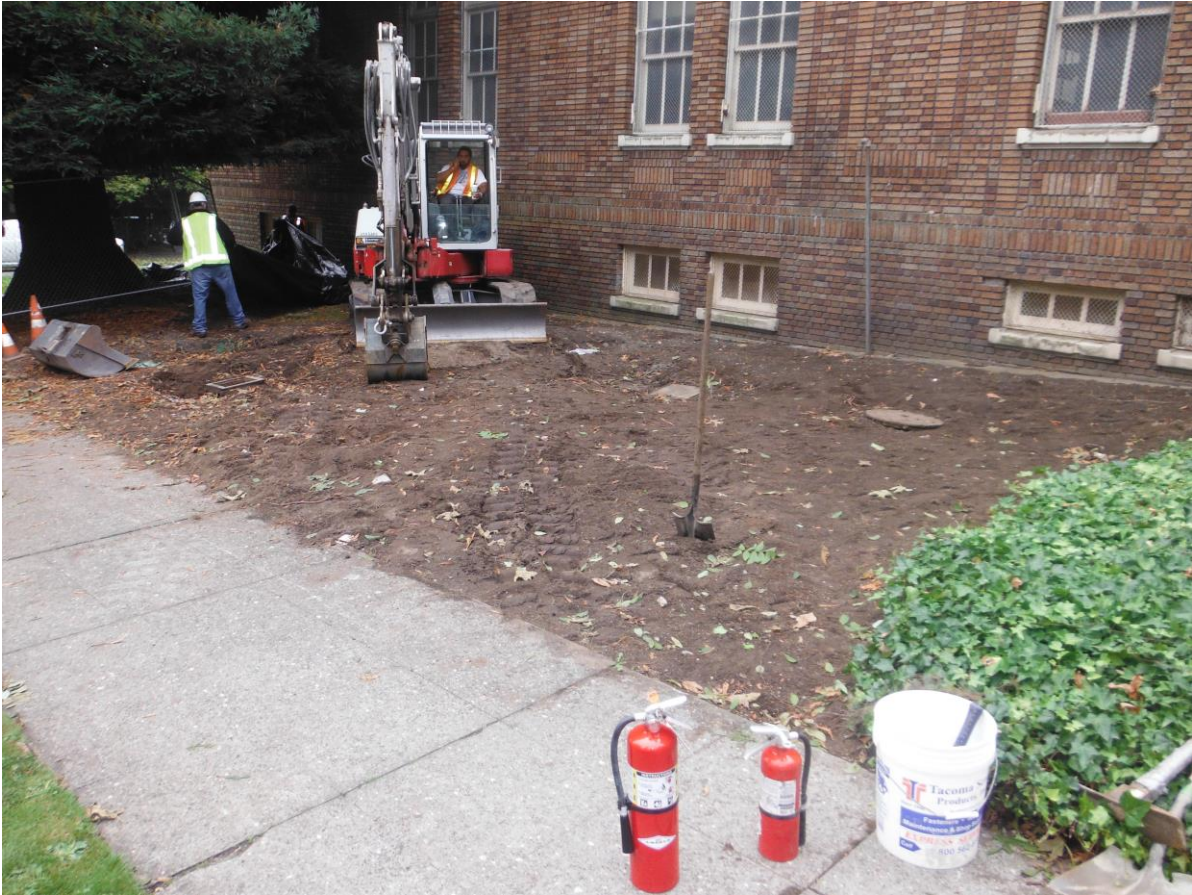
Location of 2 USTs along north exterior of building.

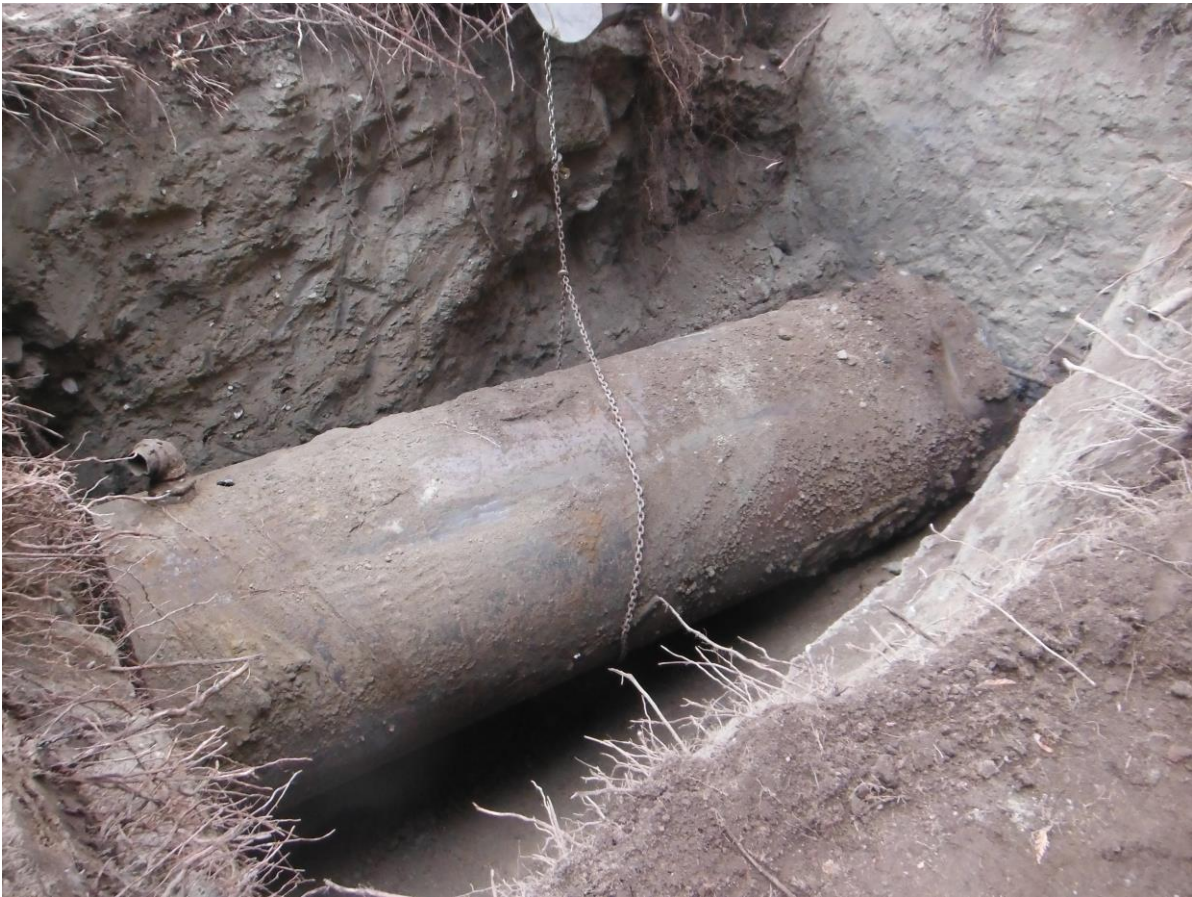
Removal of UST closest to building.

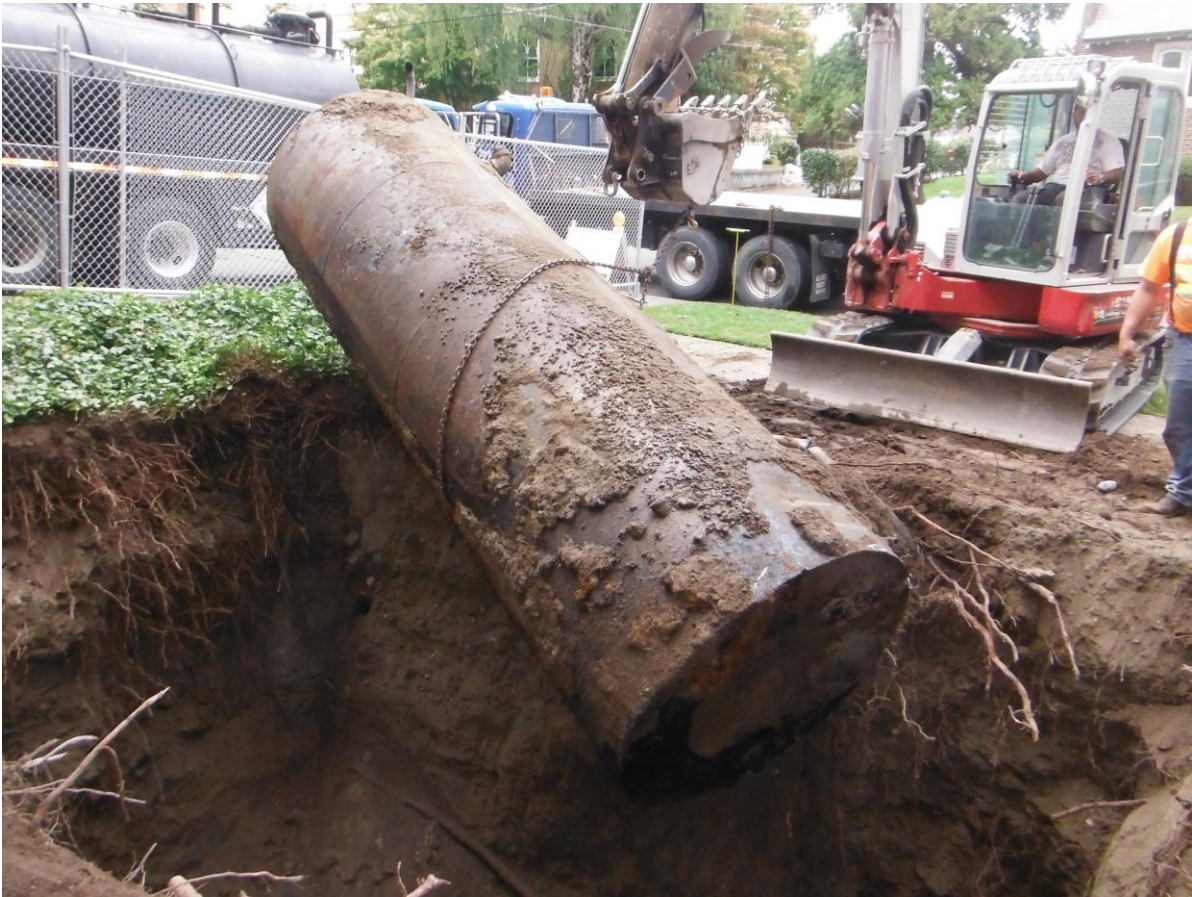
The tank was in good condition at the time of removal, with no obvious evidence of holes or leakage. However, a slight petroleum odor was noted in the soil beneath the tank. As a result, approximately one foot of soil was removed from the bottom of the pit and disposed of offsite as contaminated material by Marine Vacuum Service. A copy of the disposal receipt for this soil is attached as Appendix F.

UST closest to building. No obvious evidence of holes or leakage.

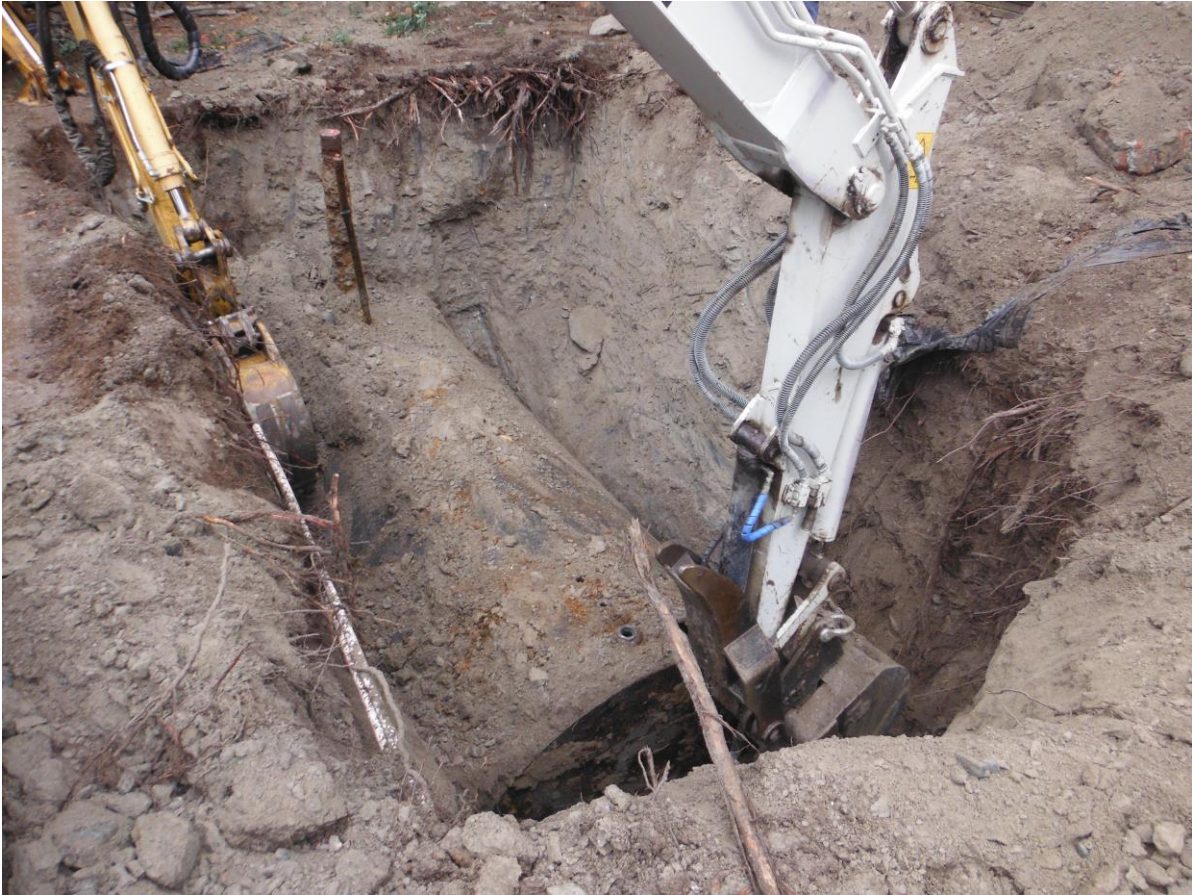
Removal of UST furthest from building.

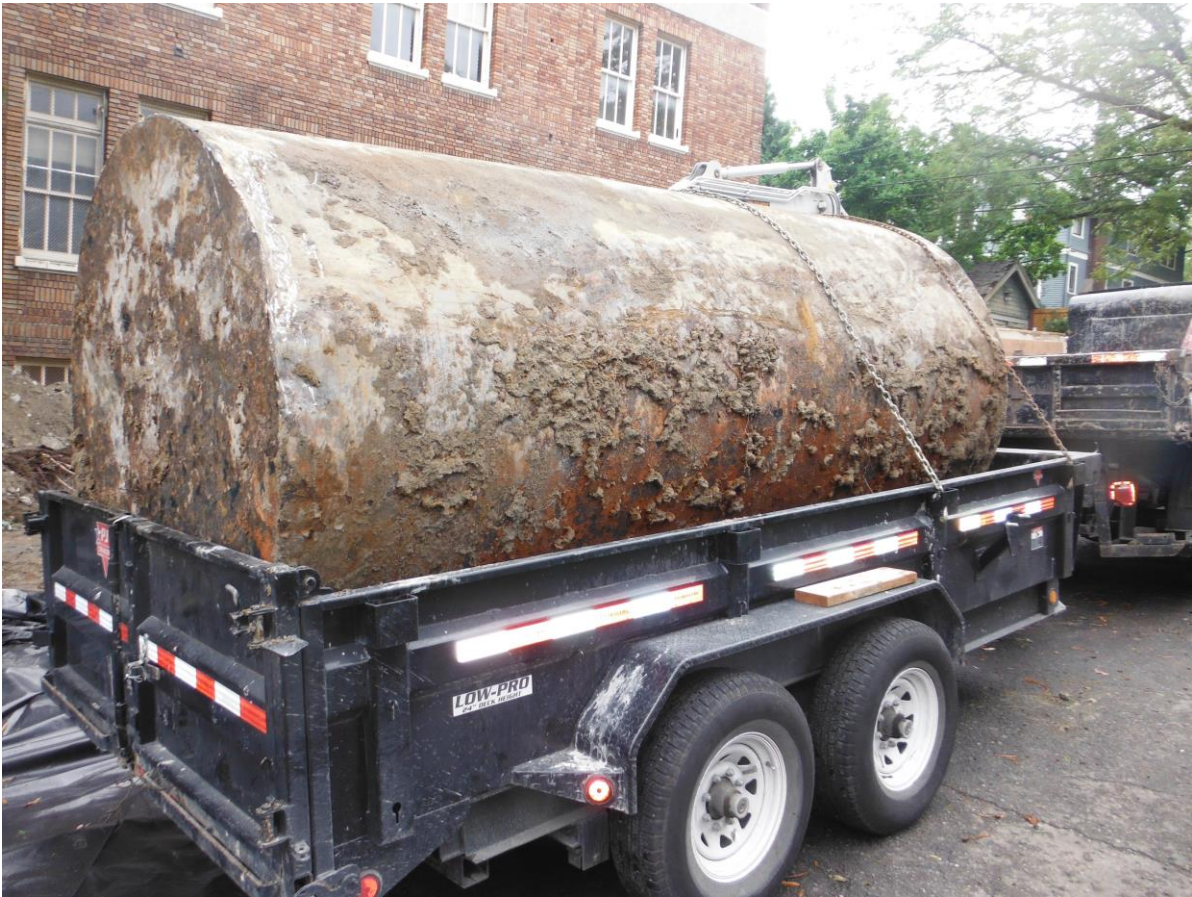
UST furthest from building. No obvious evidence of holes or leakage.

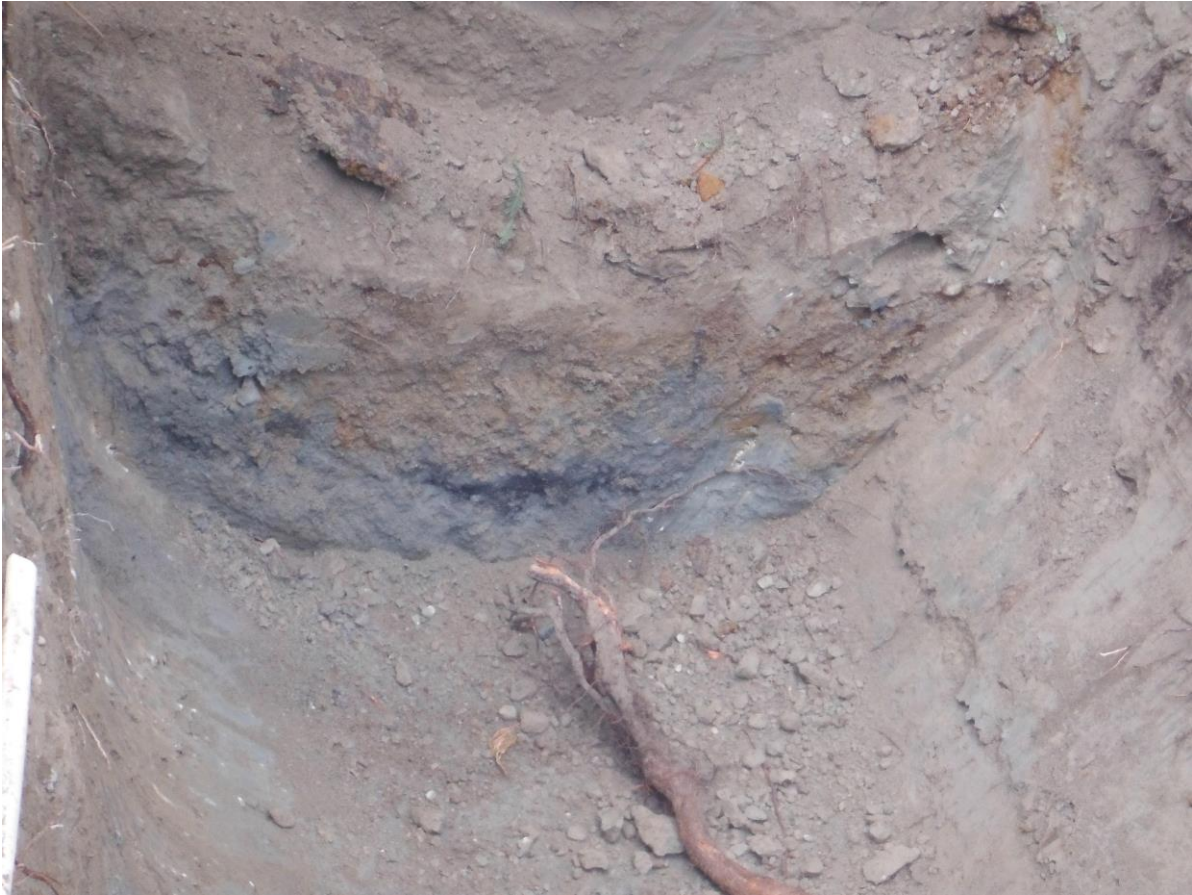
The tank was in good condition at the time of removal, with no obvious evidence of holes or leakage. However, discolored soil with a petroleum odor was noted beneath the bottom eastern-half of this tank, and along the lower northeast sidewall area. As a result, approximately one foot of soil was removed from the bottom of the tank pit, while soil along the lower northeast sidewall area was over-excavated. This soil was disposed of as contaminated material by Marine Vacuum Service. A copy of the disposal receipt for this soil is attached as Appendix F.

Tank pit furthest from building. Contaminated soil along lower northeast sidewall area.

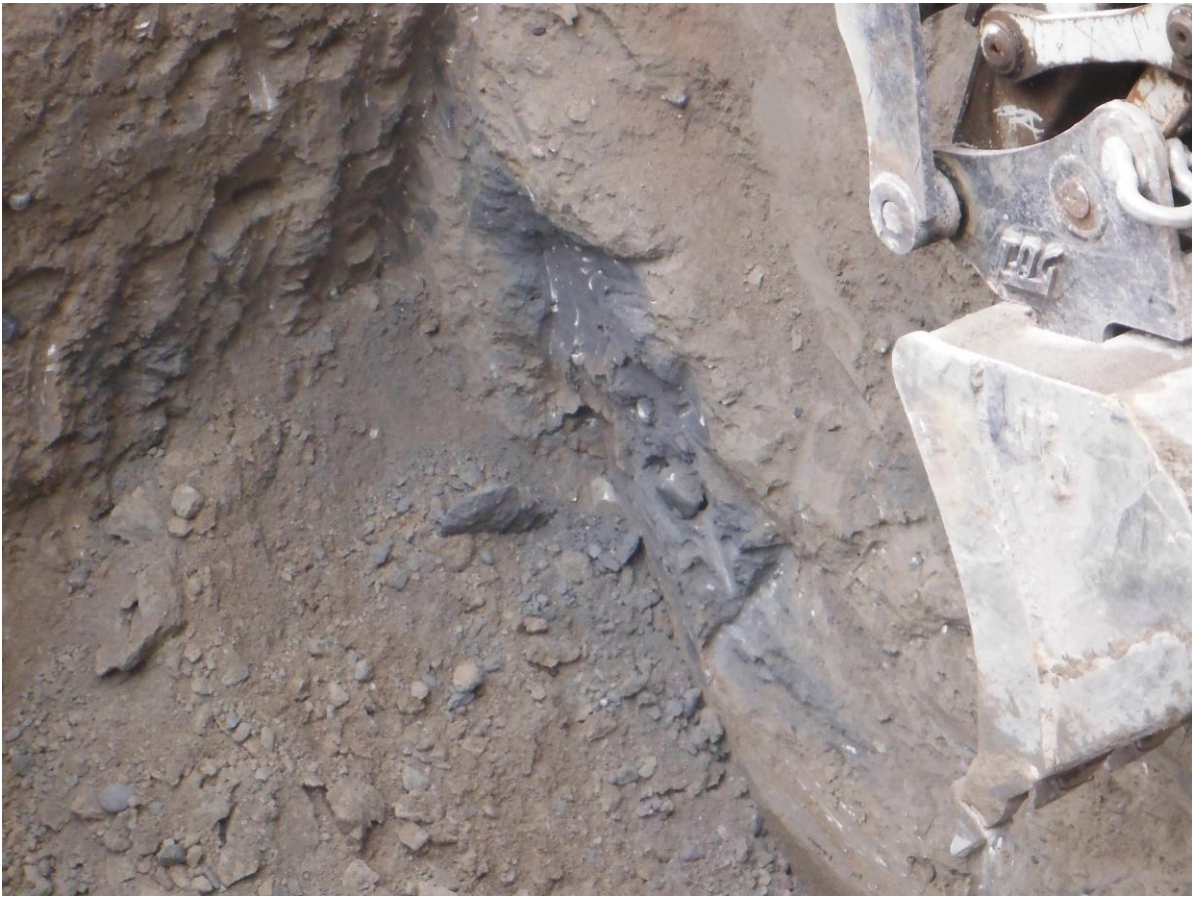
Tank pit furthest from building. Removal of contaminated soil along lower northeast sidewall area.

Contaminated soil from the tank excavation pits was removed and properly disposed of.
