Landmark NOMINATION Application

Name (common, present, or historic): Rodgers Tile Company

Street and Number: 117 Yale Avenue North

Seattle Landmark Nomination

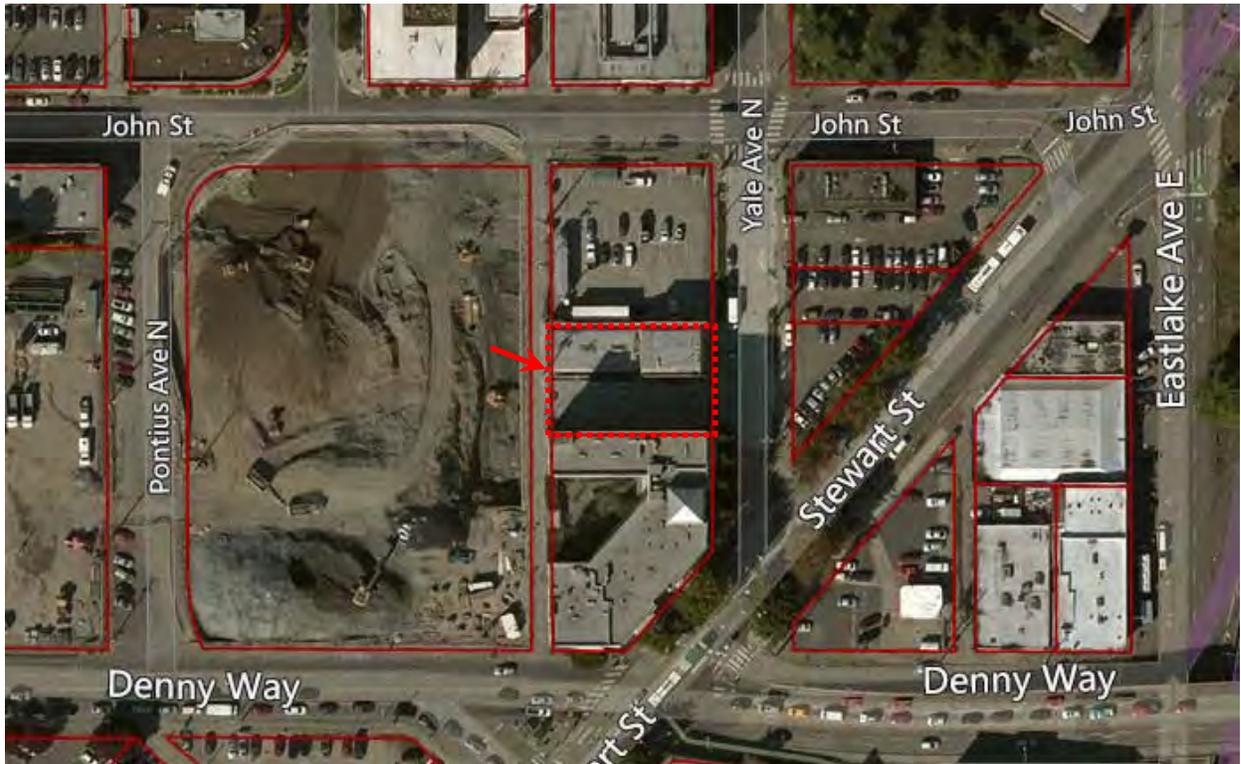
Fig. 2 – Aerial photo showing subject site. Parcel indicated by red dotted line. North is up.
 The large site on the left was a former bus maintenance building which is now being redeveloped into a major Seattle City Light substation.

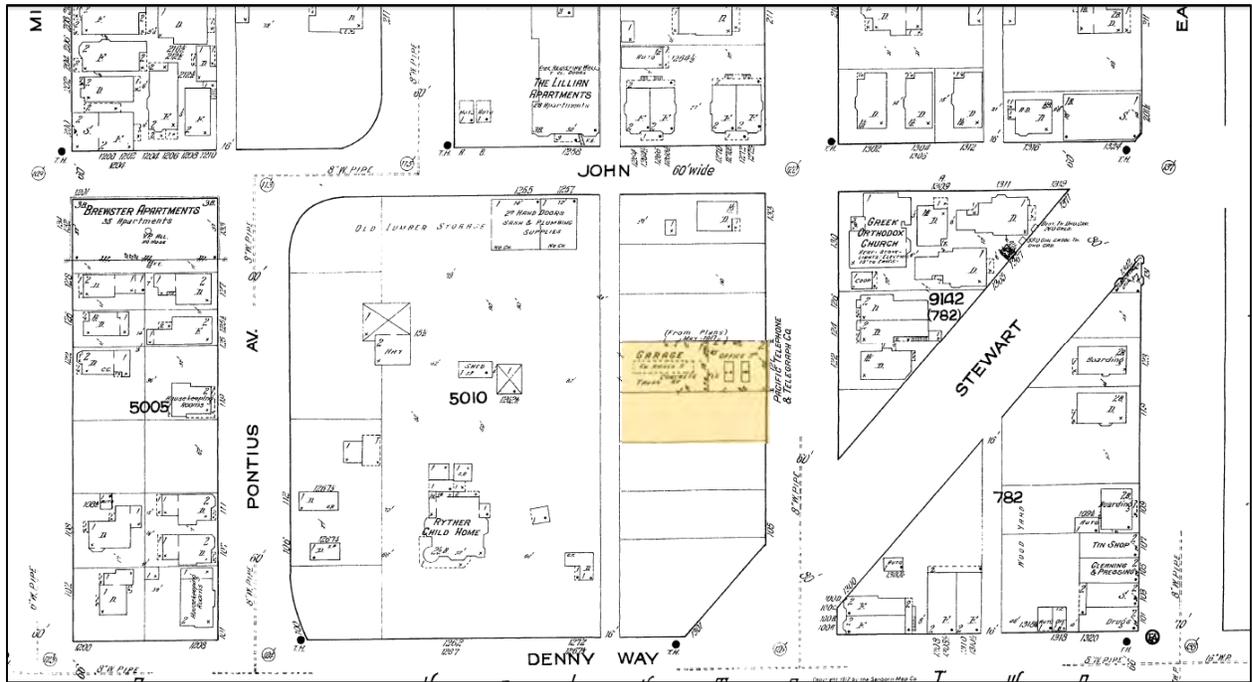
Fig. 3 – 1917 Sanborn fire insurance map. North is up. Subject site indicated by shaded box. At this time only the north portion had been built, a garage for the Pacific Telephone and Telegraph Company. Note Ryther Child Home behind the site, formerly the Pontius mansion.

The 1917 Sanborn fire insurance map indicates that the north half of the subject parcel was developed in May of that year as an office and garage to be leased to the Pacific Telephone and Telegraph Company (PT&T). While no historic images were found for that structure, very faint architectural drawings by Seattle architect Edwin J. Ivey are on file, showing a slightly more ornate version of the north portion of the existing building. PT&T was the successor firm to the earlier Sunset Telephone & Telegraph Company, which constructed several two-story telephone exchange buildings in neighborhoods throughout Seattle in the early 1900s, which Ivey's design appears to resemble in architectural scale, proportion, and symmetry.¹⁵ Sanborn map notes indicate that the front portion of this building was two stories with a one-story truss-roof garage extending to the alley at the rear—essentially describing the condition of the north portion of the building today. The first floor appears to have been entirely given over to garage space, and on the map the second floor was labeled “offices.” A 1923 newspaper article described the building as leased and housing the “plant school,” presumably the training facilities and shops, for the PT&T service and installation department, which was to move that year to a larger consolidated facility at Minor and Fairview Avenues.¹⁶

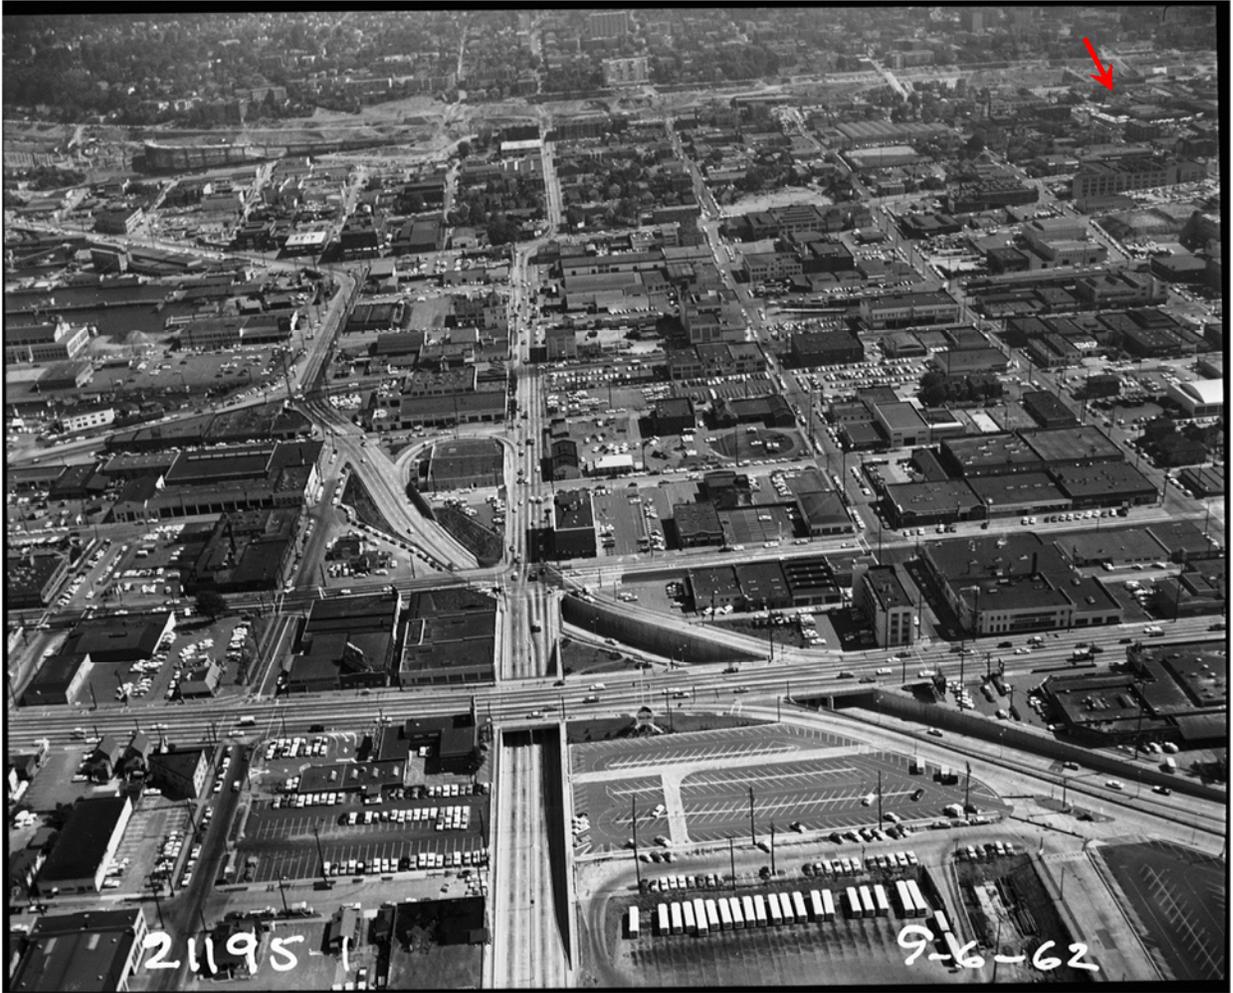
Fig. 15 – Aerial view in 1962, showing the largely light industrial character of the neighborhood. North is left. Interstate 5 is under construction at the top of the photo. Other cross-neighborhood arterials show the impact of the automobile on the area. Subject building near red arrow. (SMA 73481)

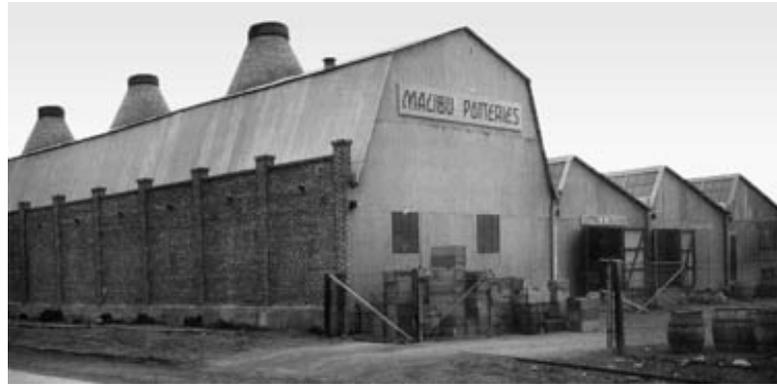
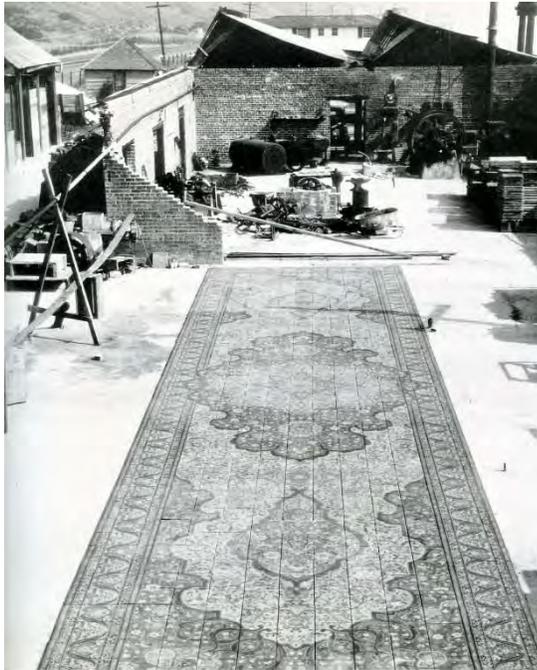
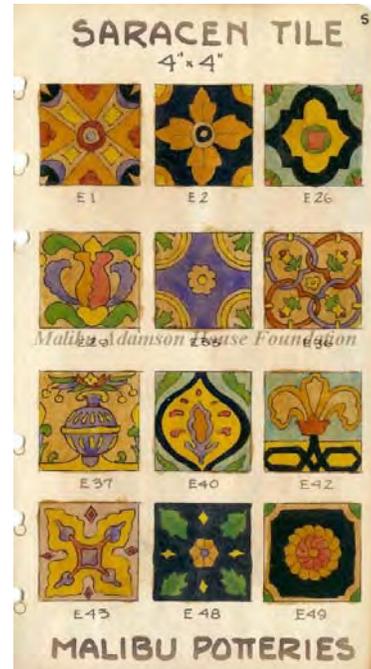
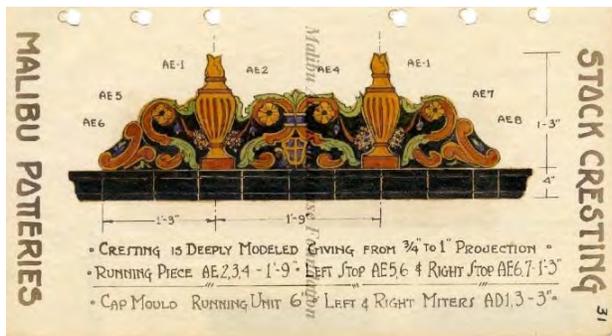
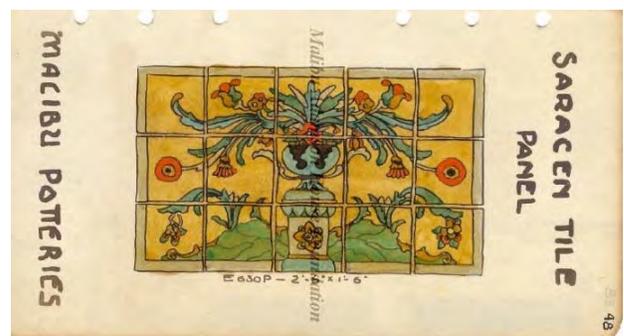
Fig. 23 – Malibu Potteries, images of factory in California, and catalog pages, c. 1928.

The company was known for ornate tiles and custom compositions, including fountains, panels, and even tile “Oriental rugs” shown at middle left. (Courtesy of Adamson House Foundation, Malibu, California)

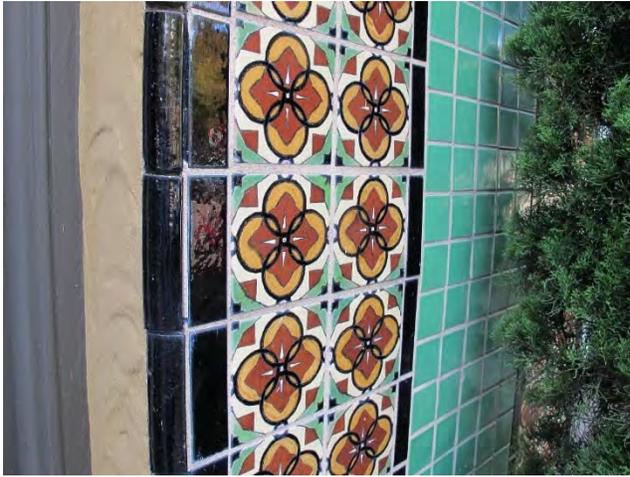
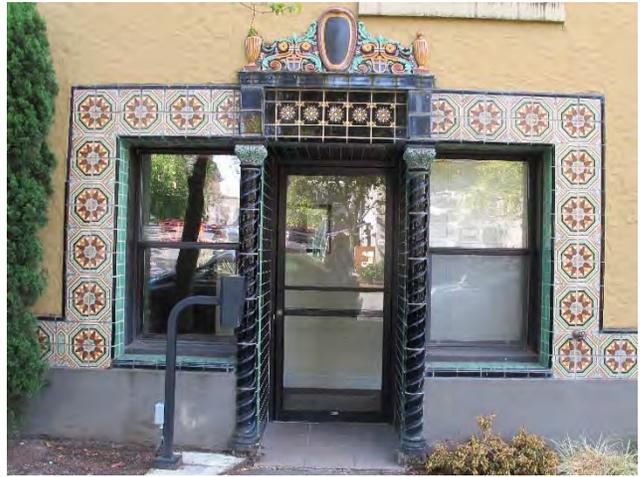
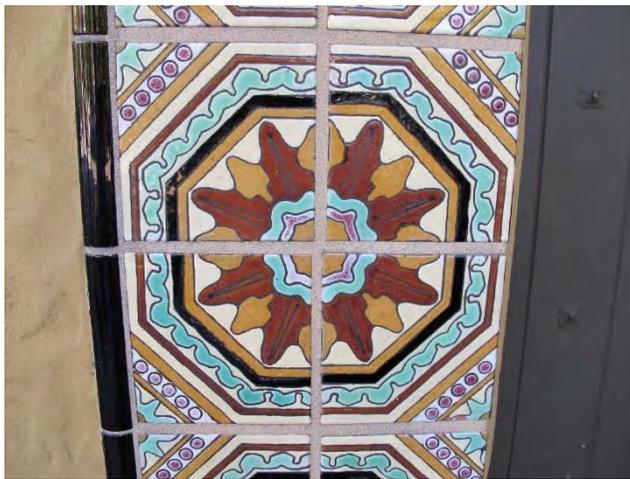
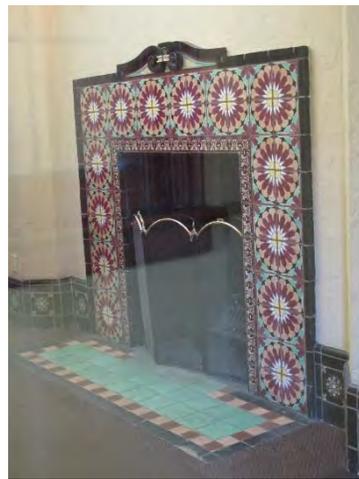
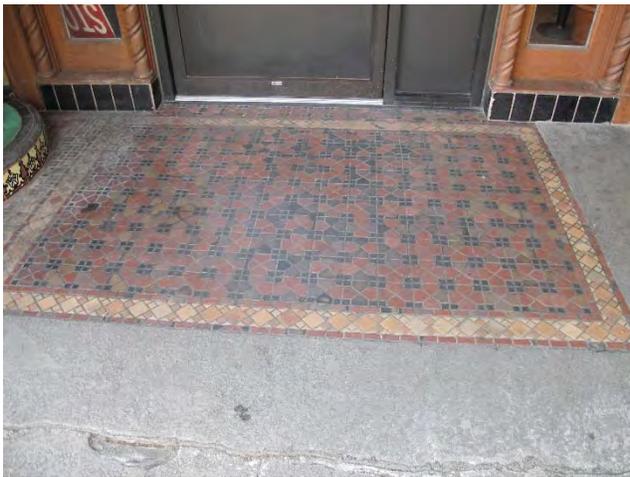
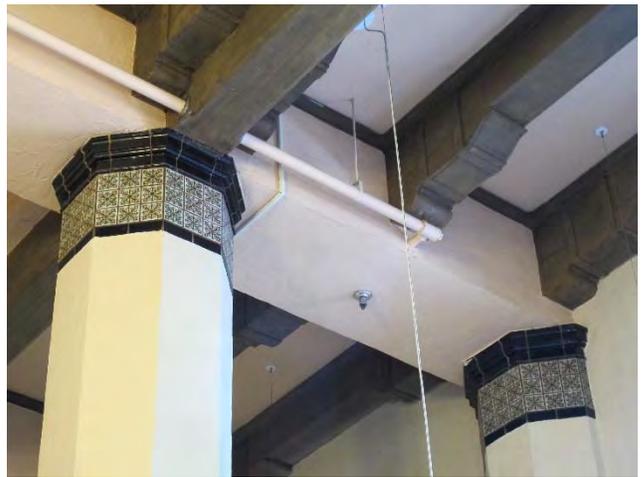
Fig. 26 – Tuscany Apartments (1928, Huntington & Torbitt), detail of tile.
The building was originally called the Piedmont Apartments.

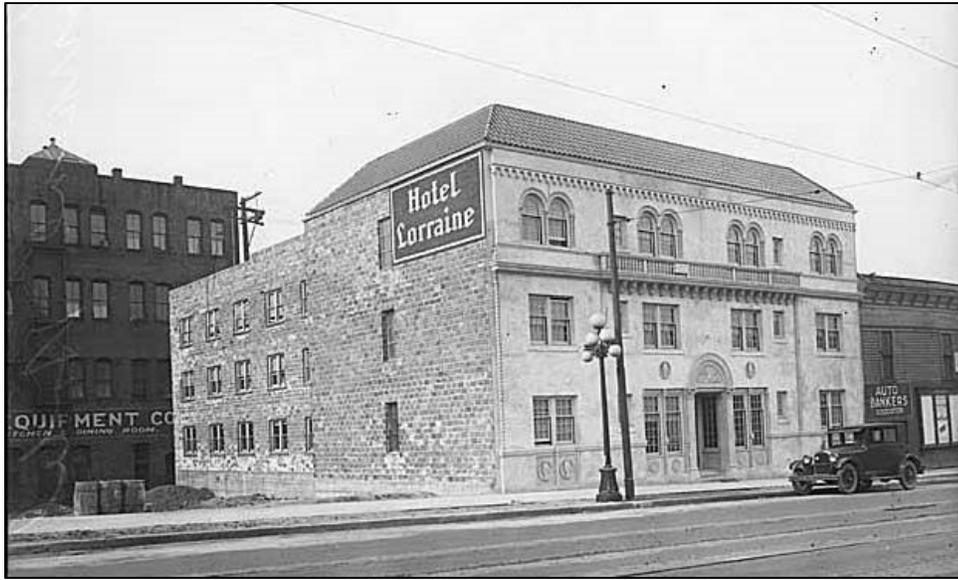
Fig. 27 – William Tell Apartments / Hotel Lorraine (1927) at 2327 First Avenue, is an example of the Italian Renaissance Revival style, and a designated Seattle landmark. (MOHAI PI-23672)

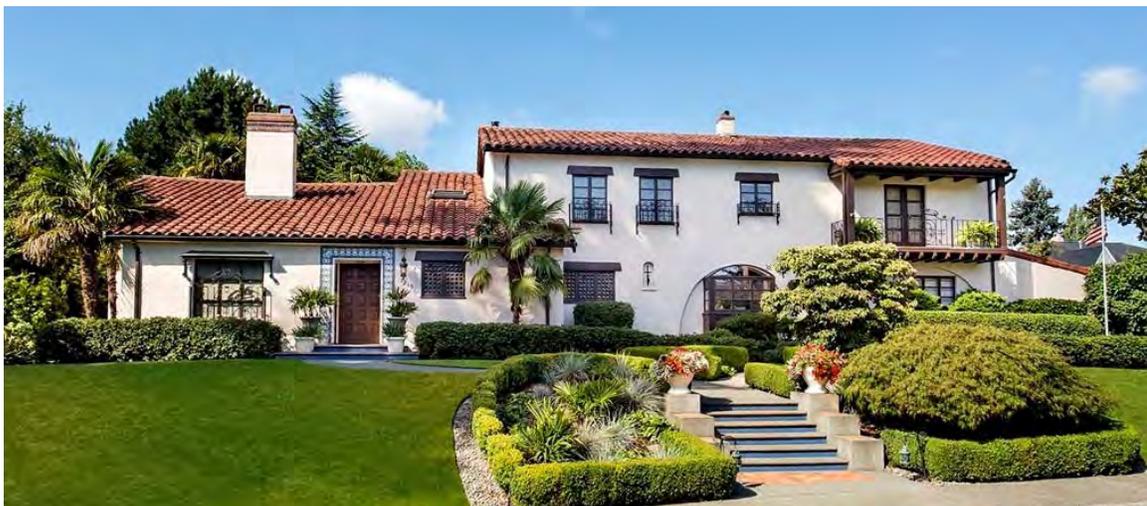
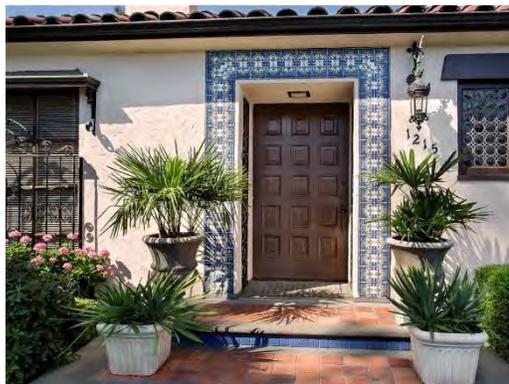
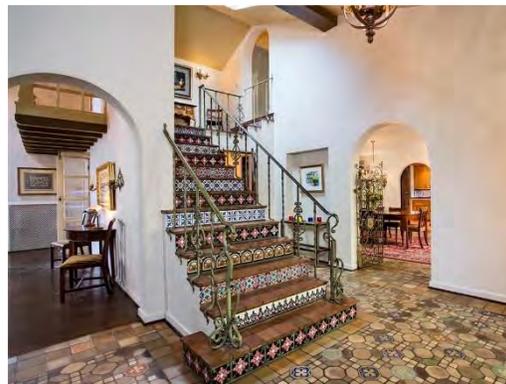
Fig. 28 – (Three photos above) 1215 Shenandoah Drive East (1929), features interior and exterior tile, and is an example of Spanish Colonial Revival style. (www.realtor.com)

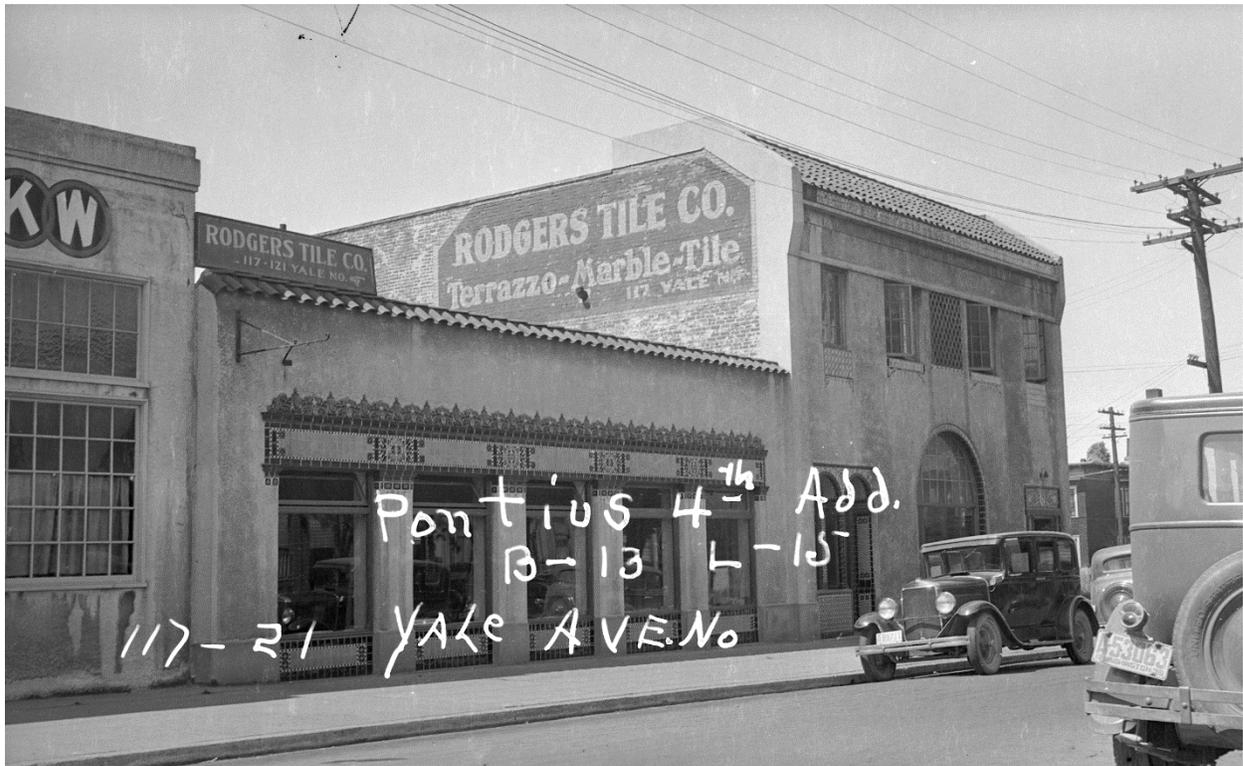
Fig. 35 – 1937 tax assessor photo of the subject building.

- Windows:
 - All windows at the main or east elevation (except for the clear leaded glass window portion in the upper part of the large arched window which dates to either 1917 or 1927) replaced during building renovations between 1996 and 2002.
 - All windows at the south and north elevations replaced during building renovations between 1996 and 2002.
- Decorative tile on east elevation removed in 1942 (all visible in 1937 tax assessor photo):

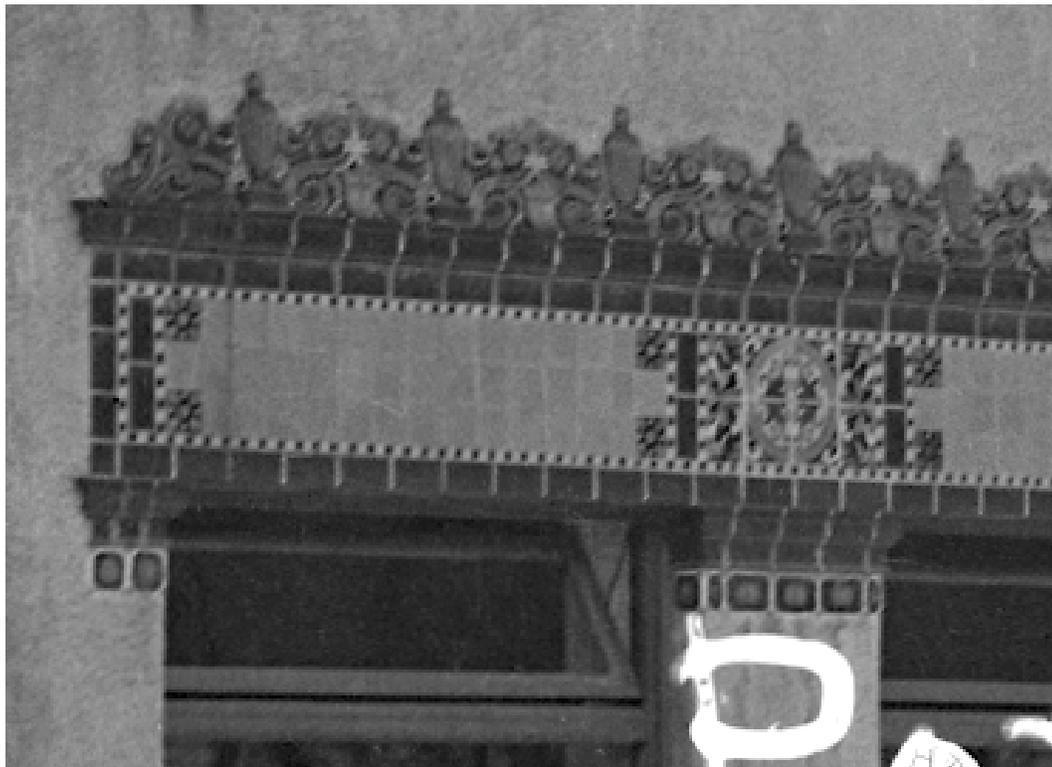
Fig. 36 – Detail, 1937 tax assessor photo.

Ornate frieze above tile band was apparently removed in the 1942 renovations. The frieze appears to match the “stock cresting” item in the Malibu Potteries catalog (see earlier figure).

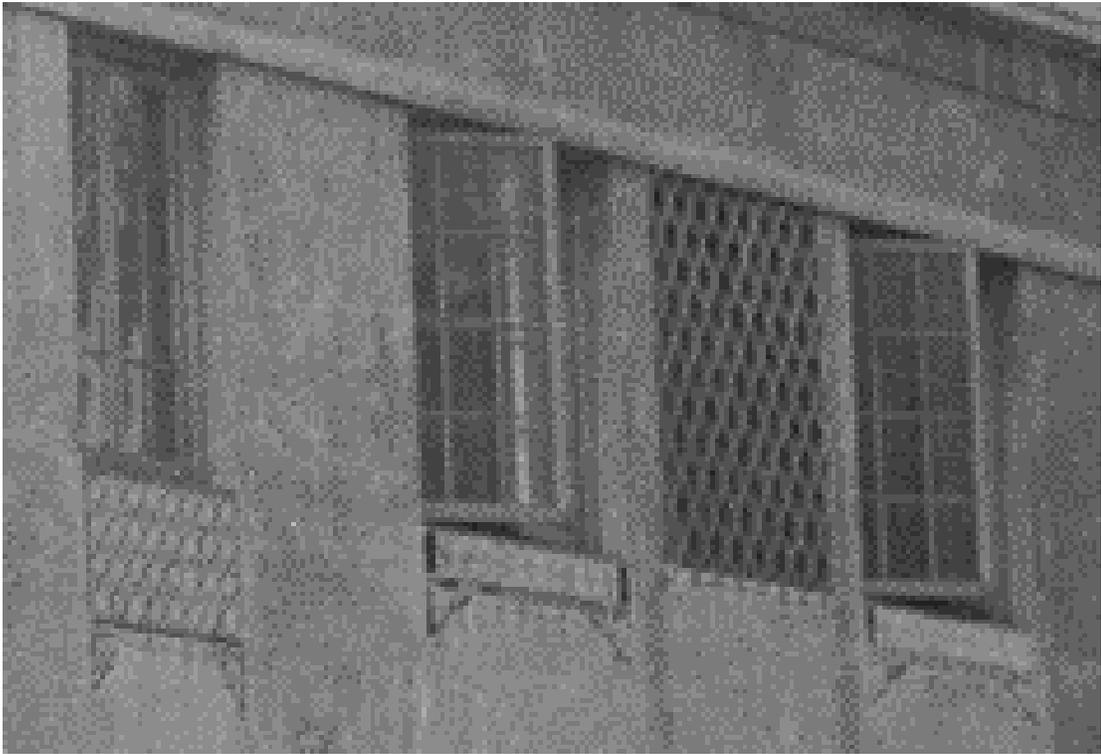
Fig. 37 – Detail, 1937 tax assessor photo.

Note casement windows, tile or metal lattice between windows at right, and tile sills, all no longer intact.

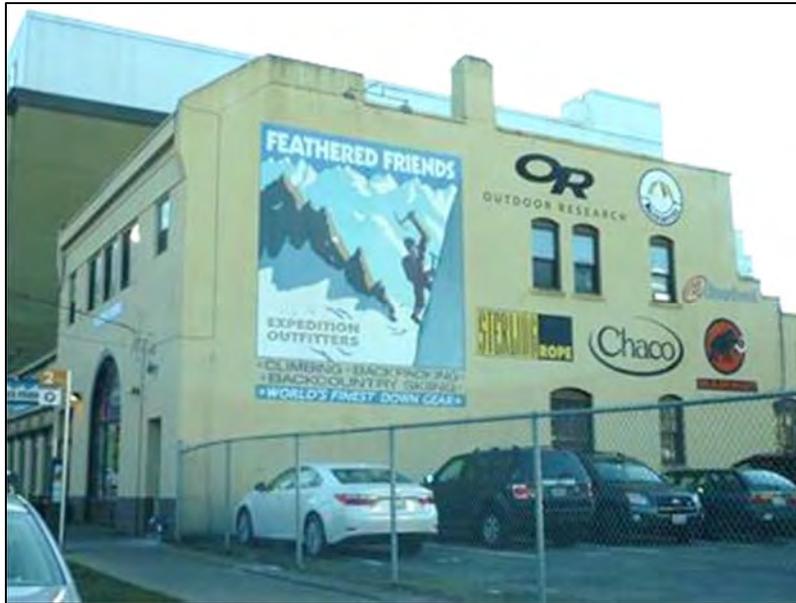
Fig. 39 – Tax assessor photo, c. 2008, showing unobstructed view of east part of north elevation. (King County Tax Assessor; original image poor)

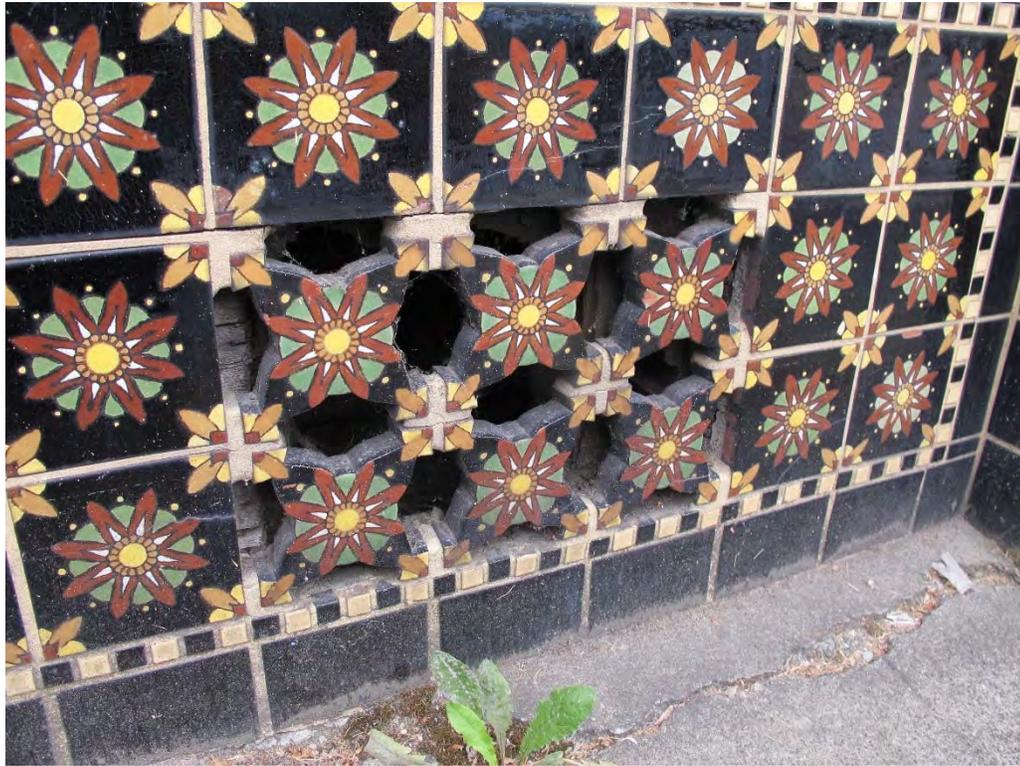
Fig. 49 – East elevation, detail of tile, arched window bulkhead. Tiles cut for vent.

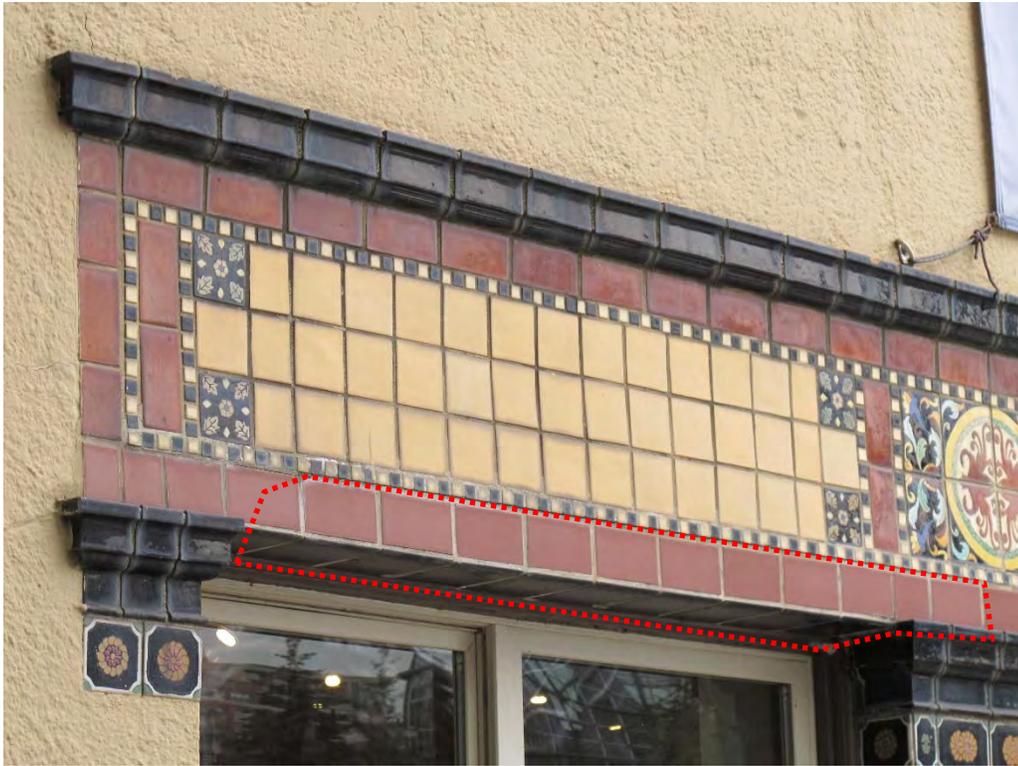
Fig. 55 – East elevation, detail of tile. Red and black header tiles replaced during 1996-2002 repairs and renovations are identified by dotted line (original tiles are darker in hue and have a more reflective surface). Such repairs occurred at each window header of this part of the elevation.

- In-kind replacement of field tile at window headers for the five windows on left half of east elevation (using best available match; exact tile match was not possible).

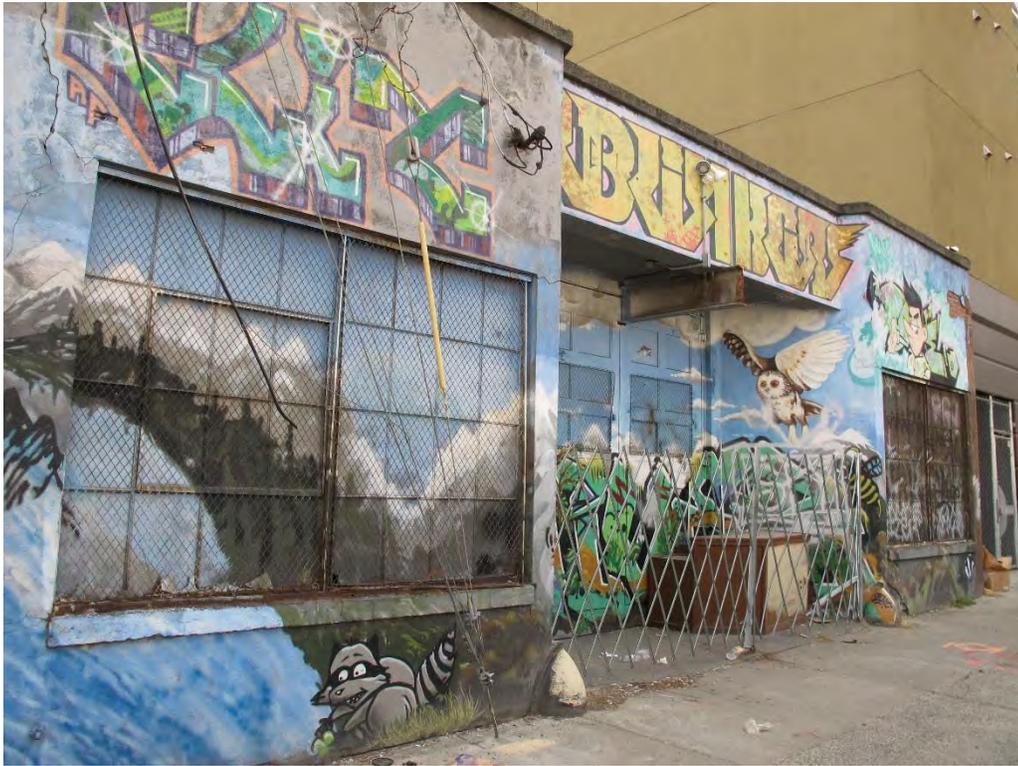
Fig. 65 – West elevation, detail. Note wide flange beam above double doors for traveling hoist.

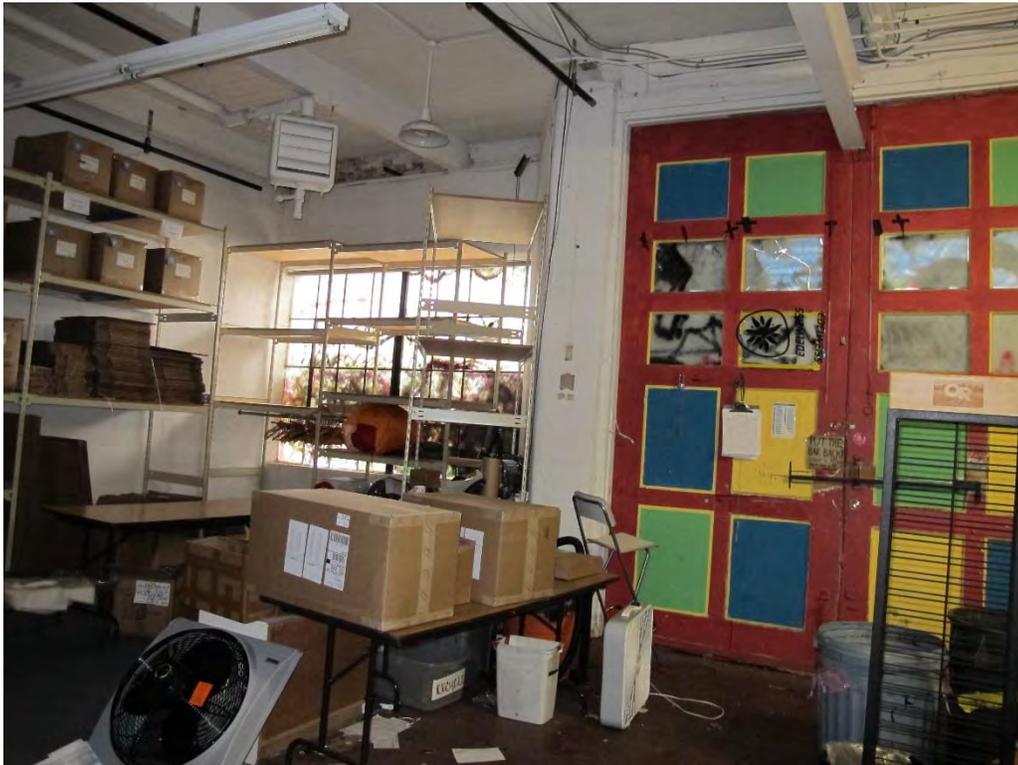
Fig. 89 – Interior, storage space in south central part of building, showing former skylight.

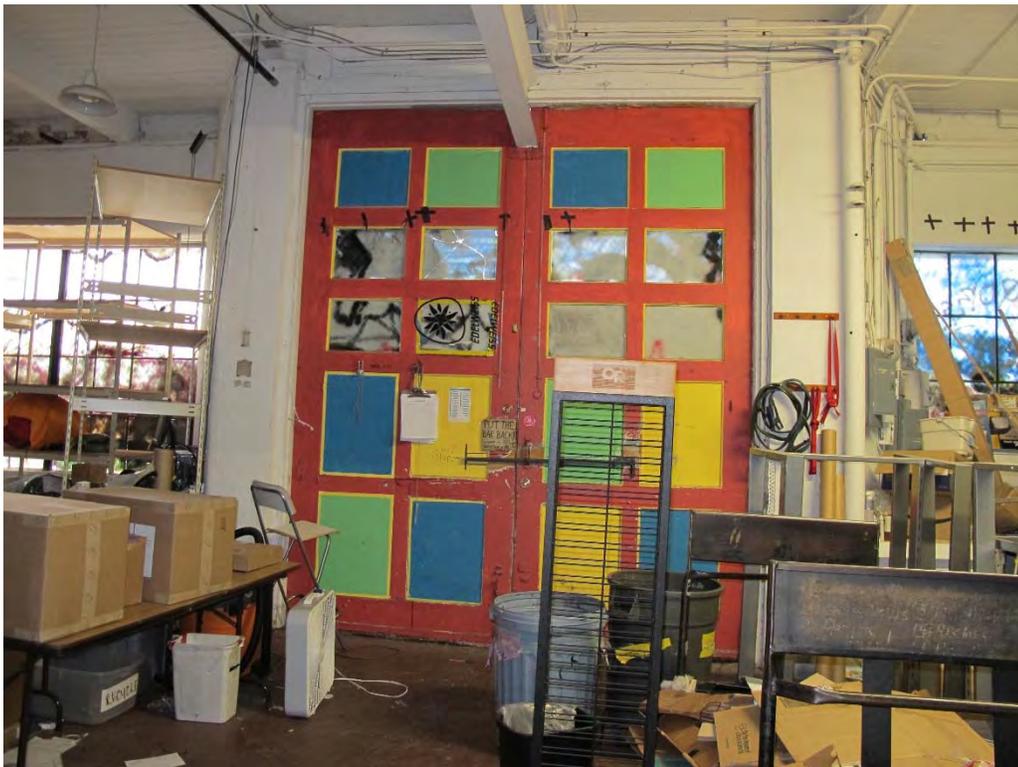
Fig. 92 – Interior, storage space in southwest building corner.
Note wide flange beam above double doors for traveling hoist mechanism.

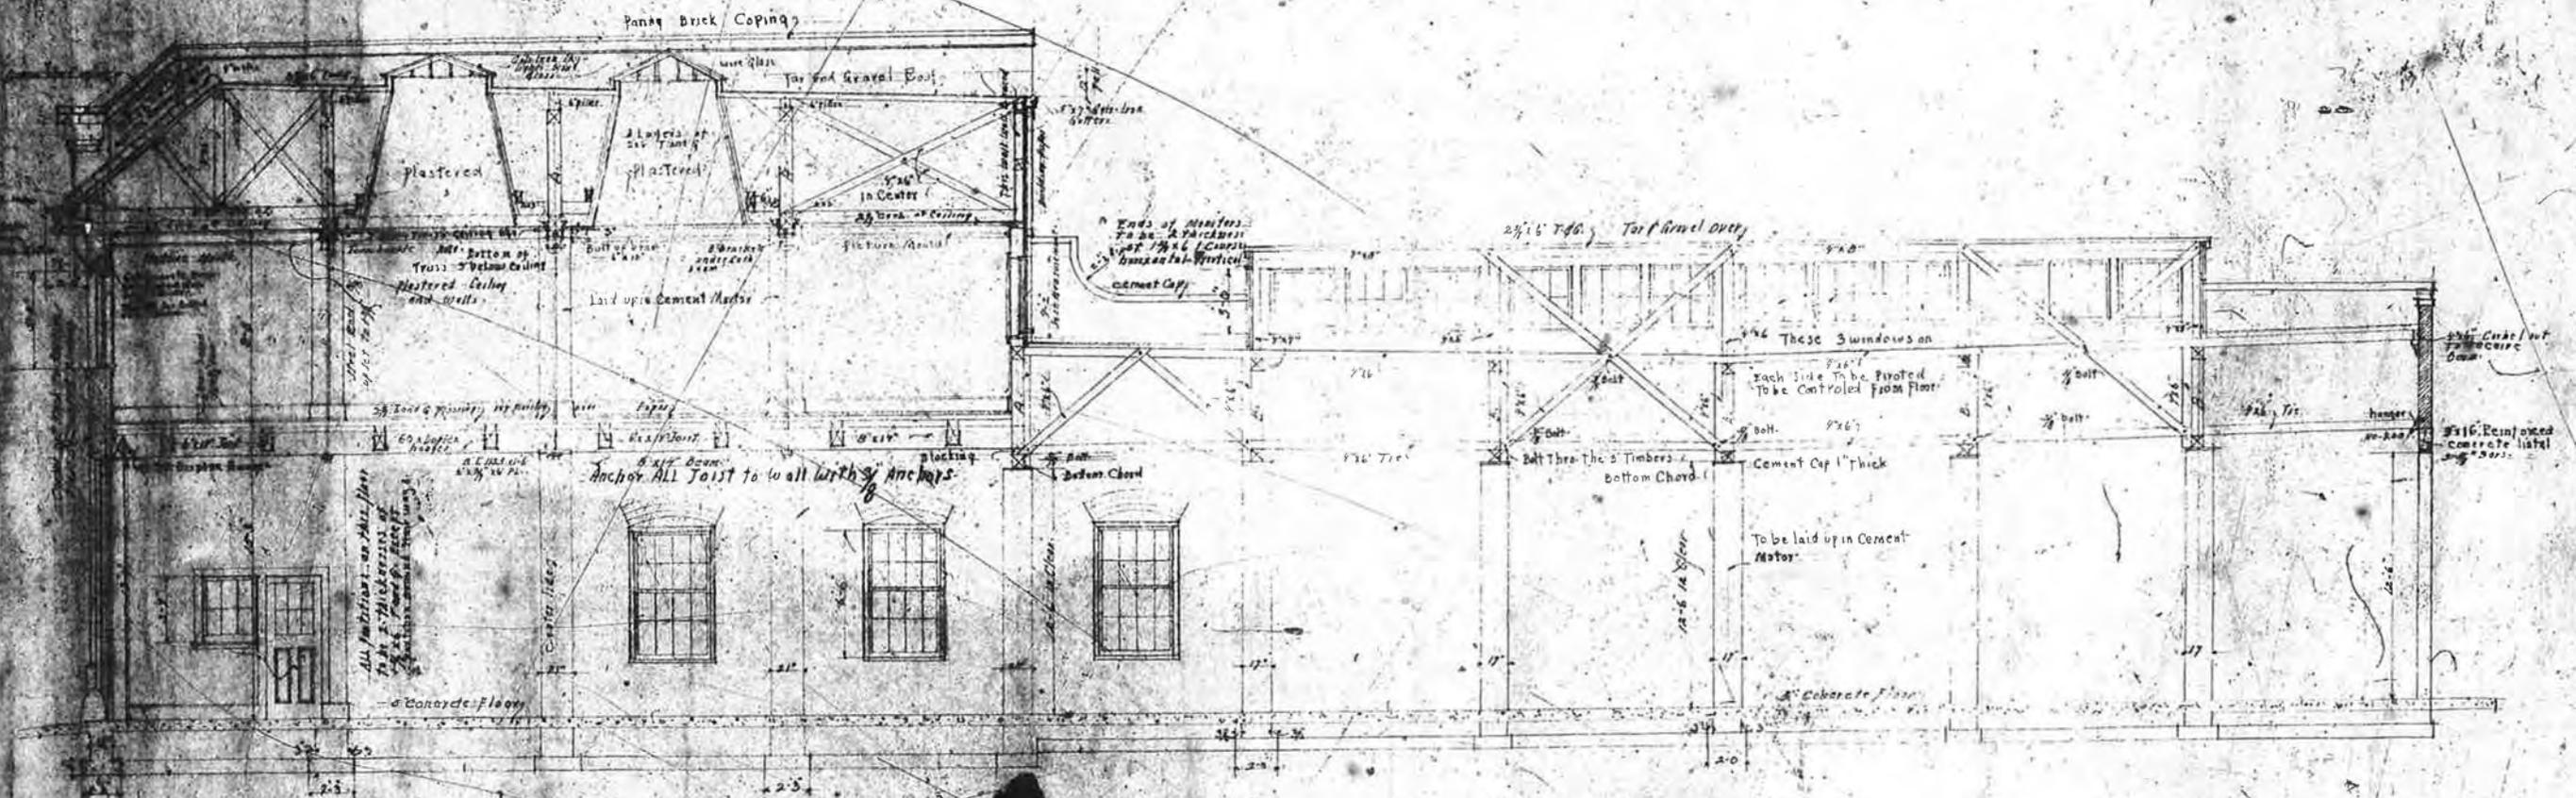
LONGITUDINAL SECTION
1/8" Scale

1917 section of north portion of building, by Edwin J. Ivey.

BUILDING FOR THE PACIFIC TELEPHONE AND TELEGRAPH COMPANY.
ON LOT 16 - BLK 13 - PONTIUS 4th ADDT.
EDWIN J. IVEY ARCH: 402-3 BOSTON BLK.

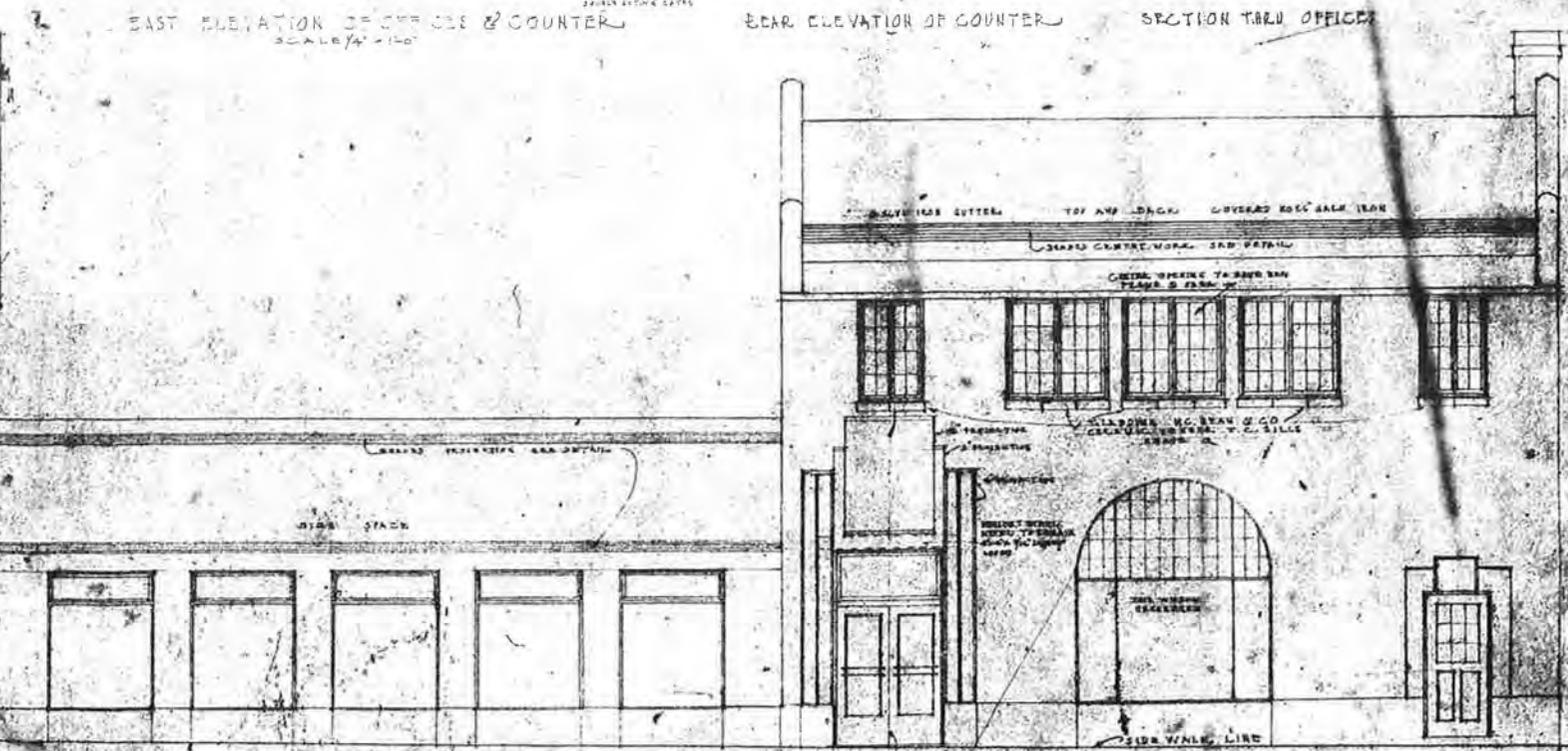
Although the east elevation was not updated with proposed Art Deco elements (such as around the main entry), at this time much tile ornament was removed from the exterior elevation.

In 1942, the upstairs was renovated into an apartment; the plan remains largely intact on the second floor. The plan of the first floor proposed in 1942 is no longer completely intact.

ALTERATIONS IN SALES BUILDING
 1121 YALE AVENUE NORTH SEATTLE
 HALF SCOTT MOYER CARCO OWNED
