1620 16th Avenue Landmark Nomination

BOLA Architecture + Planning

January 15, 2019

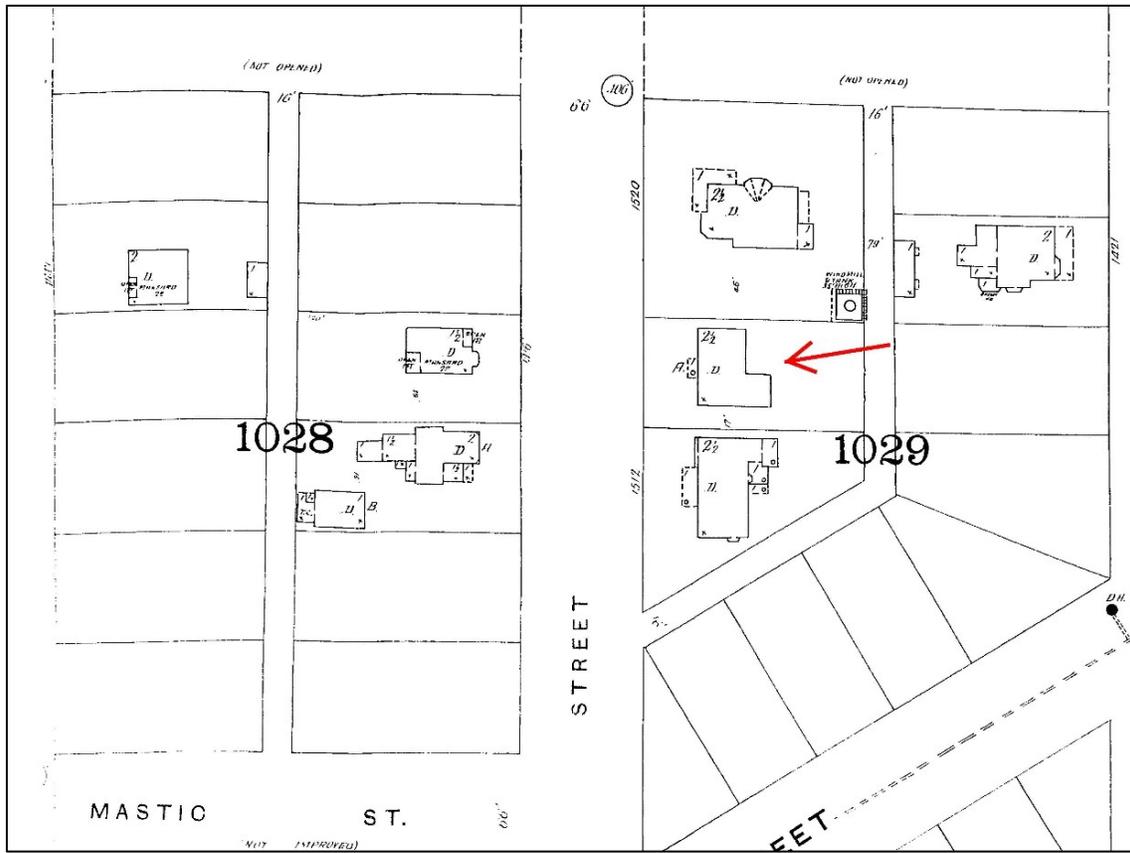
Figures 5a, 5b and 5c. Above, an excerpt from an 1893 Sanborn Insurance Map, Vol. 2, Sheet 84 showing the blocks on both sides of what was later renamed 16th Avenue. Inserts, below, from a Sanborn map of 1905 (left) and an updated Sanborn map of 1950 (right) showing later construction on the subject site, including the northeast expansion, southeast addition, and the garage (Volume 2, Sheet 223; Seattle Public Library).

According to current King County assessor's data, the lot size is 60' by 120' and 7,200 square feet (0.17 acres). The parcel is located mid-block, between E Olive and E Madison Street. A 16'-wide paved alley runs behind 1620 16th Avenue. The layout of parcels on the block are shown on an early Sanborn Insurance Company map from 1893. At that time, 16th Avenue was identified as Joy Street, while 17th Avenue was Chestnut Street and E Pine was Mastic Street. These early names were changed by ca. 1905. (Figures 5A – 5C)

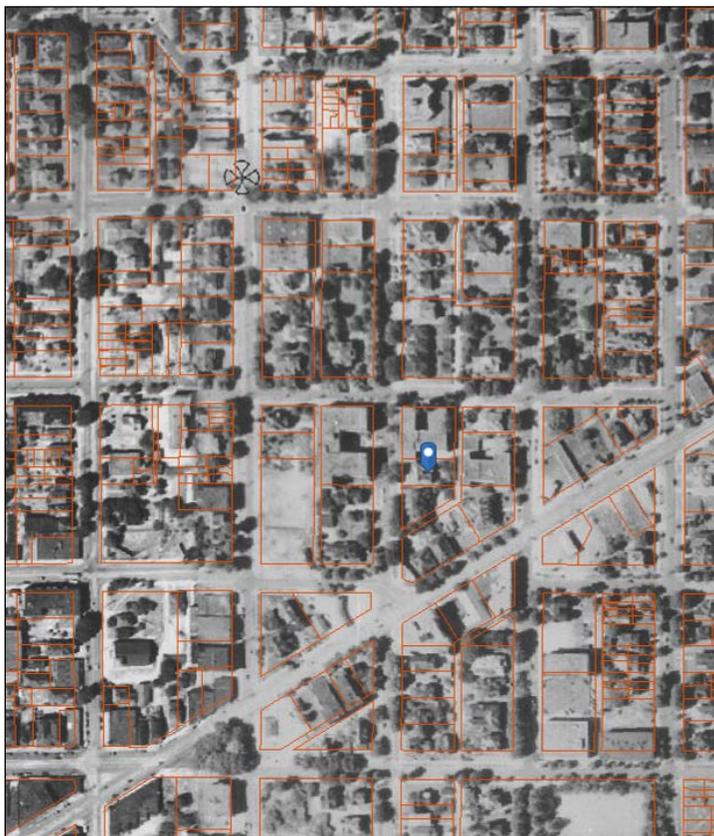
Figure 6. Above, an excerpt from the 1912 Baist Map, Plate No. 7. North is oriented up. A blue arrow identifies the site of the building at 1620 16th Avenue. It appears similar to other wood-frame houses in the area in contrast to larger apartment buildings, which are generally indicated by the pink color denoting masonry construction. The garage is shown on the site, which is accessible from the alley, streetcar lines are indicated along nearby E Madison Street, 15th Avenue, and western parts of E Pine Street (DorpatLomontSherrard blog).

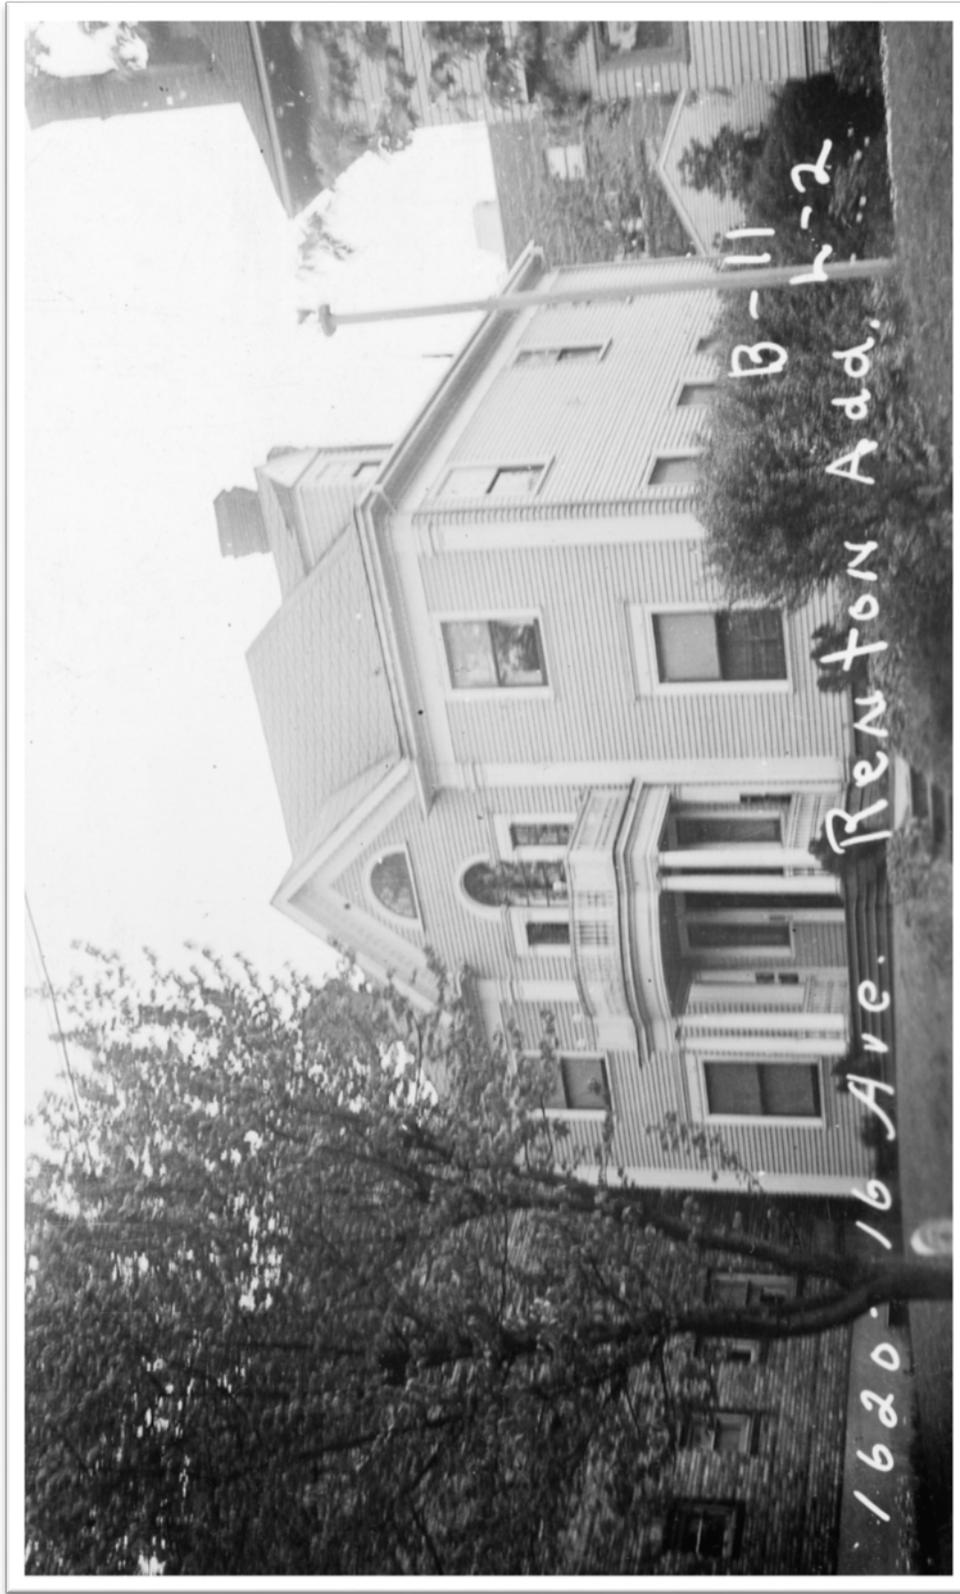
Figure 17. Above, the King County Tax Assessor's record photograph from August 1937.

The original building features some characteristics of the Colonial Revival style, notably on the primary west facade. (Figures 17 – 18) Constructed with wood framing and originally clad with narrow horizontal wood siding, it appeared upright with vertical proportions. As shown in the 1936 tax assessor's record photo, the hipped roof features slightly curved eaves, and gable roofed wall dormers at the attic level on the south and east sides, along with a pedimented front cross gable with eave returns. (Figure 17) The roof overhangs project slightly beyond over a frieze ornamented with dentils, which is carried around the building. The roof retains two brick chimneys although the fireplaces that they once served no longer operate.

The building's construction was cited in 1936 record as "medium, special," with "medium" interior and exterior, and "cheap" foundation, while the current building quality is noted as "good." By 1936, the foundation was concrete. Changes to original exterior features are apparent by comparing the 1936 and 1954 tax record photo and current conditions (**Figures 17 & 18**).

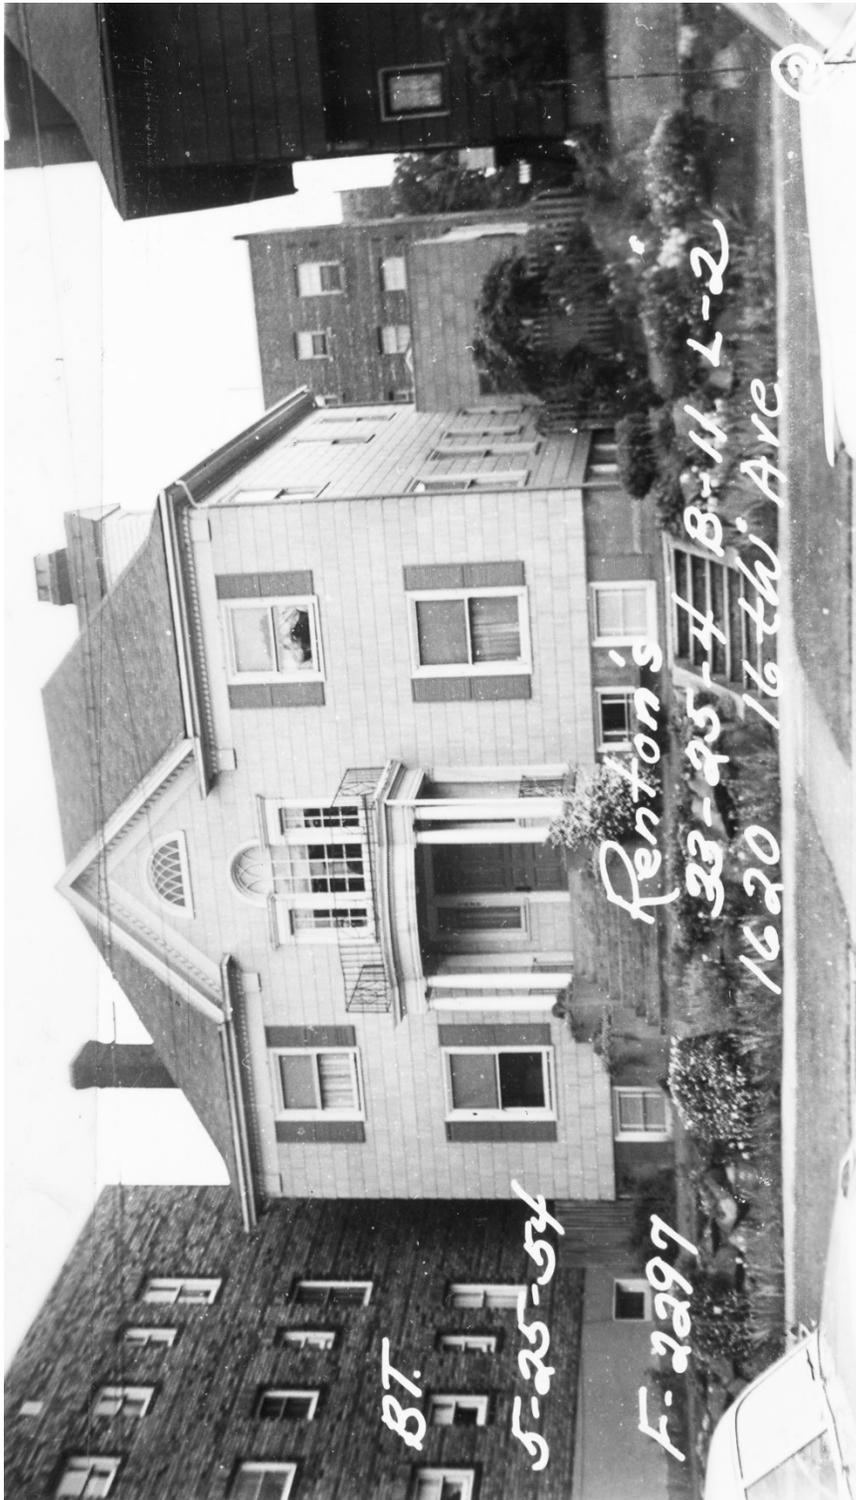
Figure 18. Above, a similar photo view as Figure 17, dating May 25, 1954. By this date the building was modified to accommodate a basement and a one-story flat roof addition made at the southeast corner. Original siding was replaced by asbestos shingles with tall exposure, and engaged wood pilasters, corner trim and decorative window was removed. The porch were rebuilt with stepped concrete steps and cheek blocks and the portico's original turned wood balustrades were replaced with simpler metal railings.

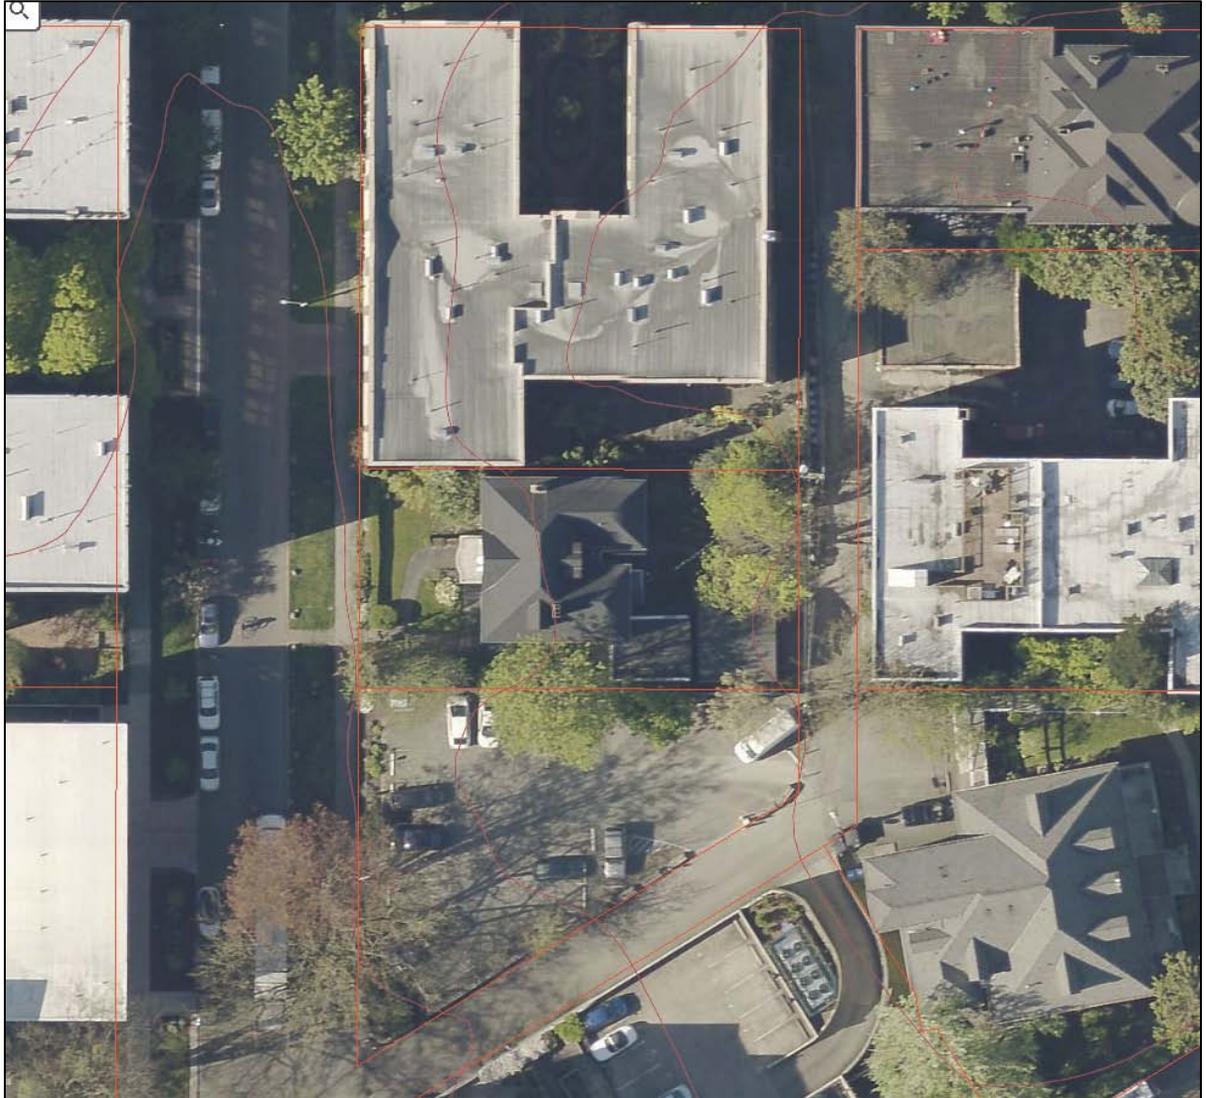
Figure 19. Above, a current aerial map of the subject property. North is oriented up (King County Assessor i-Map, aerial photograph with topography, April 2018).

In the teens and 1920s, many wood-framed and brick clad apartment houses were constructed as the city grew denser in response to the needs of its rising population. Examples of these types of buildings include three apartment buildings on the same block as 1620 16th Avenue (**Figures 19, 21 & 23**).

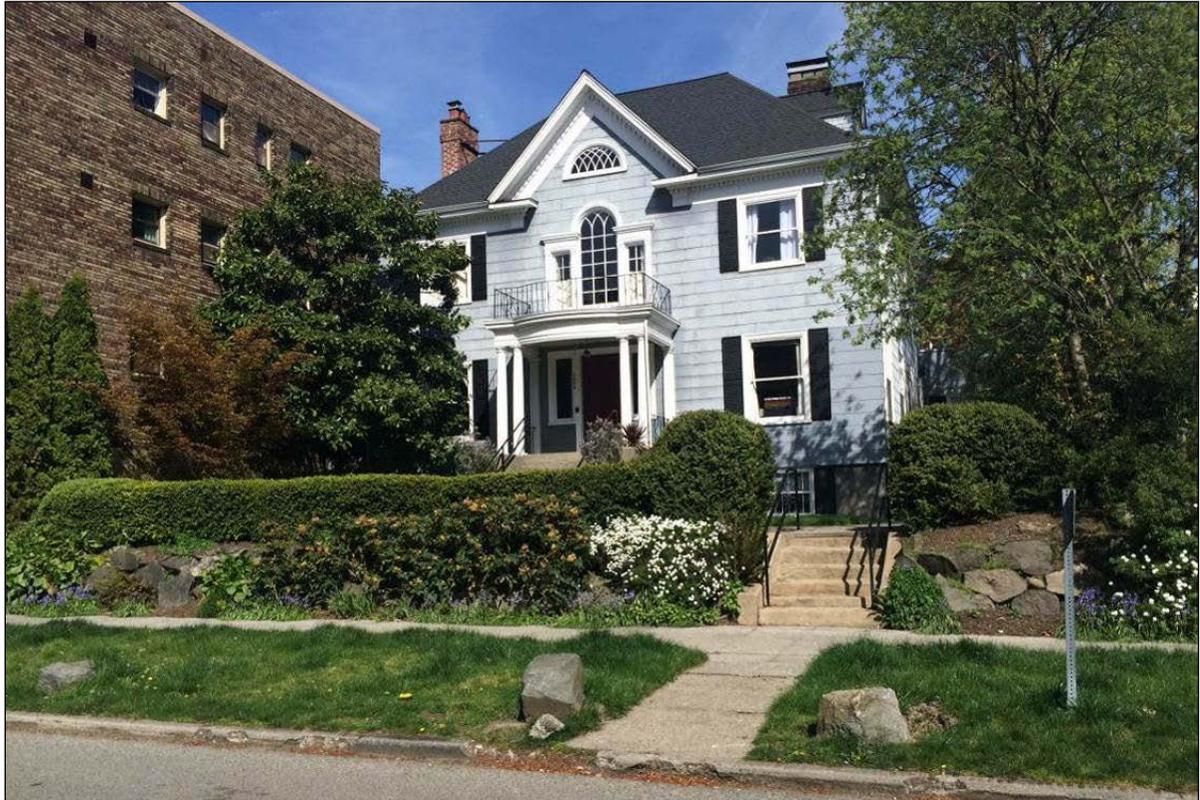
Figure 26. Above, view looking northeast at the primary (west) facade and front yard from 16th Avenue.

The primary facade is composed with a single story, flat roofed porch detailed with a semi-circular front projection, and paired wood columns at the outer edges. It originally featured turned wood balustrades at the first floor landing and roof. Other elements on this facade include a central Palladian window at the second floor and an arched head window above it at the attic level, both with divided lights. The wood panel-type central entry door at the first floor is flanked by sidelights. Original windows that remain are largely wood frame, double-hung types; central ones on the east and west facades contain divided lights. (Detailed jamb trim on the Palladian side windows provides a sense of what may have been typical original window trim.) Currently there are shutters at each of the four front windows. (Figures 26 – 31)

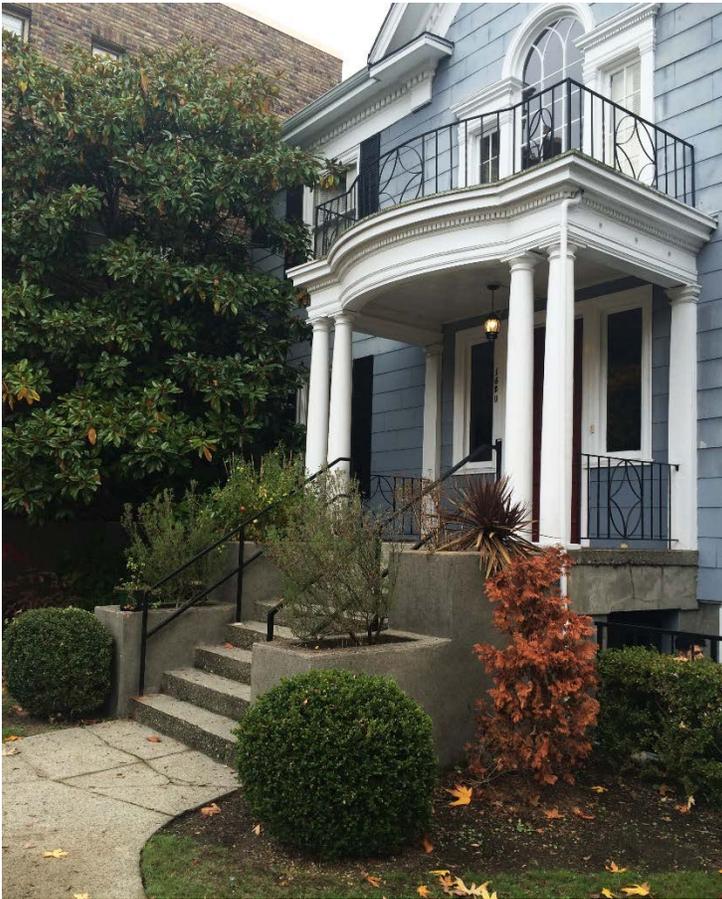
Figure 27. Above, the entry porch entry and entry to the basement apartment.

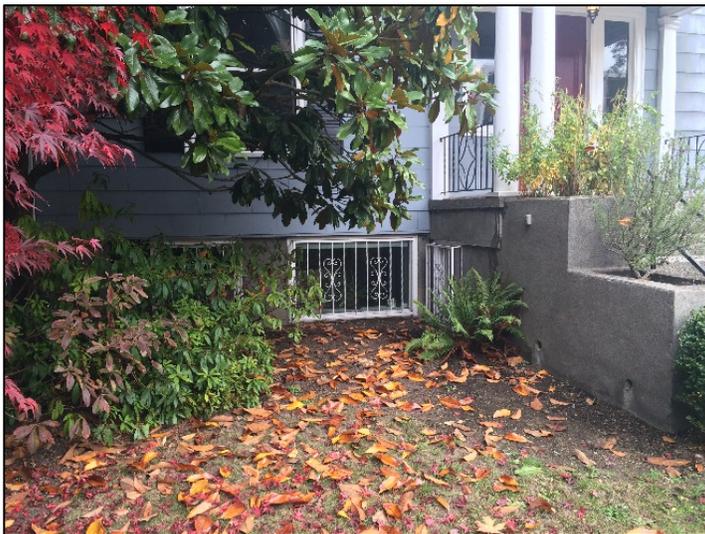
Figure 28. Below, detail view of basement window, and concrete porch steps and cheek blocks.

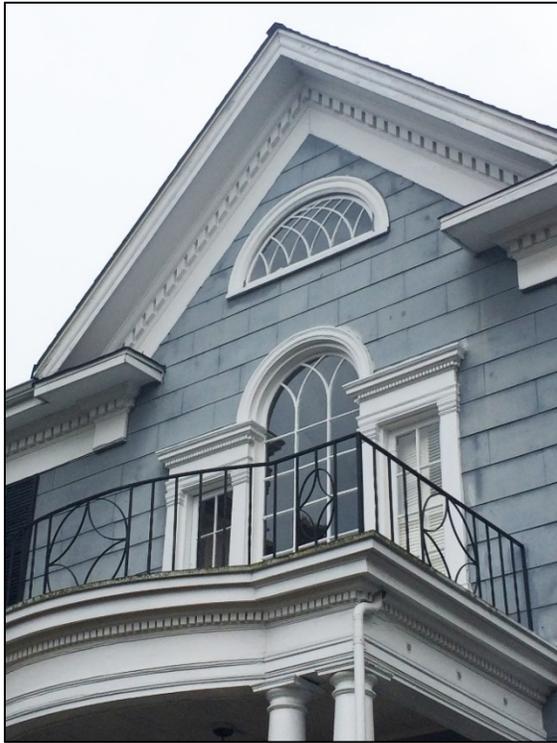
Figure 29. Above, a detail view of the upper story windows and trim, non-original balustrade and siding.

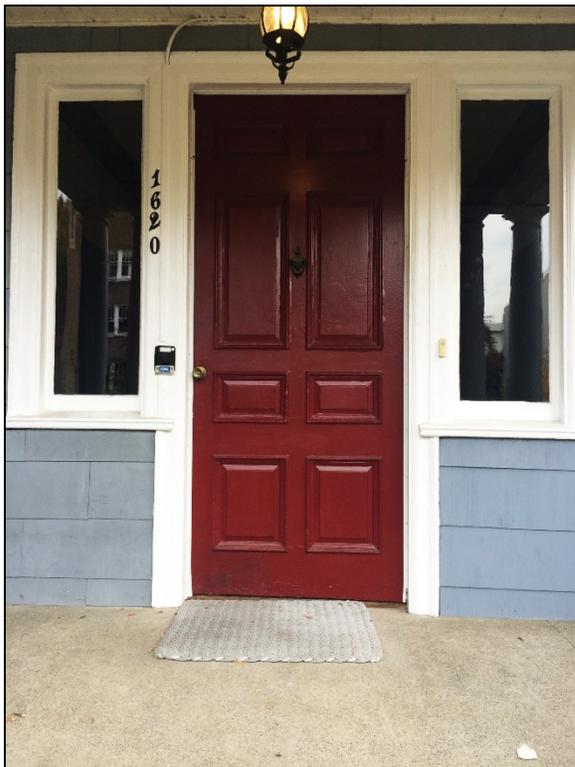
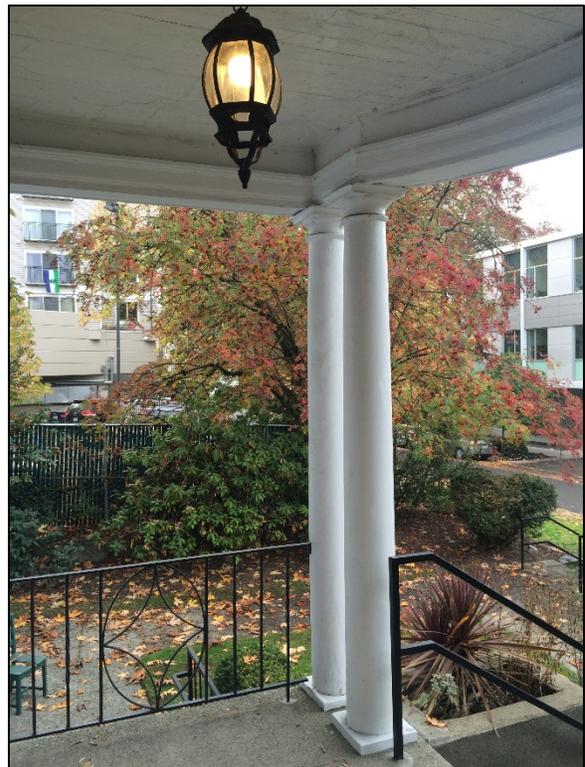
Figures 30. & 31. Below, detail views of the entry and front porch.

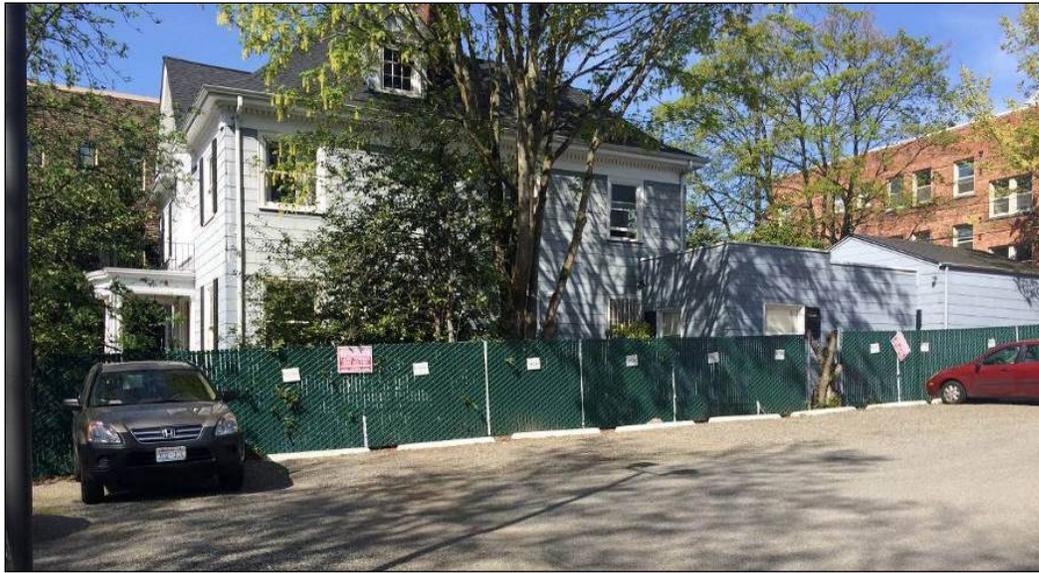
Figure 32. Above, view looking north at the south and part of the west facade.

The primary building on the site is the dwelling. A tall, two-story residence, it contains an attic and basement, and has a primary front facade facing west onto 16th Avenue. Its massing consists of a steep hipped roof with a north-south ridgeline, and a U-shaped footprint. A 6' by 12' front portico is situated at the center of the symmetrically composed primary facade (Figures 27 and 31 – 32). The building's north, south, and east facades, which face onto side and rear yards, appear secondary (Figures 32 – 33 and 42 – 43).

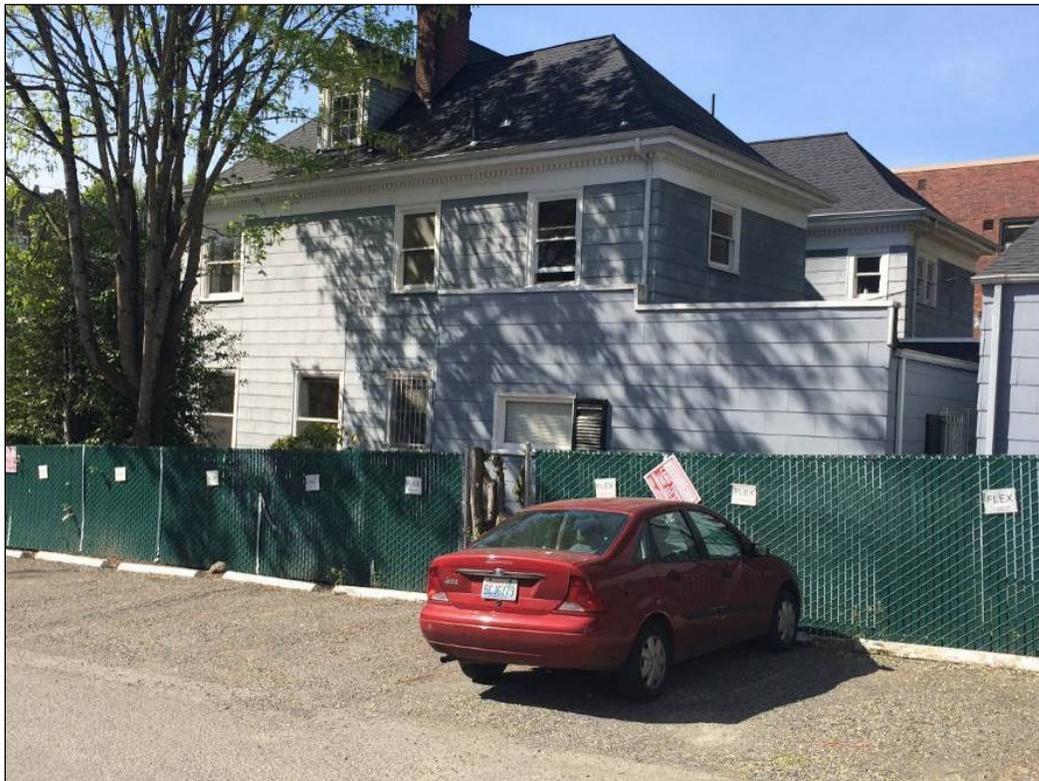
Figure 33. Below, looking northwest at the south facade, back wings, single-story southeast addition and a portion of the detached garage.

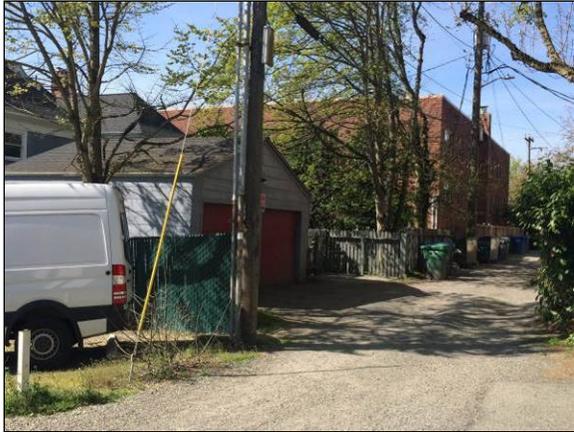
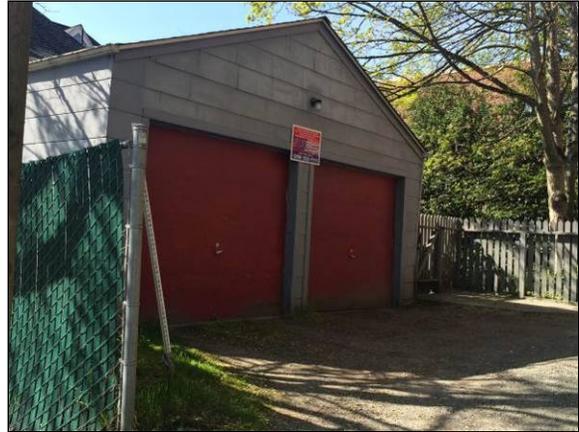
Figure 34 & 35. Above left and right, looking northwest from the alley at the detached two-car garage and back fence.

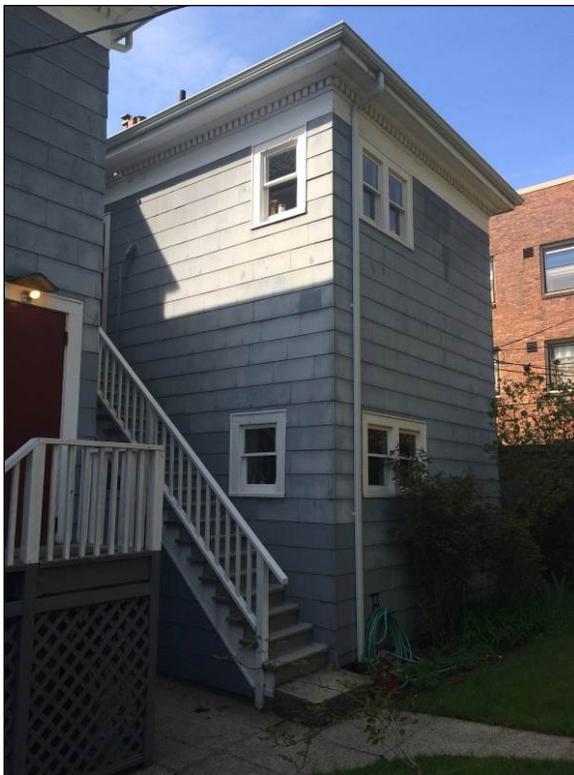
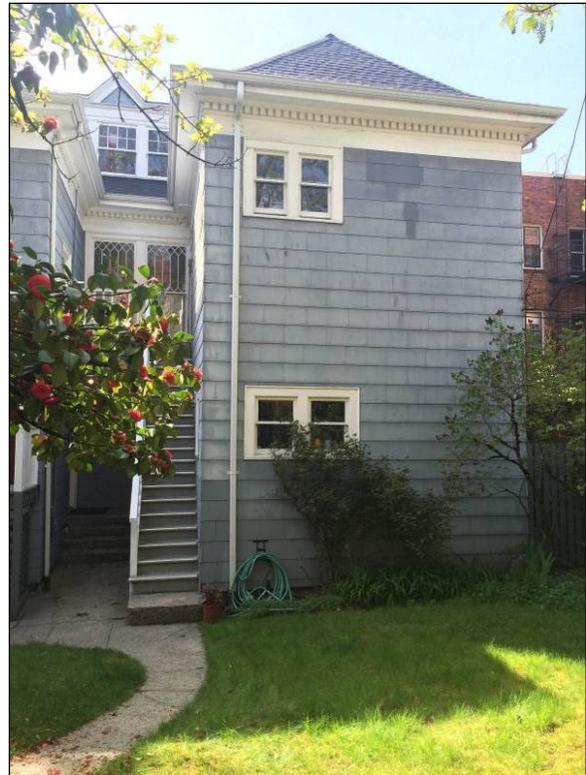
Figure 36. & 37. Below left and right, views looking west and northwest at the back northern wing and partial southern wing.

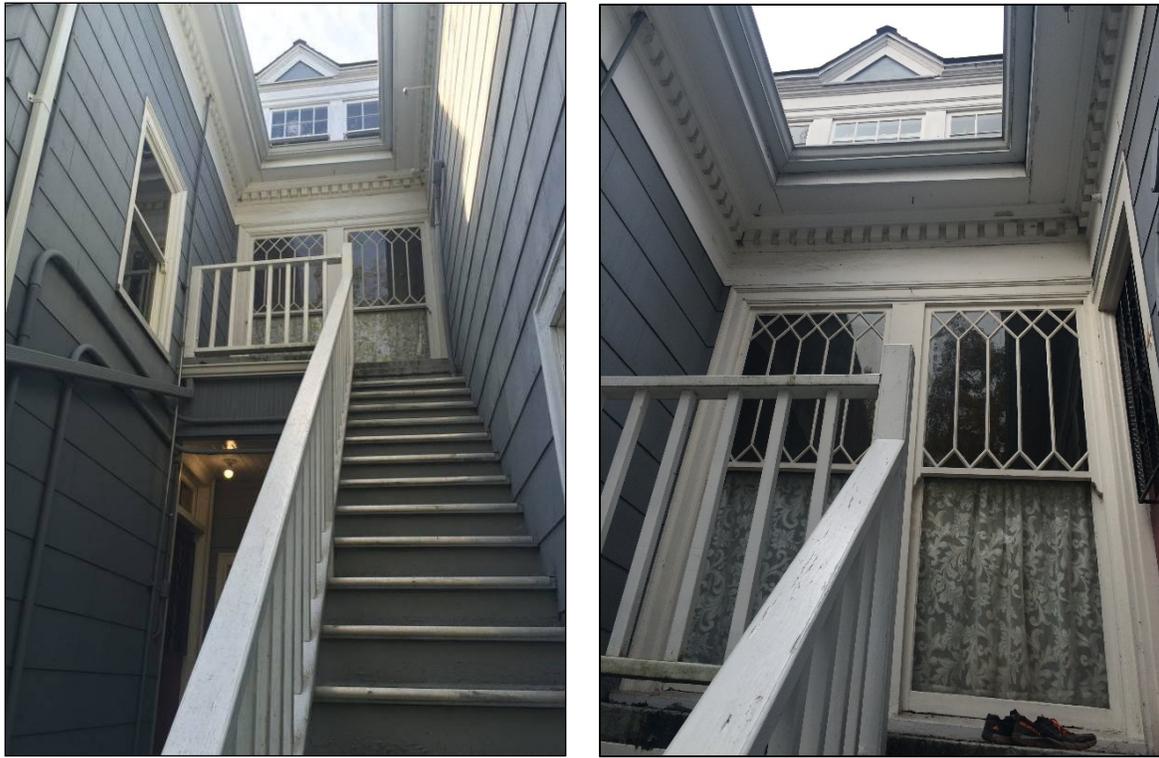
Figures 38. & 39. Above left and right, the opening and exterior stair between the two east wings. Paired windows in the center with decorative divided lights, open onto the interior stair landing, while other windows into the apartments are simpler 1:1 sash. The attic dormer windows visible above.

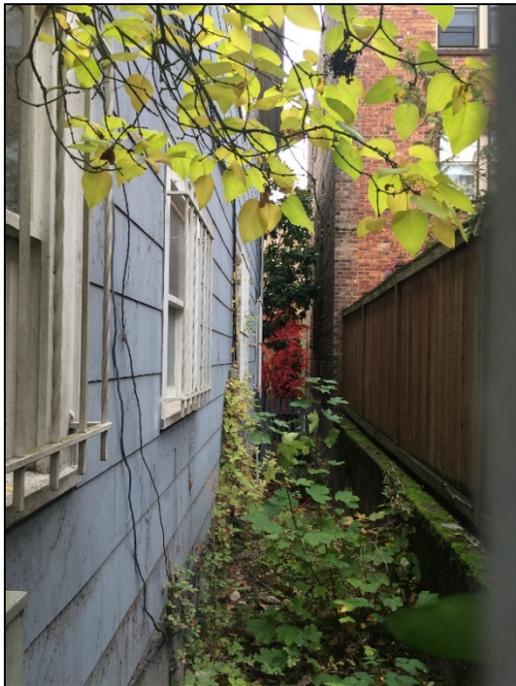
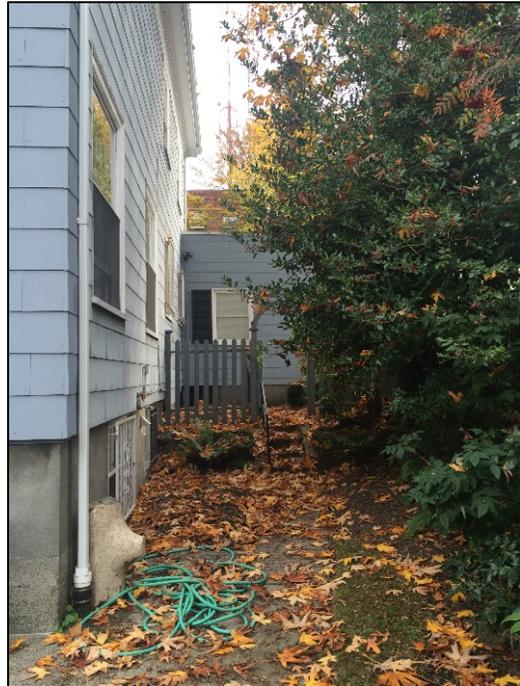
Figures 40. & 41. Above left and right, view looking southwest west at the southeast addition and south back wing, and stair detail.

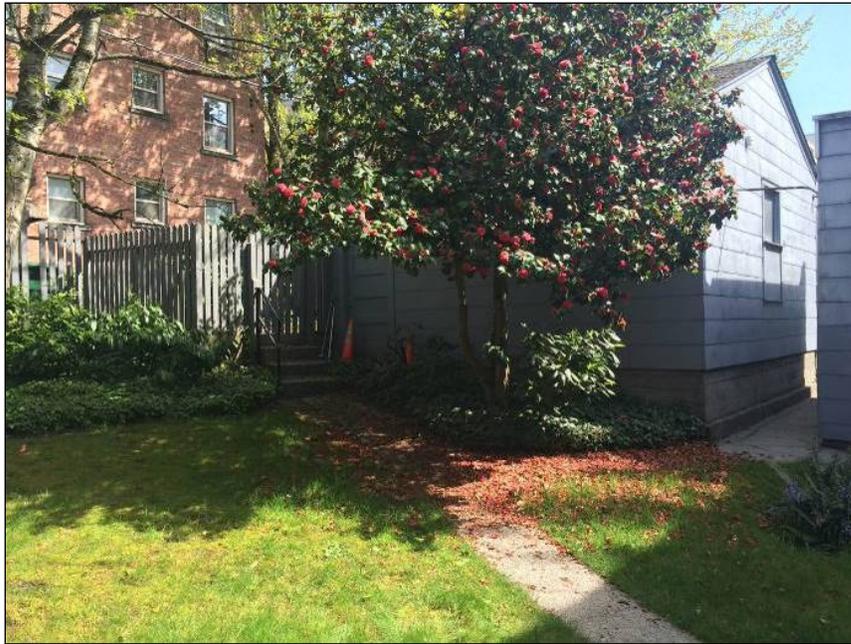
Figure 44. Above, looking southeast in the rear yard at the garage.

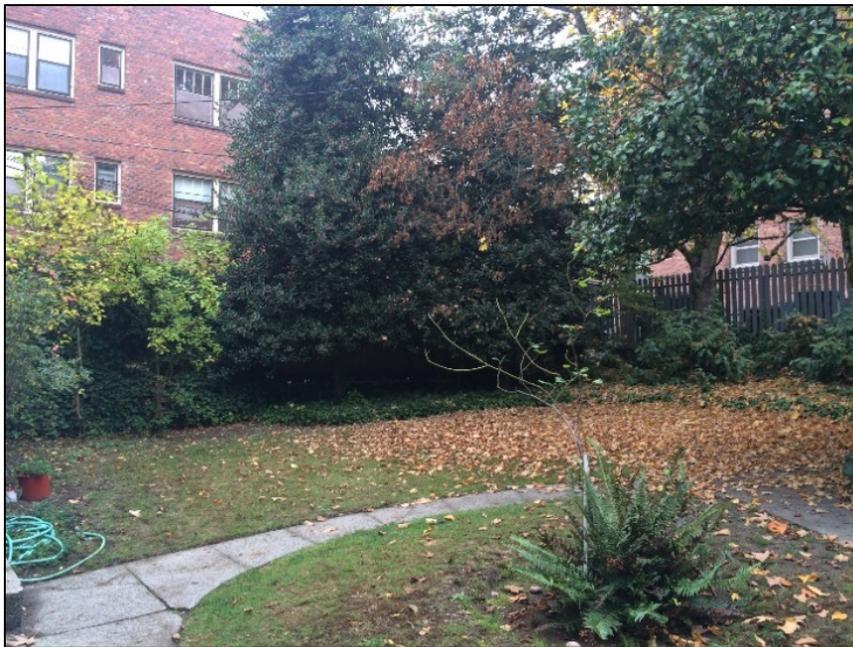
Figure 45. Below, looking northeast at the back yard and neighboring buildings.

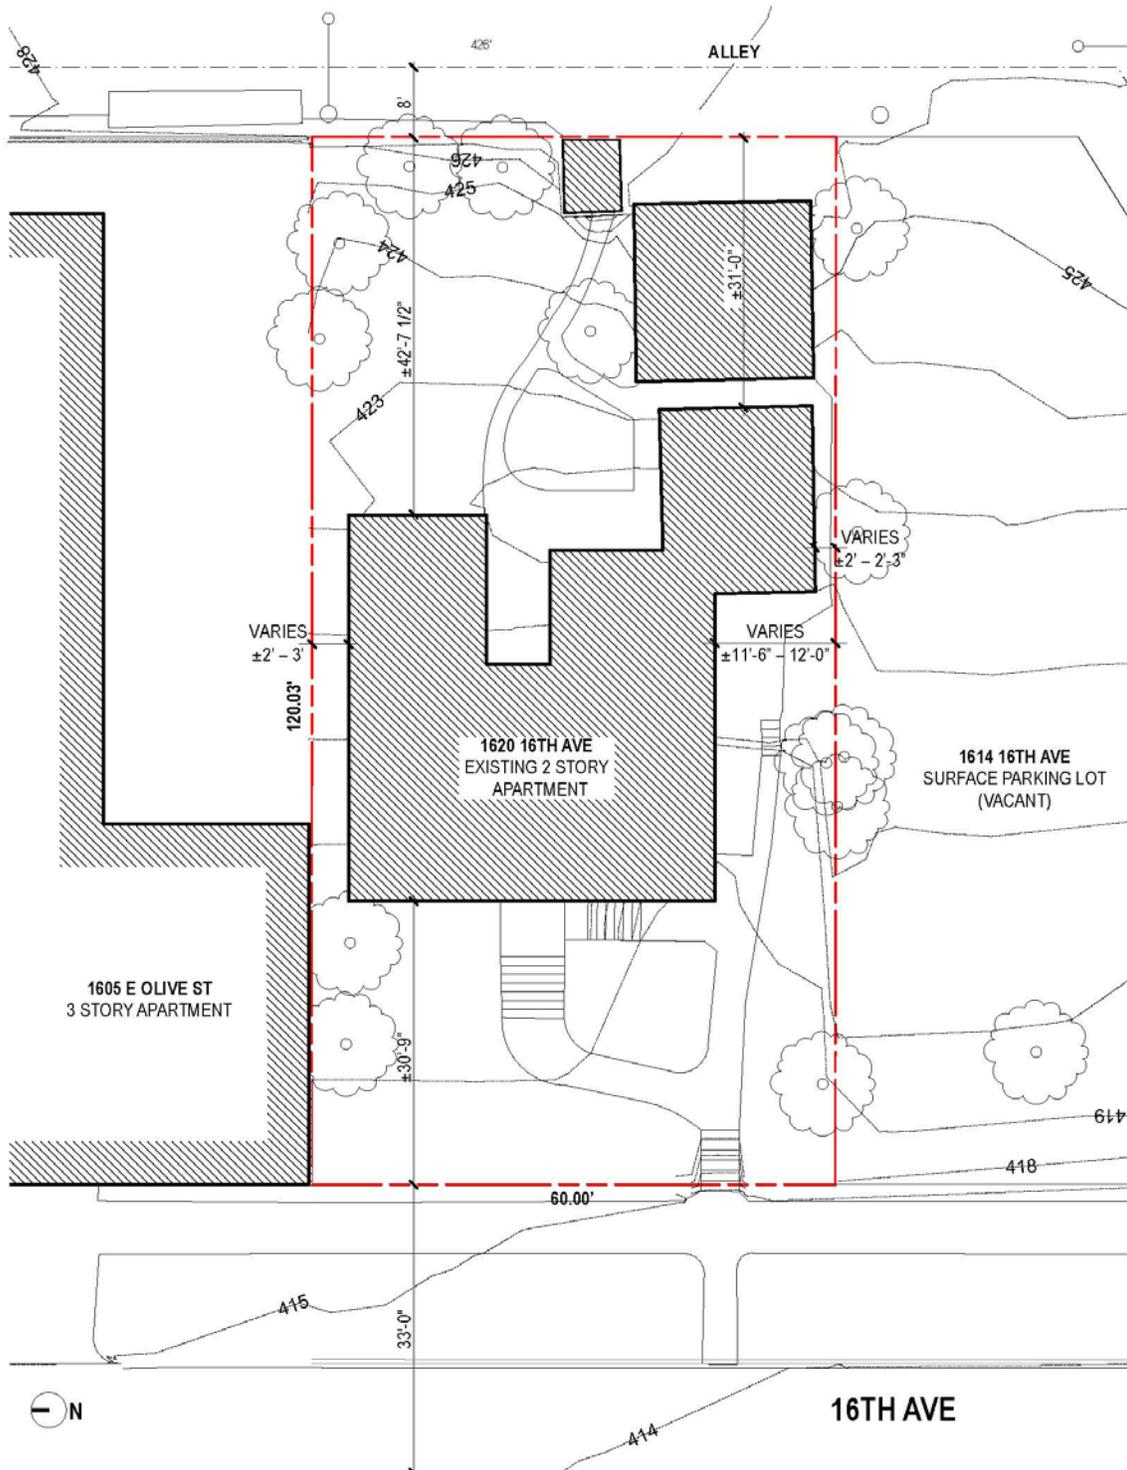
Figure 50. Above, a current site plan of 1620 16th Avenue. (Weinstein A/U, 2018)

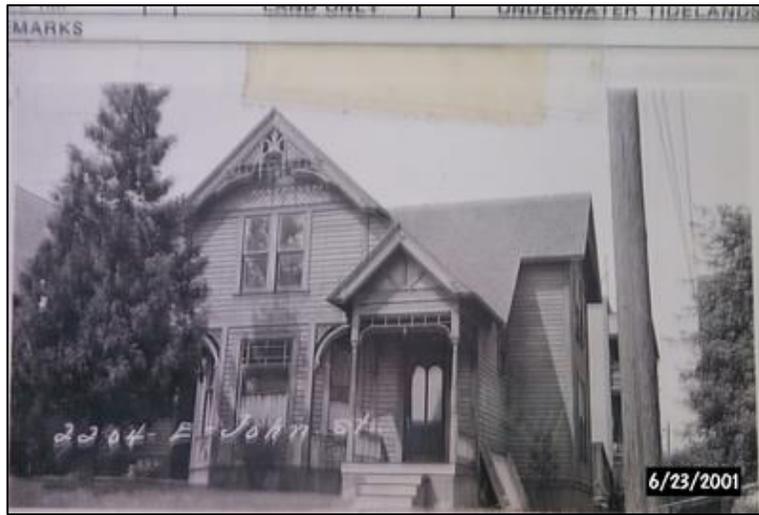
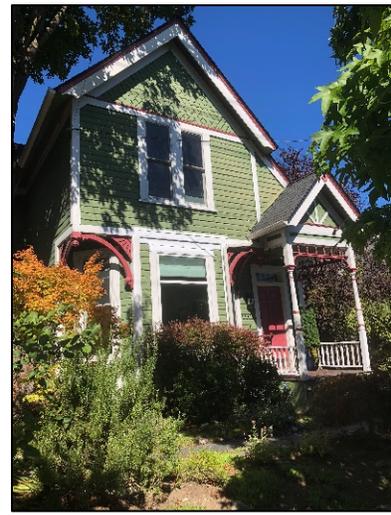
Figure 51 A & B. 2204 E John Street (1890), Parcel 095500-0120
Below left, 1937; below right, current.

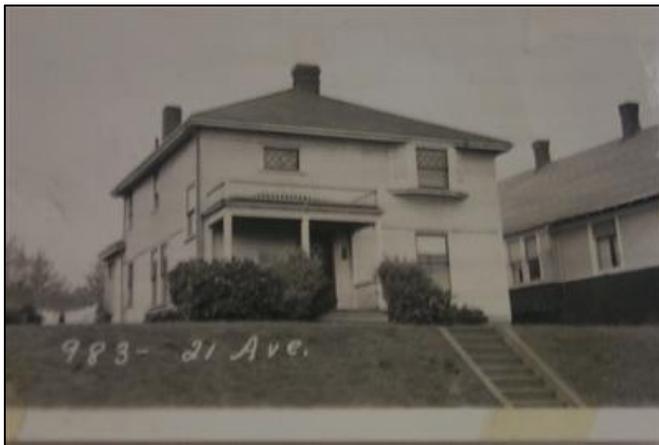
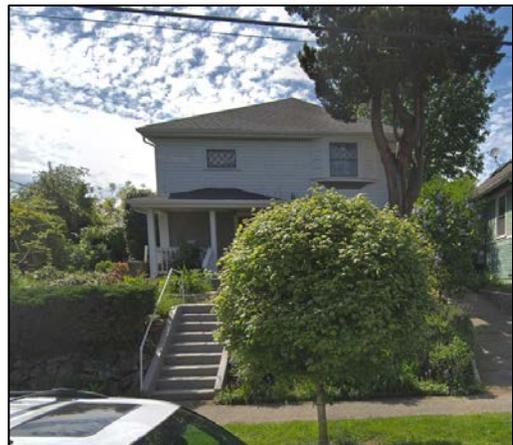
Figures 52 A & B. 983 21st Avenue (1893), Parcel 722850-1375
Below left, 1937; below right, current view (Google, 2018).

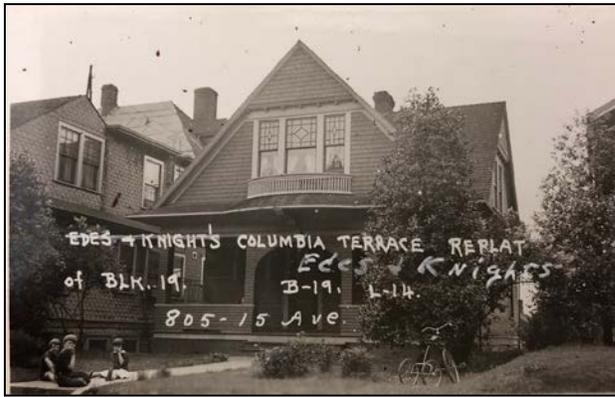
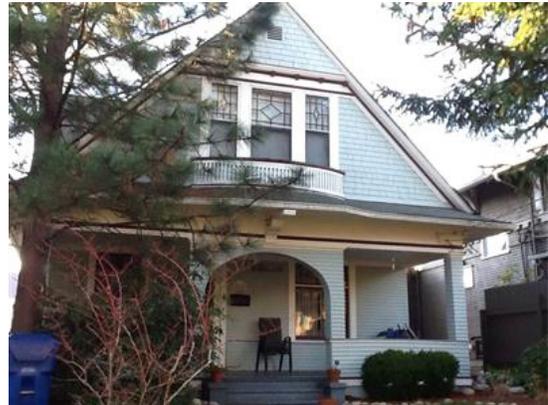
Figures 53 A & B. 805 15th Avenue (1895), Parcel 1710400070
Below left 805 15th Avenue (1895), Parcel 171040-0070

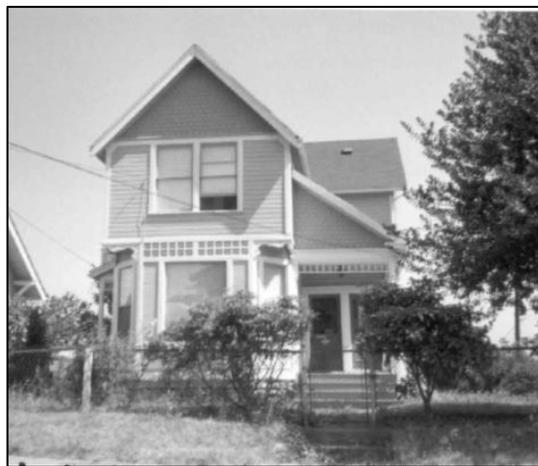
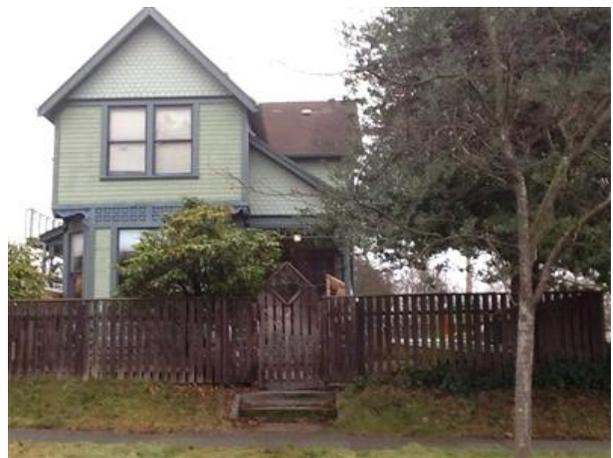
Figures 54 A & B. 802 21st Avenue (1895), Parcel 912610-1345
Below left, 1991 (DON); below right, current (King County 2018).

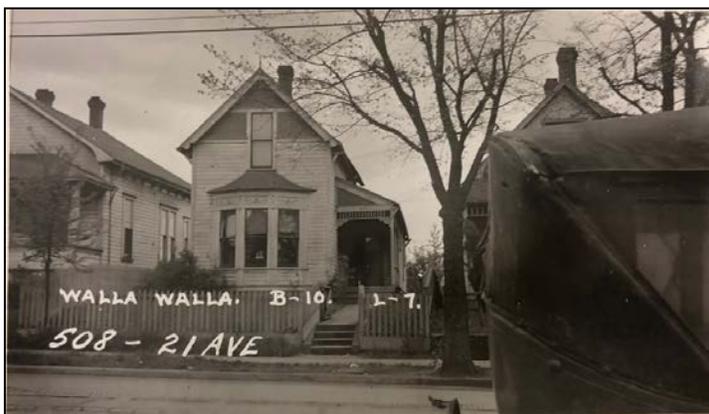
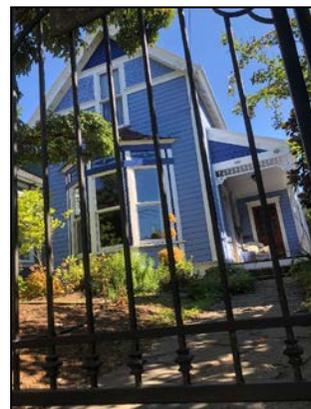
Figures 55 A & B. 508 21st Avenue (1894), Parcel 912610-0980
Below left, 1937; below right, current.

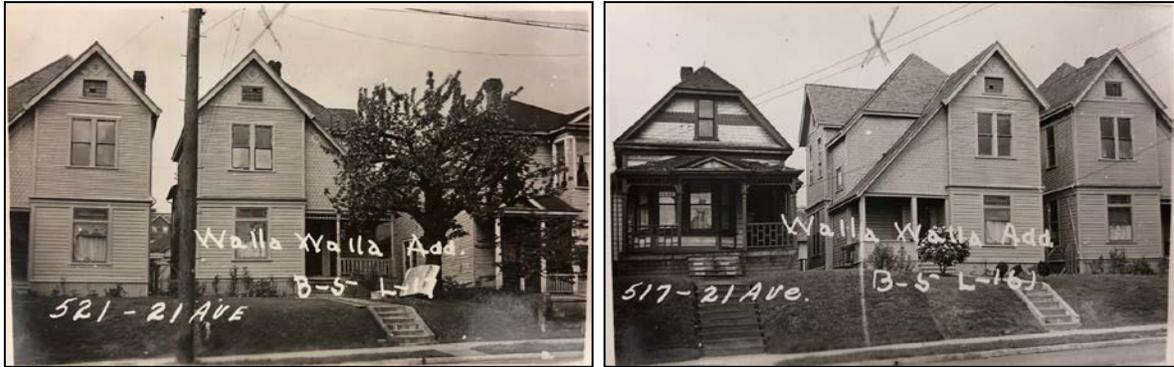
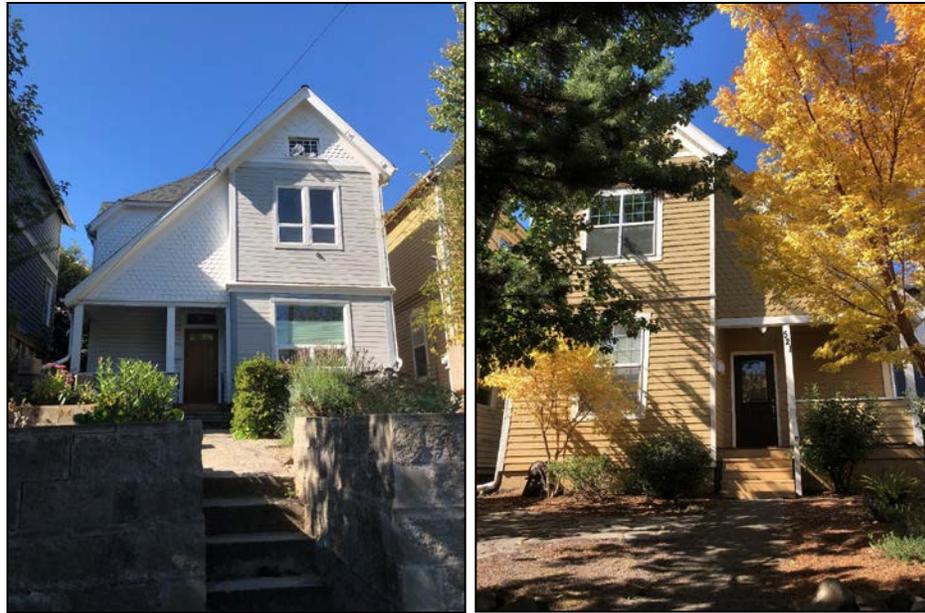
Figures 56 A-D. 521 & 517 21st Avenue (both 1895), Parcel 912610-0535 (521) & 912610-0530 (517)
Below left and right, 1937; bottom left and right, current.
