The City of Seattle

Landmarks Preservation Board

Name: Licton Springs Park

Licton Springs Park

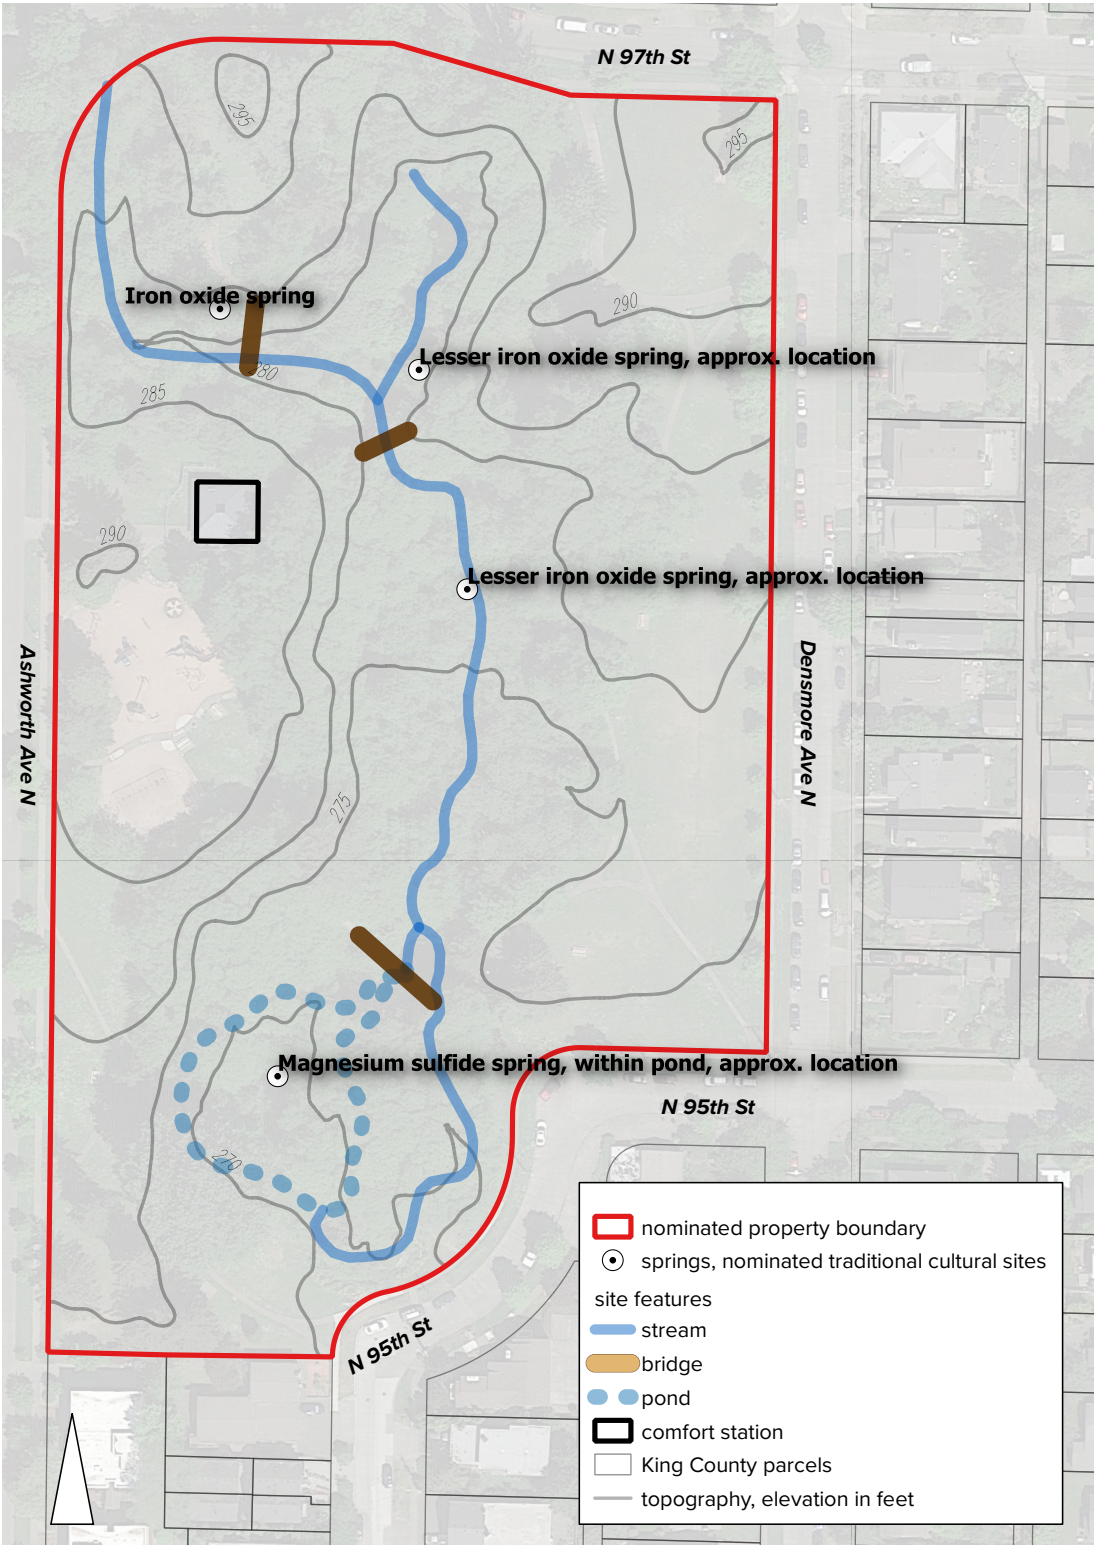
Figure 3. Site Plan.

Park spatial organization follows general landform conditions arising from the stream channel through the park. The park is oriented length-wise north to south. The overall organization consists of a central riparian area that follows the stream alignment from north to south through the park with a small pond at the south end. A lawn, comfort station, and children's play area occupy the central west portion of the park, along Ashworth Avenue N. Lawn areas extend along the length of the park's east side along Densmore Avenue N. A network of trails traverses the park, with sidewalks around the park perimeter. **(See figure 3)**

Site topography generally slopes from a high elevation of 295 feet at the north end to 270 feet at the south end. The shape of the park's ground plane generally relates to the park's spatial organization. The children's play area and comfort station occupy a level area, with the lawns consisting of gently sloped grade. The approximately 10-foot drop in grade from the children's play area to the stream occurs steeply at the north end of the park and gently at the south end. This steeper topography at the north end constrains the stream flow and then broadens out to the south for a more expansive riparian area and pond. **(See figure 3)**

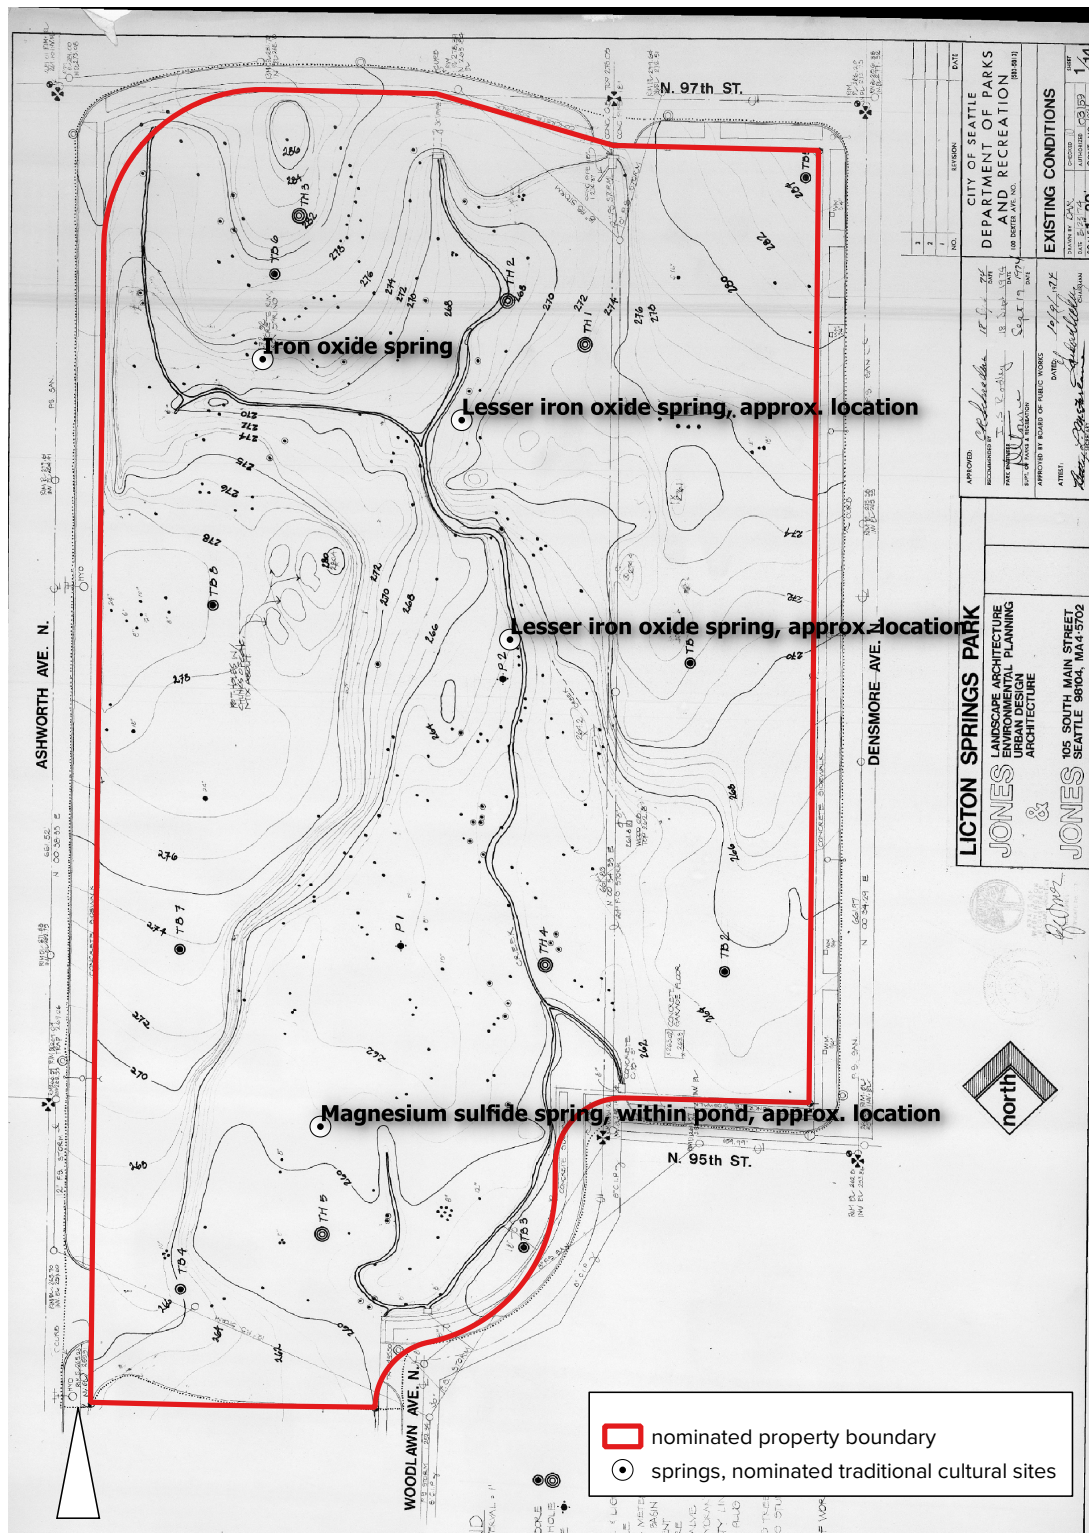
Figure 12. 1974, existing conditions, courtesy Jones and Jones.

- 1974: park renewal including removal of fill to create the pond and existing topography within the site. The pond was developed as filtering mechanism for drainage water entering the park. Development of the existing circulation systems, comfort station, and vegetation within the site. Installation of the existing granite ring around the iron oxide spring. (See figures 12-15)

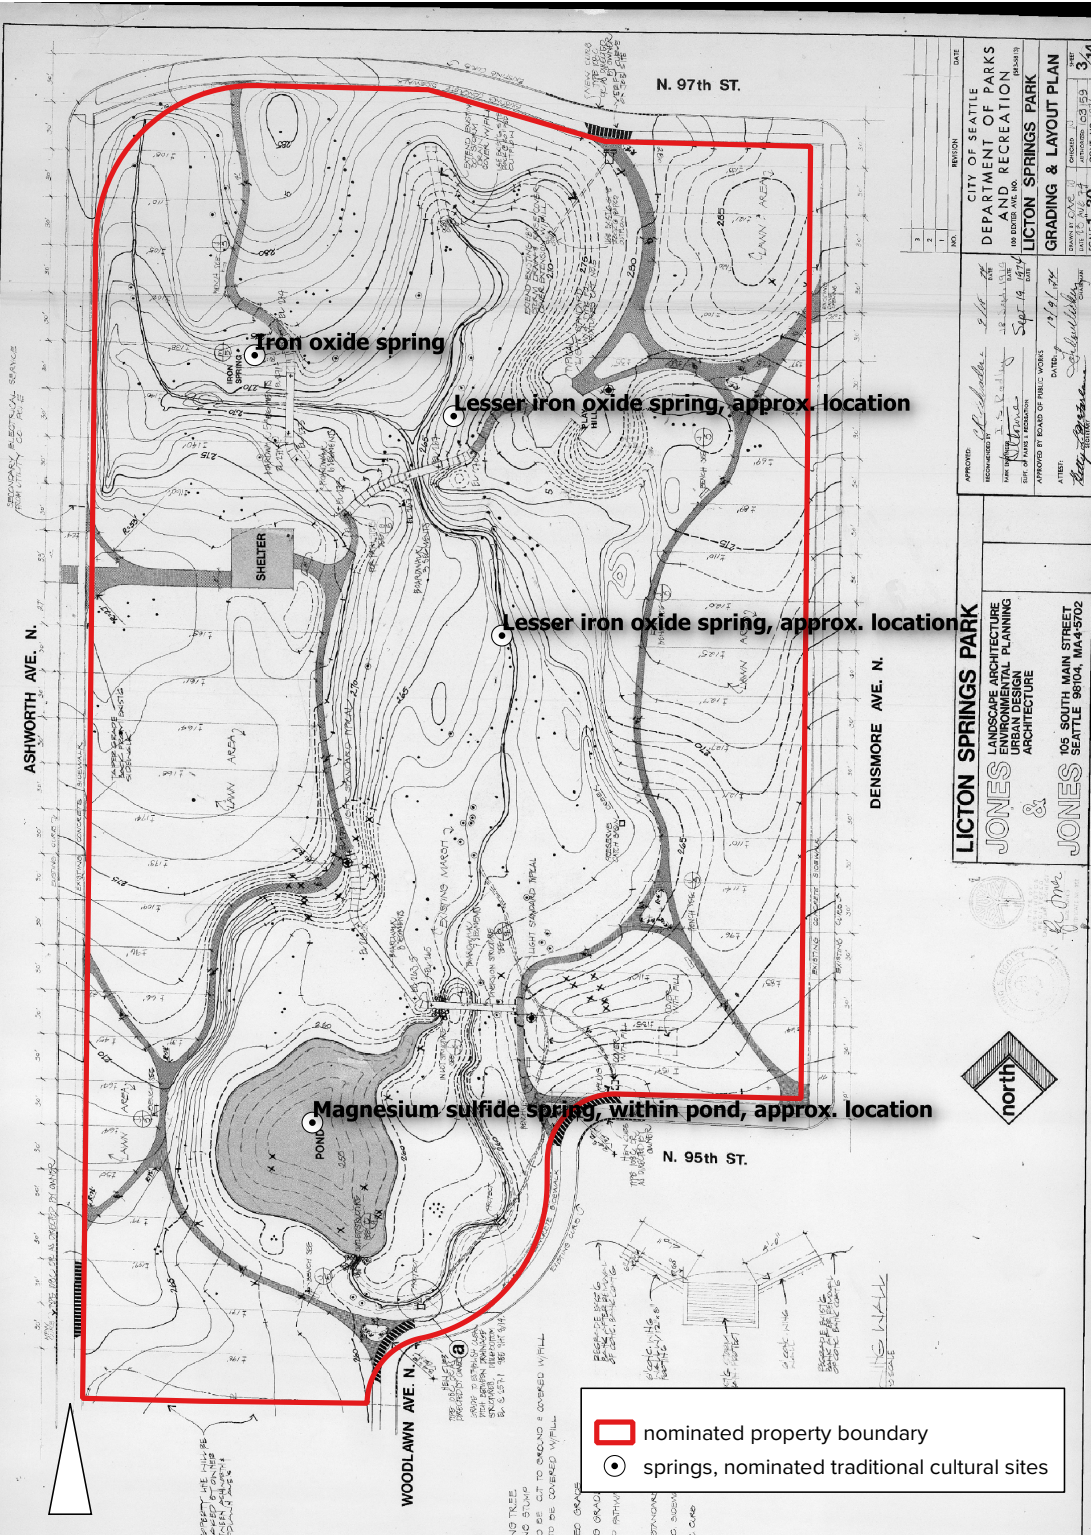
Figure 13. 1974, grading and layout, courtesy Jones and Jones.

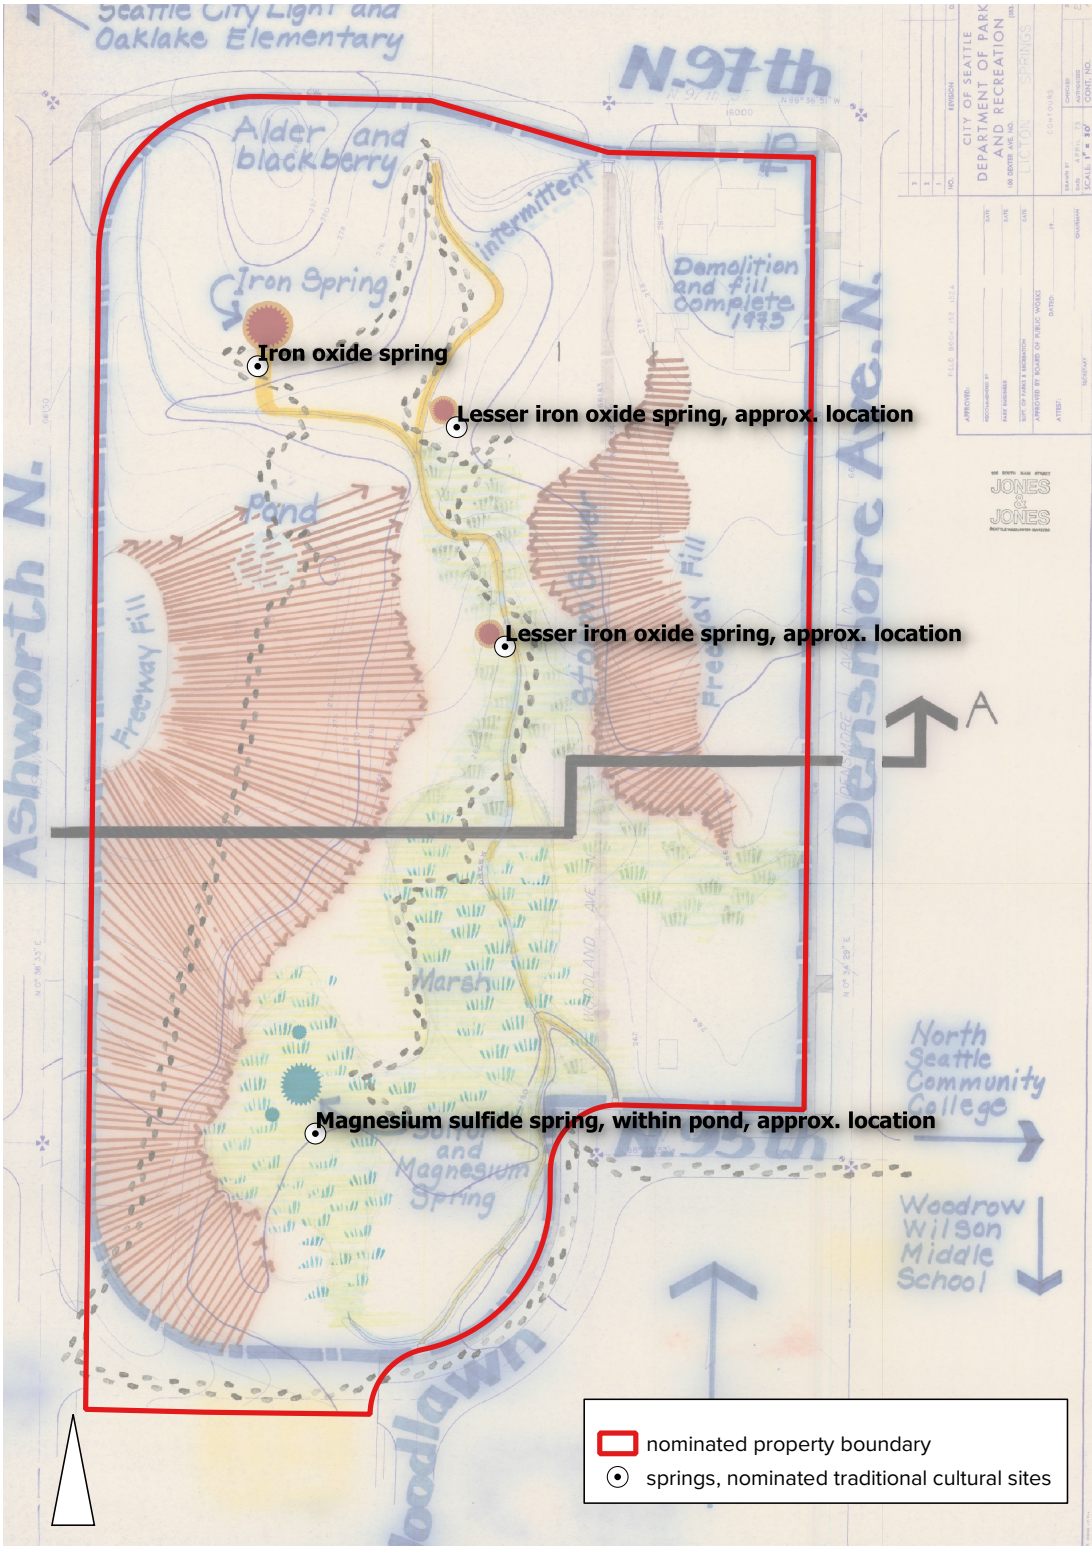
Figure 14. 1974, site analysis, courtesy Jones and Jones.

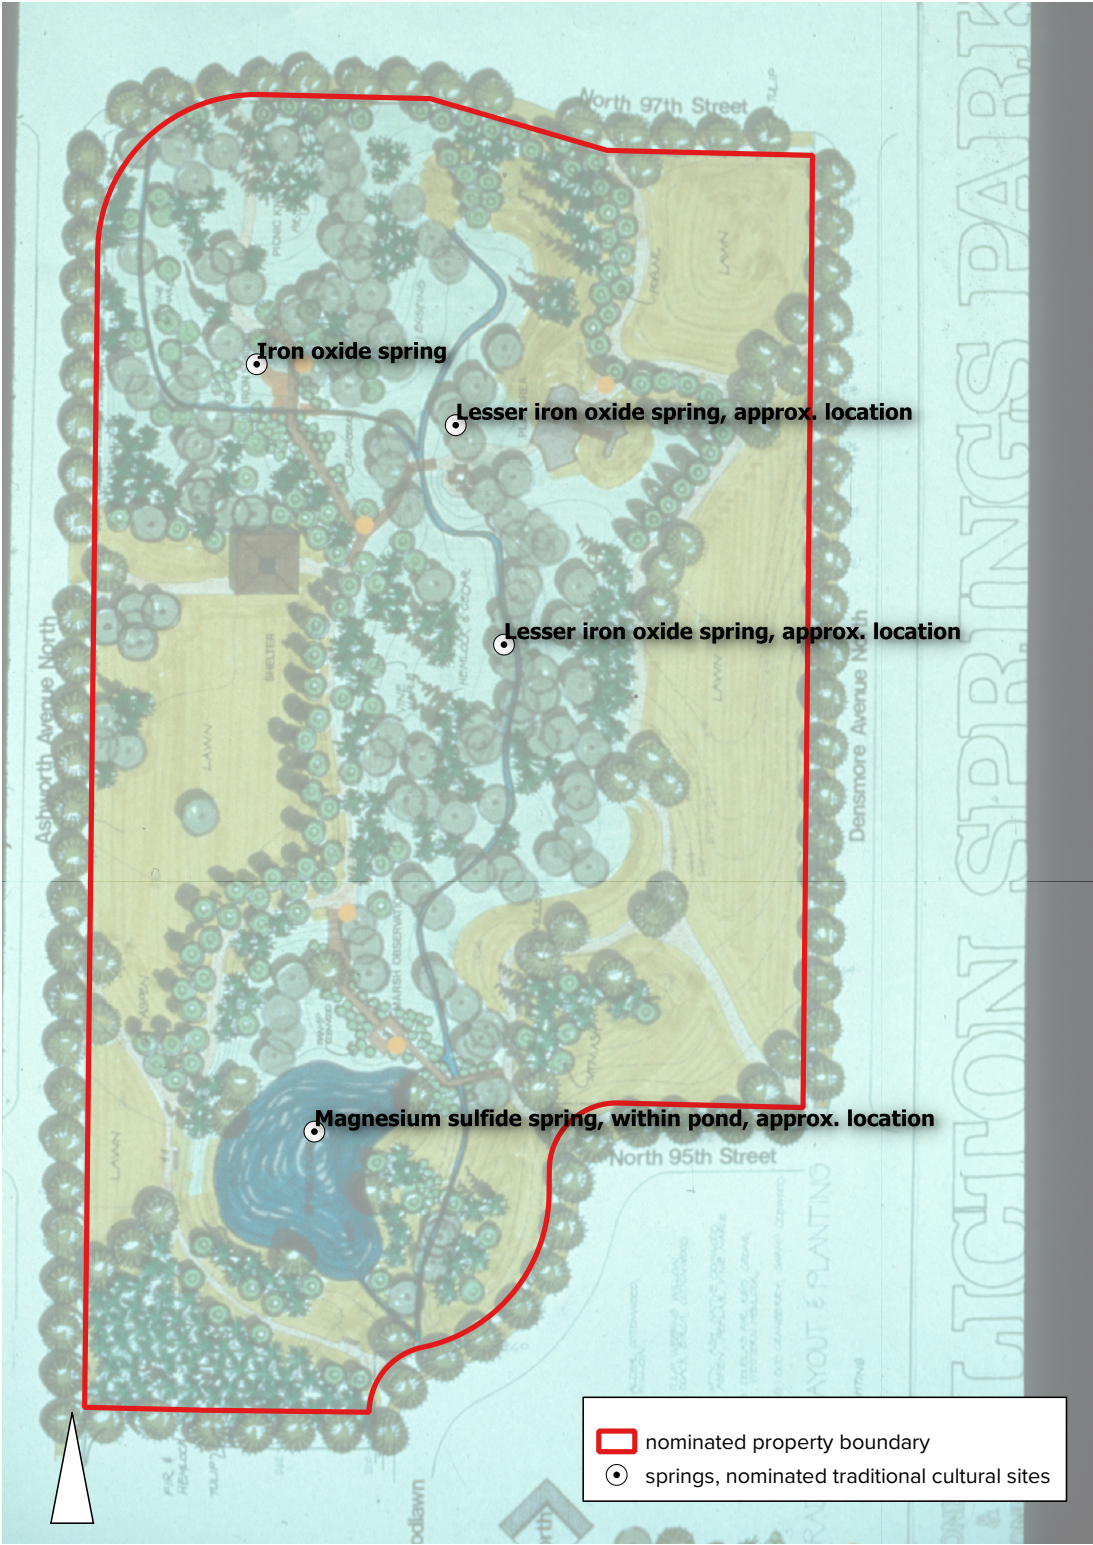
Figure 15. 1974, design, courtesy Jones and Jones.

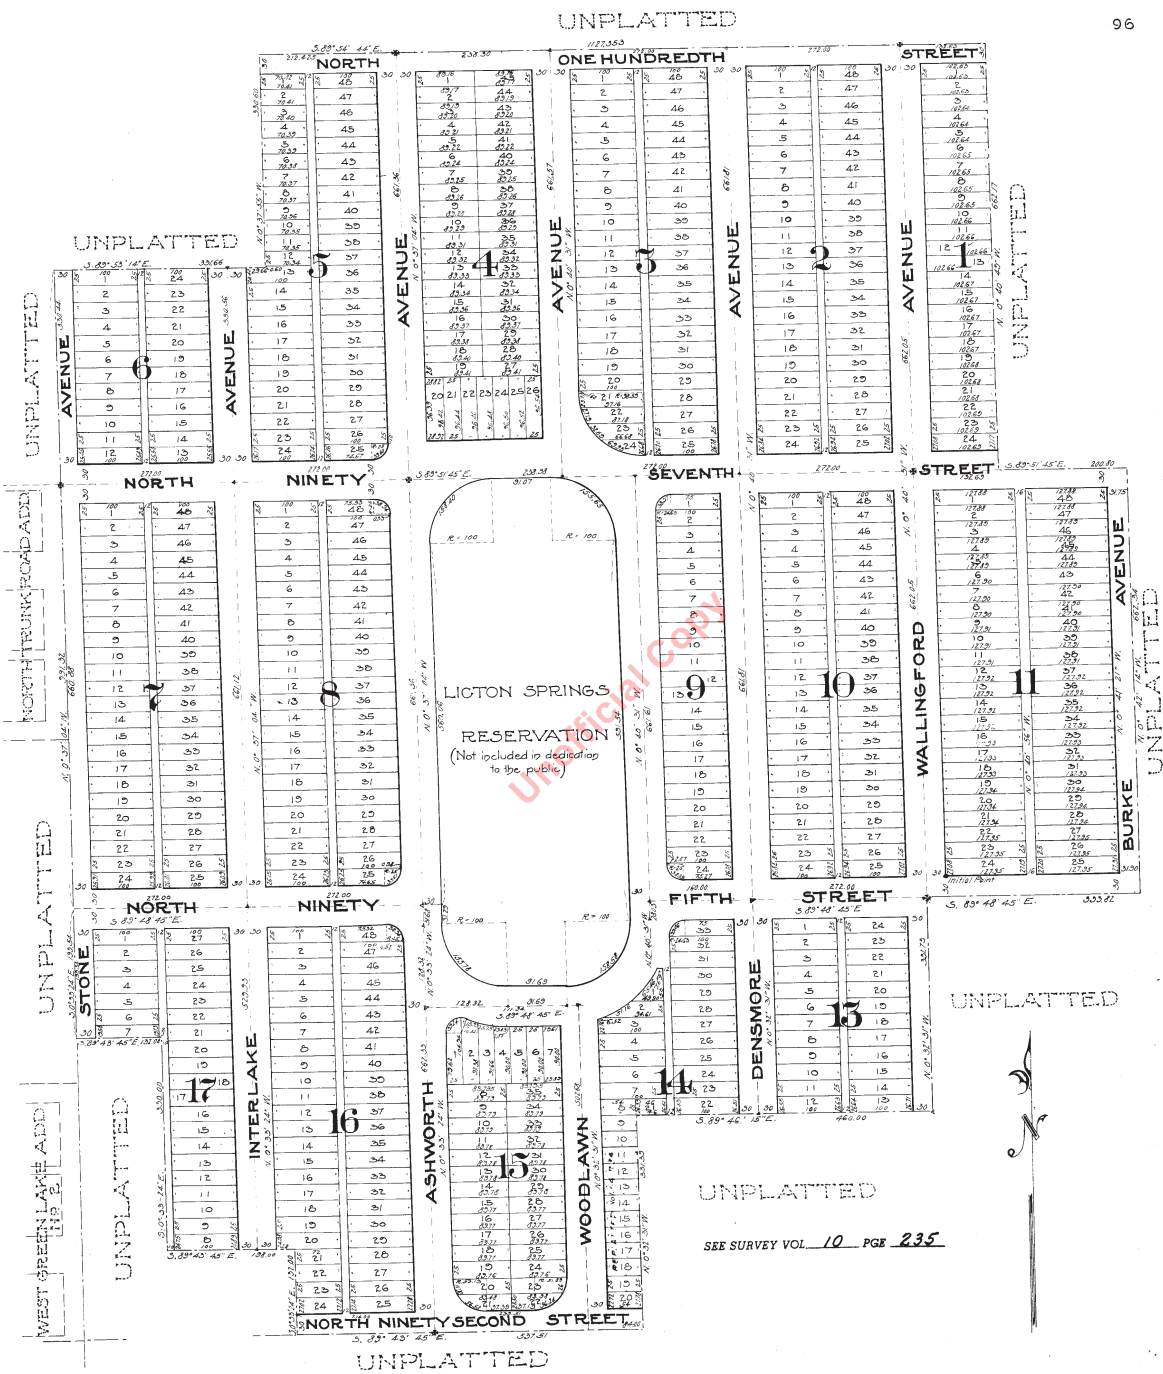
Figure 16. 1909 Licton Springs plat, courtesy King County iMap.

- 1870: David Denny 160-acre land purchase, inclusive Licton Springs. Denny constructed a summer residence near the springs by the 1890s.
- 1909: C. R. and Pearl M. Harold and the Licton Park Mineral Springs and Land Company, a Washington state corporation, purchased and platted the area as a residential subdivision named Licton Springs Park. Within the 1909 plat, the majority of the park area was designated the Licton Springs Reservation and was not included in the dedication to the public, instead reserved by the above plated land owners. W. M. Elliott was president and T. Jerome secretary of the Licton Park Mineral Springs and Land Company. The plat was filed for record at the request of land developer Calhoun, Denny and Ewing, Incorporated on May 29, 1909. **(See figure 16)**

Instead the C. R. and Pearl M. Harold and the Licton Park Mineral Springs and Land Company platted 600 building lots, retaining only a smaller area as open space within the development. One remnant of the Olmsted proposal that was built, however, is a portion of the street network, where Woodlawn Avenue curves to connect with N 95th Street. (See figure 16)

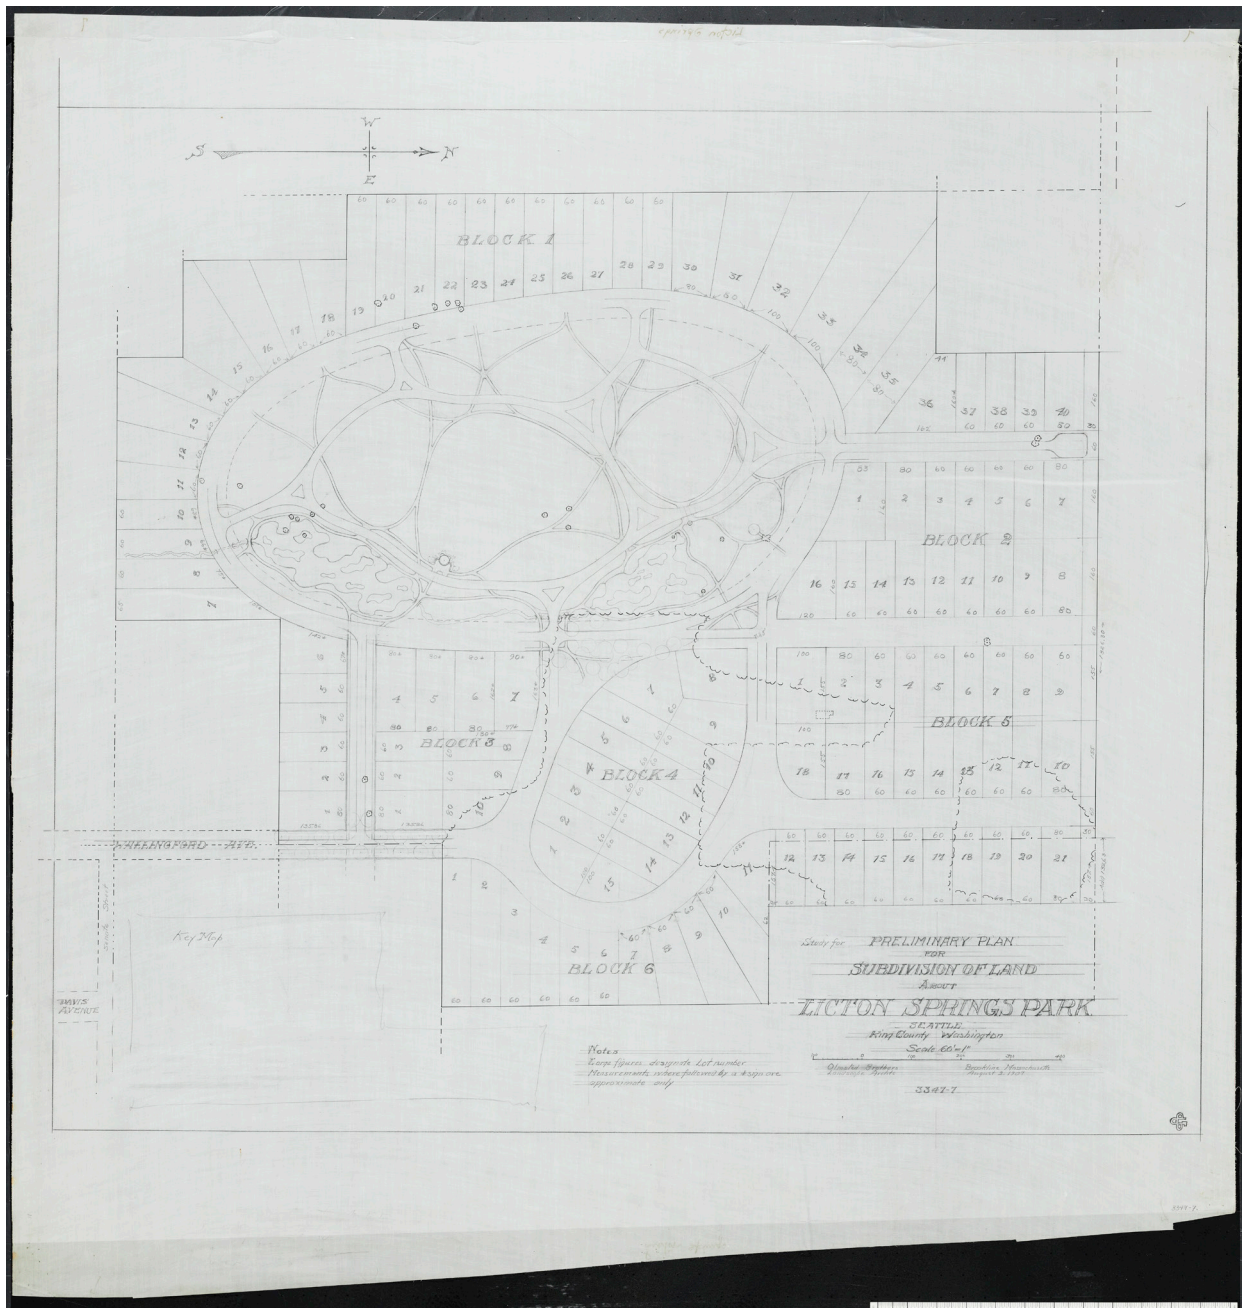
Figure 17. Plan number 7, study for preliminary plan for subdivision of land about Licton Springs Park, Seattle. Job no. 03347, courtesy Olmstedonline.org.

The Olmsted Brothers of Brookline Massachusetts were retained by Calhoun, Denny and Ewing, Inc. to prepare plans for the new subdivision and a park around the mineral springs. The Olmsted Brothers proposed an organic layout with a park, rustic drives, paved streets and home sites. It included rustic shelters over the two spring basins, bridges, paths, and clearing the reserve around the springs as well as preservation of the original, rustic Denny cabins. The Olmsted Brothers plan for the subdivision and park were not built. (See figures 17-18)

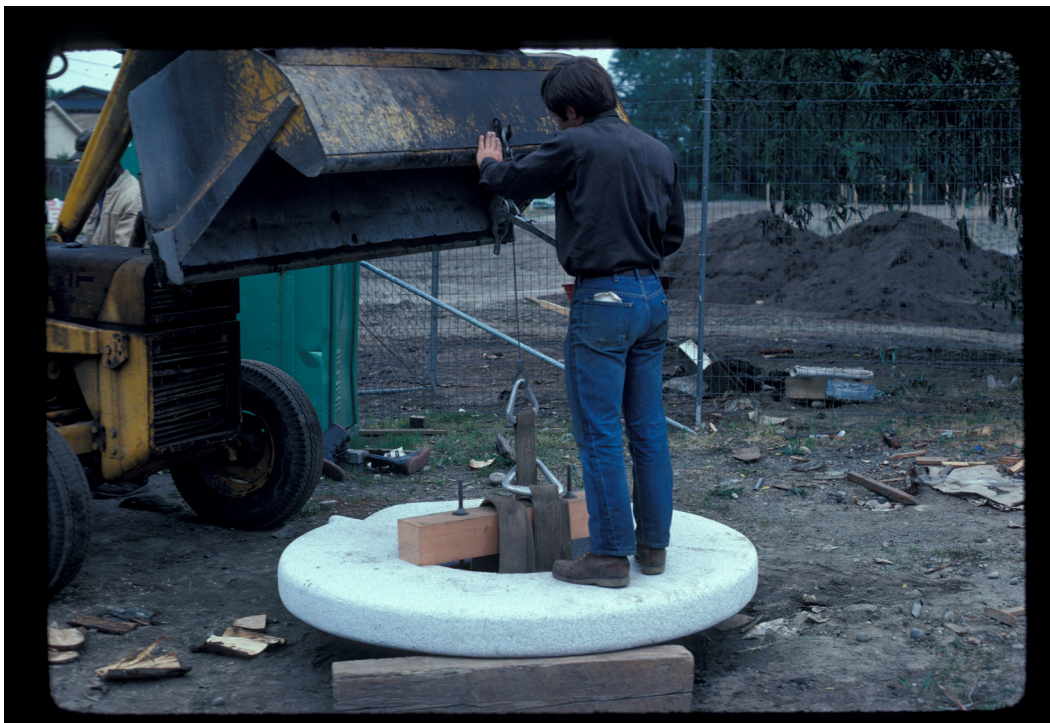
Figure 34. ca. 1974 view during the park renewal of the existing granite ring at the iron oxide spring being prepared for installation. Source: Jones and Jones.

Water features are both functional and aesthetic components of the landscape. The springs and stream predate the park. The springs are connected to the area's natural hydrologic system and mineral deposits and contribute to the stream flow and alignment through the park. They consist of the main iron oxide spring at the north end of the park, two lesser iron oxide springs (lesser based on flow rate), and a magnesium sulfide spring at the south end of the park. The magnesium sulfide spring resides below and contributes to the pond water volume. The stone ring around the iron oxide spring directs water flow to a narrow channel that feeds the stream. Iron oxide is brought to the surface by the water flow in solution with the ground water and deposited in solid form in the spring basin, on the stone ring, and along the channel to the stream. **(See figure 21, 34-35, 70-73)**

In 1968, the Forward Thrust bond issue passed, providing funds to build Licton Springs Park. The park was designed by Jones and Jones in 1974, with work completed in 1975. (See figures 29, 32, 34-38)

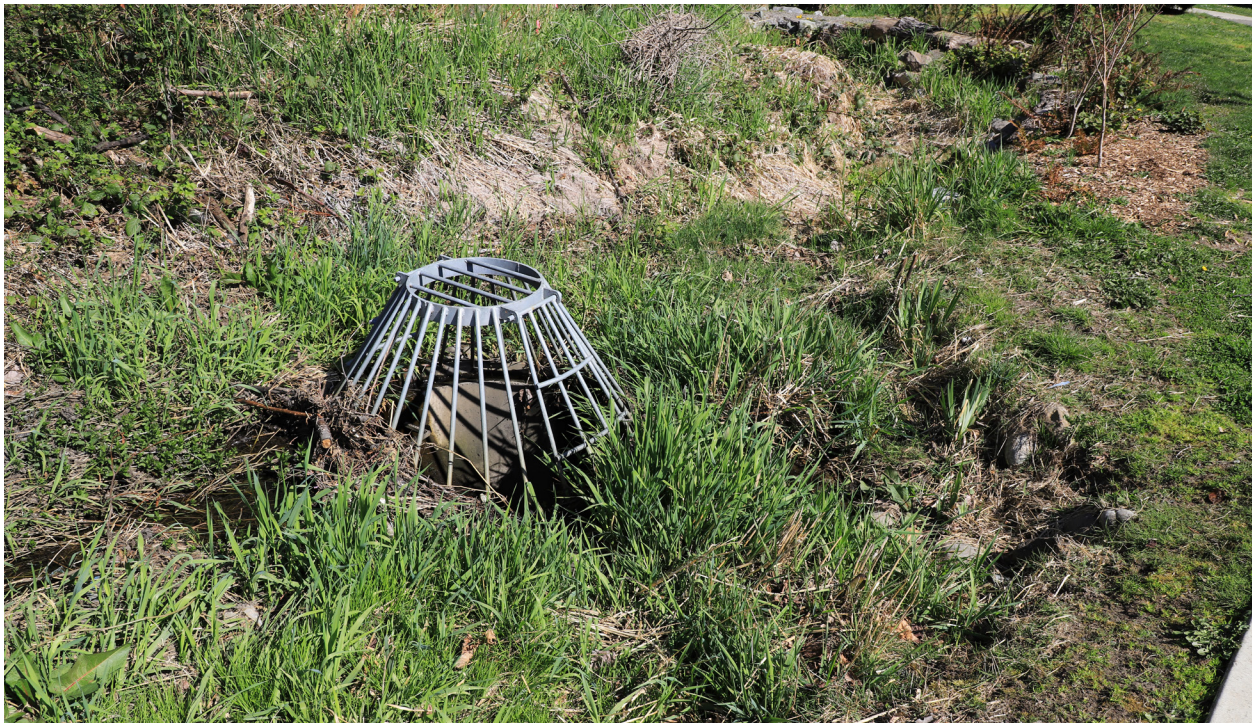
Figure 50. Culvert detail where water leaves the park.

The stream flows from two culverts at the north end of the park that discharge drainage and groundwater. At the south end of the park the stream returns to a culvert, continuing its flow and eventually entering the piping of the City's drainage system at N 88th Street. Within the park the stream channel generally ranges from one to three feet wide. The wetland area at the south end of the park accommodates increased standing water volumes during periods of heavy rains and area drainage. Plant material across parts of the stream help to slow the rate of stream water flow through the park. The stream channel is natural in character, meandering along its course with vegetation, rocks, exposed tree roots, and decaying tree branches extending down to the water edge with mixed rock and soil stream bed. **(See figure 25-26, 37, 50-52, 66, 84)**

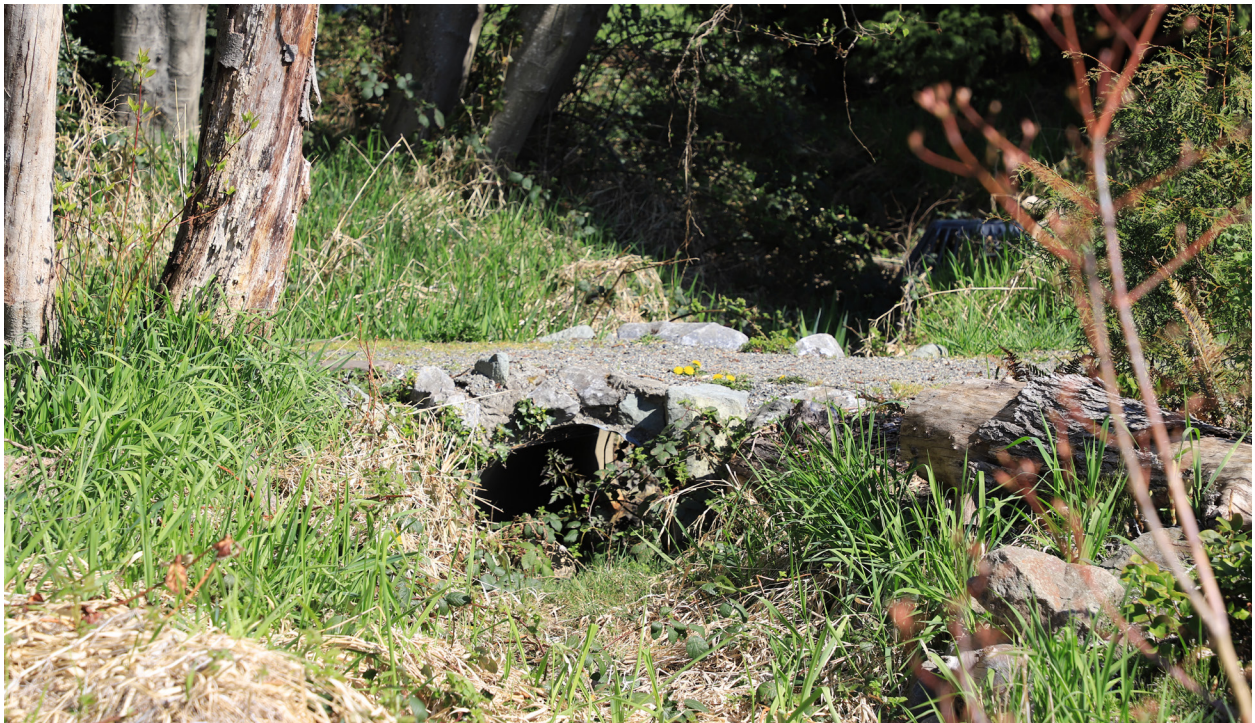
Figure 52. View of the culvert and gravel trail over the culvert.

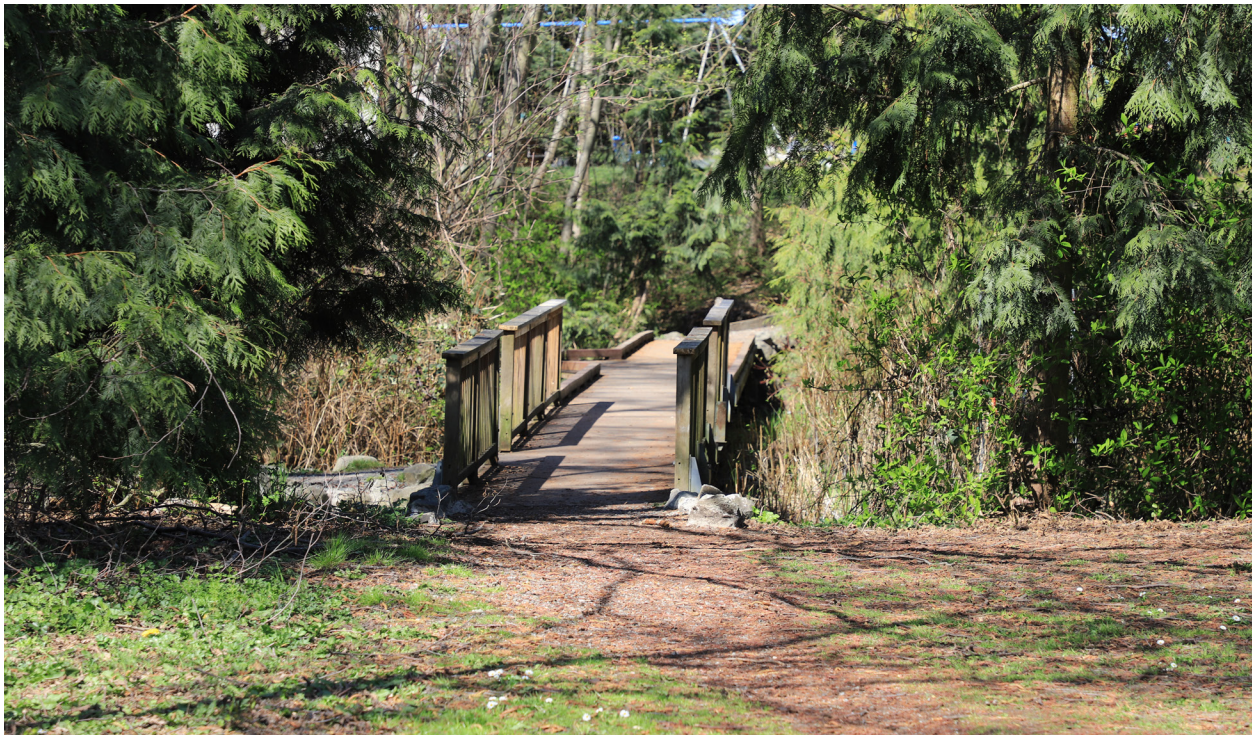
Figure 57. View of the southernmost bridge, looking west.

between the posts and clad with lap siding. A standing seam metal clad hip roof with broad eaves shelters the interior spaces. Heavy timber beams provide the roof framing with exposed beam ends along the eaves. A concrete slab floor extends throughout the building. The building is open on the southwest corner, enclosed with screens on the northeast corner, with restrooms and utility spaces in the northwest and southeast corners. Play equipment within the play area includes several slides, a merry-go-round, and other equipment and stems from ca. 2016 upgrades to the park's equipment. A low, plywood formed concrete retaining wall is located to the northwest of the play area. Refer to circulation for information on the bridges. Interpretive signage is located at the comfort station, the iron oxide spring, and along the riparian area and pond to educate visitors on the cultural and natural history of the park. **(See figure 57-58, 60, 64, 65, 83)**

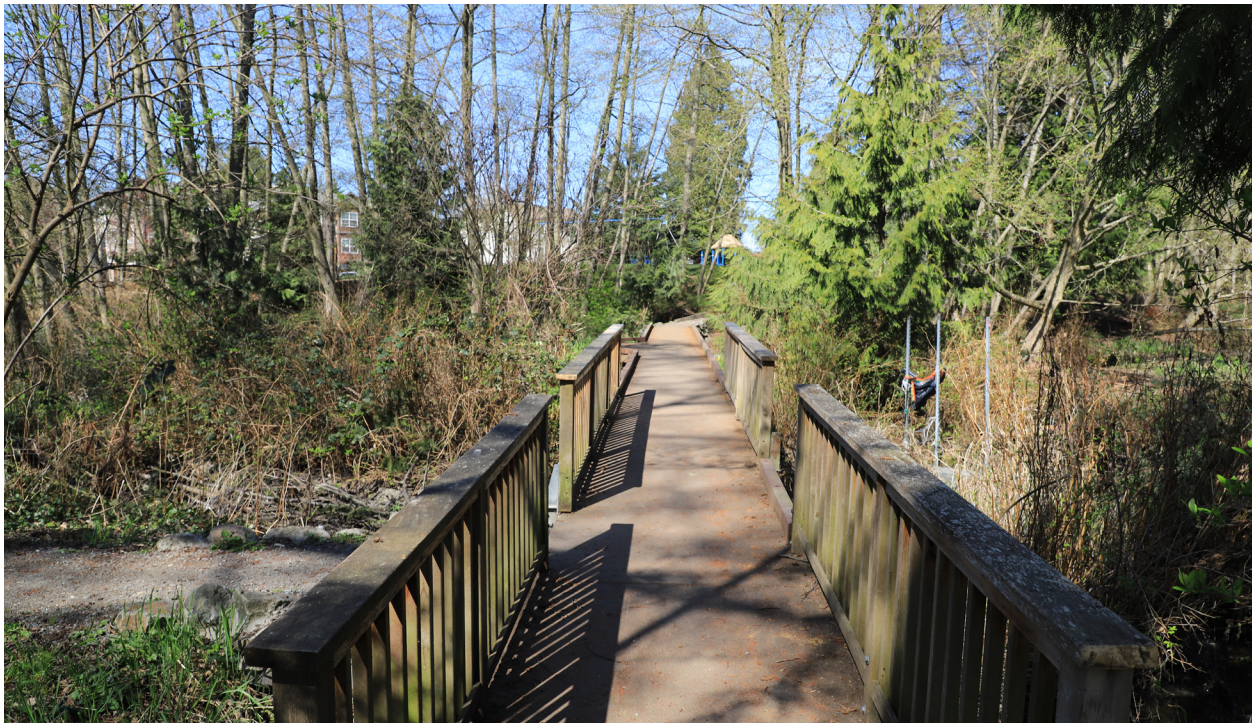
Figure 58. Detail view of the bridge, looking west.

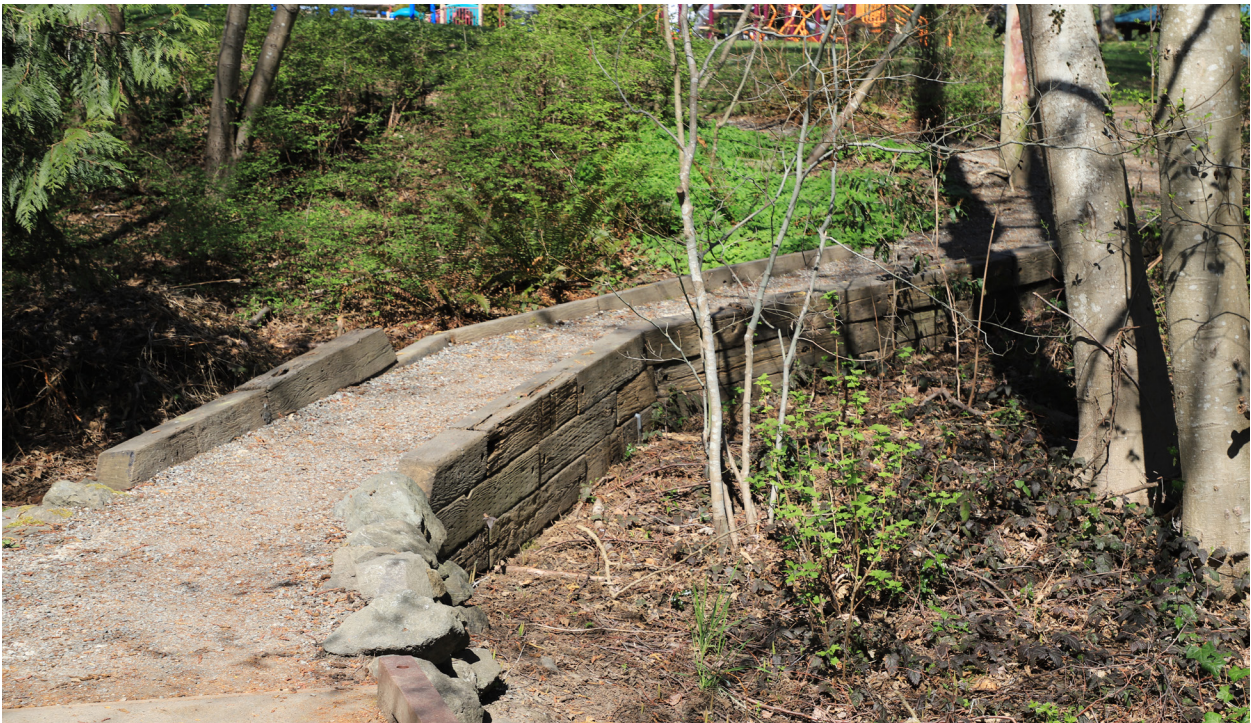
Figure 60. View of the pressure treated retaining wall along the trail, looking north.

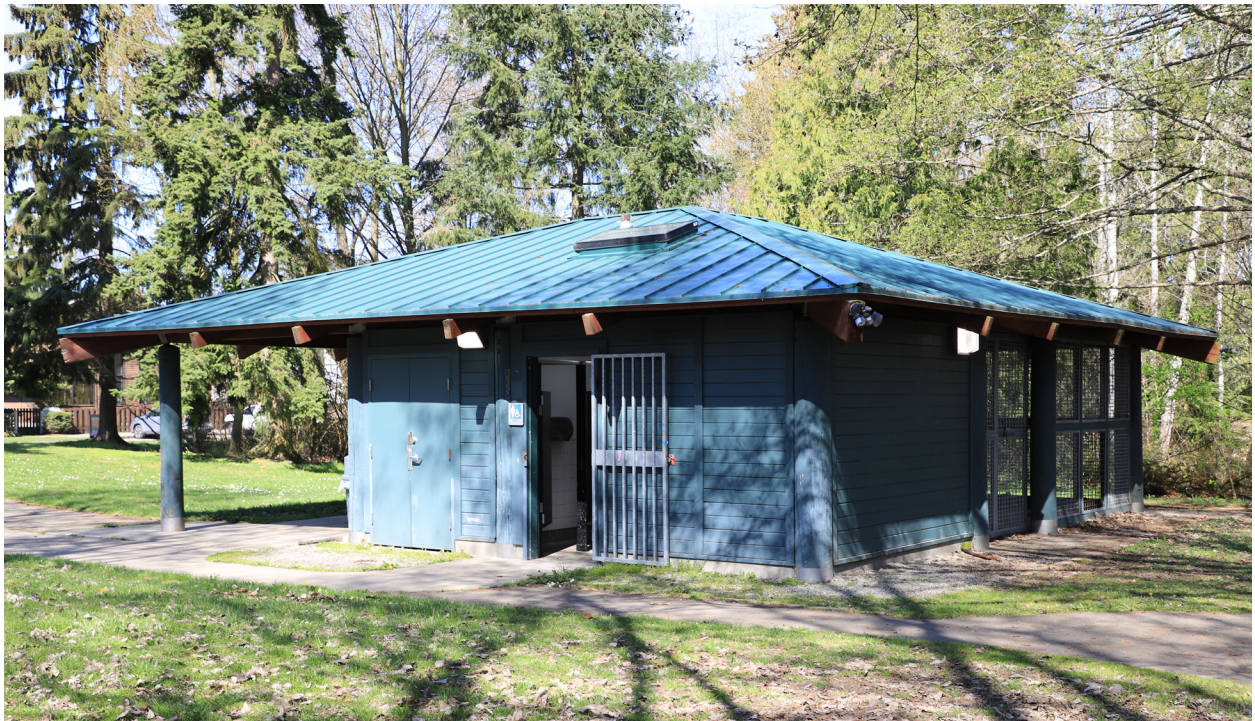
Figure 64. View of the southeast corner of the comfort station.

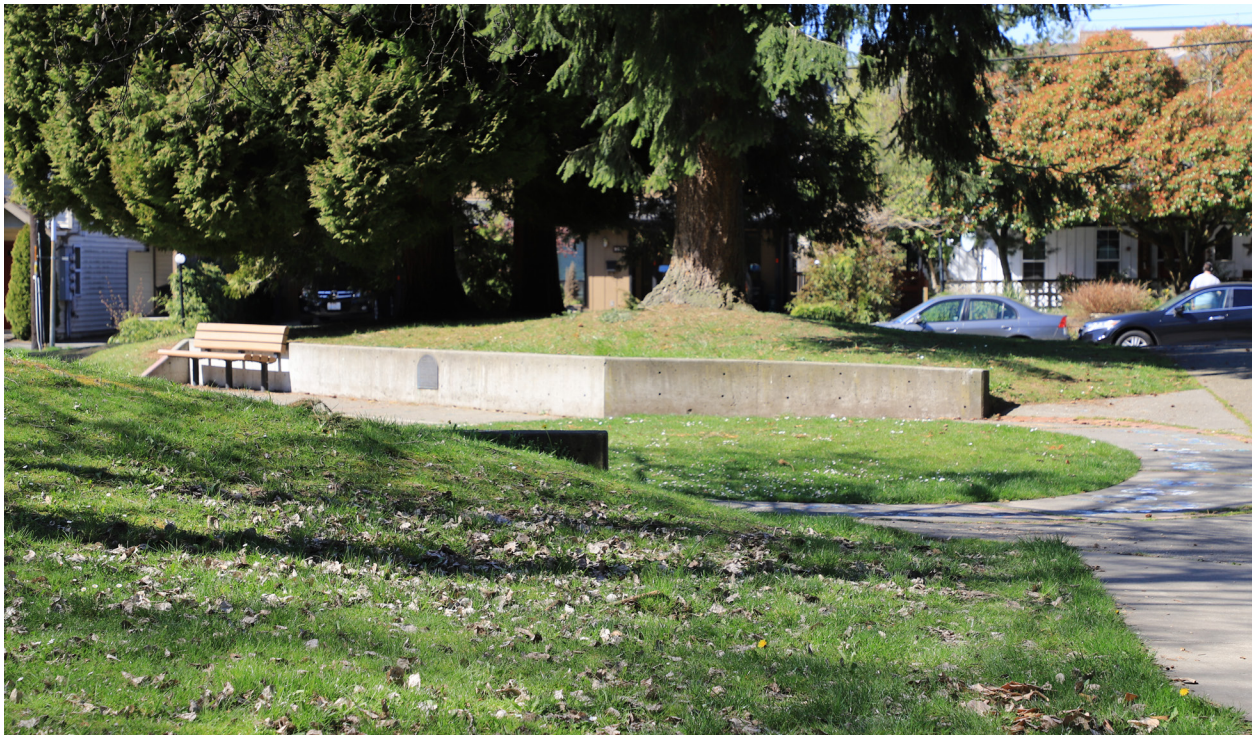
Figure 65. View of the concrete retaining wall north of the play area, looking west.

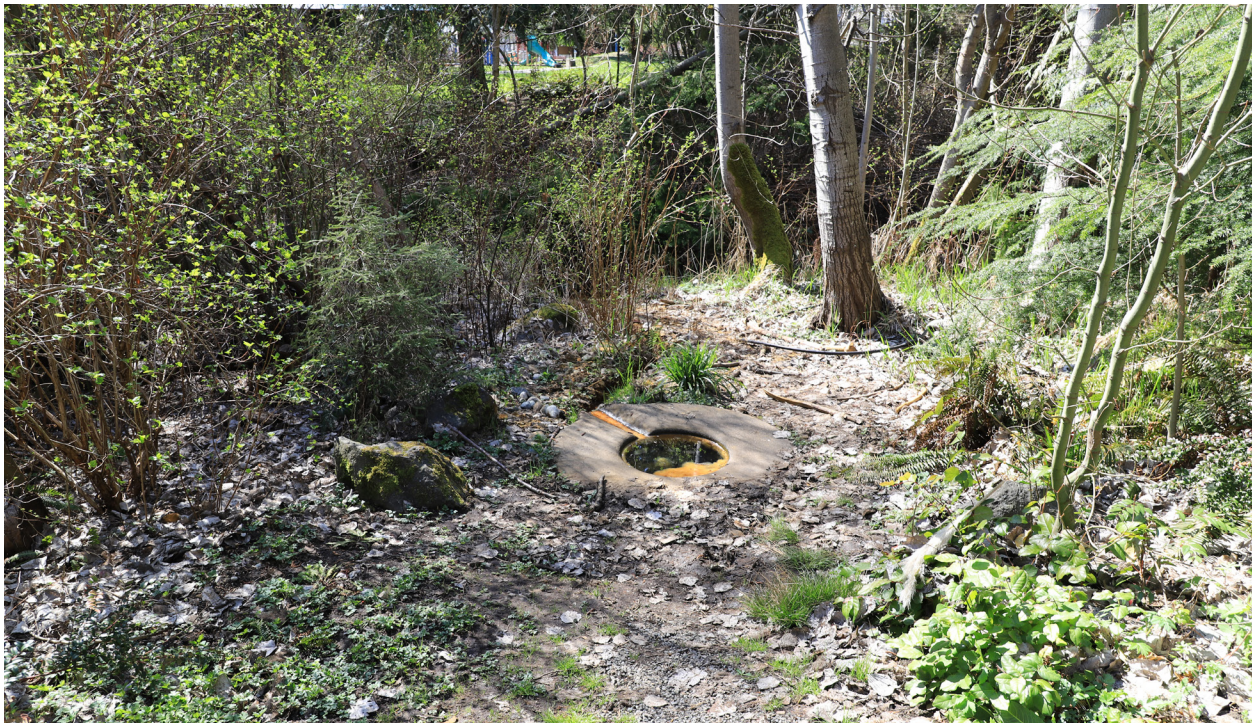
Figure 70. Iron oxide spring, looking southwest from the trail.

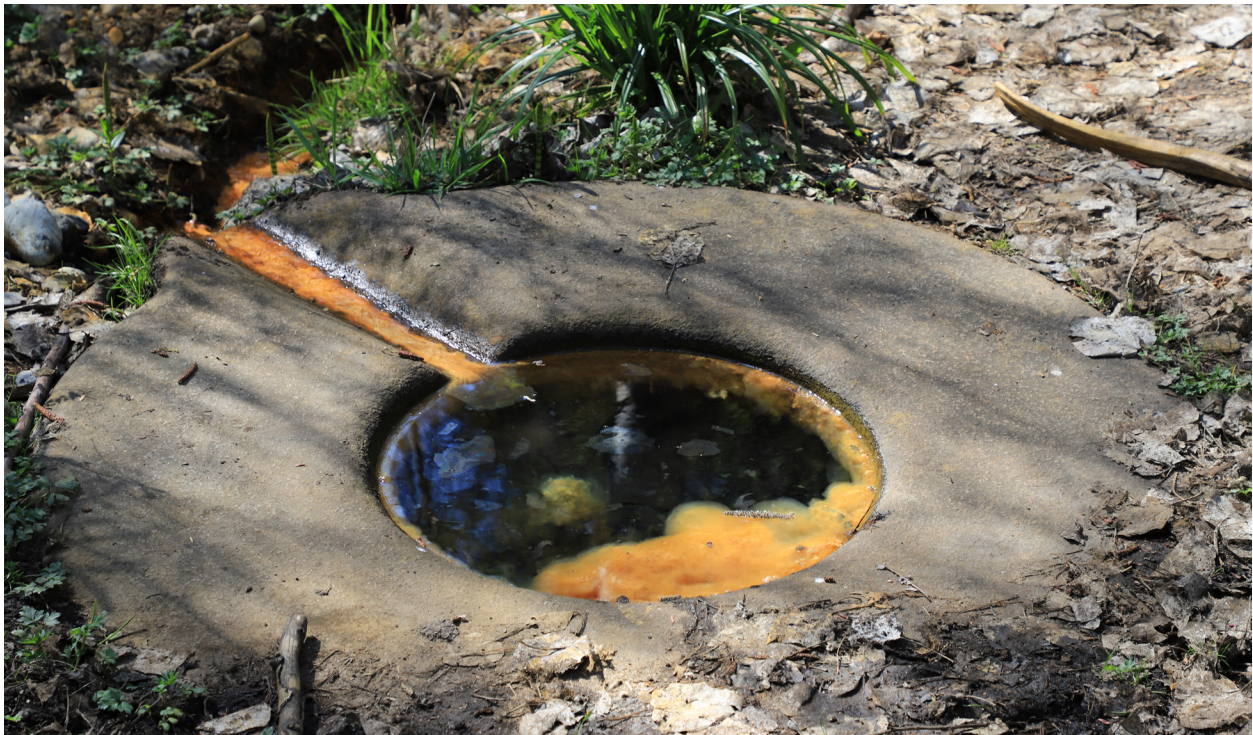
Figure 71. Iron oxide spring detail, showing the granite ring.
