The City of Seattle

Landmarks Preservation Board

Name: Licton Springs Park

Licton Springs Park

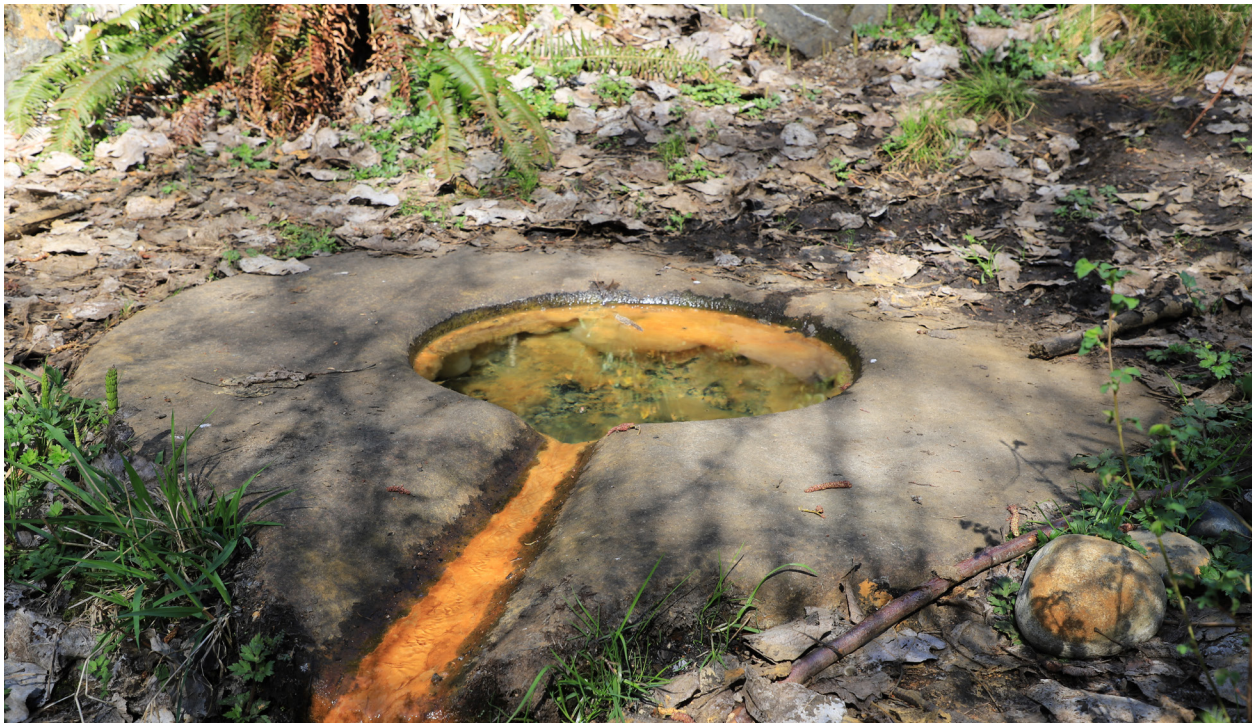
Figure 72. Iron oxide spring detail, looking northeast towards the spring.

Water features are both functional and aesthetic components of the landscape. The springs and stream predate the park. The springs are connected to the area's natural hydrologic system and mineral deposits and contribute to the stream flow and alignment through the park. They consist of the main iron oxide spring at the north end of the park, two lesser iron oxide springs (lesser based on flow rate), and a magnesium sulfide spring at the south end of the park. The magnesium sulfide spring resides below and contributes to the pond water volume. The stone ring around the iron oxide spring directs water flow to a narrow channel that feeds the stream. Iron oxide is brought to the surface by the water flow in solution with the ground water and deposited in solid form in the spring basin, on the stone ring, and along the channel to the stream. **(See figure 21, 34-35, 70-73)**

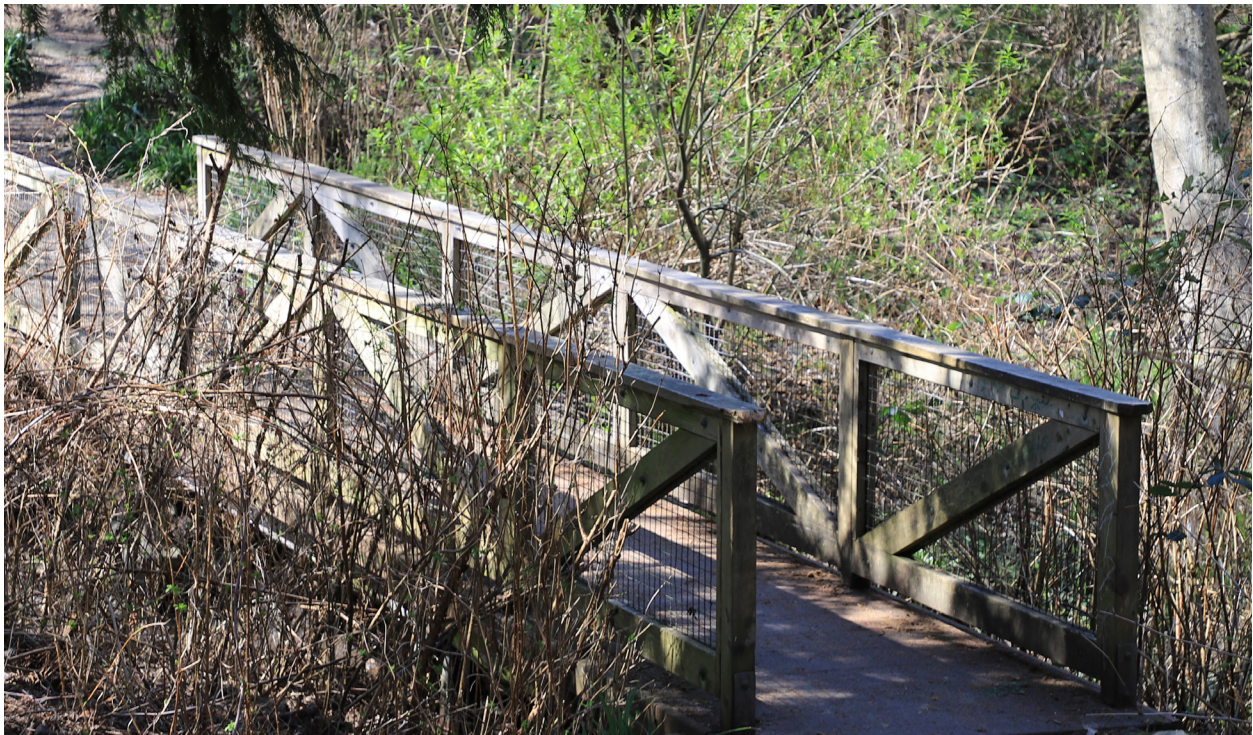
Figure 83. View of the middle bridge looking west.

between the posts and clad with lap siding. A standing seam metal clad hip roof with broad eaves shelters the interior spaces. Heavy timber beams provide the roof framing with exposed beam ends along the eaves. A concrete slab floor extends throughout the building. The building is open on the southwest corner, enclosed with screens on the northeast corner, with restrooms and utility spaces in the northwest and southeast corners. Play equipment within the play area includes several slides, a merry-go-round, and other equipment and stems from ca. 2016 upgrades to the park's equipment. A low, plywood formed concrete retaining wall is located to the northwest of the play area. Refer to circulation for information on the bridges. Interpretive signage is located at the comfort station, the iron oxide spring, and along the riparian area and pond to educate visitors on the cultural and natural history of the park. **(See figure 57-58, 60, 64, 65, 83)**
