The City of Seattle

## Landmarks Preservation Board

**Name:** Parrington Hall (Science Hall)

# Parrington Hall

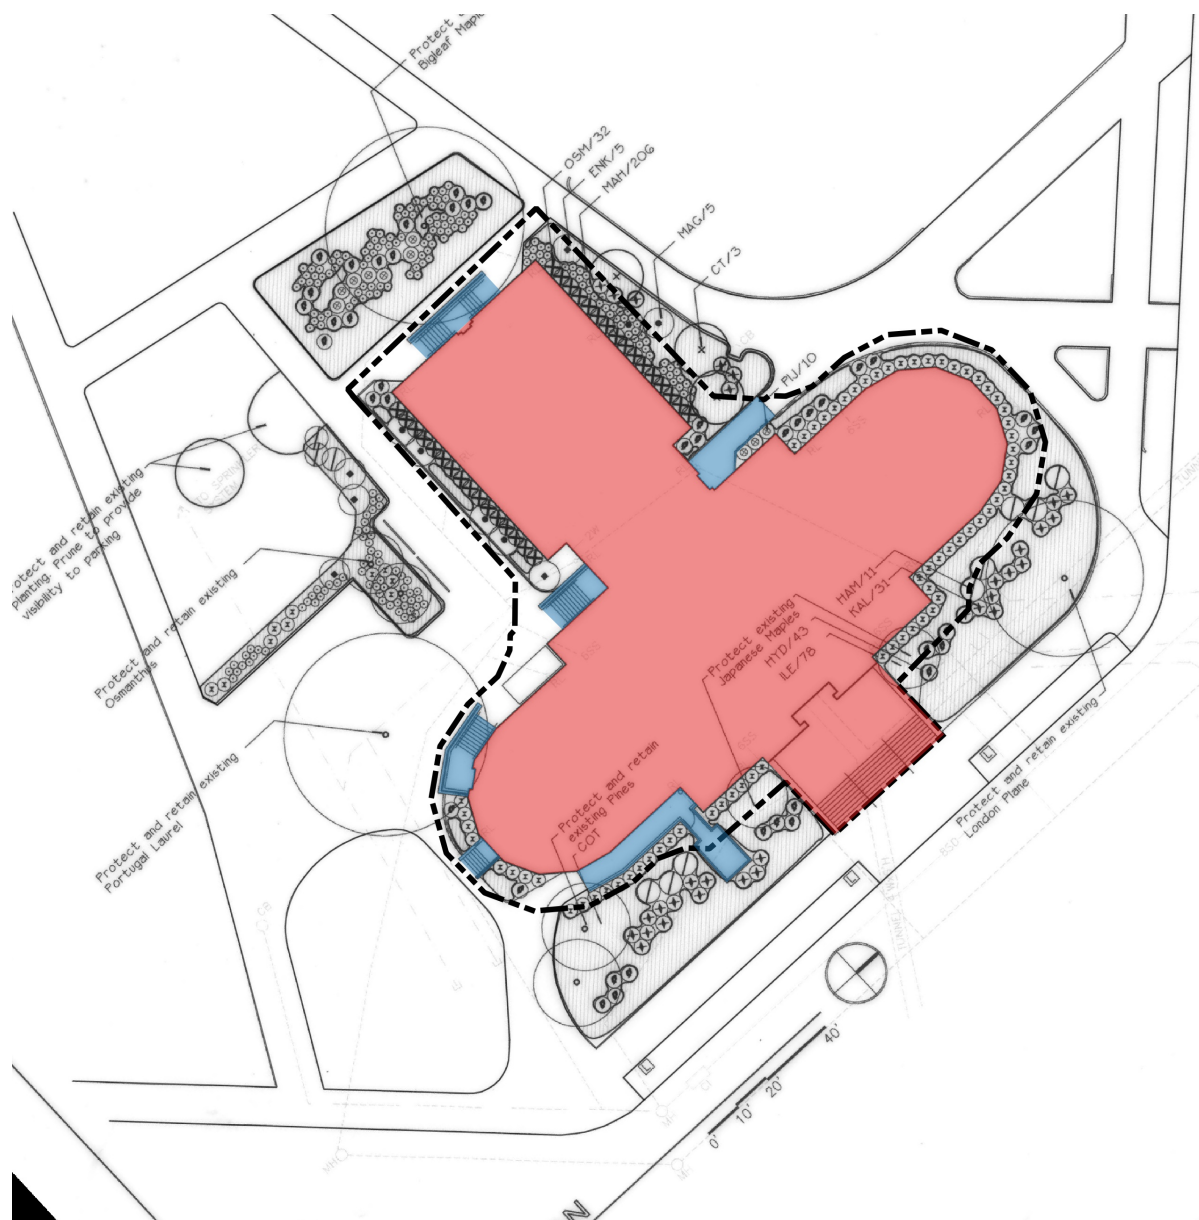
**Figure 3.** Site Plan. This map shows the nominated building (in red), its contemporary additions (in blue), nomination boundary, and related plantings and circulation (from a 1998 UW Site Plan).

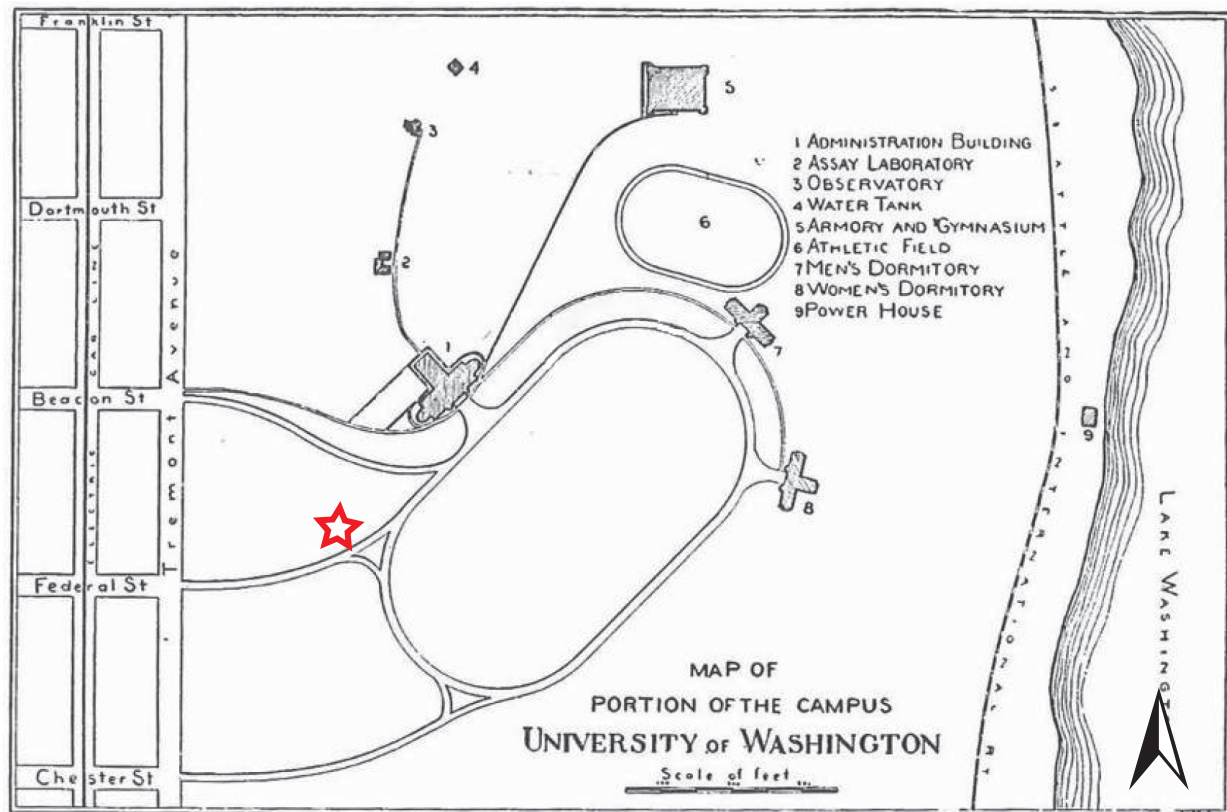
**Figure 8.** Above. Oval Plan (Fuller Plan), ca. 1898. This plan predates its construction, but the Science Hall was placed in accordance with this plan. Its location is marked in red.

At its new location, the university once again desired to create a campus plan to guide development. Engineer professor A.H. Fuller developed a plan for the campus, called the Oval Plan, in 1898 (see Figure 8). The Oval Plan only included the northern portion of the campus. At the time the Oval Plan was developed, four buildings were present on campus: the Administration Building, Observatory, a men's dormitory (Meriwether Lewis Hall, 1896), and a women's dormitory (William Clark Hall, 1896). Fuller's Oval Plan made sense of the four buildings' locations and recommended future buildings be grouped in an oval around an open space. Science Hall (known today as Parrington Hall) was the first building constructed in accordance with this plan, followed by a power house. Science Hall was located south and west of the Administration Building. Fuller's plan also established the basic circulation relationship between the street grid west of 15th Avenue NE and the campus.

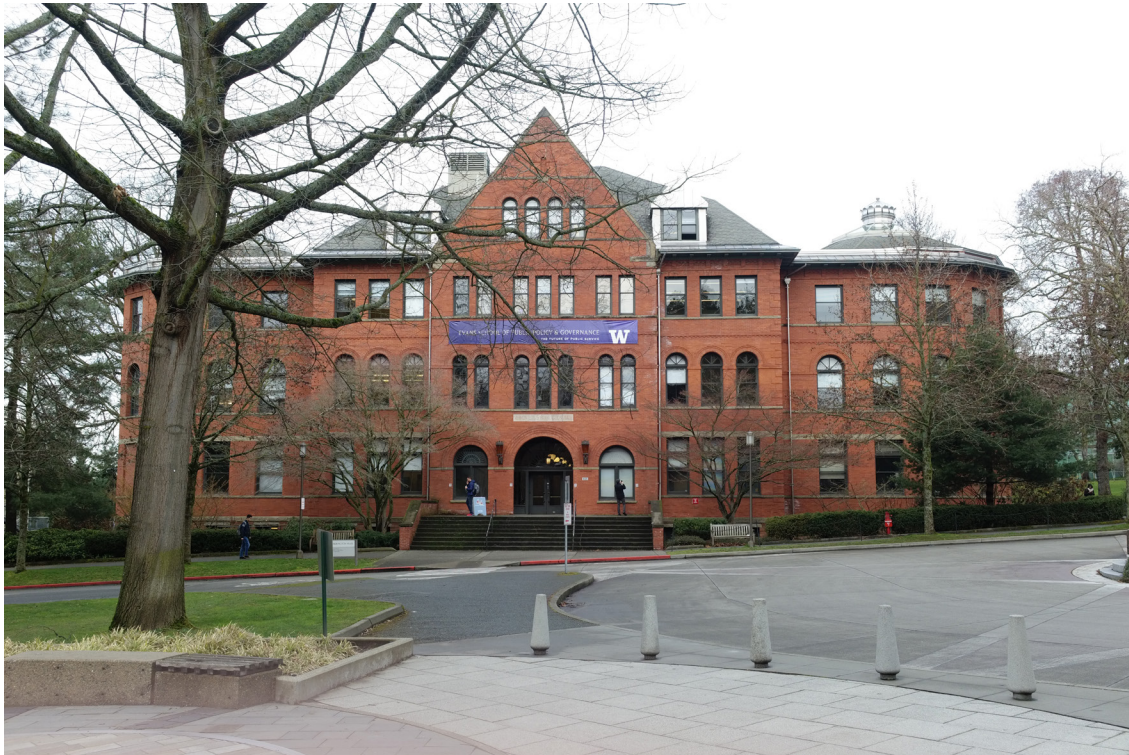
**Figure 18.** South elevation of Parrington Hall looking north towards the main (south) entrance.

Exterior walls consist of stretcher veneer brick over the load-bearing brick masonry structure. A quarry faced sandstone water table wraps along the base of the first story. Solid, recessed brick panels at the side wings correspond to lecture hall locations. (See Figures 18-30).

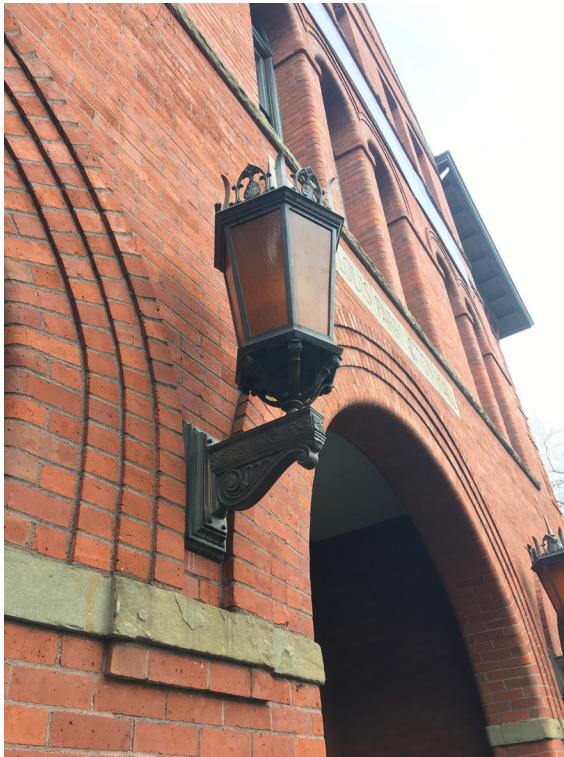
**Figure 28.** Detail of brickwork and lantern at primary entrance on south elevation.

A variety of subtle brick and stone detailing at the upper stories provide visual interest across the facades. Rounded brick are used at the inner corners of entrances and window openings jambs and soffits. Decorative corbeling (projecting out of brick courses beyond the wall plane) follows the curve of round-arched window and doorway openings. At the

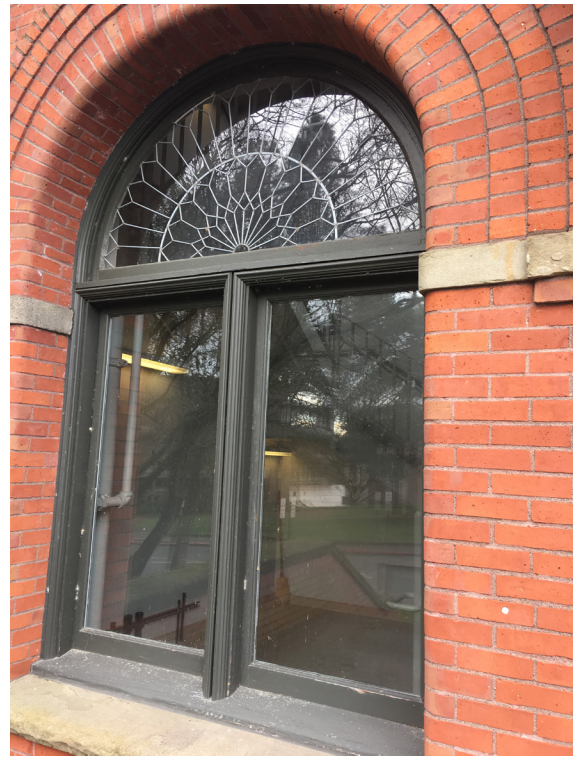
**Figure 29.** Detail of window with leaded glass arched transom, south elevation.

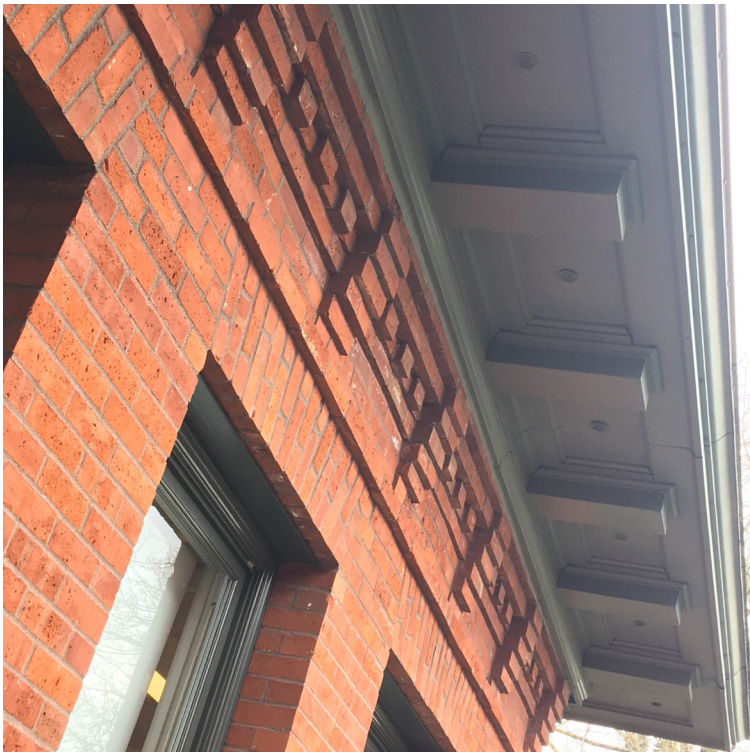
**Figure 30.** Detail of brickwork and soffit under roof eave.

At the top of the building's walls a thin band projects out just above the jack arch brick window headers. Corbeled brackets and dentils step out above this thin band to transition to the broad roof soffit. At the front wall gable, honed finished stone block replicate a decorative bargeboard with curved lower ends supported on stone blocks and ending in a single pyramidal block. Horizontal quarry faced stone bands break the gable wall into sections.

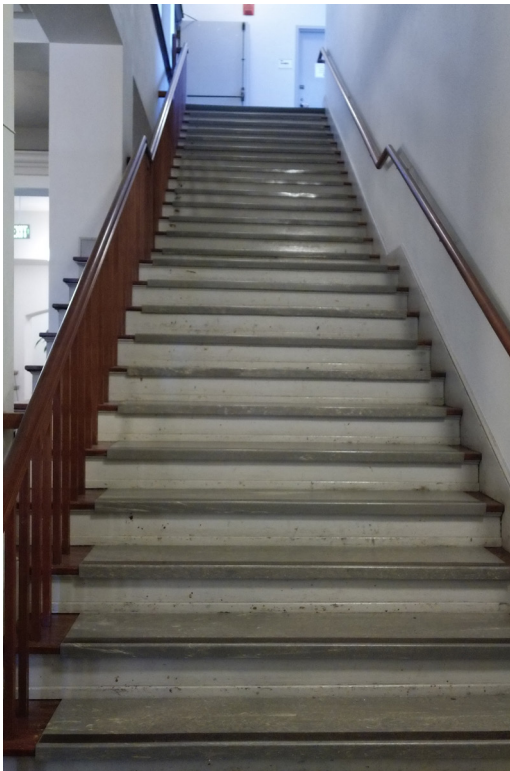
**Figure 33.** View looking up east stair of main stair hall. Note the covering on the treads and new handrails.

The central stairs feature direct flights between each floor with intermediate landings. Mahogany tread (stained) with a center Marmoleum runner, and painted risers comprise the stairs. A painted stringer matching the corridor baseboard follows the stairway rise. Round wood hand railings extend along both sides of each flight and connect to wood newels. Square spindles support the inner railings, with outer railings attached to the gypsum board clad walls. Fire enclosures occur at each floor.

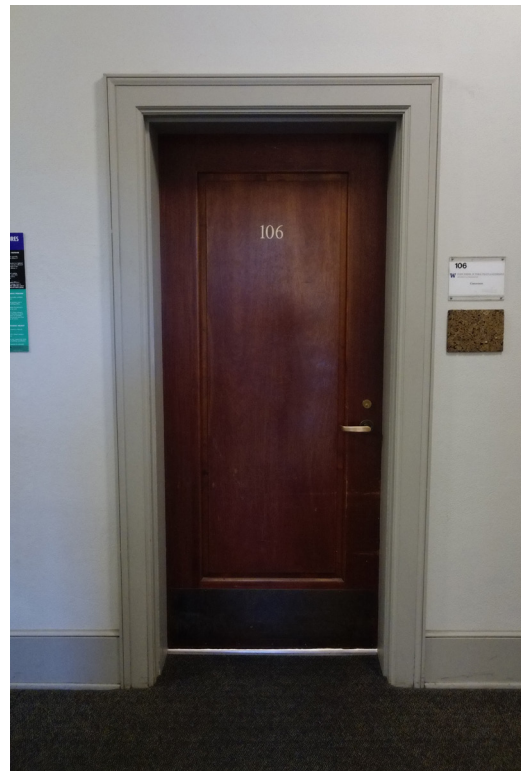
**Figure 34.** Example of replacement doors present throughout the building.

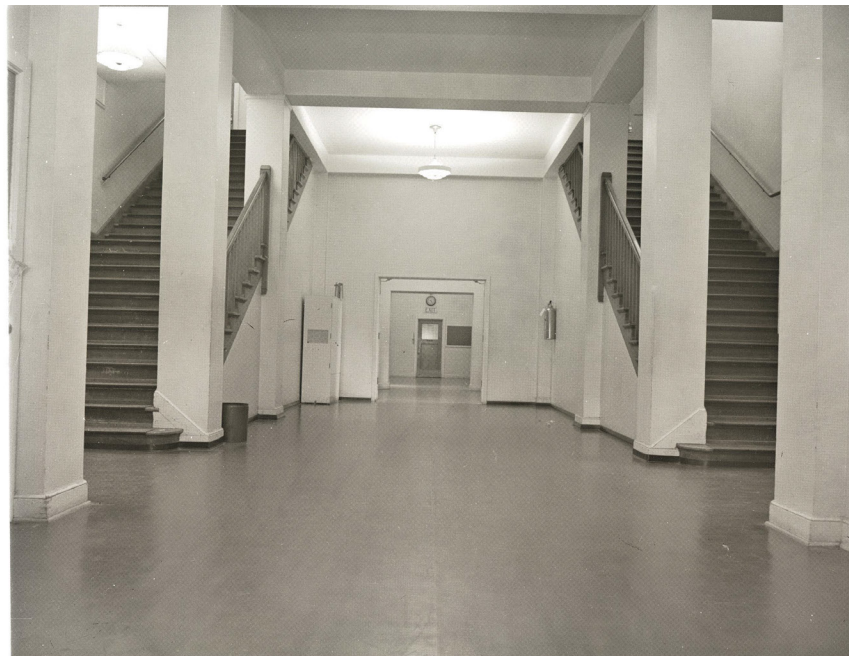
PARRINGTON HALL STAIRWAY AT 2ND. FLOOR  
(1ST. FLOOR SIMILAR)

**Figure 42.** Stairway at 2nd floor, 1974. UW Facilities Library.

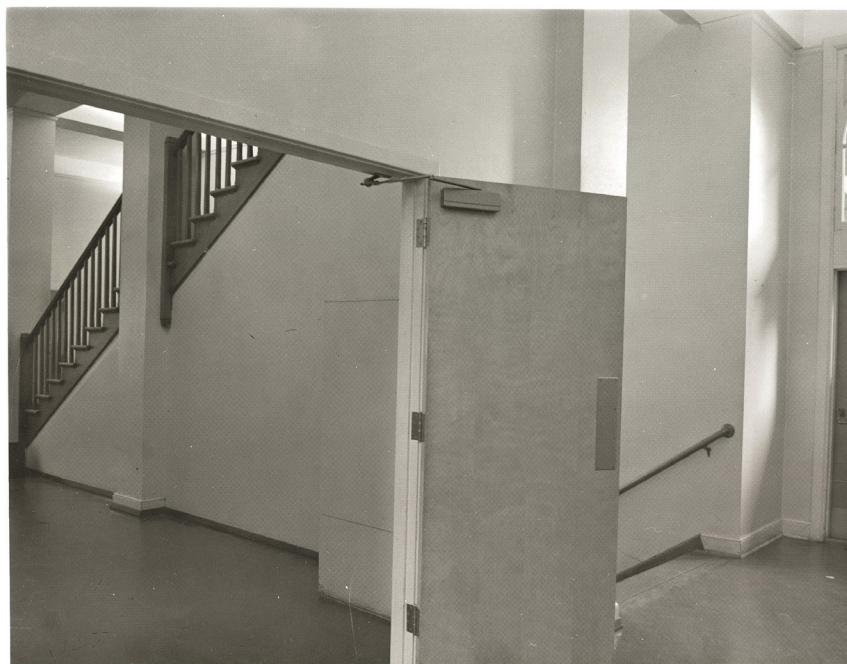
PARRINGTON HALL 2ND. FLOOR CORRIDOR  
CONNECTING STAIRS AND FIRE EXIT

**Figure 43.** 2nd floor corridor, 1974. UW Facilities Library.

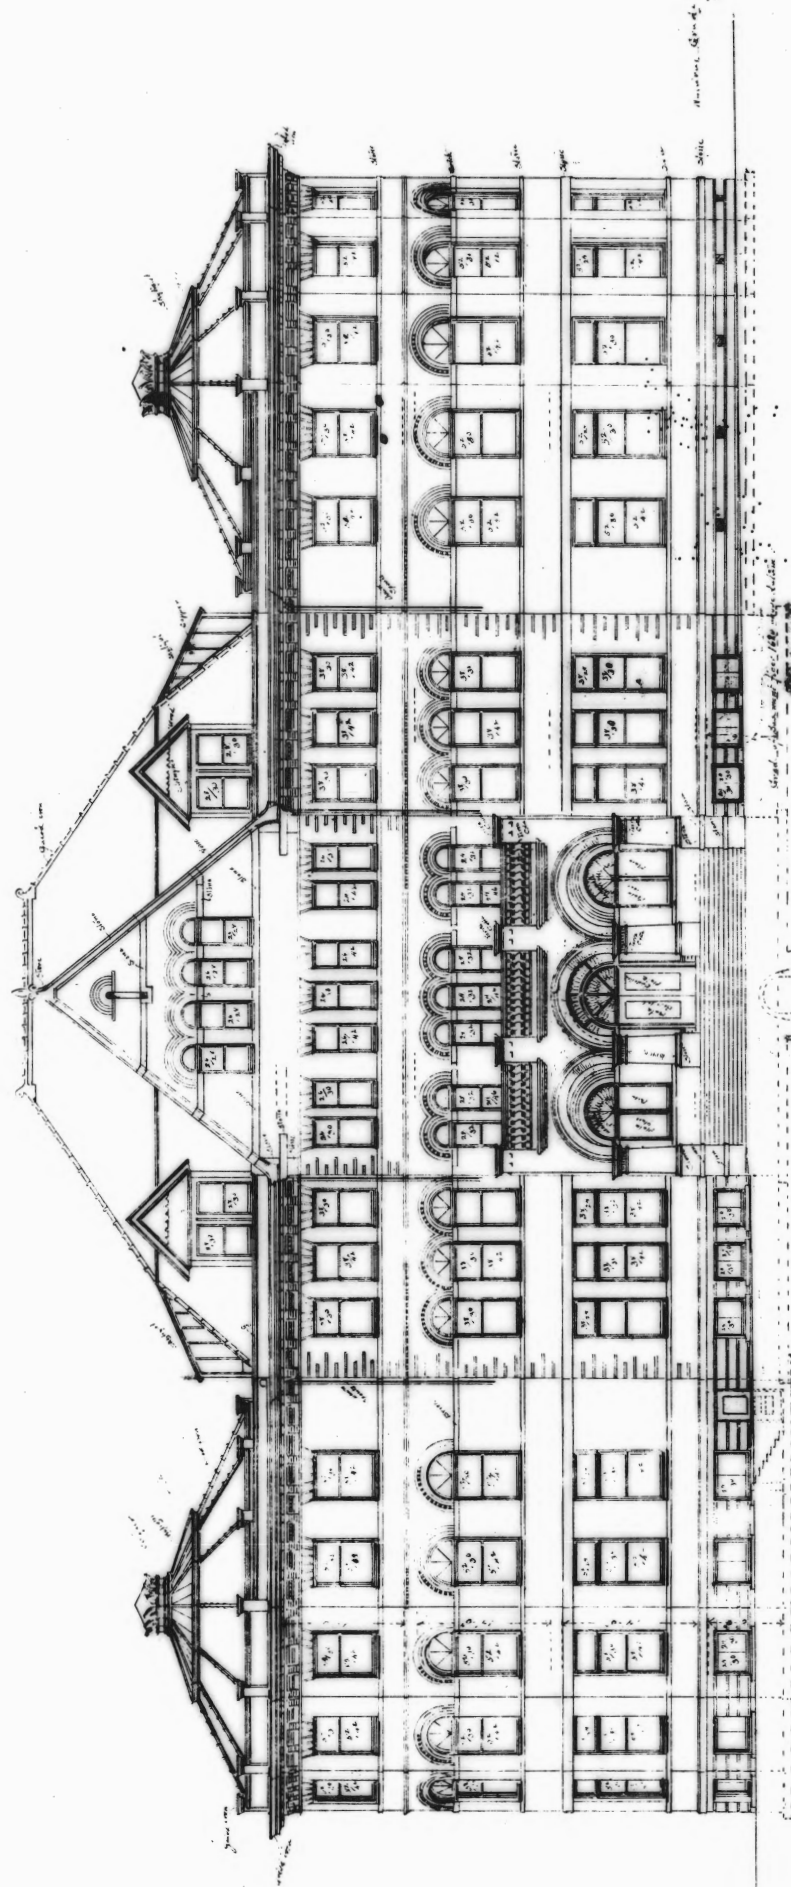
# Front (South) Elevation

FRONT ELEVATION SCIENCE HALL  
SEATTLE WASH.  
DRAWN BY ALAN ADLER

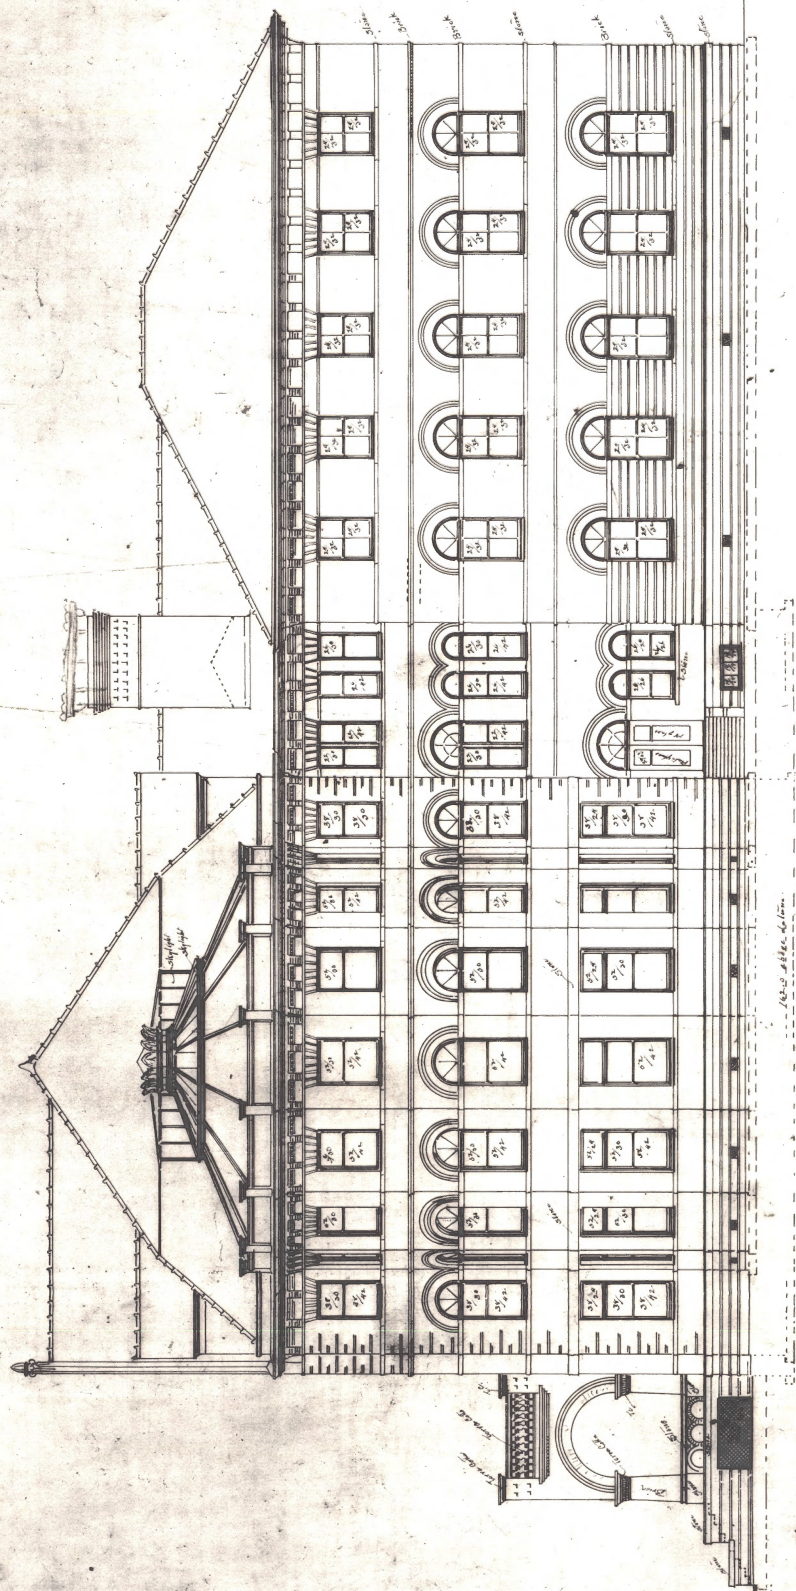
## Side (East) Elevation

side ELEVATION (EAST)

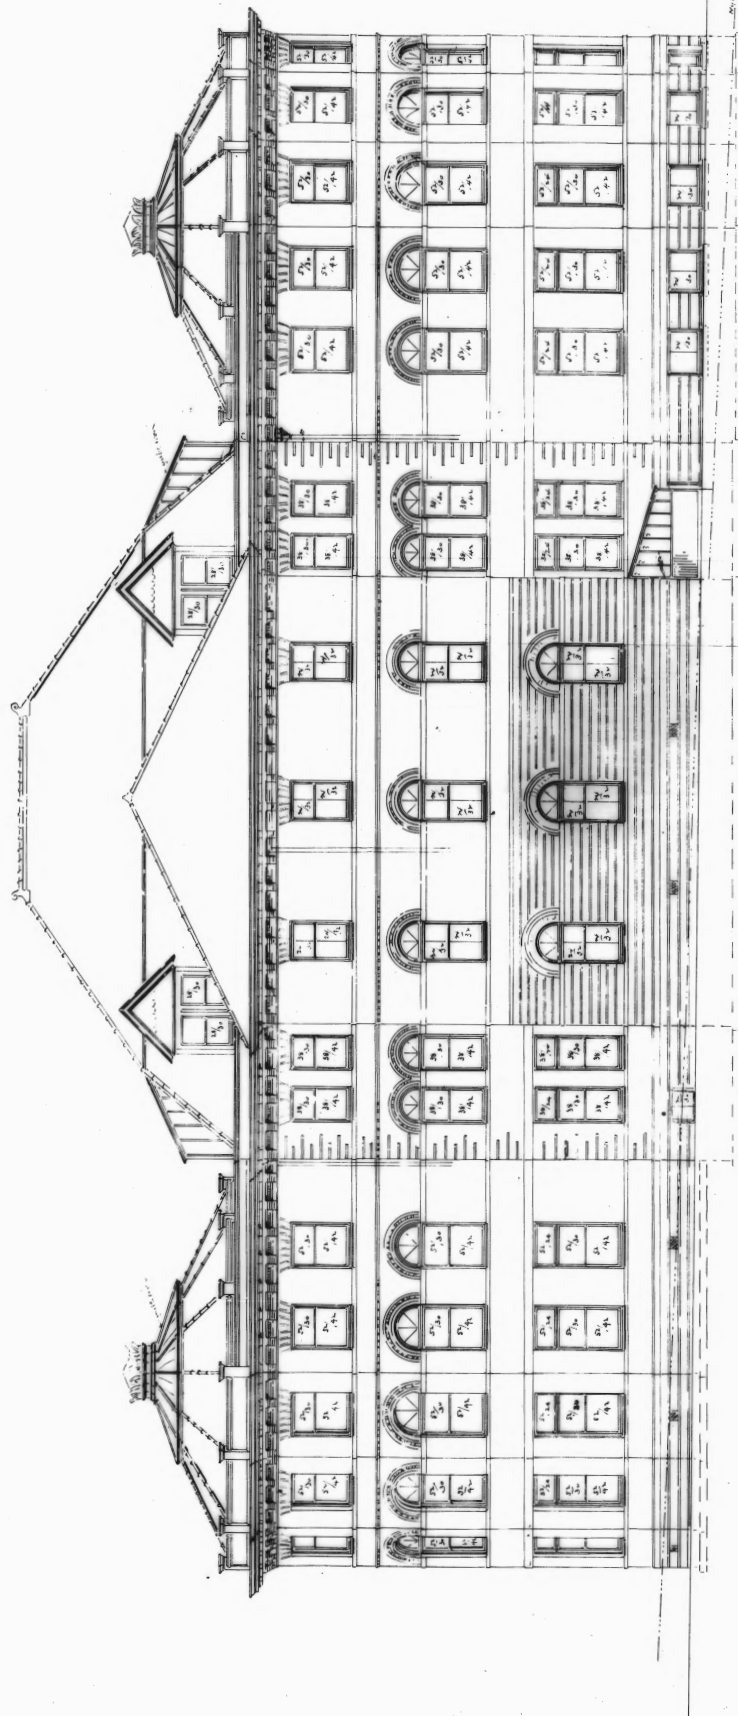
## Rear (North) Elevation

## REA-ELEVATION:

SCALE:  $\frac{1}{8}'' = 1 \text{ Foot}$

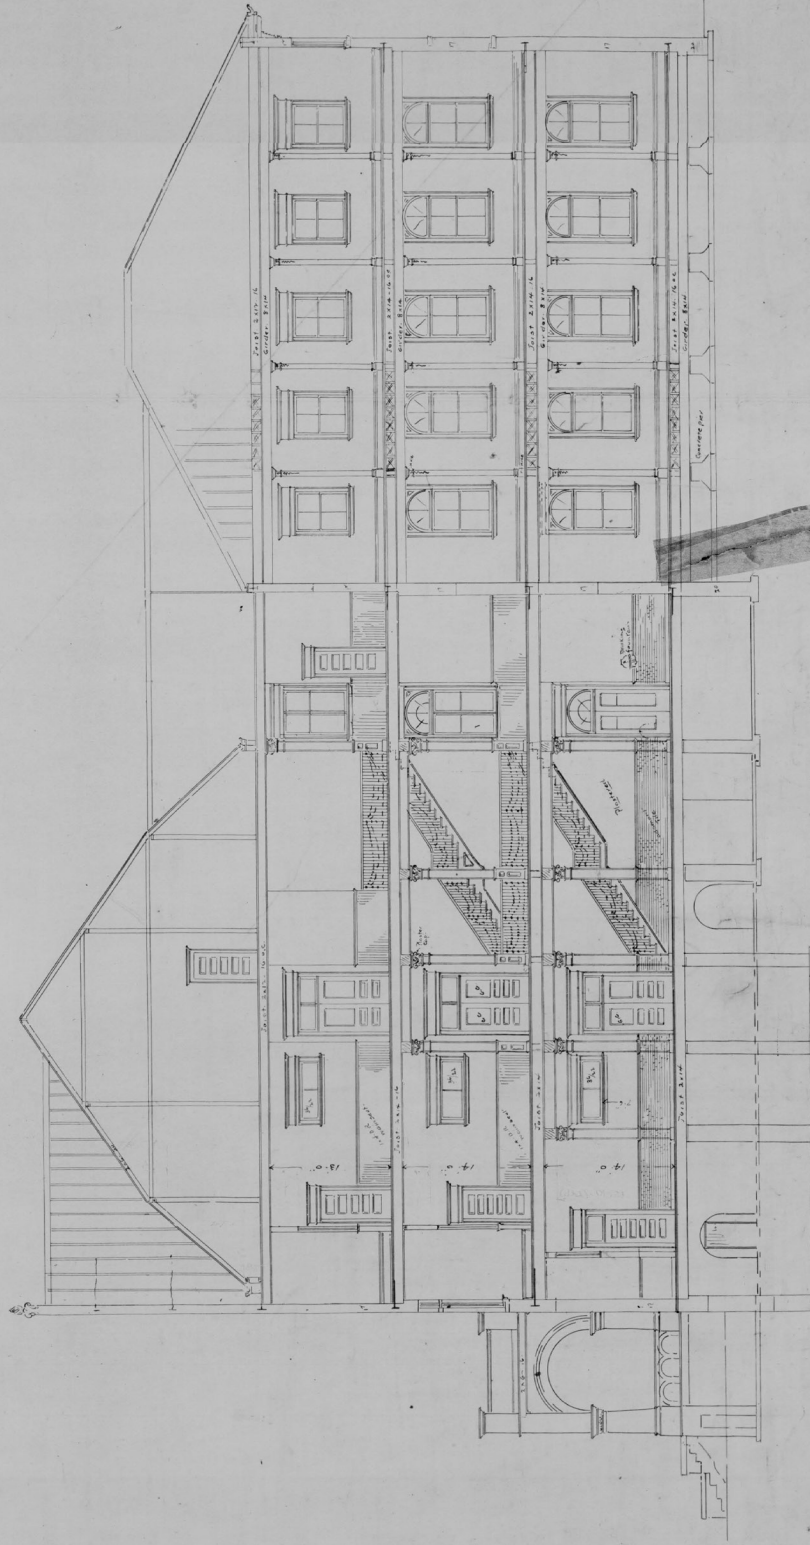
# Cross Section

CROSS-SECTION  
Scale 1/8" = 1 Foot

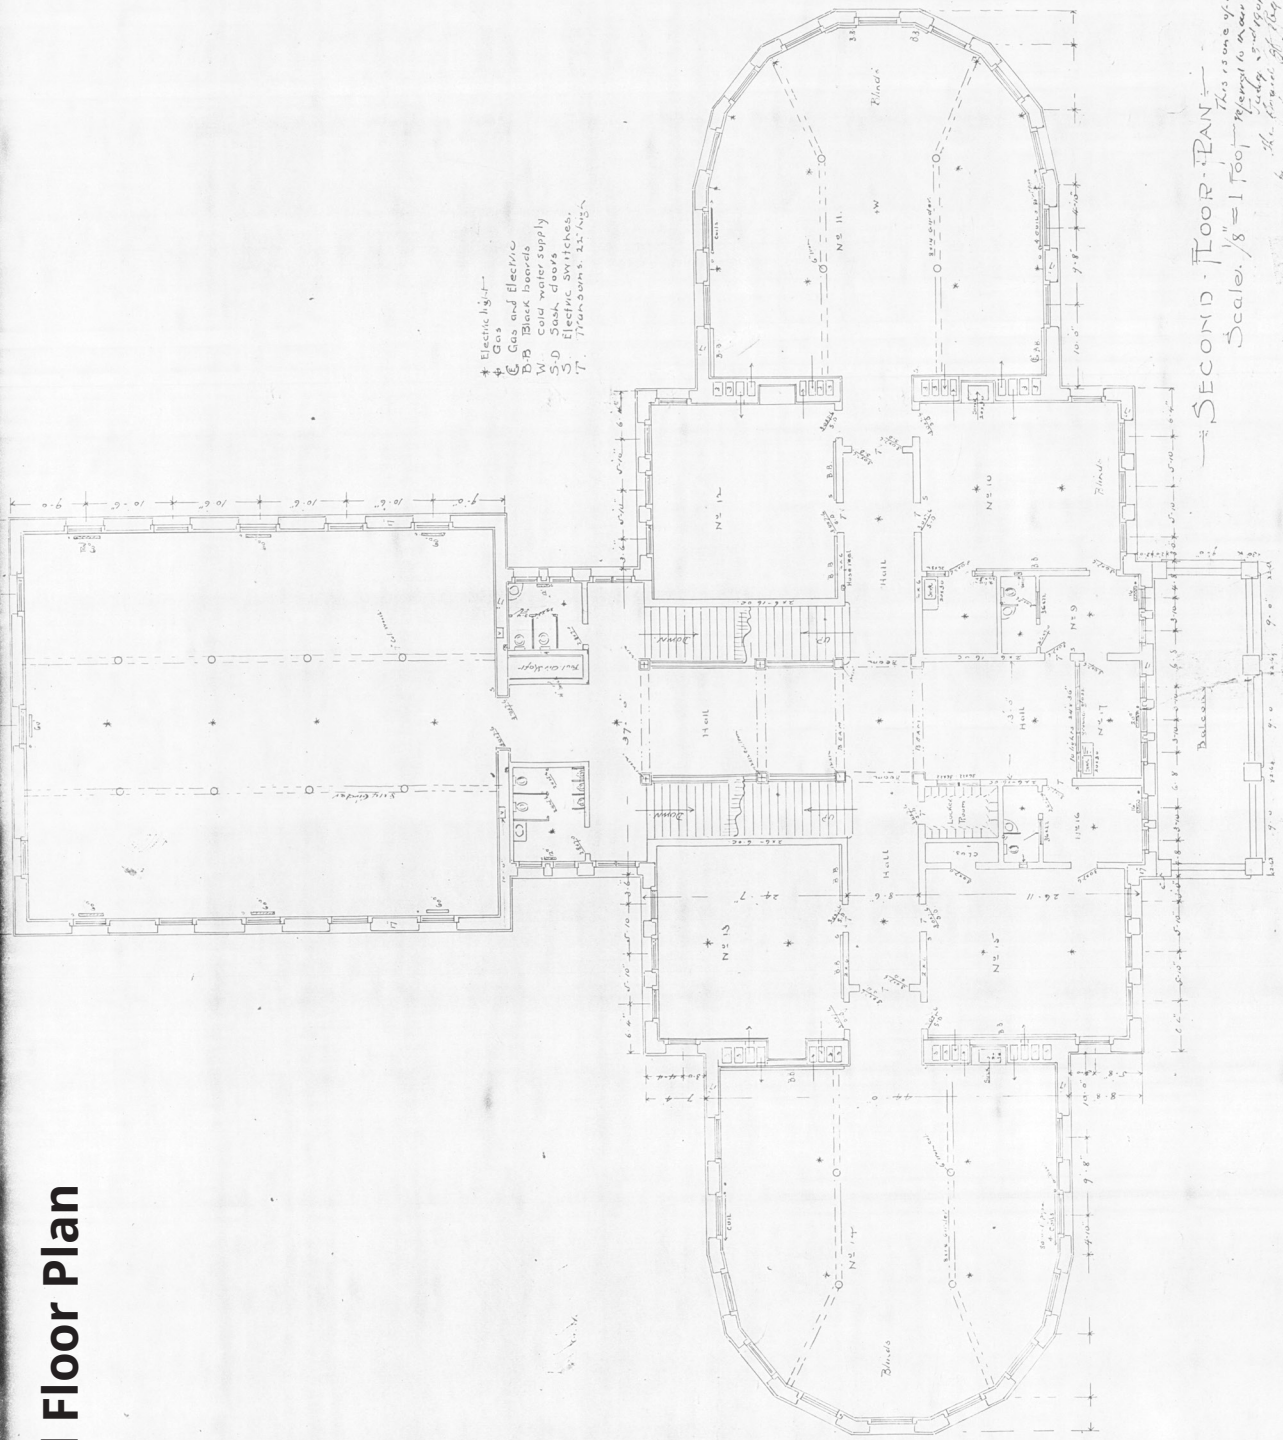
# Second Floor Plan

## SECOND FLOOR PLAN
